SSC-220

**A LIMITED SURVEY OF
SHIP STRUCTURAL DAMAGE**

Final Report
on
Project SR-189, "Ship Structure Reliability Analysis"
to the
Ship Structure Committee

Seth Hawkins, George H. Levine, and Robert Taggart
Robert Taggart, Inc.

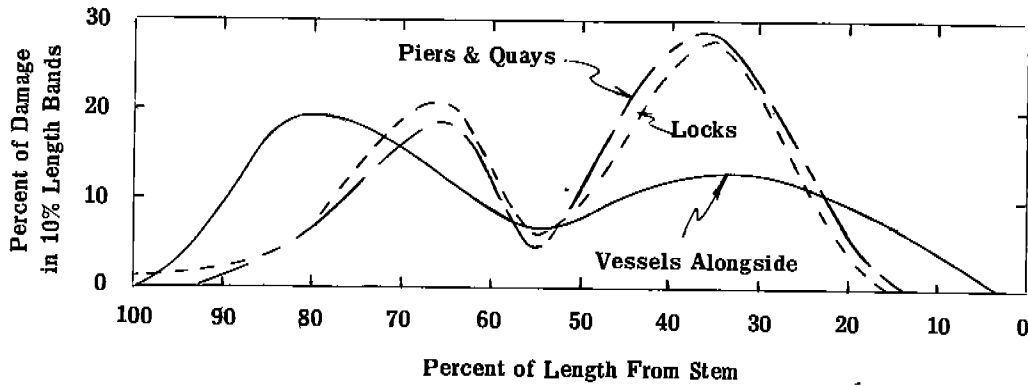
Fig. 3 - Longitudinal Distribution of Collision Damage

Comparisons of individual ship results by cause did not show any marked differences so they were combined. Figure 3 shows the longitudinal distribution of damage due to striking piers and quays, damage from collisions with vessels alongside, and damage due to striking locks.

It can be noted from Figures 3 and 4 that the longitudinal and vertical damage distributions from collisions with piers and locks are markedly similar whereas collisions with vessels alongside result in distributions with different characteristics. Pier and quay collisions tend to cause somewhat greater damage at the waterline than do collisions with locks. Lock collisions tend to produce more damage just below the sheer strake which is probably related to accidents occurring when ships are on the low-water side of the lock.

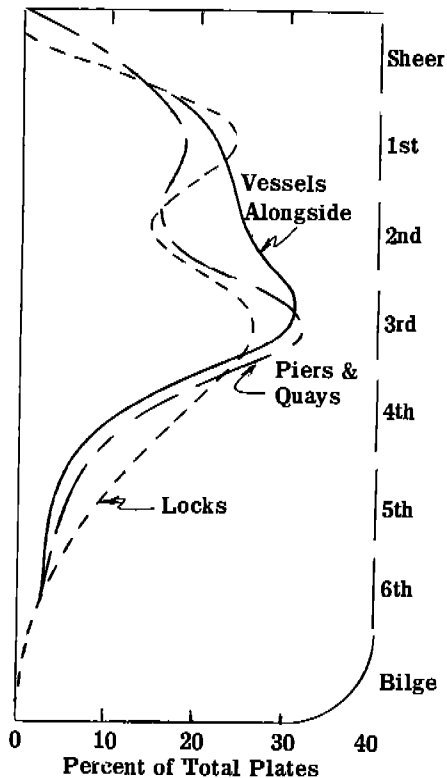
Fig. 4 - Vertical Distribution of Collision Damage

The data for the same ten ship designs provided the basis for an evaluation of vertical extent and location of damage related to the same three causes. Information from the survey data sheets on individual damaged plates was tabulated for each design. This information was then totaled and analyzed to determine trends in vertical distribution of damage. Tables 6, 7, and 8 summarize the results for pier, vessel alongside, and lock collisions respectively and the results are displayed graphically in Figure 4.

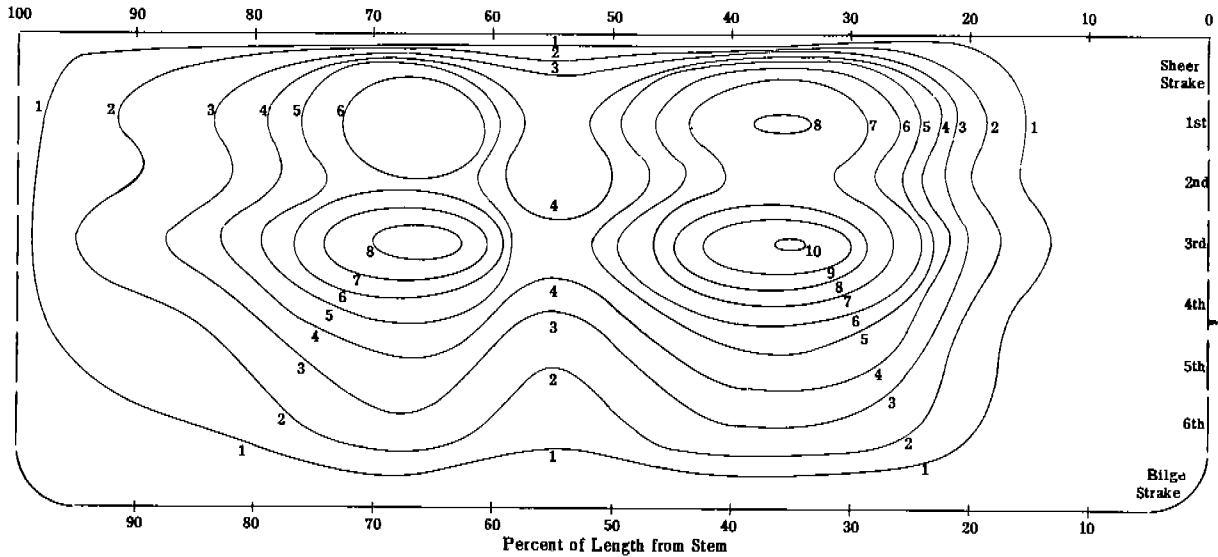
Fig. 5 - Damage Location Probability Contours From Collisions With Piers, Quays, and Locks

The longitudinal and vertical damage distributions for collisions with piers, quays, and locks have been combined to produce the contours of Figure 5. These are contours of equal damage probability; they are labelled with an arbitrary scale ranging from 1 to 10, i.e., from lowest to highest probability of damage in the region of the hull along the lines of the contours. A similar set of contours, based on data from collisions with vessels alongside, is given in Figure 6.

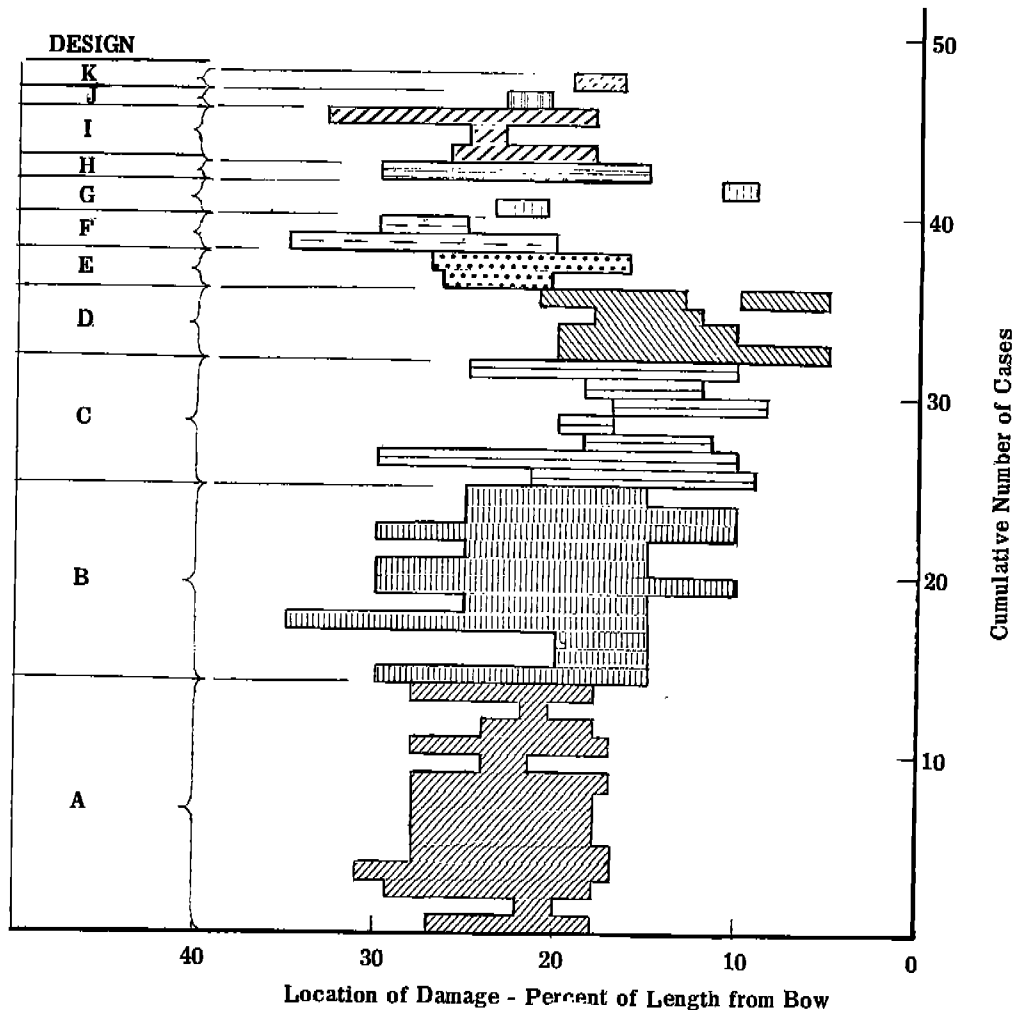
Fig. 7 - Extent and Location of Slamming Damage for Various Cargo Ship Designs

The longitudinal extent and location of slamming damage, as a function of ship length, is shown in Figure 7 for each ship of each design. In general, this type of structural damage is centered at approximately 20% of the length from the bow and extends as far forward as 5% of the length from the bow and as far aft as 35%. Figure 8 shows the distribution of slamming damage relative to ship length.

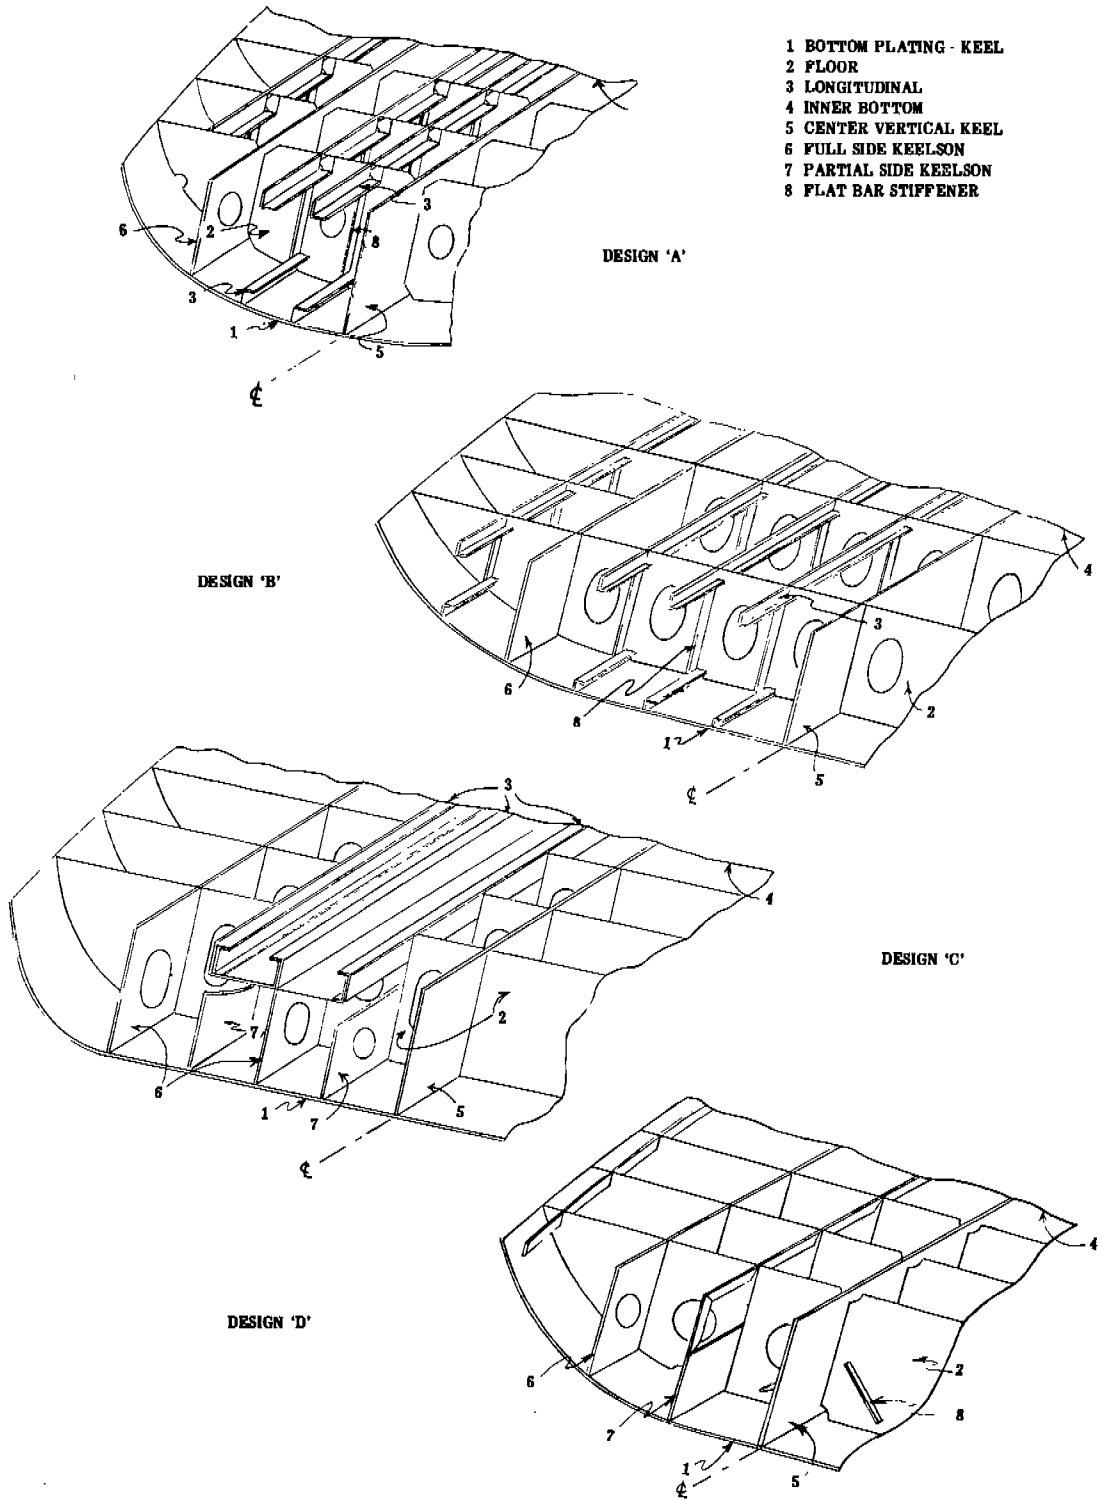
Fig. 9 - Structural Details in Area of Bottom Damage

The body plan of Design 'A' indicates generally U-shaped forebody sections typical of many U. S. cargo ship designs. Figure 9 shows a sketch of the structural arrangement in the area of interest. Although details were not available, it was ascertained that all ships in this class sustained damage of the type described above during their first year of operation. After recognizing this slamming damage problem, additional longitudinals were added on all ships of this class. No further casualties were experienced.

Figure 9 shows a sketch of the structural arrangements of Design 'B' in the major region of failures. Over a period of years structural modifications were made to some of the ships in this class in order to obviate slamming damage. Details as to exactly what improvements were made, and whether they were successful, have not been ascertained.

All but one of the casualties to ships of Design 'C' involved the flat keel and A-strakes, port and starboard; the remaining case involved damage to the flat keel. All cases resulted in deformation of the plating. Figure 9 shows structural details in this area. Some structural modifications have been made to ships in this class but details of these modifications and their relative success in reducing slamming damage were not found.

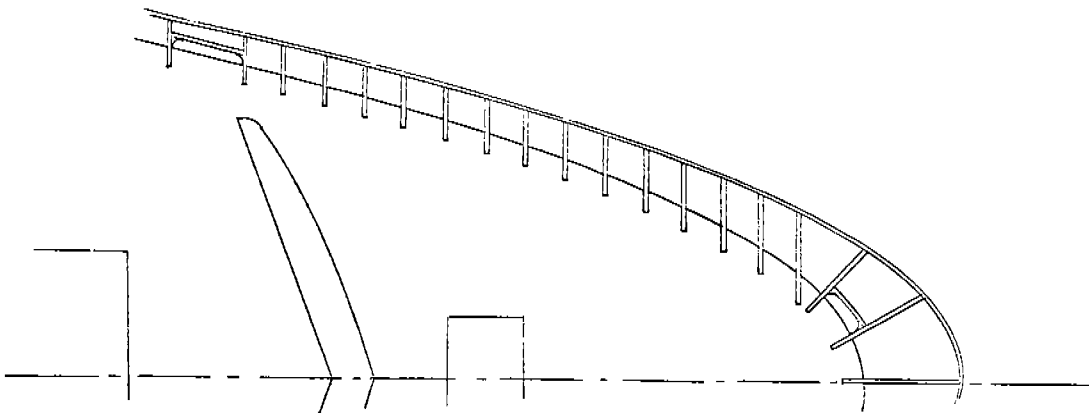
Three of the five ships of Design 'K' sustained a total of five casualties in the forecastle area. For the most part the damage occurred in an area between 6 feet and 35 feet aft of the forecastle head. Bulwark brackets and knees as well as deck plating, deck beams, and girders were deformed or fractured in the area shown in Figure 10.

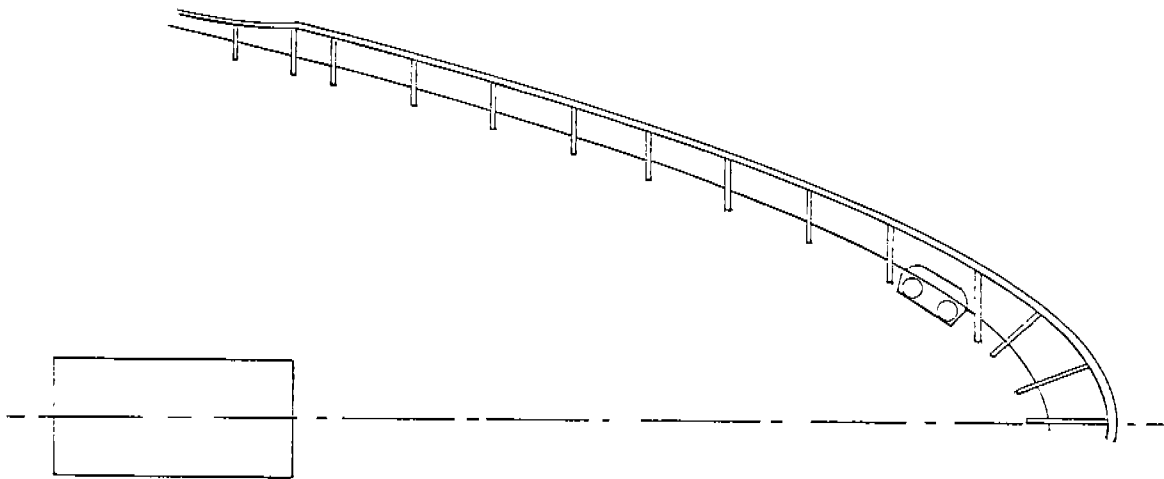
Design 'M' is a tanker which has had five structural casualties in the area of the forecastle. Three of the cases involved only fracturing of bulwark brackets. One case, however, included deformation and fracture of the bulwarks, deck plating, and internal structural members. In this instance the bulwarks were set out and the deck plating was set up, indicating that for this casualty the damage resulted from moving water trapped on the forecastle. The remaining case involved fractured and deformed hull plates in the vicinity of the hawse pipe both port and starboard. Figure 10 also shows the forecastle arrangement of this ship.

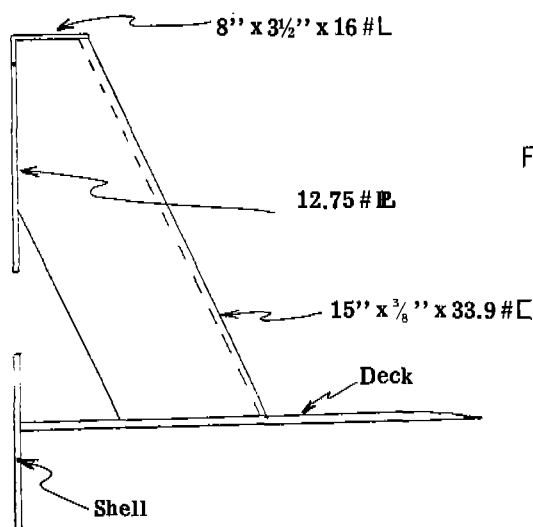
Fig. 11 - Sketch of Bulwark, Design 'A'

Design 'A' also sustained weather deck damage which is of interest. Three of the 11 ships in this class had a total of four casualties. One casualty involved damage to the forecandle and appears to be an isolated instance. The other three casualties, however, involved damage to bulwarks much farther aft, by hatch numbers 3, 5, and 6. In one instance 60 feet of bulwark was torn away and missing; in another 30 feet of bulwark was seriously distorted along with the fracturing of a number of bulwark brackets. Since side bulwark damage occurred relatively infrequently and, since one-half of the occurrences were on ships of this design, it is suspected that the bulwark arrangement on Design 'A' is marginally adequate at best. Figure 11 shows a sketch of the bulwark structural design for this ship in the area where the damage occurred.
