SSC-294

**FURTHER SURVEY
OF IN-SERVICE PERFORMANCE
OF STRUCTURAL DETAILS**

SHIP STRUCTURE COMMITTEE

1980

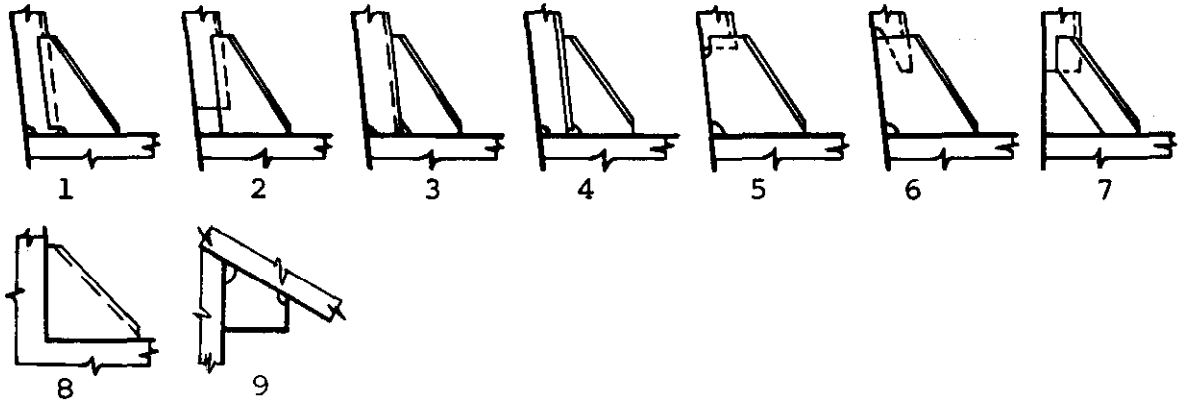
M.

The transition brackets of family group "M" were quite common near the turn of the bilge and, thus, were quite susceptible to corrosion. Proper design, such as drain holes to prevent standing water and elimination of inaccessible areas, coupled with a regularly enforced maintenance program, would have prevented failures in this area.

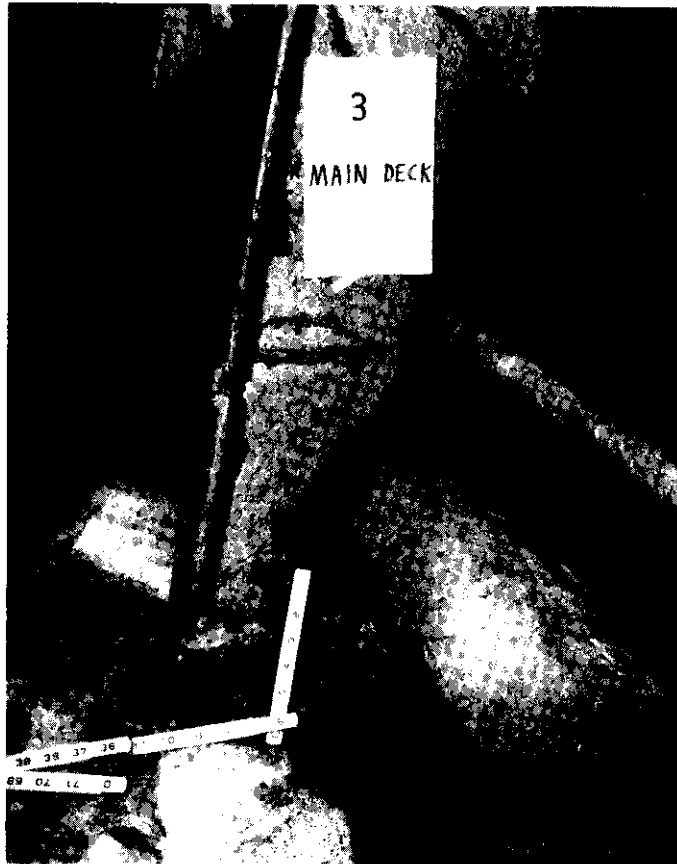
FIGURE 6

FAILED TRIPPING BRACKET ON HATCH COAMING OF A GENERAL CARGO SHIP

This is a view of a hatch coaming bracket on main deck. The lower end of each of the brackets were removed by the ship's crew in order to replace the large pipe at the right. Poor workmanship was evident in the replaced bracket as shown by the jagged cutout for the pipe and the sharp notch at the lap weld where a crack started and progressed the entire width of the web. Numerous failures were found among these brackets.

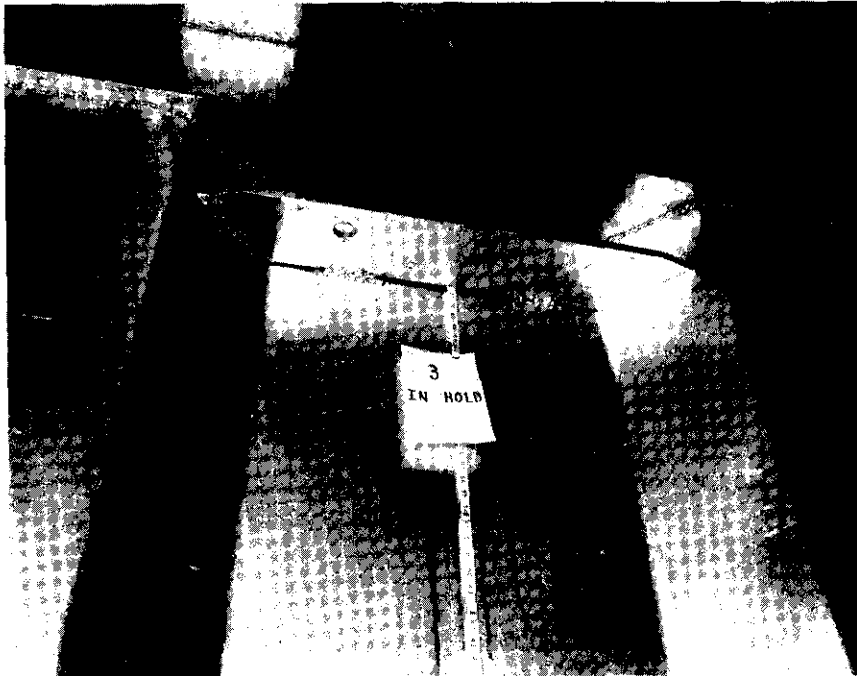
FIGURE 29

FAILED PANEL STIFFENER ON A GENERAL CARGO SHIP

Photographer is standing in the cargo hold looking up at a panel stiffener on a longitudinal corrugated bulkhead. The weld cracks were due to poor welding and possibly buckling of the bulkhead while the ship was in a seaway. The hole drilled in the stiffener is sometimes used to tie down cargo. This often produces failures.
