SSC-337

SHIP FRACTURE MECHANISMS

**A NON-EXPERT'S GUIDE FOR
INSPECTING AND DETERMINING THE CAUSES OF
SIGNIFICANT SHIP FRACTURES**

SHIP STRUCTURE COMMITTEE

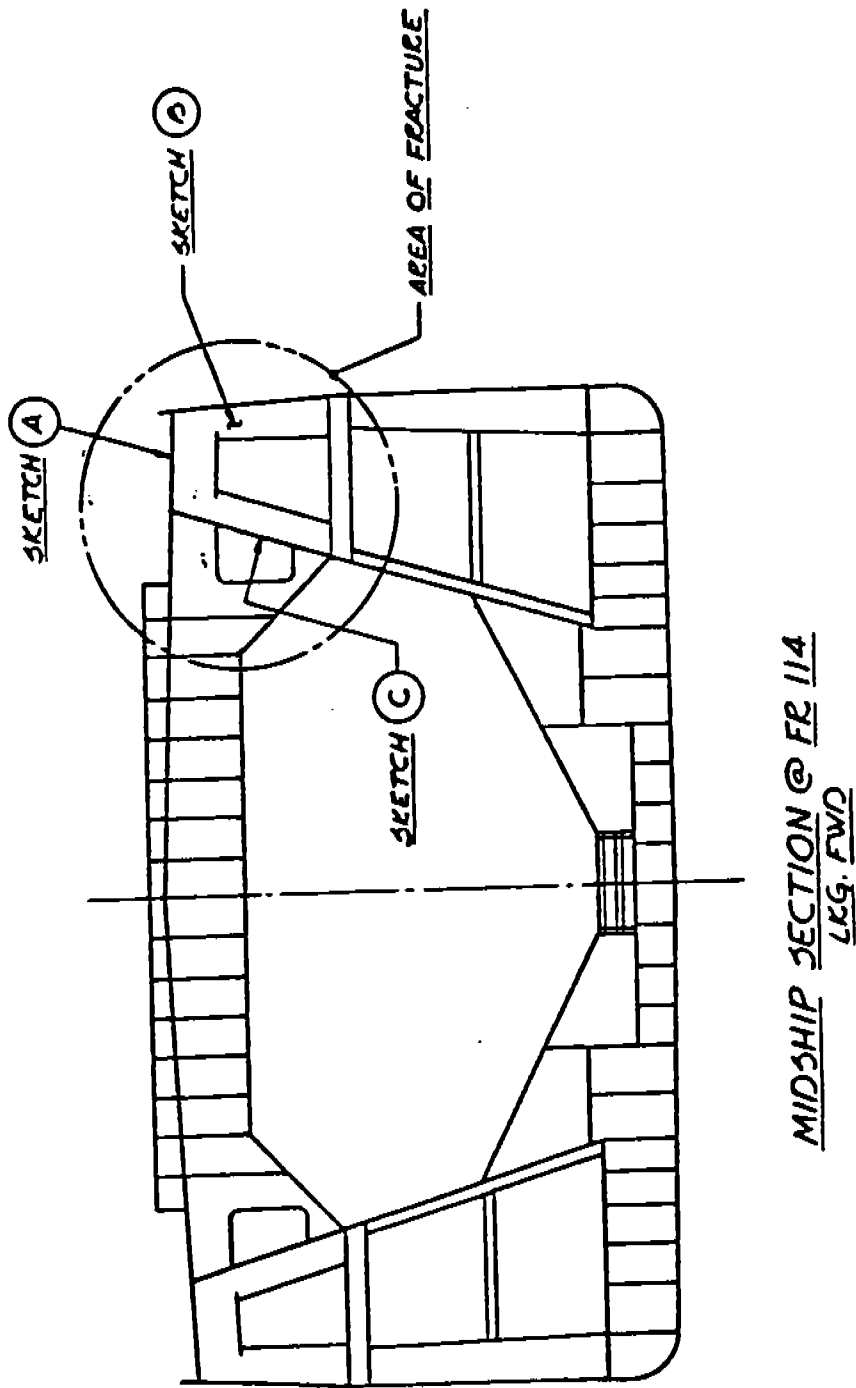
Figure 4-1. Midship Section Indicating the Area of Fracture on the Great Lakes Bulk Carrier

The fracture occurred on the bulk carrier on its last voyage prior to layup for the 1984 winter season. The ship was sailing Lake Huron when the crew heard a loud noise. An inspection by the crew revealed a fracture in the main deck on the starboard side near amidships.

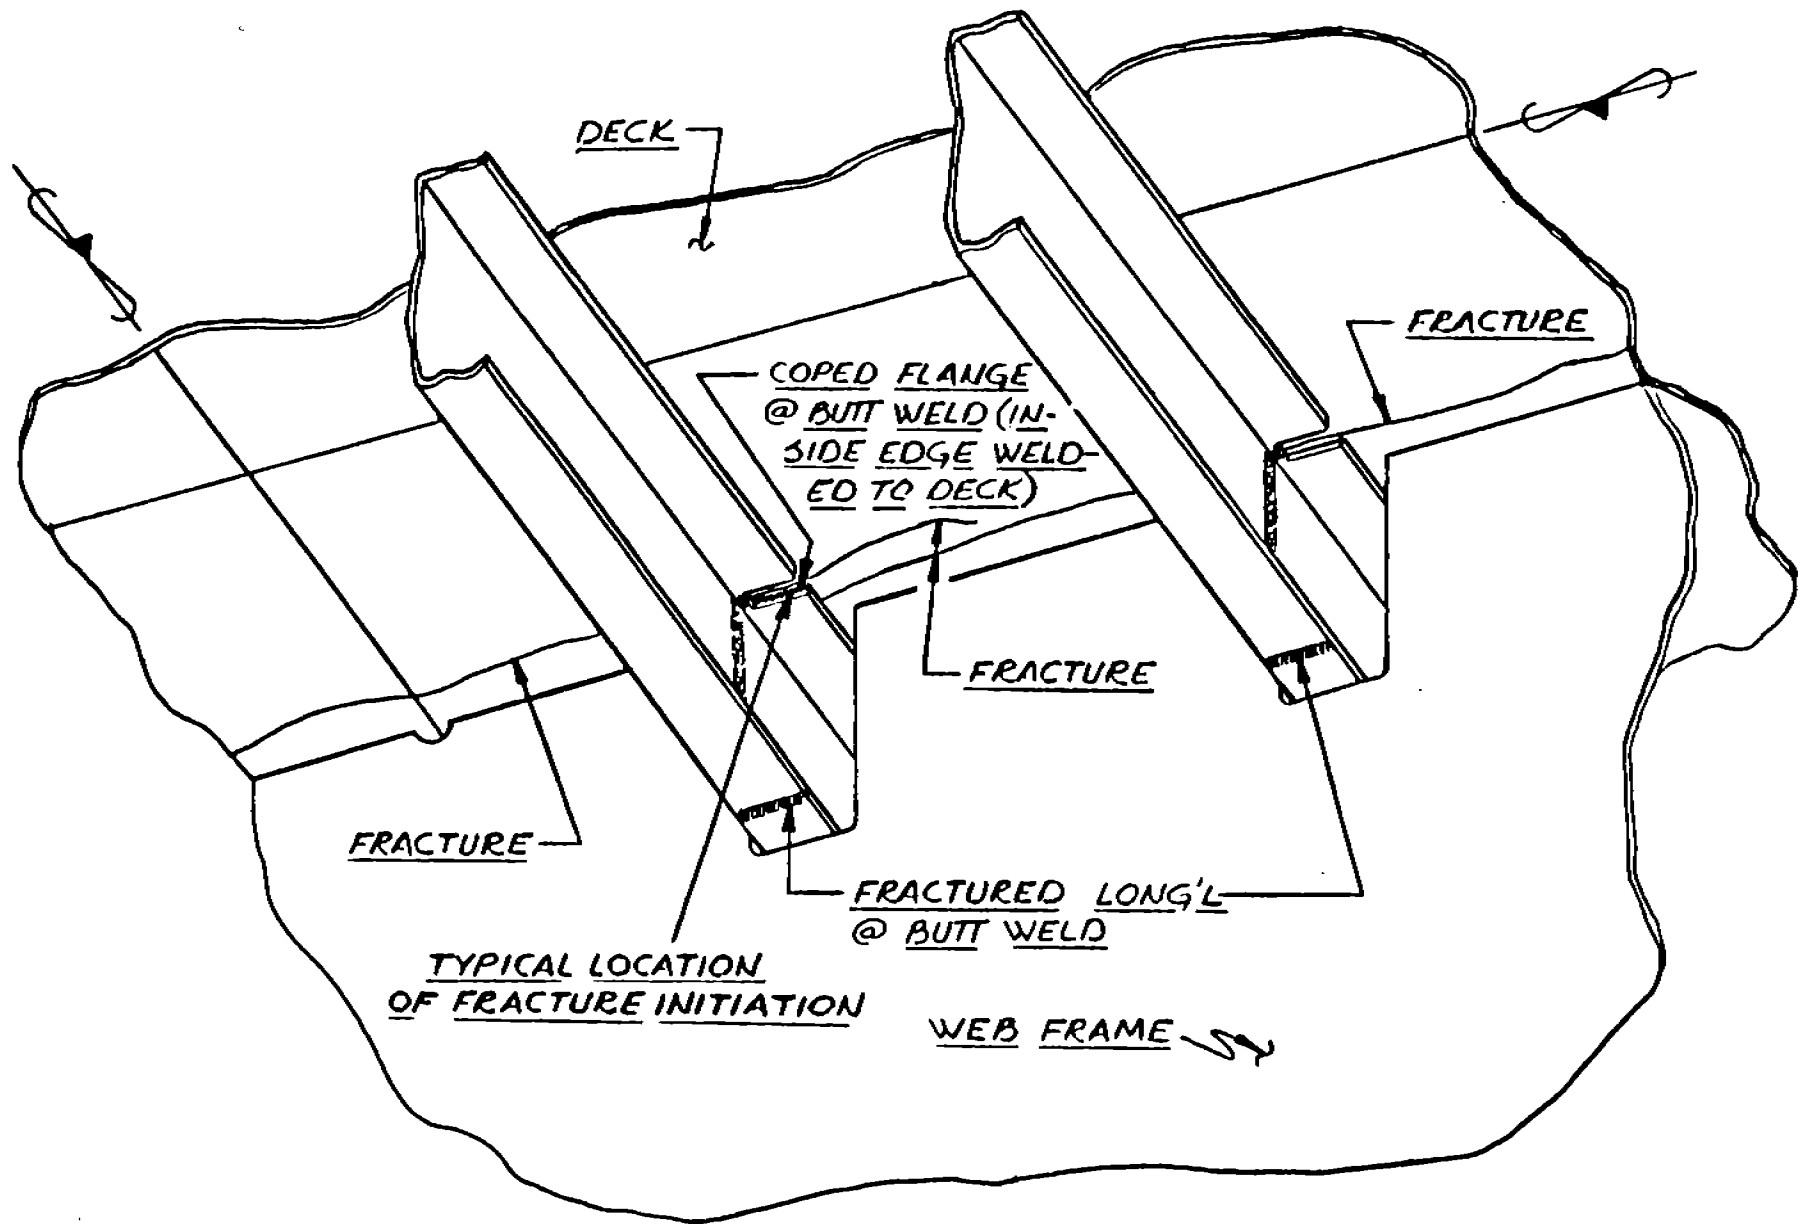
Figure 4-5. Construction Details Associated with the Initiation of the Fracture on the Great Lakes Bulk Carrier

The significant fractures all originated at longitudinals where the flange was cut for butt welding. The initiating defects at the origin were small. However, the ship operated for over 30 years with those poor fabrication details, suggesting relatively high forces in the ship structure from adverse weather at the time of fracture. This is also suggested by the multiple origin points. Because the fracture originated at poor fabrication details (notches), it is surprising that the ship survived in service for many years without fracturing.

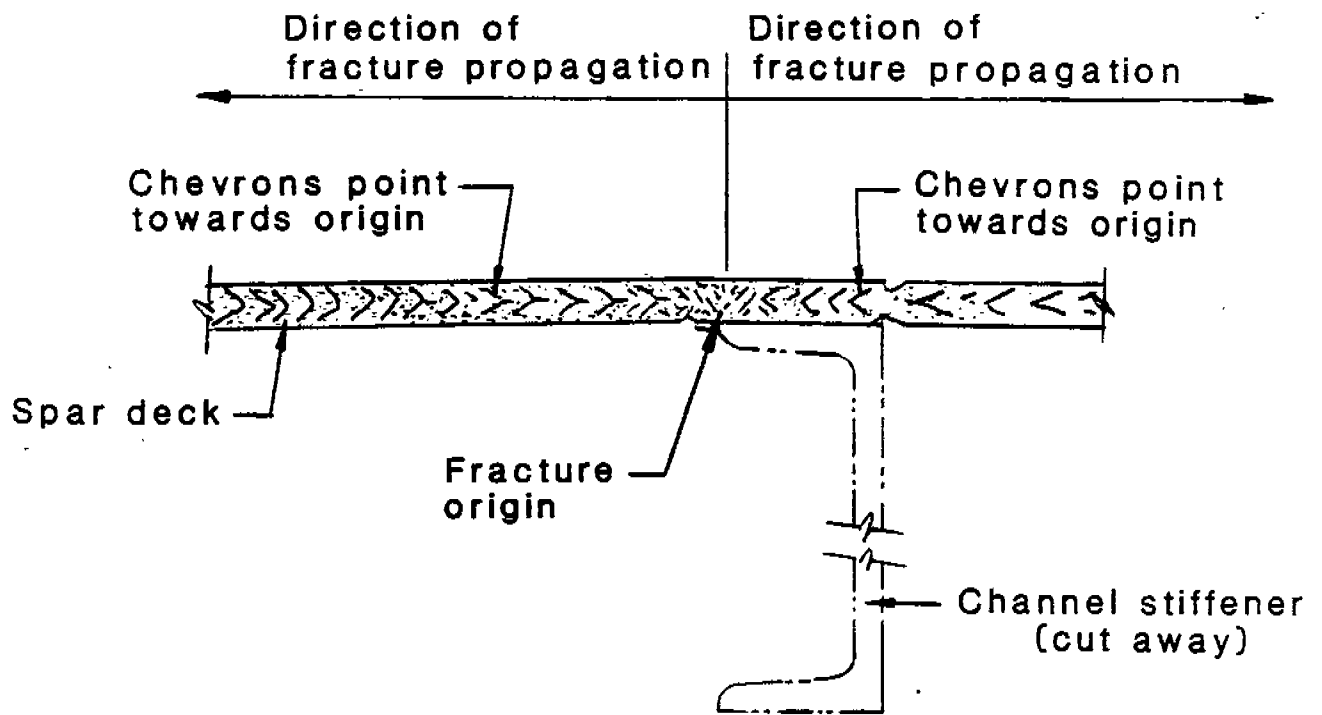
Figure 4-7. Location of the Fracture Origin in Sample Number 1.

The origins of the various fractures were located by inspecting the edge of the fracture samples and establishing the orientation of chevron patterns. All the samples taken had clearly developed chevron marks. Examples of these markings on the surface of piece No. 1, which were typical, are seen in Figure 4-7. Sample No. 1 was cut from the spar deck plating located at the edge of the hatch coaming and extending outboard along part of the fracture surface as shown in Figure 4-6. Clear chevron markers point to the initiation site located in the transverse weld joining the coped out longitudinal flanges to the deck plate as shown in Figure 4-5. The fracture ran in two directions: under the hatch coaming and outboard across the deck through sample No. 9 and on into sample No. 2 where it terminated. As far as sample No. 9 is concerned, the fracture simply extended through this plate and did not directly result in propagation of fractures into the longitudinal bulkhead.

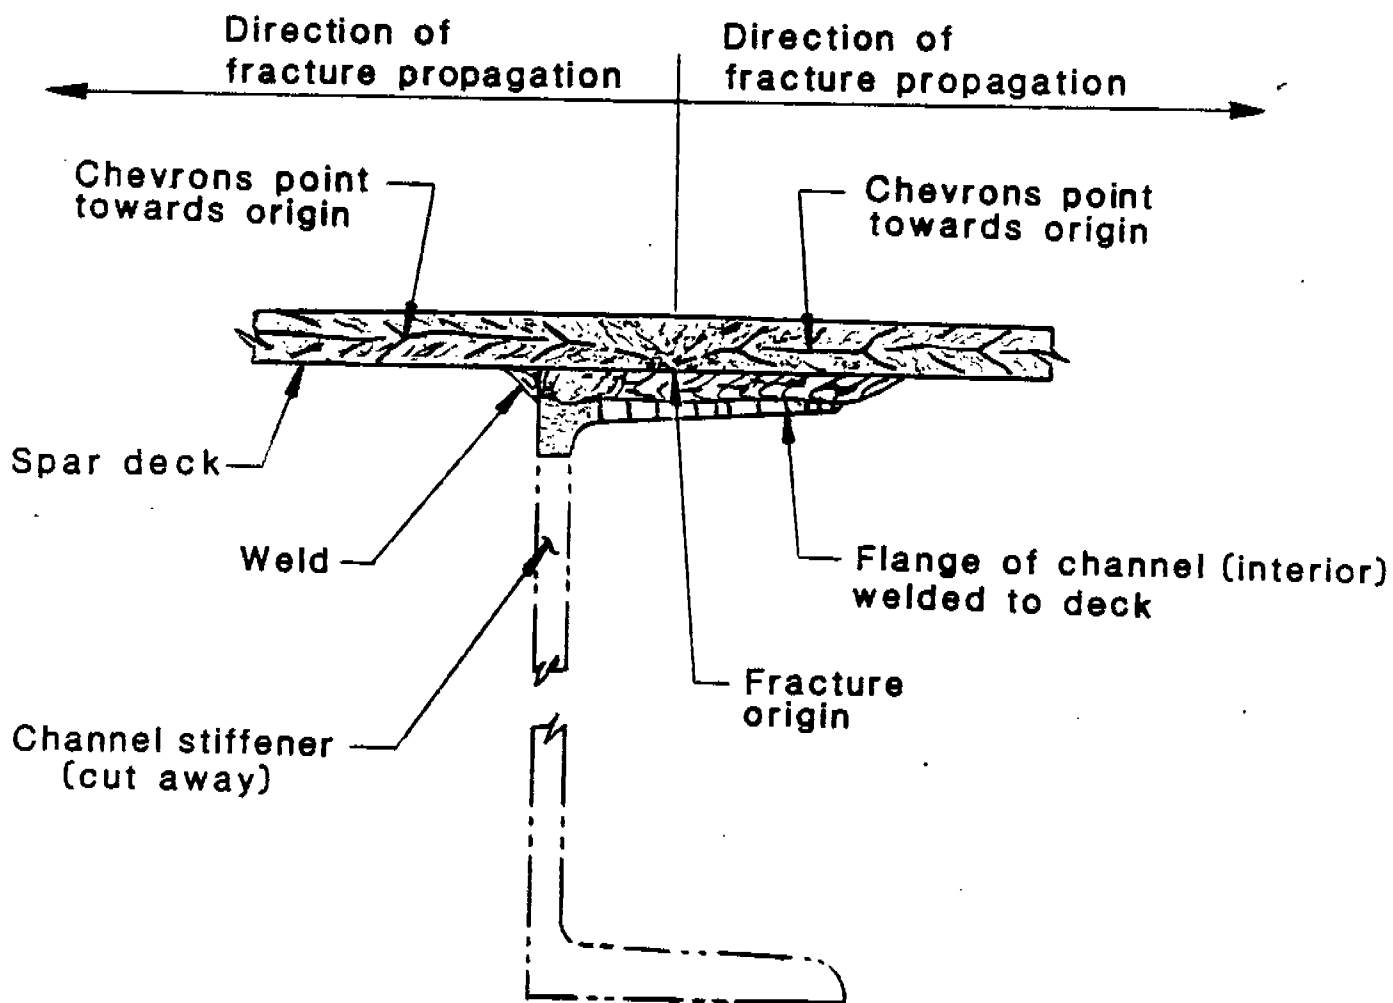
Figure 4-8. Location of the Fracture Origin in Sample No. 6.

Sample No. 6 contains two separate fractures. Cutting the sample to reveal the fracture surfaces showed that the aft-most fracture extended inboard and outboard. From Figure 4-8 it can be seen that the chevrons point toward the

weld of the flange cutout. The chevrons in the forward-most fracture in Sample 6 point outboard indicating that the fracture propagated inboard. The chevrons in the corresponding fracture in sample No. 7 point outboard indicating this fracture propagated inboard. Therefore, this fracture had to initiate somewhere between Samples Numbers 6 and 7, and shown in Figure 4-9 and probably at one of the two longitudinal flange cutouts.

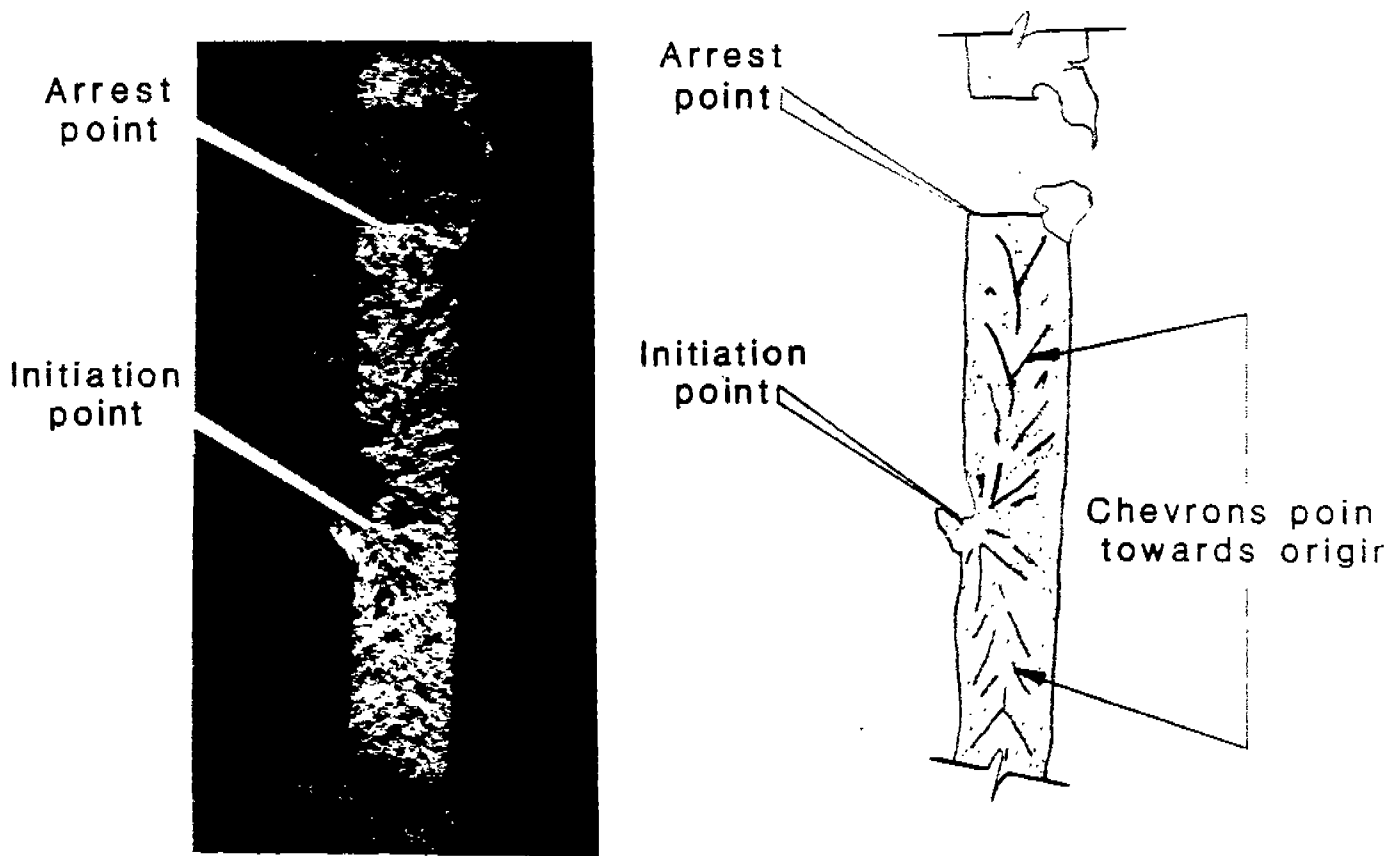
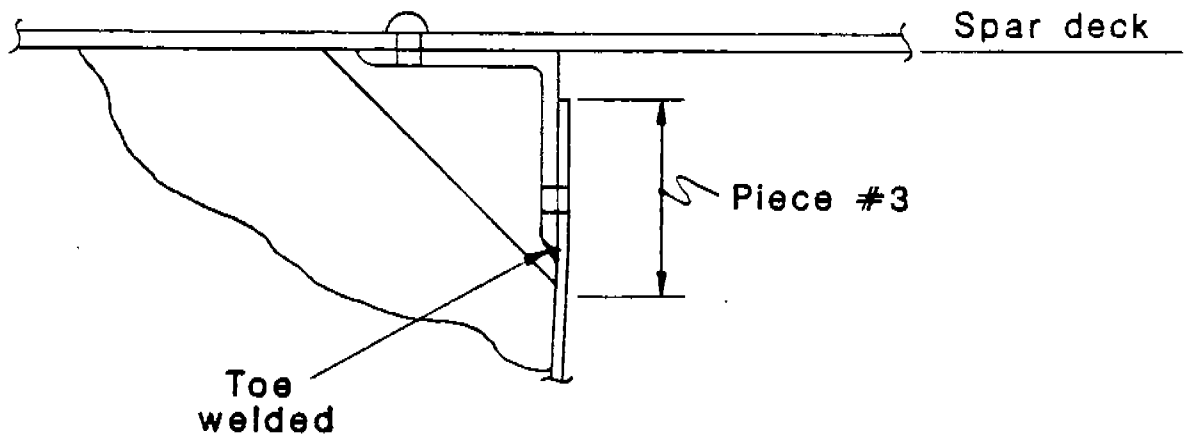
Figure 4-10. Piece No. 3 (Top of Longitudinal Bulkhead) Initiation Site Showing Crack Entering Piece No. 3 through Weld of Angle to Piece No. 3. Crack Goes to Rivet Hole on Right and Down the Bulkhead

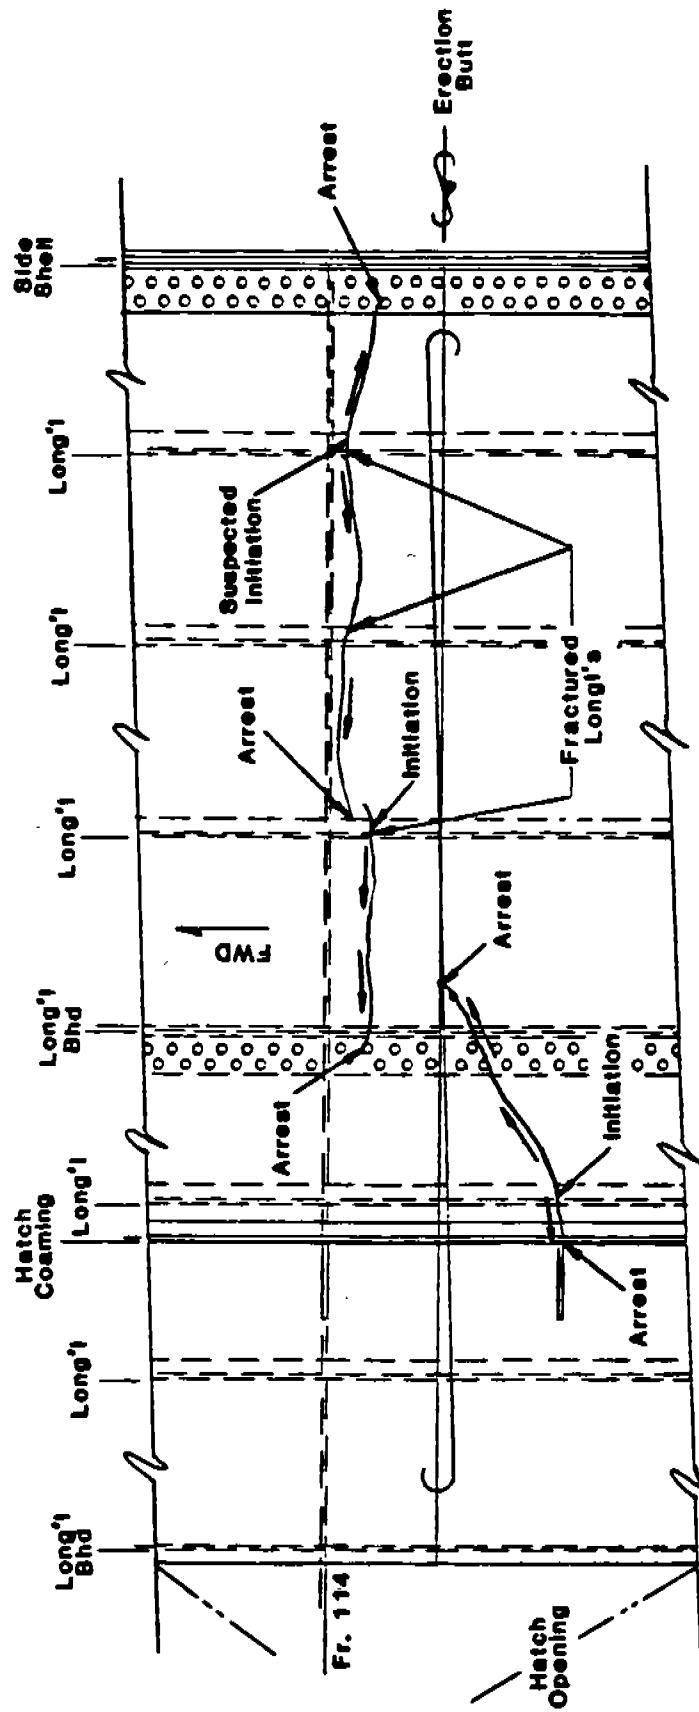
Figure 4-11. Plan of Spar Deck. Fracture Initiation and Arrest Points
