SSC-337

**SHIP FRACTURE MECHANISMS
INVESTIGATION**

SHIP STRUCTURE COMMITTEE

1990

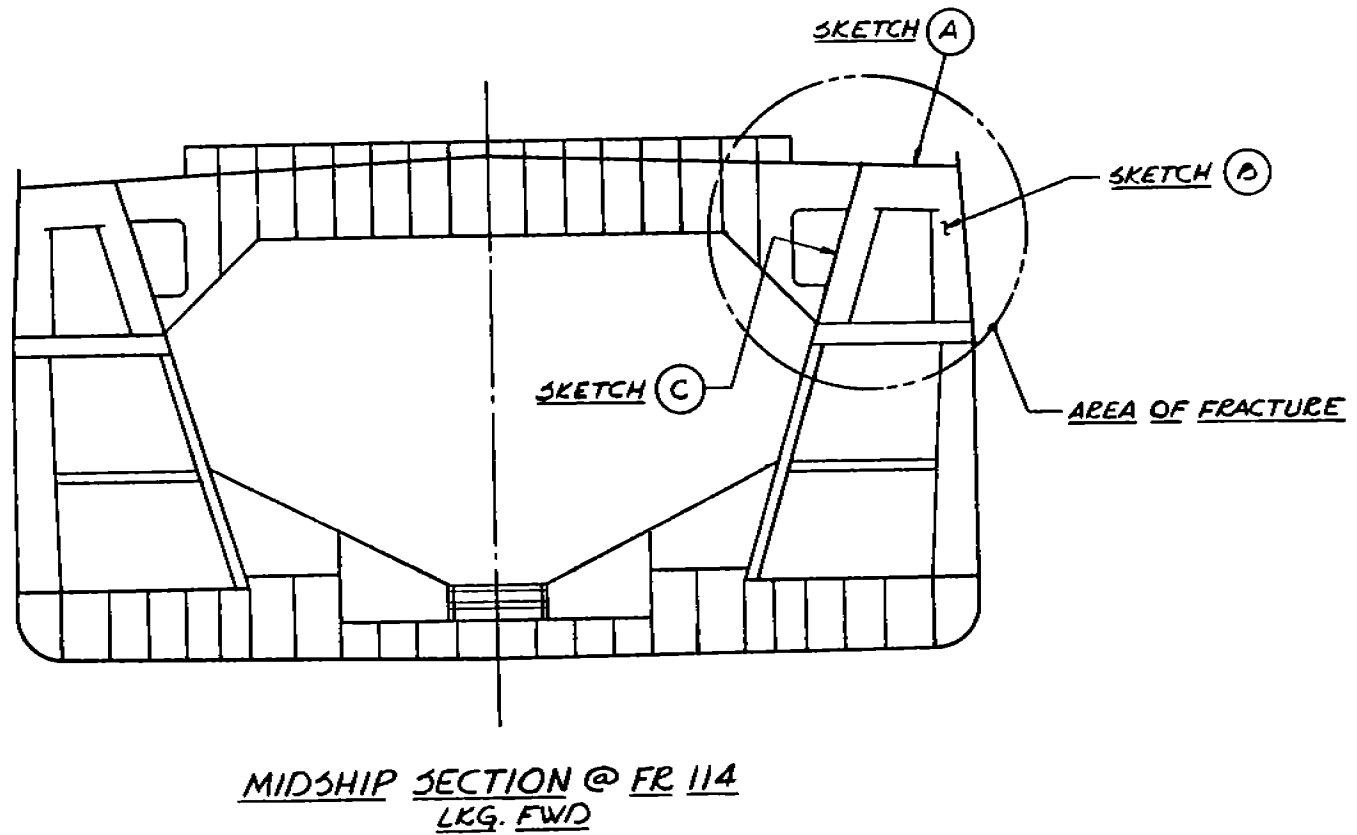
Figure 3-1 Midship section indicating the area of fracture on the Great Lakes bulk carrier

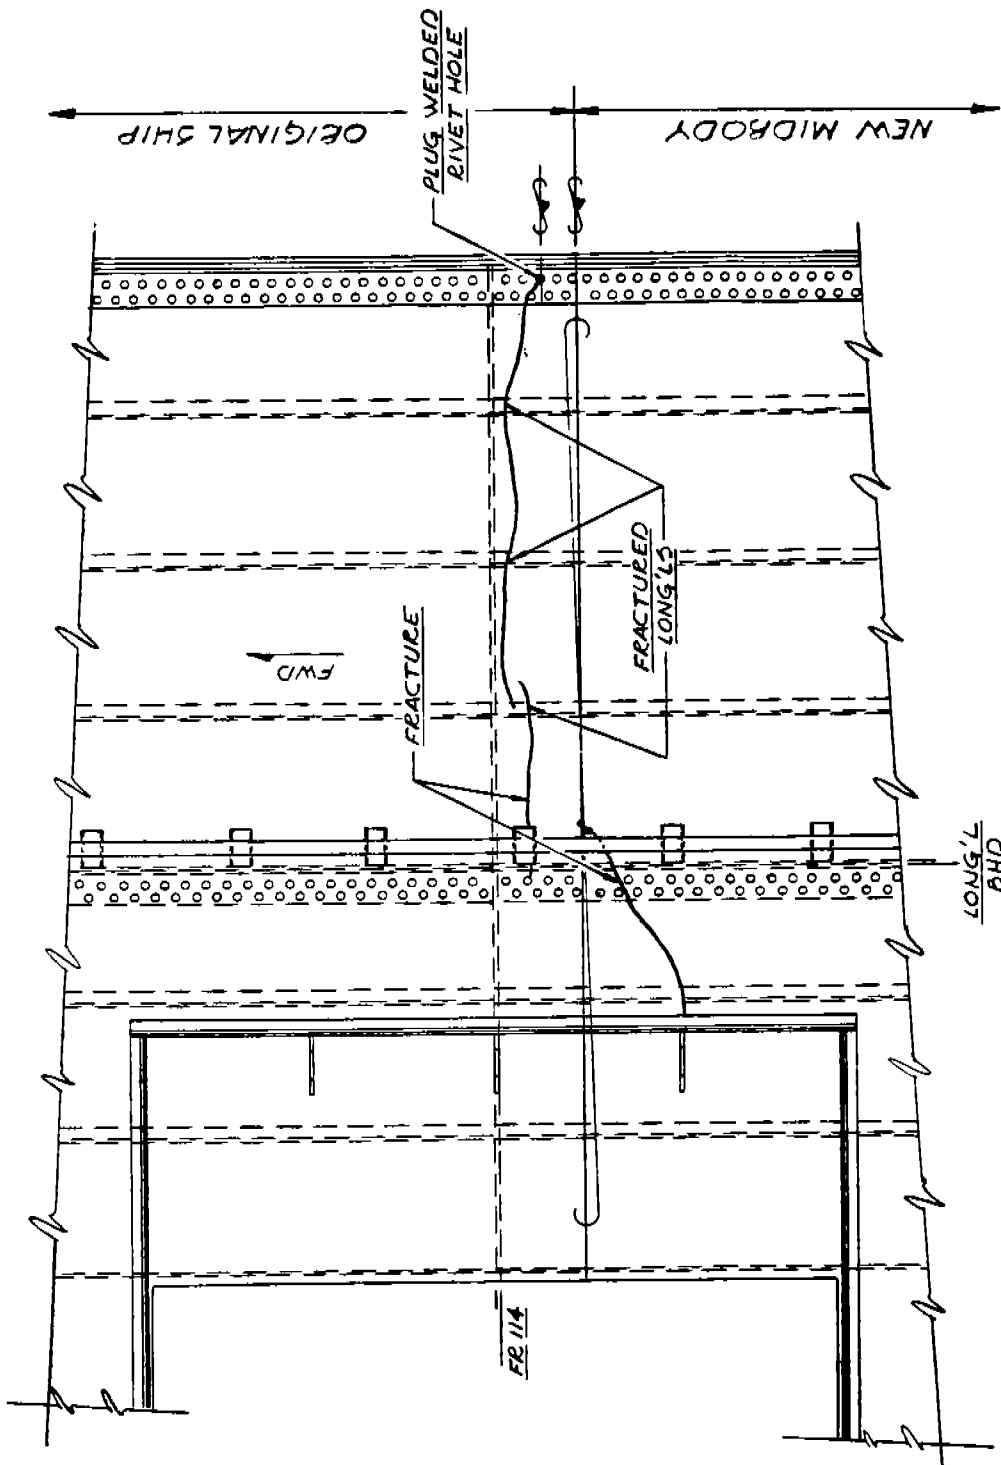
SKETCH A
 PLAN OF SPAR DECK @ FR 114

Figure 3-2 Fracture path on the spar deck of the Great Lakes bulk carrier

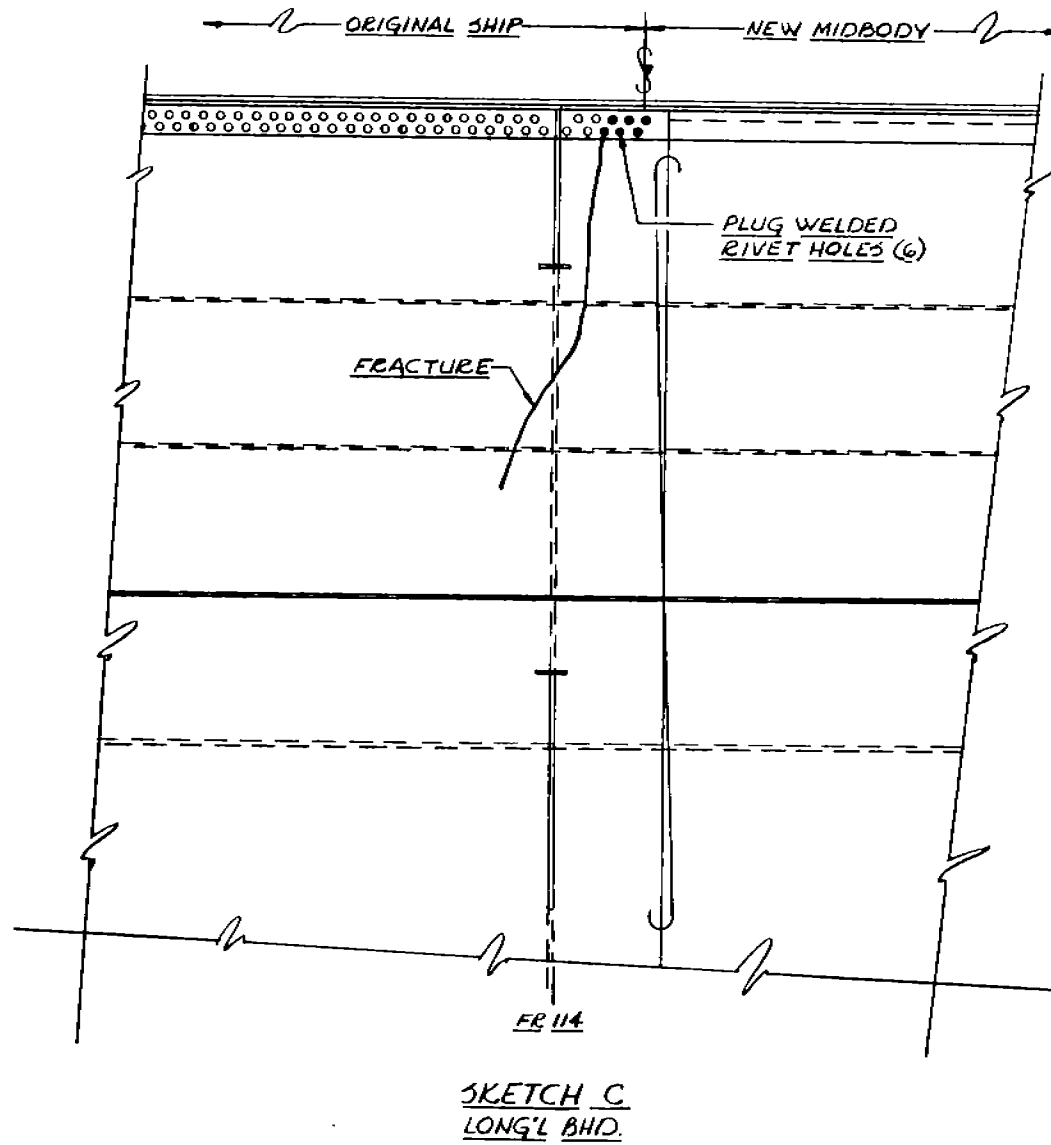
Figure 3-4 Fracture path in the Longitudinal Bulkhead of the Great Lakes Bulk Carrier

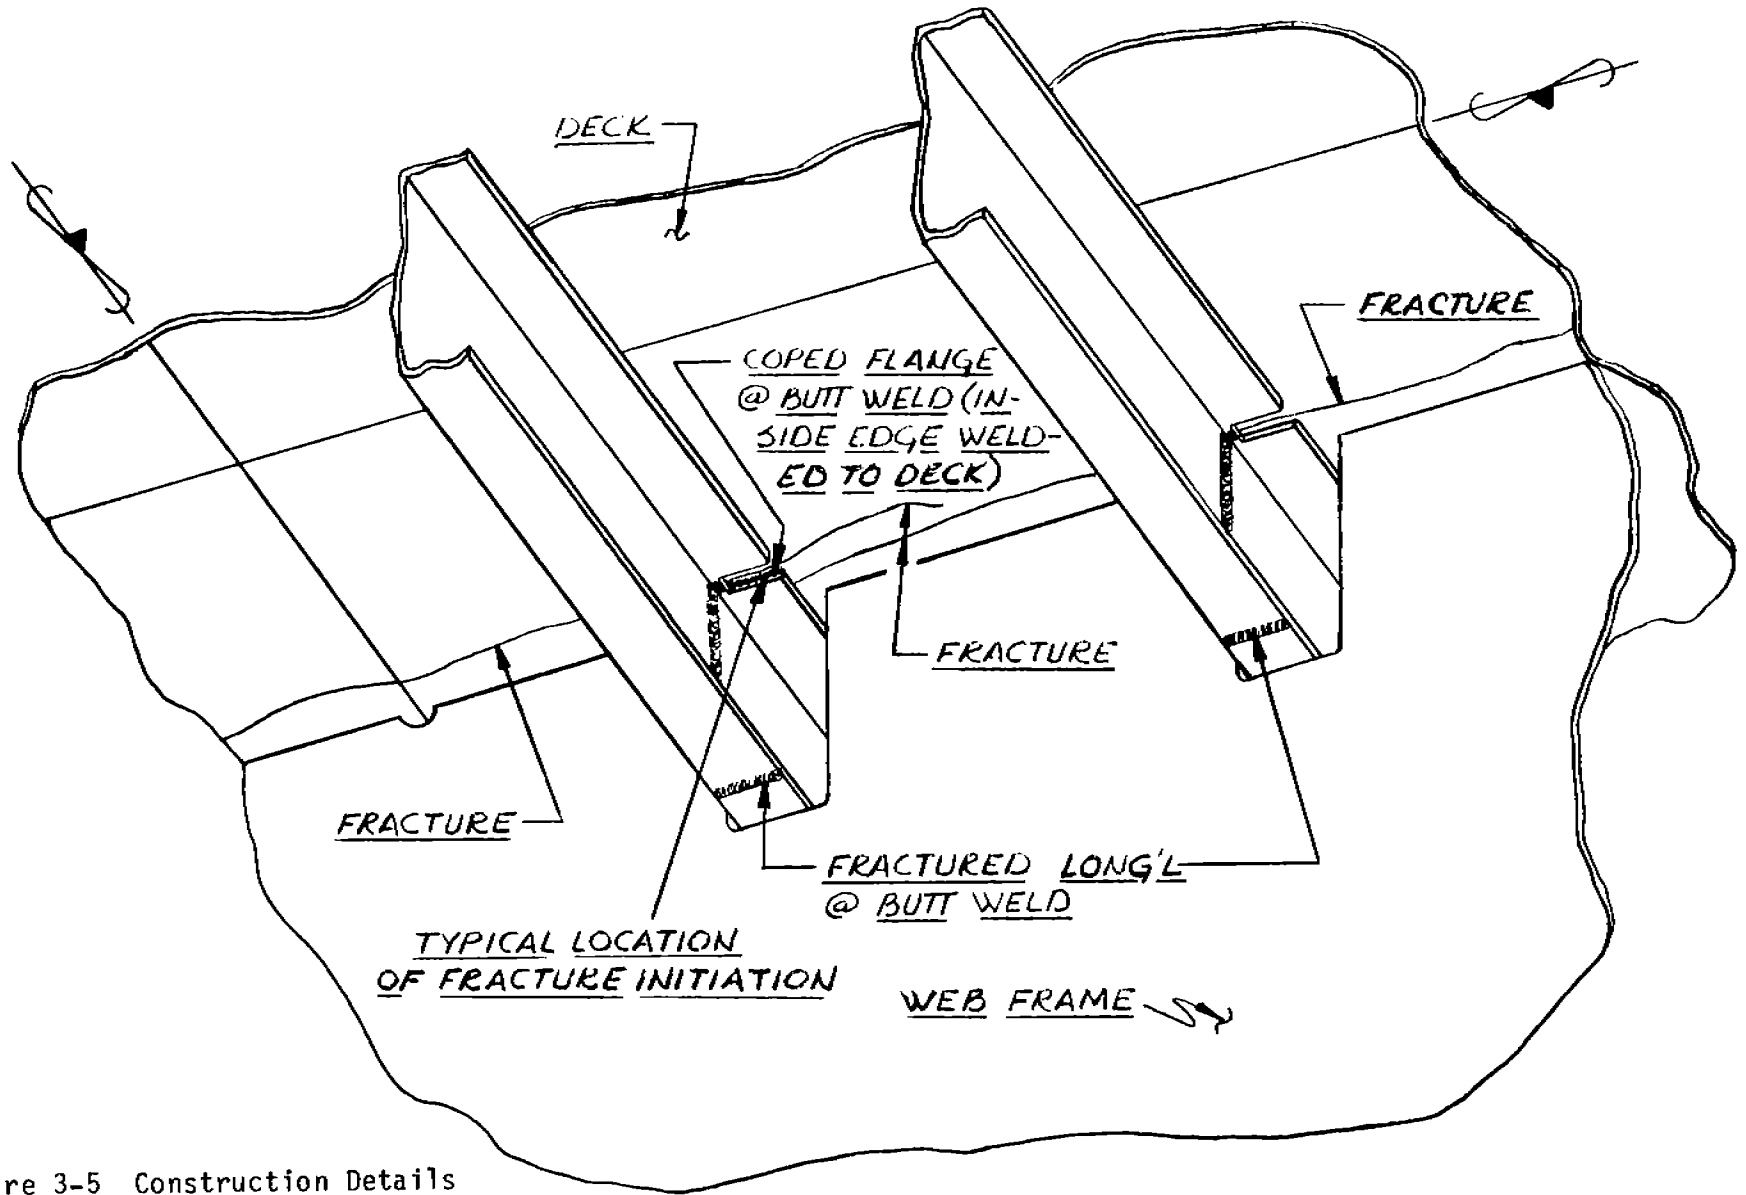
Figure 3-5 Construction Details associated with the Initiation of the Fracture on the Great Lakes Bulk Carrier

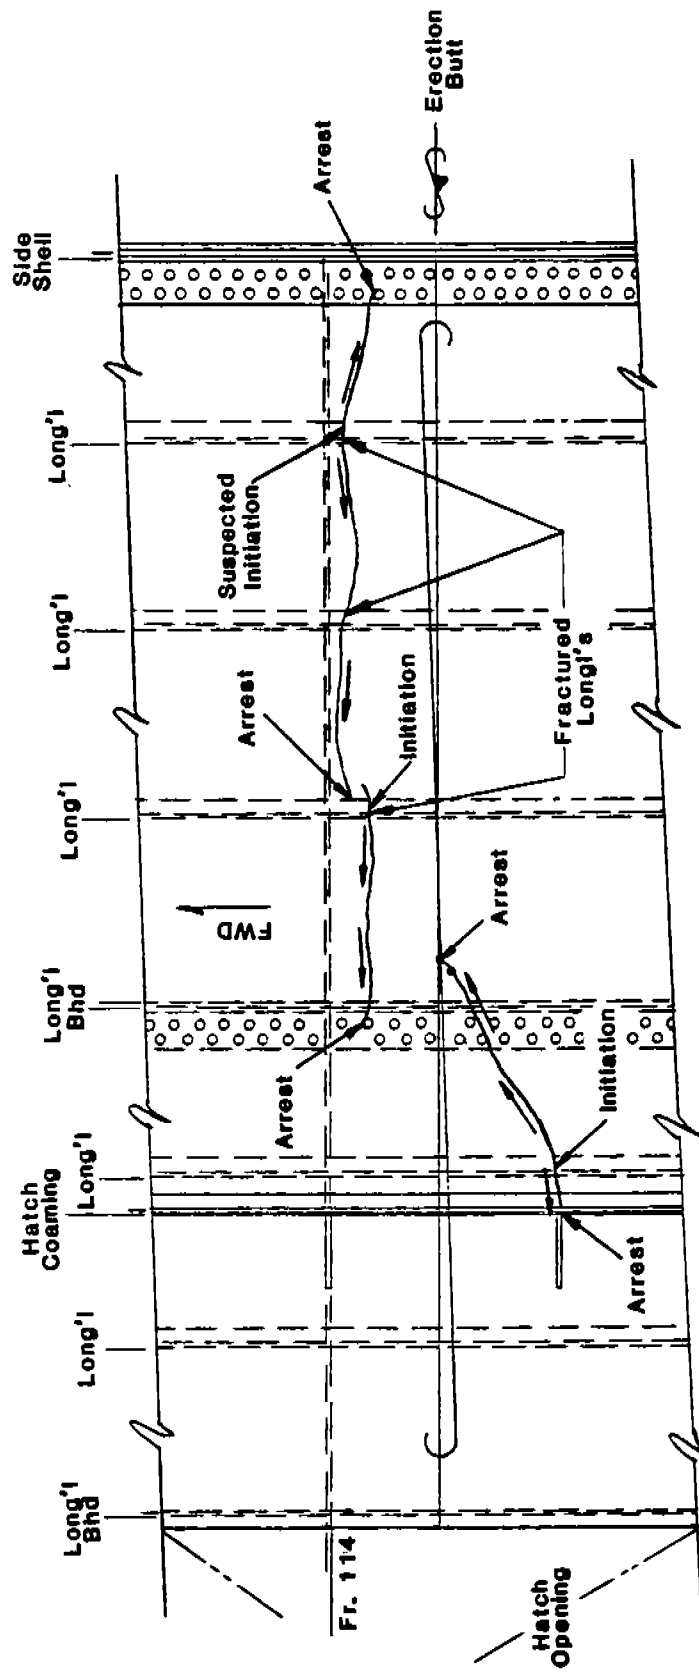
Figure 3-14 Plan of Spar Deck Fracture Initiation and Arrest Points

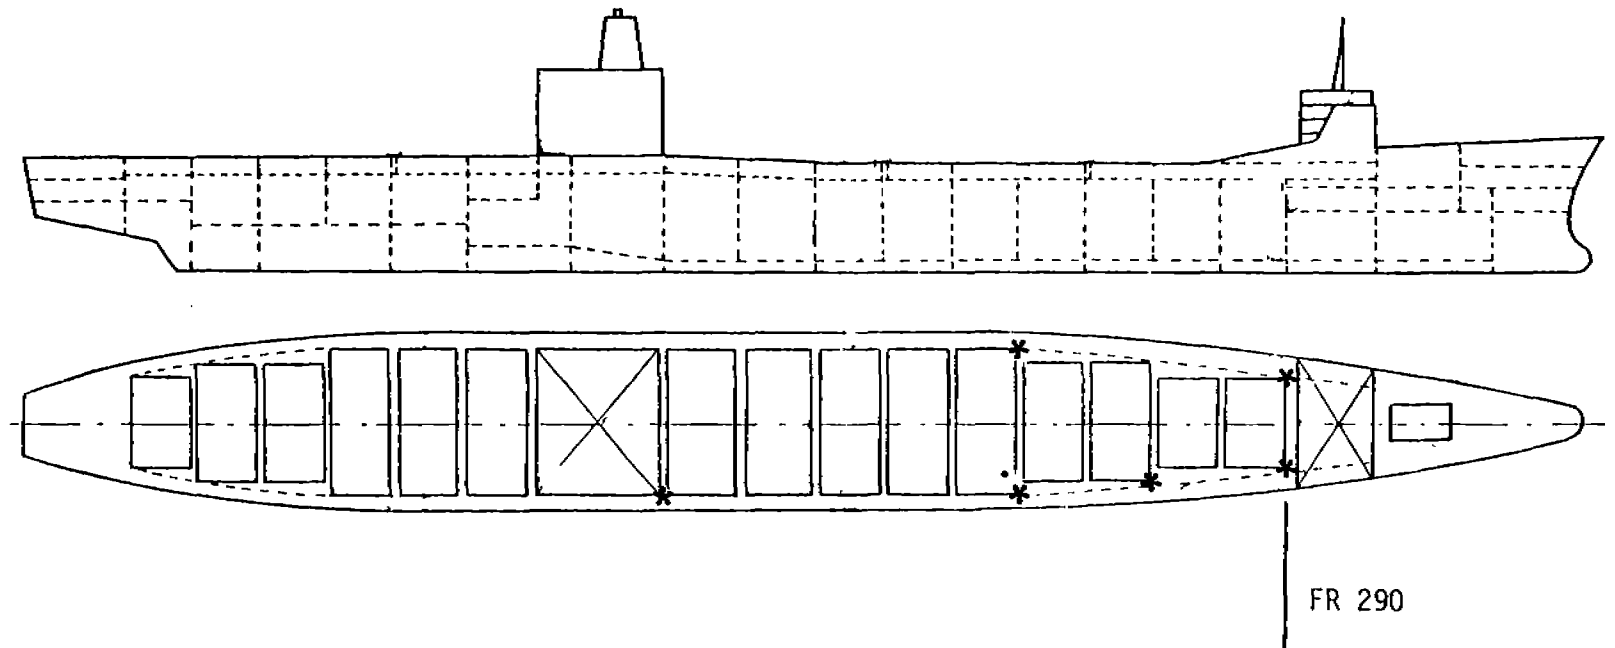
Figure 3-15 Elevation and deck lay out of the SL7 class of containerships showing frame locations of fractured hatch cut out where fatigue cracking occurred. Other locations where cracks were reported are indicated by *.

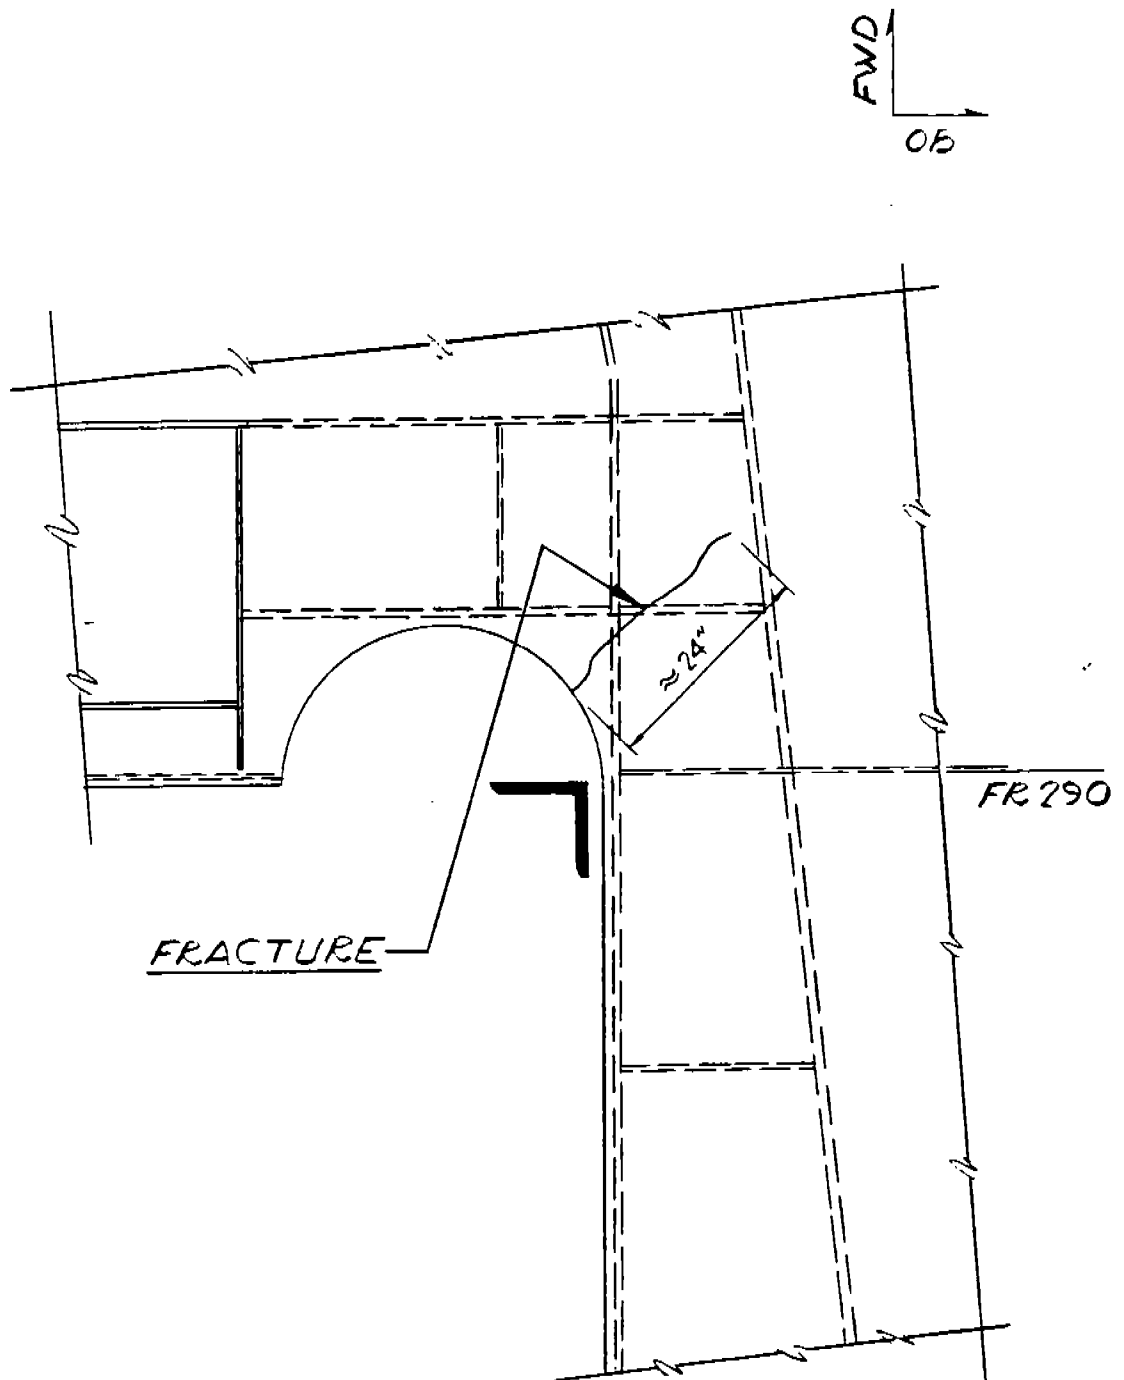
Figure 3-16 Fracture of the forward hatch cutout on the high speed containership during the second winter season

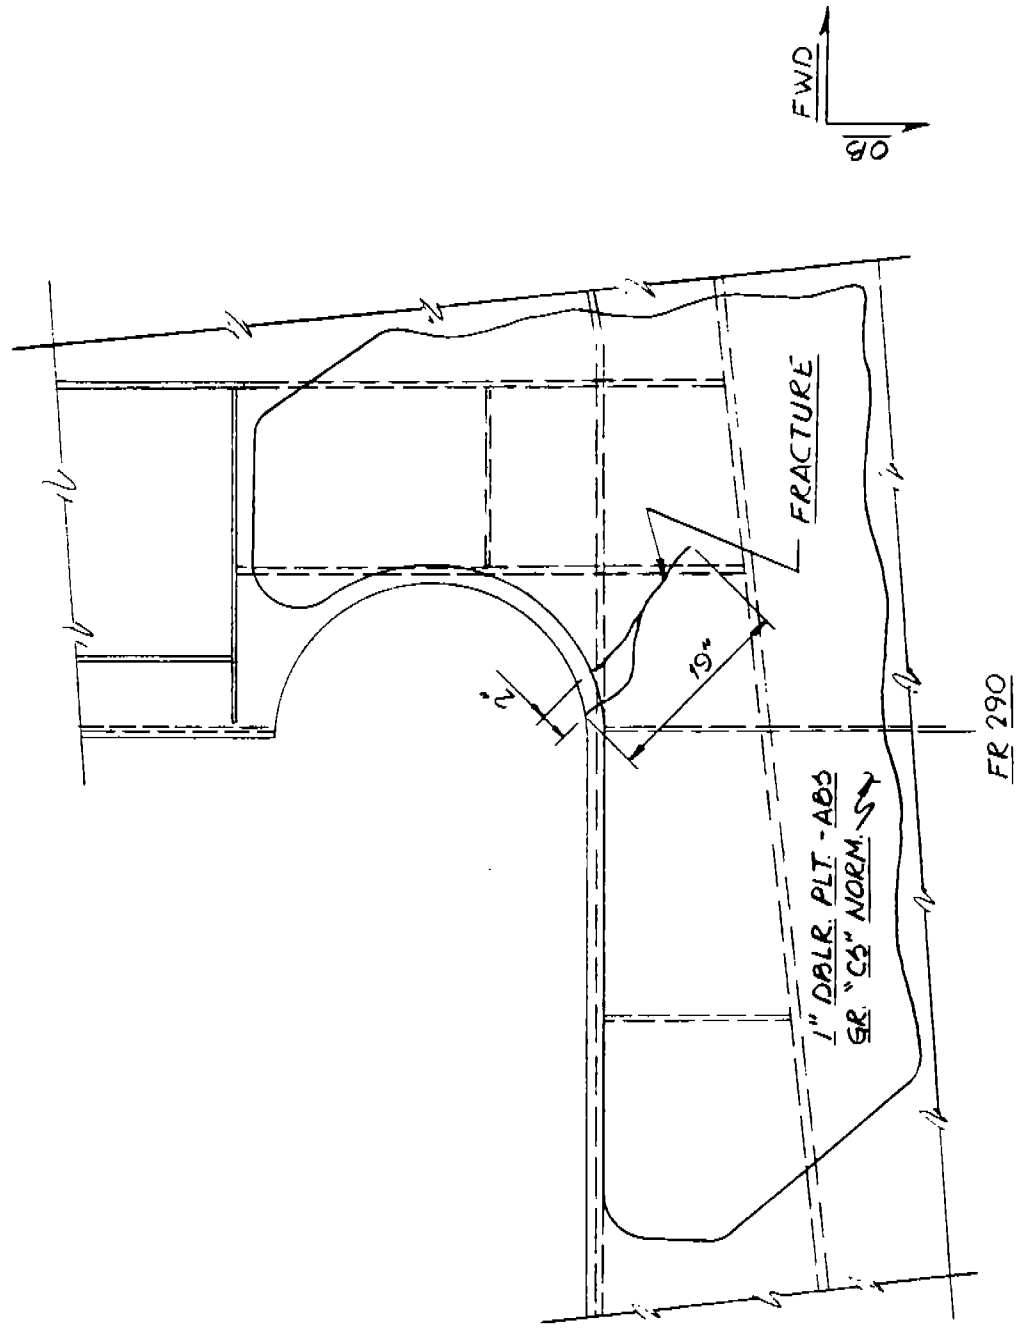
Figure 3-17 Fracture in the deck and doubler plate at the forward hatch cut out prior to 5/75

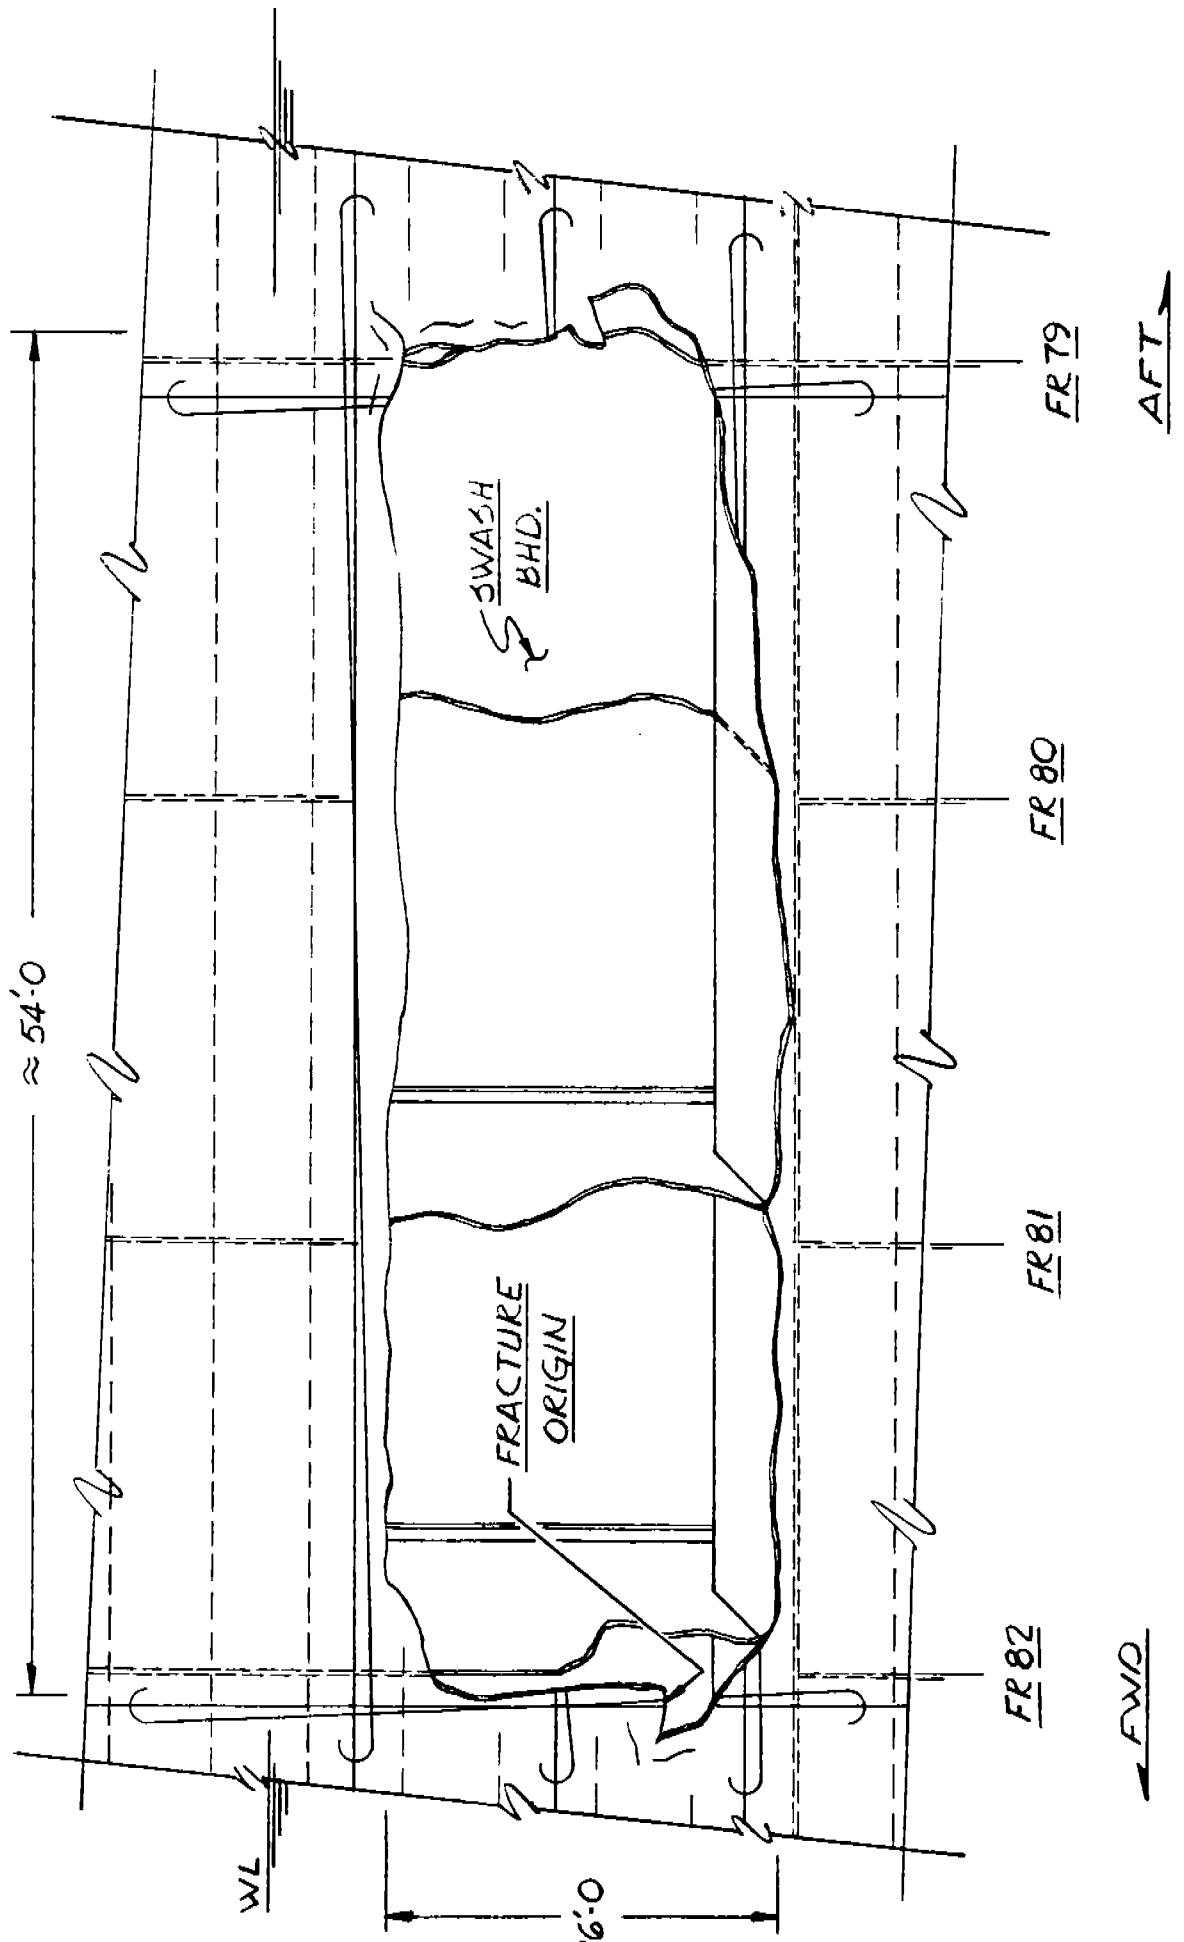
Figure 3-20 Configuration of fracture and loss of port side shell plating on the tanker

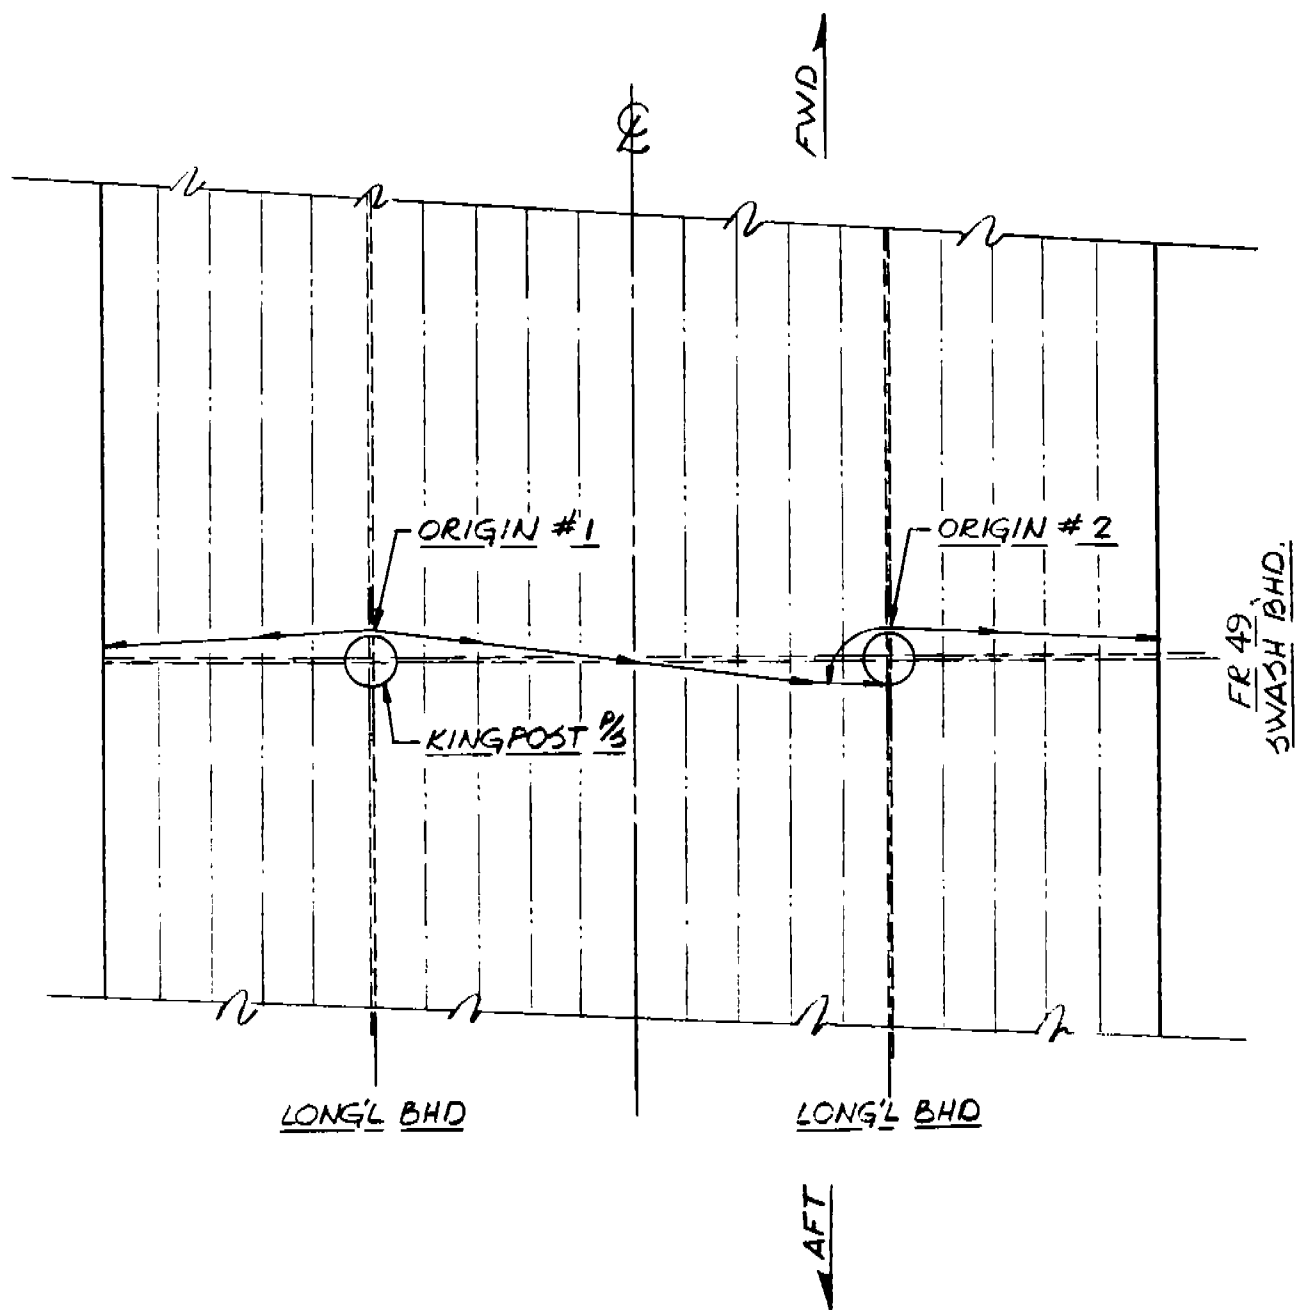
The fracture of the barge was generally in the vicinity of Frame 49, which is 42'-6" aft of the midpoint of the barge. The fracture extended completely across the main deck, down the side shell port and starboard, and across approximately 46 percent of the bottom plating. The configuration of the fracture path across the main deck is shown in Figure 3-21. The fracture originated at the base of a king post on the deck above the port longitudinal bulkhead. The king post was welded to a base plate doubler ring which was centered directly over the intersection of the transverse swash bulkhead at Frame 49

Figure 3-21 Fracture Path on the Main Deck of the Tank Barge

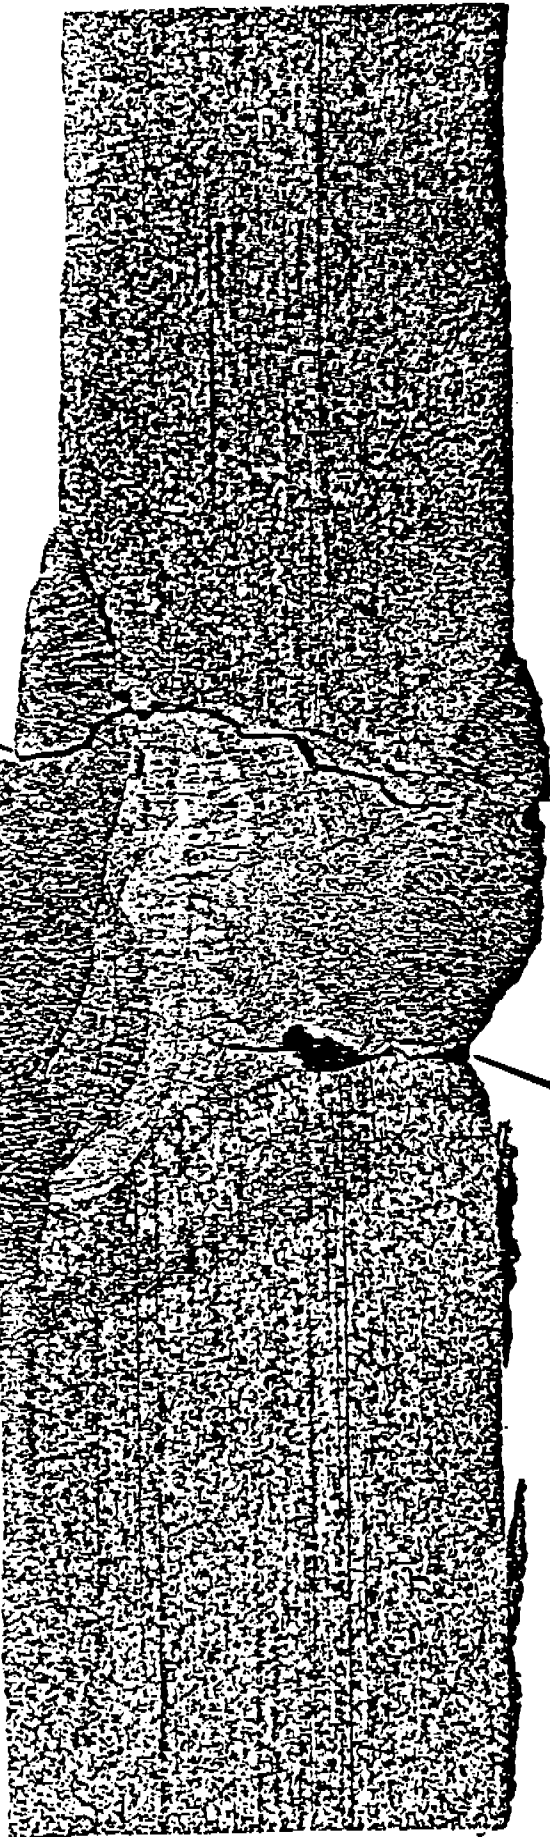
Figure 3-26 Weld Detail Used on the Converted Containership Showing Corrosion Fatigue Cracks

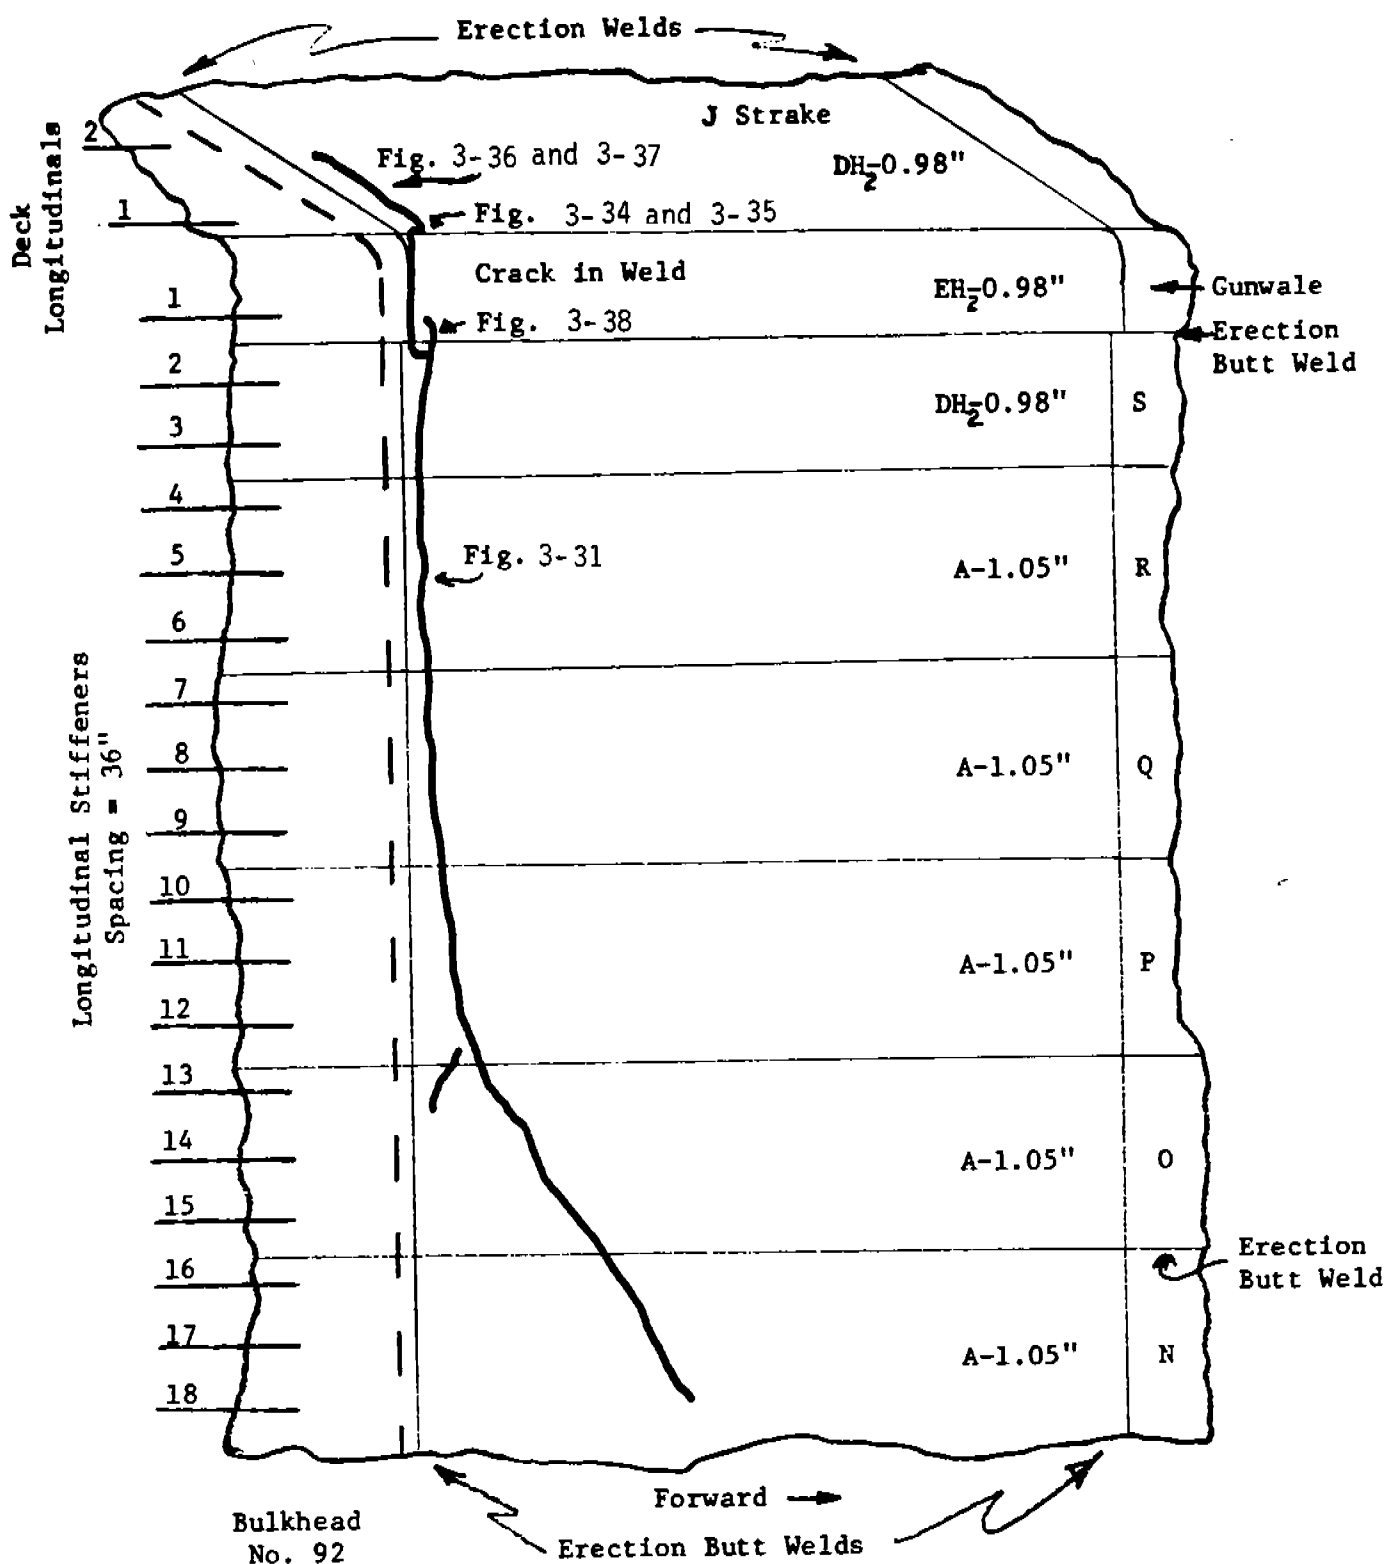
Figure 3-29 General View of Shell Fracture No. 3 Wing Tank Starboard

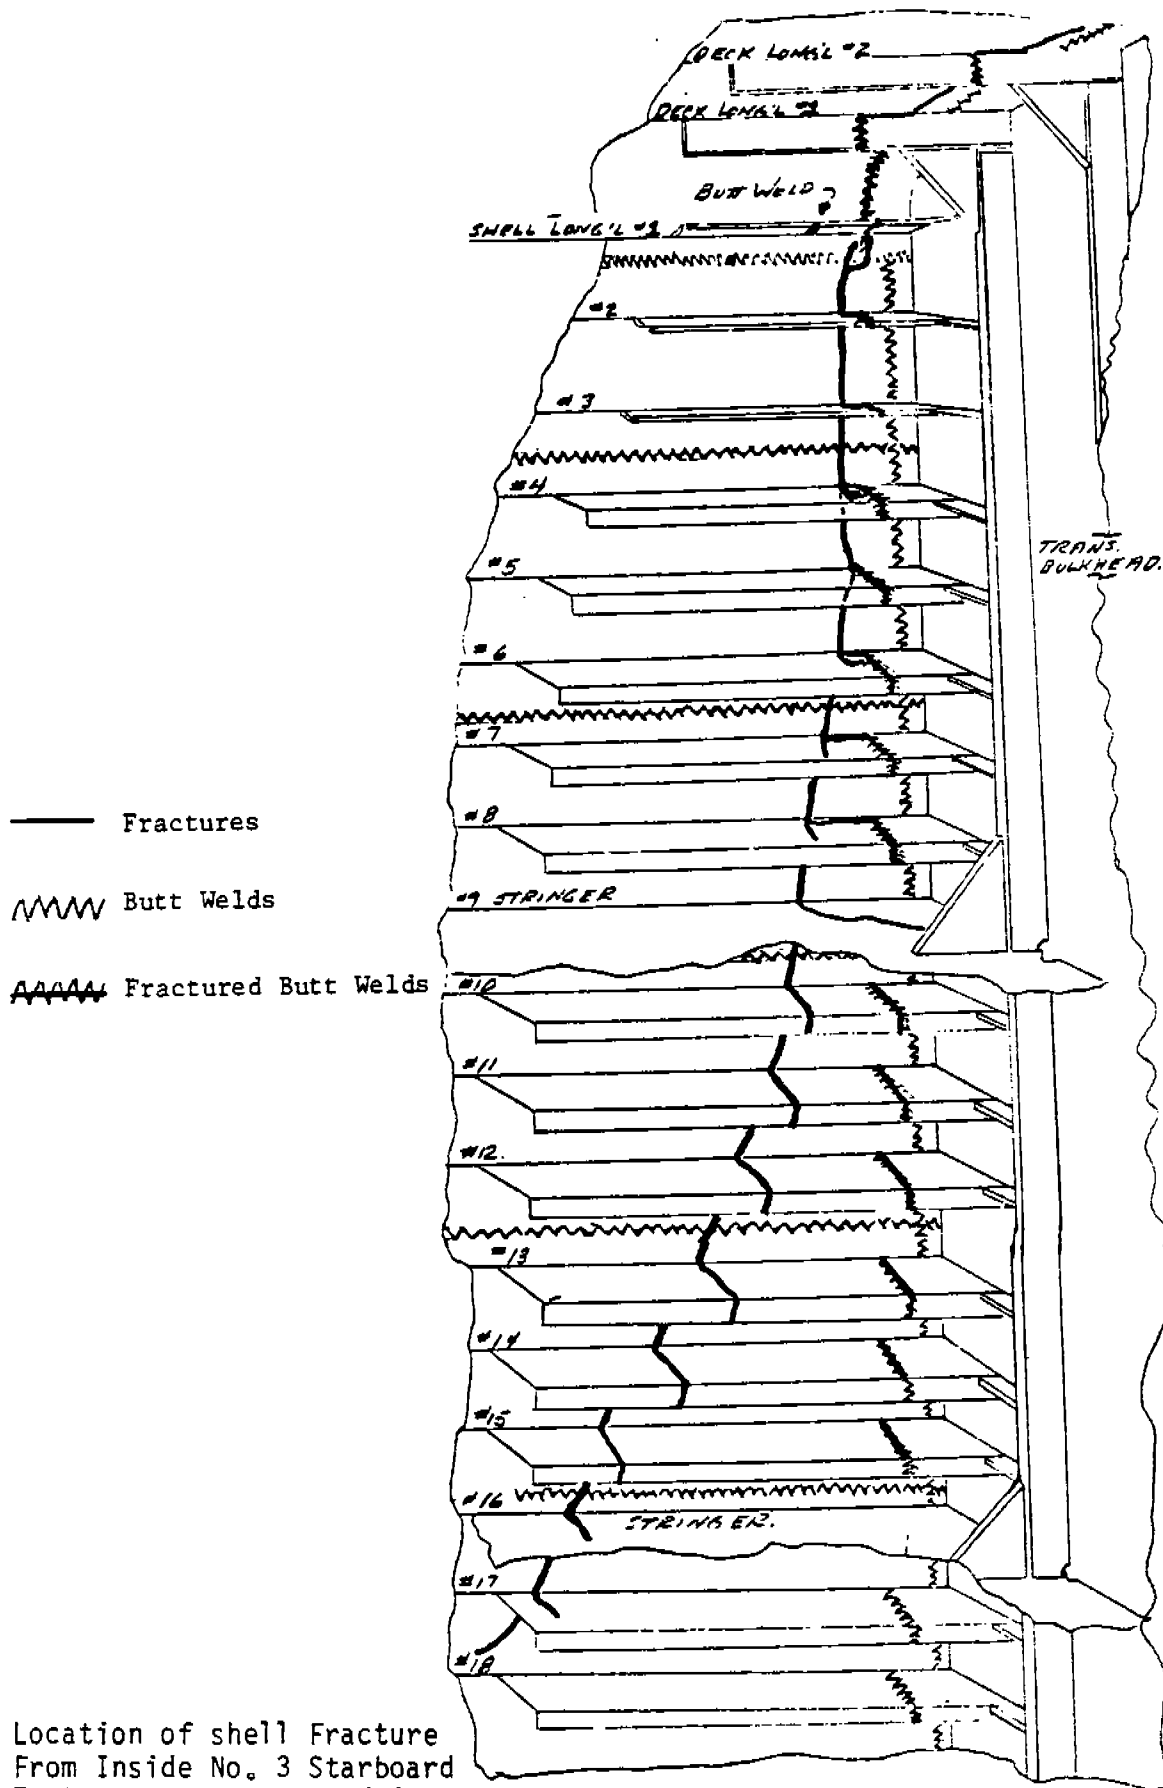
Figure 3-30 Location of shell Fracture From Inside No. 3 Starboard Tank. Fractures Found in the Longitudinals also Shown

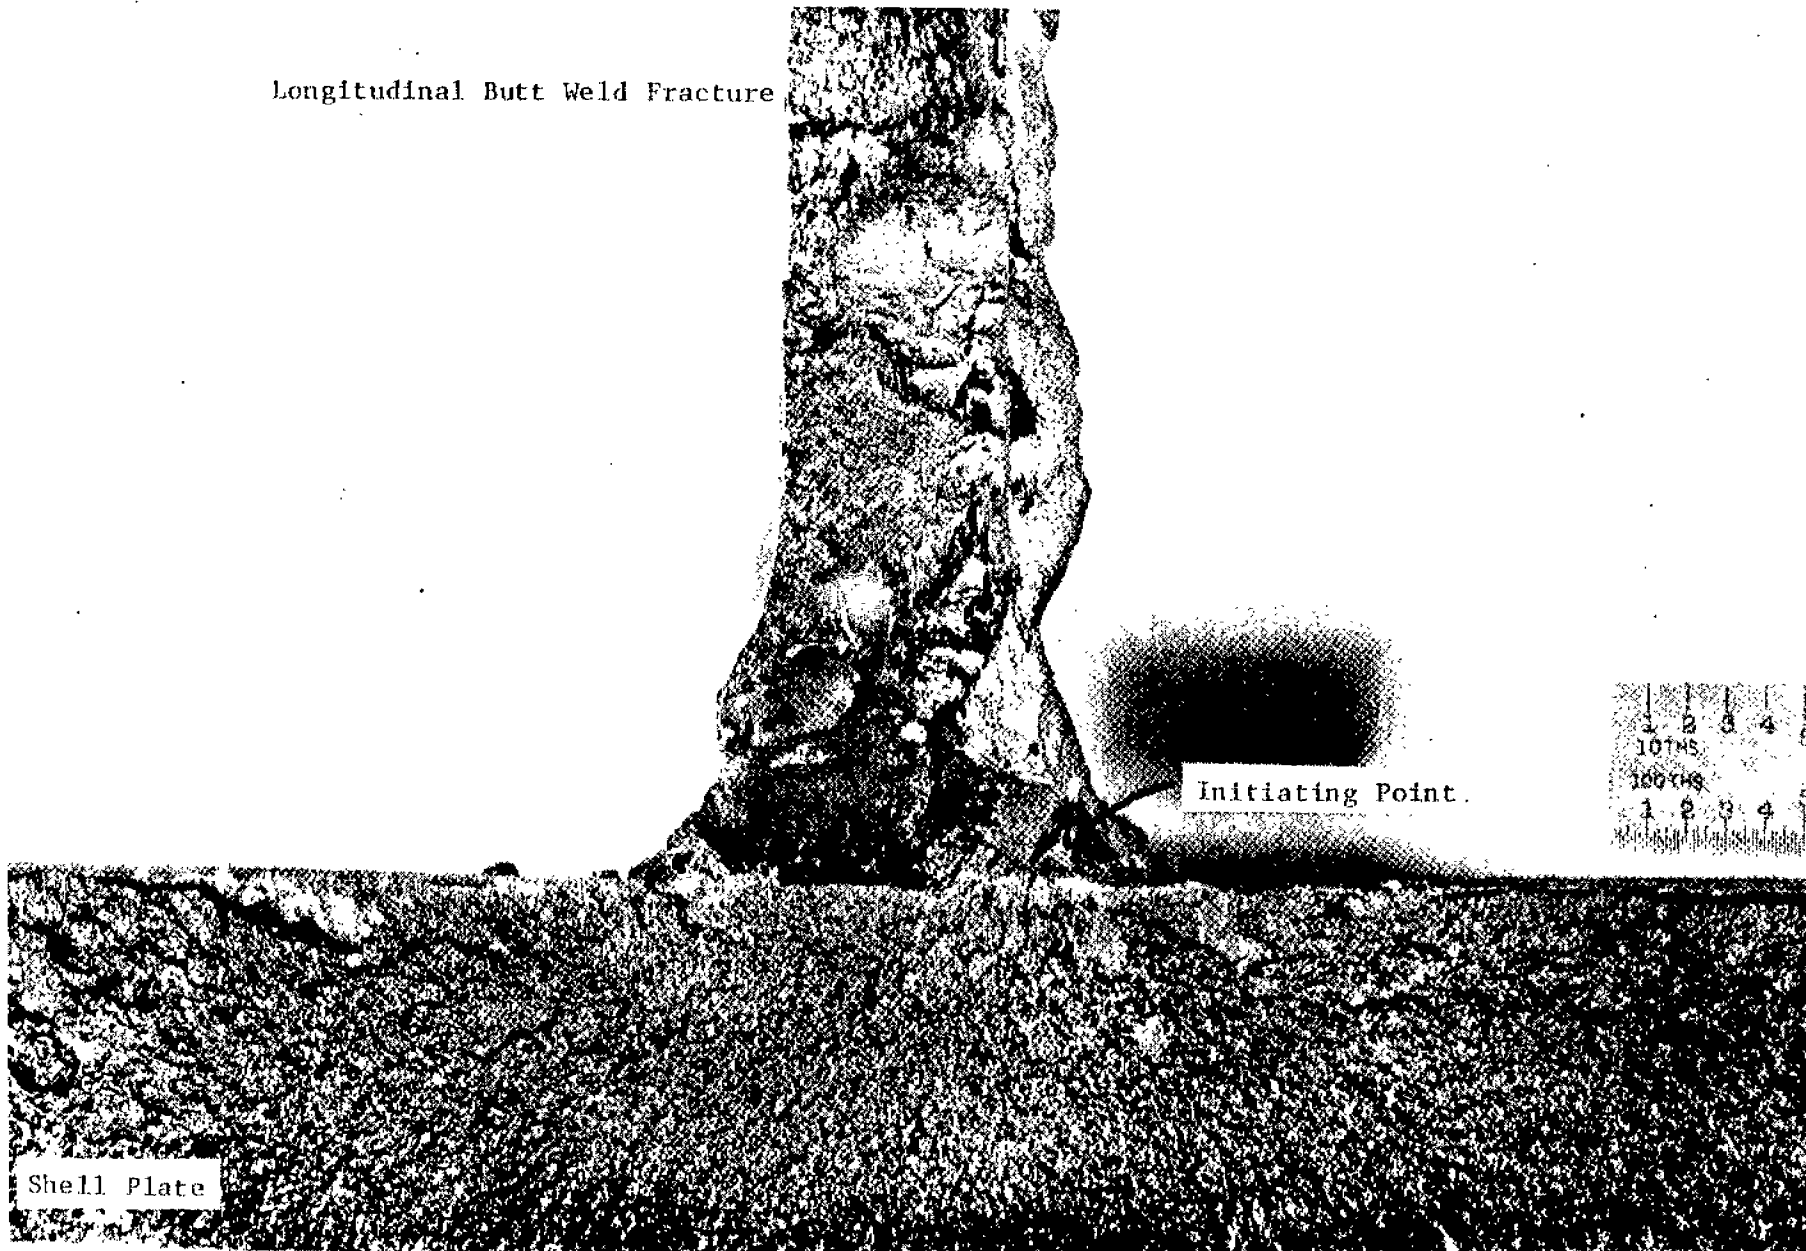
Figure 3-32 - Initiating point of brittle fracture in fillet weld joining No. 5 longitudinal to the shell plate. Specimen No. 3908; Magn. 2x.
