SSC-337

**SHIP FRACTURE MECHANISMS
INVESTIGATION**

SHIP STRUCTURE COMMITTEE

1990

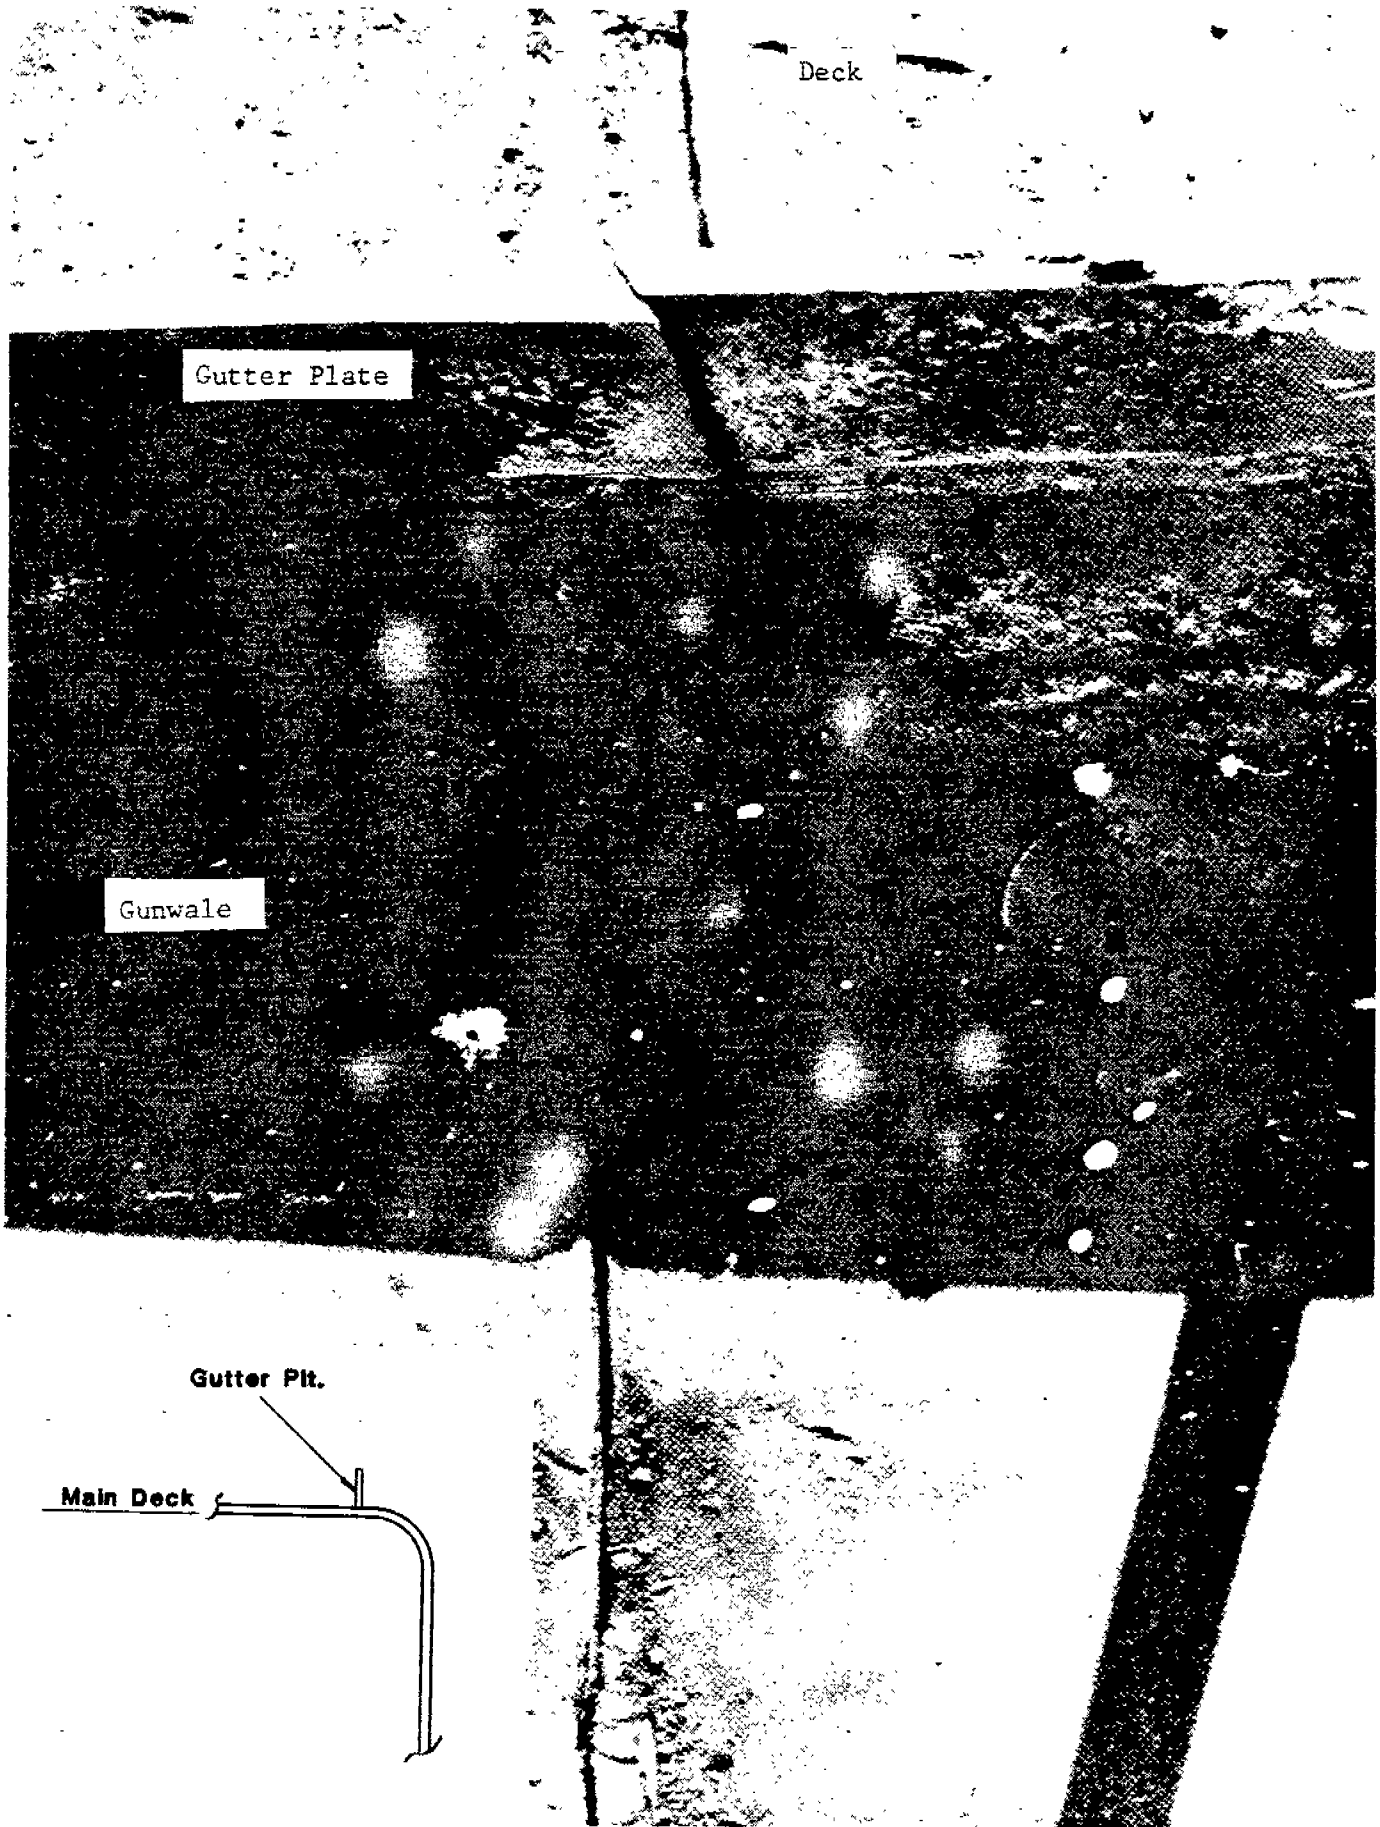
Figure 3-33 - Fracture as it passes from the gunwale plate onto the deck. Note path of fracture leaves the weld in the gunwale plate and runs parallel to the gunwale/deck weld.

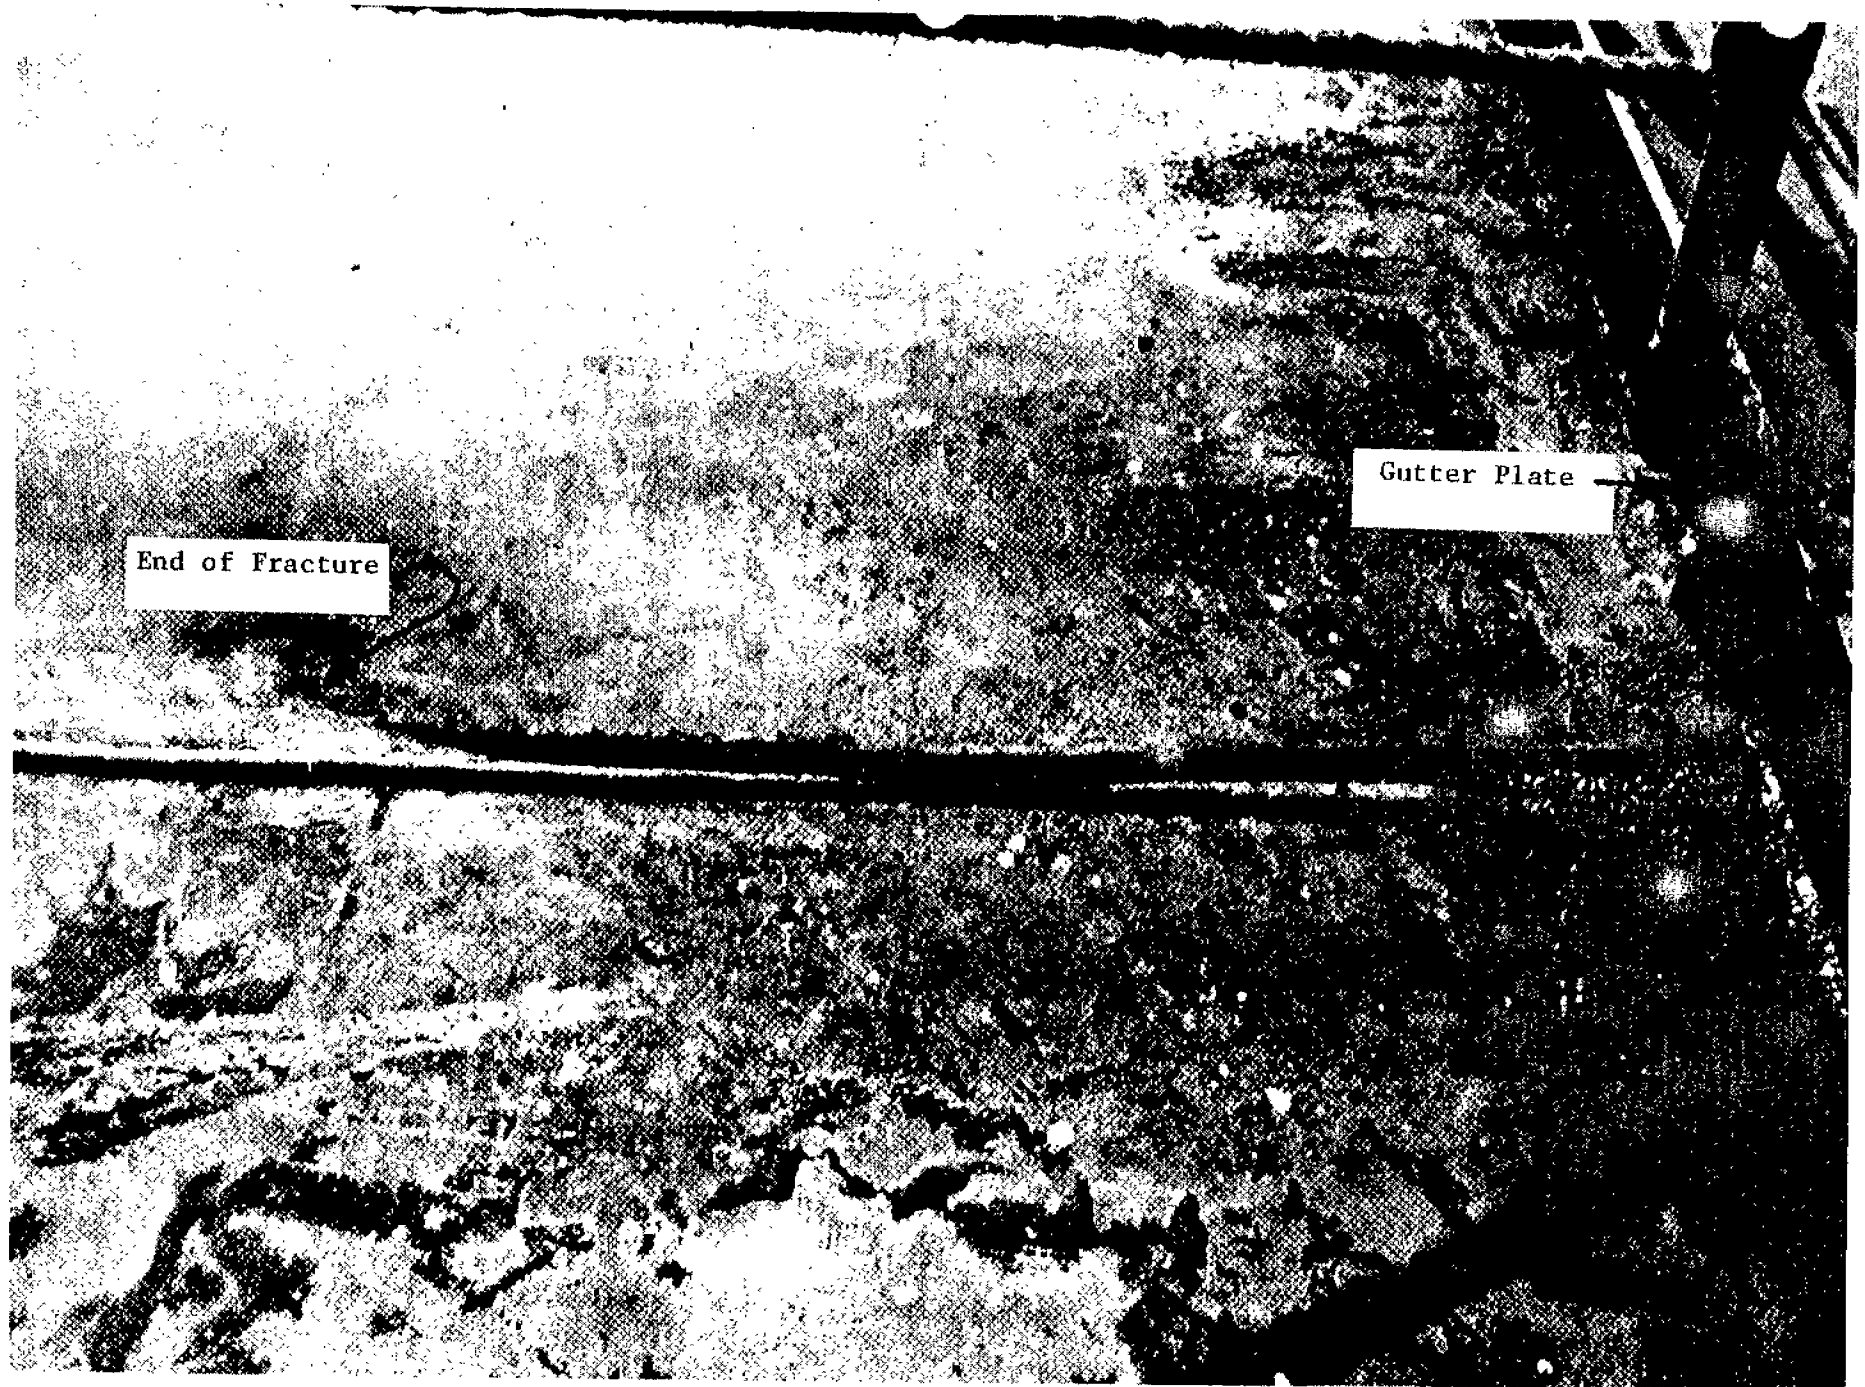
Figure 3-36 Fracture across the deck. Fracture was entirely in the plate with the fracture surface about 45° to the plate surface.

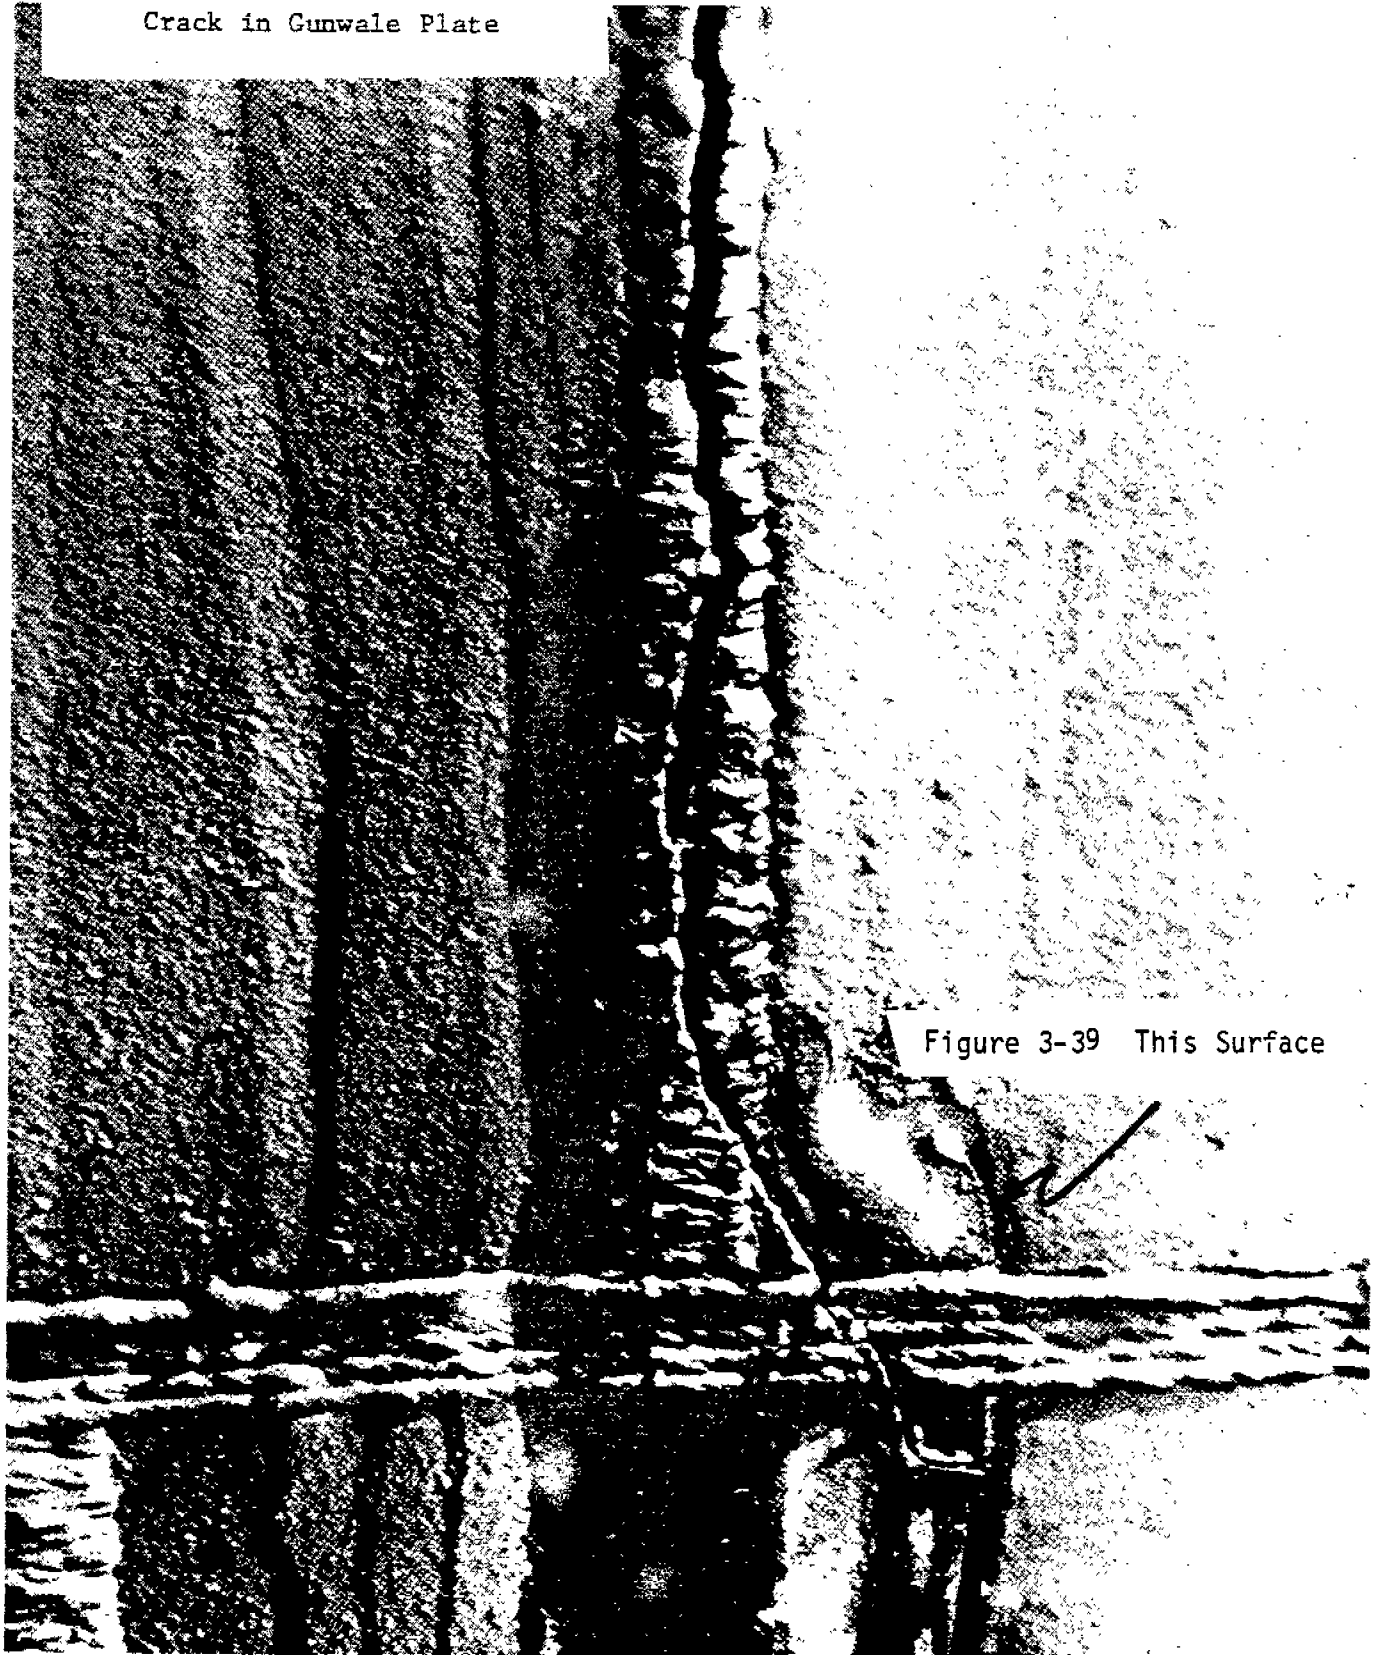
Figure 3-38 - Junction of main side shell fracture with the fracture through the weld of the gunwale plate.

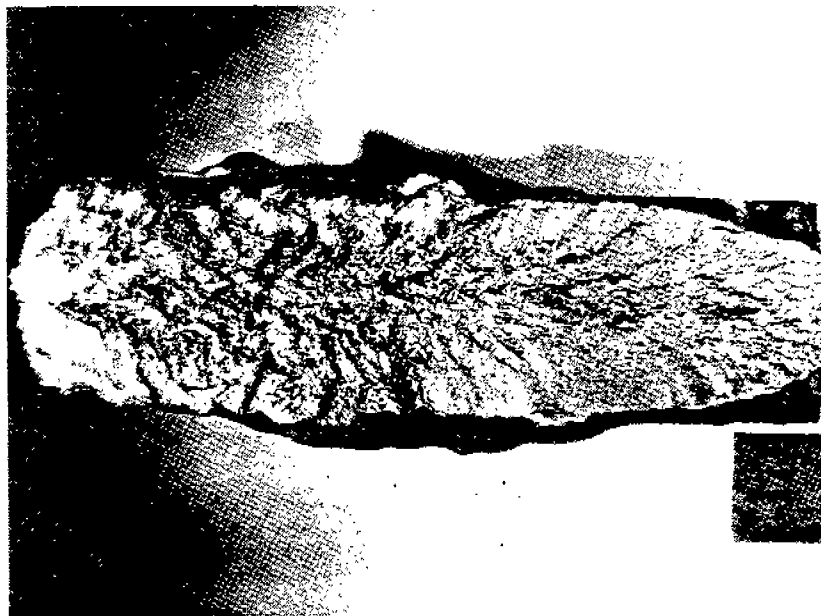
Figure 3-39 Fracture Face at End of Main Shell Fracture, see Figure 3-38. Note Chevron pattern and apparent "necking down" associated with fracture arrest. Specimen 3908, Magn. 1.2X.

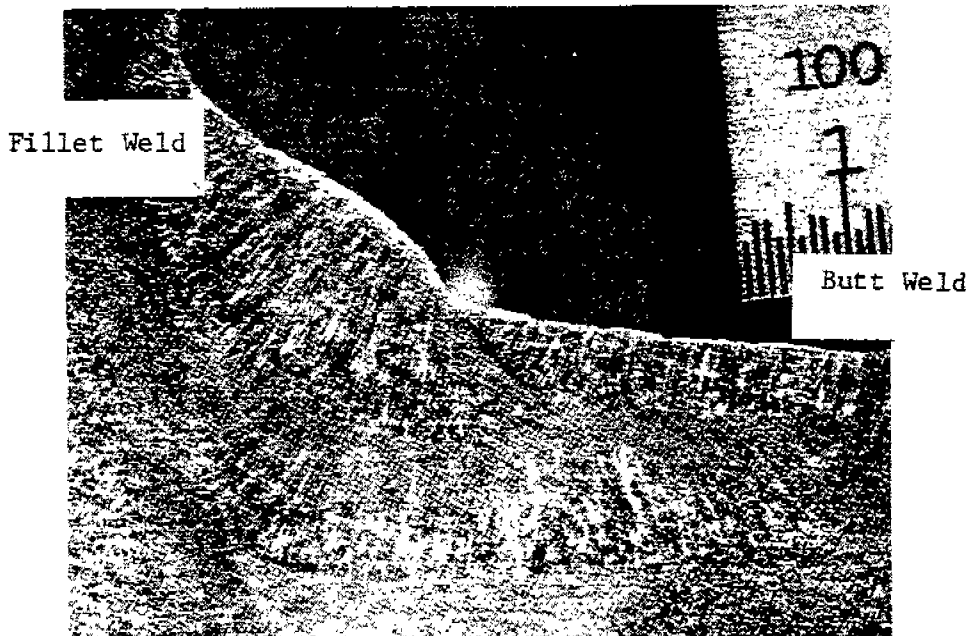
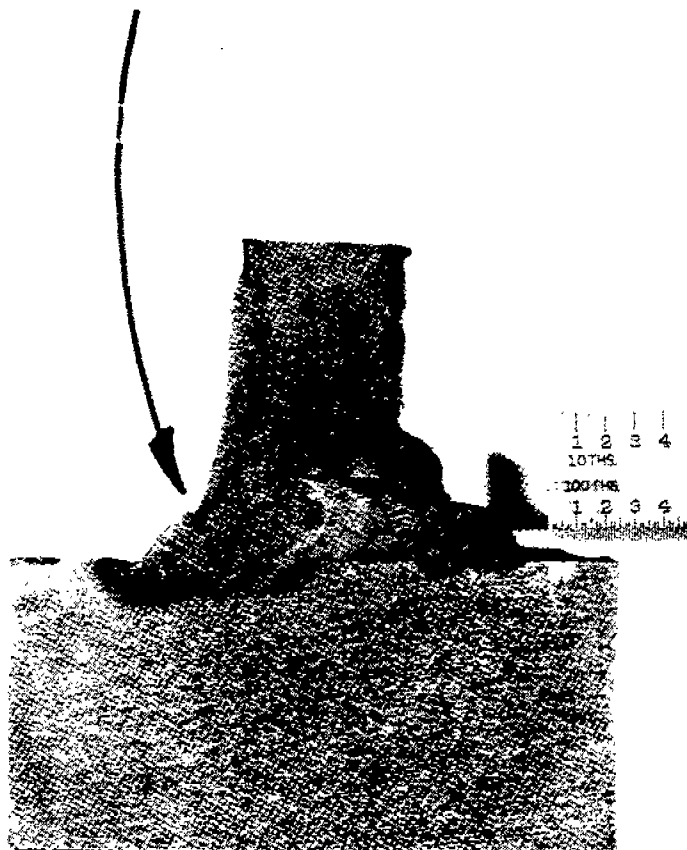
Figure 3-44 Juncture of Fillet and Butt Welds at Line A-B of Figure 3-43. Detail shows that butt weld was made over the fillet weld. Specimen No. 3908; Etch: Ammonium Persulfate; Magn. 1.5x & 5.7x.

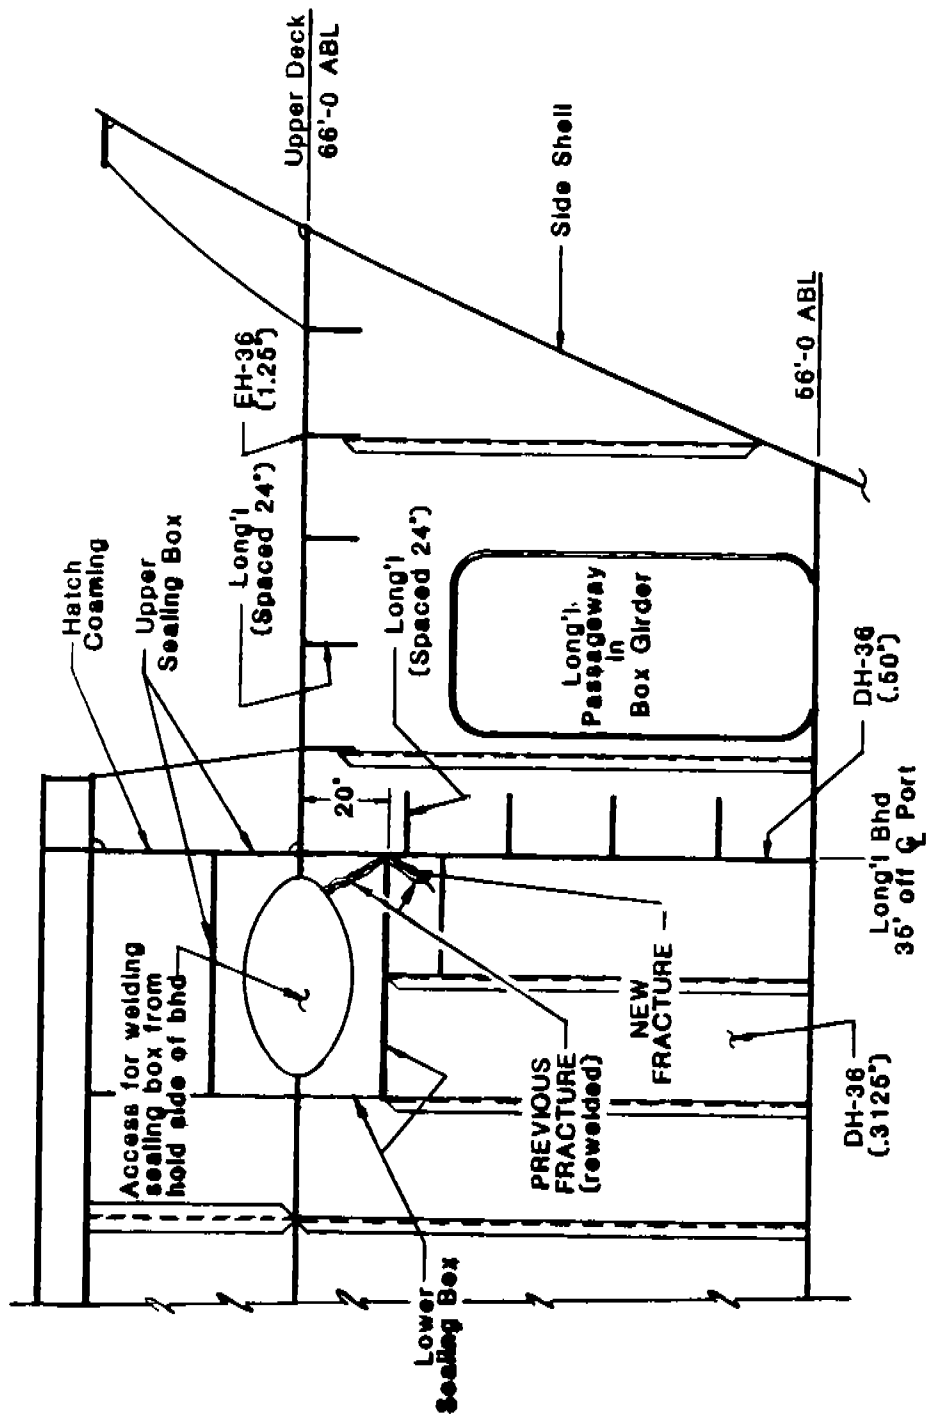
Figure 3-48 Fractured Transverse Bulkhead of a Containership

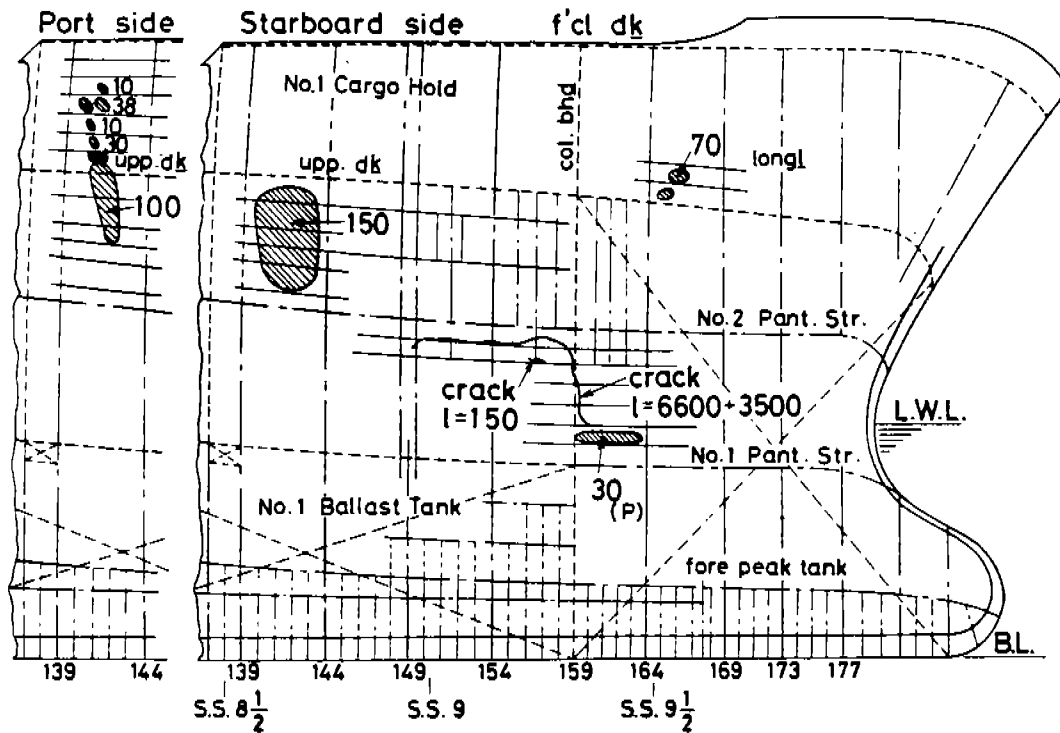
Figure 3-53 Shell Expansion and Fracture Location in the Containership Flare

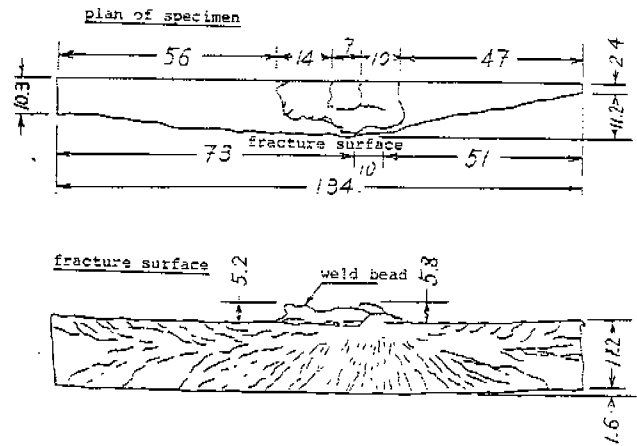
Figure 3-55 Location of the Fracture Origin of the Containership Bow Flare Fracture

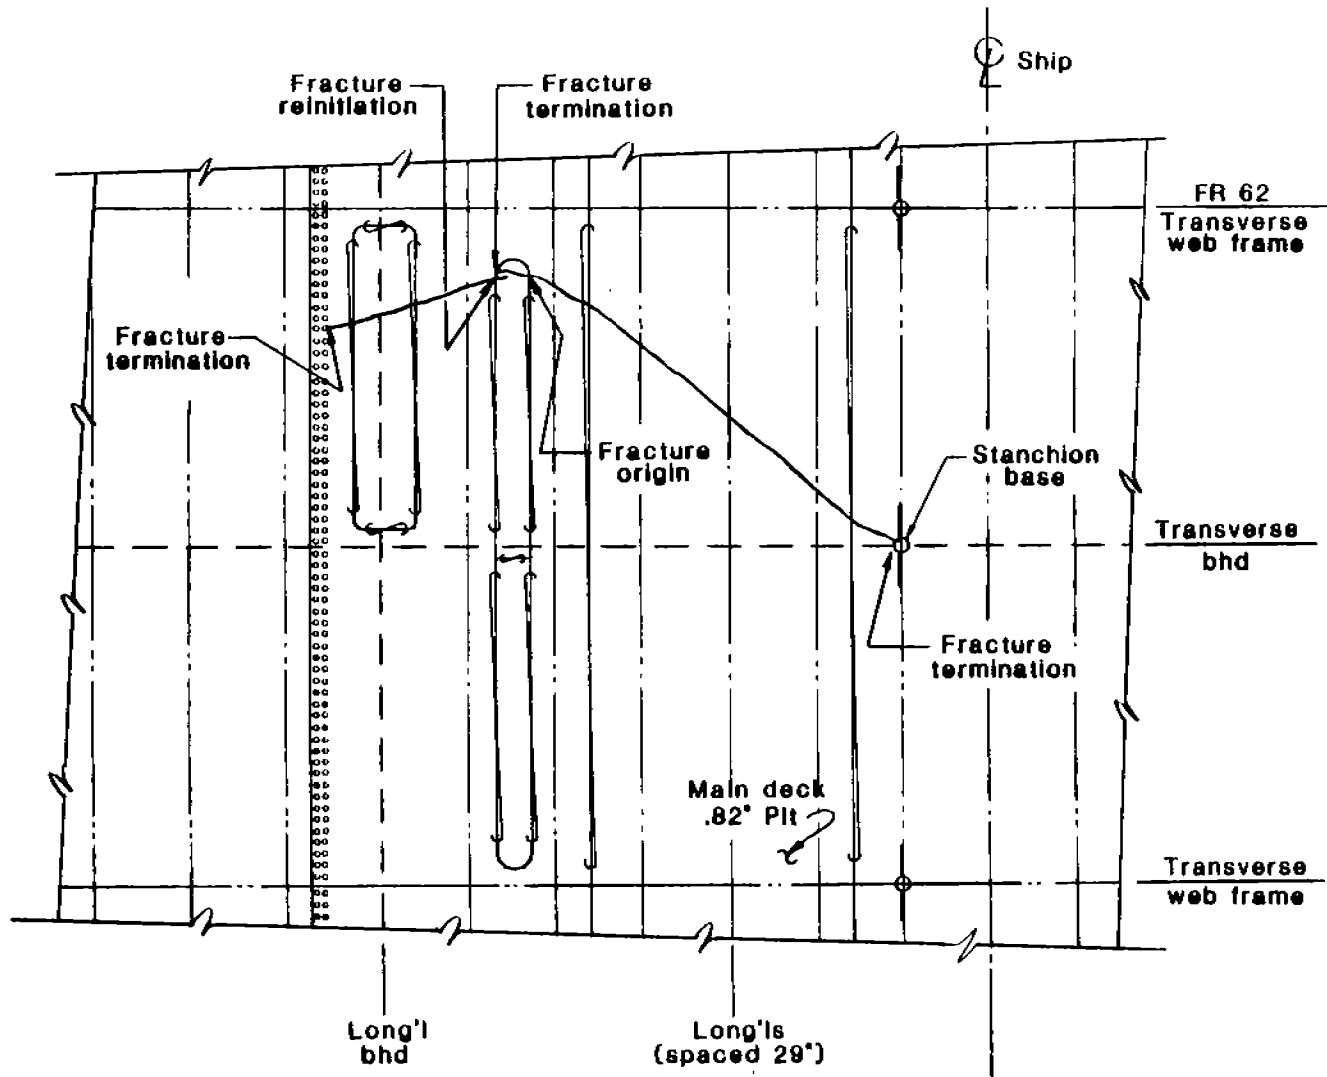
Figure 3-57 Fracture in the Deck of the Jumboized T-2 Tanker

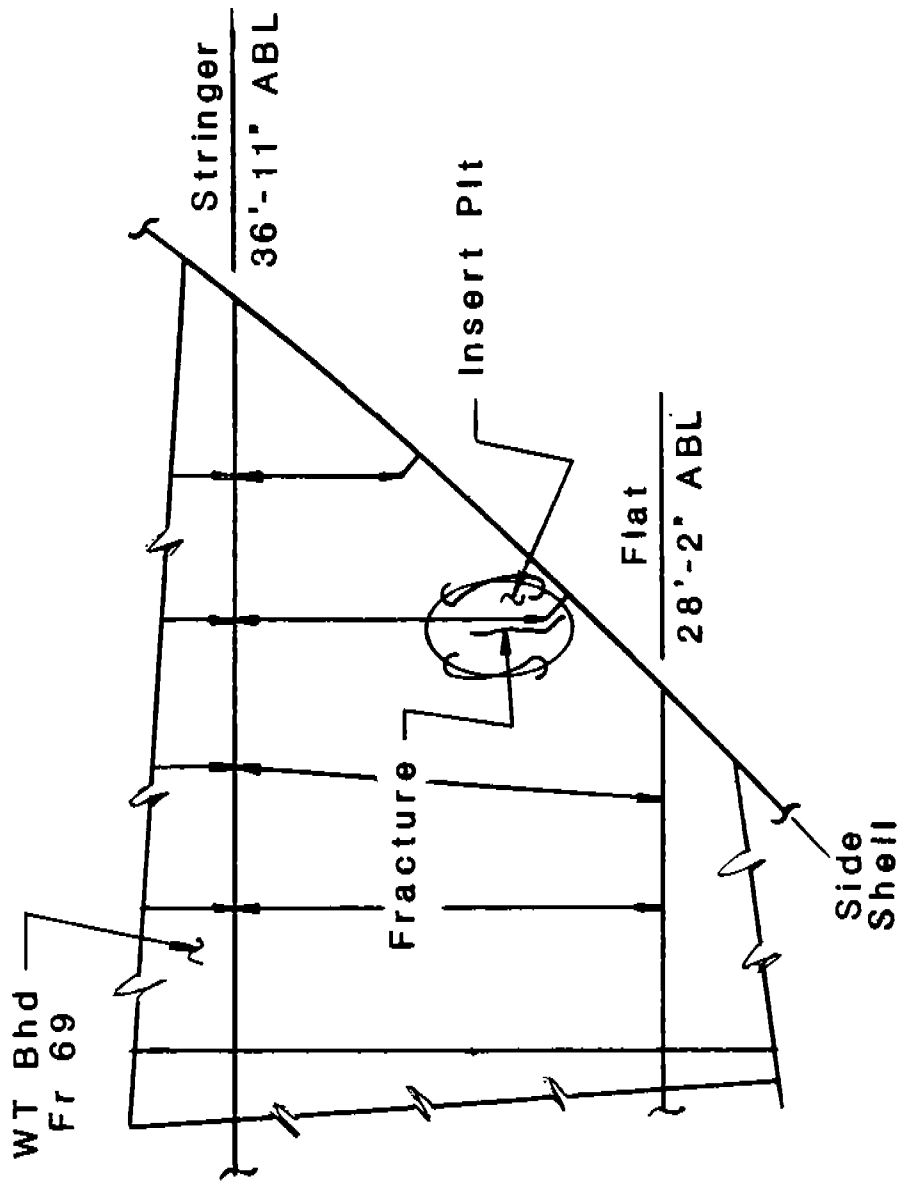
Figure 3-59 Fracture on the Transverse Bulkhead of a Tanker

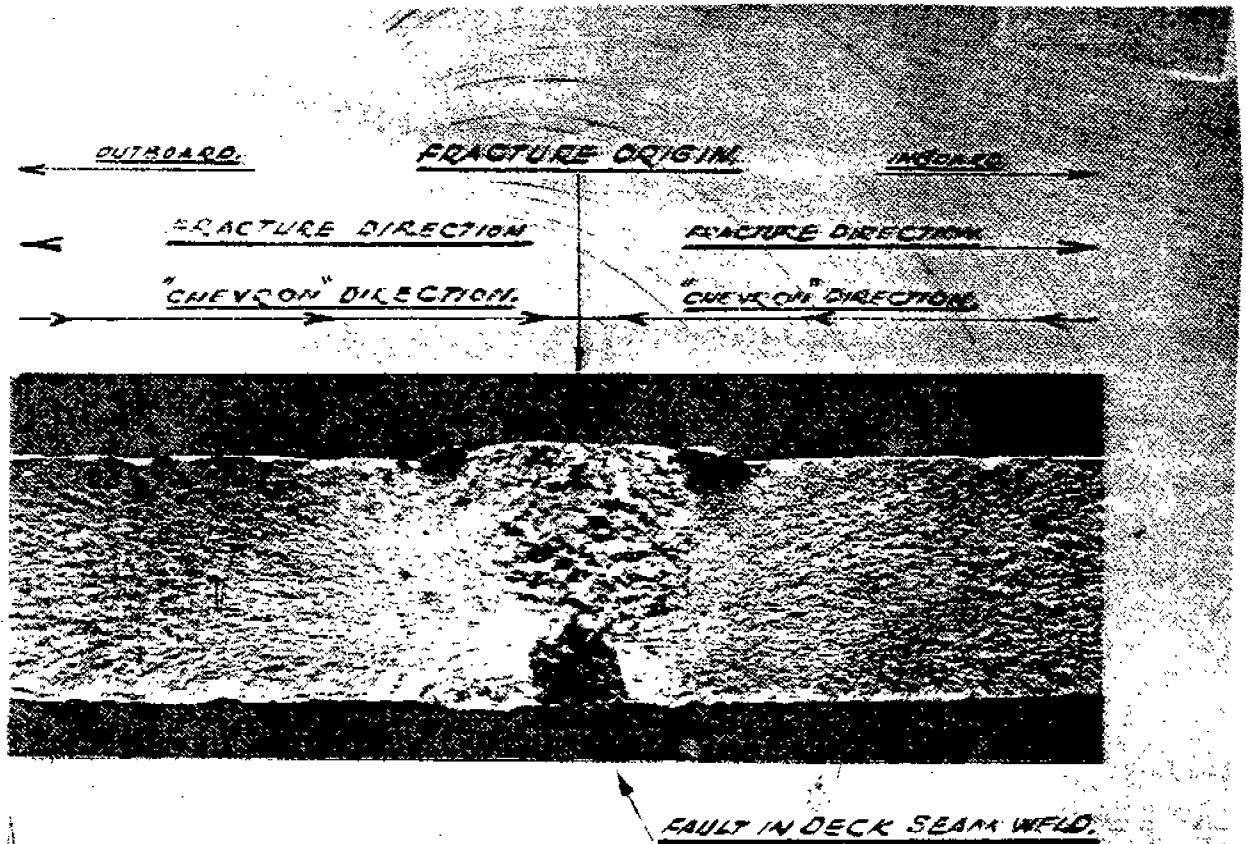
Figure 3-63 Fracture Origin of the Fracture on the Great Lakes Bulk Carrier

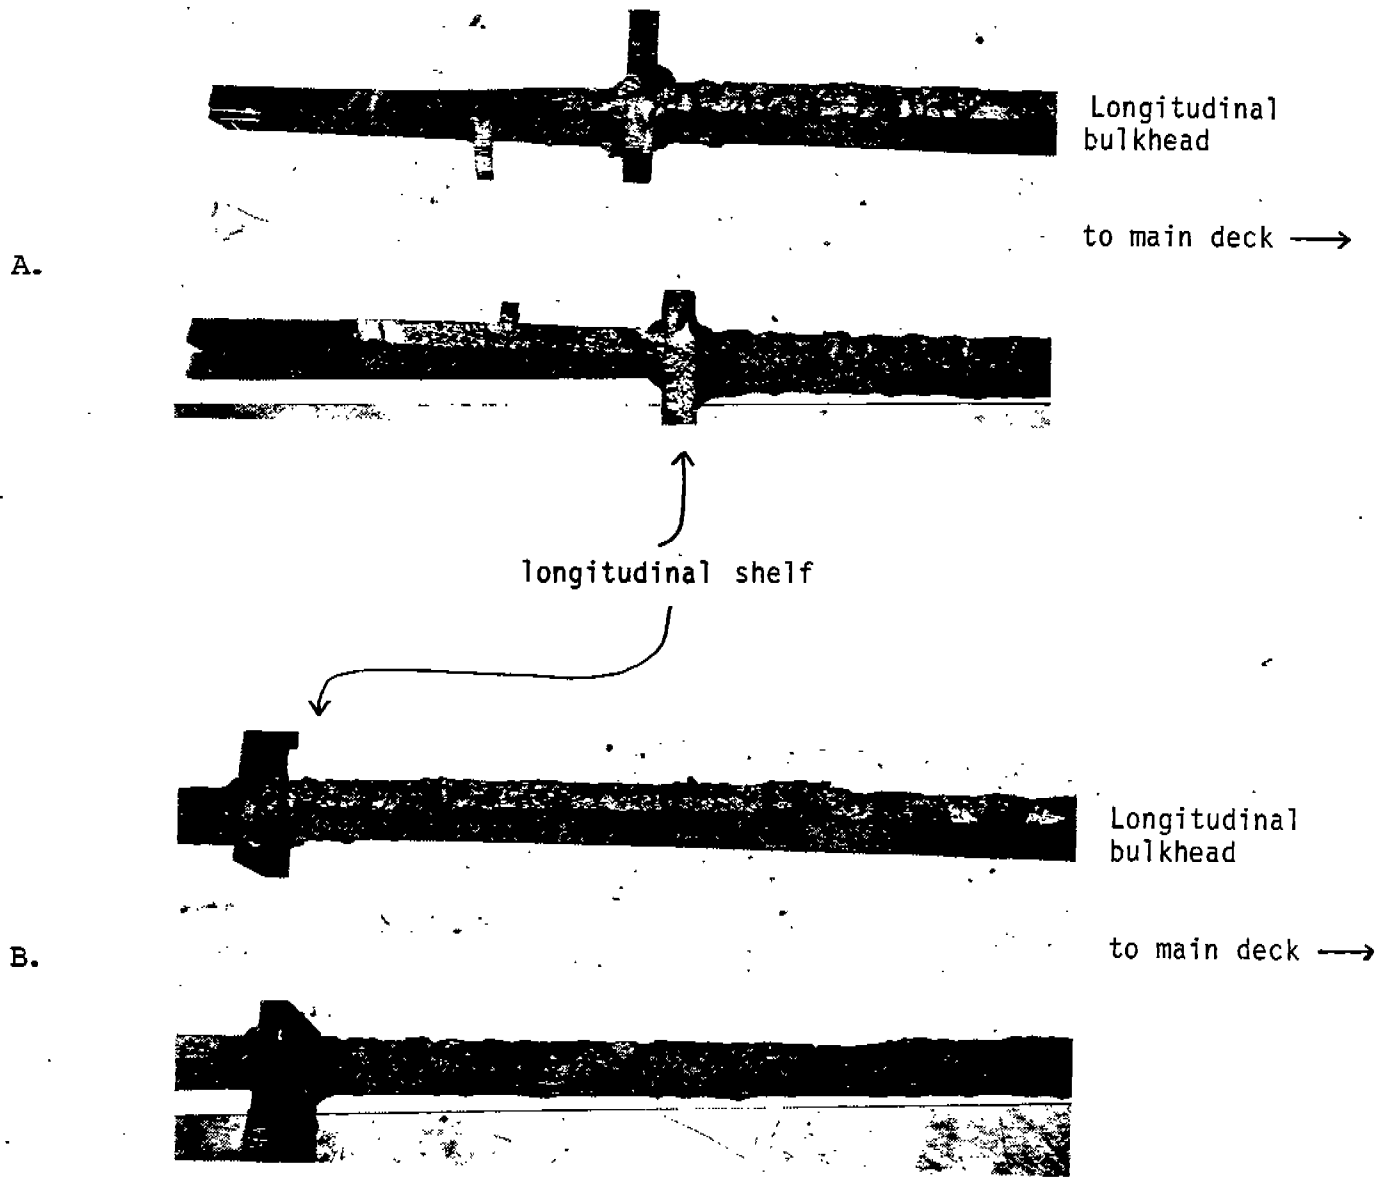
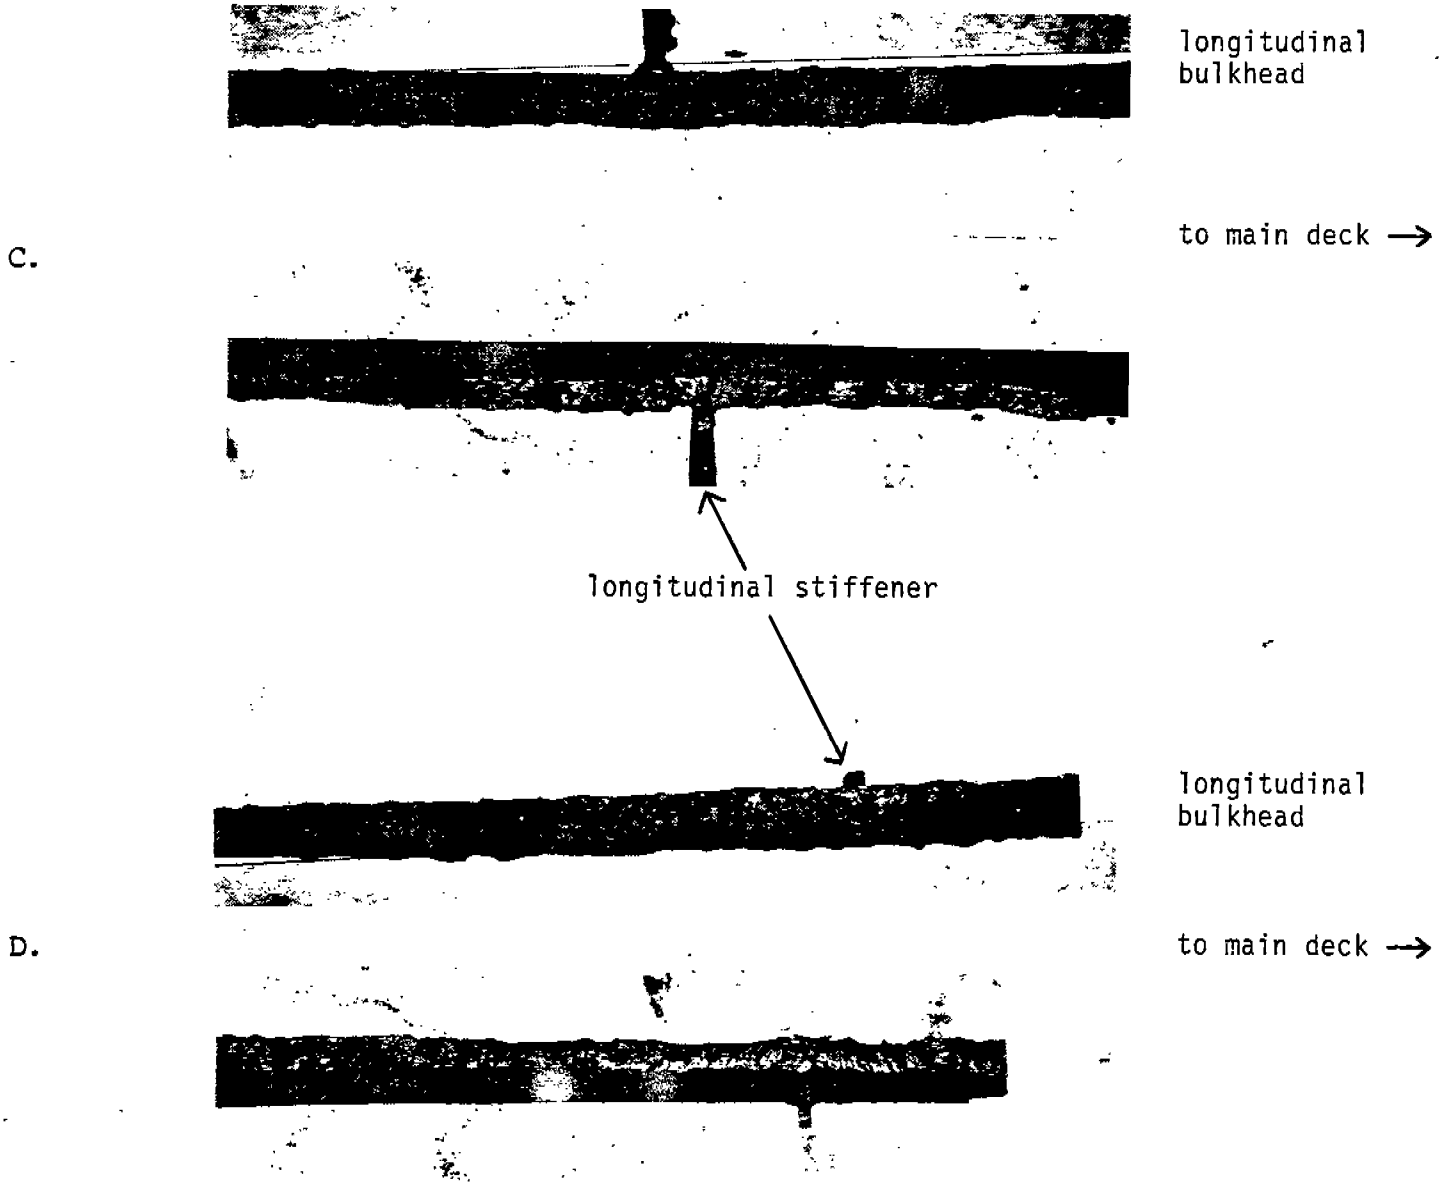
Figure 3-67 Details of the 123,000 DWT Tanker Fracture Surface

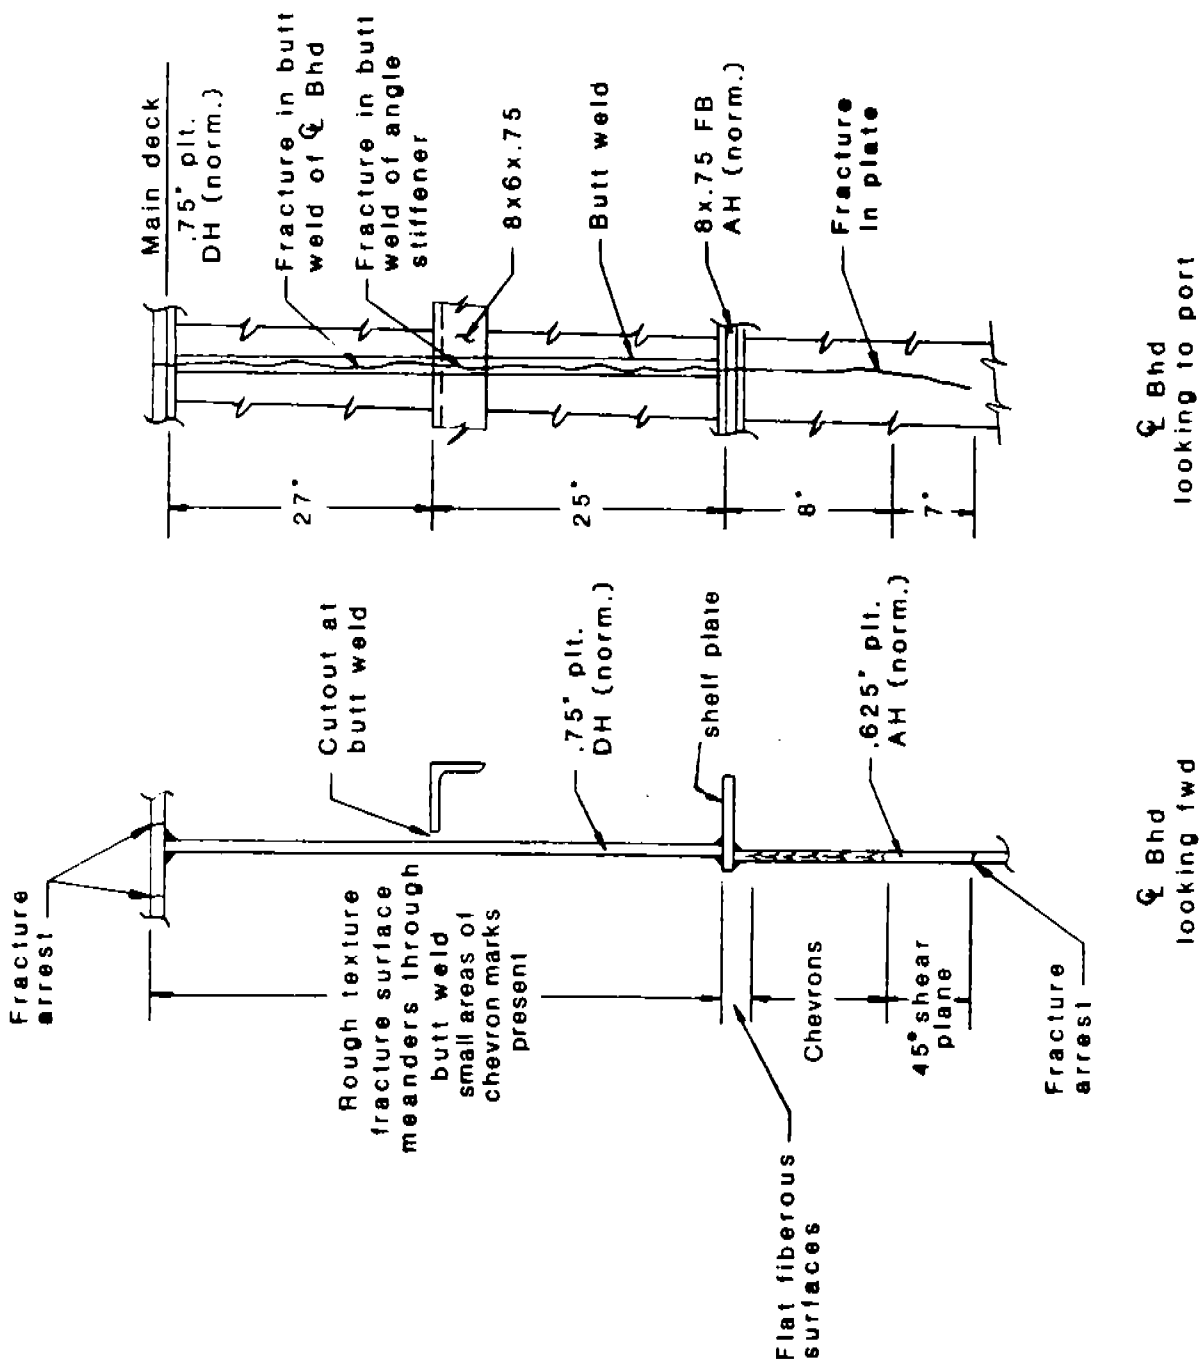
Figure 3-68 Key Illustration of the Longitudinal Bulkhead Fracture

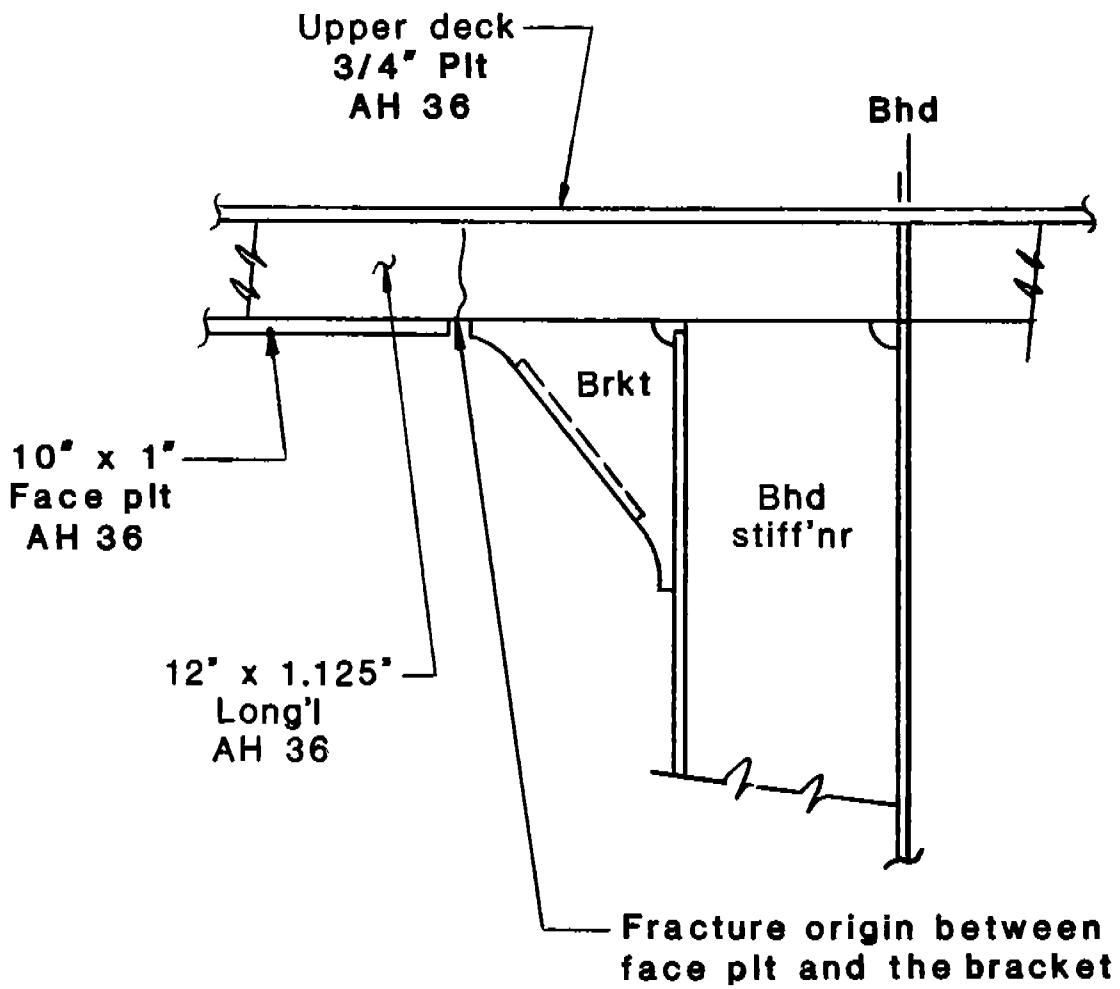
Figure 3-71 Structural Detail at the Origin of the Fracture in the 173,000 DWT Tanker
