A CRITICAL SURVEY
of
**BRITTLE FAILURE IN CARBON PLATE STEEL STRUCTURES
OTHER THAN SHIPS**

by
M. E. SHANK
Massachusetts Institute of Technology

Prepared for
**NATIONAL RESEARCH COUNCIL'S
COMMITTEE ON SHIP STRUCTURAL DESIGN**
Advisory to
SHIP STRUCTURE COMMITTEE

December 1, 1953

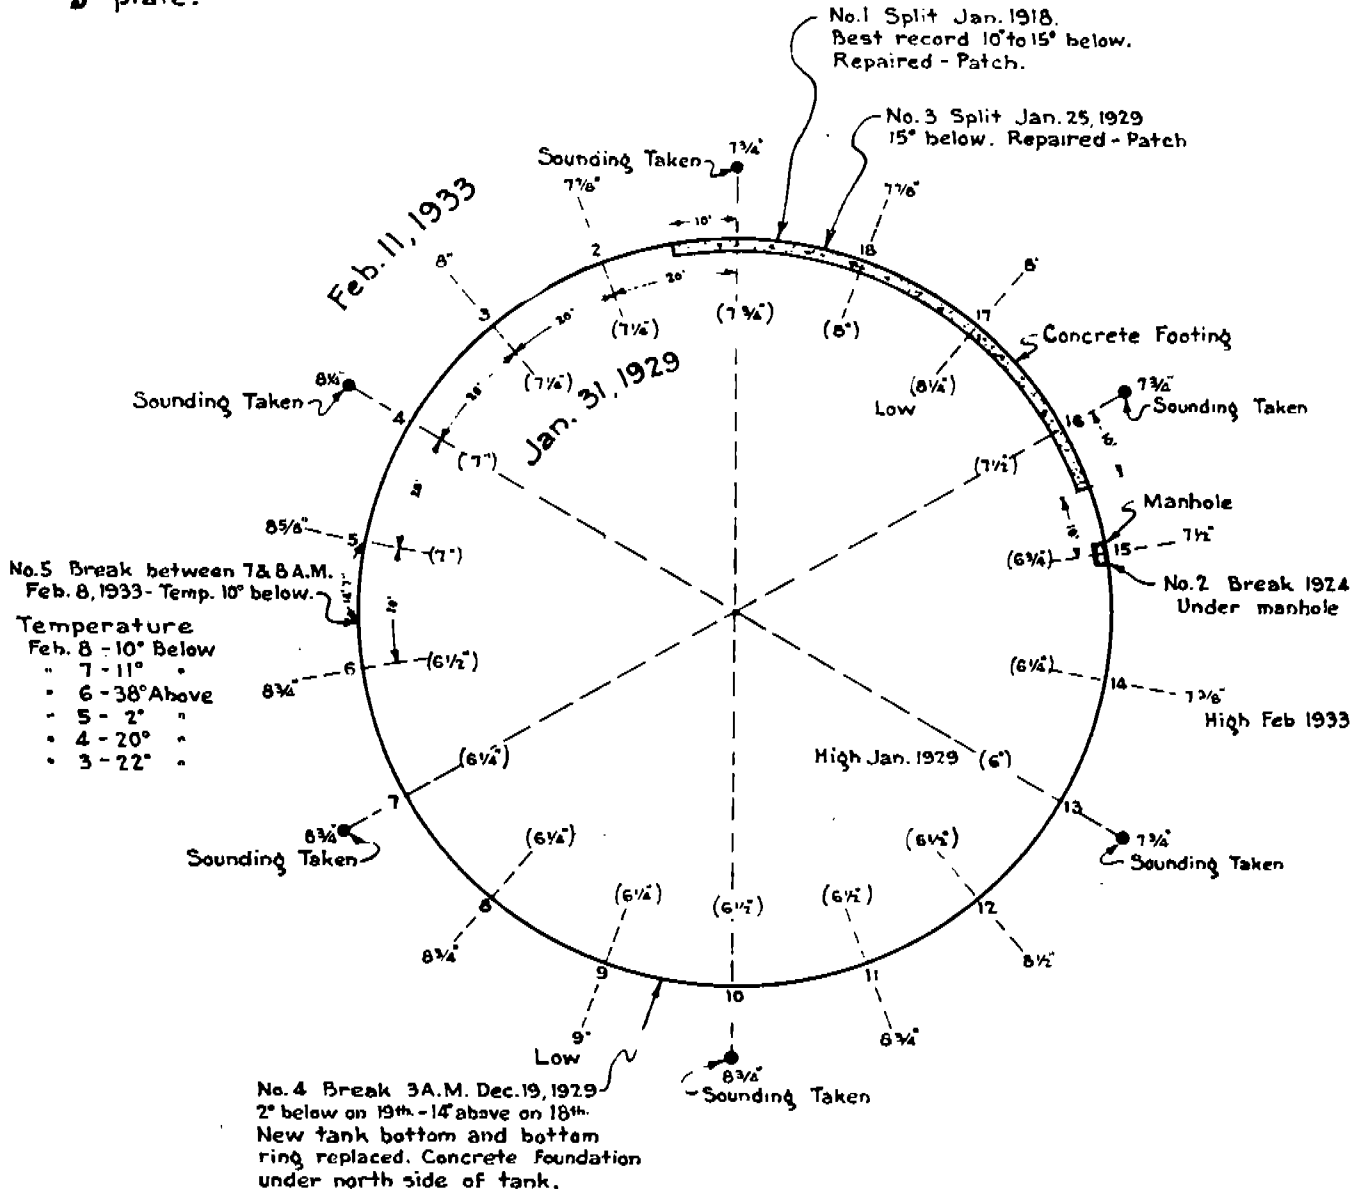
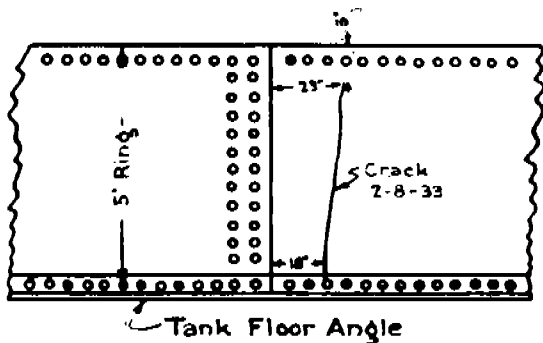
Fig. 1 Failures in riveted crude oil storage tank No. 1

1. January 1918: A split occurred in the lower ring of the tank with the result that leaking oil overflowed the fire walls. The temperature at the time of the break was below zero. The tank was repaired with a patch and replaced in service.

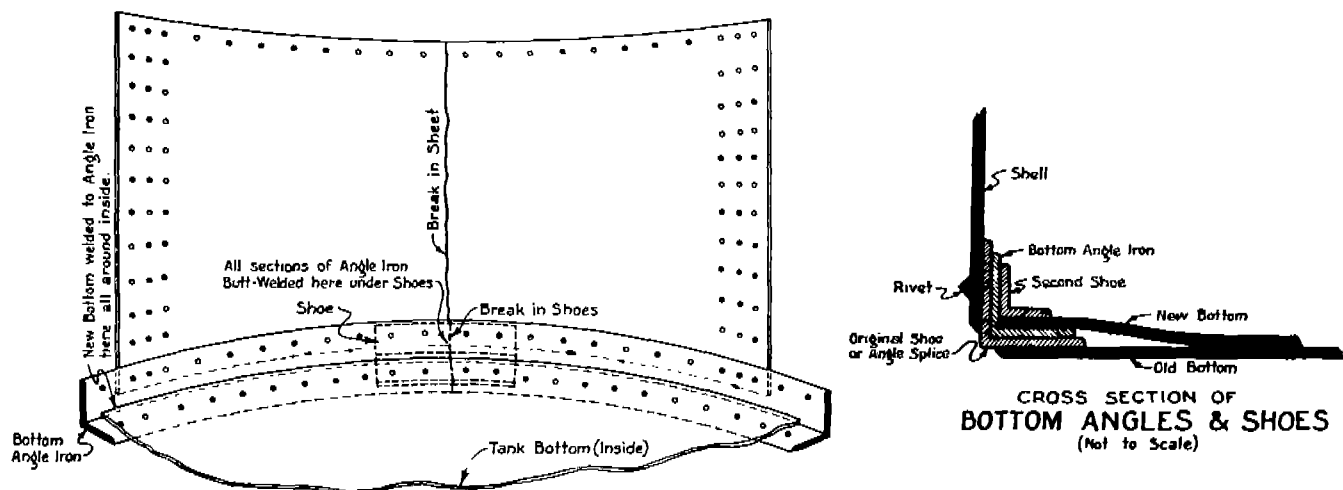
Fig. 2. Section through double bottom, and detail of failure in 55,000-bbl riveted tank No. 2

through the original crack. Evidently the shell then failed in a horizontal direction along the line of the bulge and at the same time cracked vertically until there was a continuous tear from top to bottom. Then the ends adjacent to the tear began to swing outward, the tendency being to straighten out the shell. Pieces were torn off from each end and carried away by the flow of oil. The reaction of the oil approximately opposite the point of original failure pushed over the adjacent shell and laid it on the ground with the inside uppermost. The roof remained attached to this portion of the shell and moved with it. The result was complete failure of the tank.

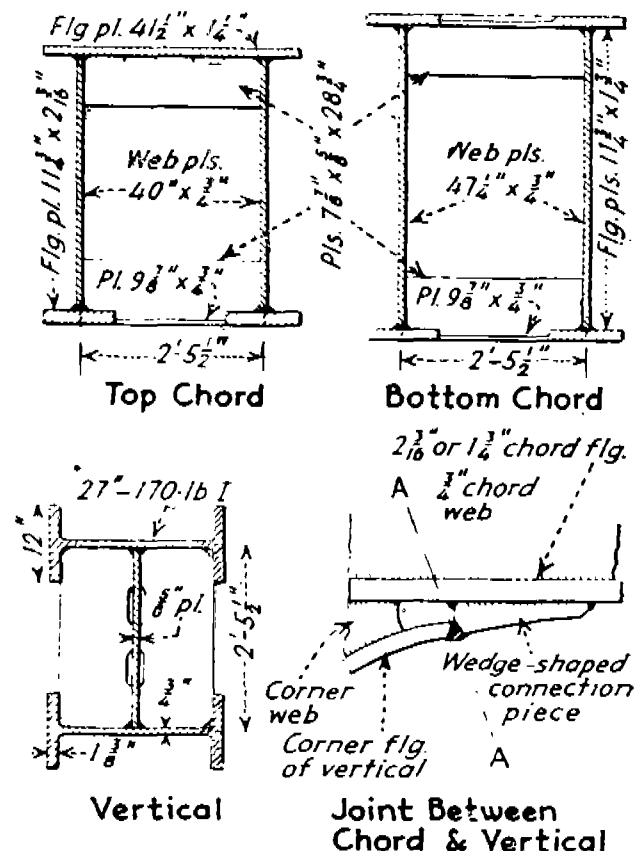
Fig. 6 Structural details of Hasselt bridge members. Numerous fractures occurred along line A-A²⁷

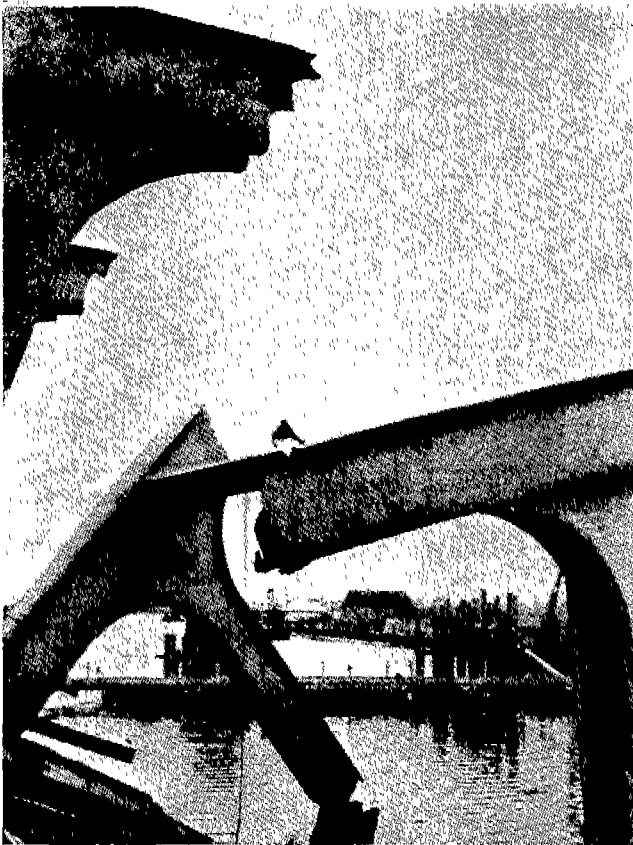
Figs 7 (left) and 8 Top chord breaks in Hasselt Bridge. Extreme brittle behavior of the steel is evident. Breaks occurred at or near junctions of verticals with chord flanges

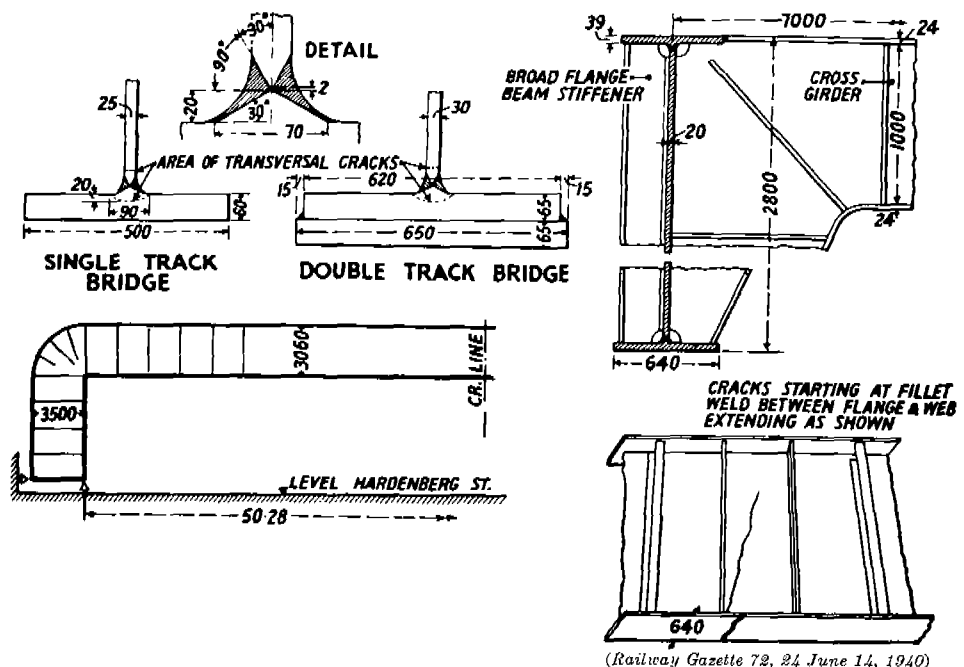
Fig. 11 Details of welded bridge failures. Left, at Zoological Gardens Station, and right, at Rudersdorf⁴²

the temperature suddenly dropped 10° C. Here also cracks started in the fillet weld between the lower flange and web, traveling up into the web, nearly across the girder, which was 2.8 m deep. The flange was 39 by 640 mm in cross section. (See Fig. 11.)

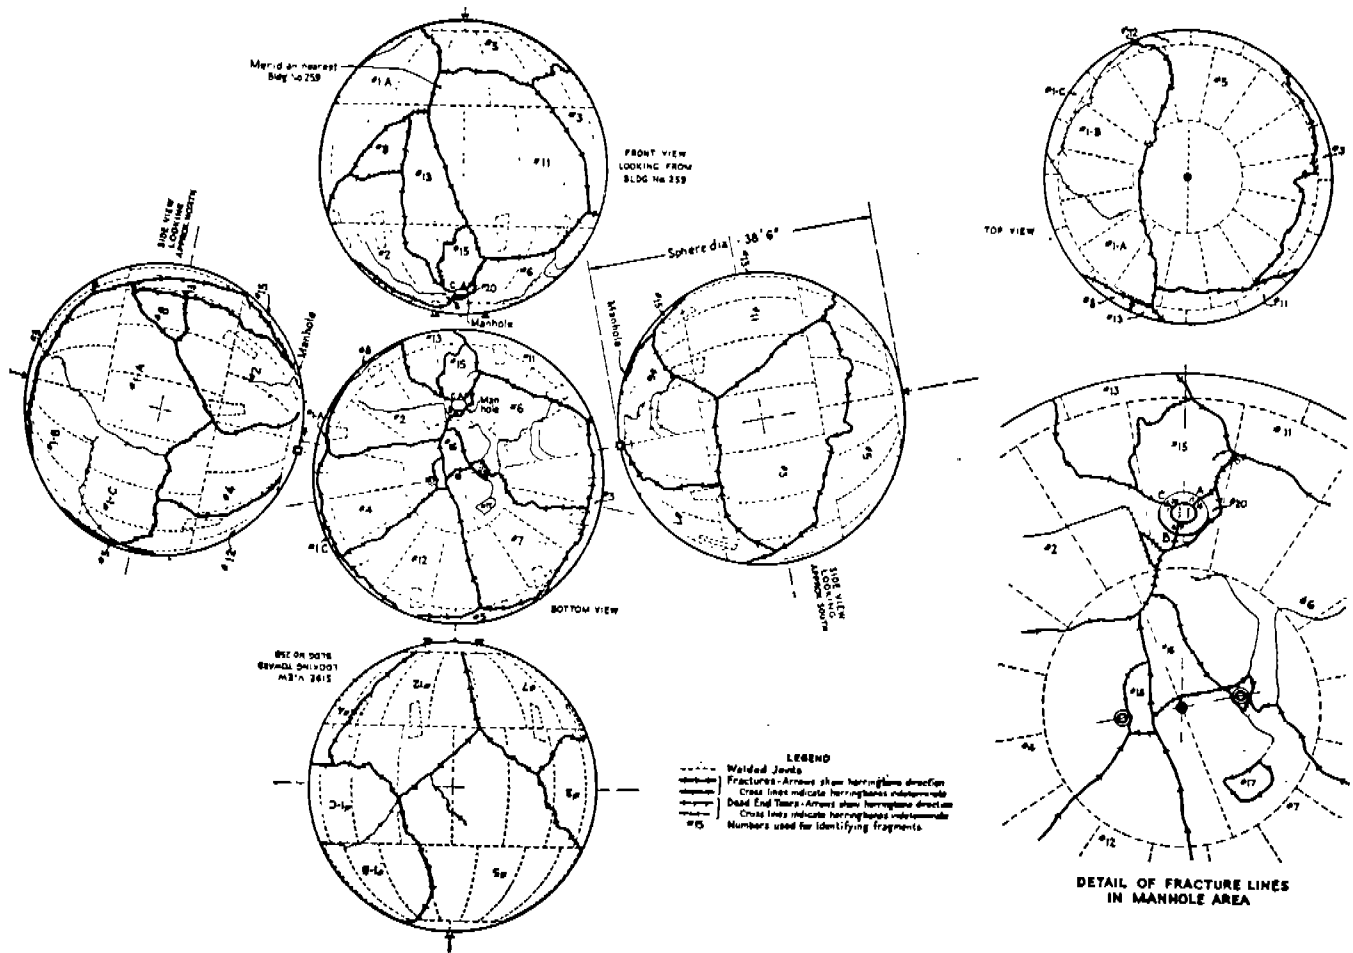
On the day of the fracture, the ambient temperature had been subzero, had risen 27° F in 7 hr, and was 10° F when failure occurred. The internal pressure was about 50 psi. The sphere burst catastrophically into 20 fragments, with a total of 650 ft of herringboned, brittle tears. The tears were plotted on a model, with directions of herringbones marked by arrows. All herringbones led back to the manhole, which was the origin of fracture. (See Fig. 12.) The intensity of the failure was greatest in the manhole region.

Fig. 12 Plot of failed hydrogen sphere at Schenectady, N. Y., showing path of brittle tears determined from the herringbone markings

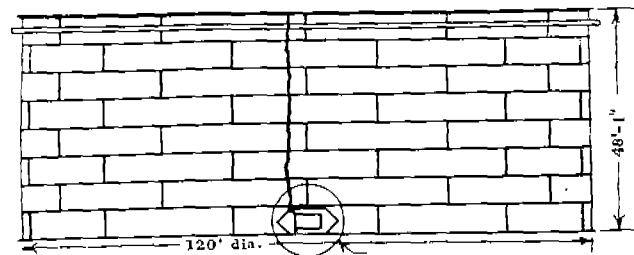
Fig. 14 Failed crude oil storage tank showing path of the crack through the tank shell

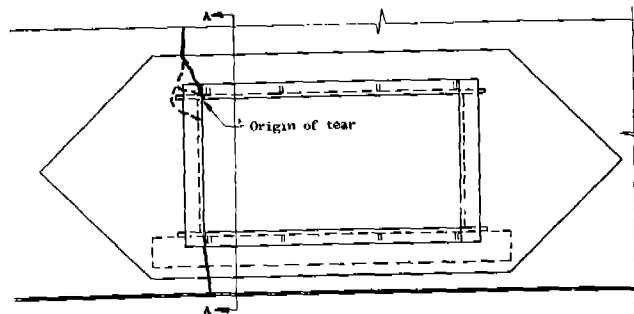
Fig. 15 Details of square cornered cleanout door in failed crude oil storage tank

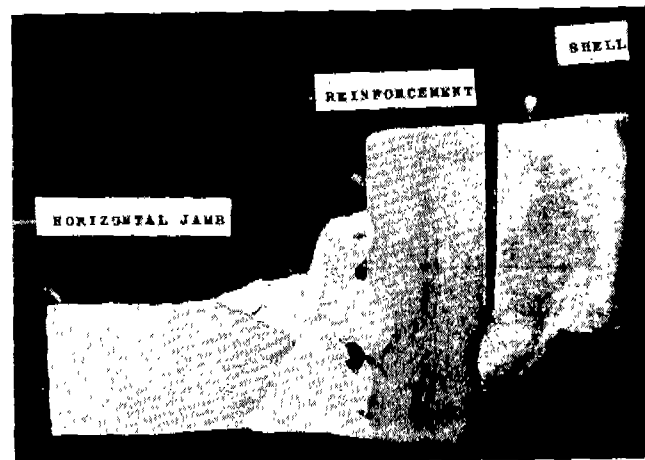
Fig. 16 Section through horizontal cleanout door jamb in failed crude oil storage tank. Note poor quality of welding as evidenced by cavities

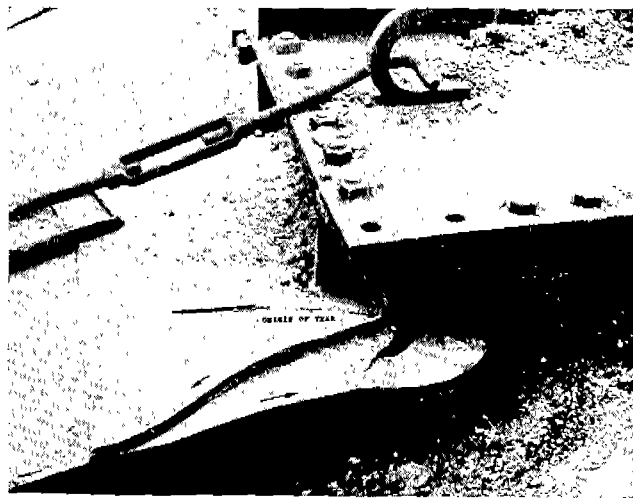
Fig. 17 Failed crude oil storage tank, showing brittle tear, with origin of fracture at corner of cleanout door reinforcing plate

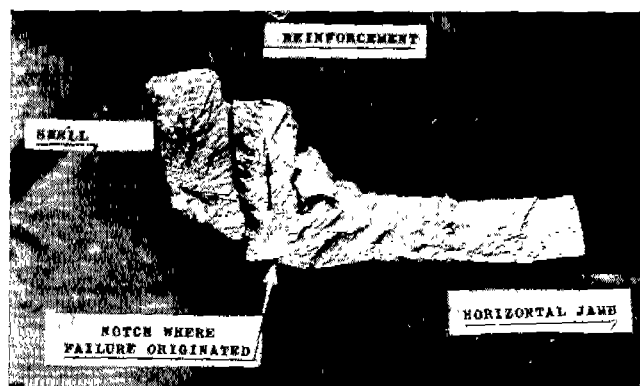
Fig. 18 Origin of fracture in failed crude oil storage tank. Arrow indicates direction of crack propagation

The investigation showed the computed stress to have been 19,000 psi, 1 ft above the lower edge of the bottom shell course, which was 0.66 in. thick. The cleanout door was rectangular with square corners, with a coincidence of a number of built-up plates and welds. It reminds one of Liberty ship hatch corners. (See Fig. 15.) The quality of welding around these corners was poor. (See Fig. 16.) Fractures exhibited typical herringbone markings. (See Fig. 17.) The origin of failure, Fig. 18, shows that the fracture was brittle from its inception, as is typical in most engineering structures.

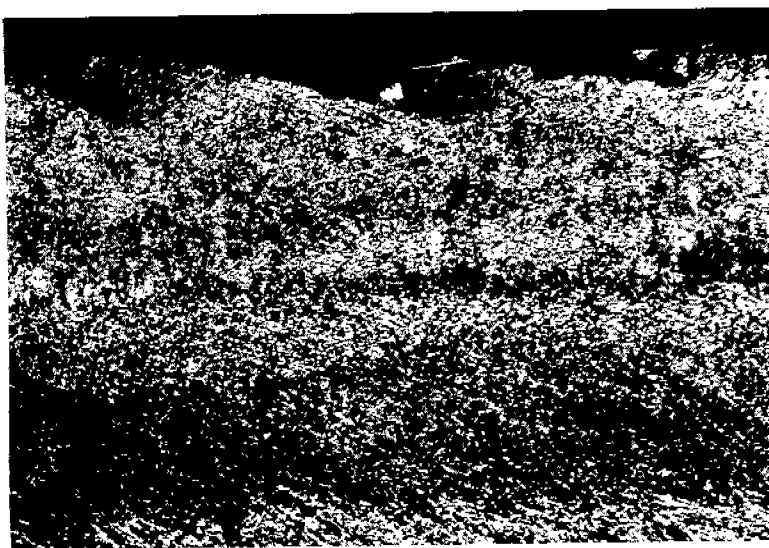
Fig. 21 European tank failures. Longitudinal section of weld, showing fissures caused by chipping tool. $\times 20$

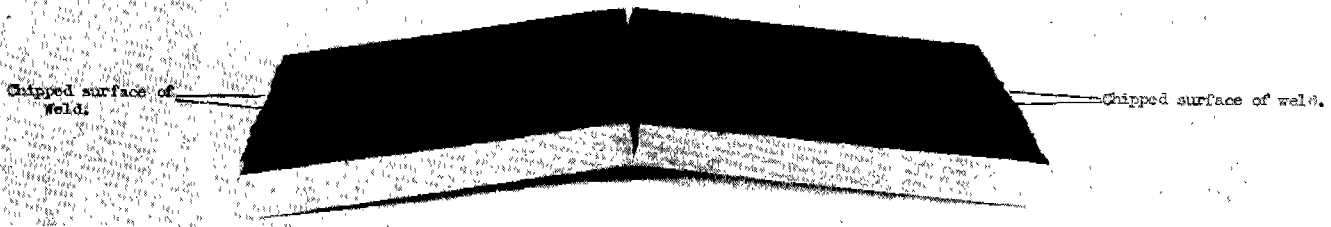
Fig. 23 European tank failures. Test plate bent at 0° C with chipped surface in tension. Brittle failure resulted. Approximately 1/4 actual size

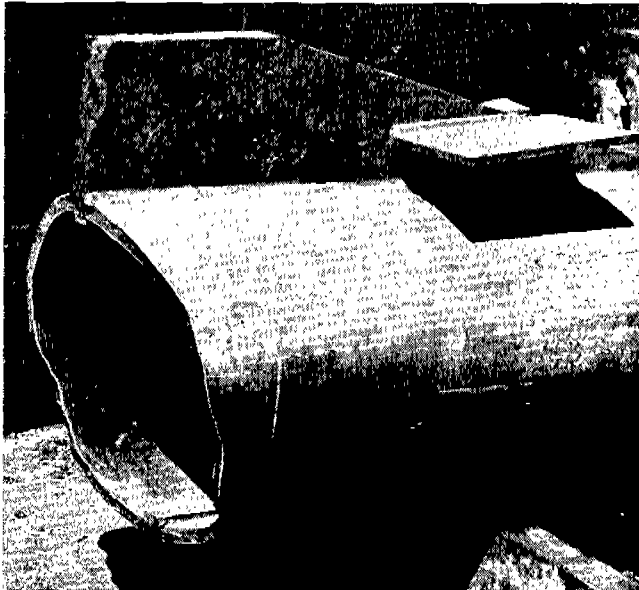
Fig. 24 Power shovel dipper stick, showing brittle failure which occurred at the bumper, which acted as a discontinuity

bumper, a piece which keeps the stick from moving too far. The bumper is a plate, sticking out in a radial plane from the tube, and as such is a discontinuity. Figures 24 and 25 show both halves of this failure. Similar failures had also occurred on other sticks at temperatures around 0 to 32° F, in all cases the failure passing through some obvious stress concentration or abrupt change in section. The circumferential and longitudinal welds have never been the source of any trouble.

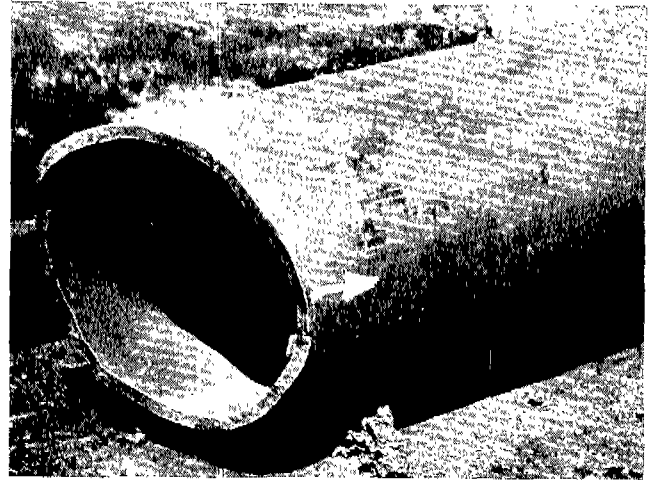
Fig. 25 Power shovel dipper stick. Mating half of fracture shown in Fig. 24

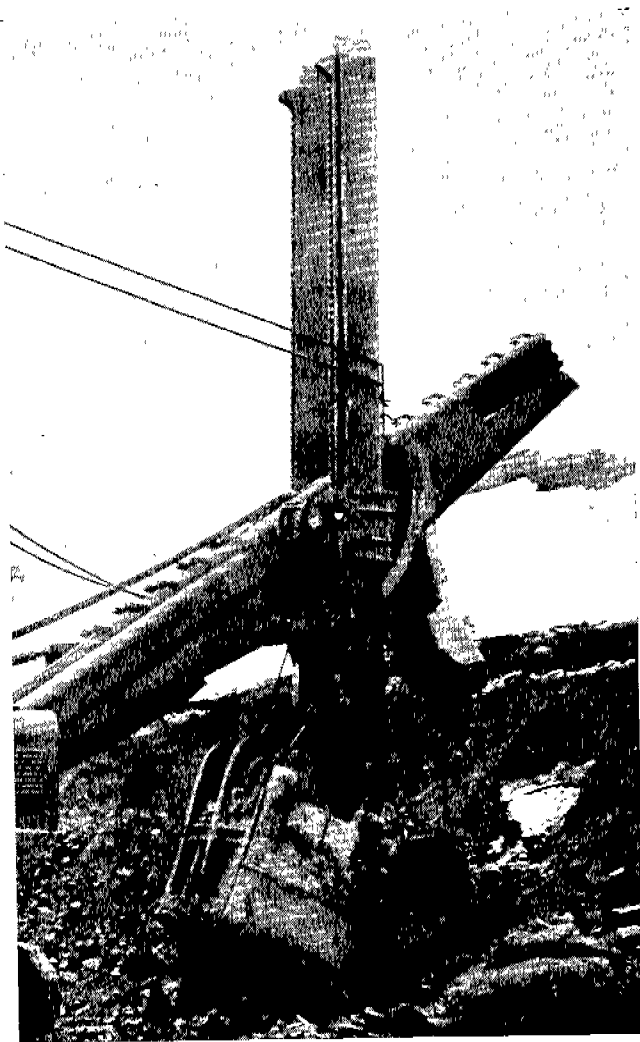
Figure 26 shows a boom which has had the end broken off. Figures 27 and 28 show the mating fractured sur-

Fig. 26 Failed power shovel boom. The end of this boom has broken off

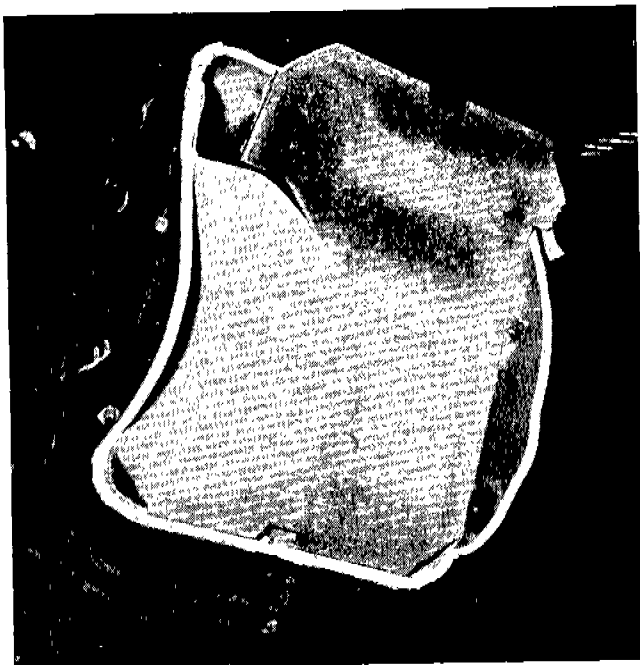
Fig. 27 Failed power shovel boom showing half of the fracture surface. Diaphragm plate and one of the backing bars appear

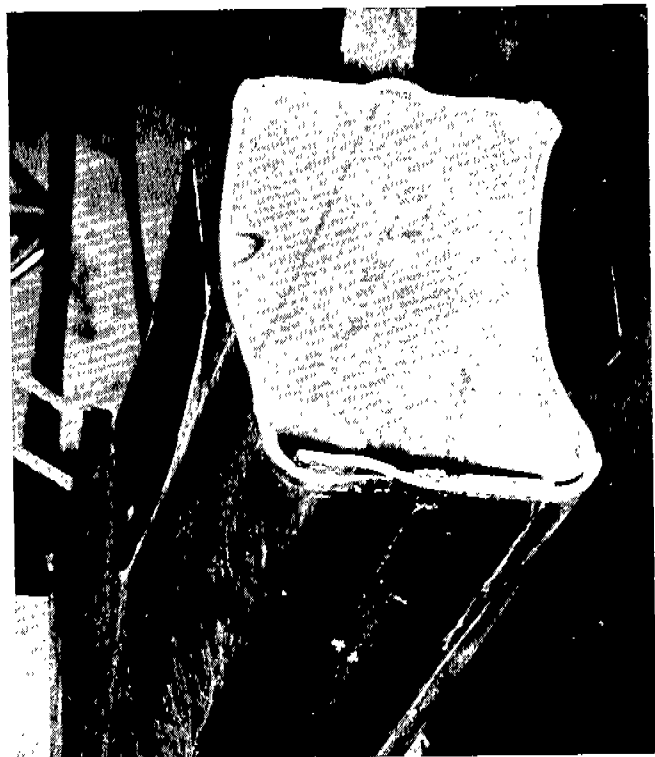
Fig. 28 Failed power shovel boom, showing other half of fracture. Both Unionmelt backing bars are shown

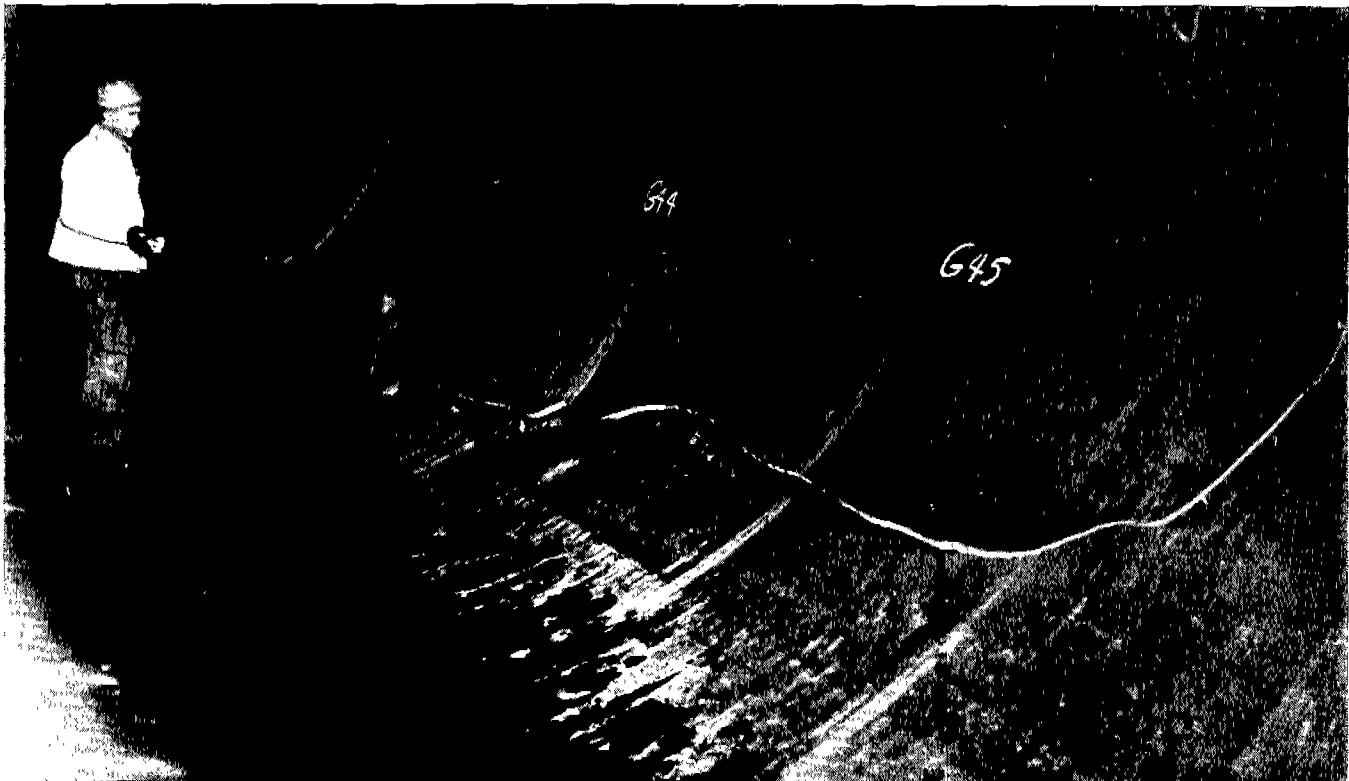
Fig. 30 Penstock failure. Proof hydrostatic pressure test produced a longitudinal brittle failure

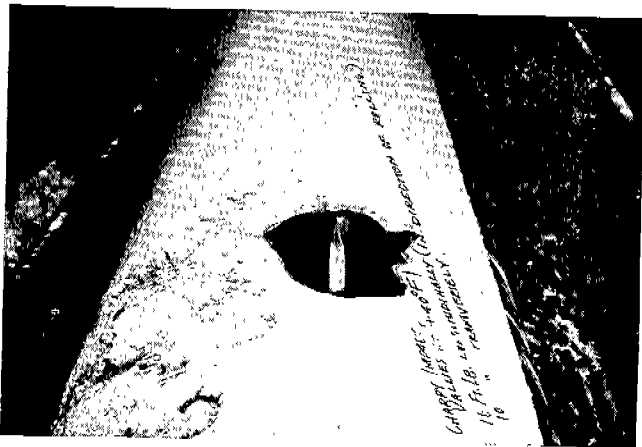
Fig. 33 Fractured drum involved in railroad wreck, showing hole punched in side. Drum is lying in gondola car and is covered with snow

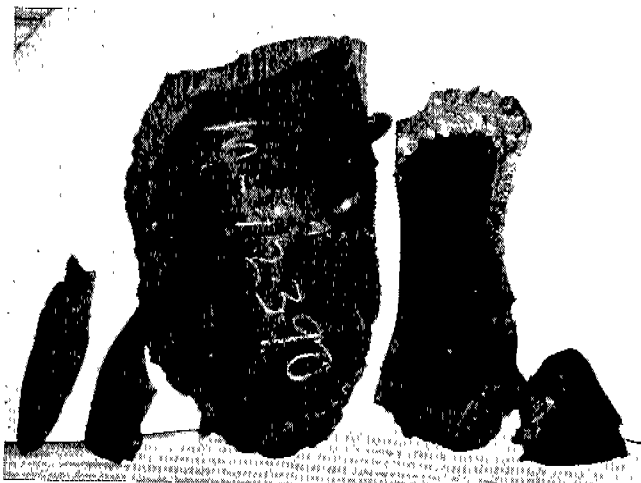
Fig. 34 Fragments from fractured drum, showing how the steel shattered

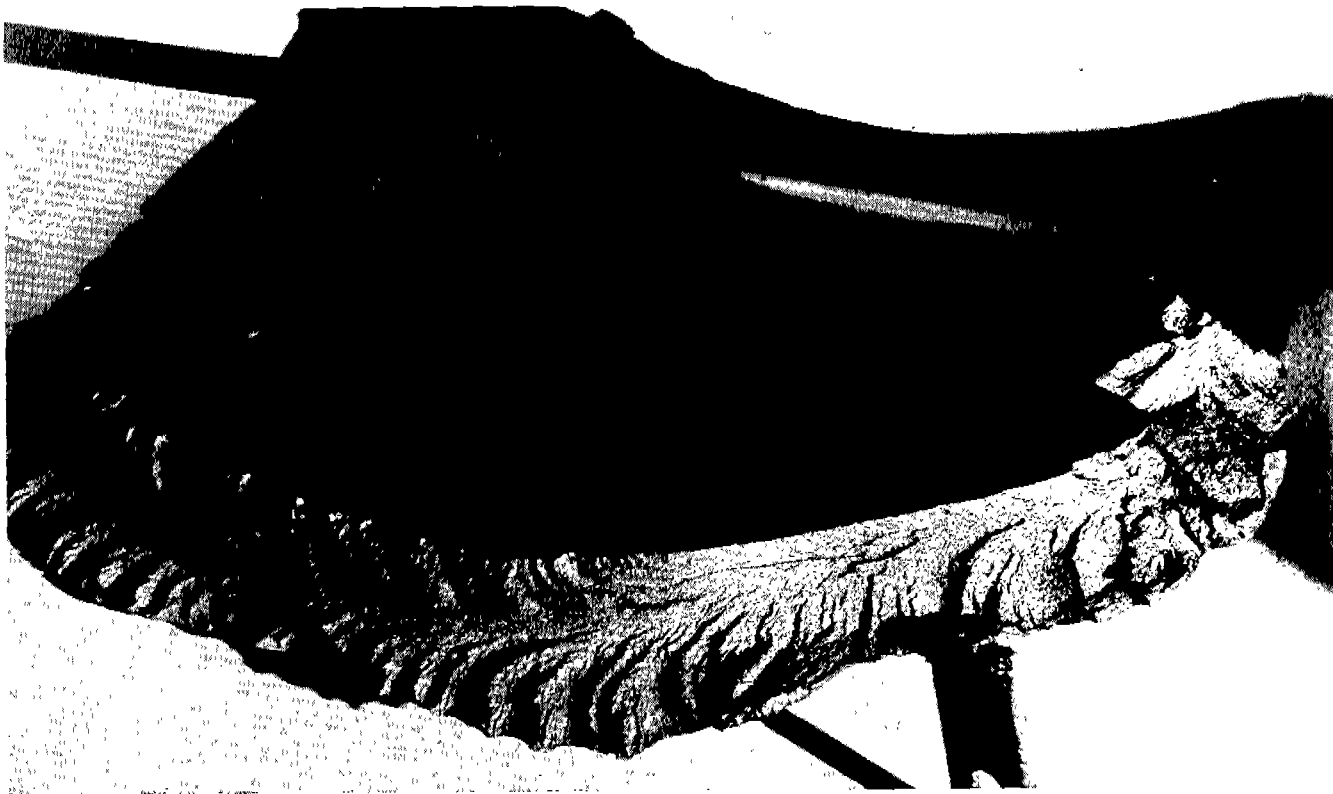
Fig. 35 Fragment from fractured drum. Note the excellent example of herringbone markings

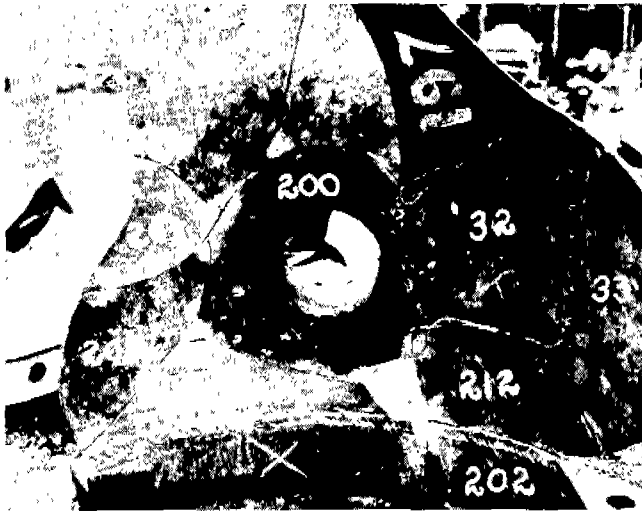
Fig. 37 Failed methane column

This shows the area about the upper 8-in. nozzle, where the defective weld was found between the nozzle wall and shell plate. This is located at the left edge of piece 32 joining piece 200.

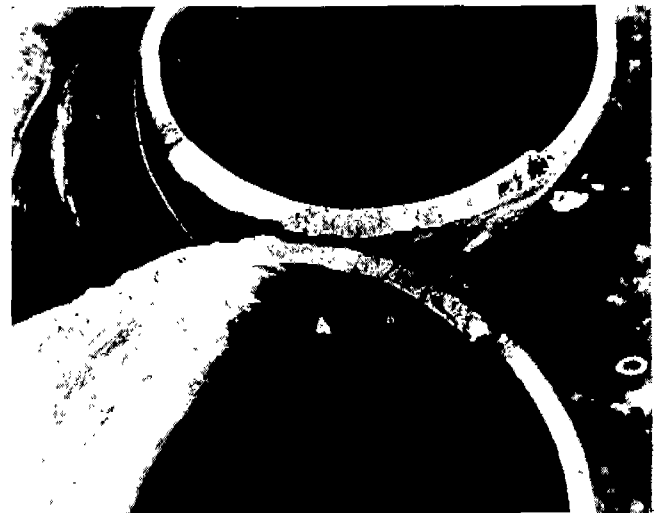
Fig. 39 Failed methane column

Faulty weld between 8-in. tube and pipe. Note lack of penetration and fusion at inside of joint. This was near the liquid line near the bottom of the column.

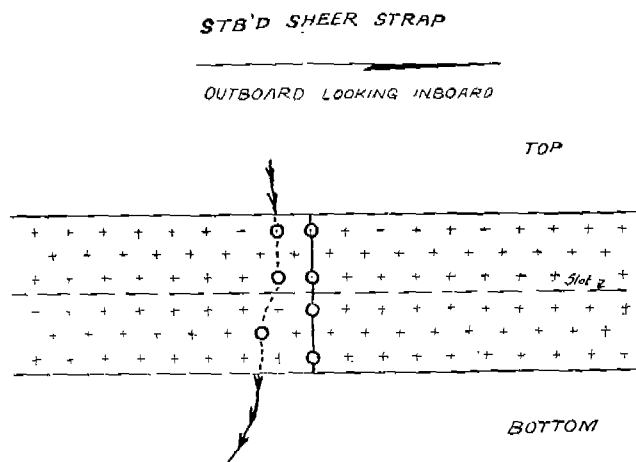
Fig. 41 Diagram of hull crack that crossed ship arrester in a nearly straight line. The arrester fracture is alongside the crack which crossed

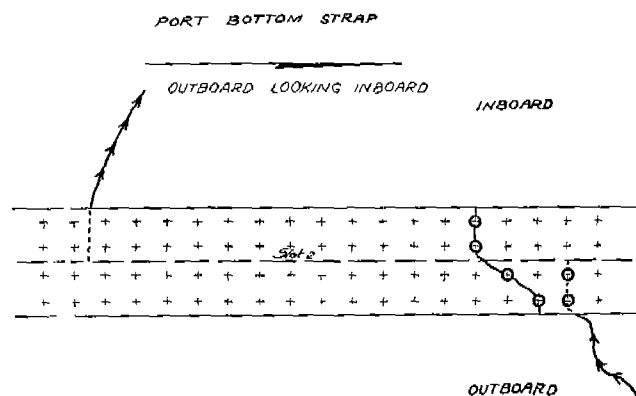
Fig. 42 Diagram of deck crack that crossed ship crack arrester. Entering and outgoing cracks were separated by 15 rivet holes. The arrester strap failed in shear in between

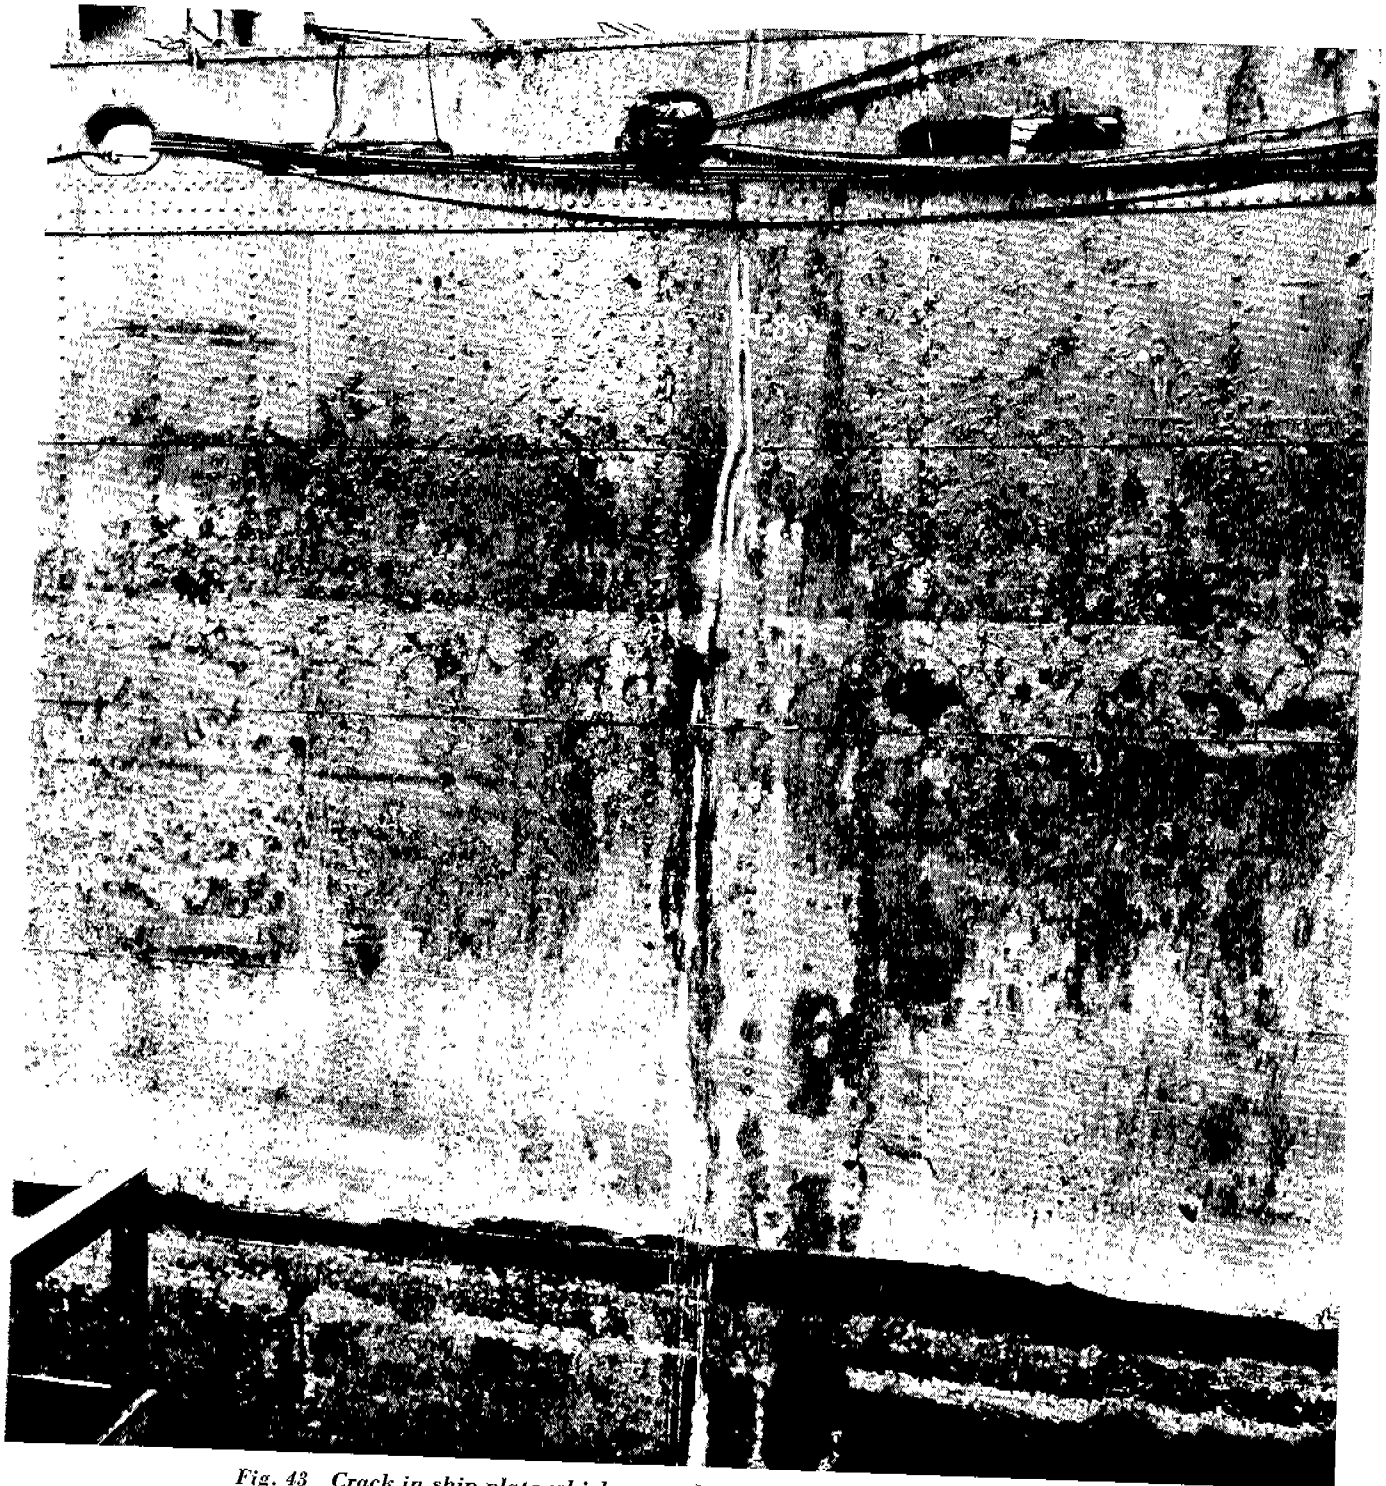
Fig. 43 Crack in ship plate which crossed an arrester in nearly a straight line

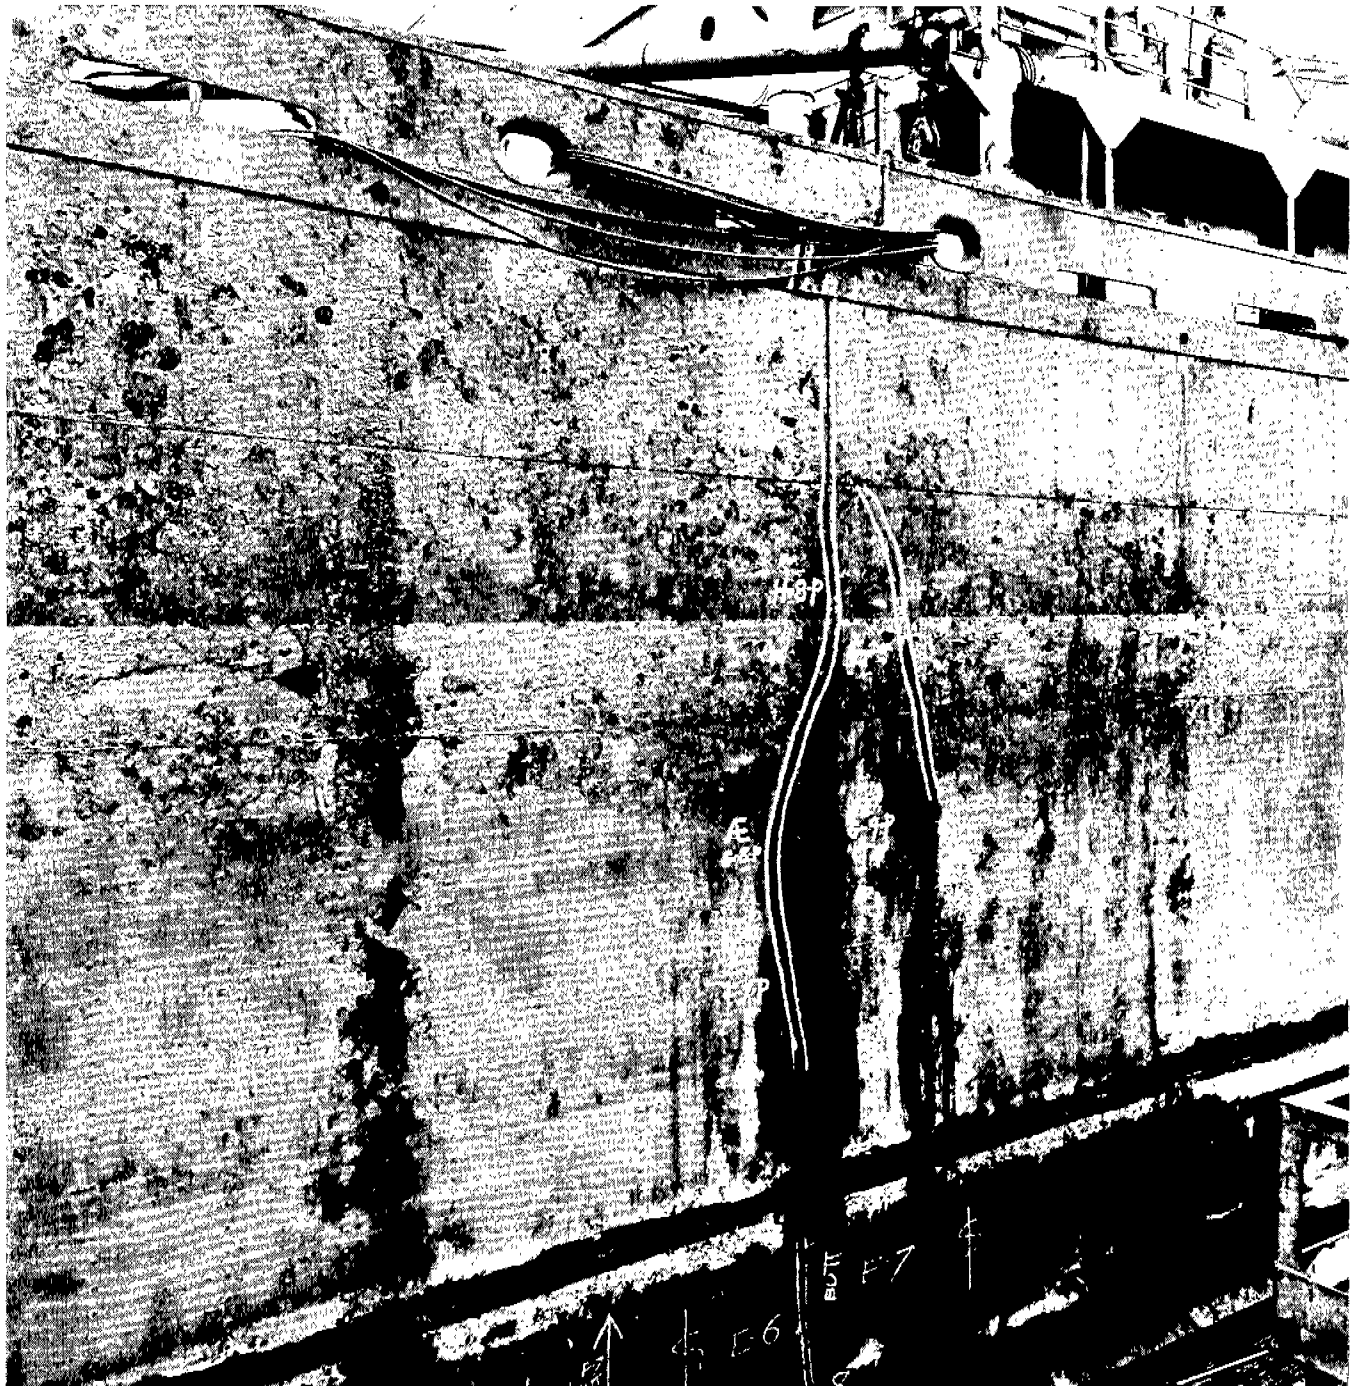
Fig. 44 Crack in ship plate which crossed an arrester, with spacing between the entering and outgoing crack
