Observation of Ship Damage over the Past Quarter Century

H. S. Townsend, Member, United States Salvage Association, Inc., New York, N.Y.

ABSTRACT

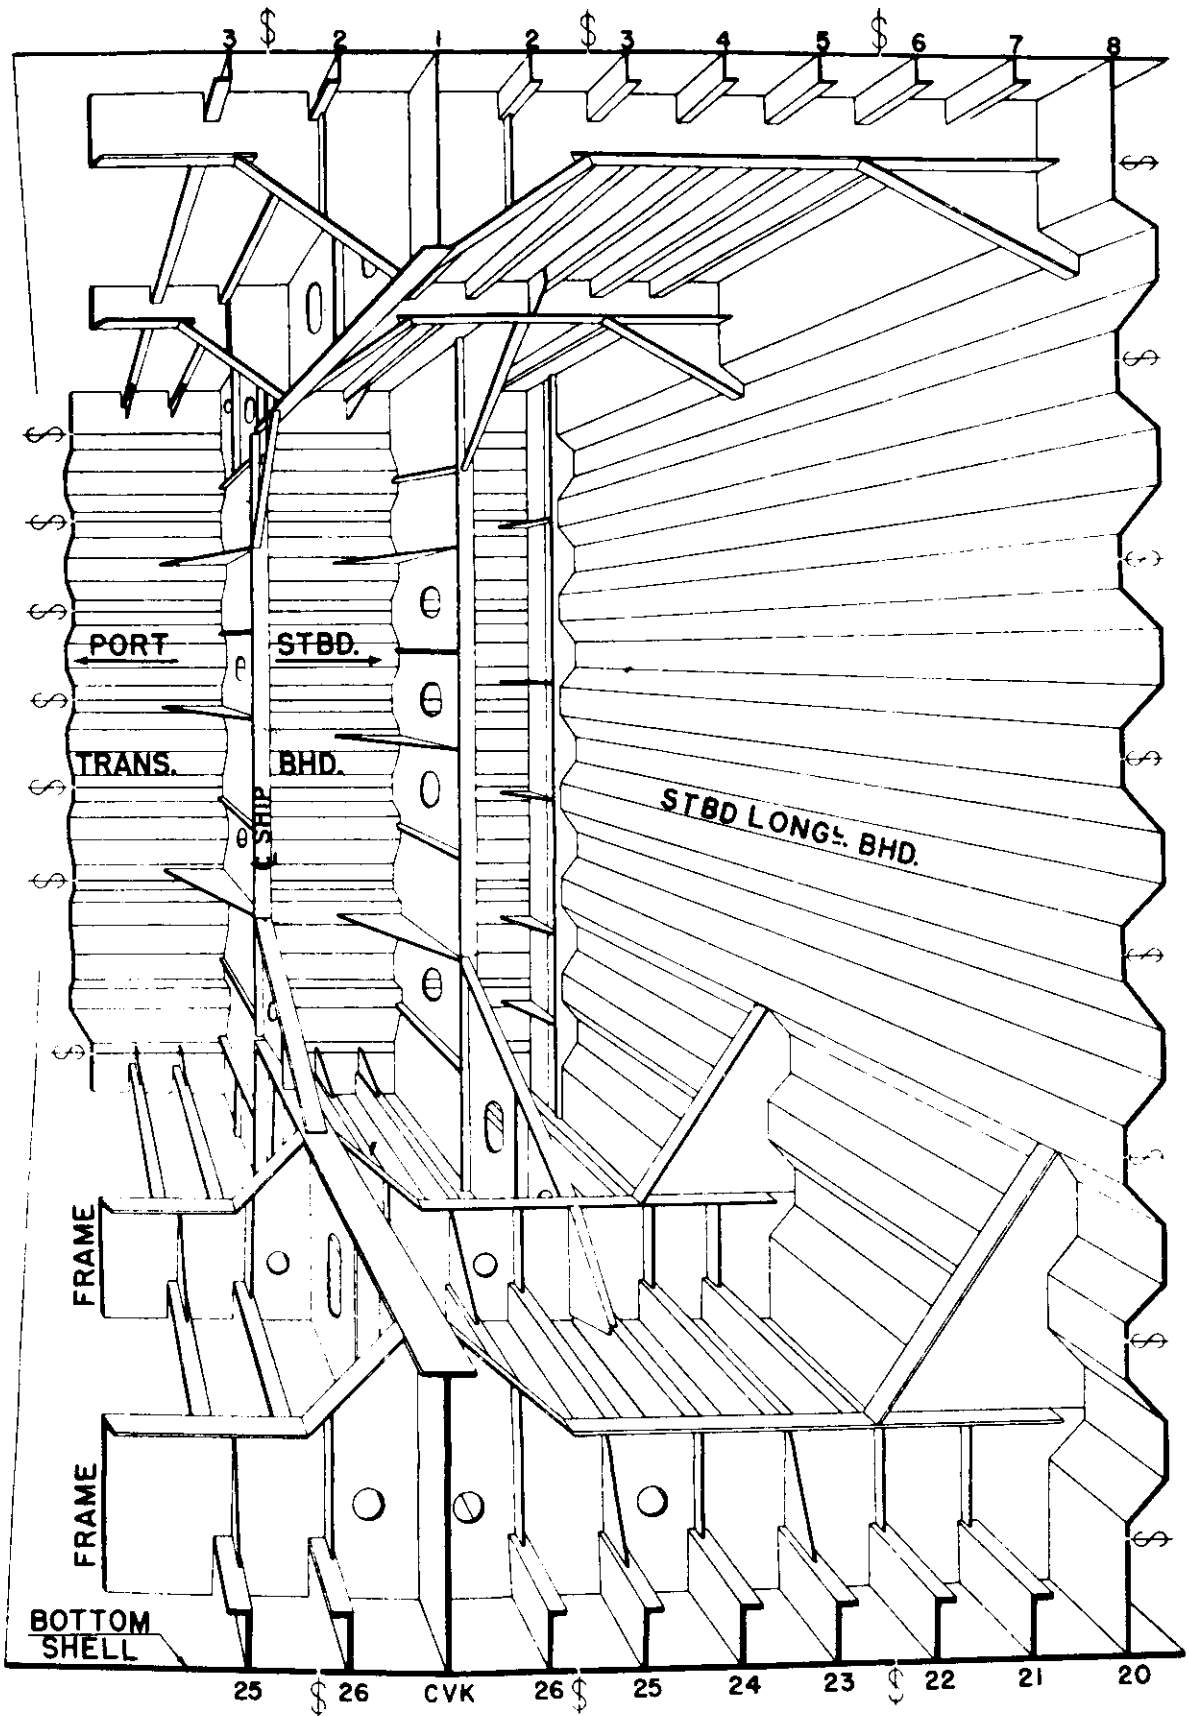
Fluted transverse and longitudinal bulkheads showed a consistent propensity to fracture in way of where the metal had been originally stressed beyond the elastic limit to form the corrugations. The circumstance became particularly evident where advanced corrosion obtained.

Figures 6 and 7 present the structural arrangement of the "T2" tanker. The fluted bulkheads and hard cornered configurations will be noted.

Fig. 6. "T2" structure (center tank)

Short of completely replacing the bulk of the internal arrangement which led to fractures, the owners followed the only course open to them, which was to chip out and weld the fractures

(often also installing doublers in way), or to replace affected material with sound metal. Access staging costs were always a significant part of the repair costs.

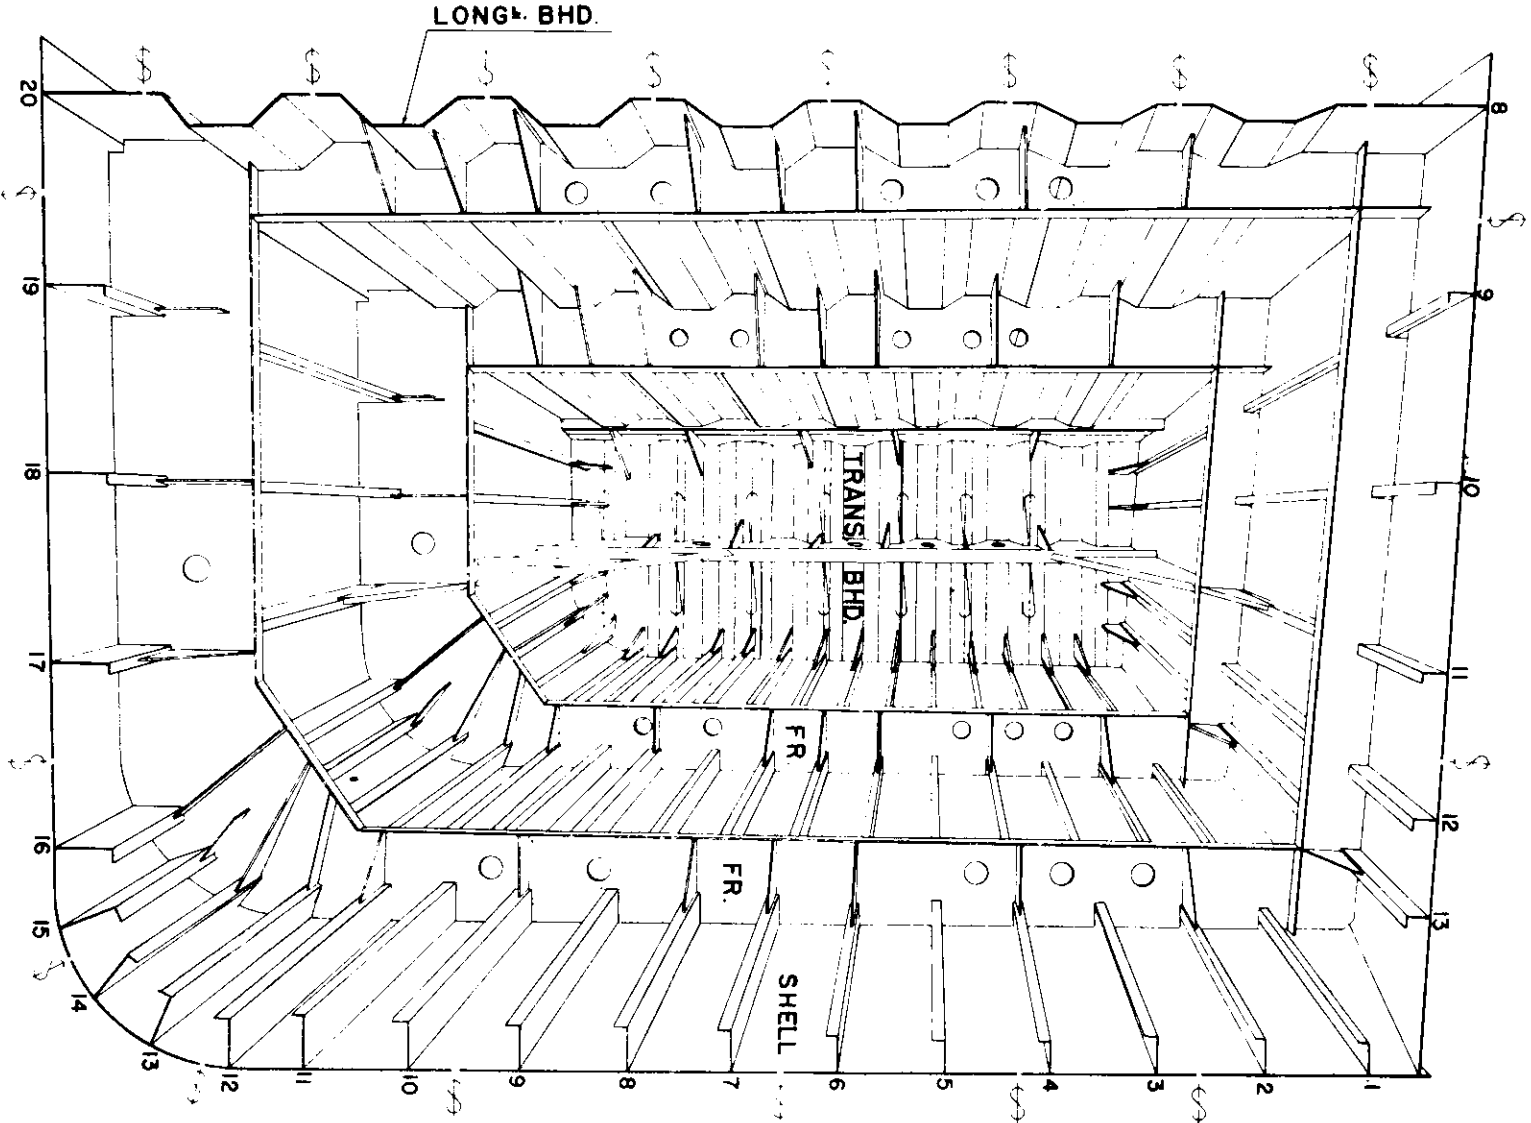
FIG. 7. "T2" structure (wing tank; web tie beams not shown)

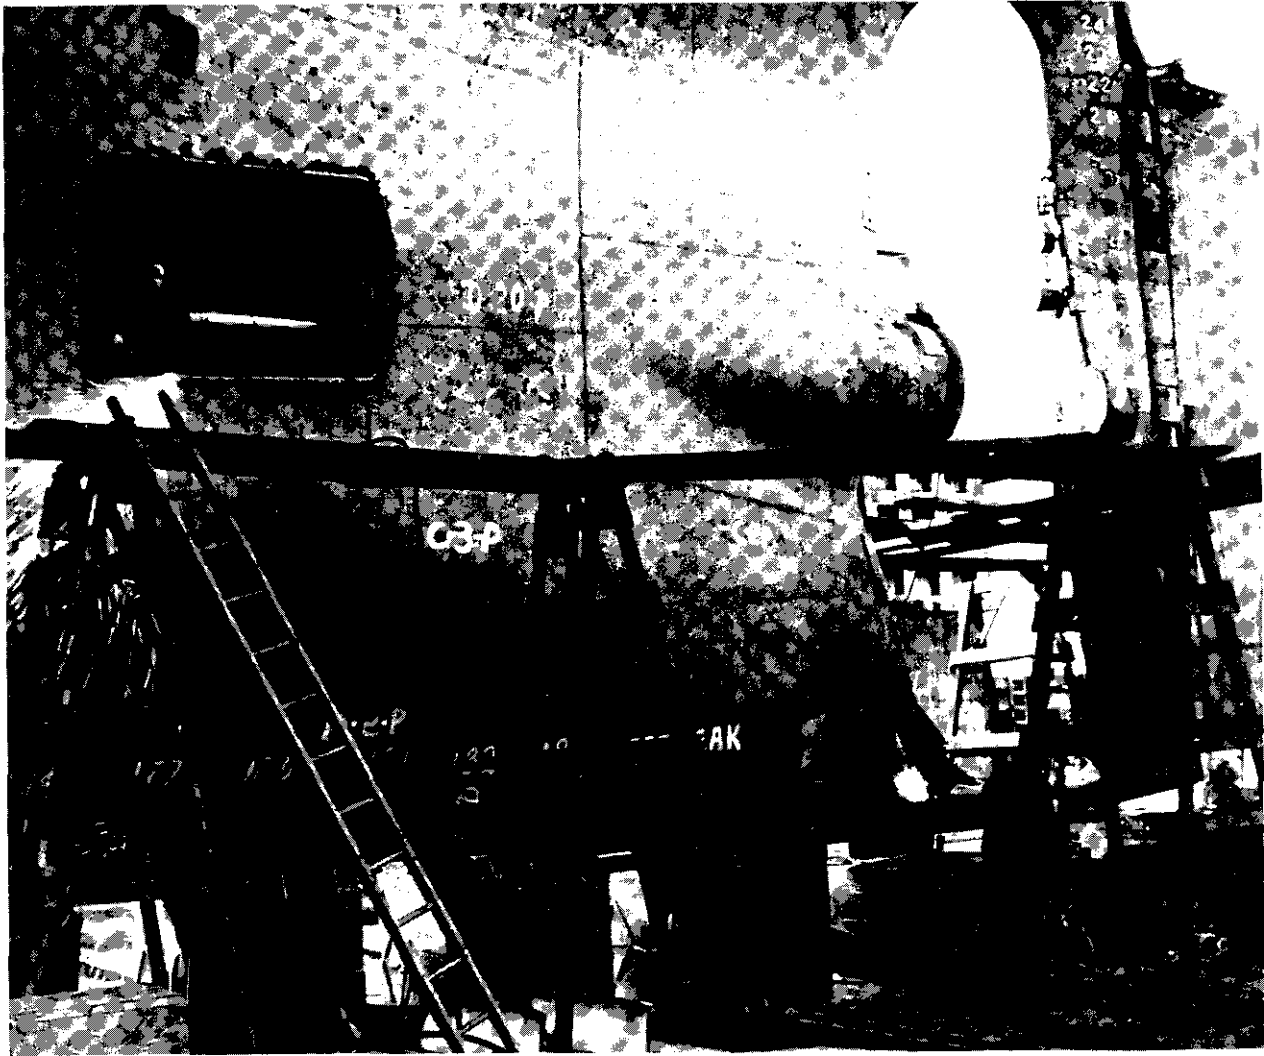
Unfortunately, for all of the types considered here, in order to remove the propeller for even the simple examination of the tapered end of the tailshaft, it was necessary to withdraw the tailshaft into the vessel, a most laborous and expensive procedure, and further, if it was necessary to remove the tailshaft from the vessel, it was generally found less expensive to make an opening in either the shaft alley or the shell to accommodate this removal rather than to attempt to move the tailshaft into the engine room spaces and out through the fidley. See Figures 15 and 16.

Fig. 16. Shell plate opening made in order to remove tailshaft

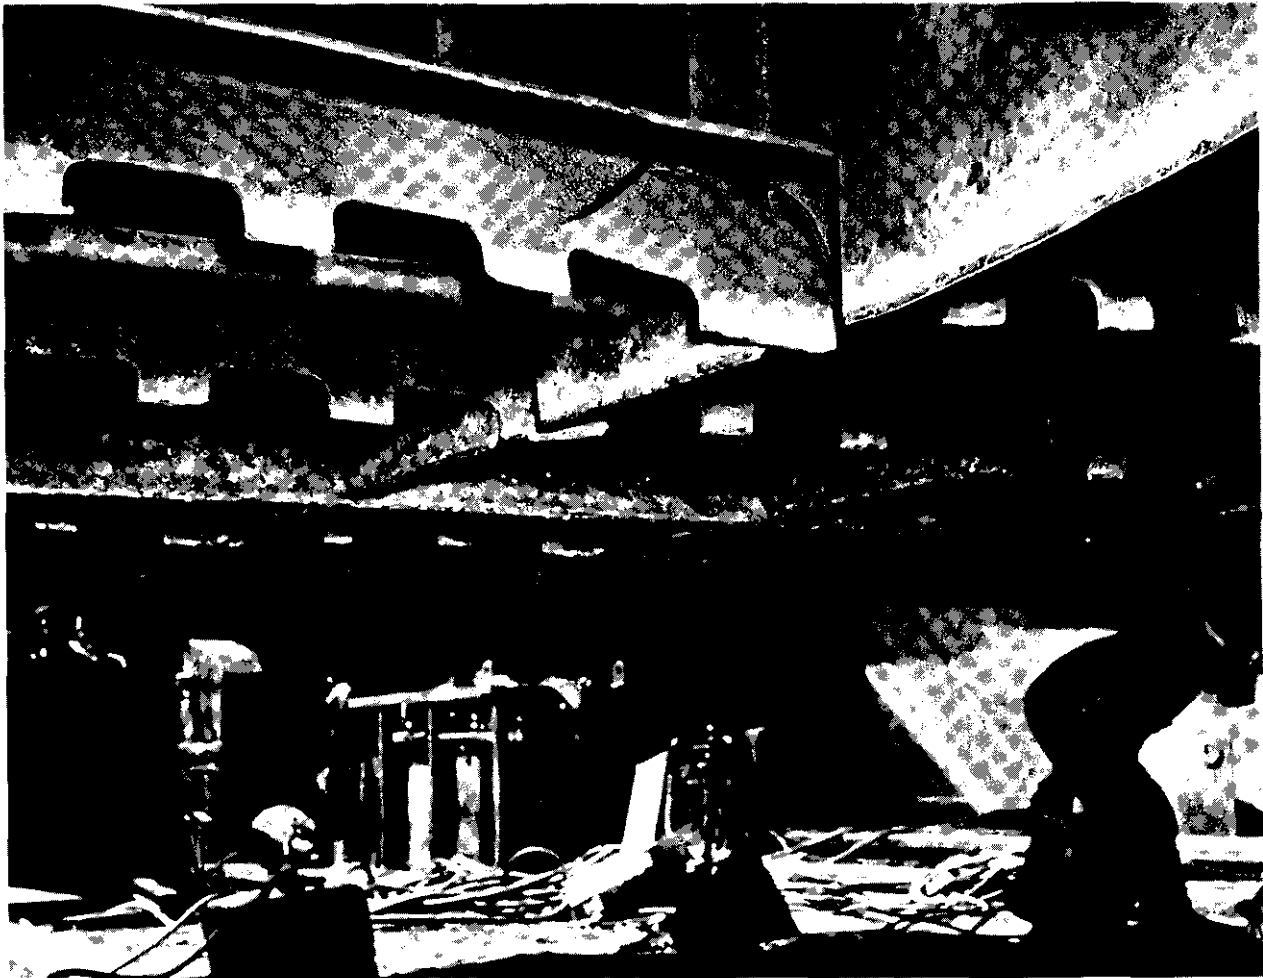
The earlier U. S. flag general cargo vessels, when operated in the North Atlantic at least, showed as severe a propensity to suffer from slamming damage as their World War II predecessors. See Figures 17 and 18. One class of these vessels, when the unsupported span of the forward bottom shell was halved, showed no further damage. The balance of the affected vessels have almost all been converted from general cargo service to container service, and are operating at a more nearly constant, relatively great forward draft, and have not shown the propensity to damage which was evident when they were purely in the general cargo trade.

Fig. 18. Slamming damage (same ship shown in Fig. 17) showing damage to internals

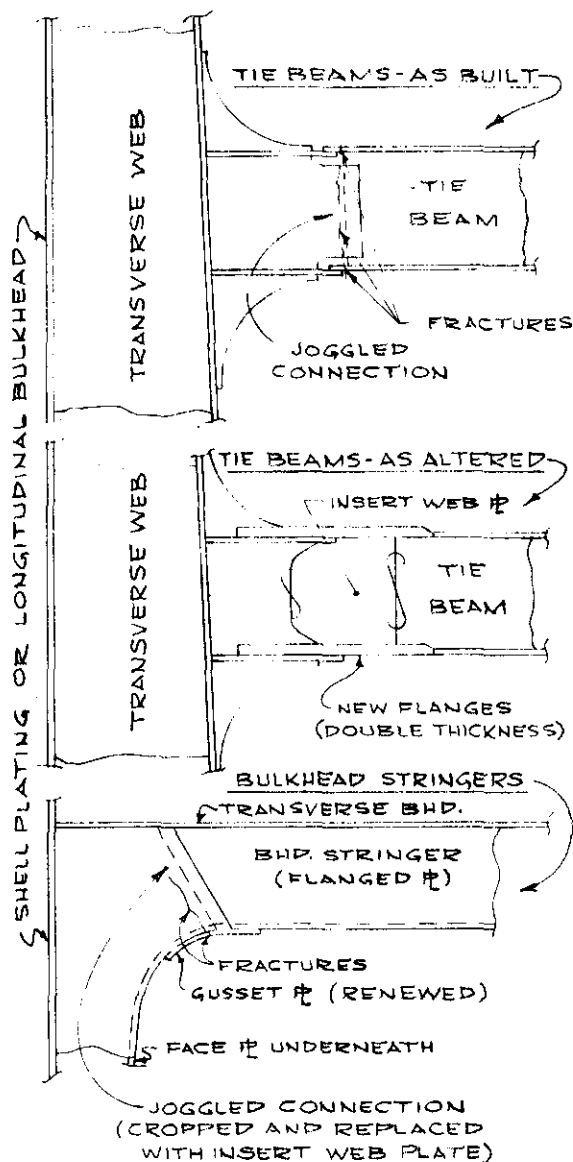
Ship designers and builders worldwide were feeling their way with tanker internal structural configurations which would not fracture in service, and it is understandable that certain of the configurations simply did not stand up. One such configuration, once again proving that stretched metal such as results from corrugations or joggles does not stand up, related to horizontal tie beams (struts) supporting the inboard and outboard portions of the web frames, and the webs of horizontal bulkhead stiffeners in the wing tanks of a class of tankers. Figure 19 illustrates the location of fractures, and also the method of altering the structure to

Fig. 19.
Fractures in way of joggles of tanker web frame tie beams and bulkhead stringers, and alterations to avoid future failures

avoid fractures in the future, which was applied in each wing tank of every vessel built with the original construction.

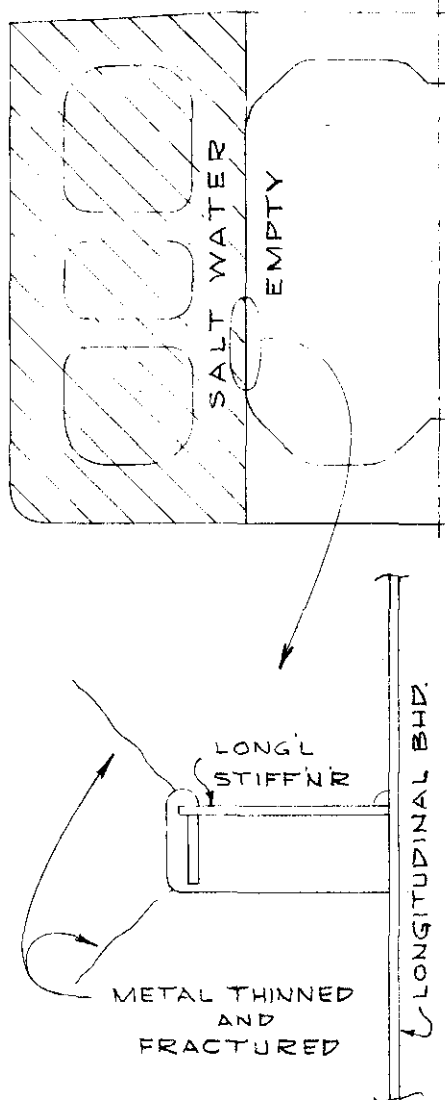
Another circumstance concerning tanker structural configuration very vulnerable to fracture, and related to the fairly recent concept of segregated clean salt water ballast spaces, is illustrated in Figure 20, which is a sketch of a transverse web frame in way of the cut-outs accommodating the longitudinal stiffeners of the longitudinal bulkheads in the clean salt water ballast tanks, the structure being uncoated. Thinning of the structure in way of the fractures shown was down to almost zero thickness after less than two years service, from original nominal 1/2" thickness, which thickness still nominally obtained in areas of low stress.

The failure was a direct result of stress set up by fluids on one side of a bulkhead only, and resultant accelerated

corrosion and loss of strength in areas of high stress, causing the metal to fail in shear in way of the cutouts. While the cutout configuration for the bulkhead longitudinals was the same in the cargo wing tanks, and the web frames in those tanks were also uncoated, the massively accelerated thinning had not occurred, and no fractures as yet obtained, obviously due to the protection against corrosion by the cargo oil.

Fig. 20.
Fractures in way of web frame cutouts in segregated clean salt water ballast tanks

In the segregated clean salt water ballast tanks there was no recourse but to crop out and replace affected metal, installing closure pieces in way of the cutouts to help absorb the shear, and clean the webs from top to bottom, and coat same.

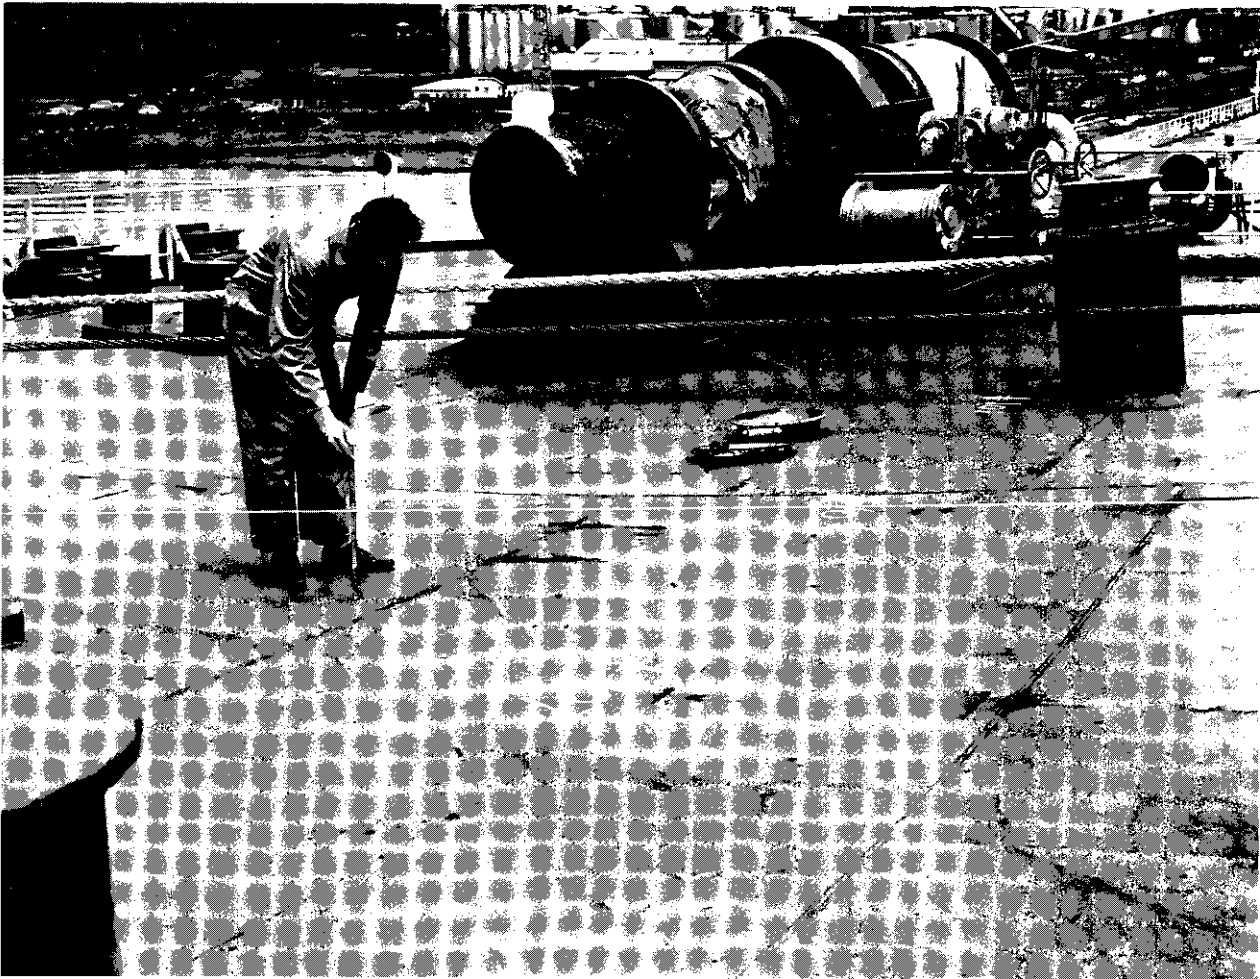
Problems relating to damage to the forecastle head and forward upper shell plating of the larger tankers, from the effects of the sea, began to show up even on the 28-30,000 tons deadweight tankers which appeared in the early 1950's. The damage related to the setting down of forecastle deck plating (see Figure 21), crippling of webs and stanchions (see Figure 22), generally accompanied with the setting in of the upper flared section of the vessel at the sides of the forecastle head, and upon occasion the indentation of the upper stem and forward side shell plating and supporting structure (see Figure 23). The damage as a type led to a revamping of classification structural criteria for forecastle head design; currently the affliction appears less frequently. The fact that the navigating bridge was moved all the way aft probably had some influence on the frequency of occurrence of this type of damage, since those in the wheelhouse were so remote from the

Fig. 21. Large tanker forecastle head damage showing set-down of deck

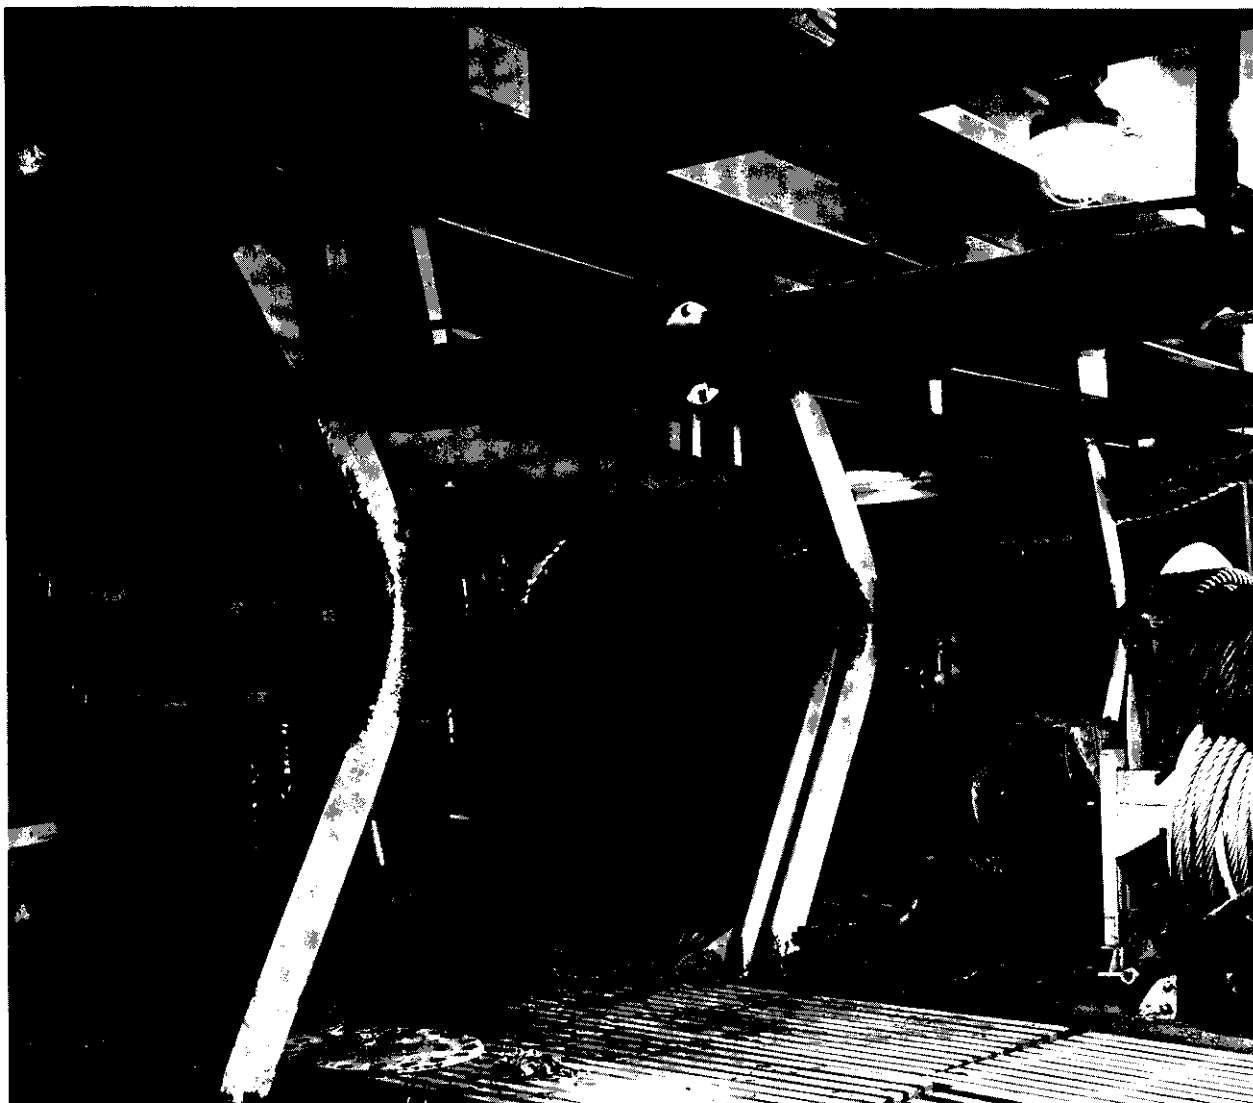
Fig. 22. Large tanker (same ship as Fig. 21) showing structure inside forecastle

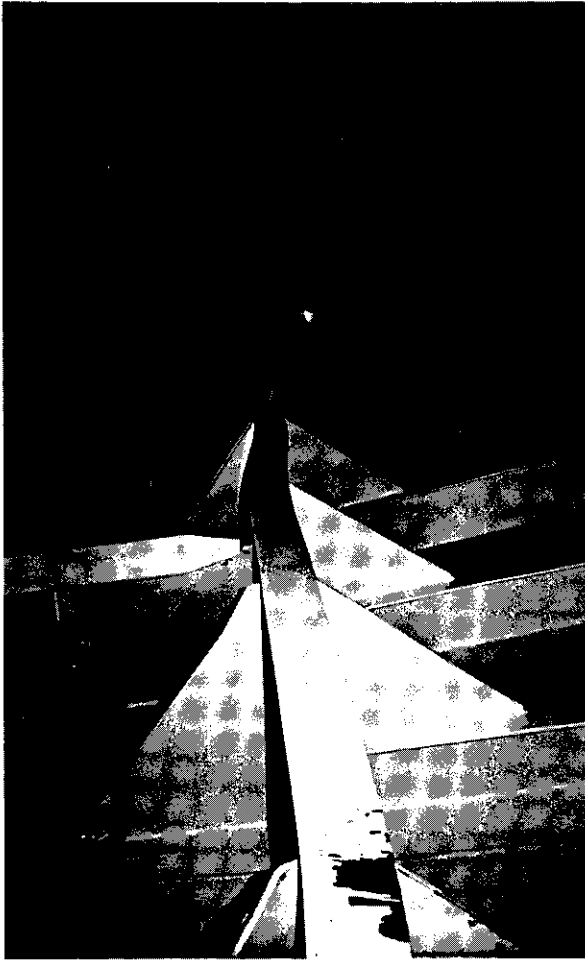
Fig. 23.
Huge tanker, showing buckling of
internal structure underdeck forward

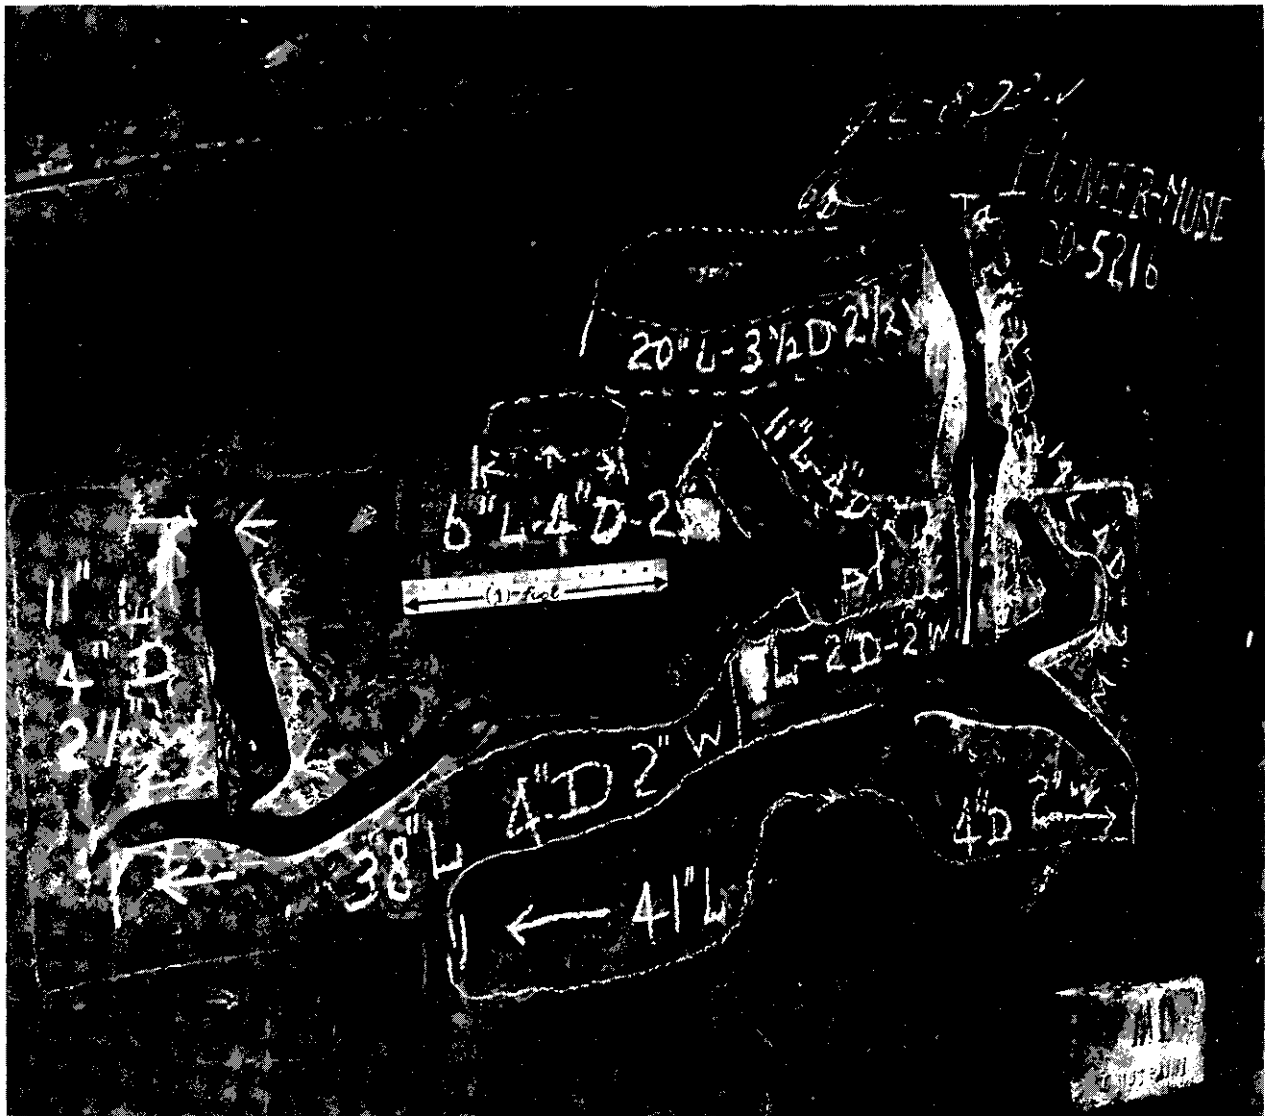
Concerning steel castings, a remarkable circumstance occurred, from the standpoint of timing, for during a four months period, approximately five years after delivery of the vessels, four cast steel "Mariner" rudder horns evidenced surface fractures which required massive chipping out and welding up of fractures, and in some cases the renewal of the entire rudder horn casting. The disease seemed to be on one side of the castings, and was in large measure laid to the rising to the surface of slag and inclusions on the affected side of these large castings which were poured on their side. See Figure 24.

Fig. 24. Cast steel "Mariner" rudder horn showing metal removal in way of fractures
