PROGRESS REPORT

FATIGUE TESTS OF SHIP WELDS

S. C. HOLLISTER, J. GARCIA AND T. R. CUYKENDALL
CORNELL UNIVERSITY
Under Navy Contract NObs-31218

Serial No. SSC-7

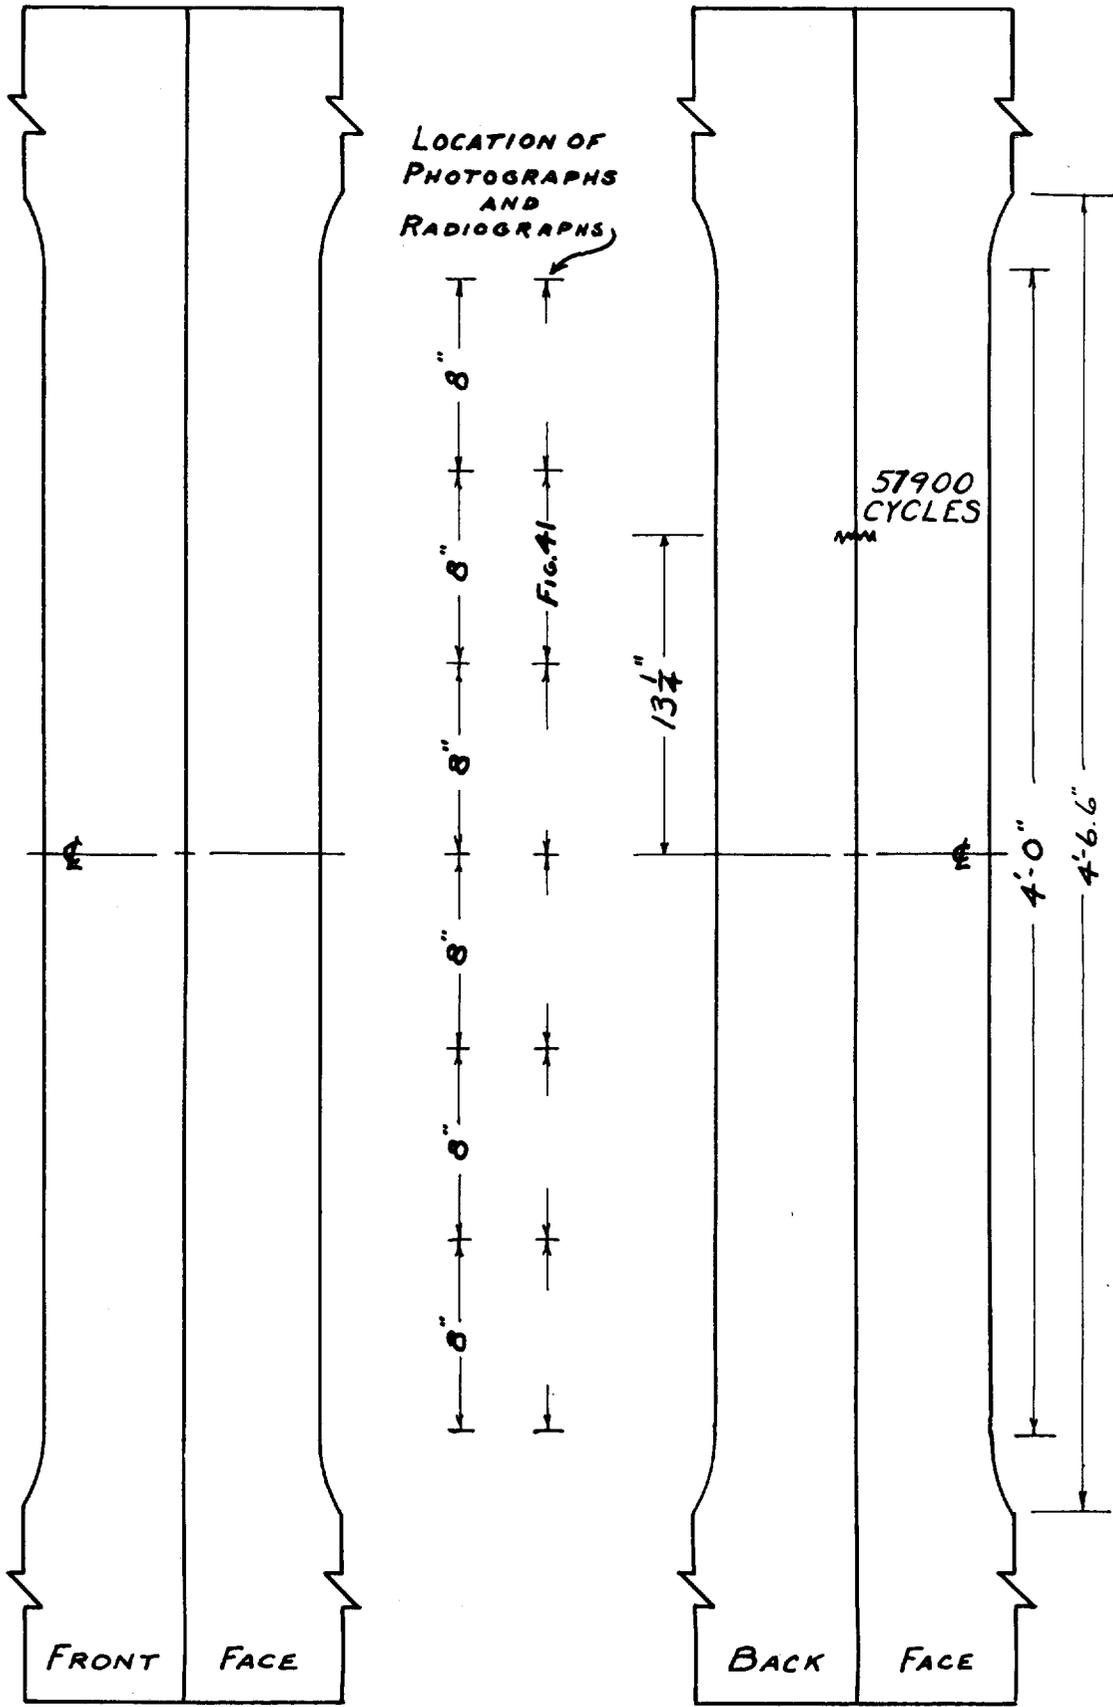
FIGURE 15

Location of Cracks, Fig. 15.

Crack No. 1-V, 57,900 cycles, back face, upper third of the test length.

The crack appeared along a ripple and at 82,500 cycles of stress it extended the full width of the weld. At 146,000 cycles the crack appeared on the front face of the specimen. At the end of the test (147,300 cycles) the fracture extended about $1/2$ " into the plates at either side of the weld. The fracture (Fig. 41) revealed poor fusion at the root. Since the outer parts of the weld metal showed large granular structure and the center portion had a smooth appearance, it is believed the crack started at or near the root.

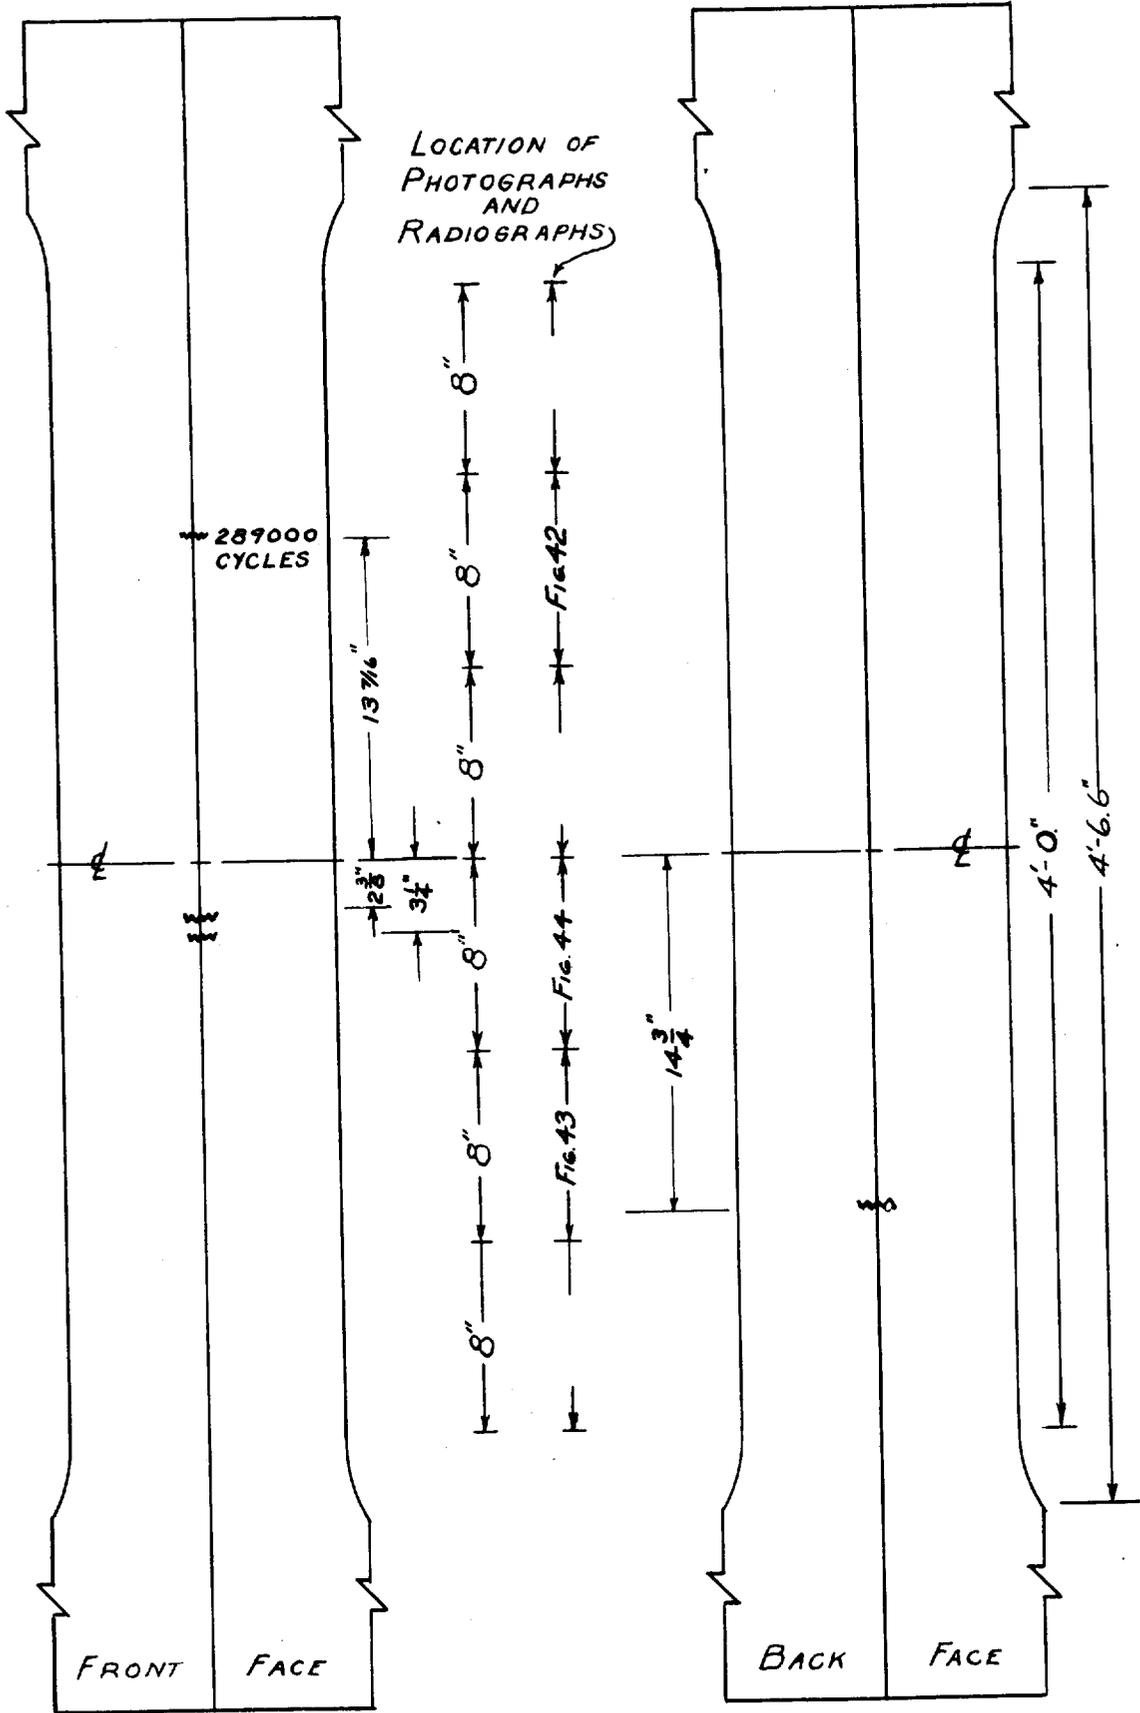
FIGURE 16

Location of Cracks, Fig. 16.

Crack 1-V, 289,000 cycles, front face, upper third of test length. The fracture (Fig. 42) showed poor fusion at the base of the root pass; this is believed responsible for the fracture which appeared on the front face.

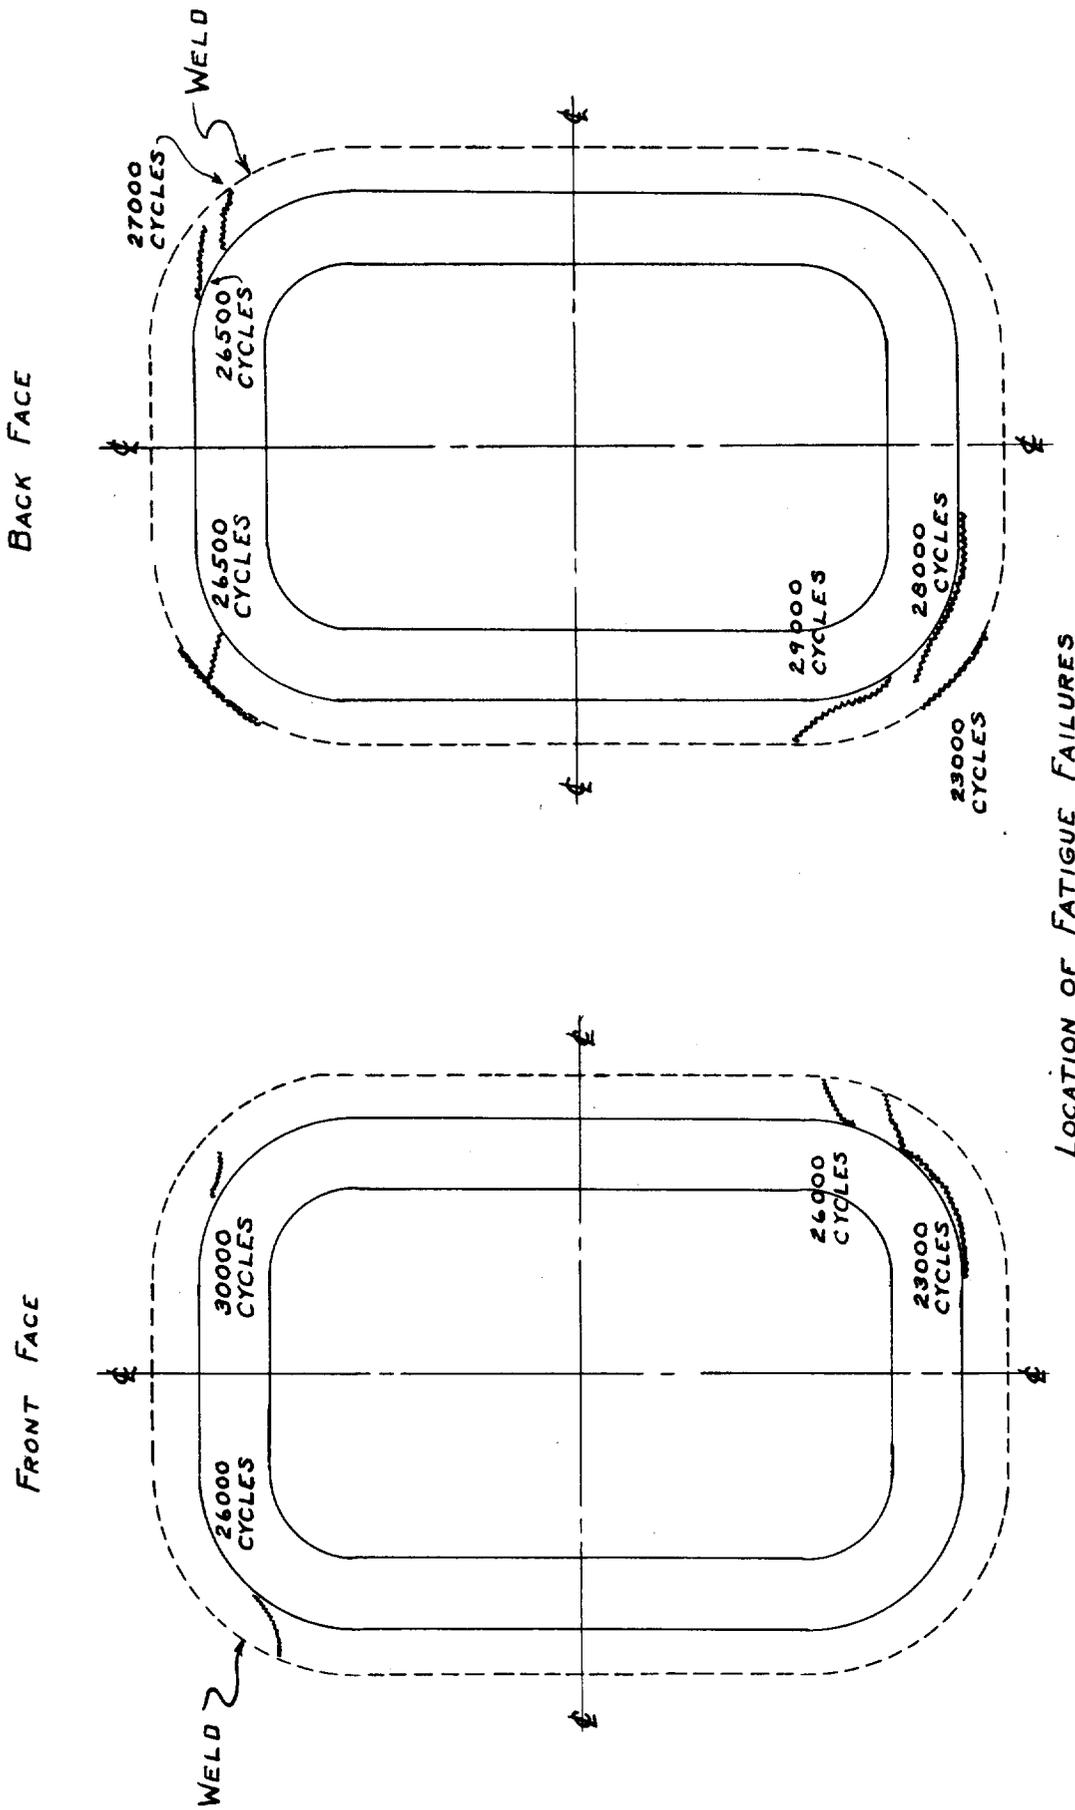
FIGURE 28

The location and the direction of propagation of the fatigue fractures in specimen B-2, Fig. 28, were practically of the same nature as those

found in B-1 and described previously.¹ It is apparent that considerable stress concentration occurs at the rounded corners of the reinforcement where its excessive stiffness does not permit sufficient deformation to distribute the stress over a large region. Furthermore, a fillet weld of the character of that employed in the B series will always result in a notch in its underside.

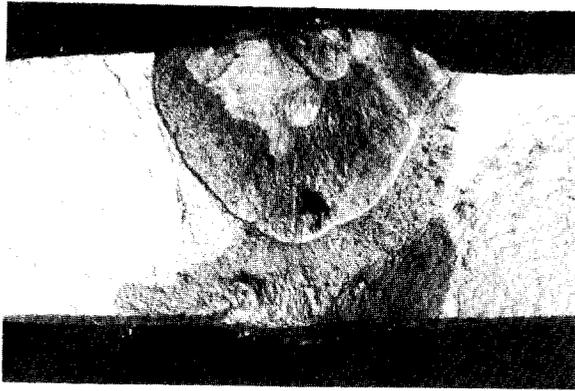
Specimen AA-1 Figure 34

Crack No. 1-V, 82,500 cycles, back face, in upper third of test length.

The crack appeared on the surface of the weld at a re-entrant angle where the common end of two successive beads formed a cleavage plane. The fracture (Fig. 34) shows that the fatigue crack started at the surface and traveled inward.

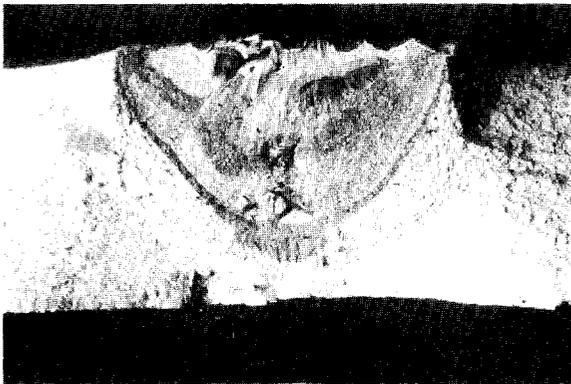
Specimen AA-1 Figure 35

Crack No. 2-V, 92,000 cycles, back face, lower third of test length. The

first evidence of the crack was at the juncture of two successive beads. From the general appearance of the fracture (Fig. 35) it was difficult to determine the origin of the fatigue crack. With reservation it might be stated that it started at the surface of the weld.

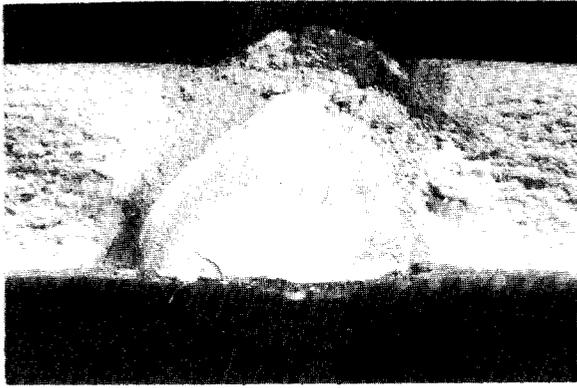
Specimen AA-1 Figure 36

Crack No. 3-V, 95,000 cycles, front face, upper third of the test length.

The fracture (Fig. 36) showed that the crack originated at the surface of the weld and propagated inward. This crack can be seen at the re-entrant angle created where a short bead overlapped a shallow bead.

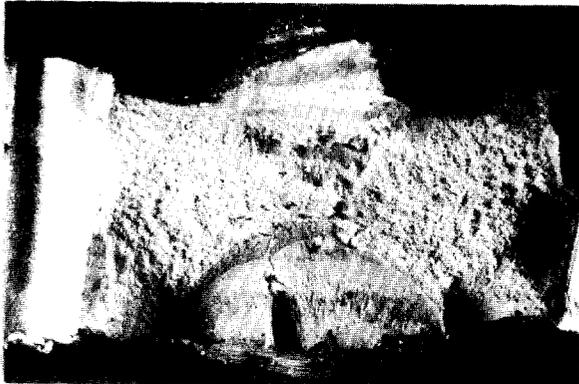
Specimen AA-1 Figure 37

Crack No. 4-V, 95,000 cycles, front face, middle third of test length. The

crack appeared at a re-entrant angle formed at the start of a short bead made to bring that part of the weld surface flush with the plate. From the fracture (Fig. 37) it is seen that the crack started at the weld surface.

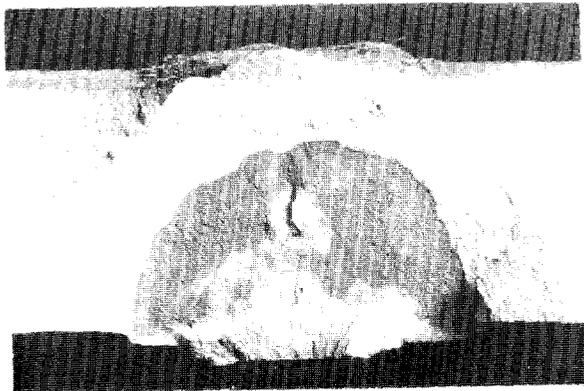
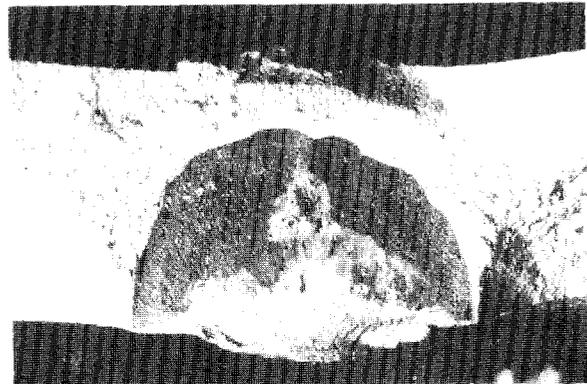
Crack No. 1-V, 57,000 cycles, front face, upper third of the test length.

The crack appeared at a deep ripple in the weld. The fracture of the weld (Fig. 38) does not indicate clearly the origin of the fatigue crack. A comparison of the crystalline appearance of the metal near the weld surface with that of the metal near the root, leads one to assume that the crack started at a point of poor root fusion.
