***Development of a Stress Corrosion Test Specimen for
Determining the Stress Corrosion Resistance of Aluminum
5XXX Marine Alloys***

***Thomas J. Summerson
Consultant
4711 E. 36th Court
Spokane, WA. 99223, USA***

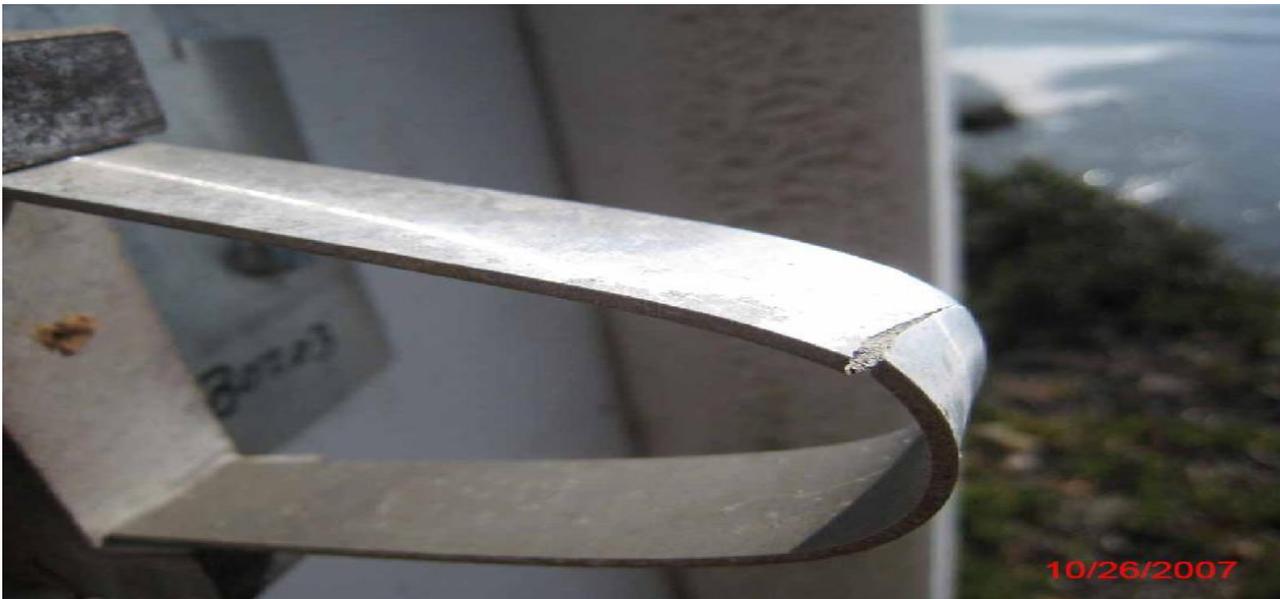
FIGURE 2

Figure 2 shows that the stress corrosion cracks occur at or near the apex of the preform where the highest residual tensional stress exists.

Stress corrosion cracked sensitized preform sheet sample with machined sub-surface in tension. Cracked in 2 weeks, Point Loma, CA.

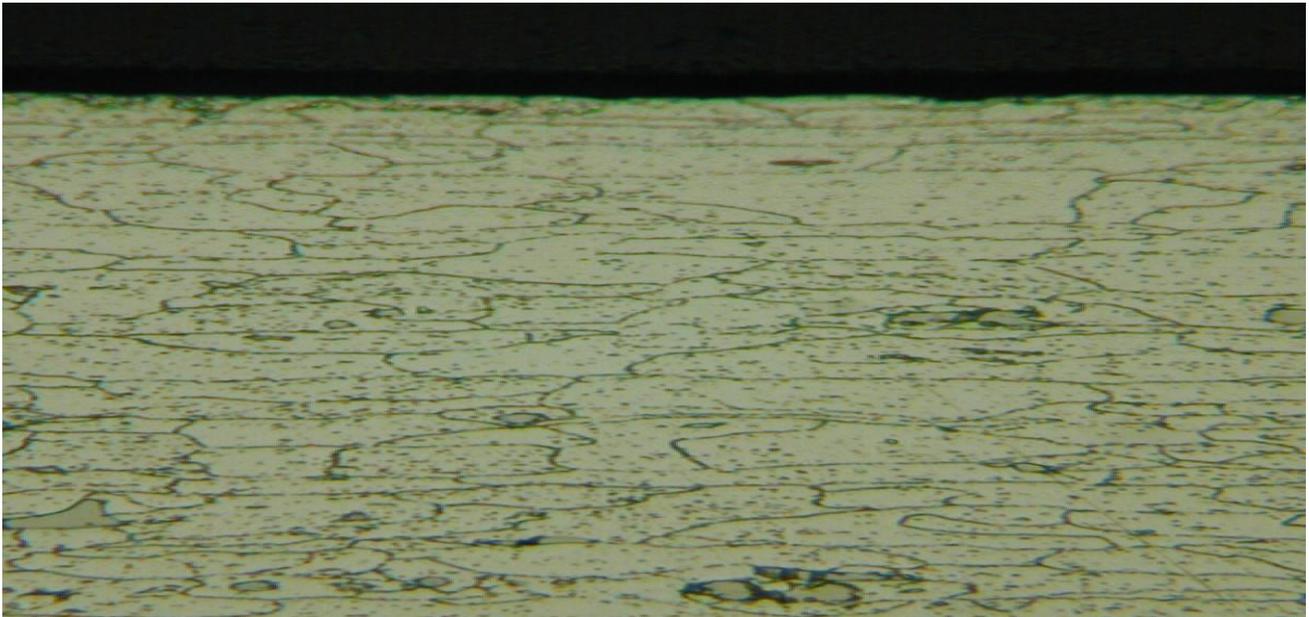
FIGURE 3

Metallographic examination was made in Spokane on the as received plate and plate heated for one week @ 250F before preforming. Figures 3 show the microstructure of the doublet plate, as received. There is selective, continuous precipitation of the Mg₂Al₃ phase along the recrystallized grain boundaries, typical of an IGC susceptible material. Figure 4 reveals how the continuity of grain boundary precipitation of the Mg₂Al₃ phase increased with heating at 250F for a week.

Microstructure of 5083-H321 doublet plate, as received. Etched, 550X

Note the continuous outlining of the recrystallized grains boundaries as of the result of the precipitation of Mg_2Al_3 .

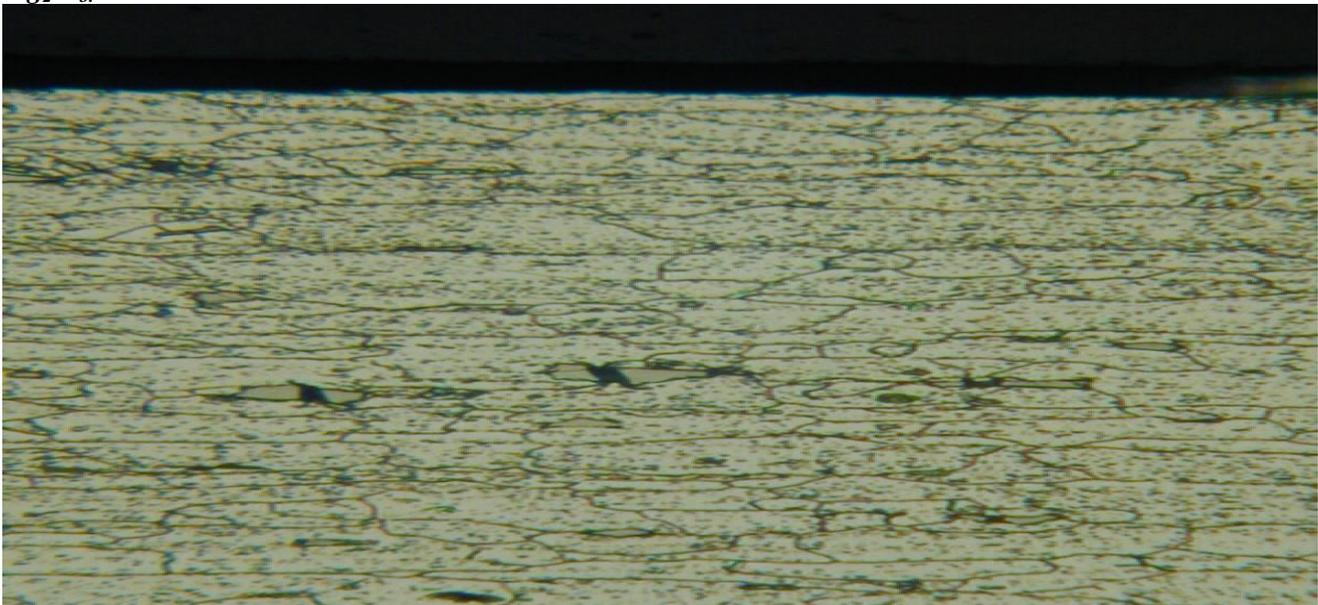
FIGURE 4

Microstructure of 5083-H321 doublet plate after heating for 1 week at 250 C. Etched, 450 X.

Compared to Figure 3, note how the intensity of grain boundary and grain matrix precipitation has increased as the result of the heating at 250 F.

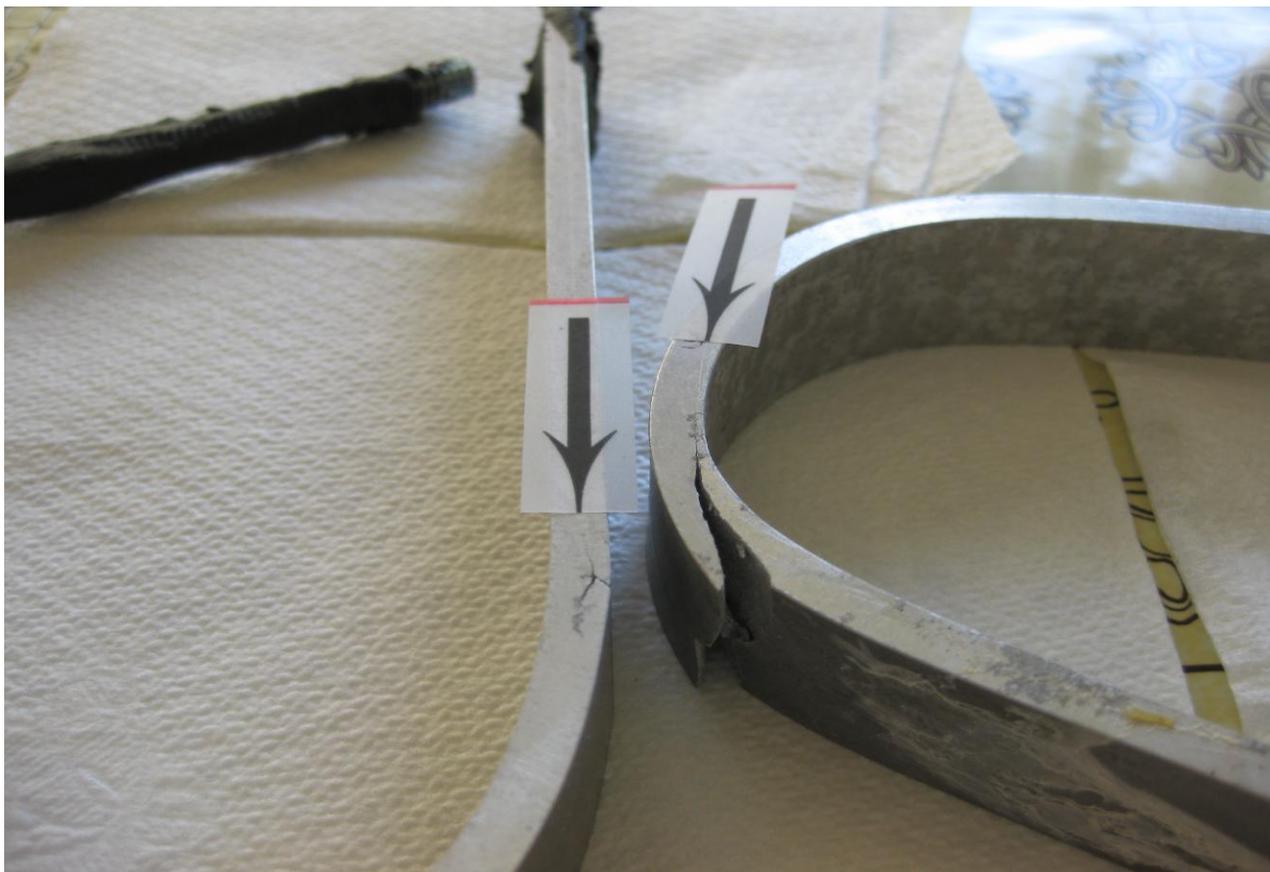
FIGURE 7

The three 5083 LT preform plate samples exhibited stress corrosion cracking within 2 to 3 weeks at Point Loma. (Mass loss 50.4 mg/cm²) Two of the SC cracked preforms are shown in Figure 5.

Two of the plate gage preforms exhibit SCC after a few weeks at the Point Loma marine atmospheric site.
