SSC-425

**FATIGUE STRENGTH AND
ADEQUACY OF WELD REPAIRS**

SHIP STRUCTURE COMMITTEE
2003

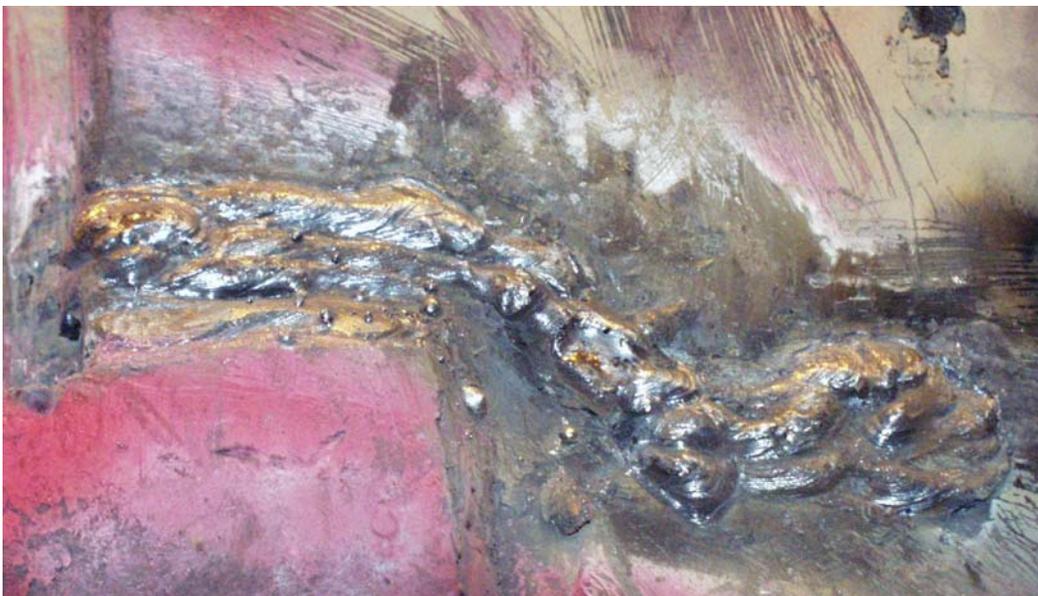
Figure 3.29: A typical crack at the top of the bracket in the complex-attachment specimen.

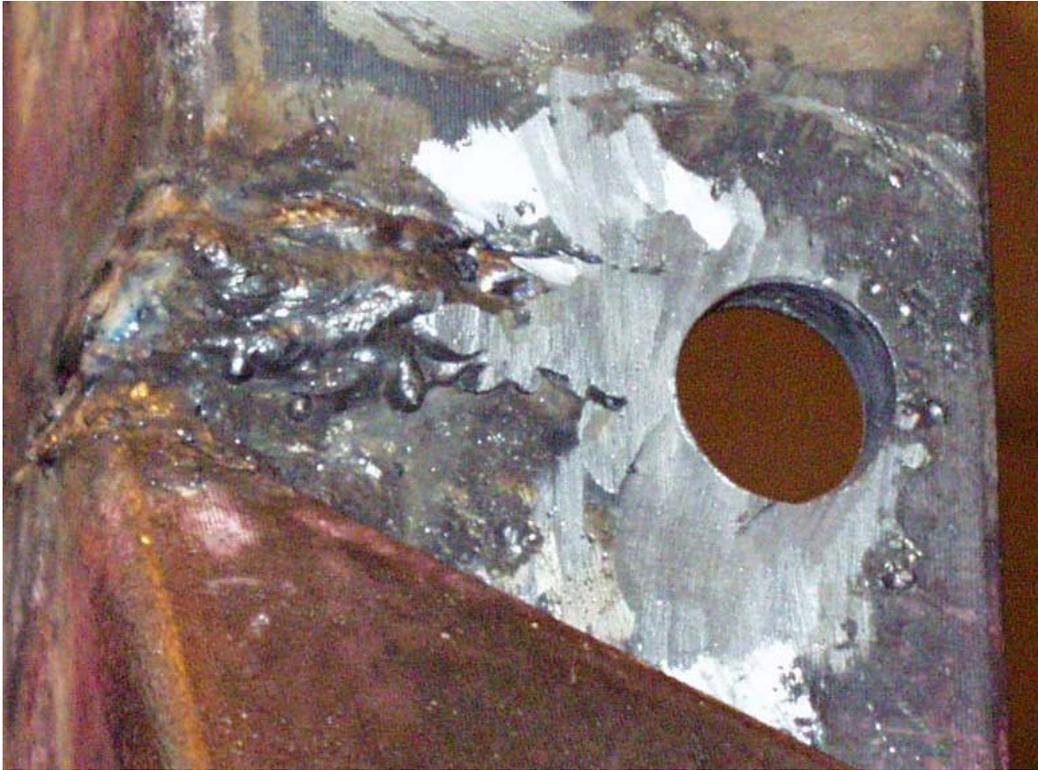
Figure 3.30: Weld repair of crack not yet through-thickness without termination holes.

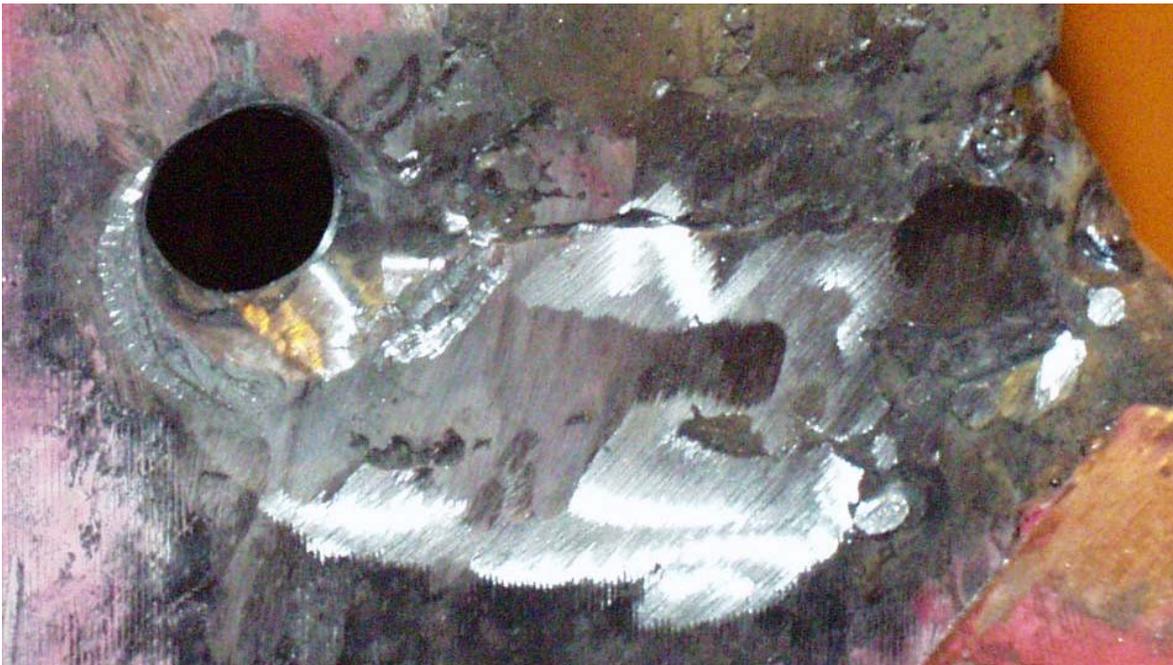
Figure 3.31: Weld repair of typical through-thickness crack with termination holes drilled to larger diameter after the weld is complete.

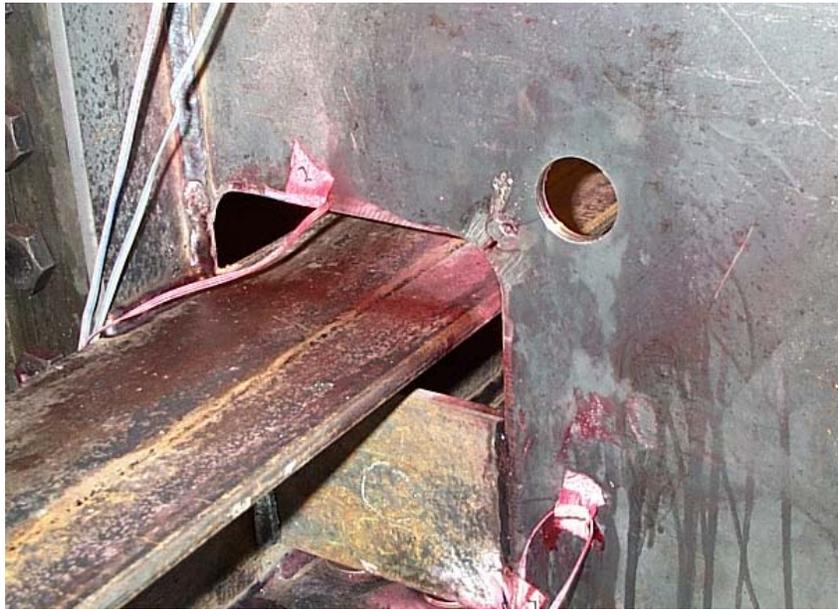
Figure 3.48 Typical crack in web frame growing out of a cutout

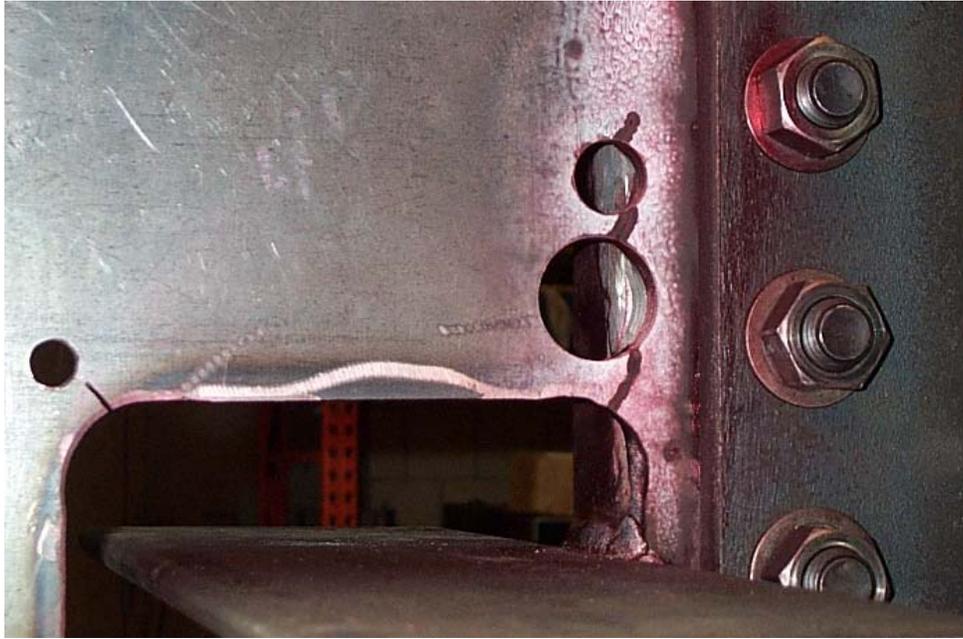
Figure 3.54 Crack forming in lug after stop hole repair

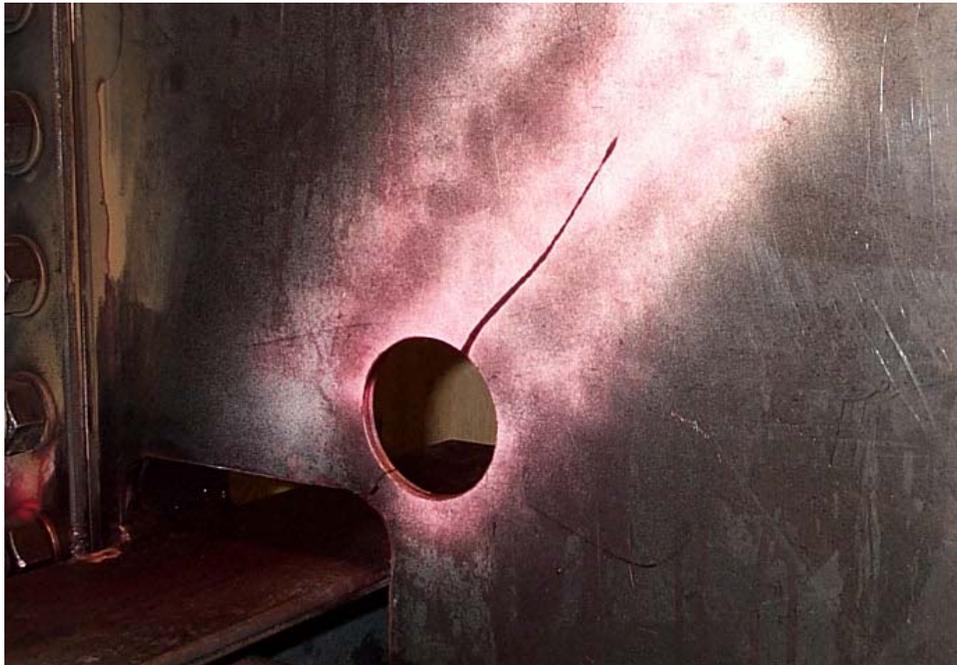
Figure 3.55 Repair failures at other radius at cutout C

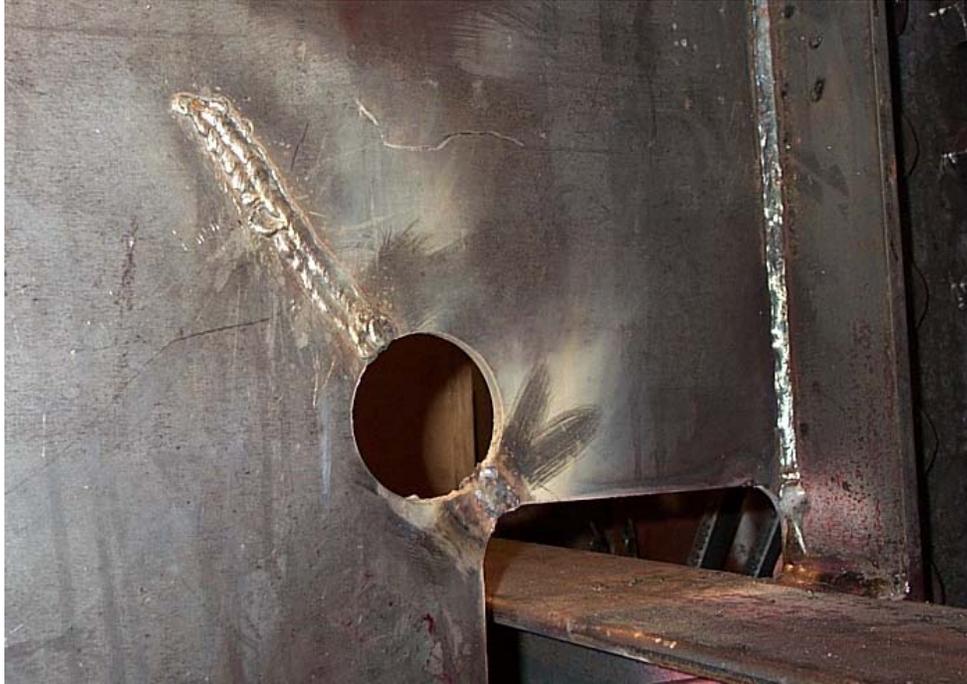
Figure 3.56 130 mm long crack after failure of 76 mm stop hole

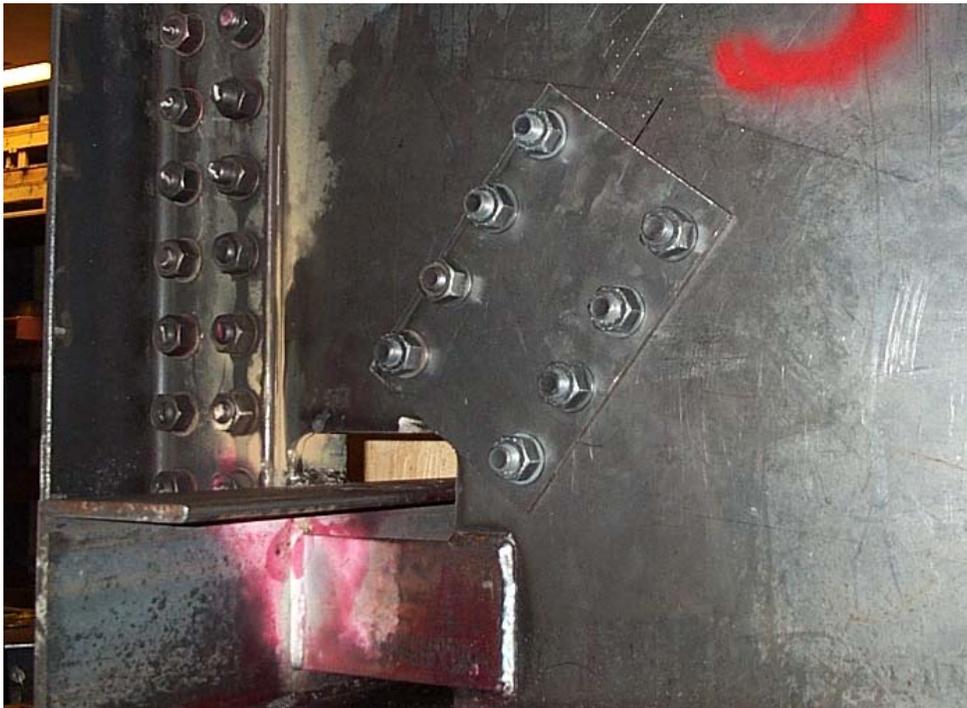
Figure 3.57 130 mm long crack after weld repairing

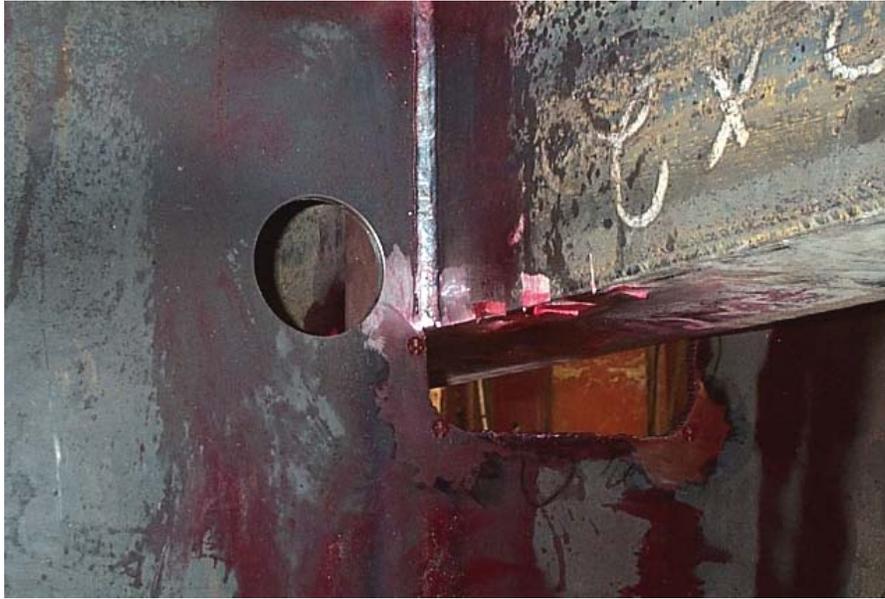
Figure 3.77: Typical crack in web frame at edge of longitudinal

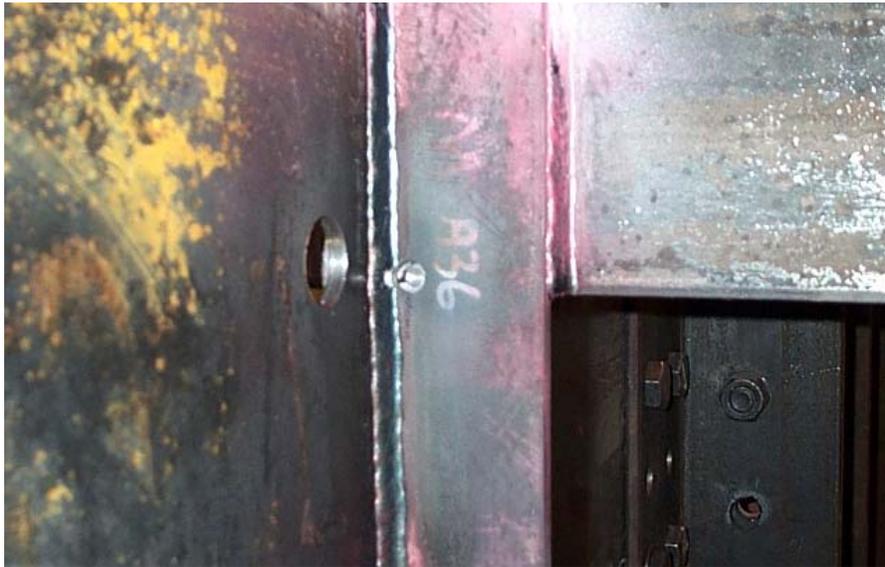
Figure 3.78: 76 mm stop hole in web frame (specimen 1)

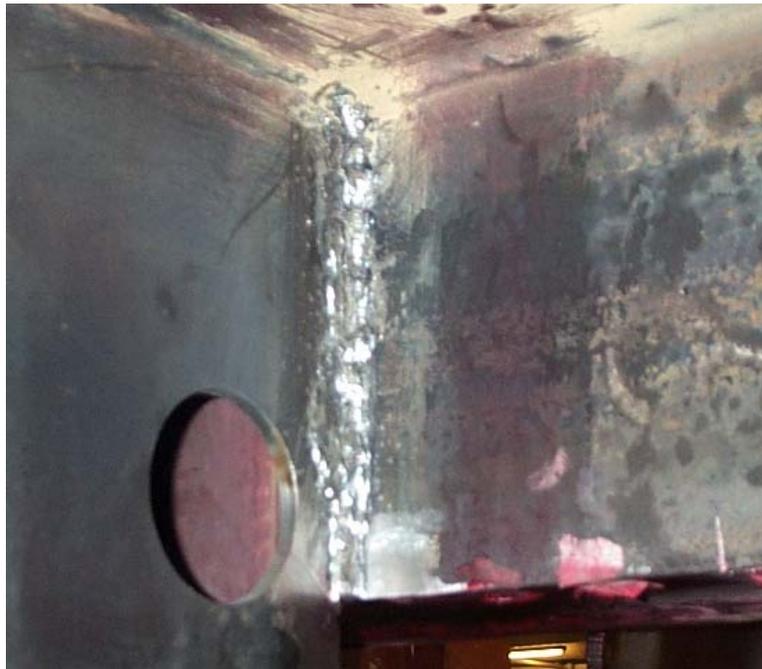
Figure 3.80: Crack along back of longitudinal at connection to web frame (specimen 1)

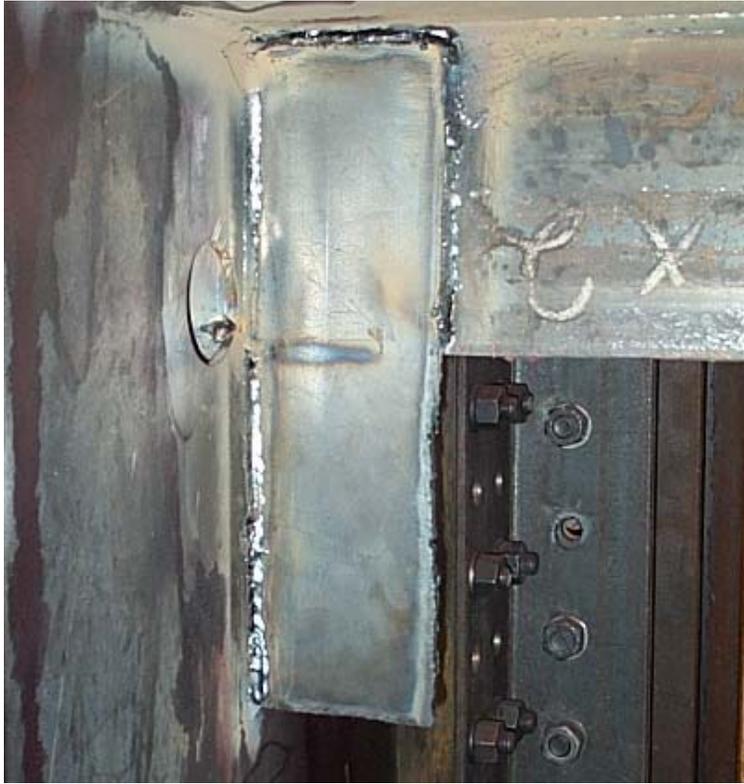
Figure 3.81: Vee-and-weld repair along back of longitudinal (specimen 1)

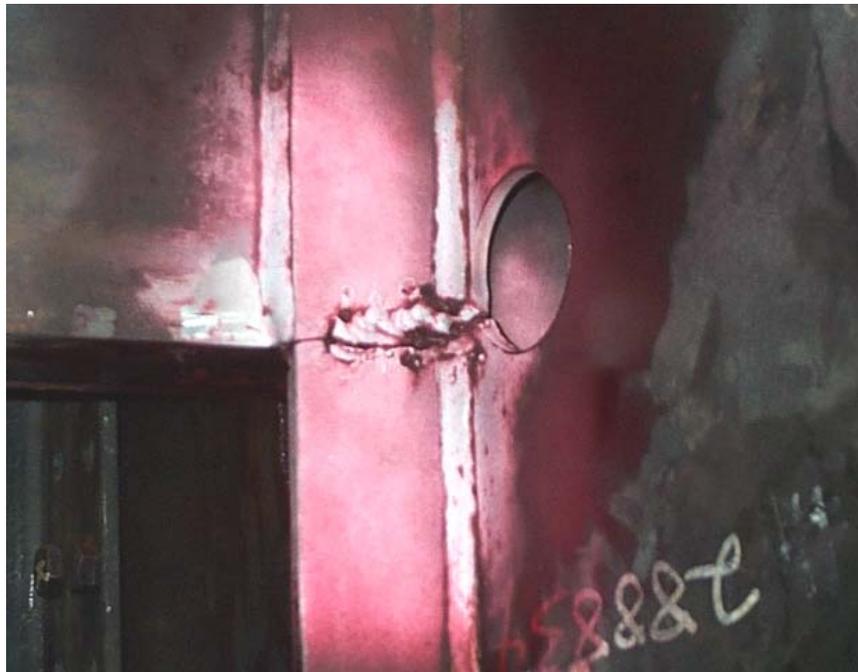
Figure 3.84: First weld repair of cracked flat bar stiffener (specimen 1)

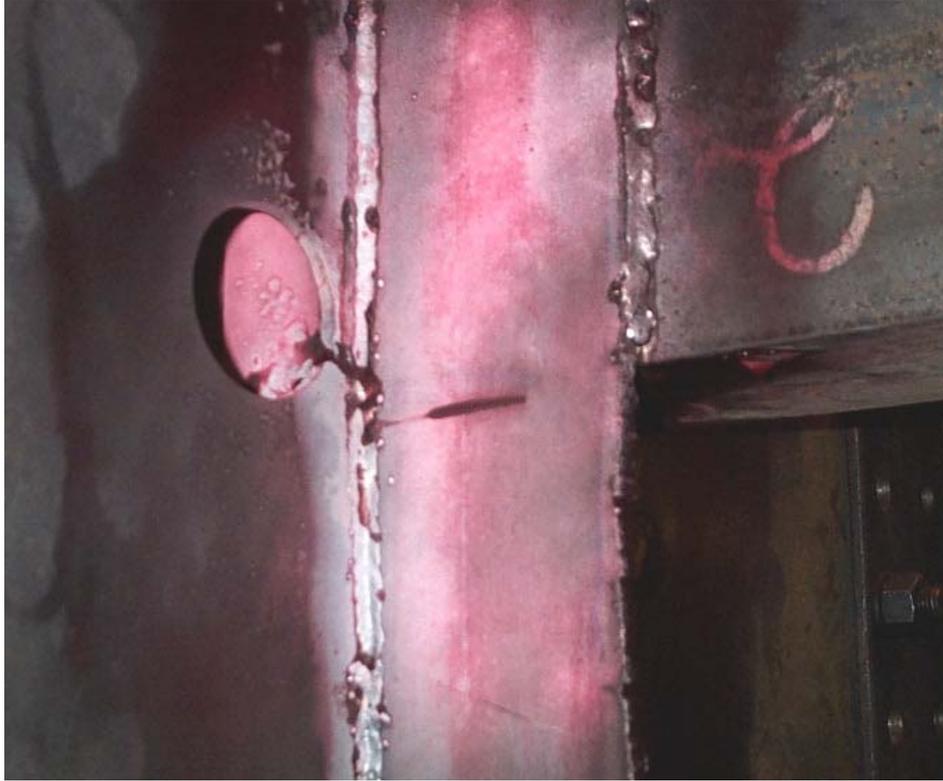
Figure 3.85: Complete failure of flat bar stiffener (specimen 1)

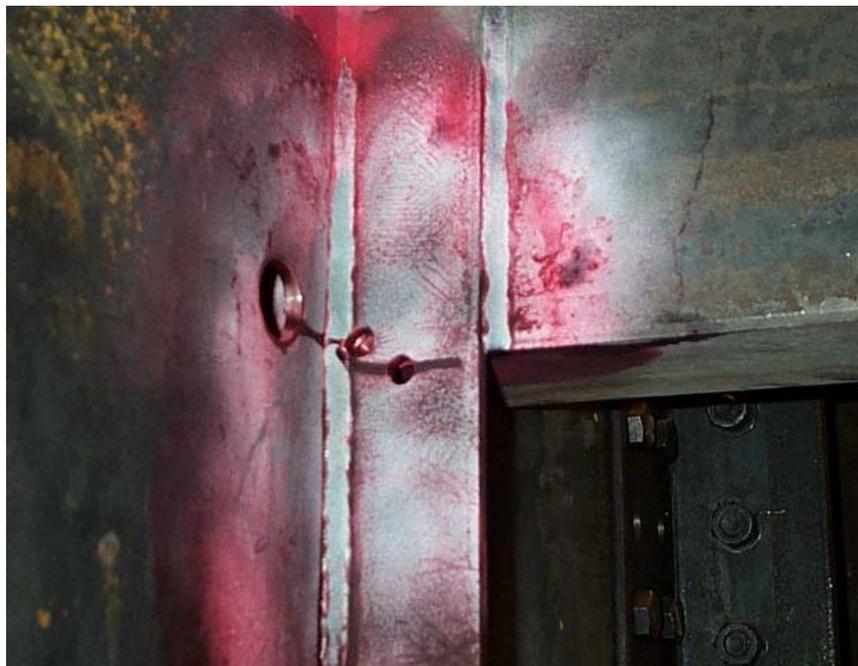
Figure 3.86: Failure of added bracket (specimen 1)
