CAUSES OF CLEAVAGE FRACTURE IN SHIP PLATE:
HATCH CORNER TESTS

E. PAUL DeGARMO, J. L. MERIAM AND M. P. O'BRIEN
UNIVERSITY OF CALIFORNIA
Under Navy Contract NObs-31222

Serial No. SSC-5

October 23, 1946

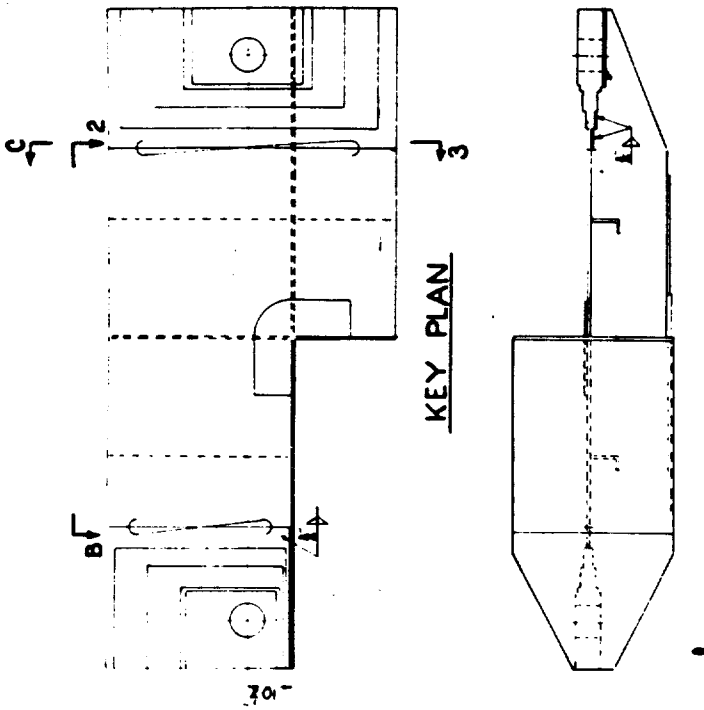
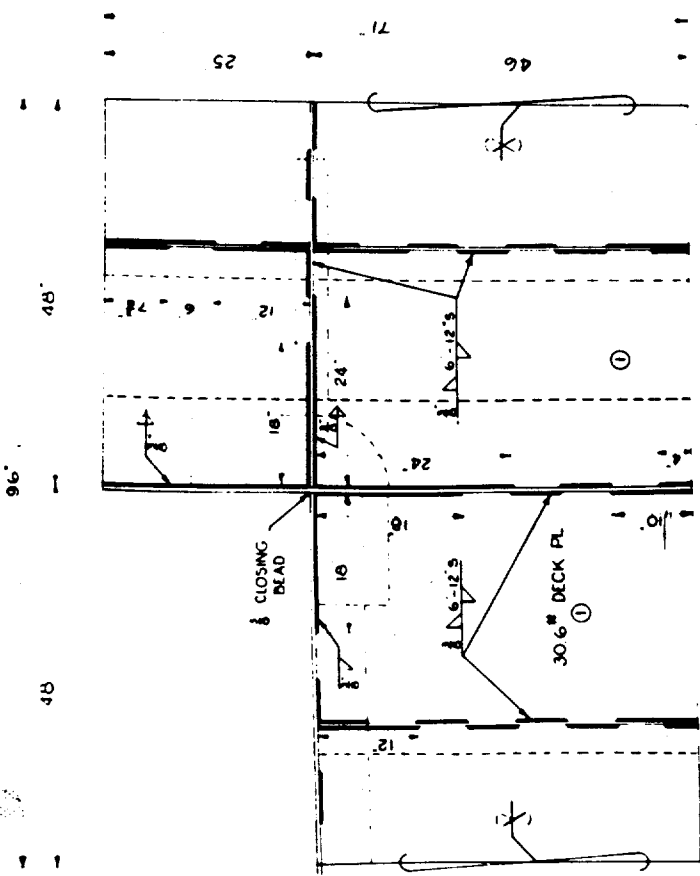
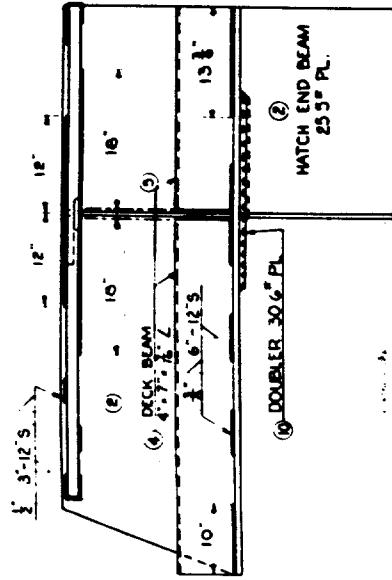
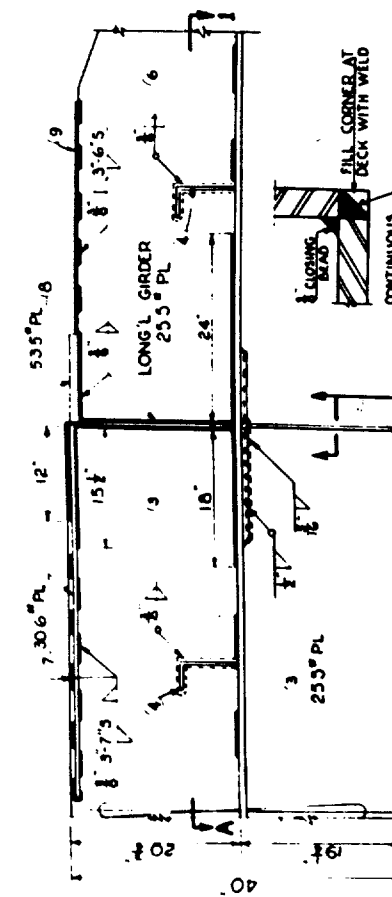
REVISED DESIGN OF THE FULL SCALE HATCH CORNER MODEL

The design of the full scale hatch corner type specimen is shown in Fig. 1. Details of the welding procedure may be found in previous reports.^{2,3} The analyses and strength properties of the seven steels which were used are given in Tables I and II.

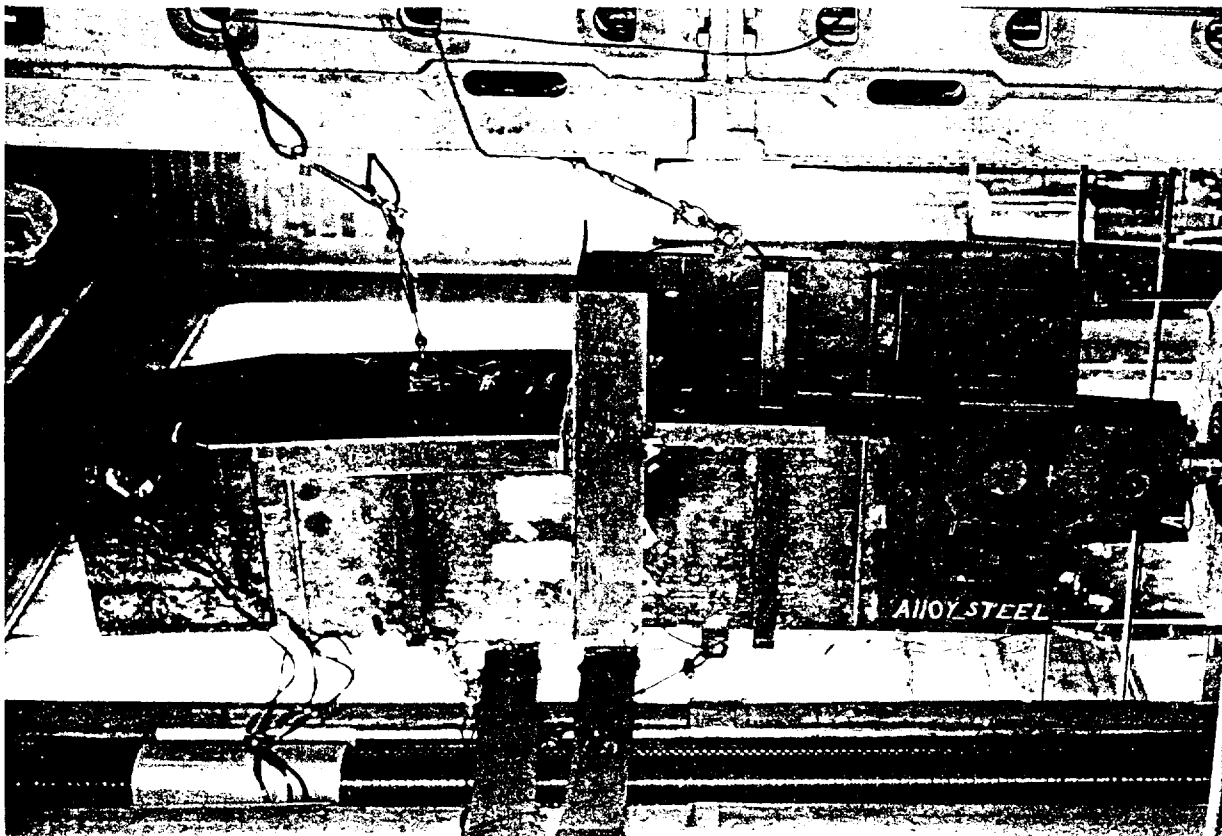
Fig. 3 Specimen 20: Overall view, below deck

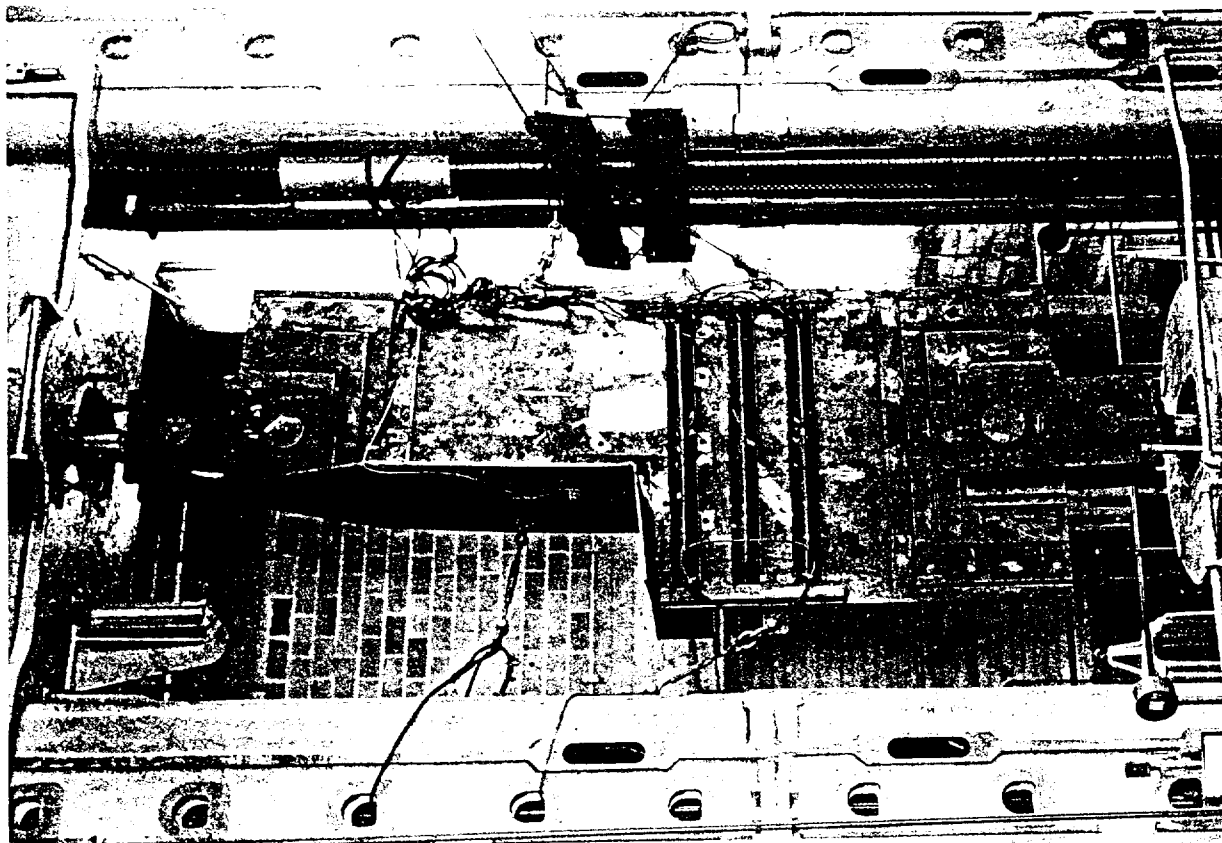
Fig. 2 Specimen 20: Overall view, above deck

Photographs of the failures in specimens 20 to 26 are shown in Figs. 2 to 41, inclusive. The load-strain curves for these specimens are shown in Fig. 42.

Referring to specimens 20 through 24, the beneficial effects of 400° F preheat are again apparent. Specimen 20 was essentially the same as specimen 8 but reached over 5,000 psi higher maximum stress. The energy absorption of this specimen was very outstanding, being about 23 per cent greater than that for any other specimen. Similarly in the case of specimen 21 as compared with specimen 4, about 7,000 psi greater stress was withstood when preheat was used. Again in the case of

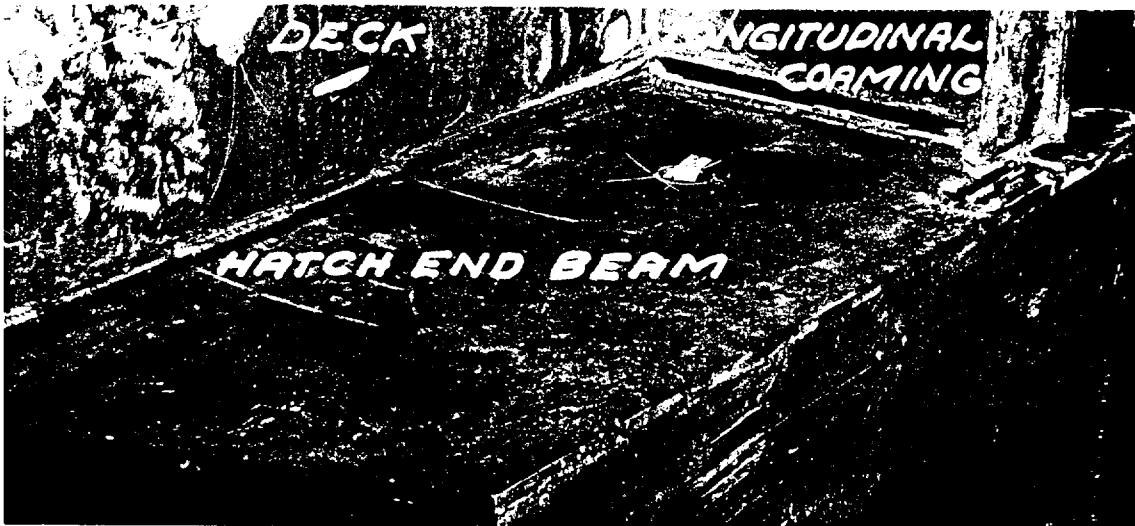
Fig. 5 Specimen 20: View of fractures from below deck, outboard, and left of hatch end beam

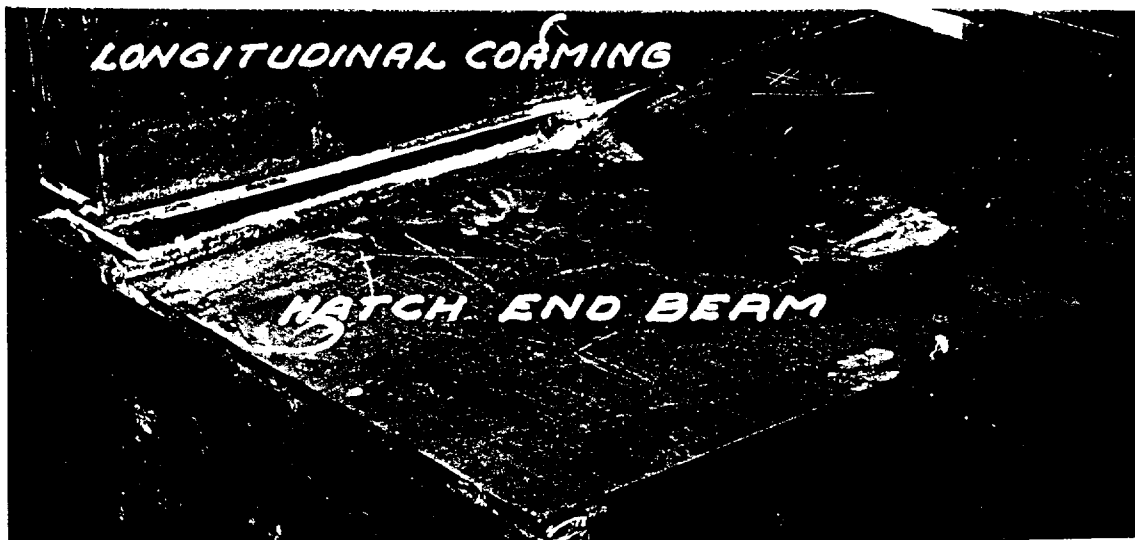
Fig. 6 Specimen 20: View of fracture in corner from inside of hatch

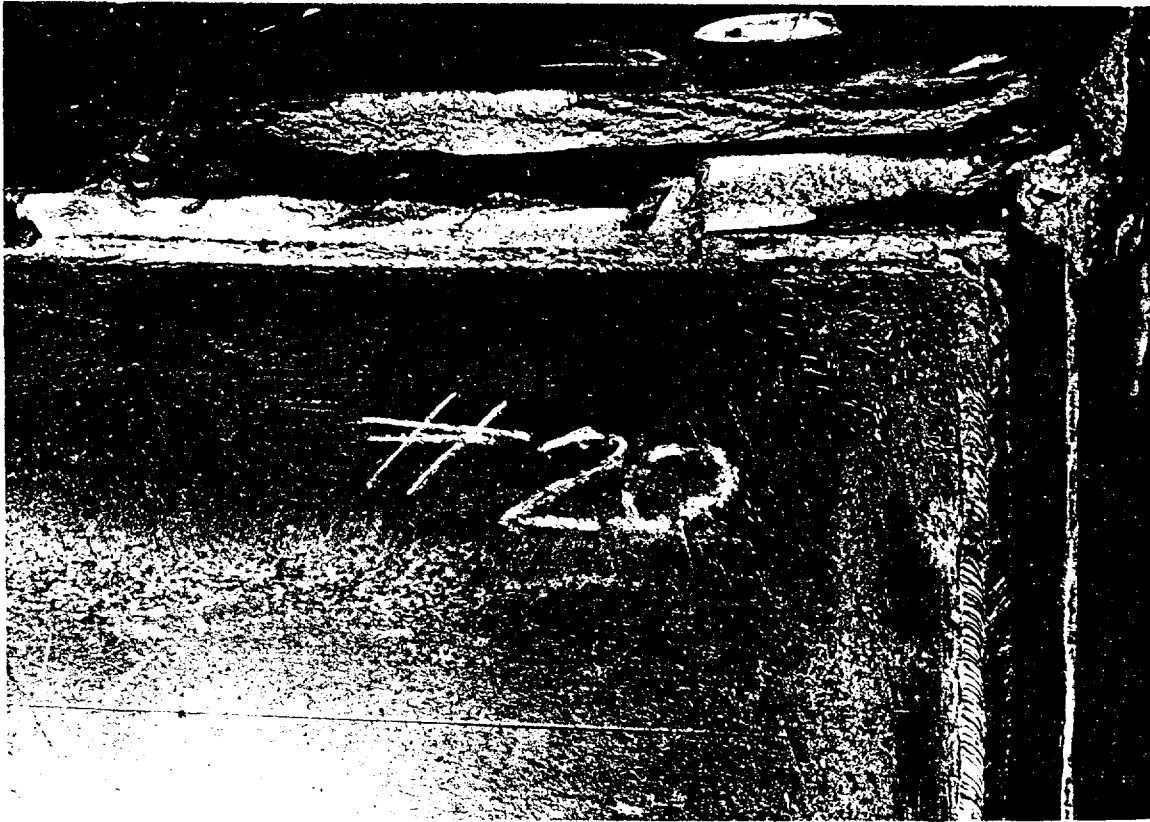
Fig. 7 Specimen 20: Deck and doubler fracture patterns, looking fwd.

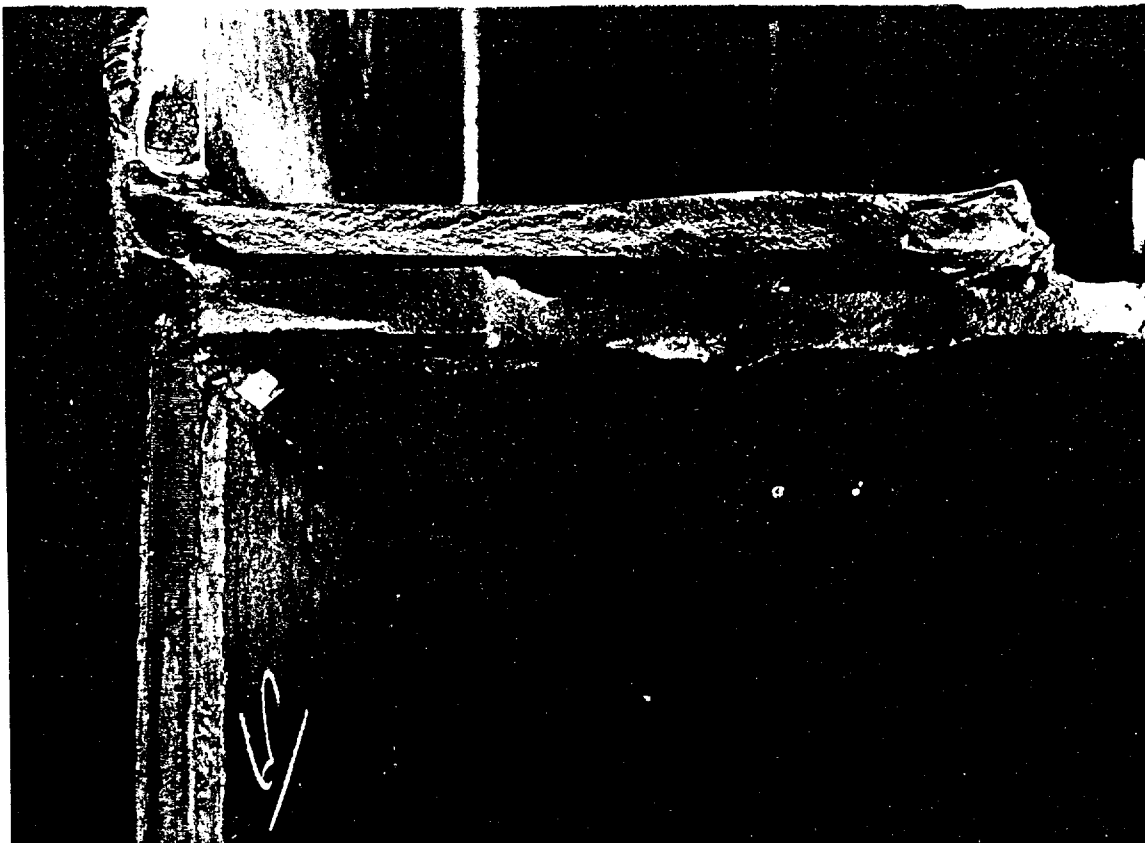
Fig. 8 Specimen 20: Deck and doubler fracture patterns, looking aft

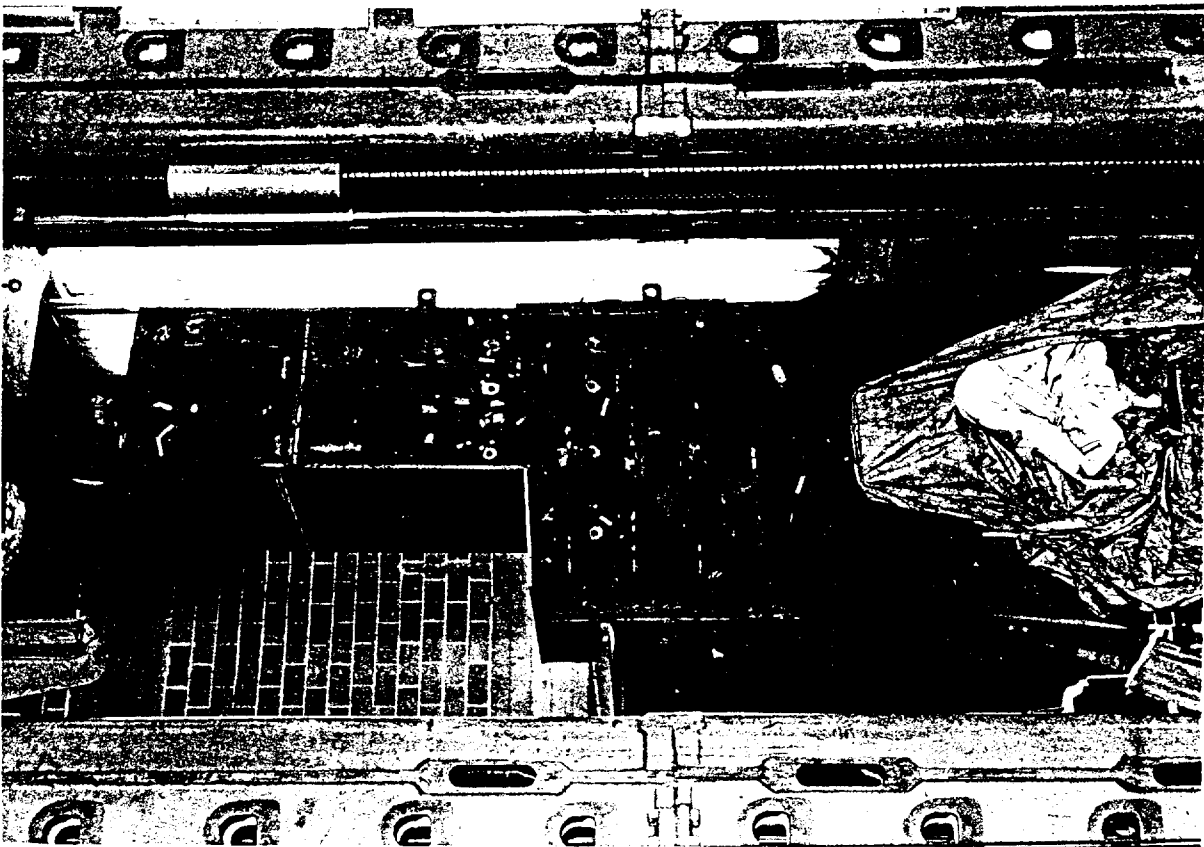
Fig. 9 Specimen 21: Overall view, above deck

It was necessary to conduct two tests on specimen 21. On the first test failure of the aft end connection occurred when the nominal stress had reached 33,000 psi. At this point small cracks had appeared in the welds at the corner of the hatch. The specimen was removed from the machine and a new end tab attached. It was then retested to failure.

It will be noted that in the case of specimen 21 the maximum stress reached during the first test was slightly higher than for the second test where failure occurred. The exact cause for this is not known but it may be due to strain age embrittlement since the retest was about two weeks after the first one. The load strain curve, shown in Fig. 42, indicates that this specimen was very nearly at its maximum possible load when the failure of the end tab occurred.

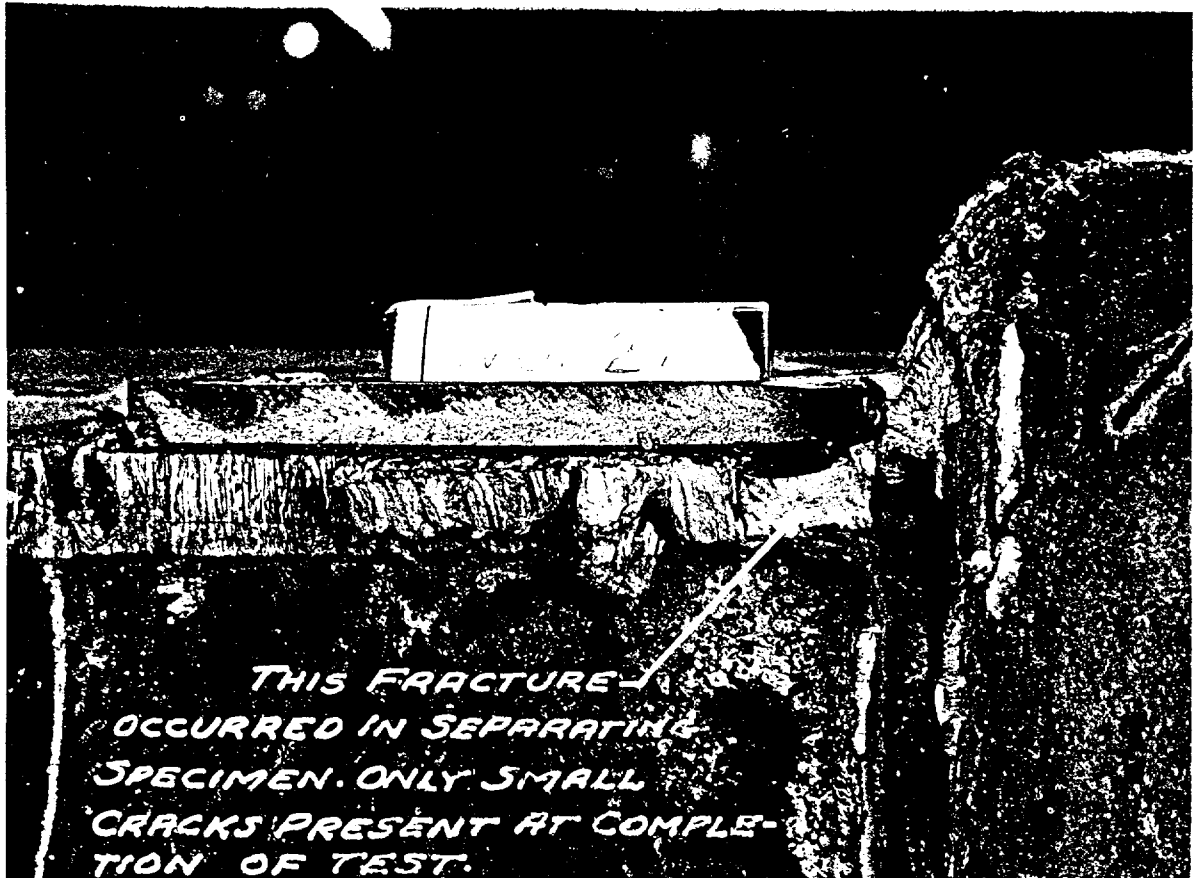
Fig. 12 Specimen 21: Fracture pattern in doubler, looking fwd.

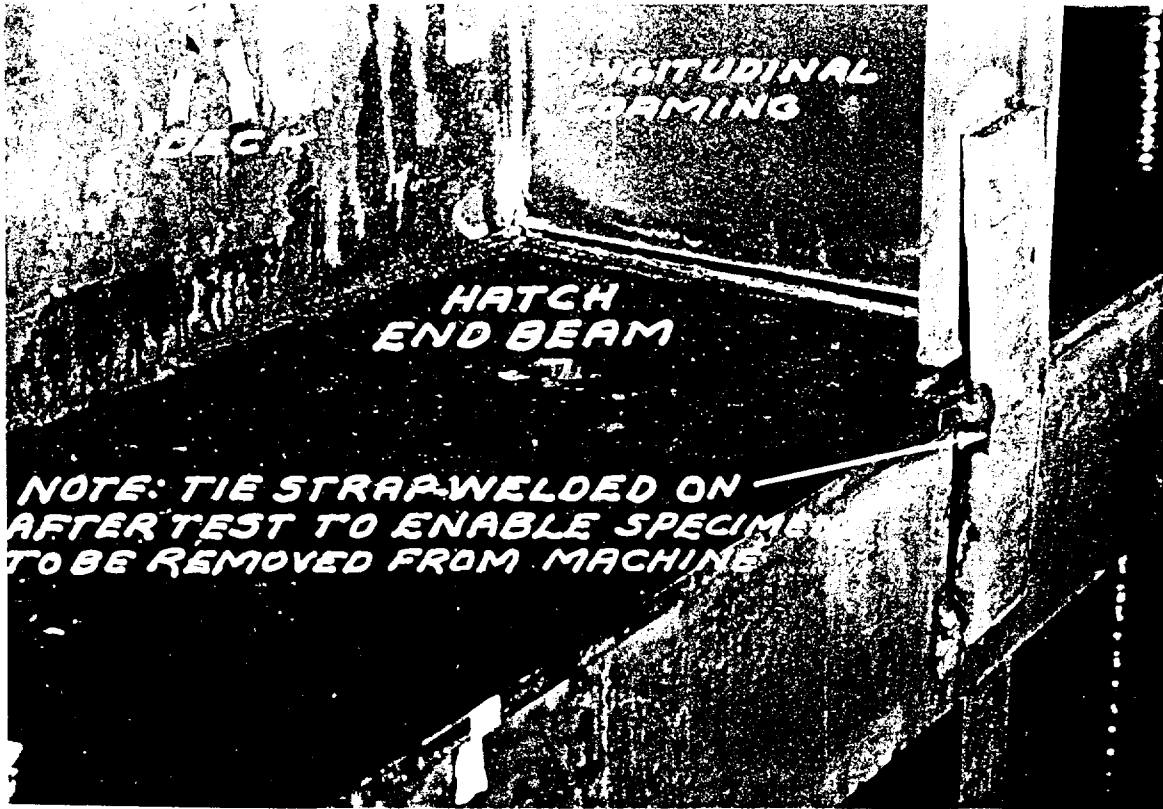
Fig. 13 Specimen 21: Fractures viewed from below deck, outboard, and aft of hatch end beam

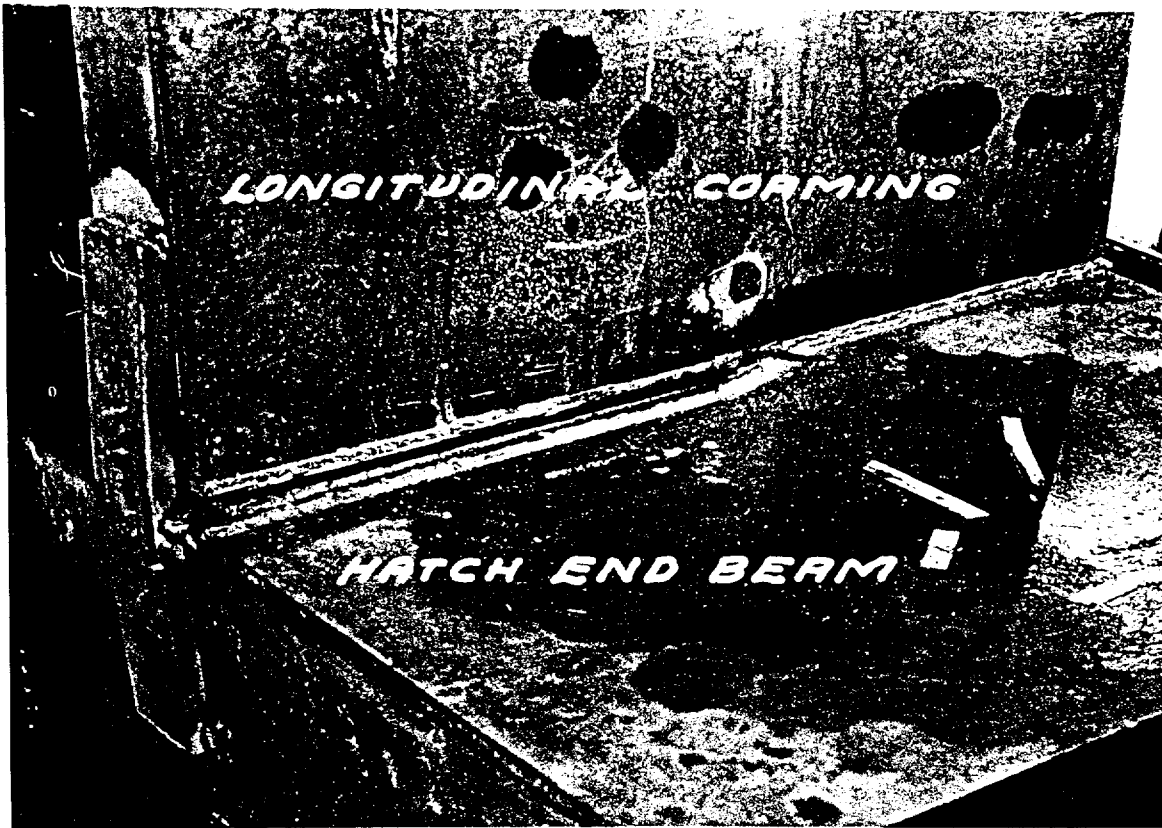
Fig. 14 Specimen 21: Fracture in corner viewed from inside of hatch

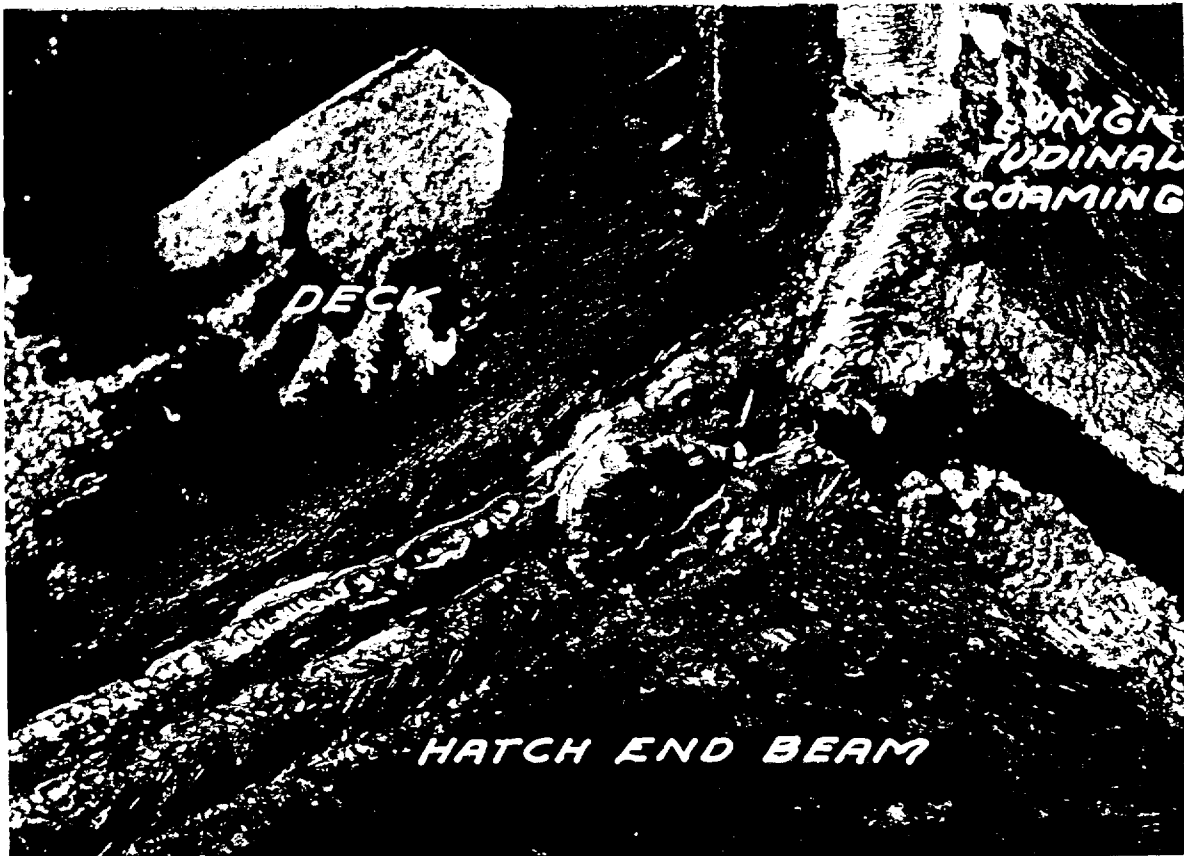
Fig. 18 Specimen 22: Fracture in deck-hatch end beam weld viewed from below deck, outboard, and aft of hatch end beam

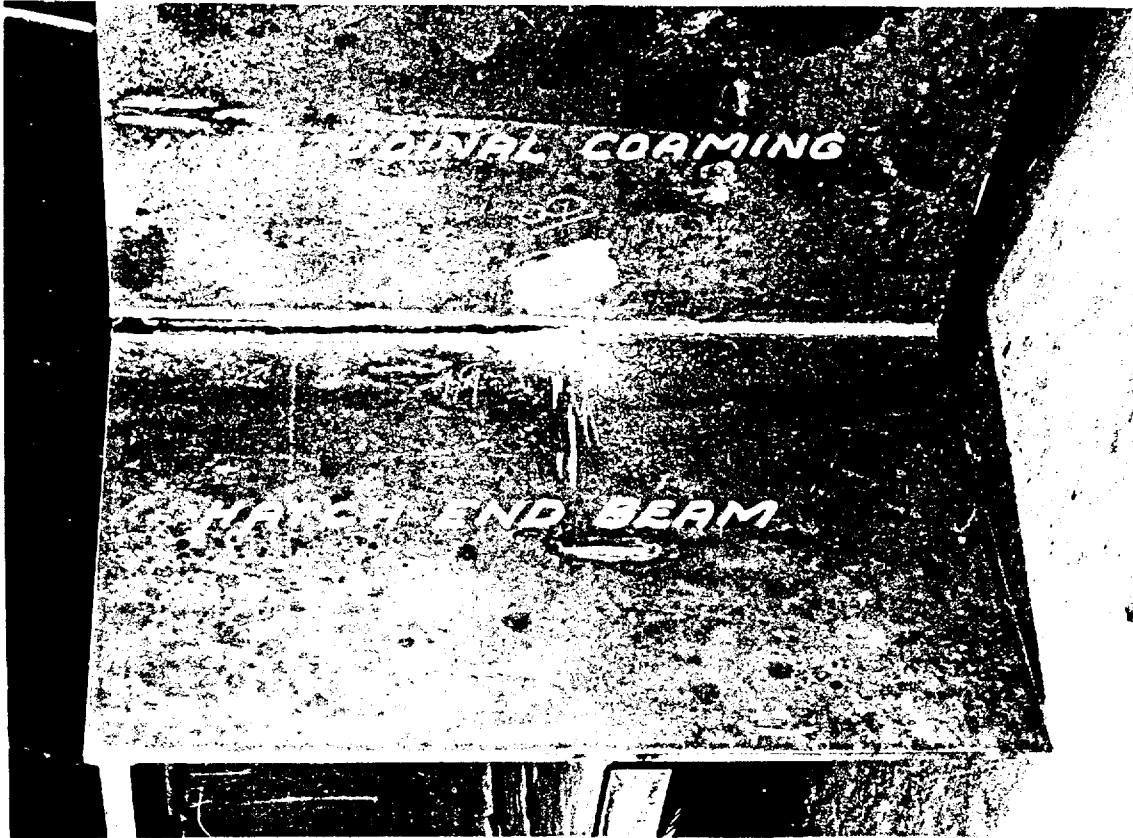
Fig. 19 Specimen 22: Fracture in corner viewed from inside of hatch

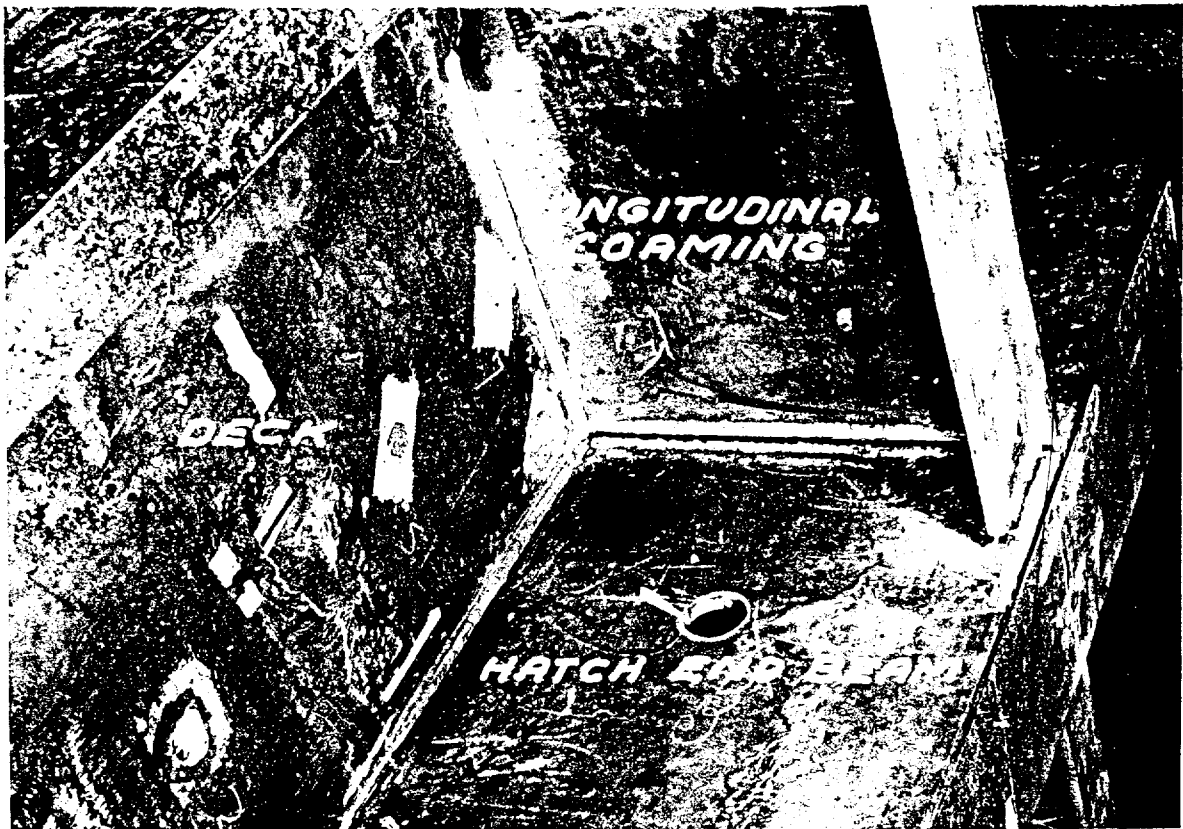
Fig. 20 Specimen 22: Fractures viewed from outboard, below deck, and aft of hatch end beam

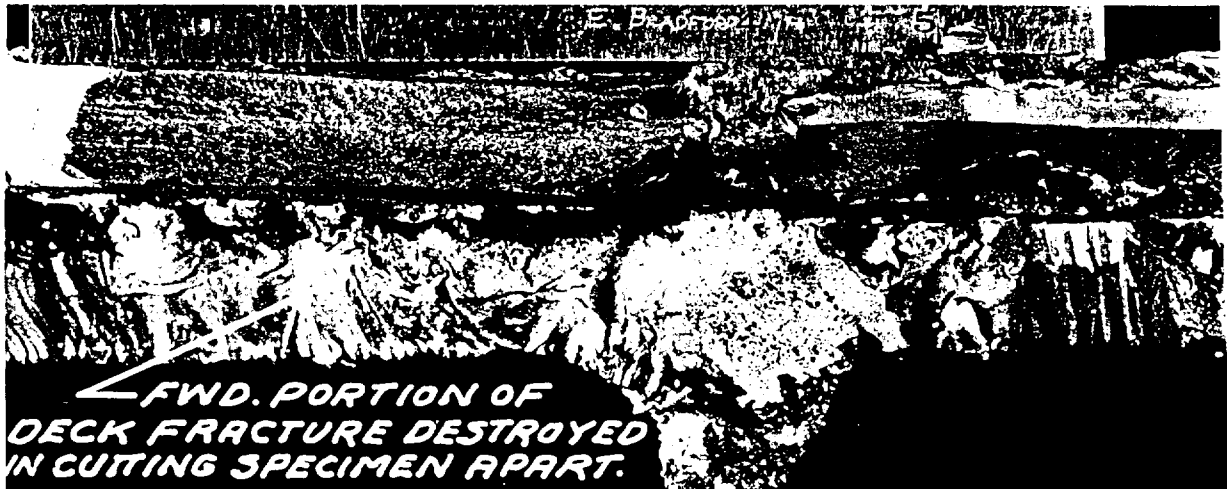
Fig. 21 Specimen 22: Fracture pattern in doubler viewed from different angles, looking fwd.

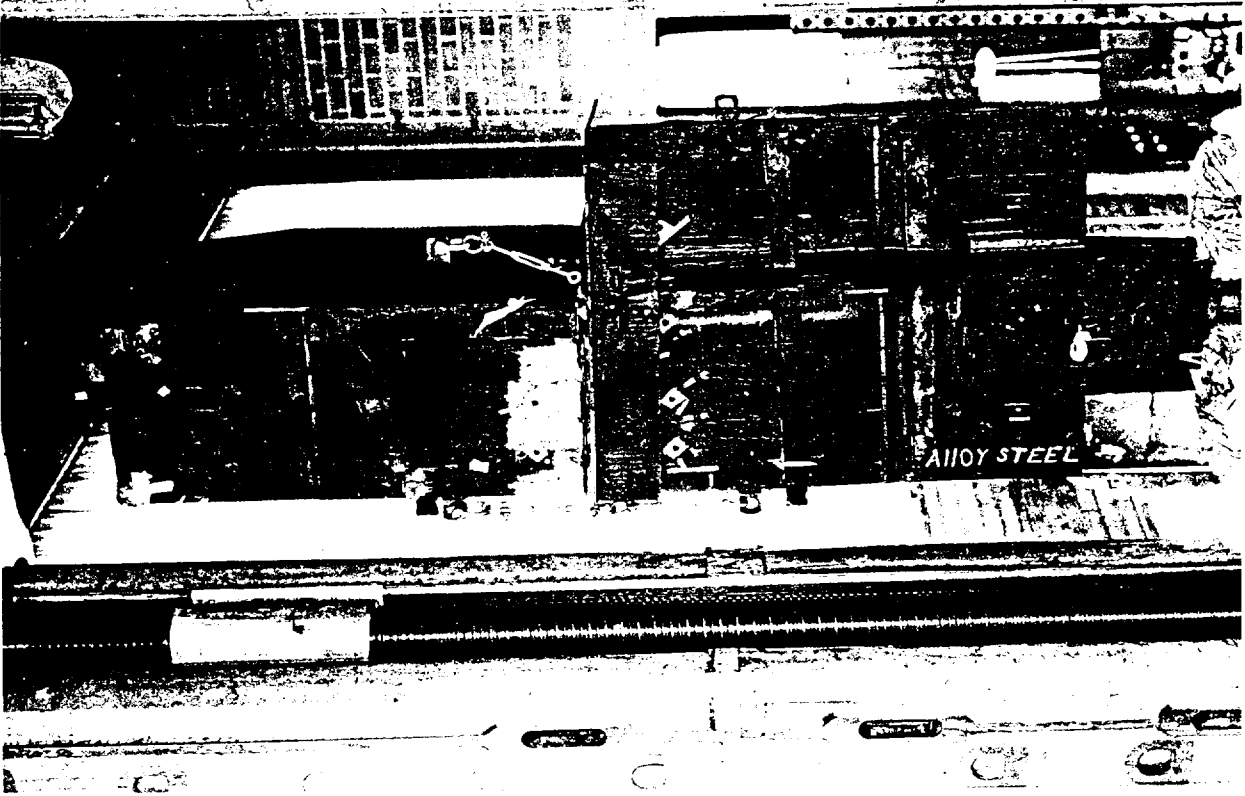
Fig. 24 Specimen 23: Overall view, below deck

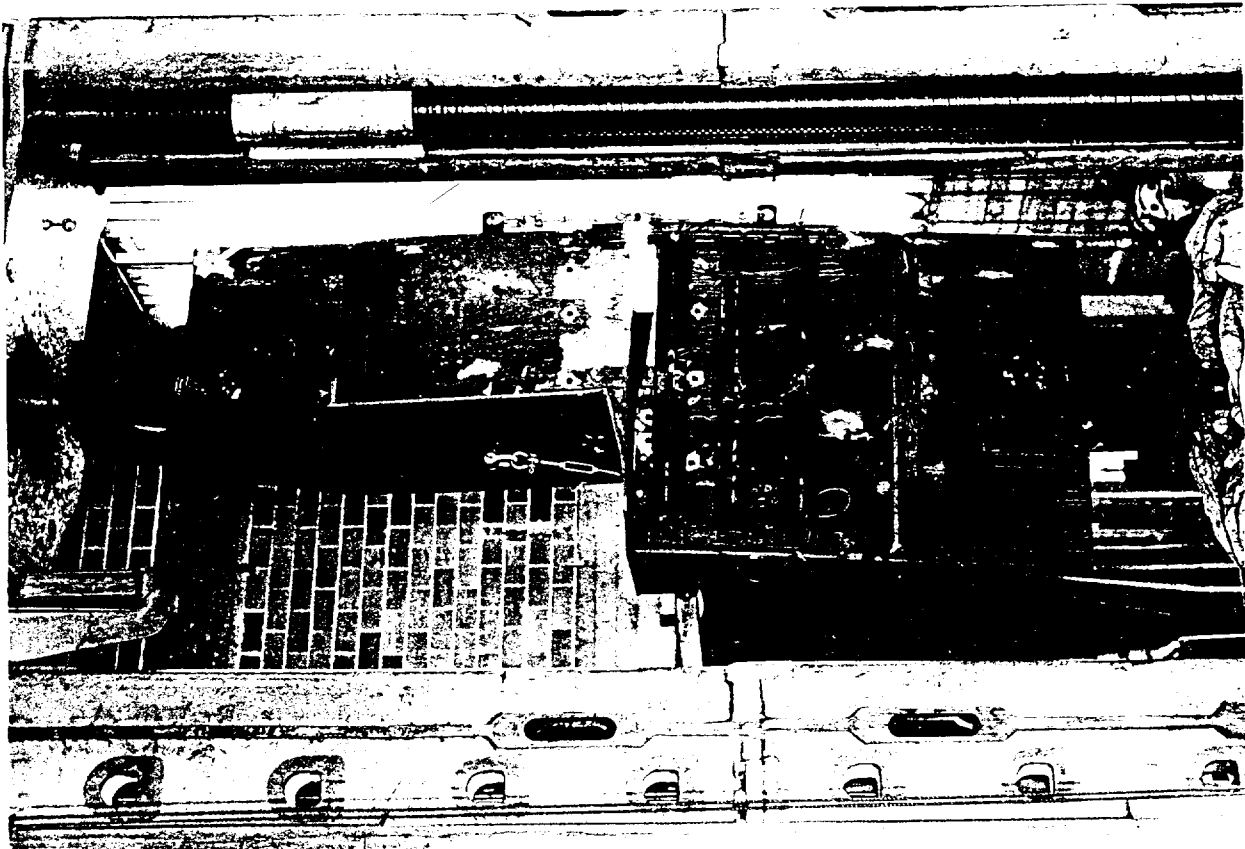
Fig. 23 Specimen 23: Overall view, above deck

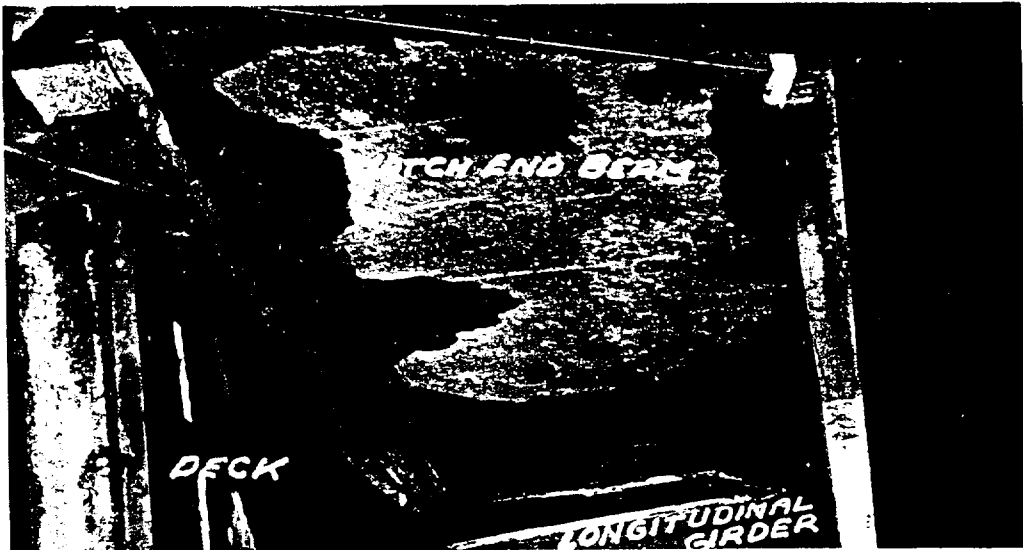
Fig. 26 Specimen 23: Fractures viewed from below deck, outboard, and fwd. of hatch end beam.

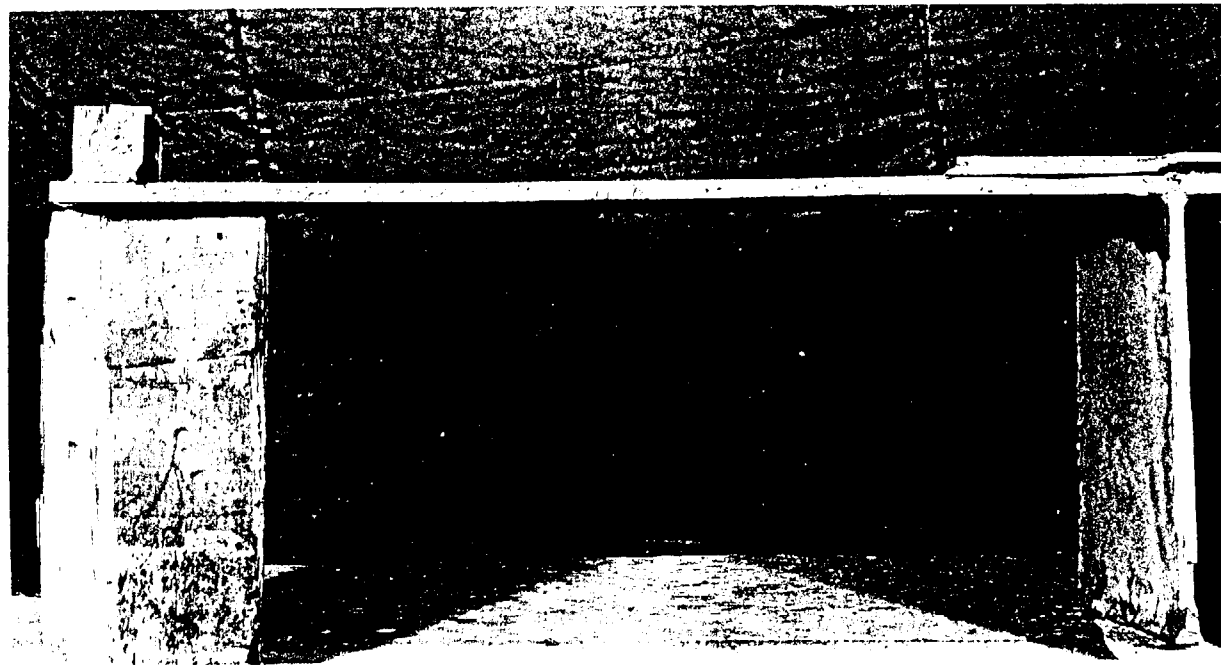
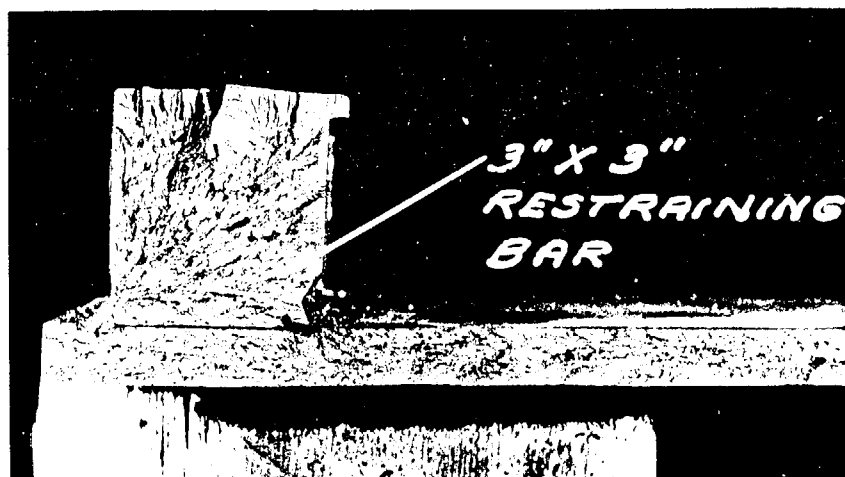
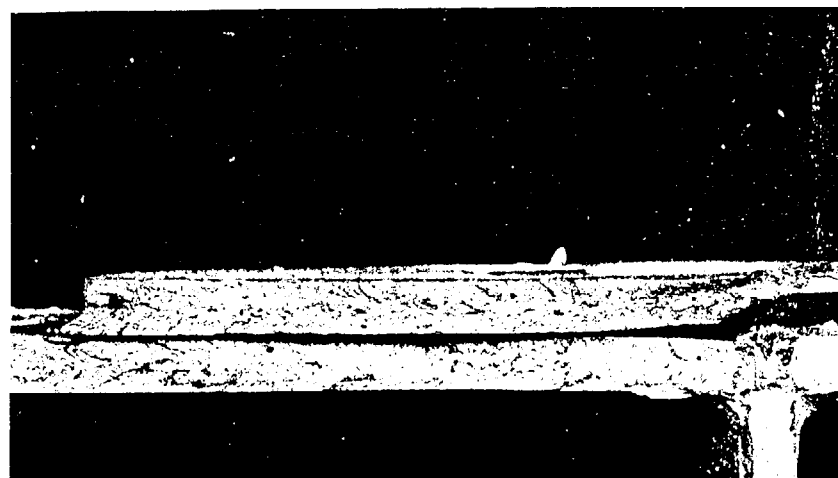
As may be seen in Fig. 28 the cleavage fracture in specimen 23 extended through the 3 in. x 3 in. bar which was attached to the outboard edge of the specimen to permit the attachment of transverse restraining beams.^{2,3} This bar had also fractured in specimen 2. However, in the case of specimen 23 this fracture was unique in that the crack went outboard in the deck plate to the outer edge and then inboard through the 3 in. x 3 in. bar.

Fig. 28 Specimen 23: Fracture patterns in deck, doubler, and 3" x 3" bar, looking fwd.

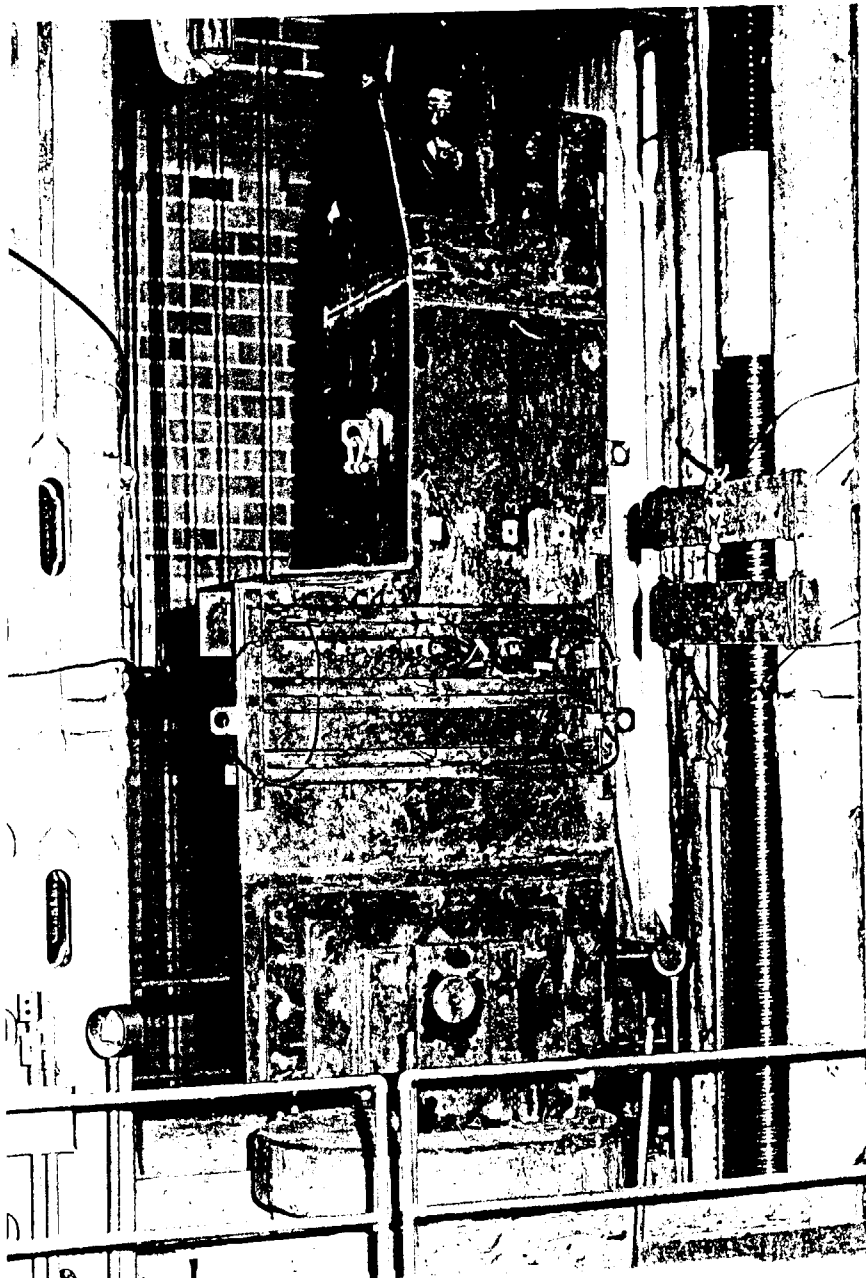
Fig. 29 Specimen 24: Overall view, above deck

The deck and doubler plates of specimen 24 were slightly laminated but it was not felt that this affected the test results.

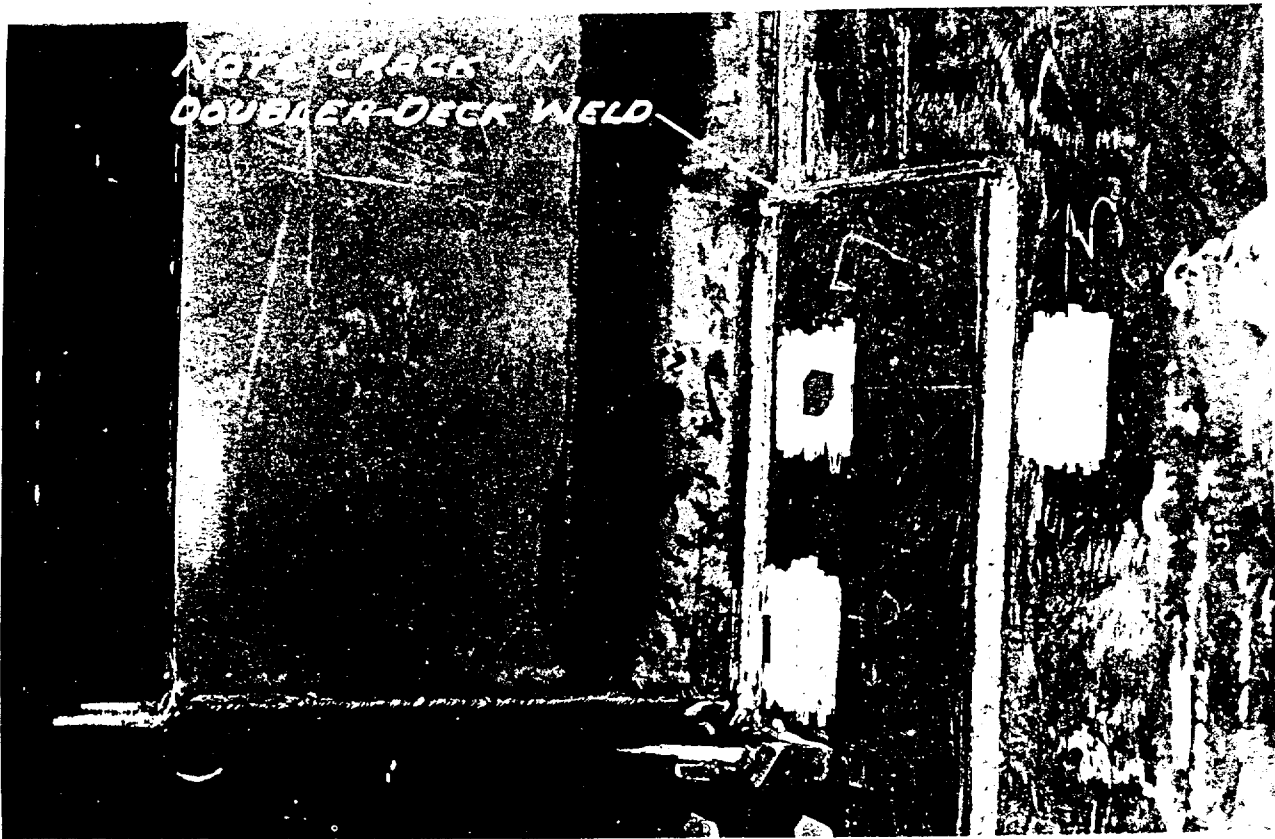
Fig. 31 Specimen 24: Fractures viewed from above deck.

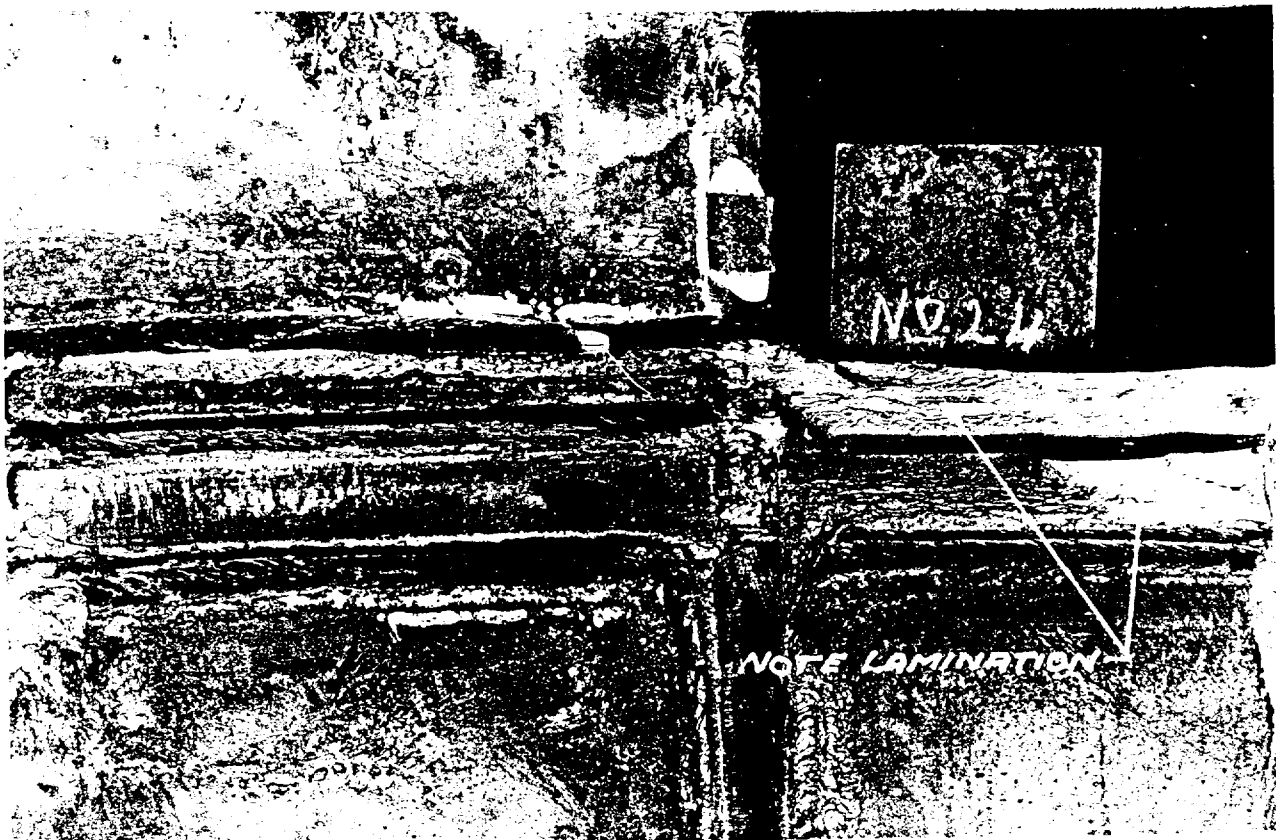
Fig. 32 Specimen 24: Looking aft at fracture patterns in deck and doubler
