CAUSES OF CLEAVAGE FRACTURE IN SHIP PLATE:
HATCH CORNER TESTS

E. PAUL DeGARMO, J. L. MERIAM AND M. P. O'BRIEN
UNIVERSITY OF CALIFORNIA
Under Navy Contract NObs-31222

Serial No. SSC-5

October 23, 1946

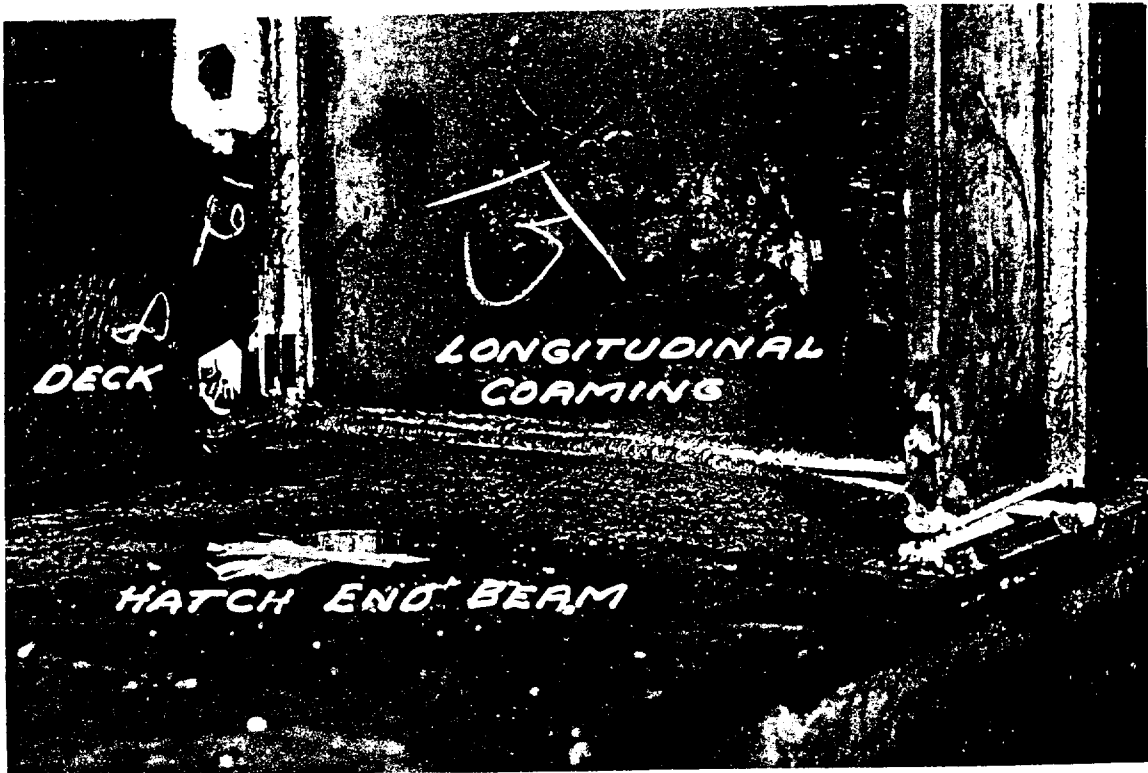
Fig. 33 Specimen 24: Fracture in longitudinal coaming-hatch end beam weld viewed from below deck, outboard, and aft of hatch end beam.

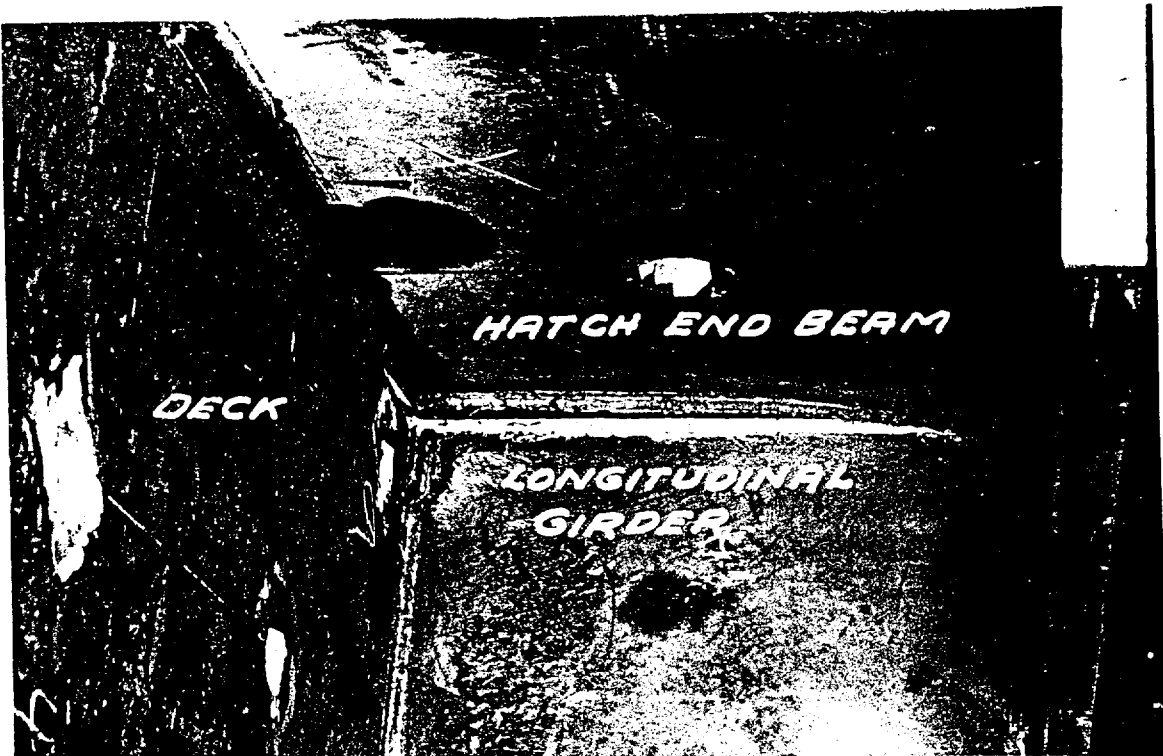
Fig. 34 Specimen 24: Fractures viewed from below deck, outboard, and fwd. of hatch end beam

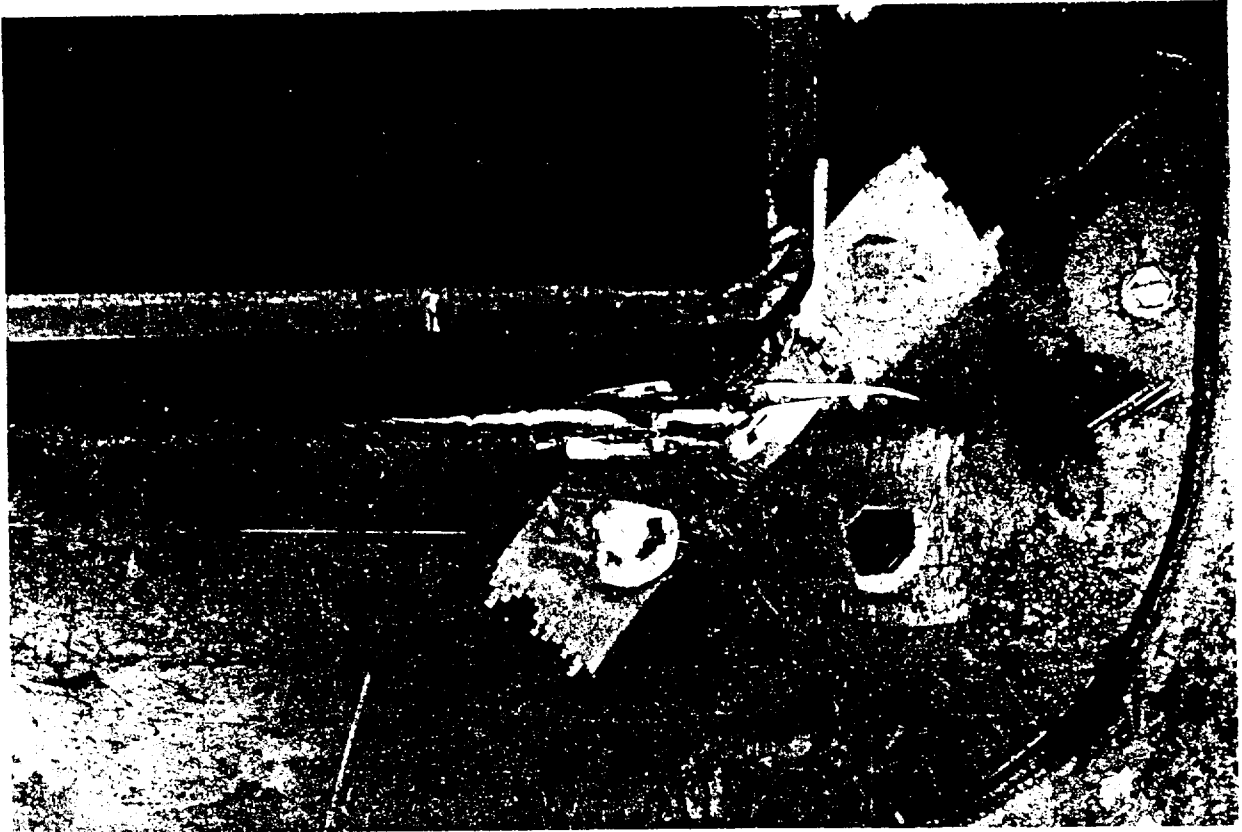
Fig. 35 Specimen 25: Fracture in doubler viewed from above

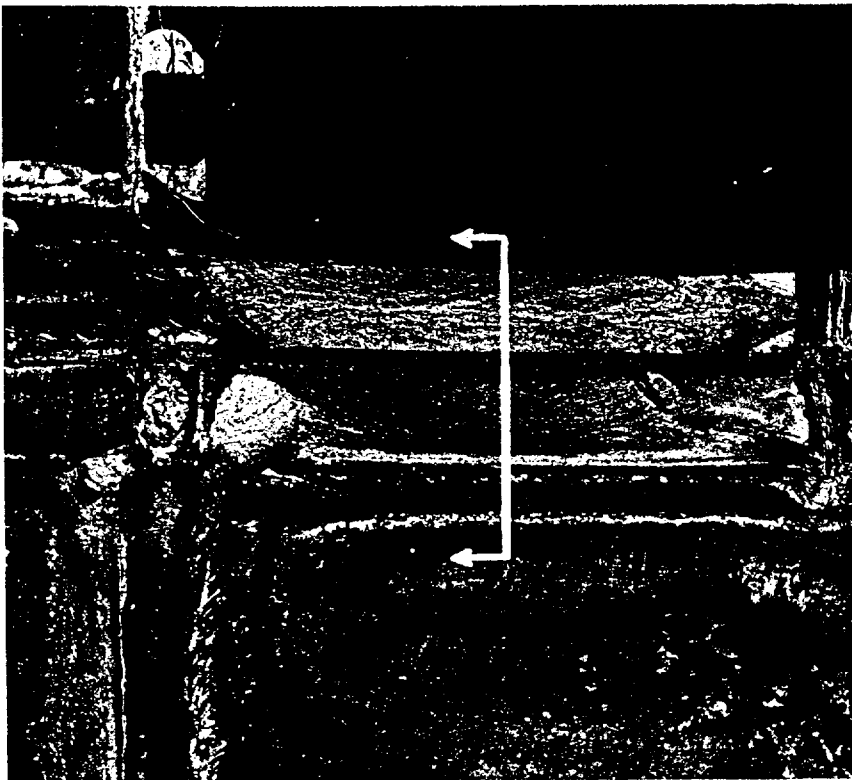
Fig. 36 Specimen 25: Deck and doubler fracture patterns, looking aft; and section, looking inboard

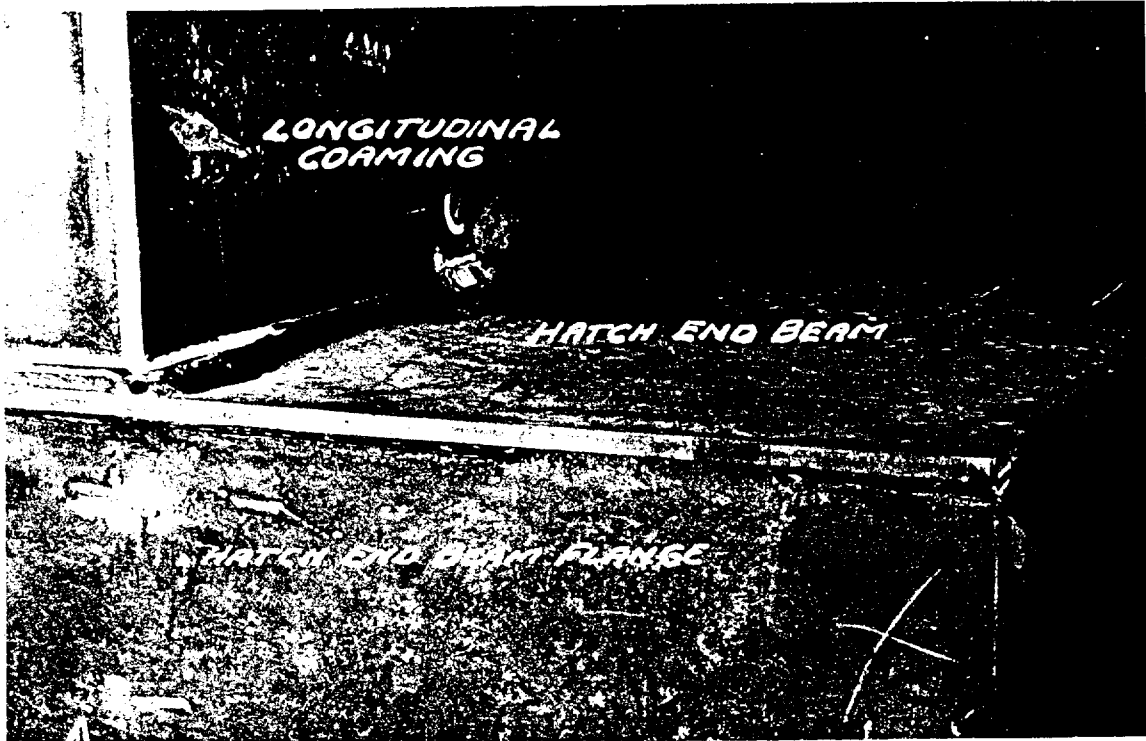
Fig. 37 Specimen 25: Fracture in corner viewed from inside of hatch

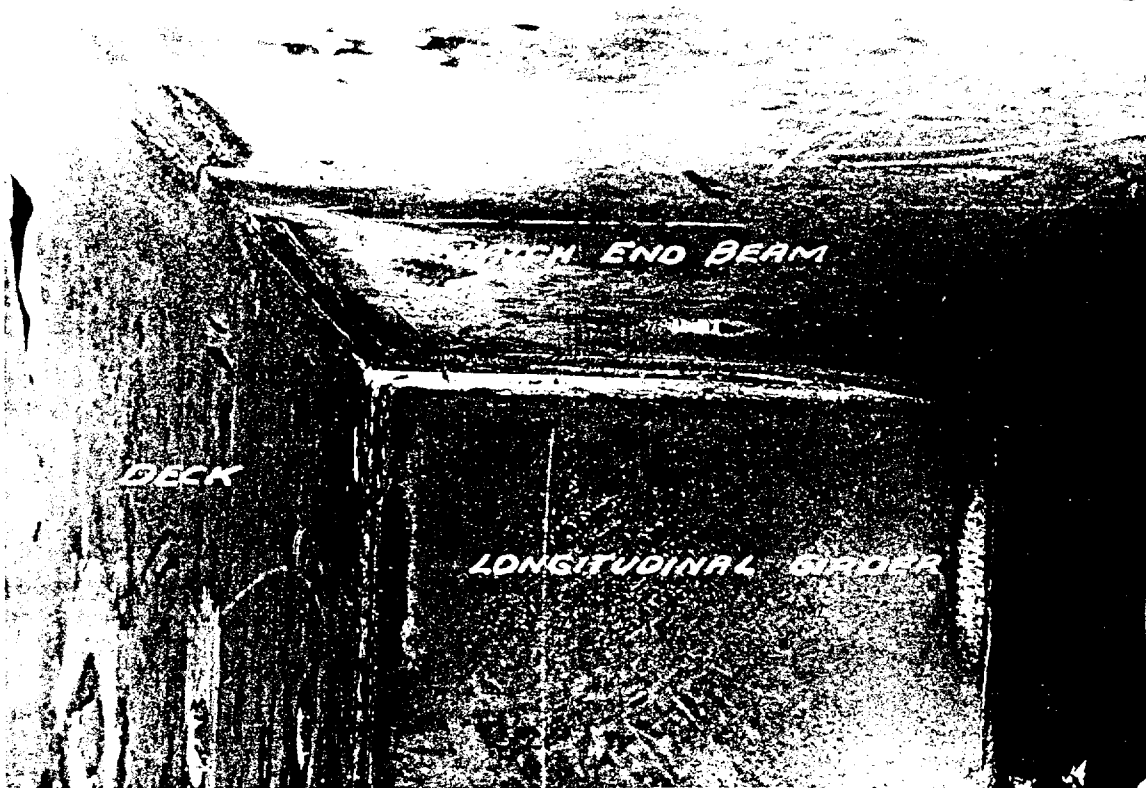
Fig. 38 Specimen 25: Fractures viewed from below deck, outboard, and fwd. of hatch end beam

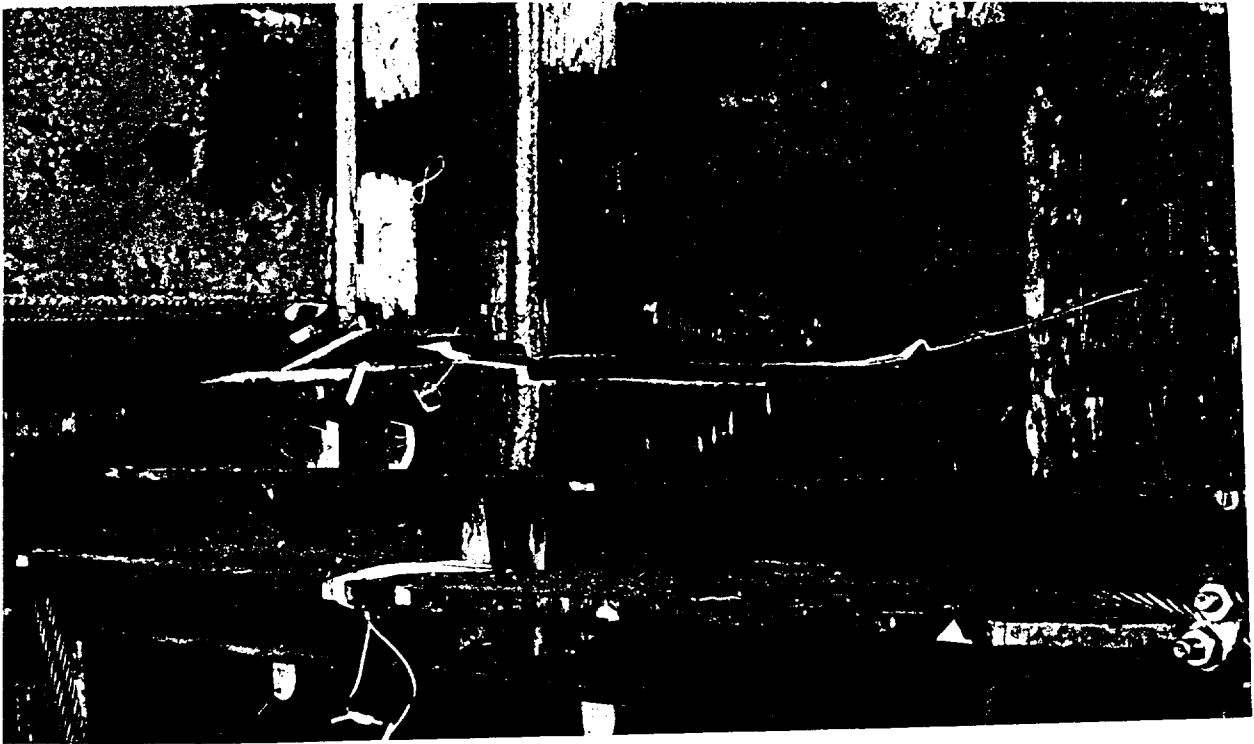
Fig. 39 - Specimen 26: Fractures in deck and doubler, viewed from above

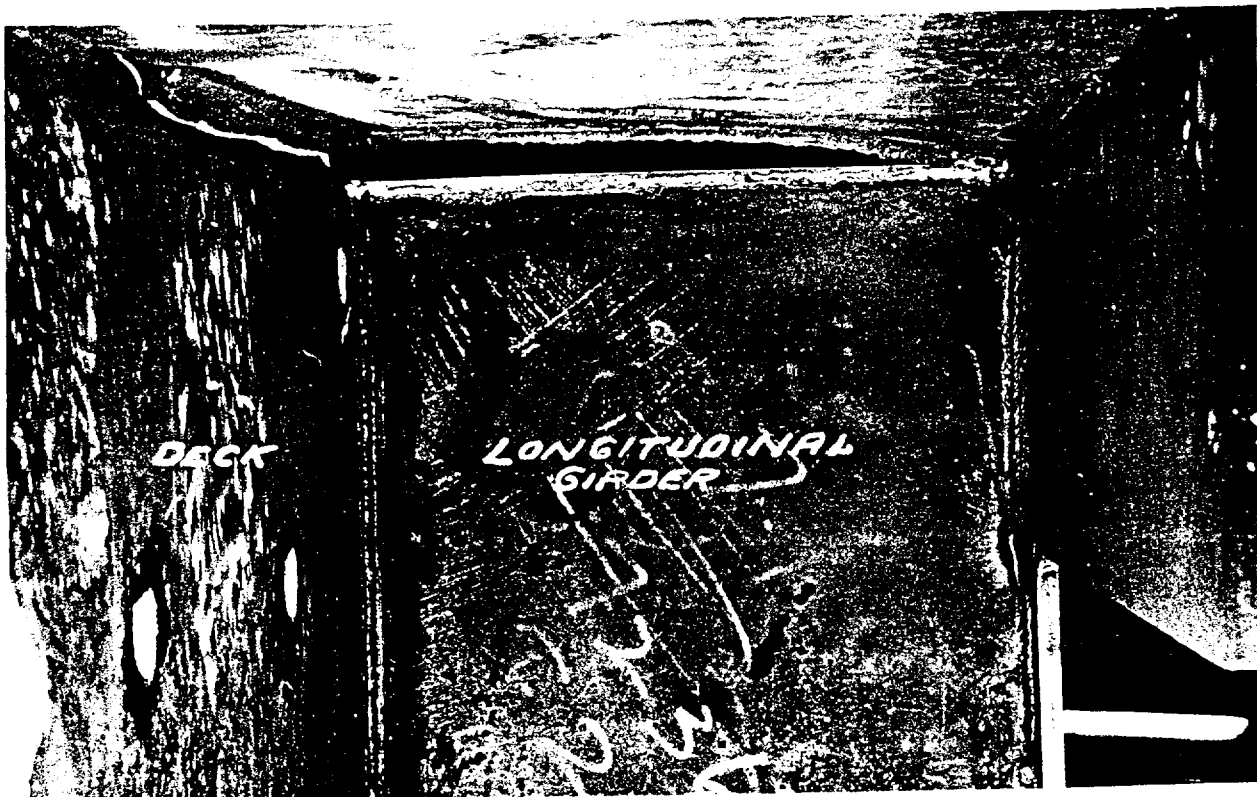
Fig. 40 - Specimen 26: Fracture viewed from below deck, outboard, and fwd. of hatch end beam

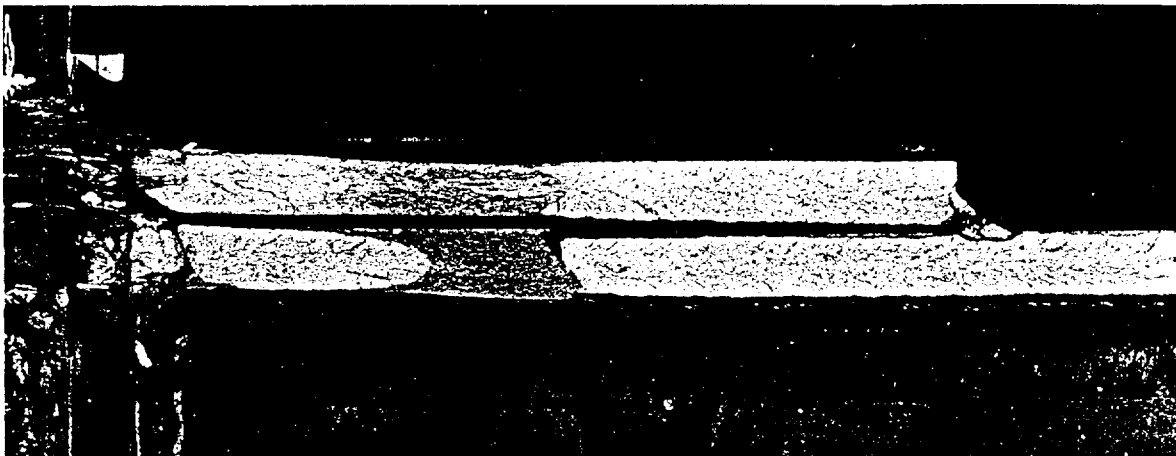
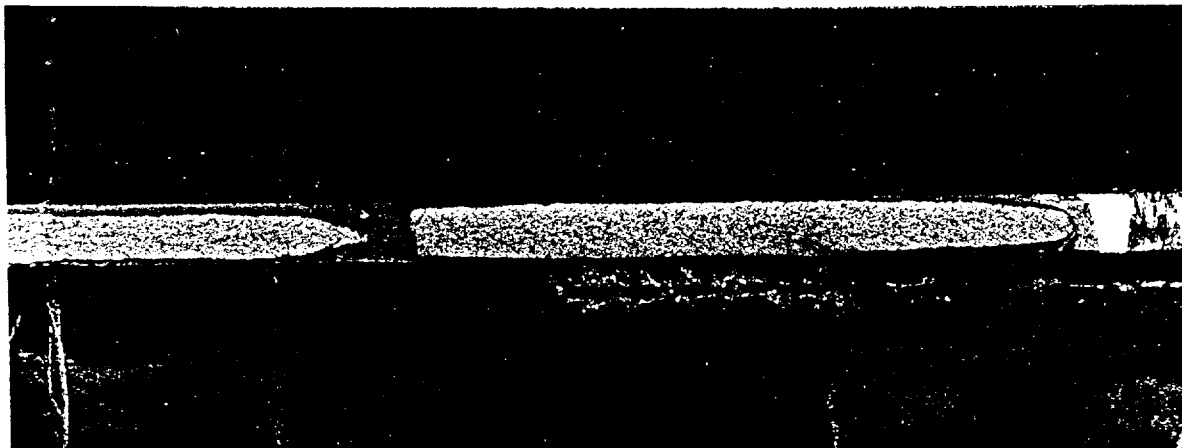
Fig. 41 - Specimen 26: Fracture patterns in deck and doubler, looking aft

Overall view of fractures

Closeup at corner

Closeup at end of fracture

Fig. 43 shows the energy temperature relationship based upon the energy values corresponding to the failure of the longitudinal joint for specimens 10, 14, 25, and 26. This curve indicates that the transition temperature for steel "C" when built into the hatch corner type specimen is about 85° higher than when determined by Keyhole Charpy tests. The fracture obtained on specimen 26, as shown in Fig. 41, is of particular interest since it started in cleavage, changed to shear, then back to cleavage, later going into shear again and then back into cleavage with a small amount of shear at the fracture edges. Although the end of the fracture was predominantly cleavage it did not progress entirely across the specimen but stopped about 12 inches from the outboard edge. At the point where it stopped there was considerable local plastic flow.

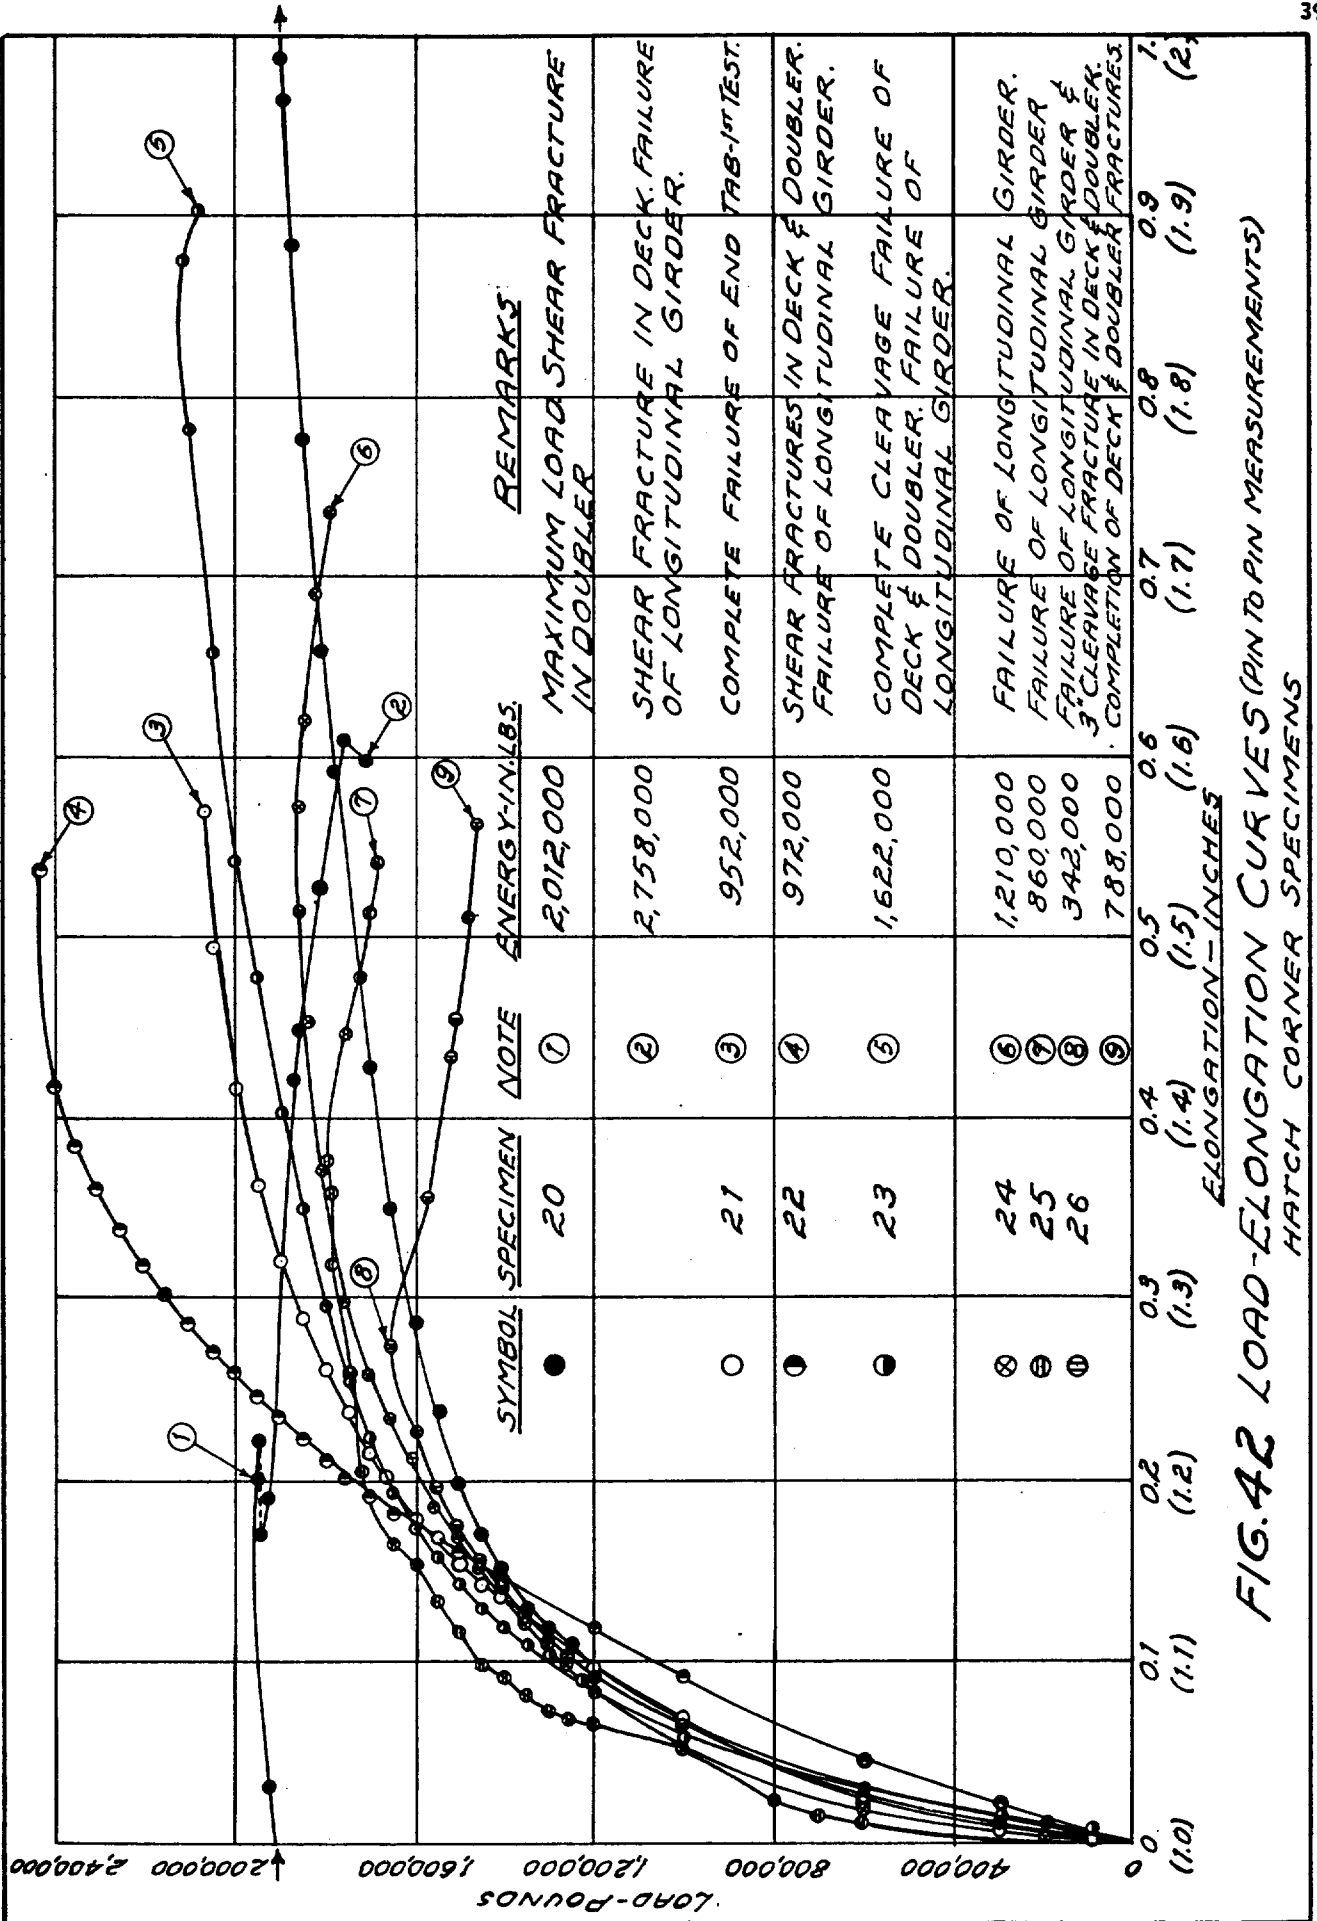
FIG. 42 LOAD-ELONGATION CURVES (PIN TO PIN MEASUREMENTS) HATCH CORNER SPECIMENS

Photographs of the failures in specimens 20 to 26 are shown in Figs. 2 to 41, inclusive. The load-strain curves for these specimens are shown in Fig. 42.

failure of the weld joints before the plate was subjected to a sufficiently high stress to bring about much plastic flow. Thus in this case the energy absorbed was the result of a rather high load and very little elongation. This can be seen in Fig. 42 which shows the load-strain curve for this specimen. The performance of this specimen indicates that if it is desirable to have high energy absorption in a welded structure, the use of alloy steel having rather high yield strength and excellent impact properties is of little use unless the performance of the welds also is improved greatly.

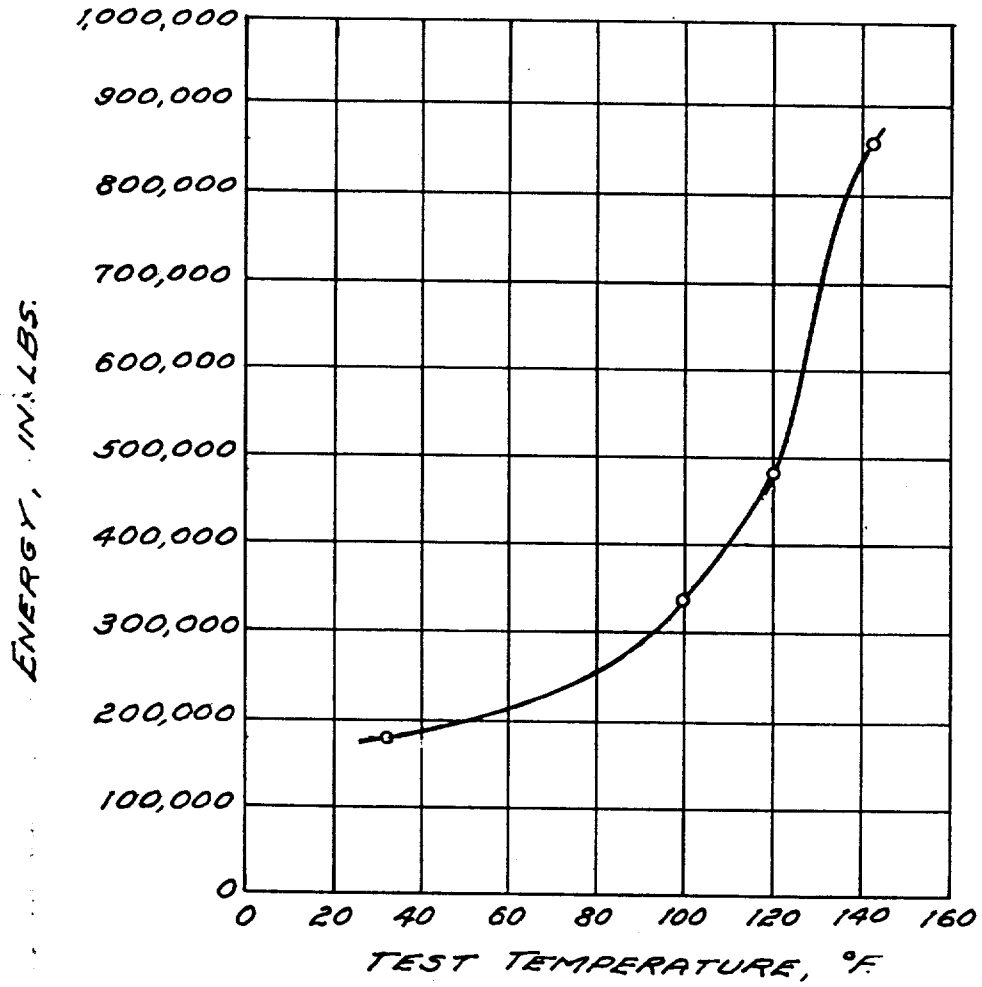
FIG. 43

ENERGY TEMPERATURE CURVE
HATCH CORNER SPECIMENS
C STEEL
