SSC-122

BEHAVIOR OF RIVETED AND WELDED  
CRACK ARRESTORS

Final Report  
of  
Project SR-134

Washington, D. C.  
National Academy of Sciences-National Research Council  
August 31, 1960

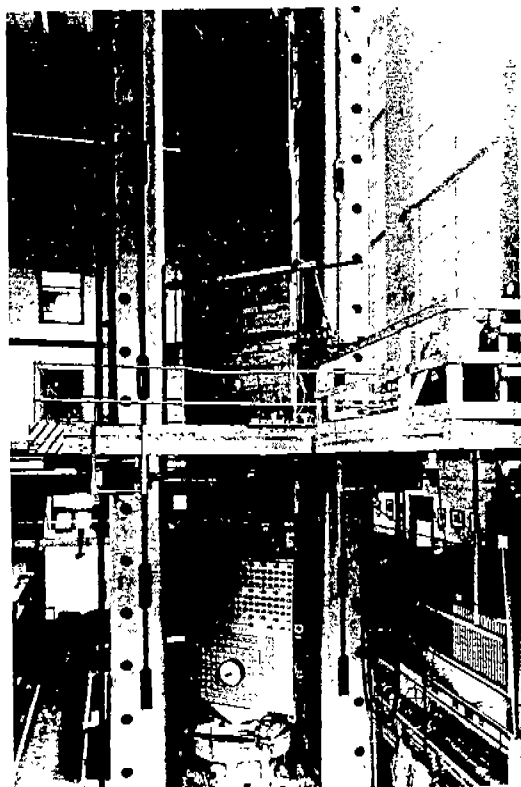
(a) Six-Foot Wide Specimen in 3,000,000 lb machine

In the remaining tests, the depth of the insert varied between 16 and 60 in., some of the longer inserts being used for more than one test. For the tests in the 3,000,000-lb hydraulic testing machine, the 6-ft wide pull-plates were 1 in. thick for Tests 4-31 and 3/4 in. thick for Tests 32-45. In this program, the length of each pull-plate varied from 3 1/4 to almost 9 ft. Therefore the overall length of the specimens tested varied from approximately 8 to 19 ft, depending upon the depth of the insert and the length of the pull-plates. The majority of the specimens, however, had an overall length of approximately 18 ft. A typical test set-up is shown in Fig. 7. Depending upon the depth of the notch at each edge of the plate, the net width of the specimen on the notch line was 2 or 2 1/4 in. less than the gross width.

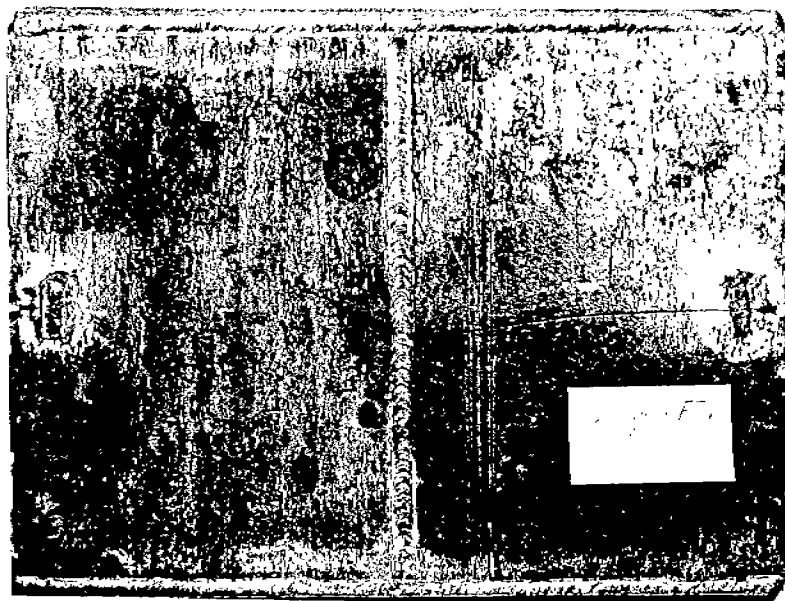
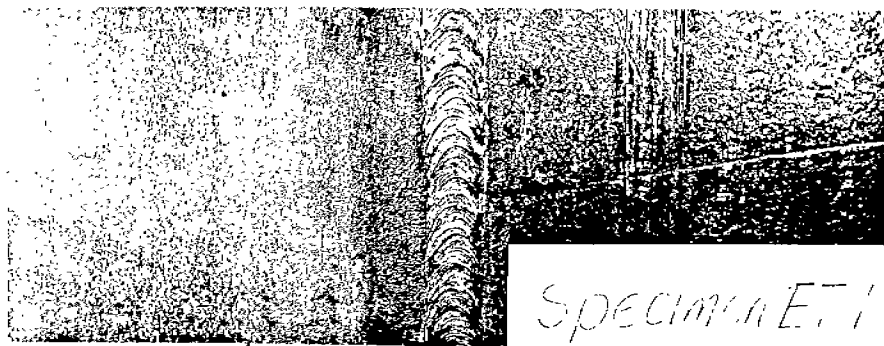
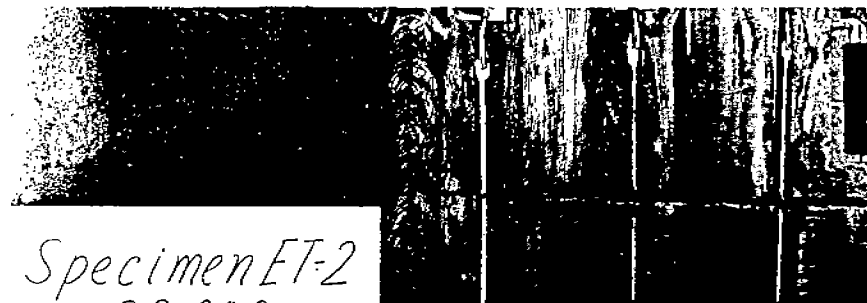
Fig. 13. Fracture Path and Surface--Test 1.

Fig. 14. Fracture Path and Surface--Test 2.

The fracture path and surface of the fracture for Tests 1 and 2 can be seen in Figs. 13 and 14. In both cases a separation is evident on the surface

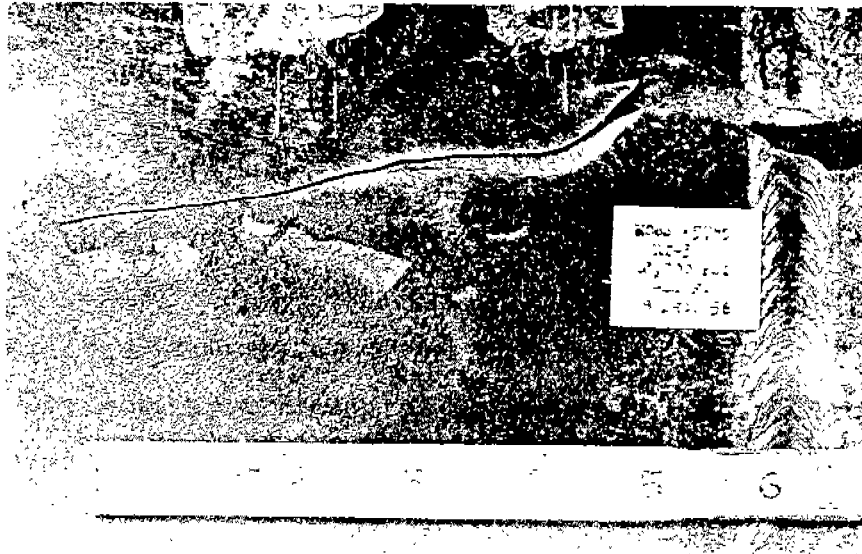
(a) Test 16, 24 in. T-Steel Strake

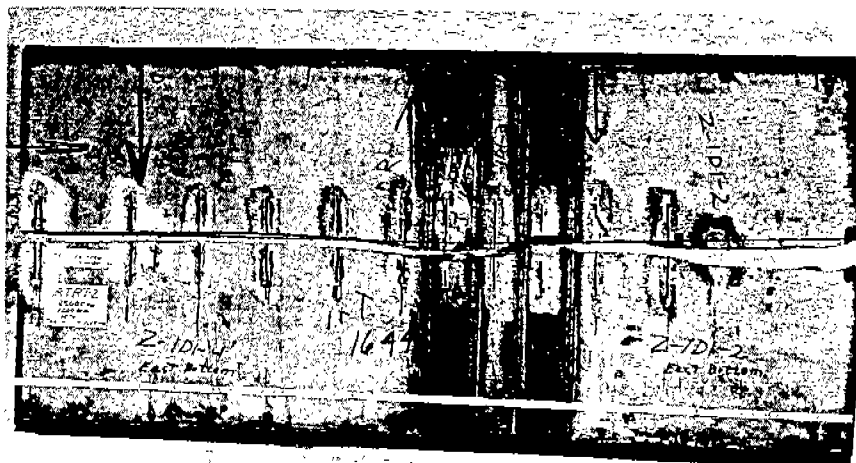
Test 12

Fig. 39. Views of Completely Fractured Inserts-- Tests 7, 10, and 12.

Crack Path and Texture. The fracture has not shown any tendency to follow a particular crack path, although the majority of fractures slope upward from the point of initiation and then level off somewhat. The crack paths for completely and partially fractured specimens are shown in Figs. 39 and 40 respectively. The maximum deviation of a crack path from the notch line was 4.90 in. for a 36-in. crack length in Test 15.

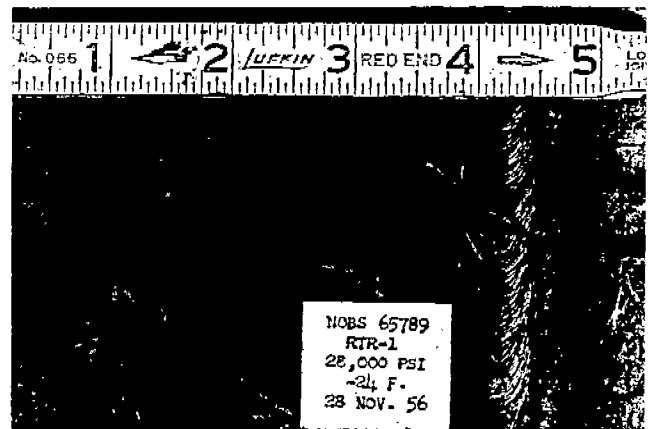
(c) Test 15, 12 in. T-Steel Strake

Fig. 45. Arrest of a 36 in. Long Crack--Tests 13, 14, and 15.

Figures 35 and 43-45 are photographs of the surface of the T-steel in the region around the end of the arrested crack. In Figs. 43 and 44 it is evident that a 4-in. wide strake of T-steel completely arrested 12- and 24-in. long cracks and that only in Test 9, where the testing temperature was extremely low, is there visible evidence of the crack beyond the butt weld in the T-steel. In specimens containing a 36-in. width of starter material, the arrested crack penetrated 12- and 36-in. wide strakes of T-steel as shown in Fig. 45. The penetration of cracks that had propagated 48 and 60 in. and then been arrested can be seen in Fig. 35. Inelastic buckling usually occurred at the far edge of the specimens in which these long crack lengths were developed.

load redistribution, a secondary crack was initiated and resulted in the complete fracture of the specimen, as shown in Fig. 30. Referring to the dynamic strain records in Fig. 26, it appears that the arrestor strake of T-steel was not subjected to a major redistribution of load. This also seems reasonable because the arrested crack in this specimen was visible across the surface of the plate to the butt weld only, whereas in other cases where a 36-in. long crack was developed (Tests 13, 14, and 15), penetration of the T-steel strake was always evident after the test was completed (Fig. 45).

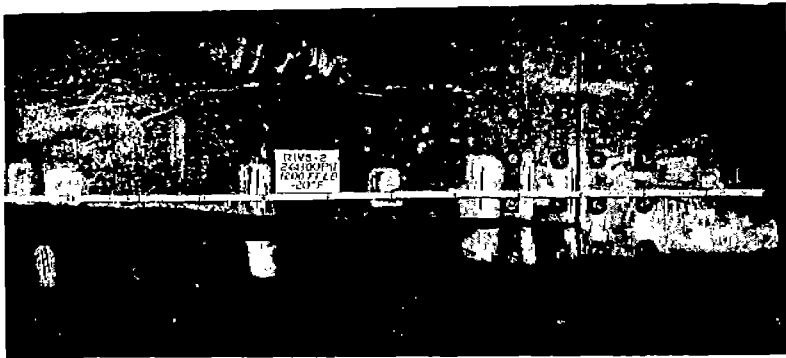
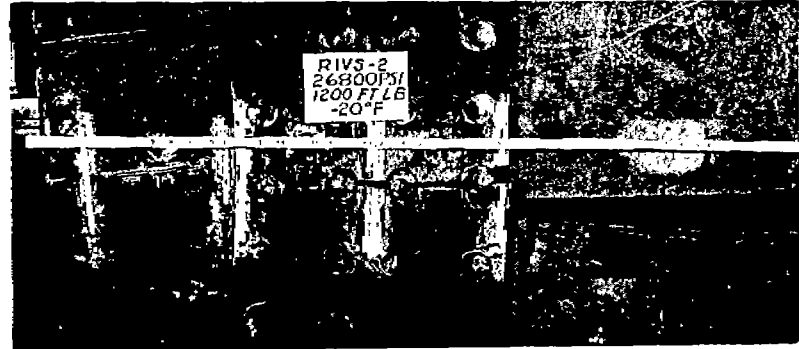
Test 20

Test 19

Fig. 51. Views of Fractured Inserts--  
Tests 19 and 20.

Under an average stress on the net section of 26.8 ksi and an average temperature of 1°F (Test 19), the brittle crack traveled slightly upward, passing between the horizontal rivet rows to the flame-cut slot in the main plate. There was no indication of fracture in the main-plate material beyond the slot (Fig. 51) or in the doubler plate.

The partial fracture from Test 19 was rewelded. In the next test on this specimen (Test 20), where the crack was initiated from the opposite edge, an average stress of 26.8 ksi, an average temperature of -19 F, and a theoretical impact of 1200 ft-lb were combined to produce a crack that propagated 54 in. across the main plate to the flame-cut slot. In addition, the doubler plate fractured across two lines of rivets, as shown in Fig. 51.
