CAUSES OF CLEAVAGE FRACTURE IN SHIP PLATE:
HATCH CORNER DESIGN TESTS

E. PAUL DeGARMO AND A. BOODBERG
UNIVERSITY OF CALIFORNIA
Under Navy Contract NObs-31222

Serial No. SSC-16

Date: December 4, 1947

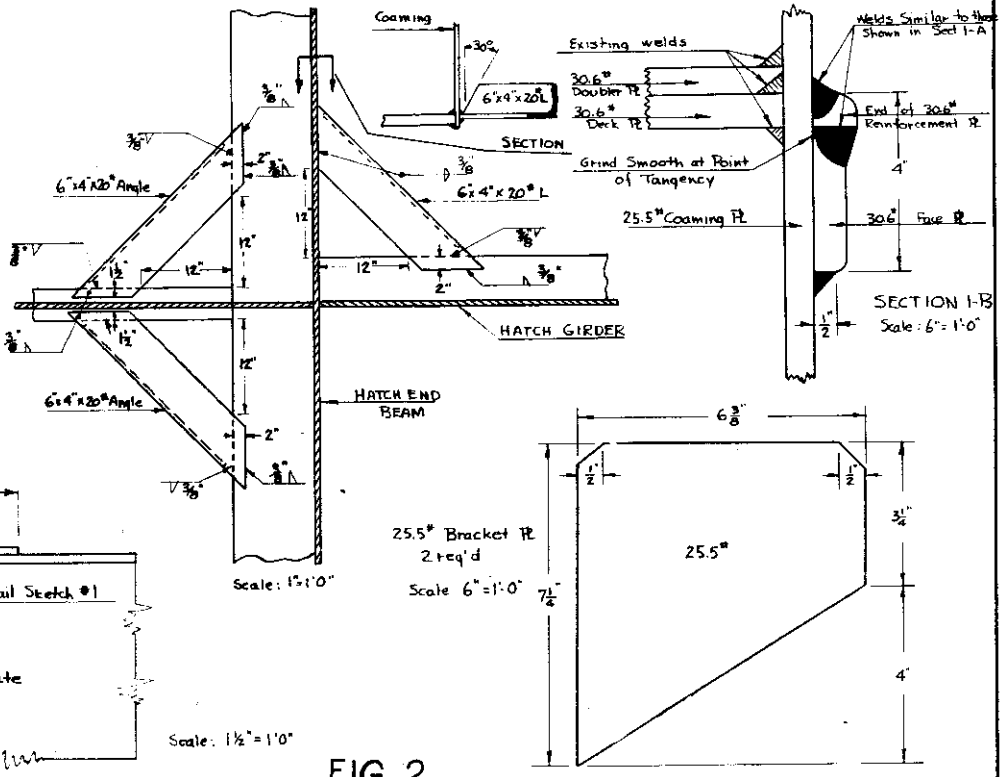
FIG. 2

Specimen 36 was the same as specimen 5 except for the addition of diagonal brackets at the bottom of the longitudinal girder-hatch end beam joint, like those shown in Fig. 2. This test was designed to isolate one of the factors which was present in the British modification. Unfortunately, upon testing, this specimen was found to have a very badly laminated hatch end beam plate so the results were not valid. Specimen 38 was a repeat of this test. However, nearly all of the 5/8 inch thick "C" steel had been used and it was necessary to make the hatch end beam of this specimen out of another piece of steel. This steel was obtained on the local market and had tensile properties as shown in Table IV. These properties are very nearly the same as those for "C" steel and it is not felt that its use for the hatch end beam of this specimen in any way affected the results obtained.

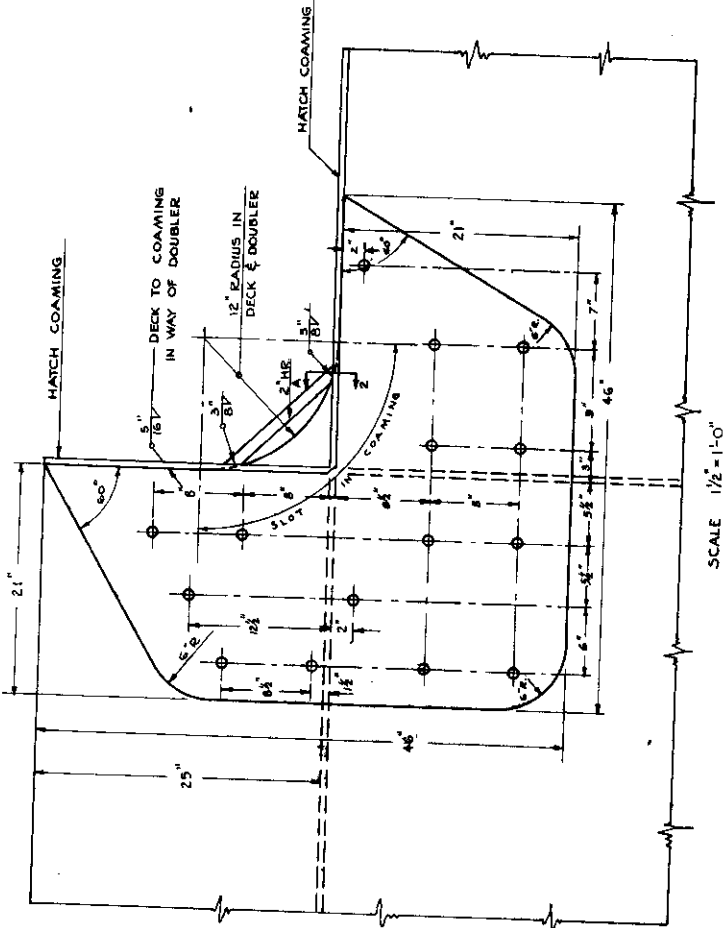
FIG. 5

On a number of "Liberty" ships operated or repaired by the British, the hatch corner reinforcement shown in Fig. 5 was used. This has been designated as British Code 1A. It involves three significant features. First, full penetration welds are used between the deck and doubler plates and the coaming. Second, an unusual shape doubler is used. Third, diagonal strapping is added at the bottom of the girder system. Specimen 31 incorporated these British modifications.

UNIVERSITY OF CALIFORNIA WELDING RESEARCH-BSEN HATCH DESIGN 112, ERS. WMC. LAB., BERKELEY, CALIF.	HATCH CORNER REINFORCEMENT (BRITISH CODE IA) FOR SPECIMEN NO. 31	SCALE AS SHOWN DR. BY J.J.D. TR. BY	APPROVED 12/19/45 DWG L-60 PANEL
---	---	---	---

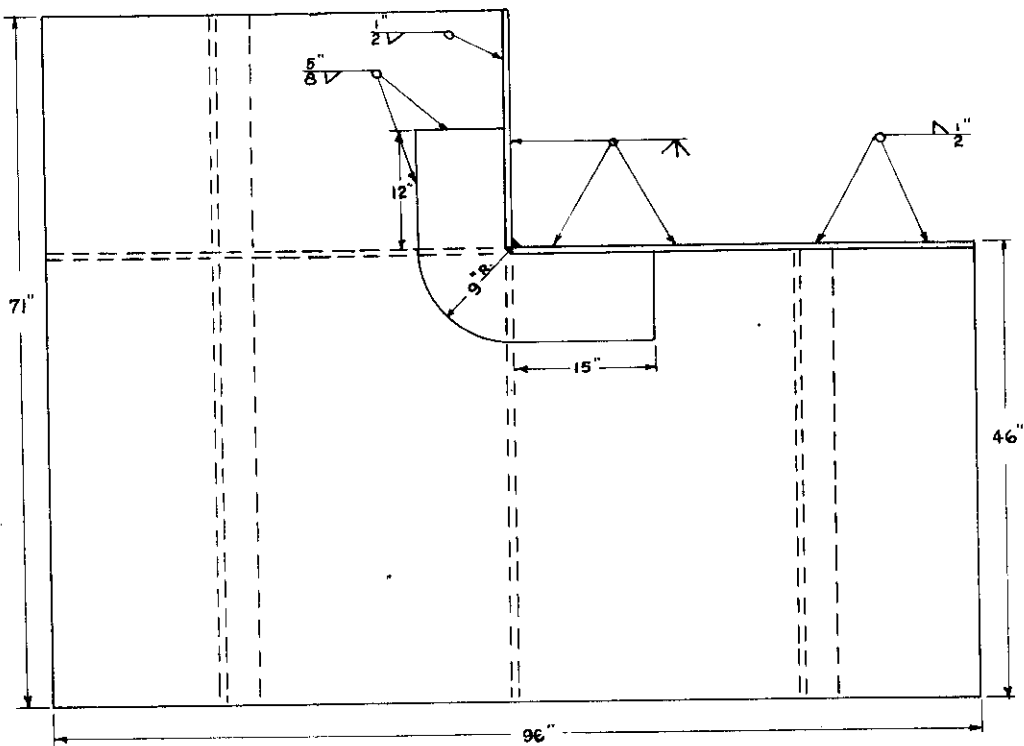
EXTENDED COAMING SPECIMEN #33

basic design by adding a triangular plate to a completed specimen. This would correspond to adding this reinforcement to an existing hatch corner on a ship. If the results were nearly as effective as found in Specimen 33, this simple procedure would be an easy and effective way of strengthening hatch corners of existing ships.

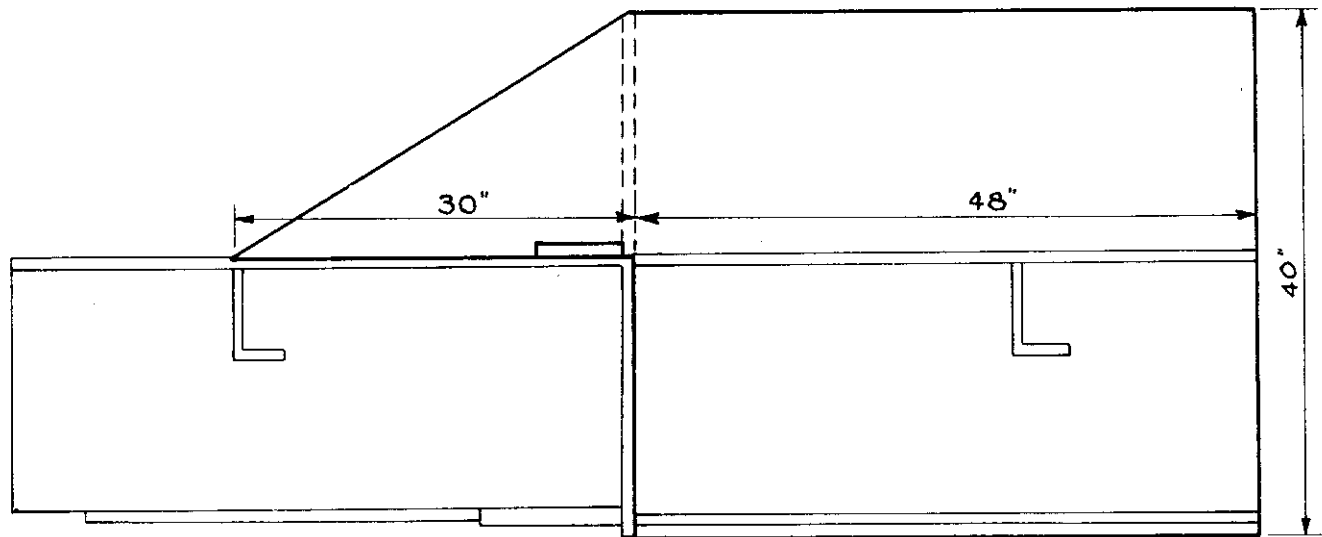
FIG. 7

PLATE LAYOUT FOR PART OF LONGITUDINAL
GIRDER AND COAMING SHOWING EXTENSION

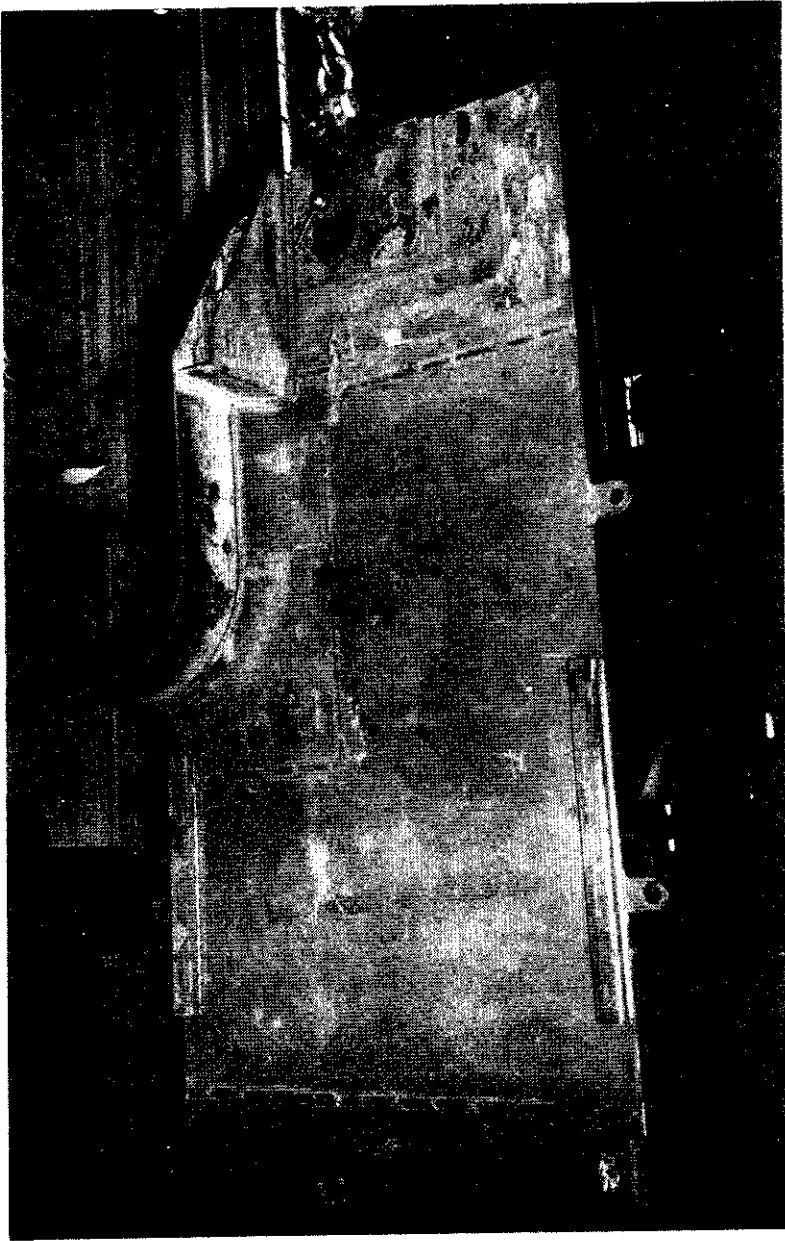
Fig. 11 Specimen 35: Above deck view before test

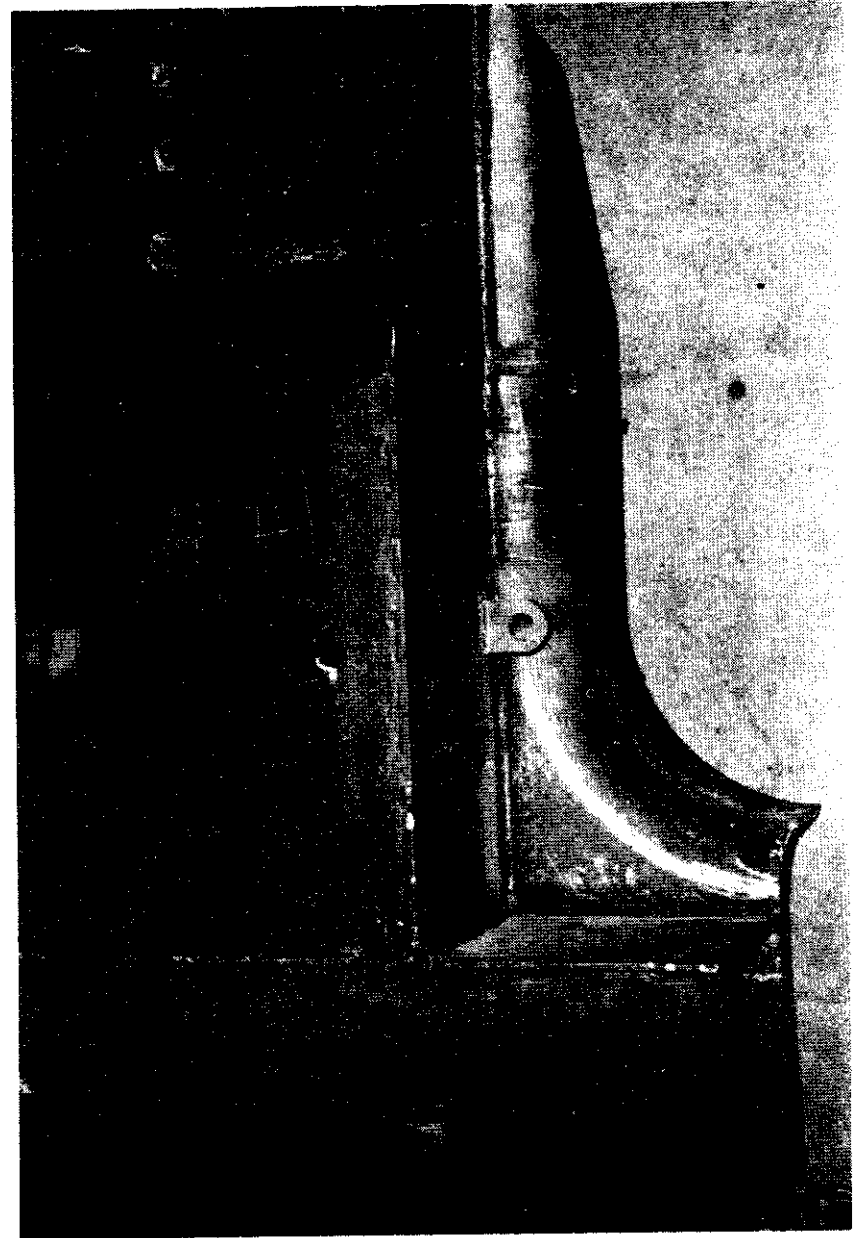
Fig. 12 Specimen 35: Below deck view before test

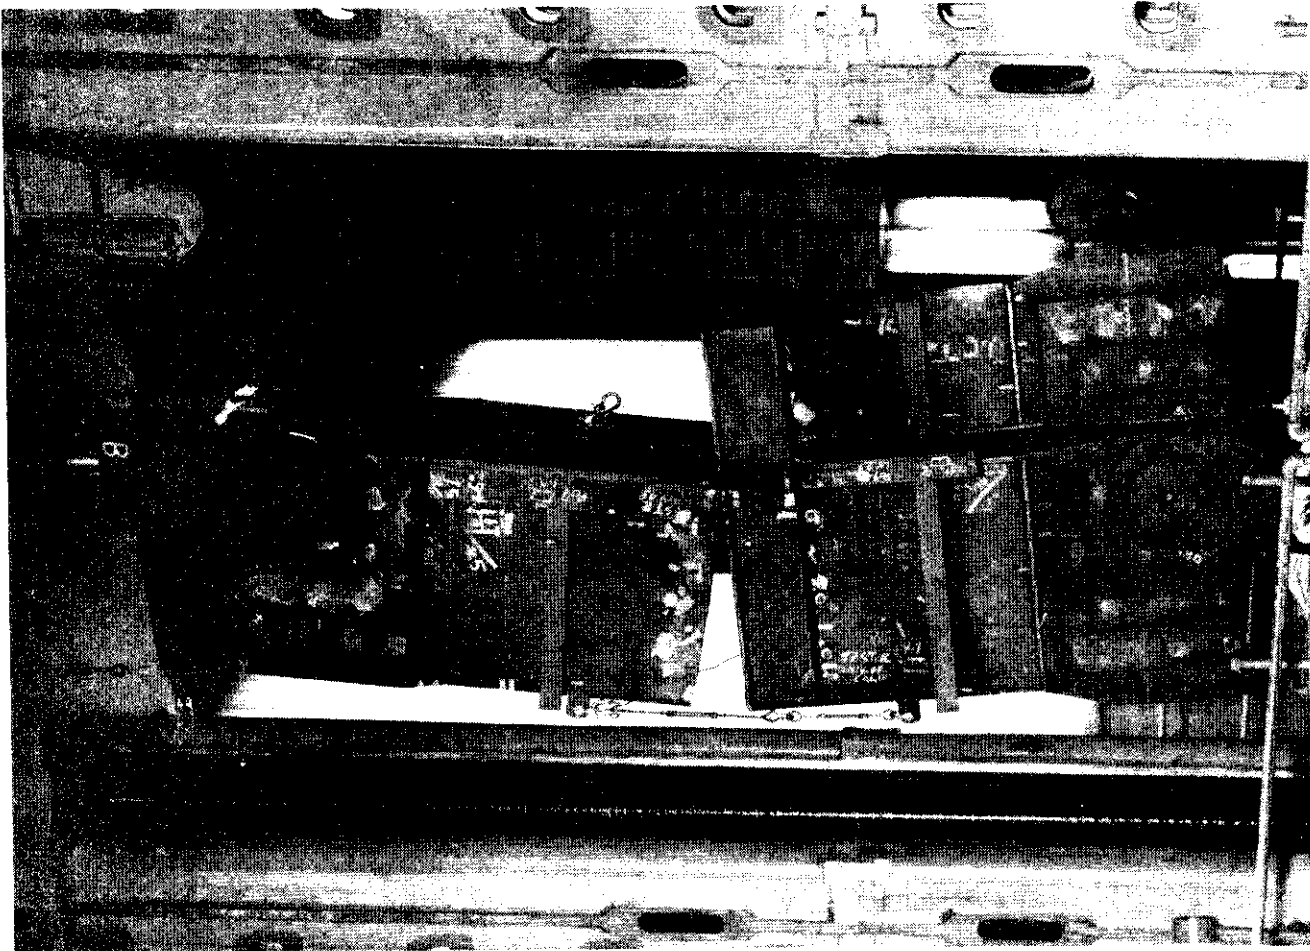
Fig. 14 Specimen 4: Overall view from below

Photographs of the various specimens are shown in Figs. 13 to 65. In order to serve as a basis of comparison, photographs of the failure in a previous specimen, No. 4, are shown in Figs. 13 to 18 inclusive. The failure in this particular specimen was typical of all cleavage fractures which occurred in

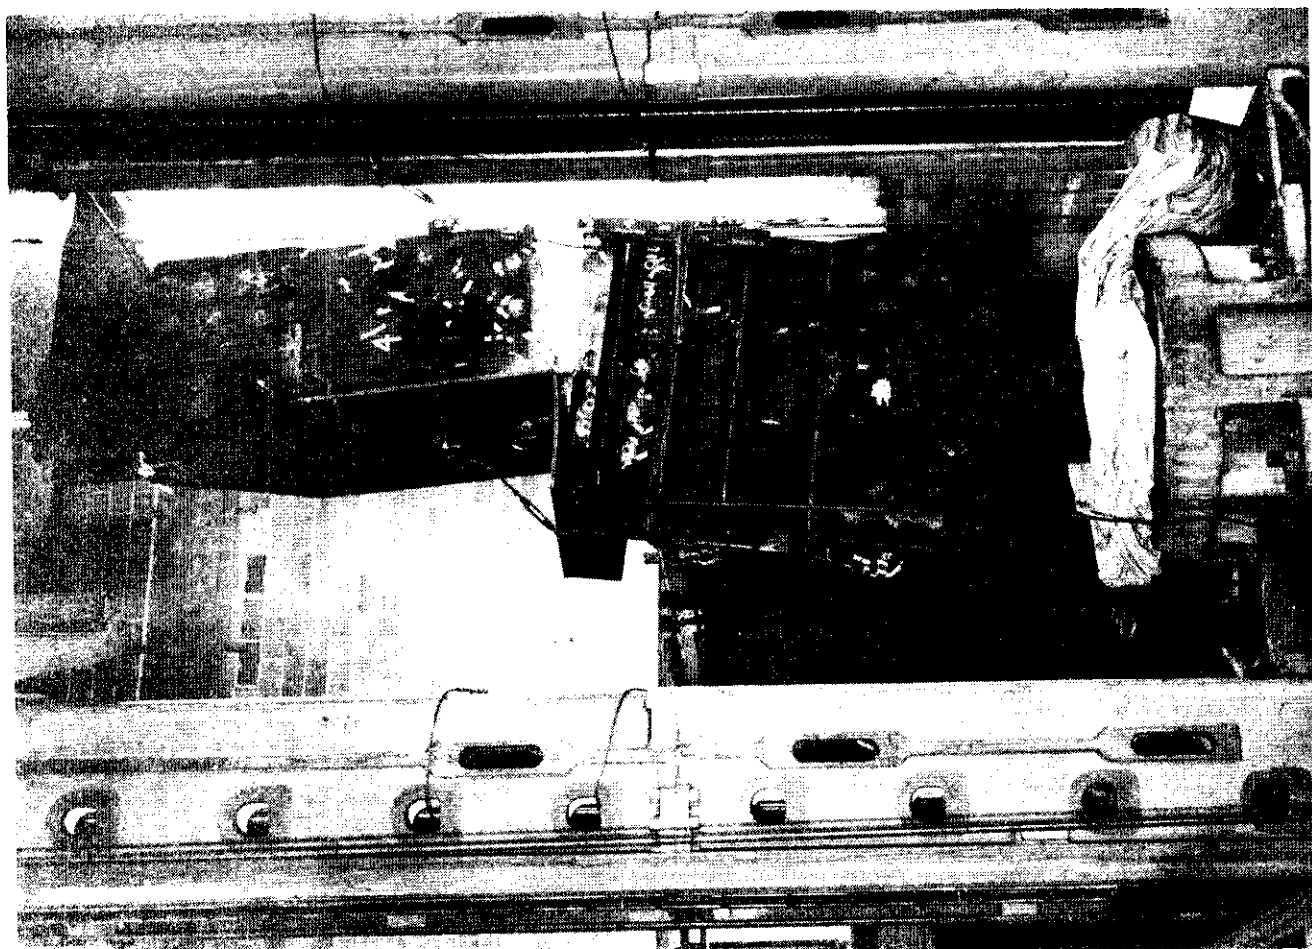
Fig. 13 Specimen 4: Overall view from above

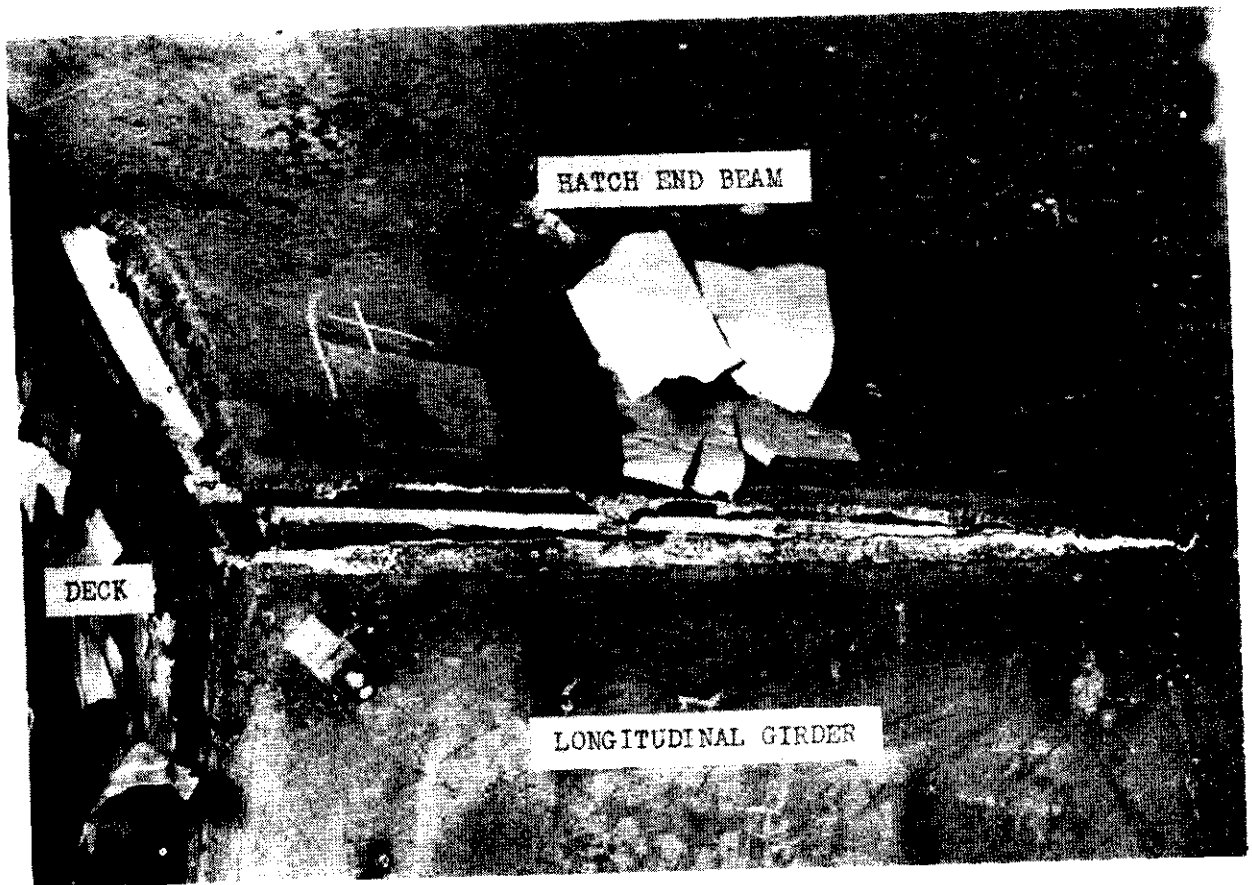
Fig. 16 Specimen 4: View of fractures from below, outboard and forward of hatch end beam

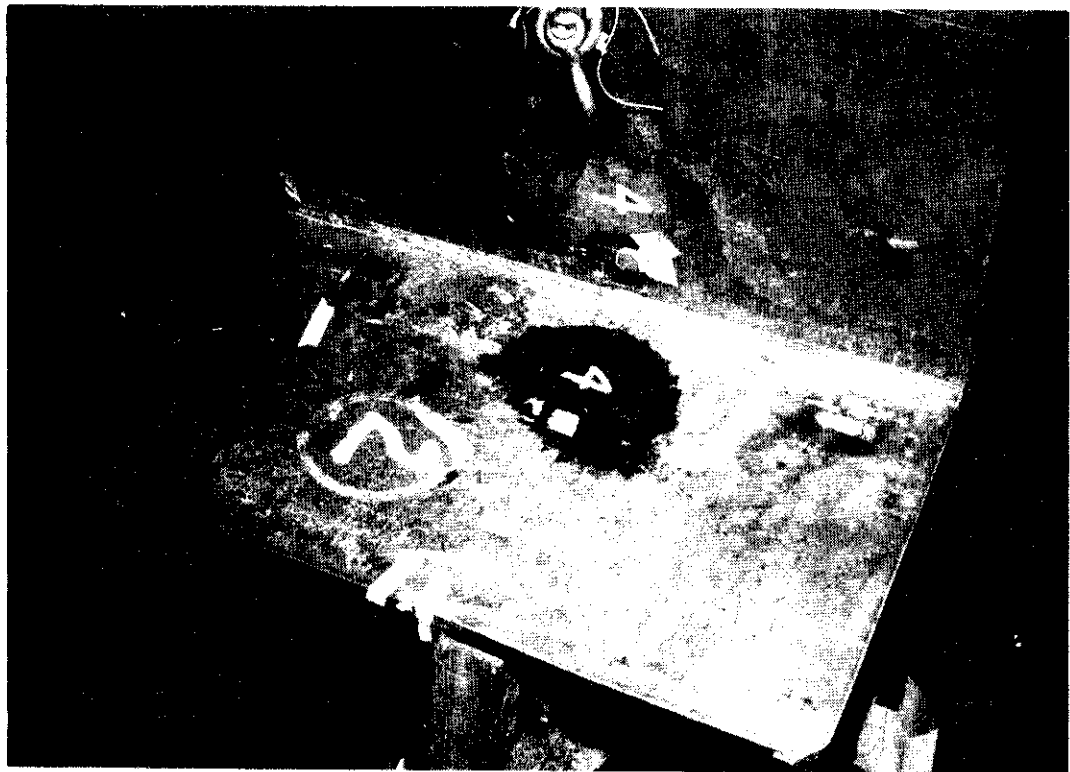
Fig. 18 Specimen 4: View of corner from inside of hatch

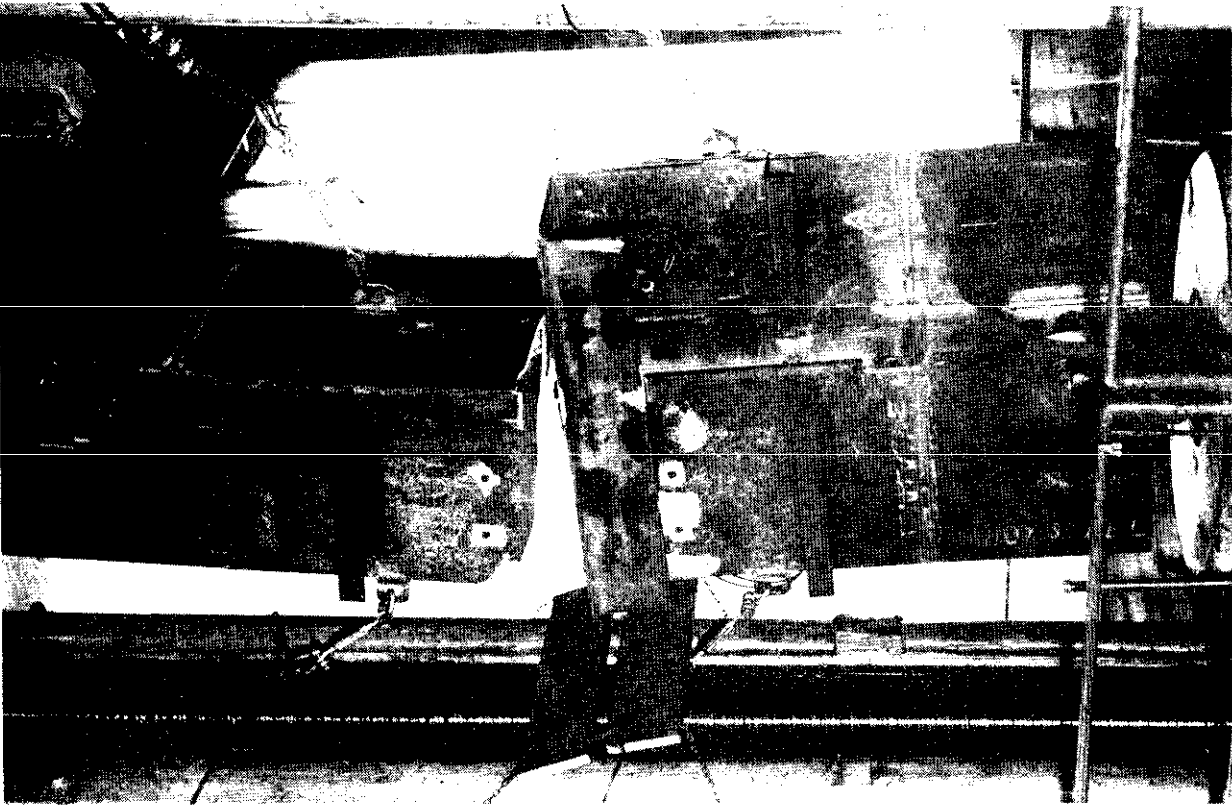
Fig. 20 Specimen 27: Overall view from below

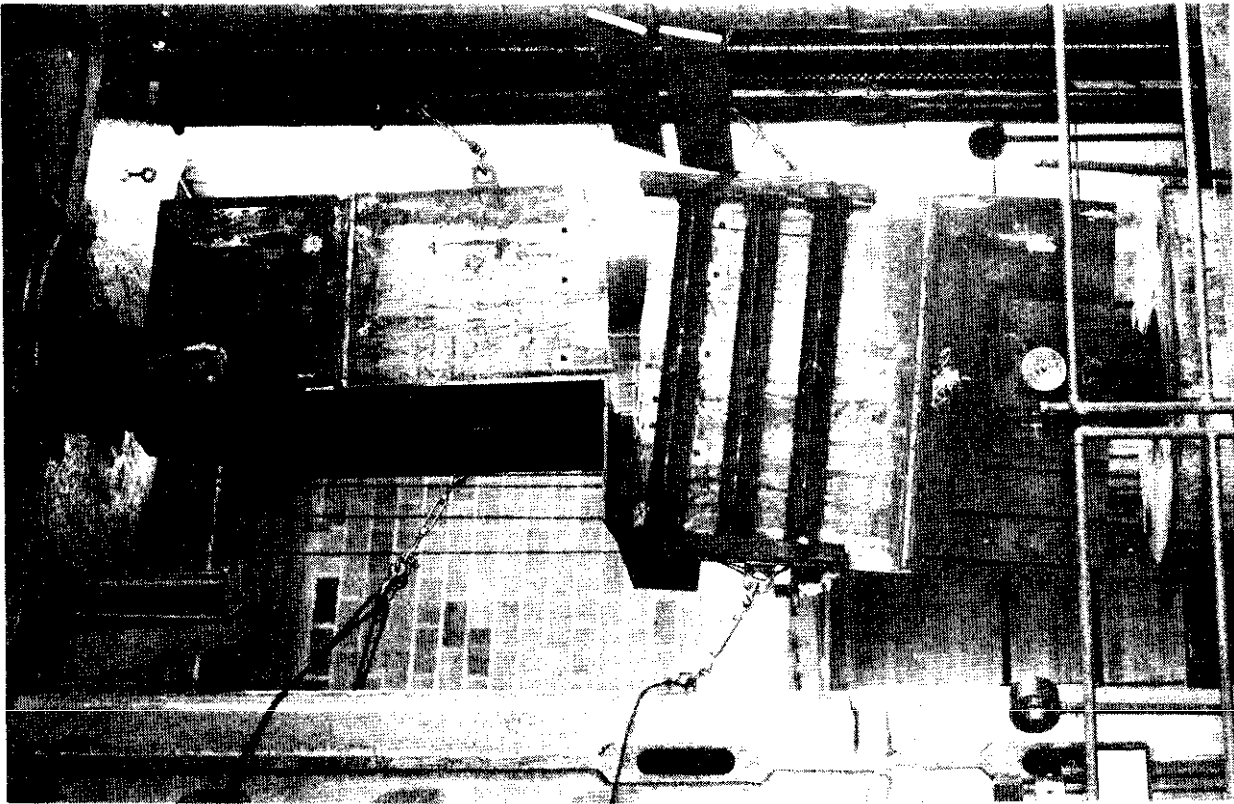
Fig. 19 Specimen 27: Overall view from above.

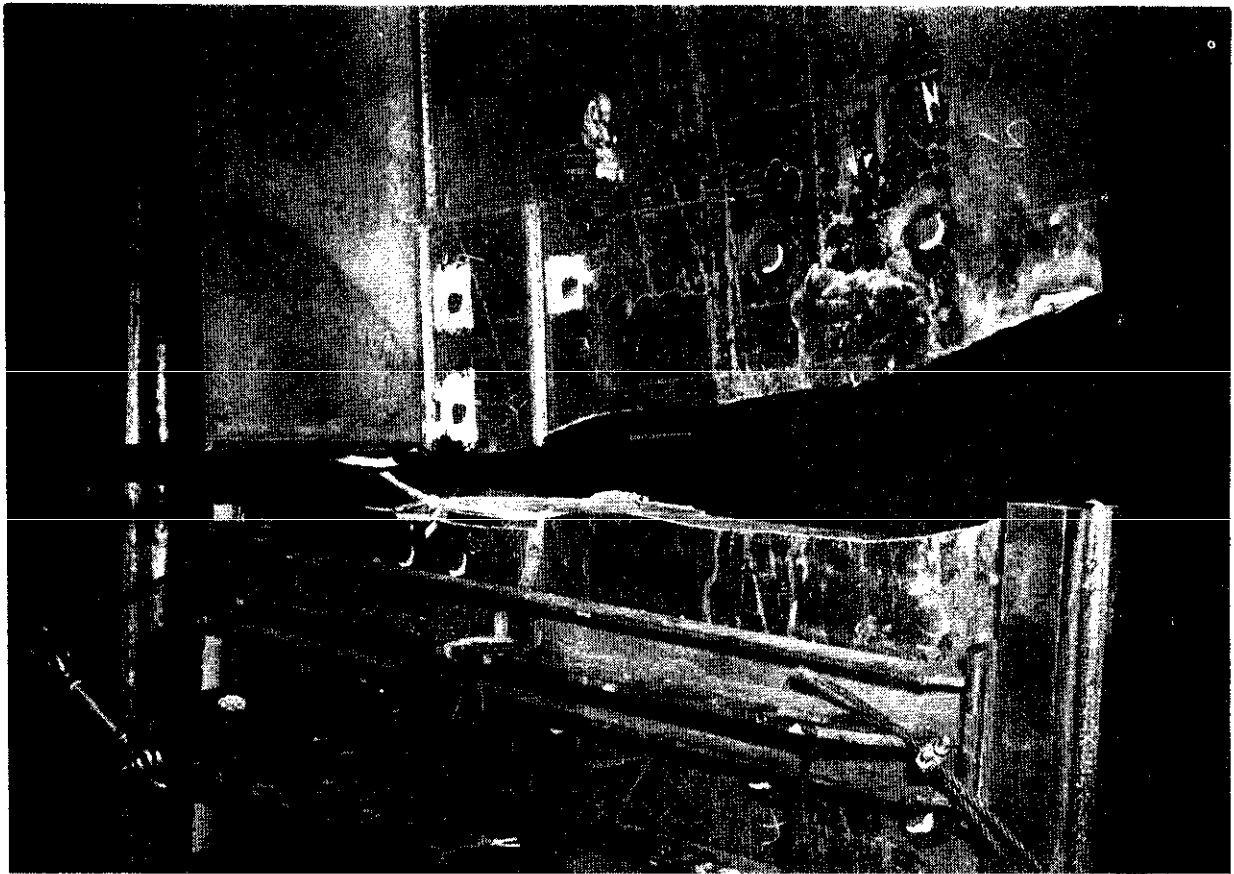
Fig. 21 Specimen 27: View of fractures from above

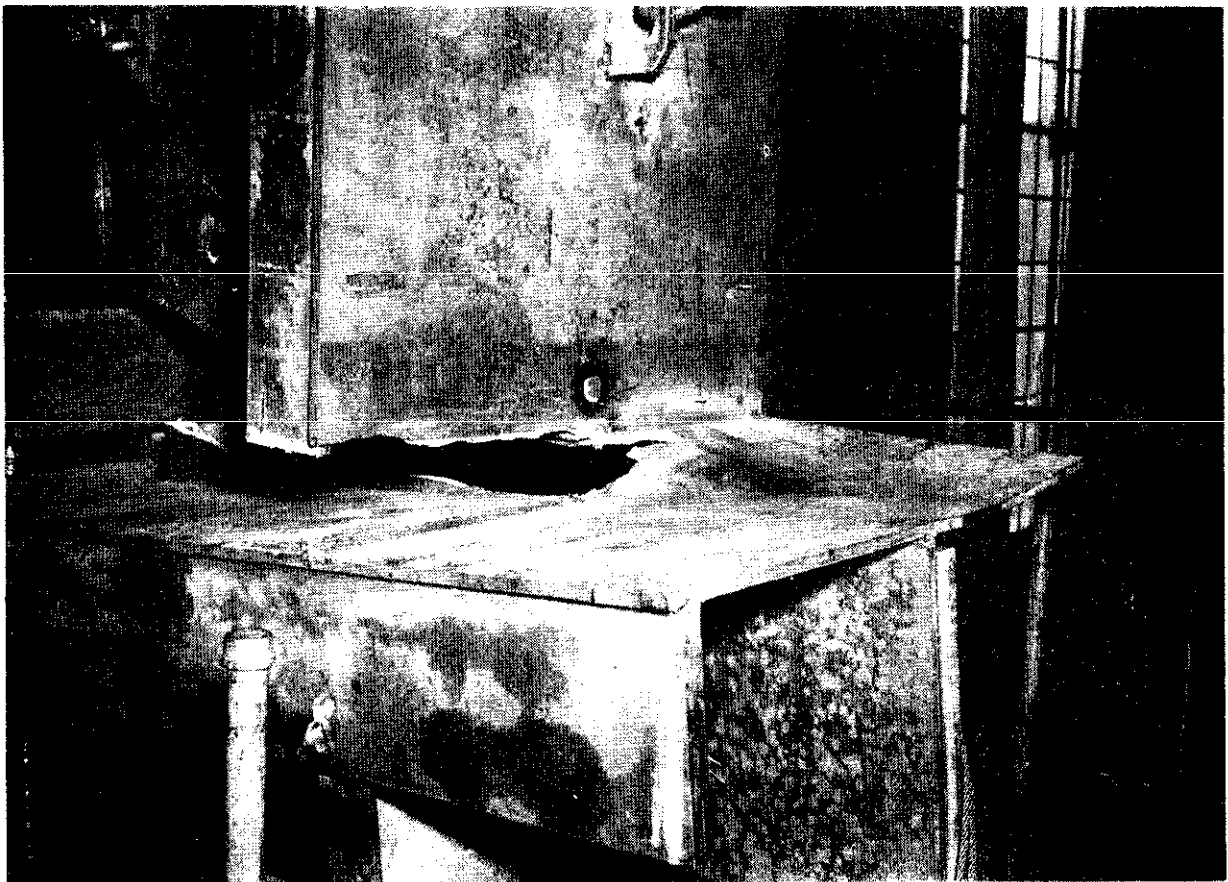
Fig. 22 Specimen 27: View of fractures from side position

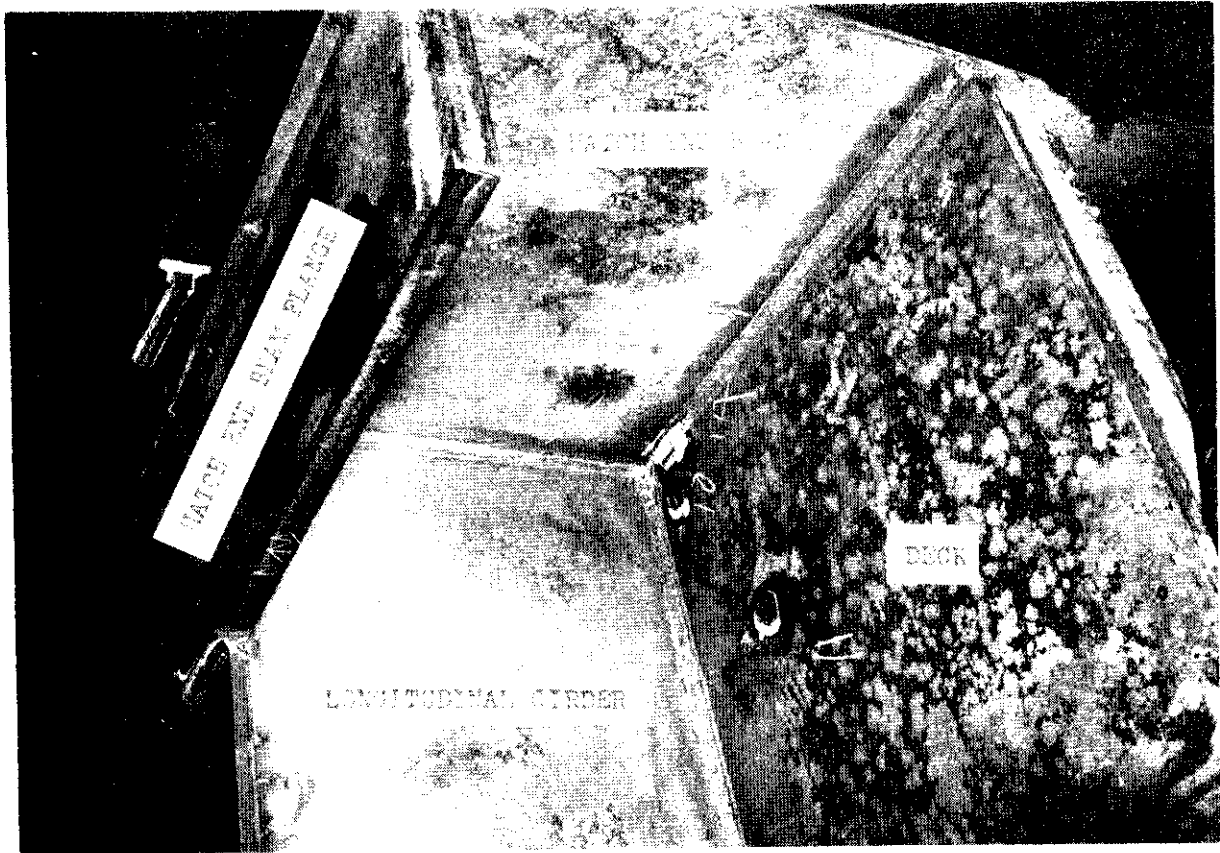
Fig. 23 Specimen 27: View from below deck, inboard, showing absence of fractures

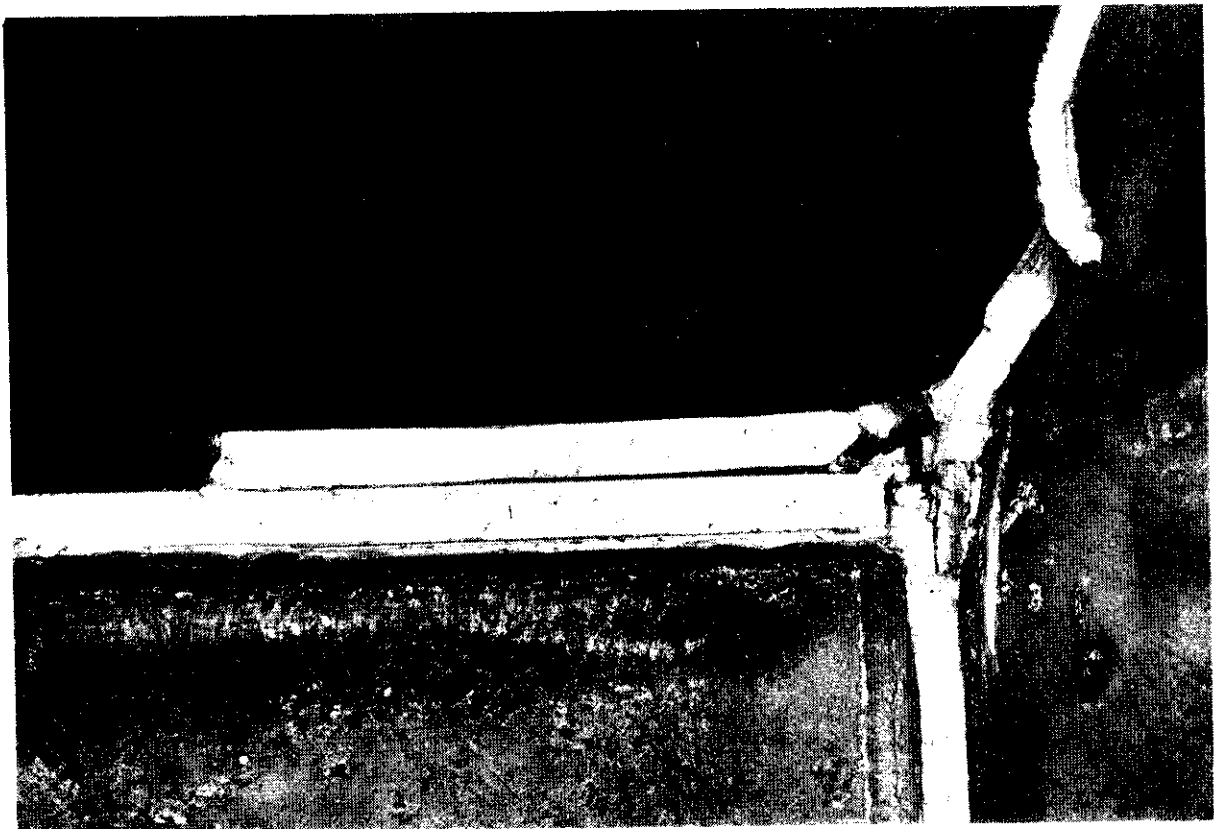
Fig. 24 Specimen 27: Close-up of fracture patterns in deck and doubler

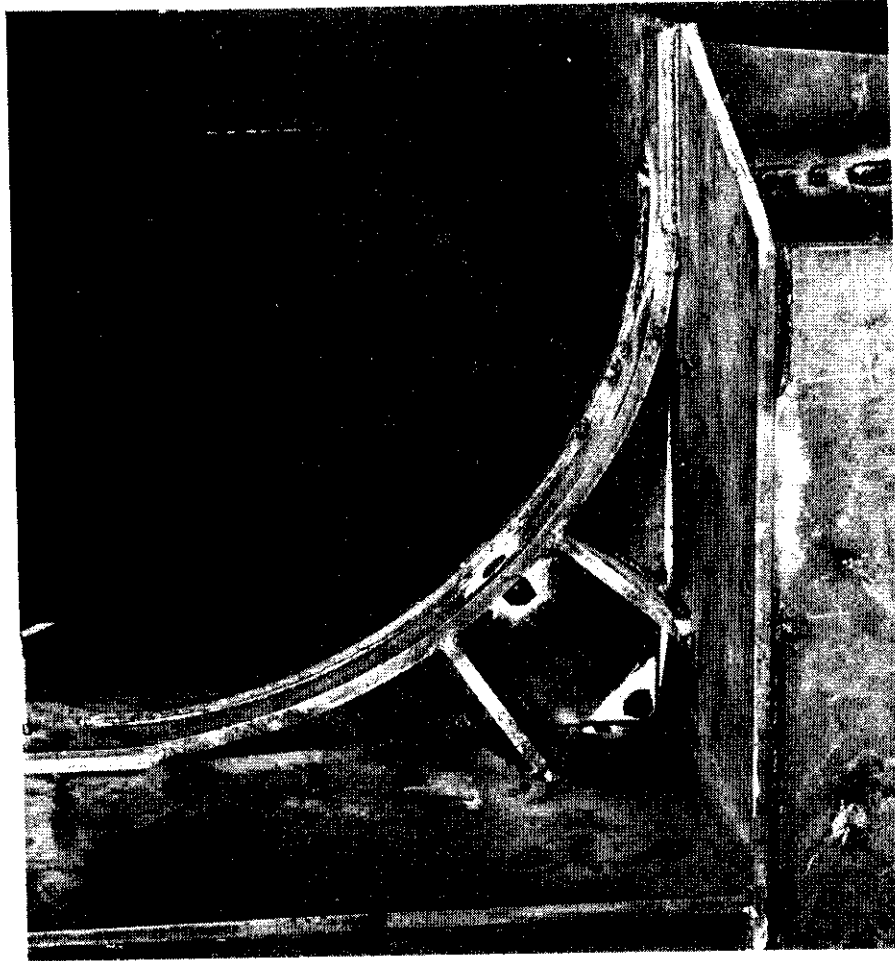
Fig. 26 Specimen 28: View of gusset plate reinforcement from below

The gusset reinforcement (Specimen 28, U.S.C.G. Code 5) gave a maximum stress increase of 30.5 per cent and increased the energy absorption at failure by 324 per cent.

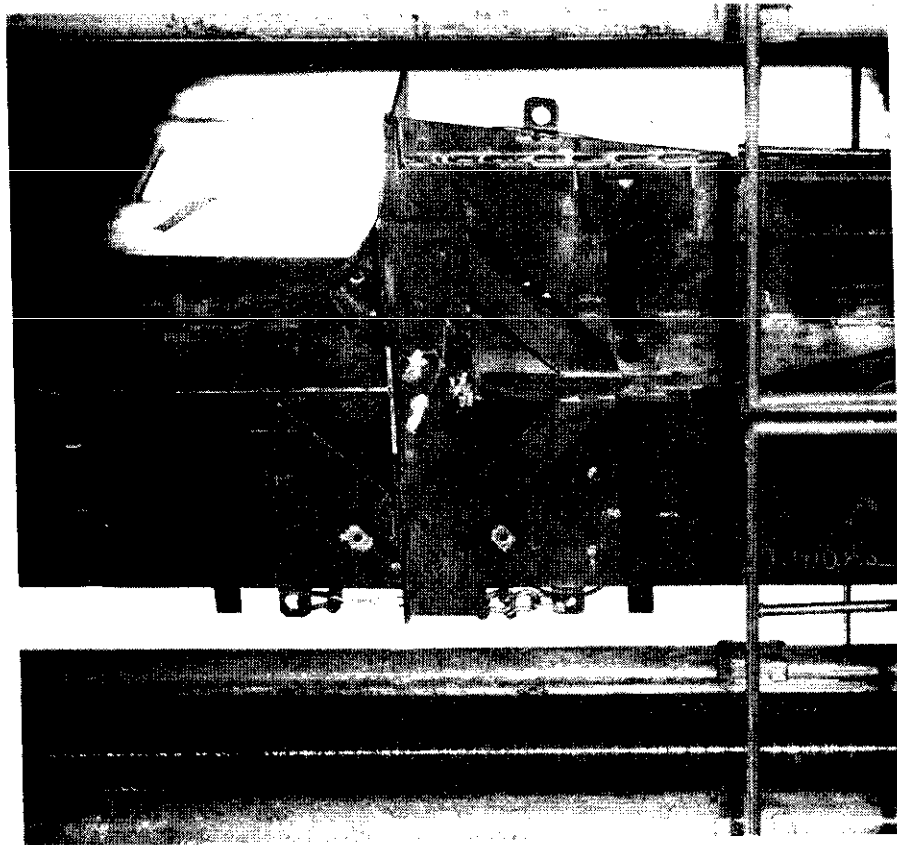
Fig. 25 Specimen 28: Overall view from below

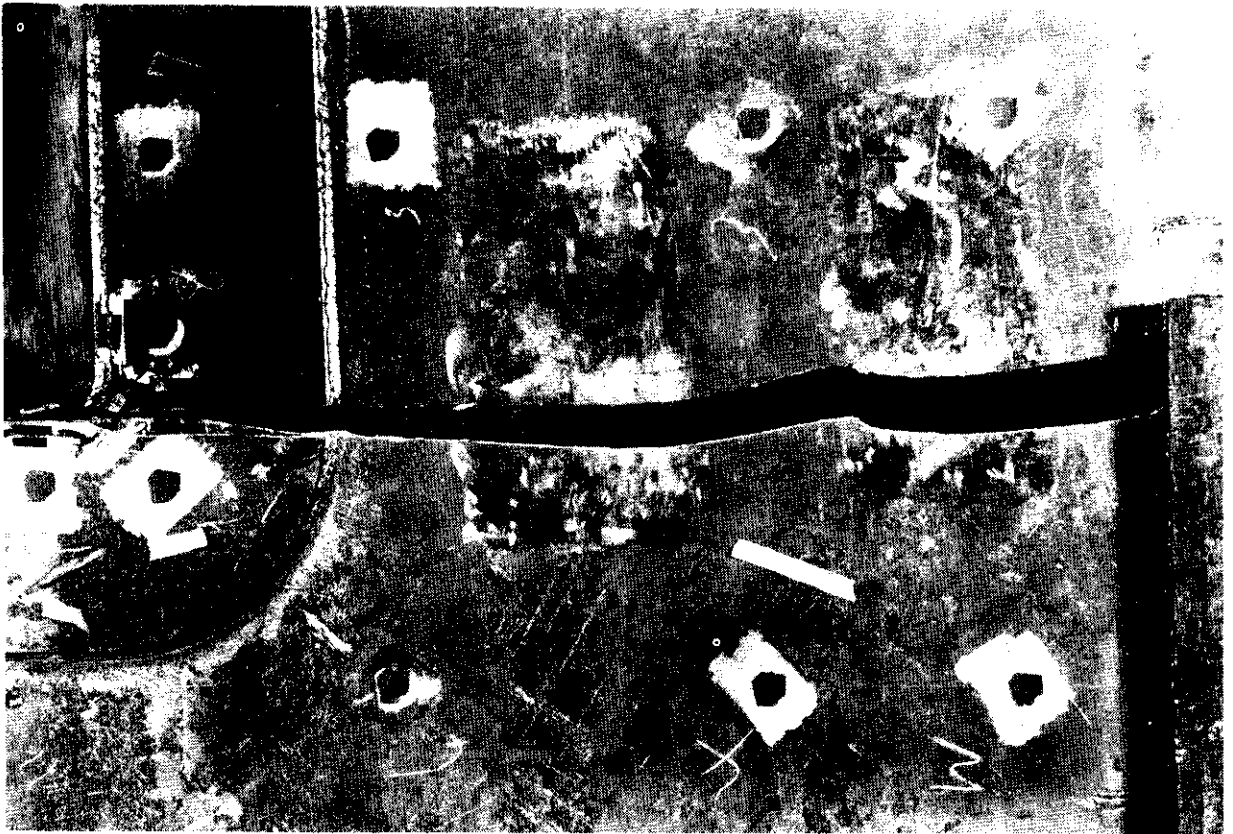
Fig. 27 Specimen 28: View of fractures from above

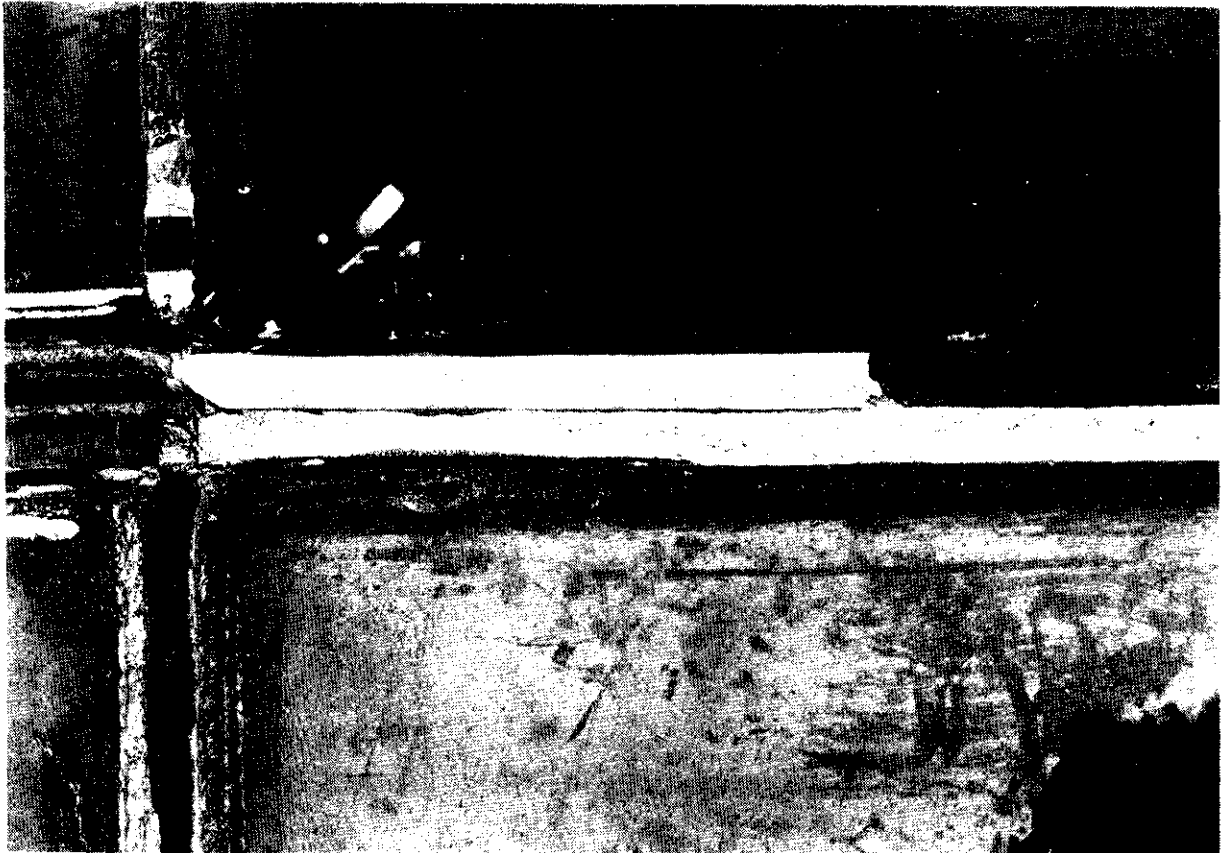
Fig. 28 Specimen 28: Fracture patterns in deck and doubler

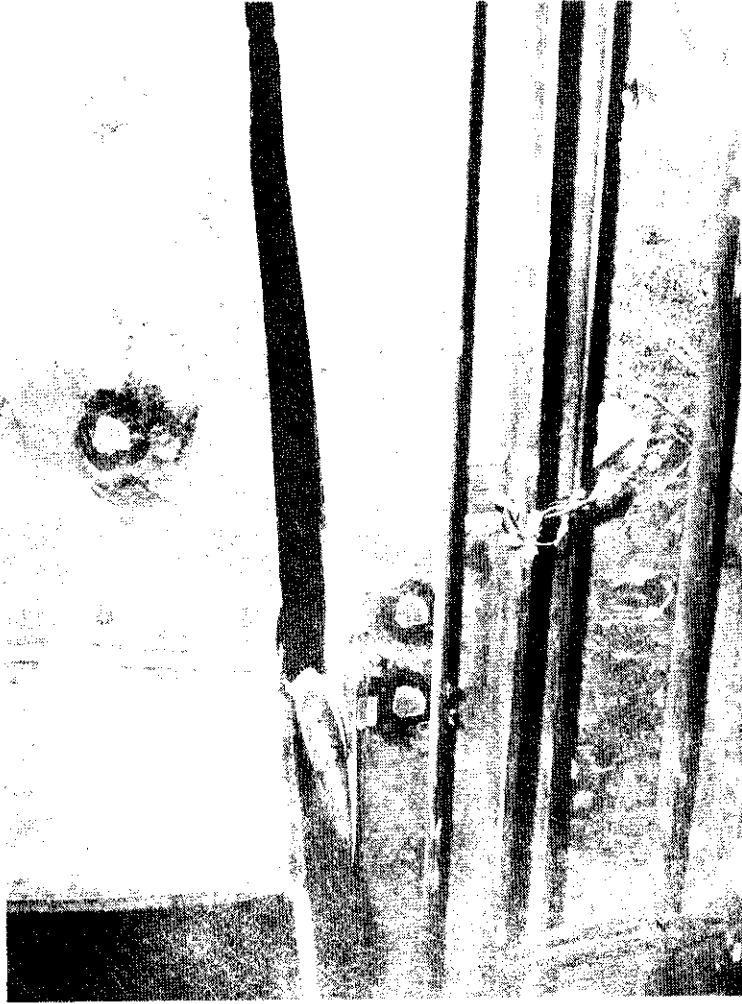
Fig. 30 Specimen 29: View of fractures from above

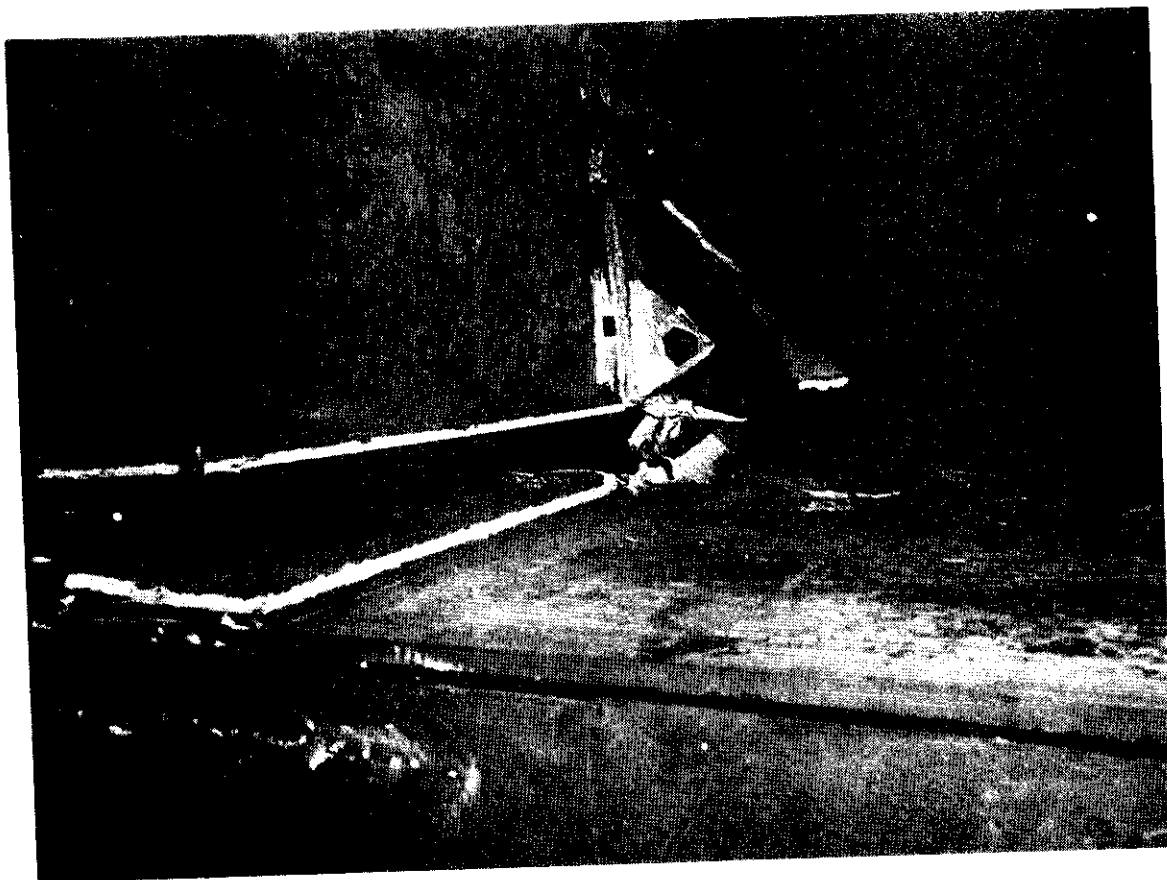
Fig. 31 Specimen 29: View of fractures from inside of hatch.

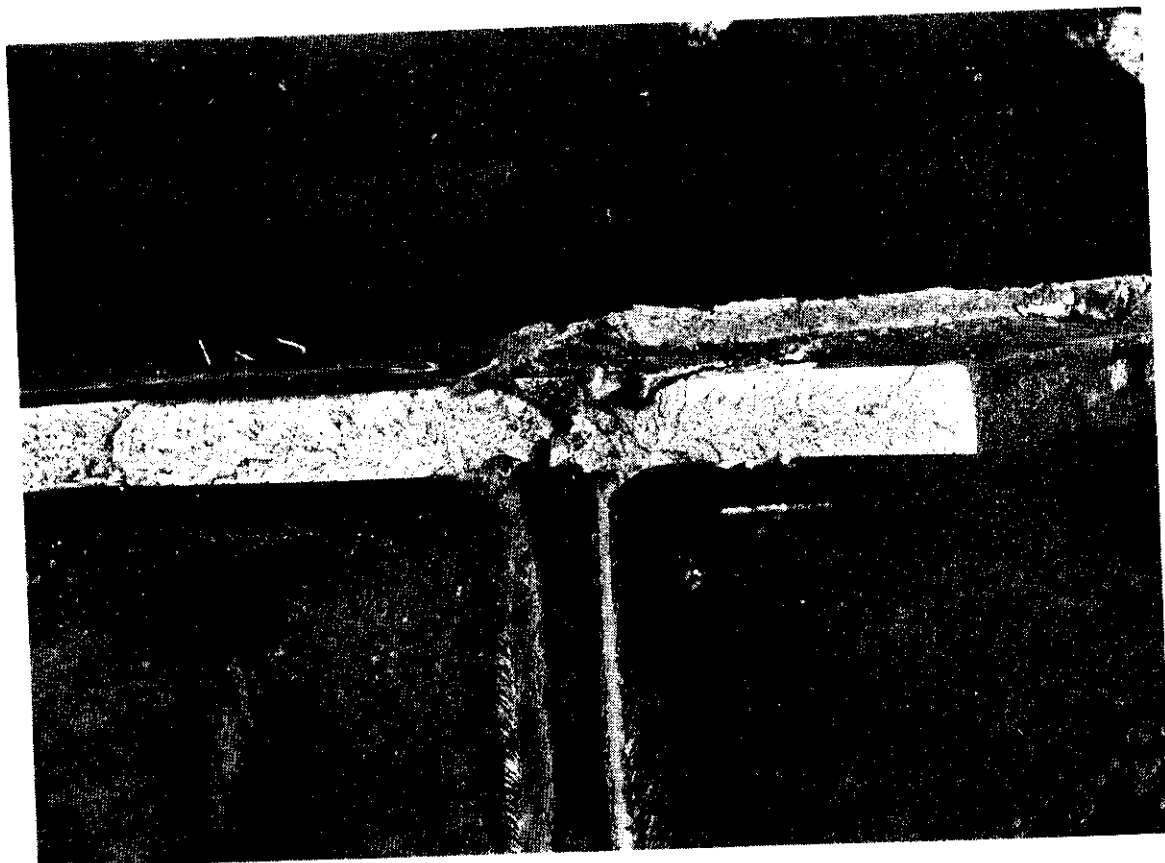
Fig. 32 Specimen 29: View of fracture patterns back at corner.
