CAUSES OF CLEAVAGE FRACTURE IN SHIP PLATE:
HATCH CORNER DESIGN TESTS

E. PAUL DeGARMO AND A. BOODBERG
UNIVERSITY OF CALIFORNIA
Under Navy Contract NObs-31222

Serial No. SSC-16

Date: December 4, 1947

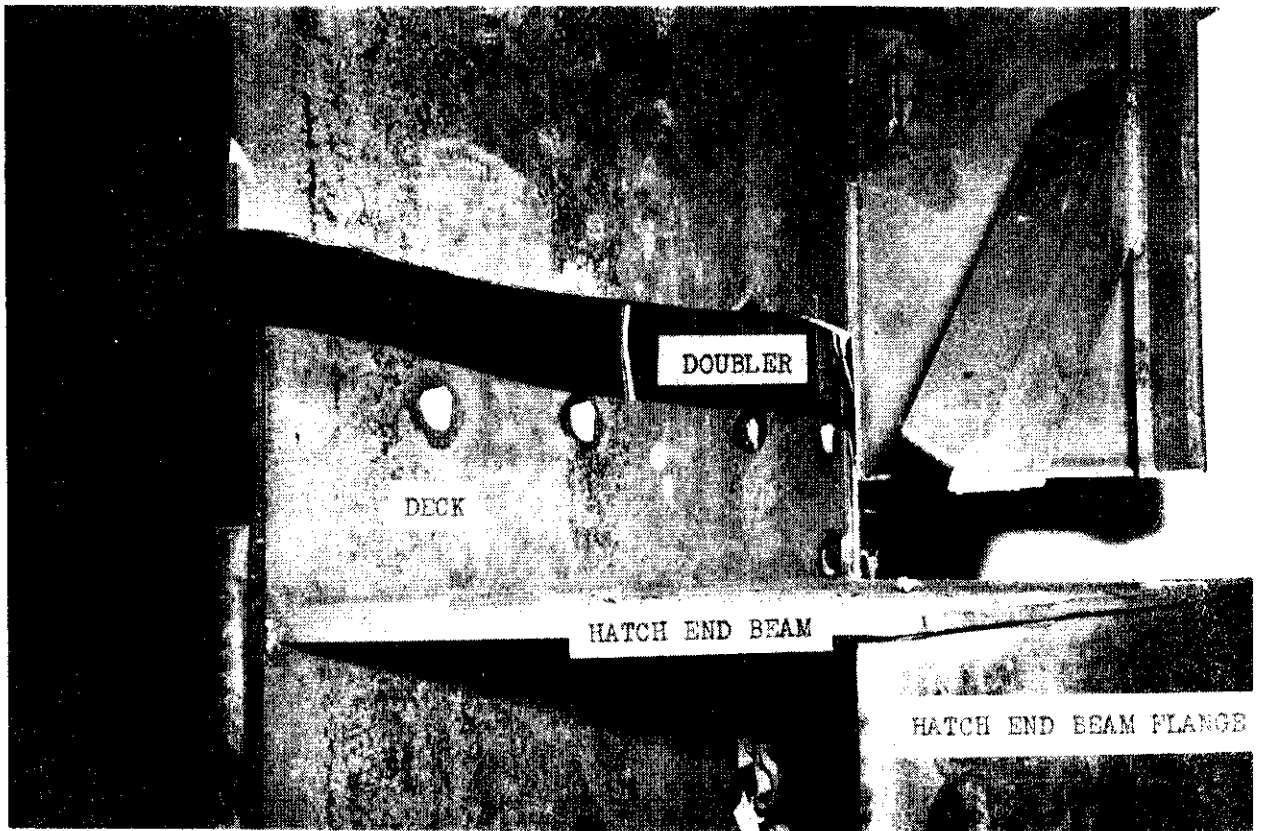
Fig. 34 Specimen 30: View of fractures from below deck and outboard

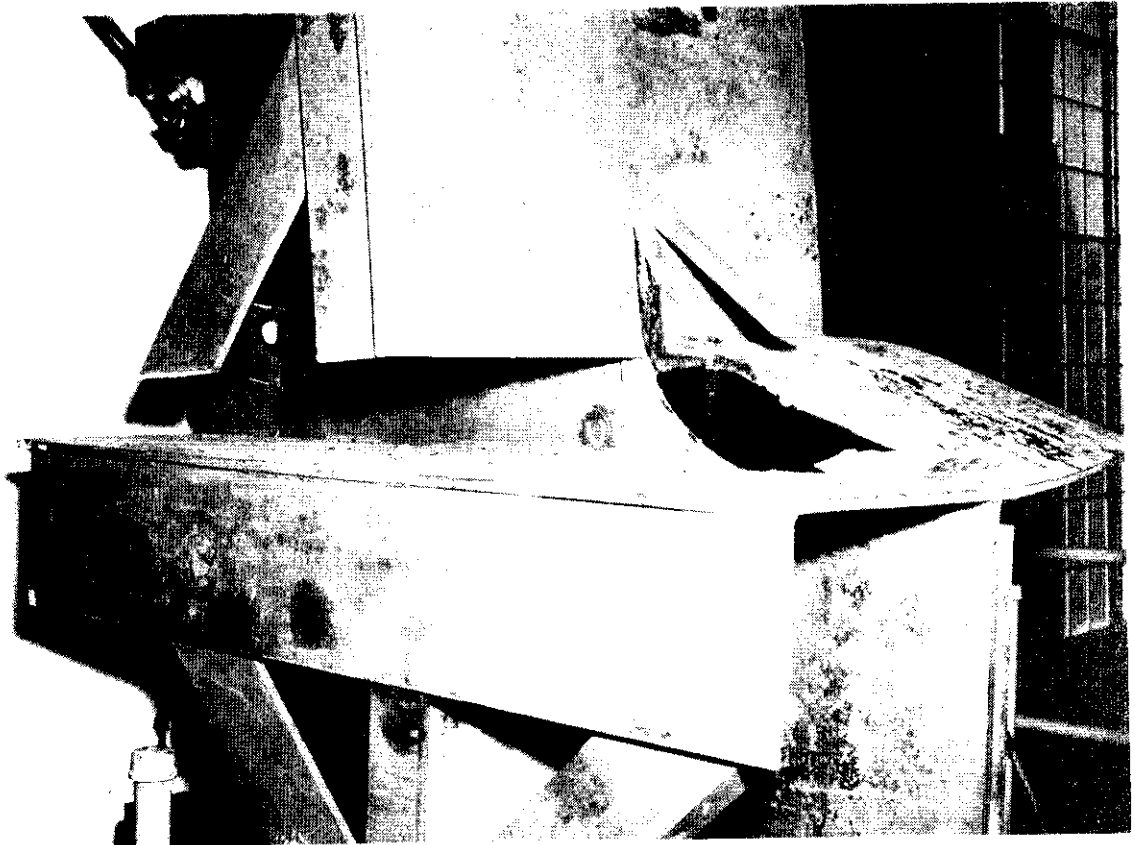
Fig. 35 Specimen 30: View of fractures from inside of hatch

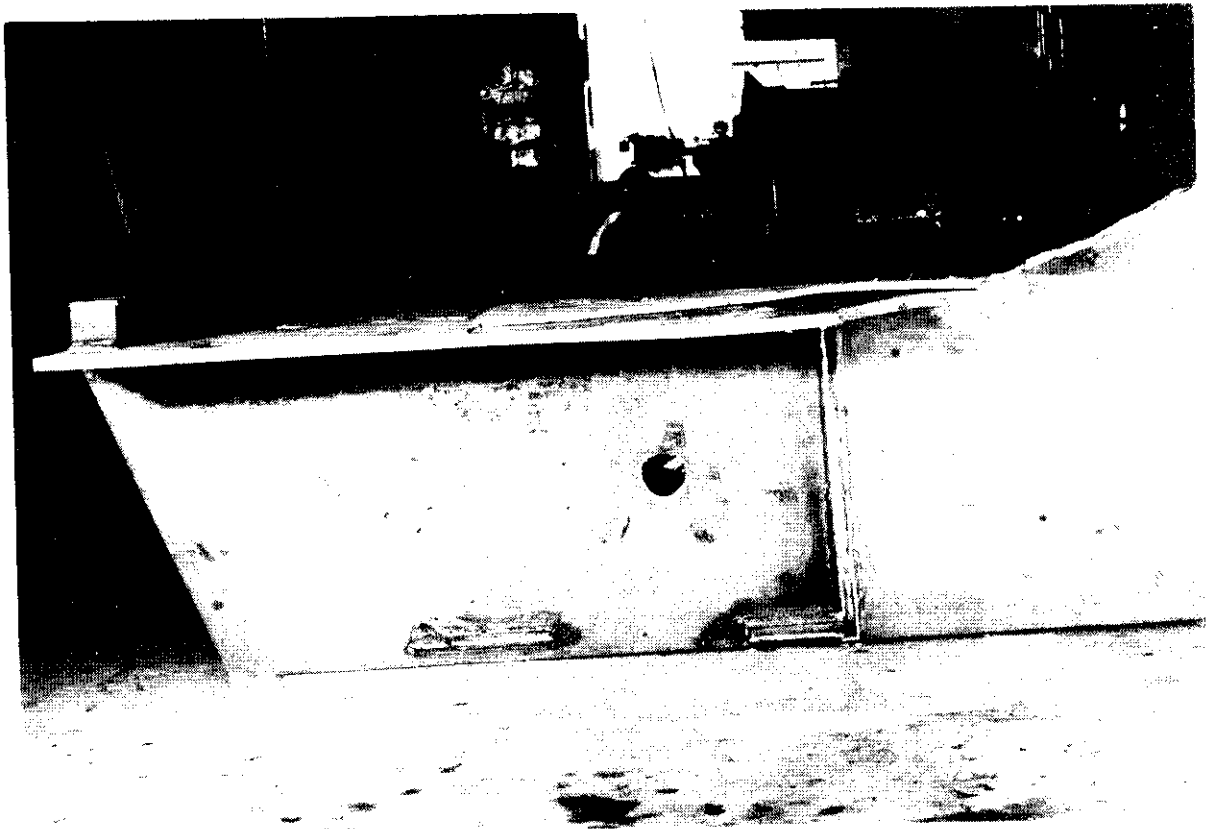
Fig. 36 Specimen 30: View of fractures in deck and doubler

The use of a radius in the deck plate at the hatch corner (Specimen 30, U.S.C.G. Code 1) produced a 52 per cent increase in maximum stress and a 1610 per cent increase in total energy absorption. The effectiveness of the doubler in this design is seen by comparing the results obtained with specimen 29 which was the same except that the doubler was omitted. It will be noted that the absence of the doubler reduced the maximum stress by 6.5 per cent and the energy absorption by over 71 per cent. It should be remembered that about one-third of the fracture in the doubler of specimen 30 was shear. This undoubtedly accounts for some of the increase in energy. While these are single tests, it appears that the doubler is very desirable in this particular design.

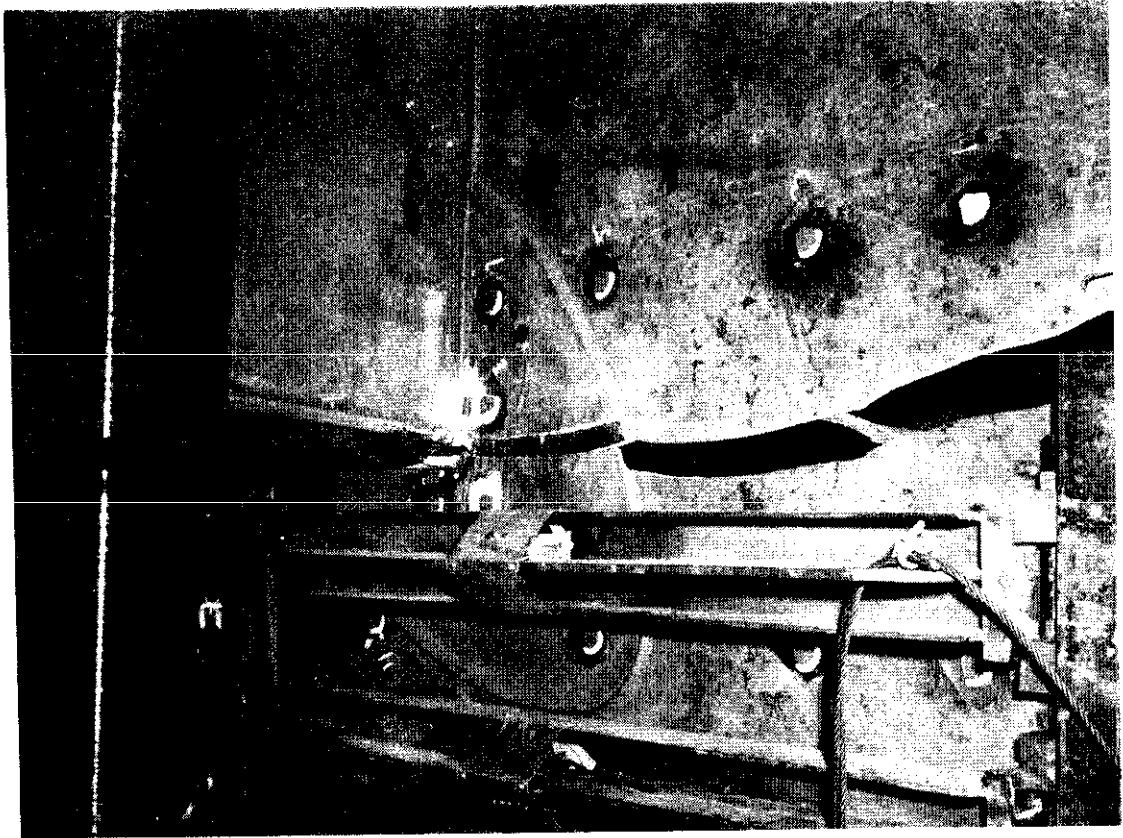
Fig. 37 Specimen 31: View of fractures from above

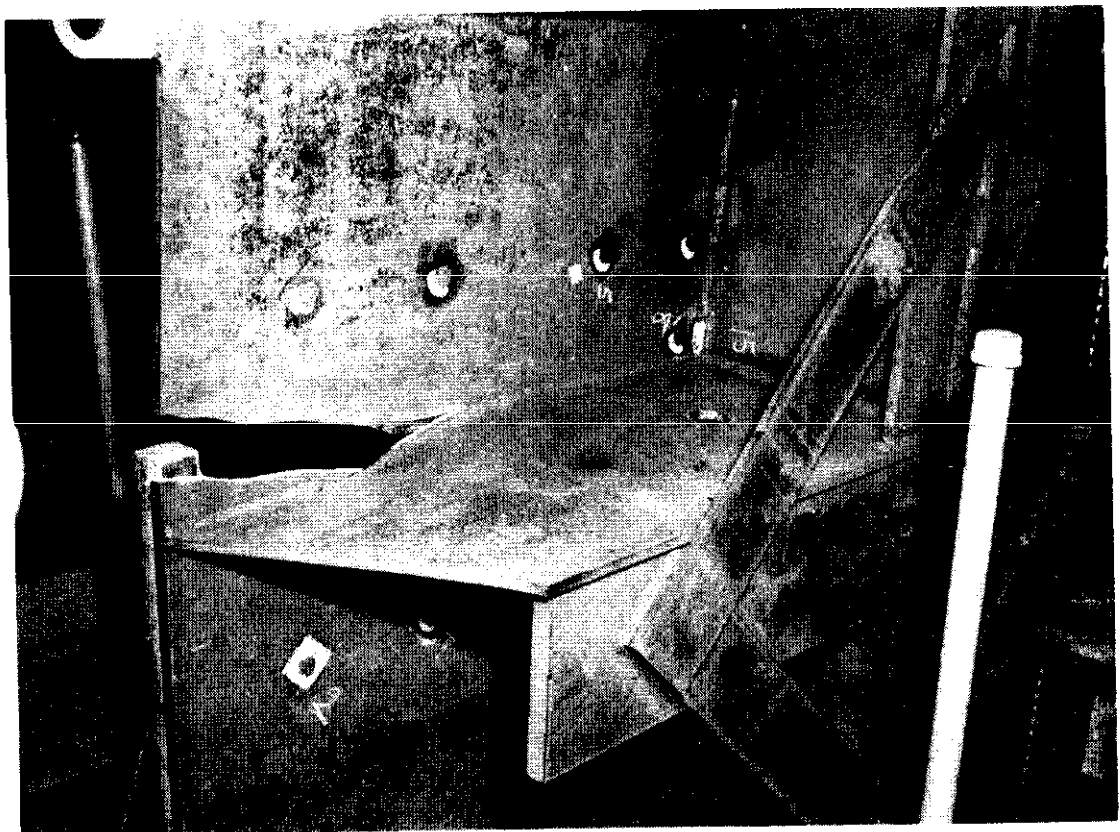
Fig. 38 Specimen 31: View from below deck, outboard and aft of hatch end beam

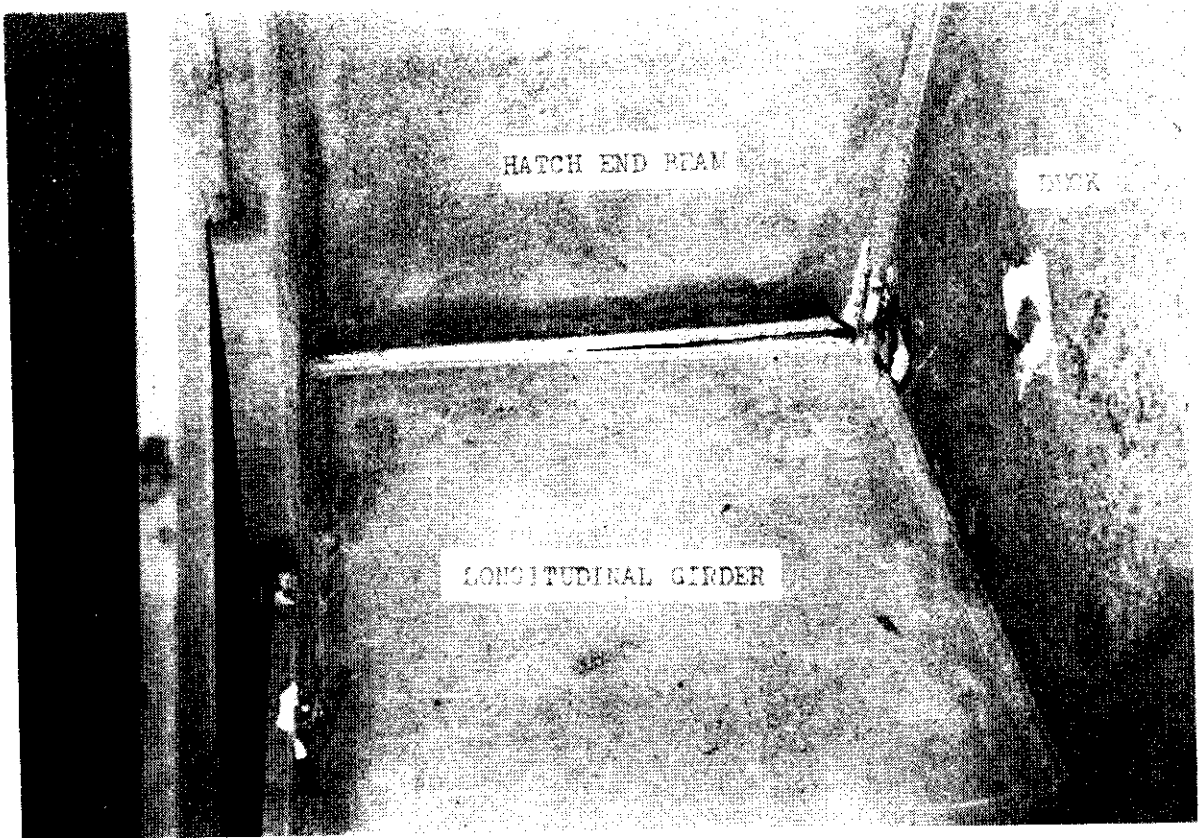
Fig. 39 Specimen 31: View from below deck, outboard and forward of hatch end beam

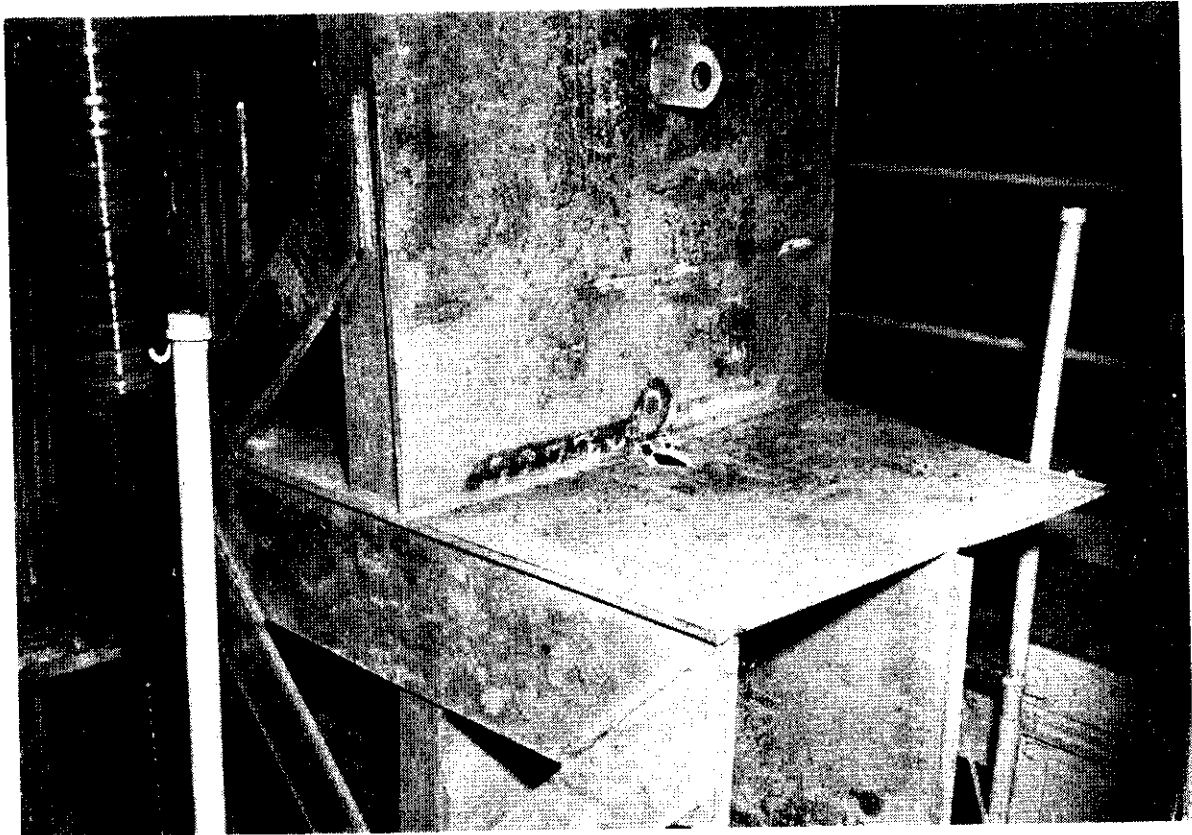
Fig. 40 Specimen 31: View from inside of hatch

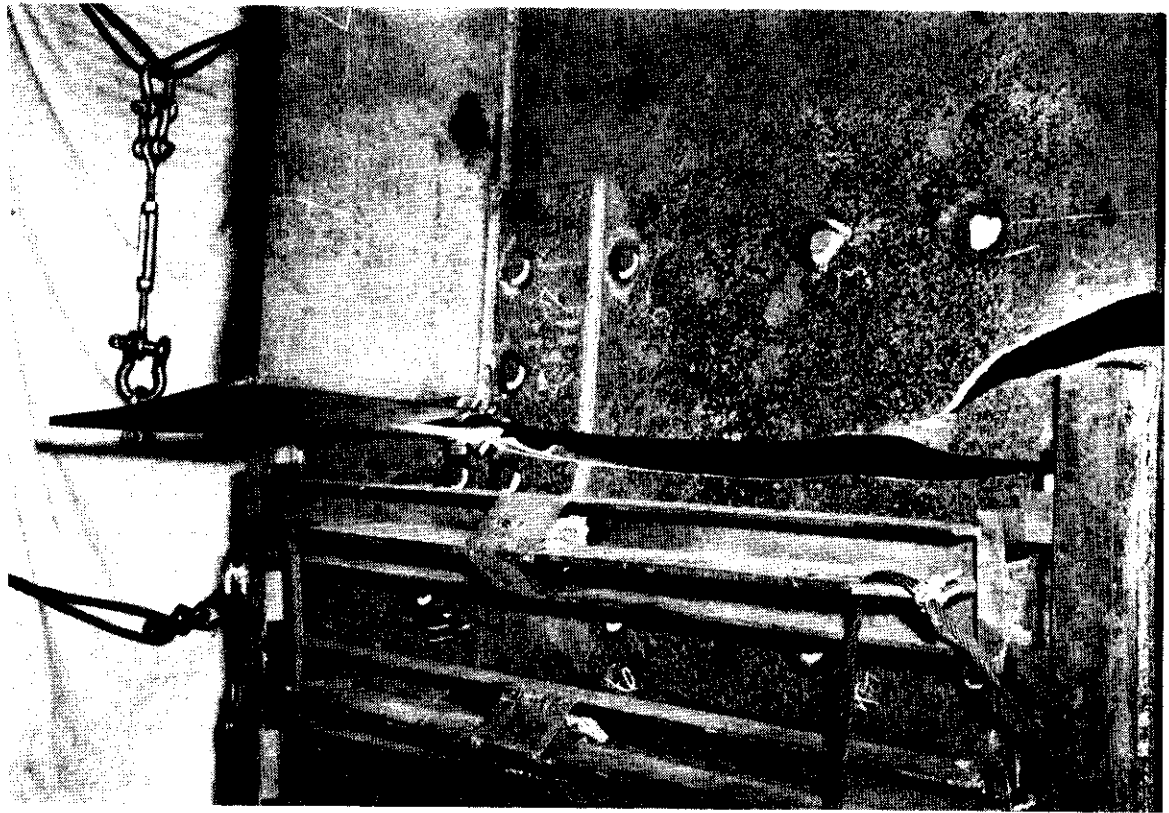
Fig. 41 Specimen 32: View of fracture from above

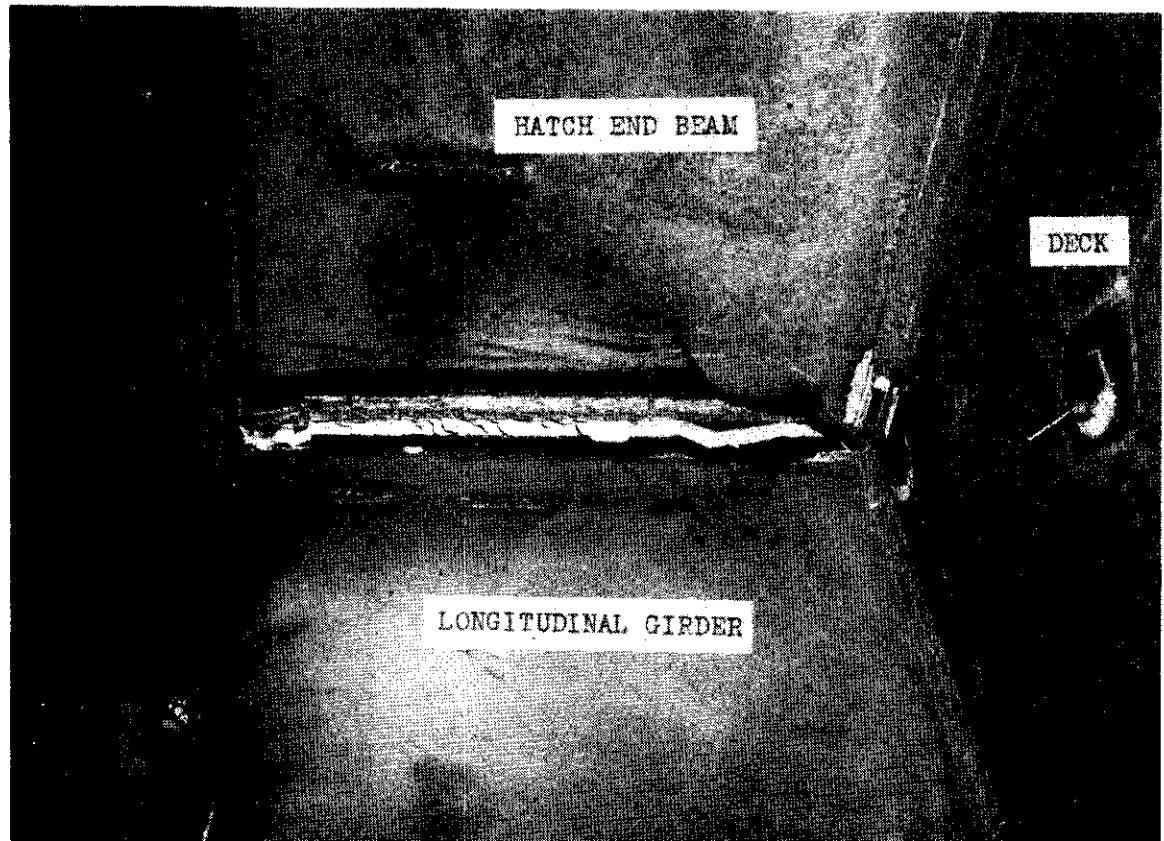
Fig. 42 Specimen 32: View from below deck, inboard and forward of hatch end beam

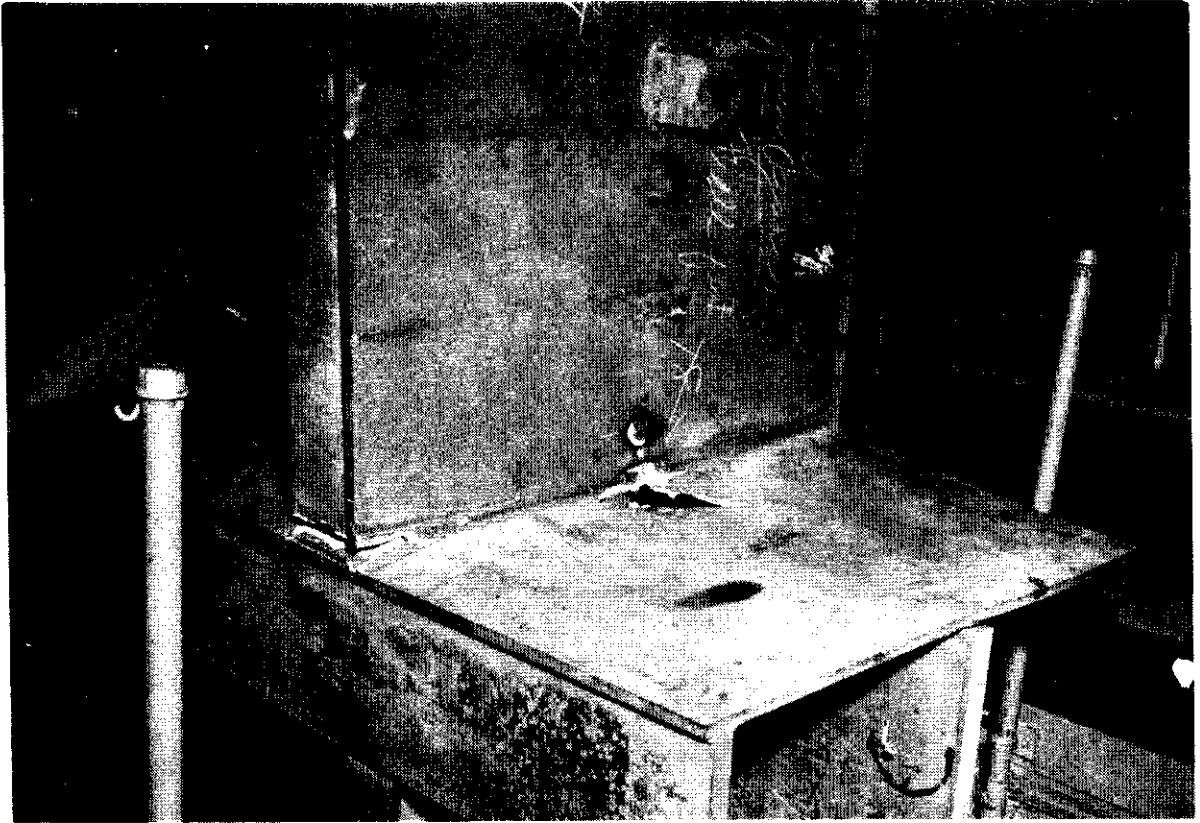
Fig. 43 Specimen 32: View from inside of hatch

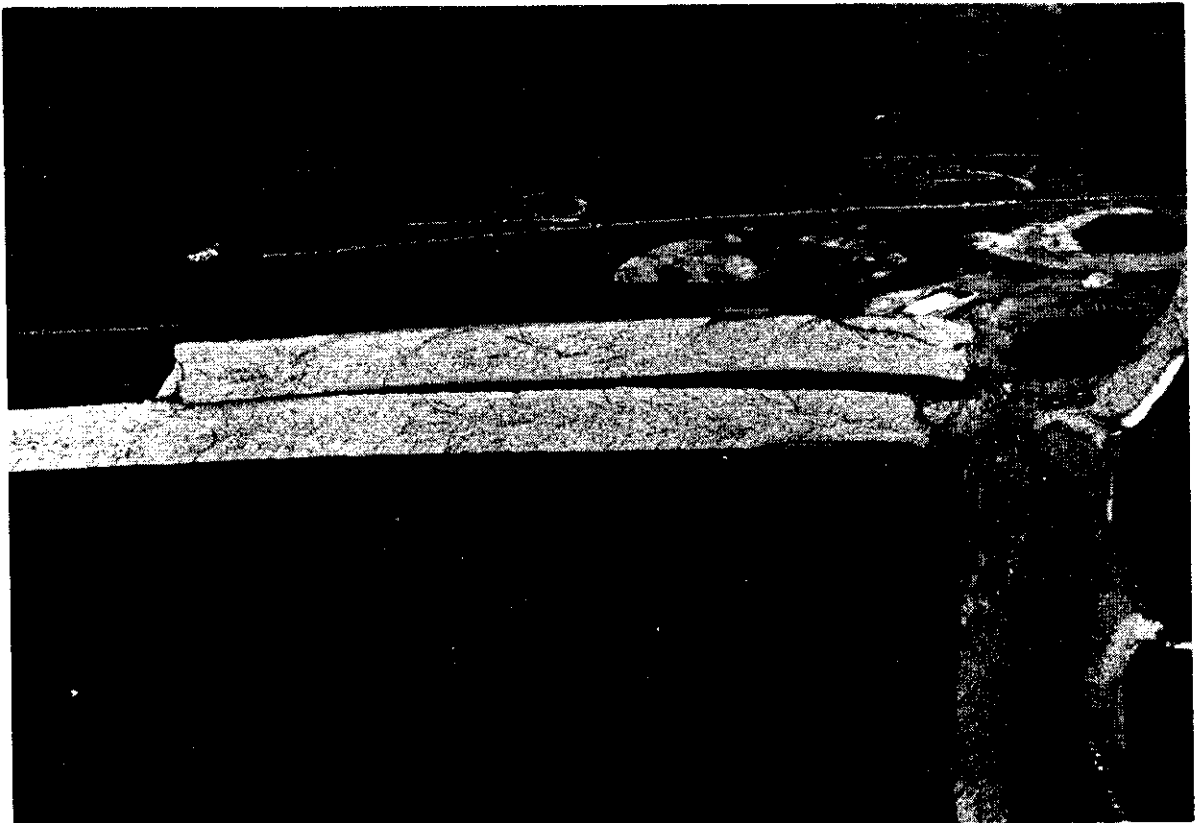
Fig. 44 Specimen 32: Fracture pattern in deck and doubler

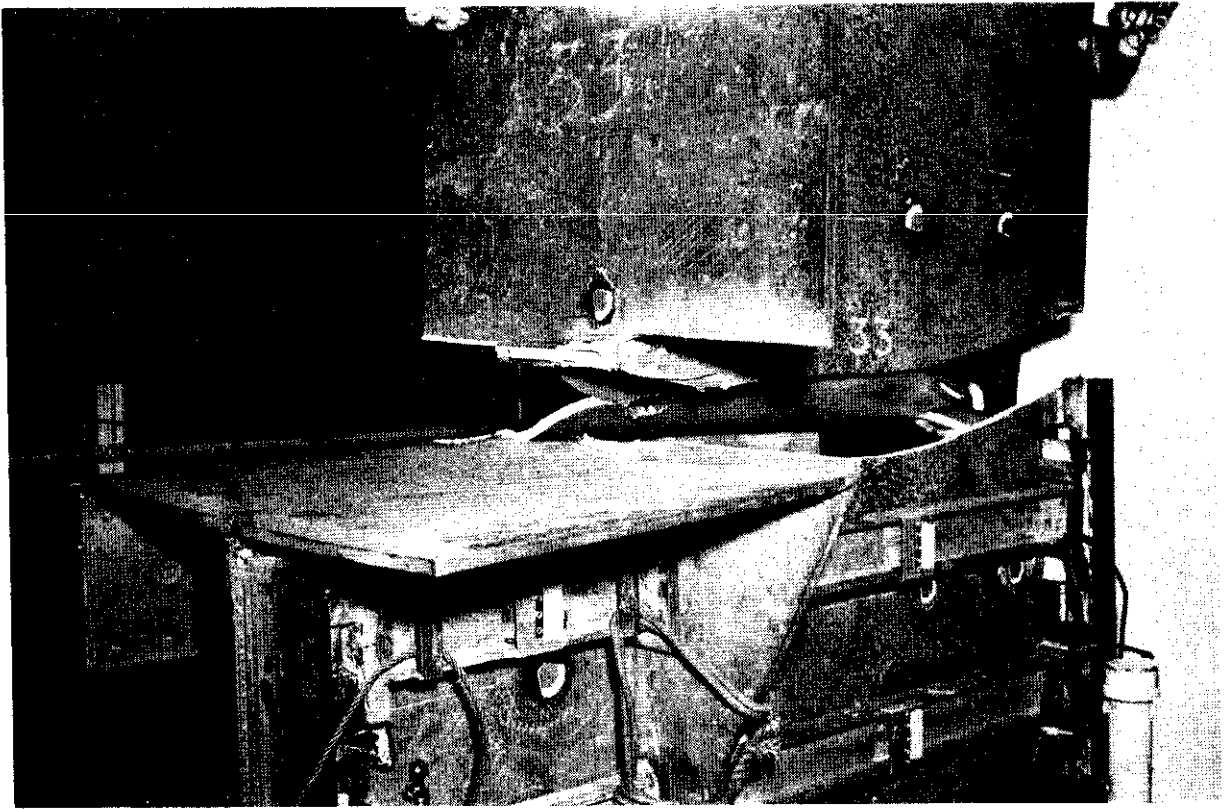
Fig. 45 Specimen 33: View of fractures from above deck and inboard

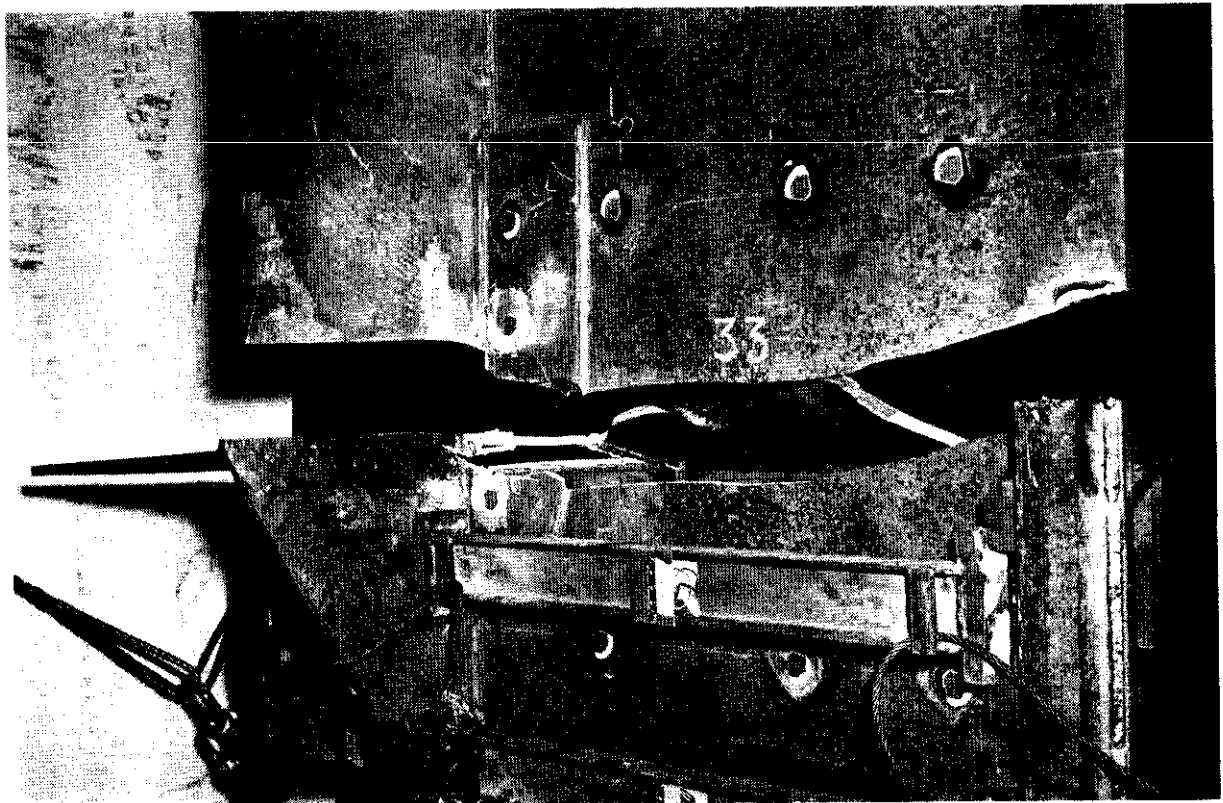
Fig. 46 Specimen 33: View of fractures from above deck and outboard

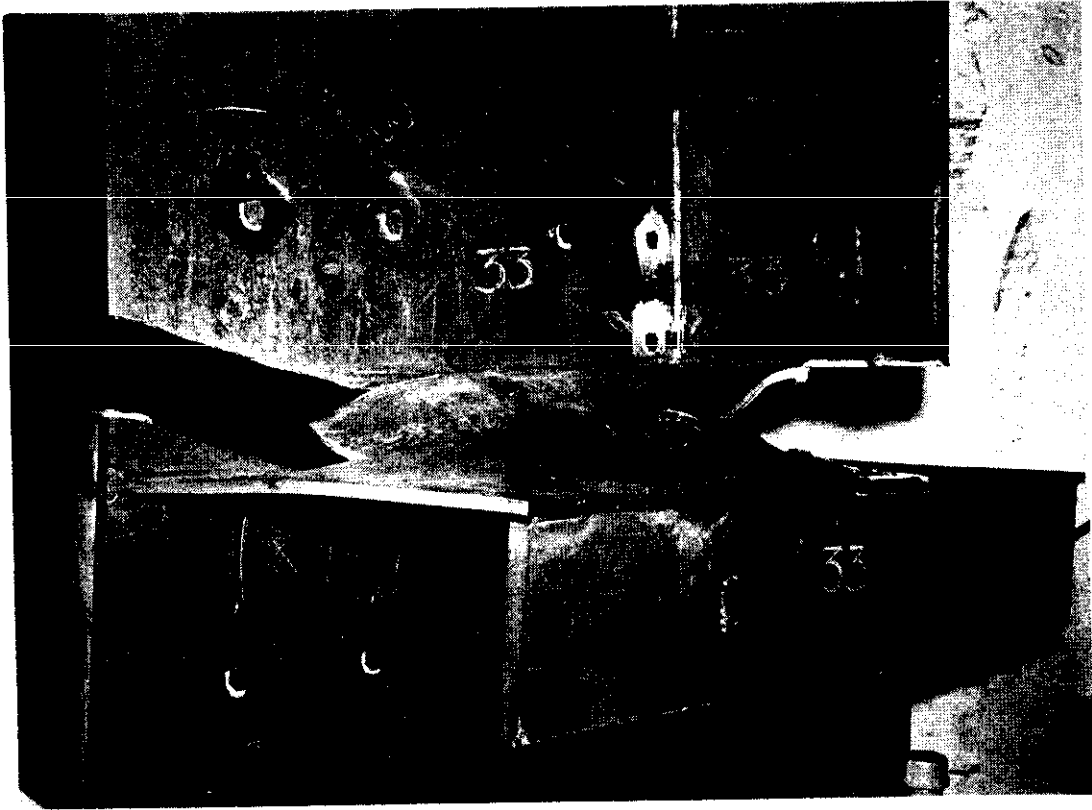
Fig. 47 Specimen 33: View of fractures from below deck and outboard

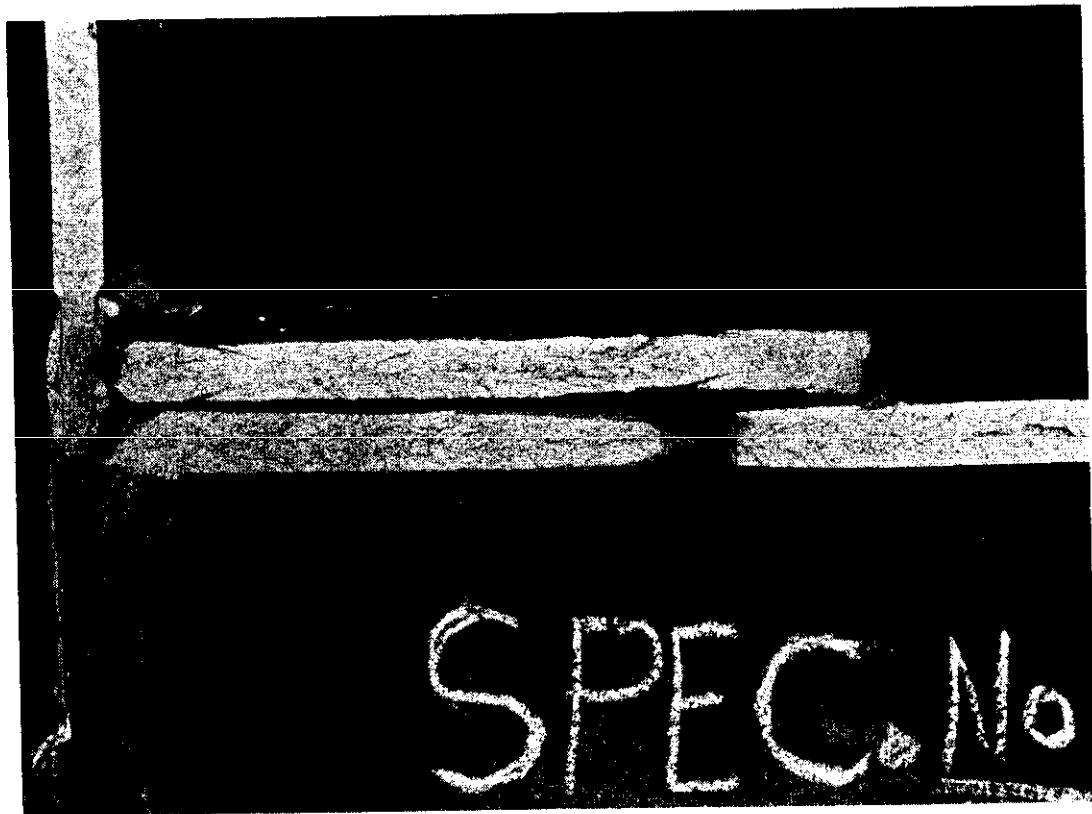
Fig. 48 Specimen 33: Fracture patterns in deck and doubler

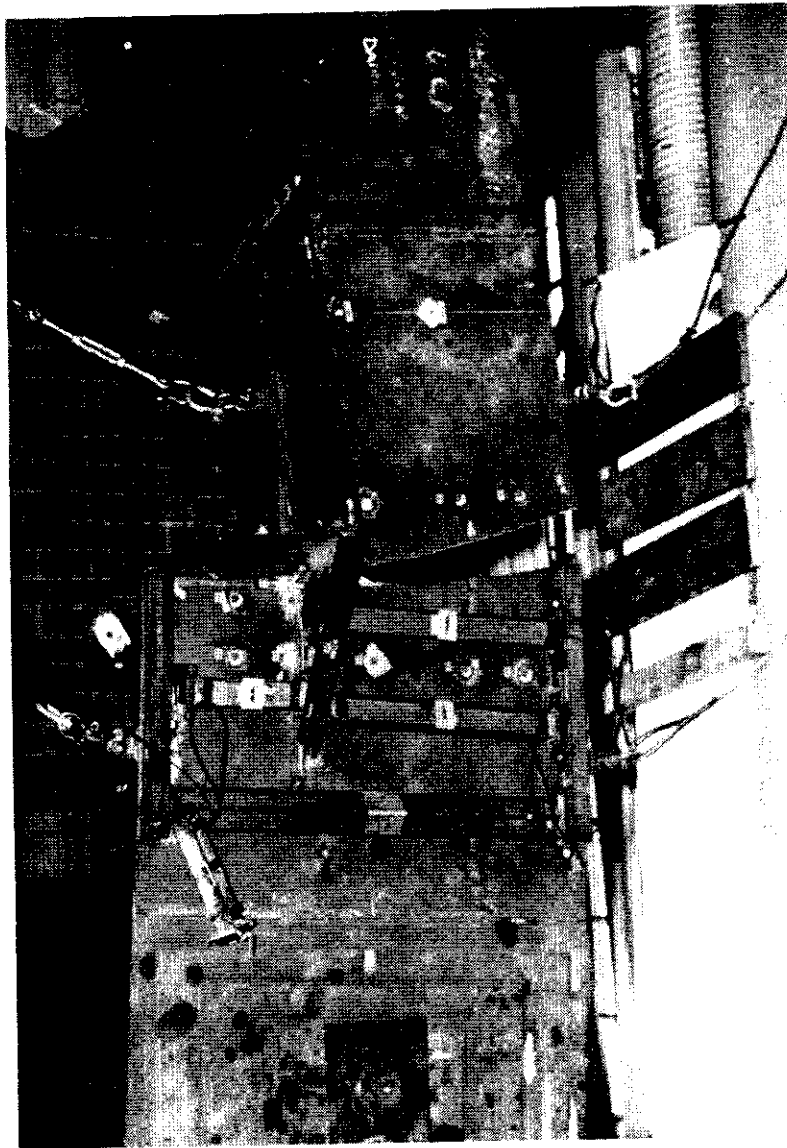
Fig. 49 Specimen 34: Overall view from above deck

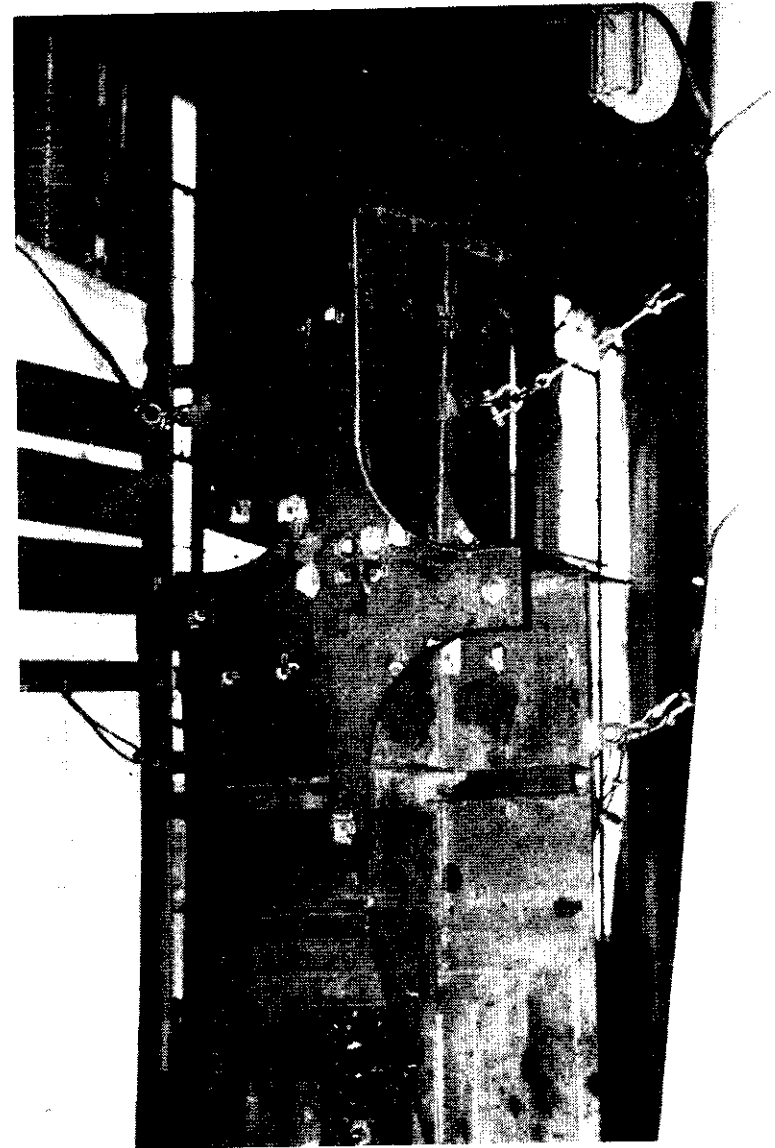
Fig. 50 Specimen 34: Overall view from below deck

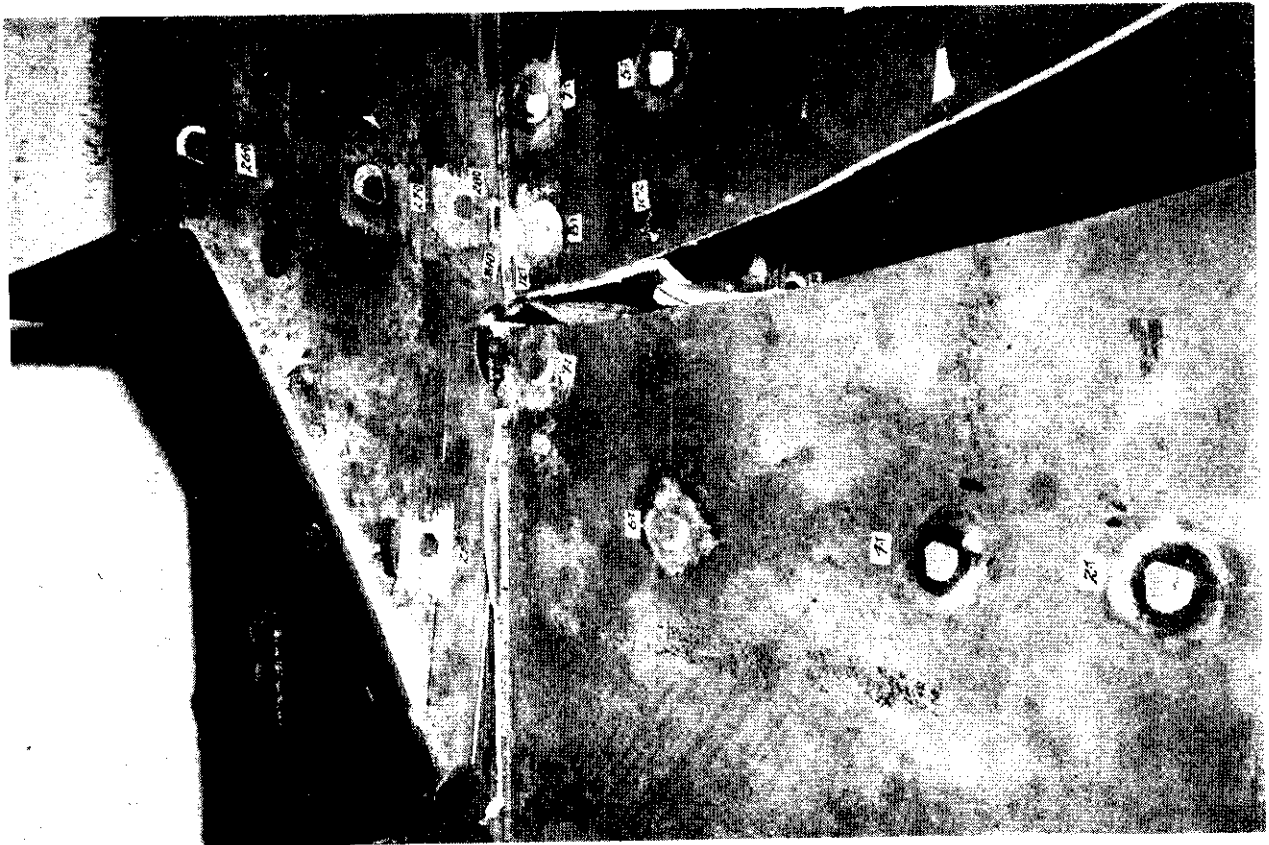
Fig. 51 Specimen 34: View of fractures from above deck

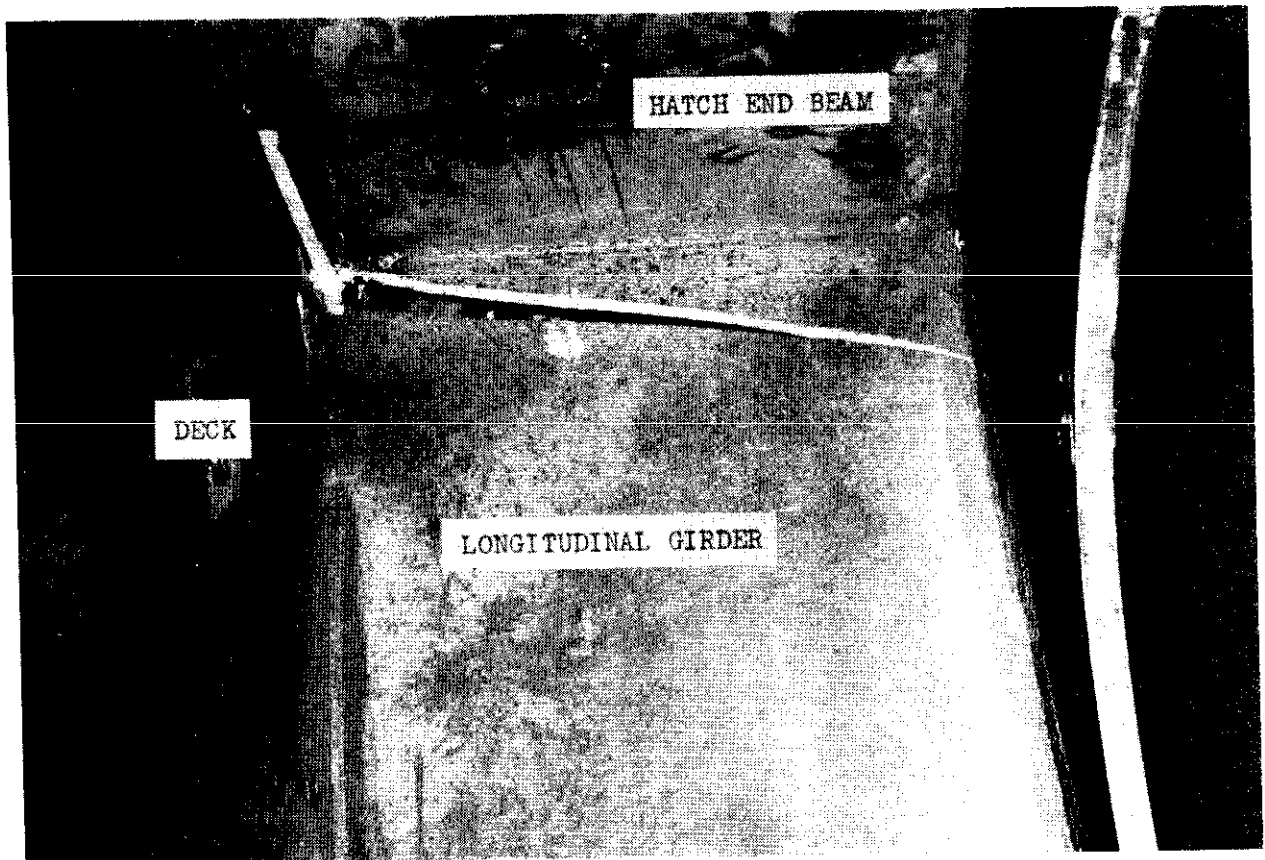
Fig. 52 Specimen 34: View from below deck, outboard and forward of hatch end beam

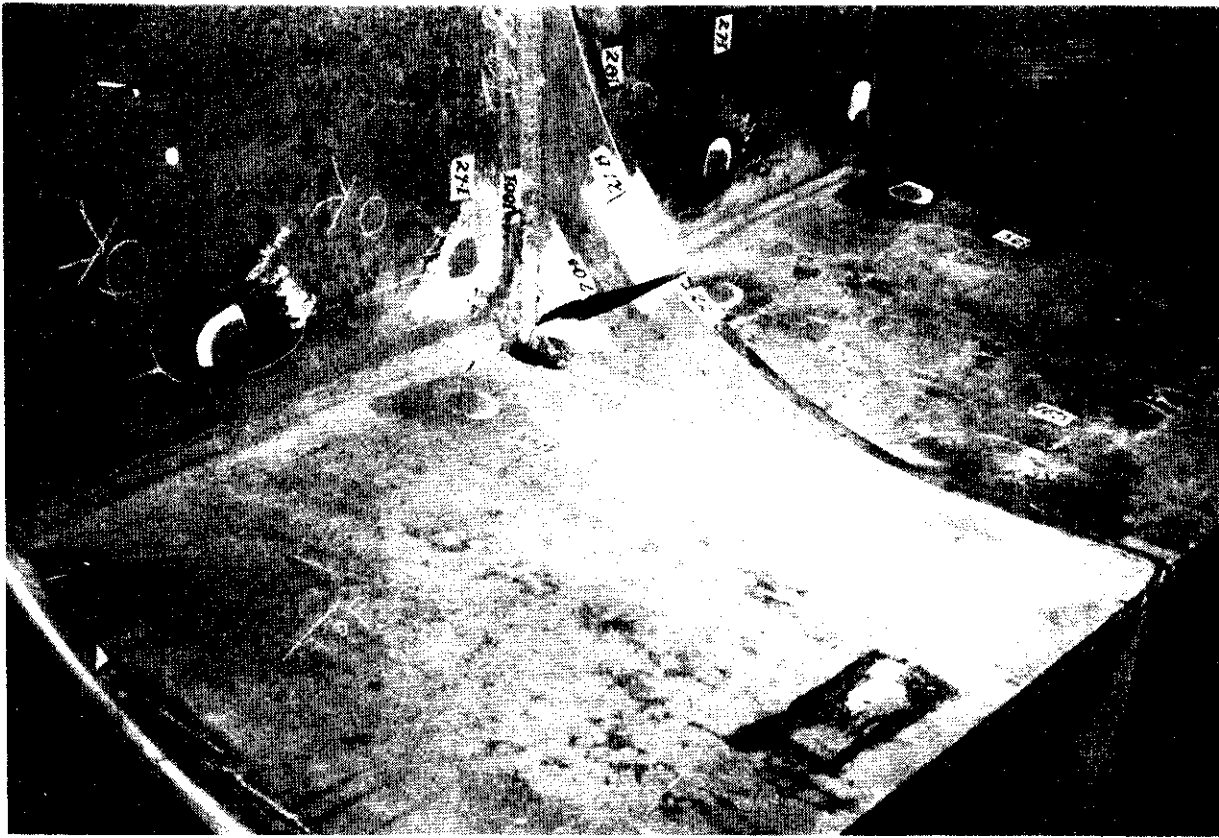
Fig. 53 Specimen 34: View from inside of hatch

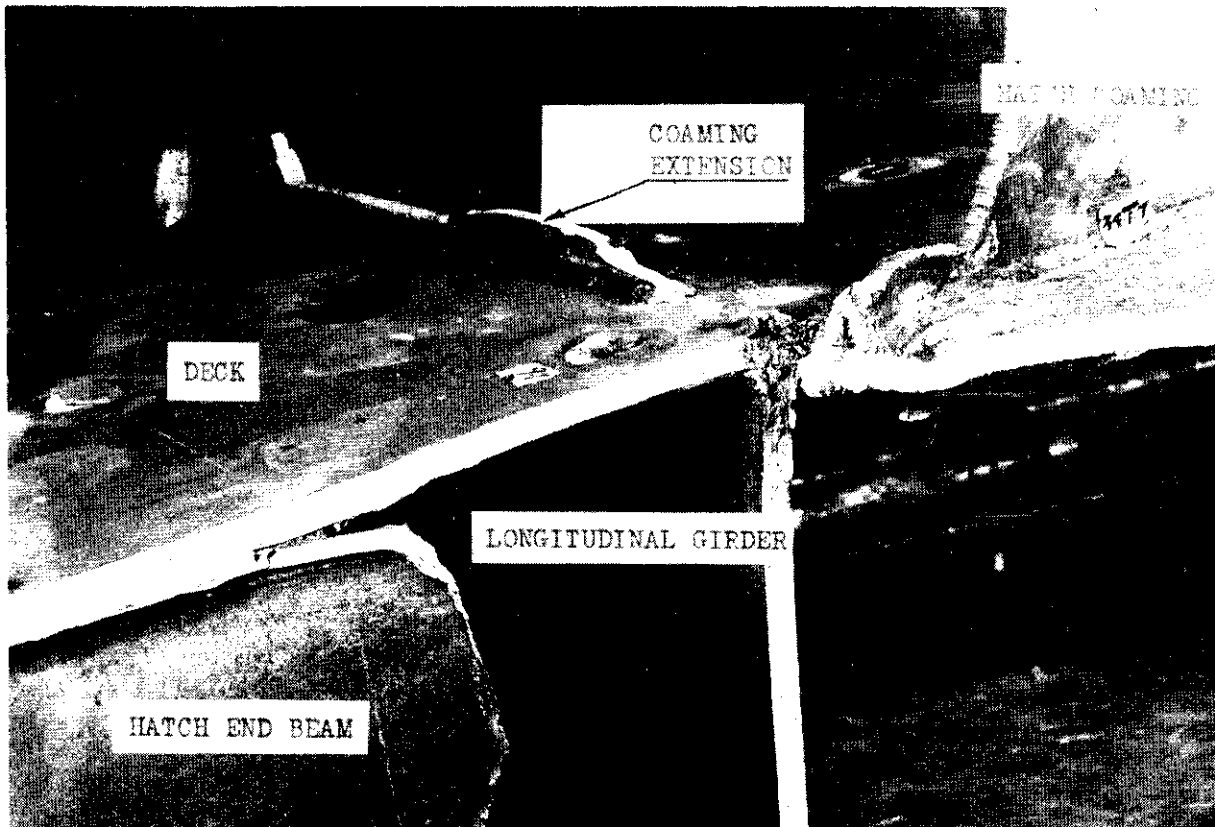
Fig. 54 Specimen 34: Fracture patterns, looking forward

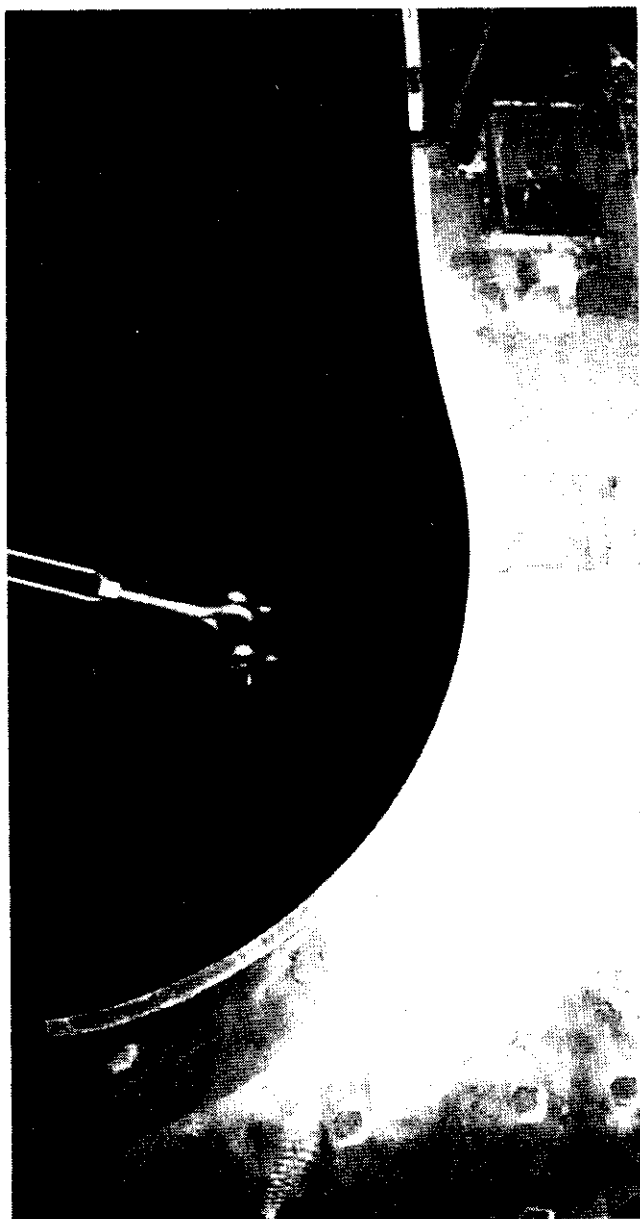
Fig. 55 Specimen 35: View showing distortion in coaming at end of first test

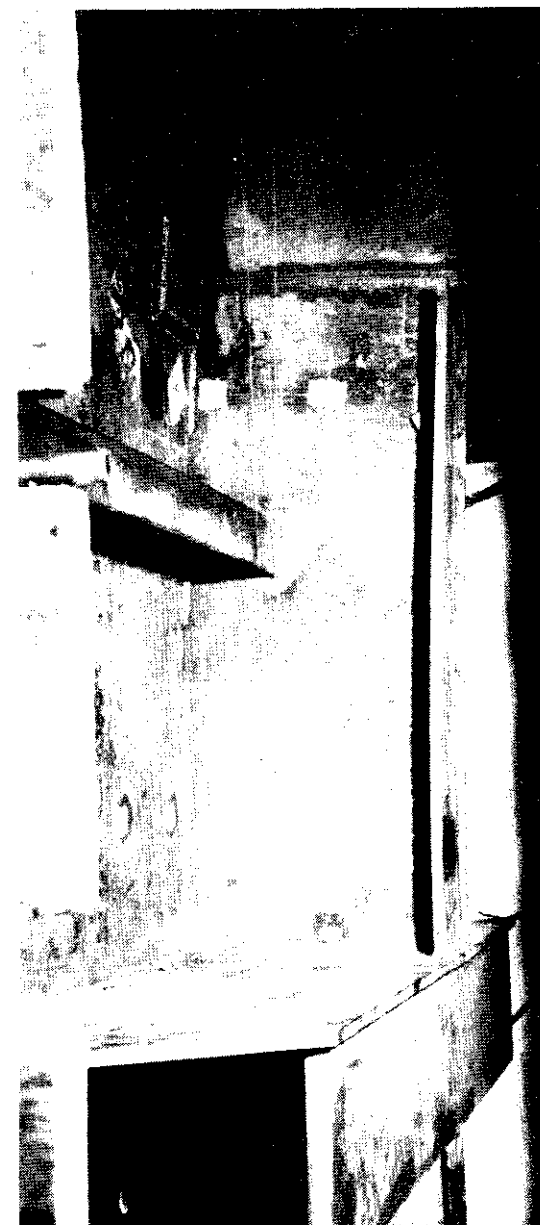
Fig. 57 Specimen 35: View showing distortion in longitudinal at end of first test
