CAUSES OF CLEAVAGE FRACTURE IN SHIP PLATE:
HATCH CORNER DESIGN TESTS

E. PAUL DeGARMO AND A. BOODBERG
UNIVERSITY OF CALIFORNIA
Under Navy Contract NObs-31222

Serial No. SSC-16

Date: December 4, 1947

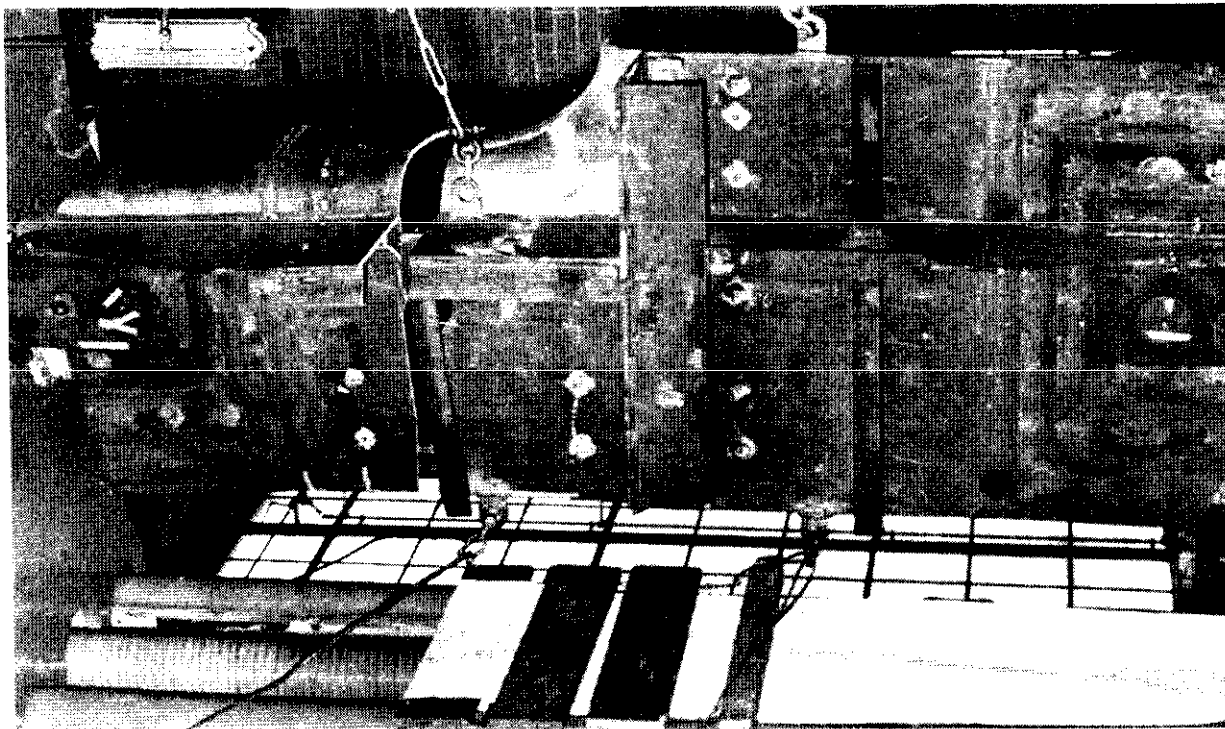
Fig. 59 Specimen 35: Overall view from below deck after failure

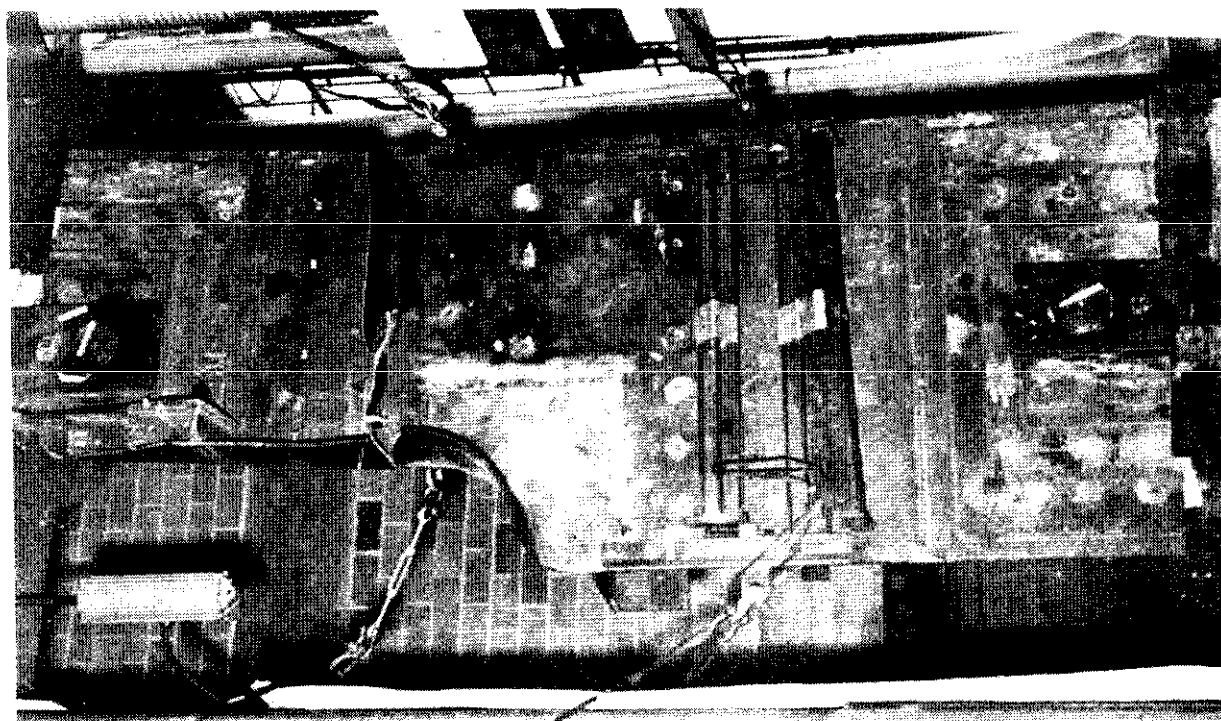
Fig. 58 Specimen 35: Overall view from above deck after failure

Perhaps the most significant fact about the test of Specimen 35 is that the fracture did not occur in the corner, as shown in Fig. 58. This is the only specimen for which this is true. The fracture originated in the cold-formed section at about the mid-point of the radius where an arc had been struck in welding on a flanging clip. At the conclusion of the tests there was no sign of any cracks of any kind in the vicinity of the corner.

While it could not be measured, observation indicated that the reduction in thickness in the deck plate on a section near the corner was probably greater than that which occurred near the fracture. There was considerably more necking near the corner than at the fracture. Since over 60 hours elapsed between the initial and second loading of this specimen, it is possible that some strain-age hardening may have occurred.

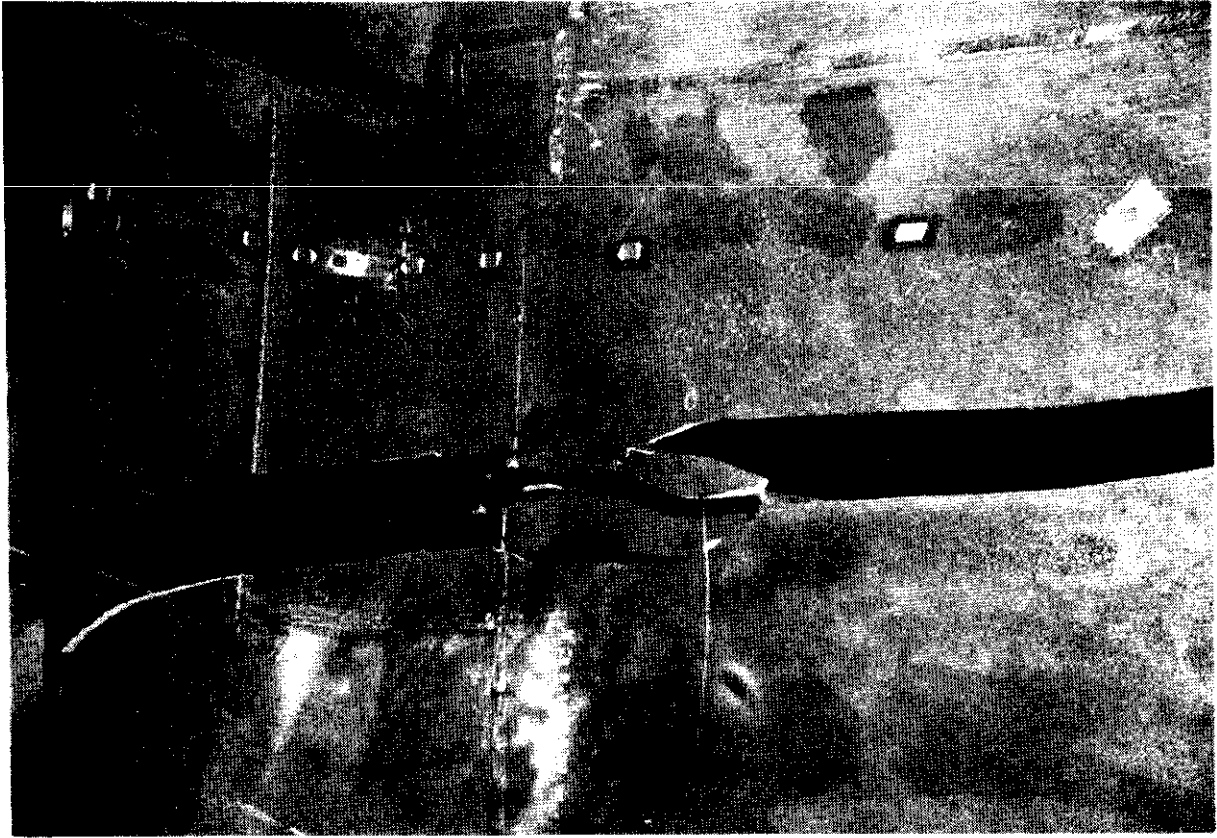
Fig. 60 Specimen 35: View of fractures from above deck

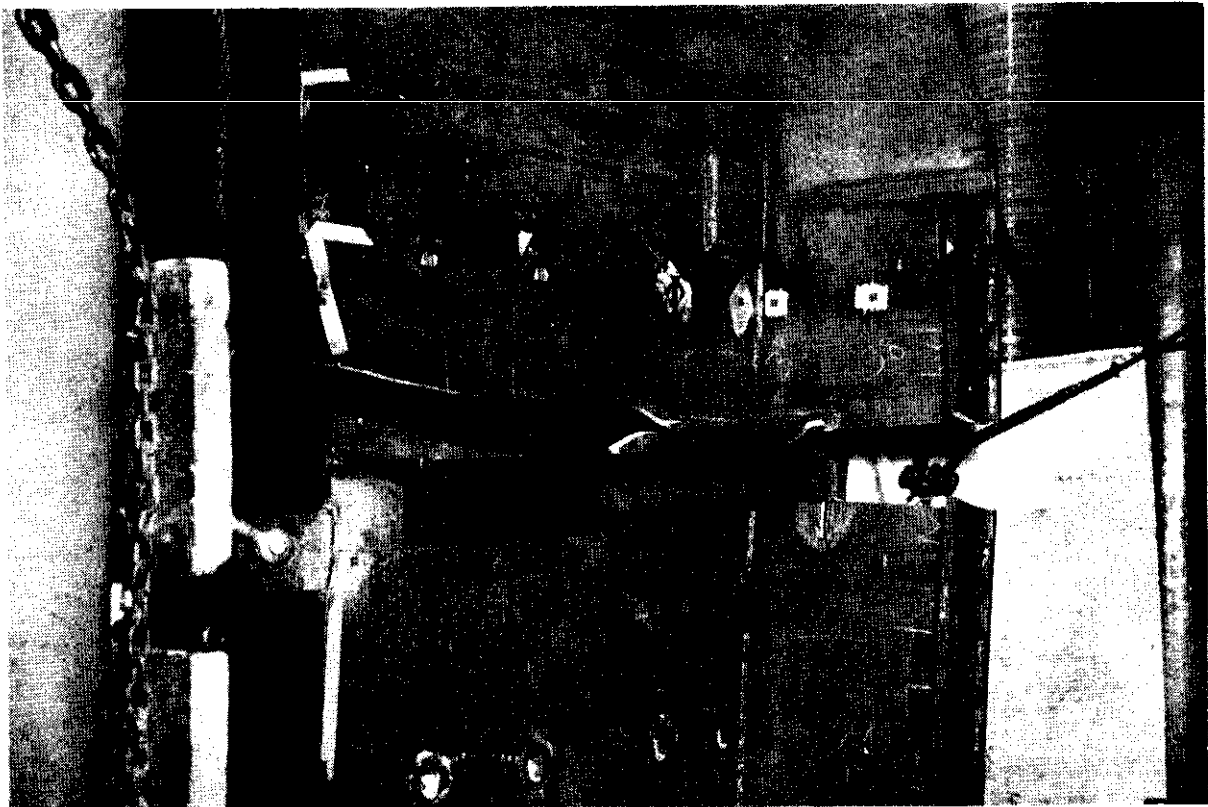
Fig. 61 Specimen 35: View of fractures from below deck

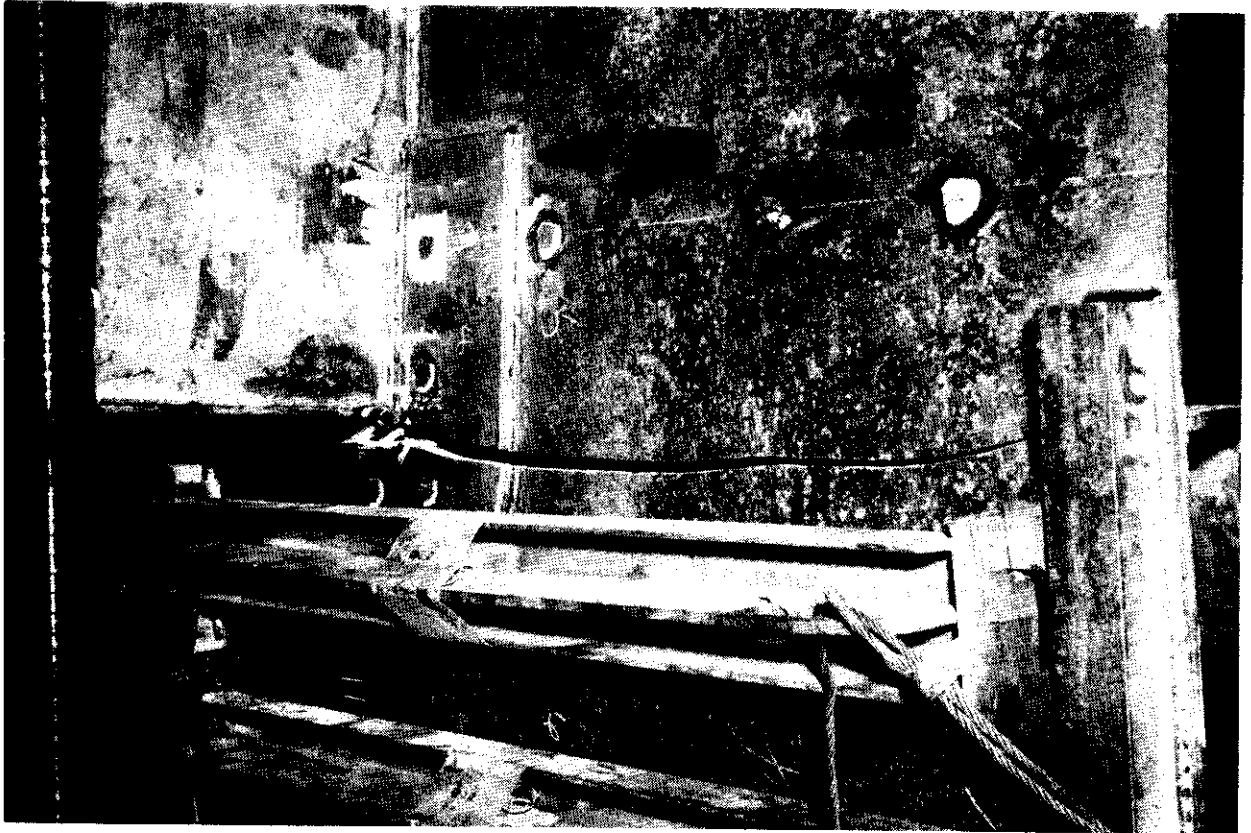
Fig. 62 Specimen 38: View of fractures from above deck

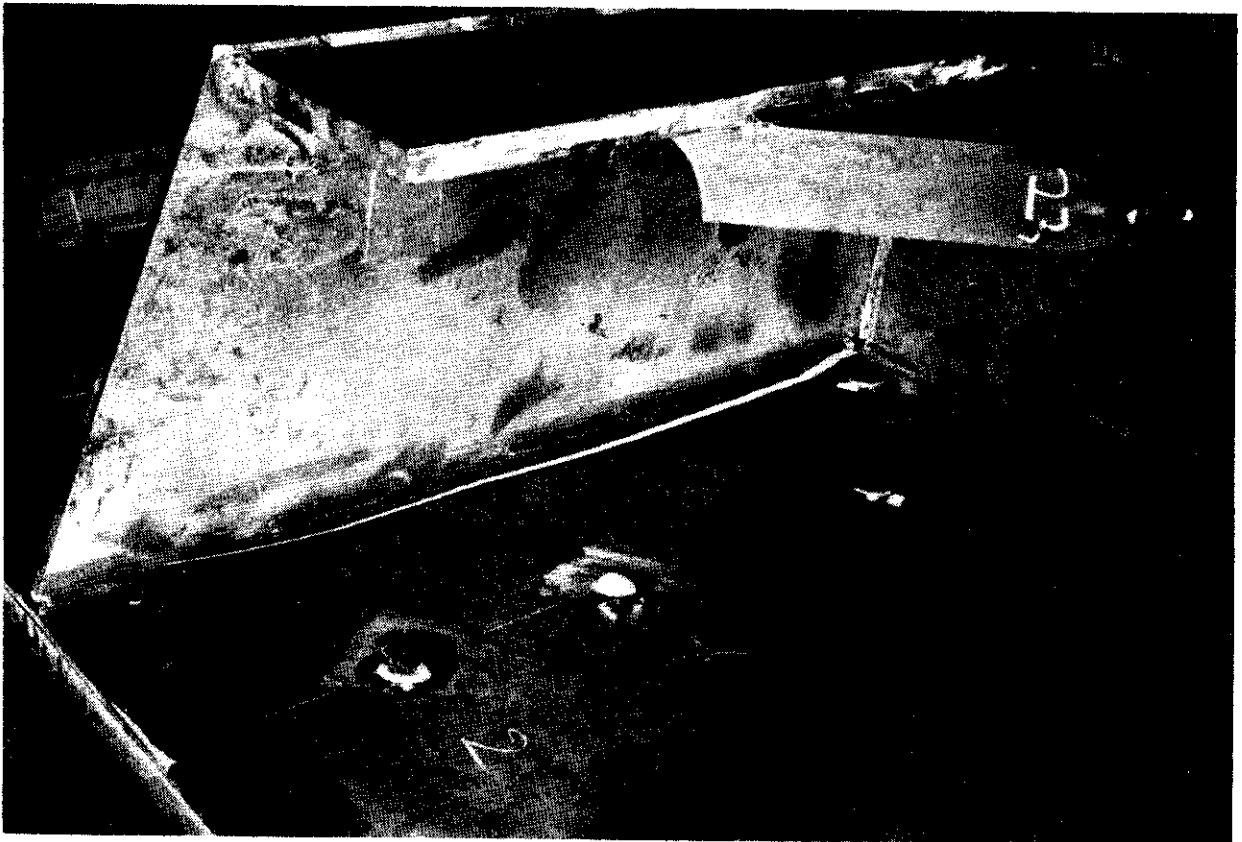
Fig. 63 Specimen 38: View of fracture from below deck, outboard and forward of hatch end beam

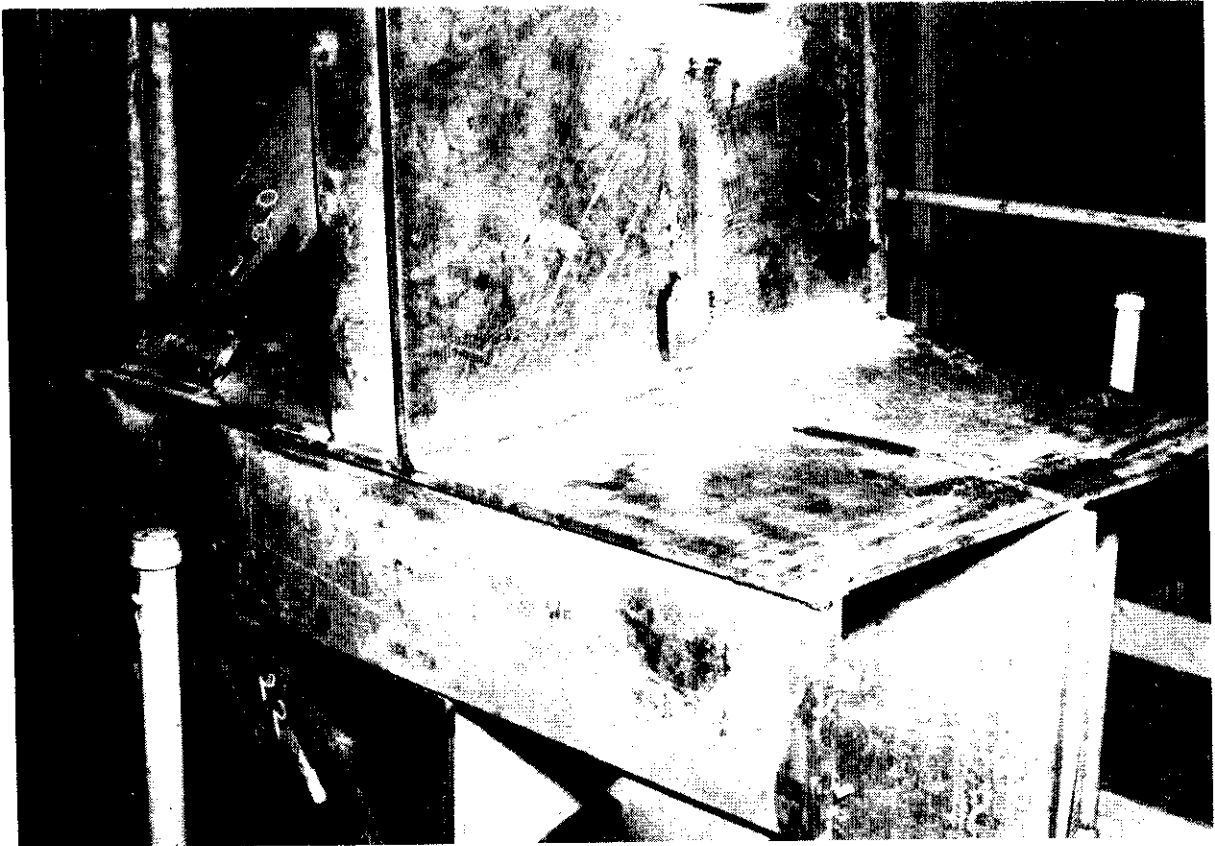
Fig. 64 Specimen 38: View from inside of hatch

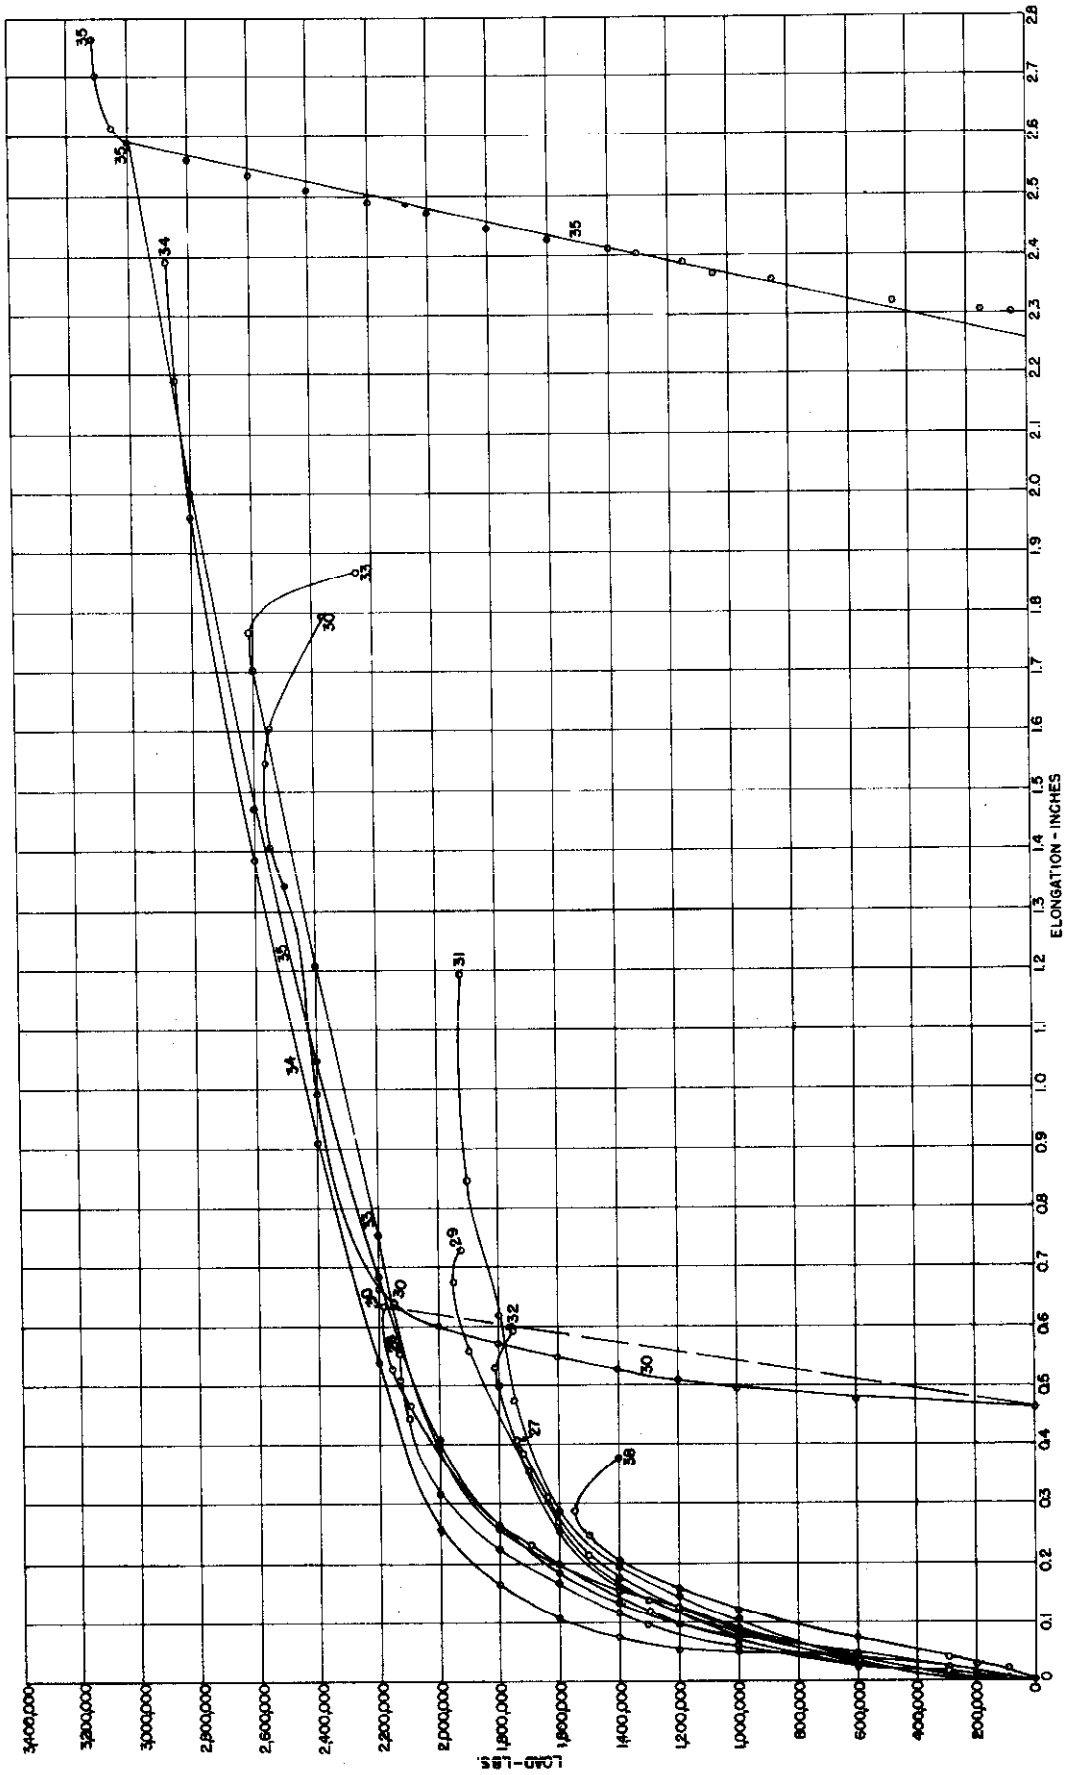
FIG 66

LOAD-STRAIN CURVES FOR ENERGY DETERMINATION

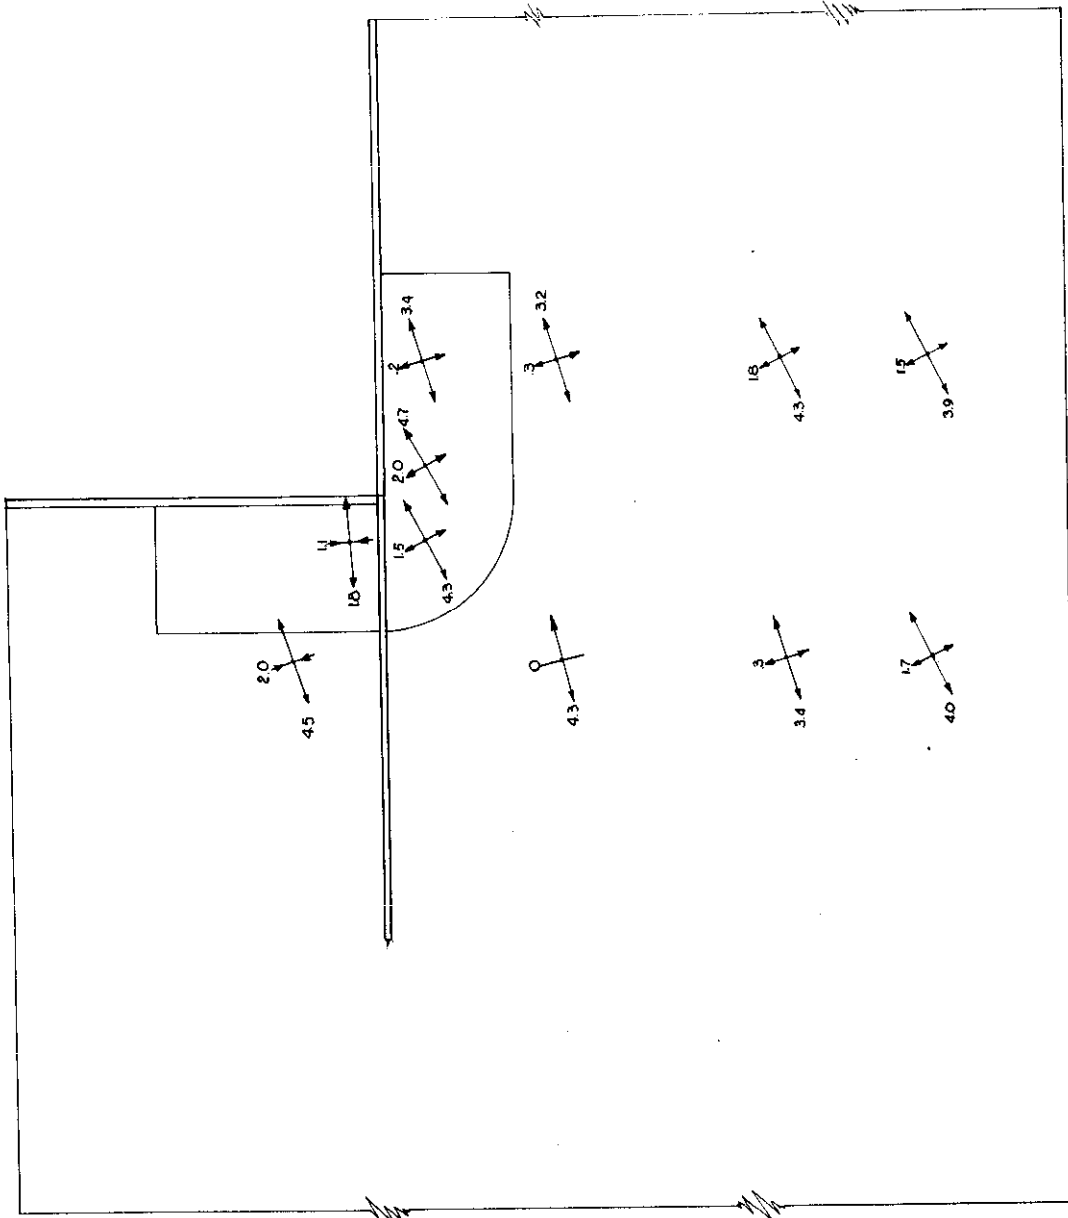
UNIVERSITY OF CALIFORNIA WELDING RESEARCH	FIG 72: PRINCIPAL STRESSES AT 200,000# LOAD SPECIMEN 33		SCALE	2" = 1'-0"	APPROVED	
	DR. BY	G.P.	TR. BY		6/15/47	DWG. PANEL

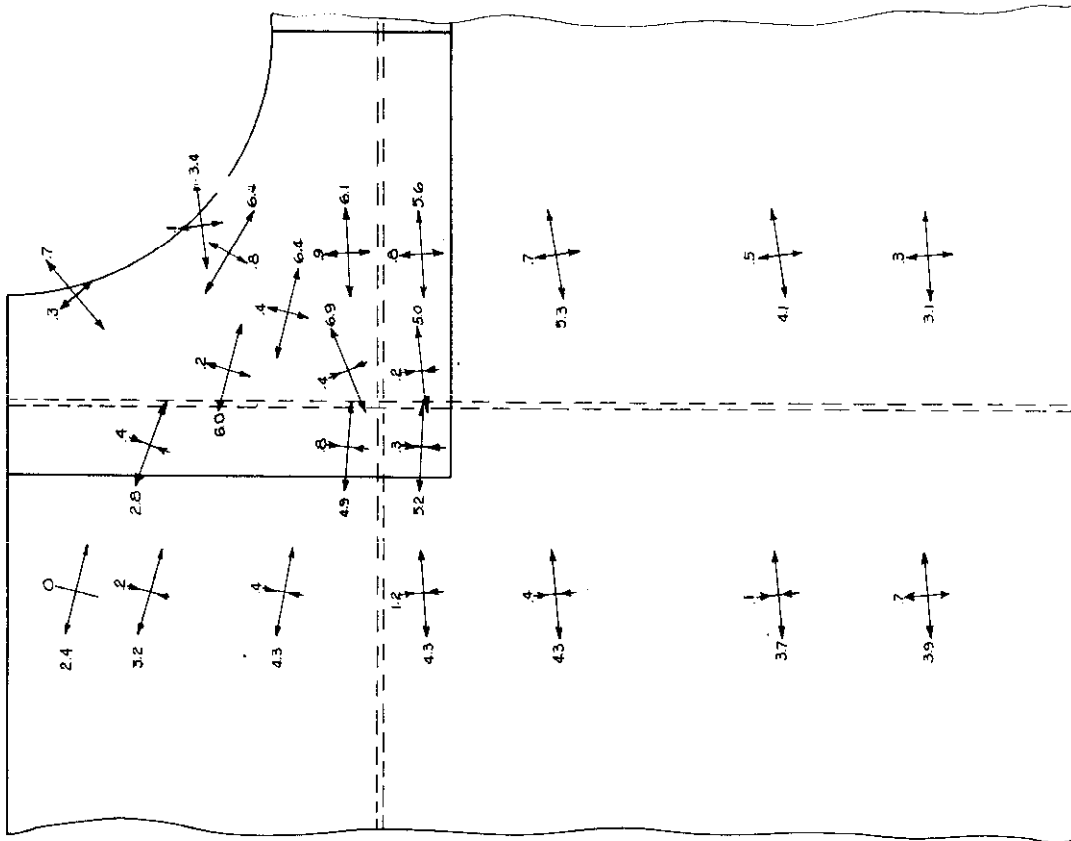
UNIVERSITY OF CALIFORNIA WELDING RESEARCH	SCALE		APPROVED	
	DR. BY	TR. BY	/ /	DWG
FIG. 74: PRINCIPAL STRESSES AT 200,000# LOAD SPECIMEN 35			/ /	PANEL

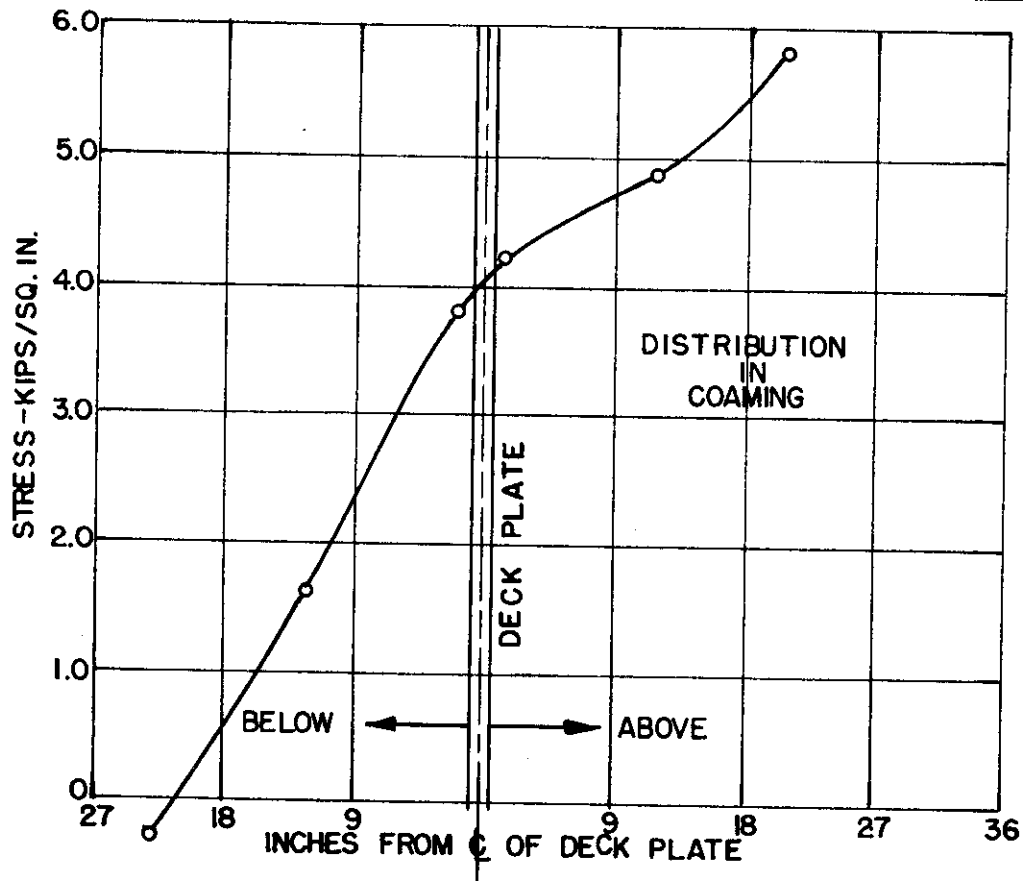
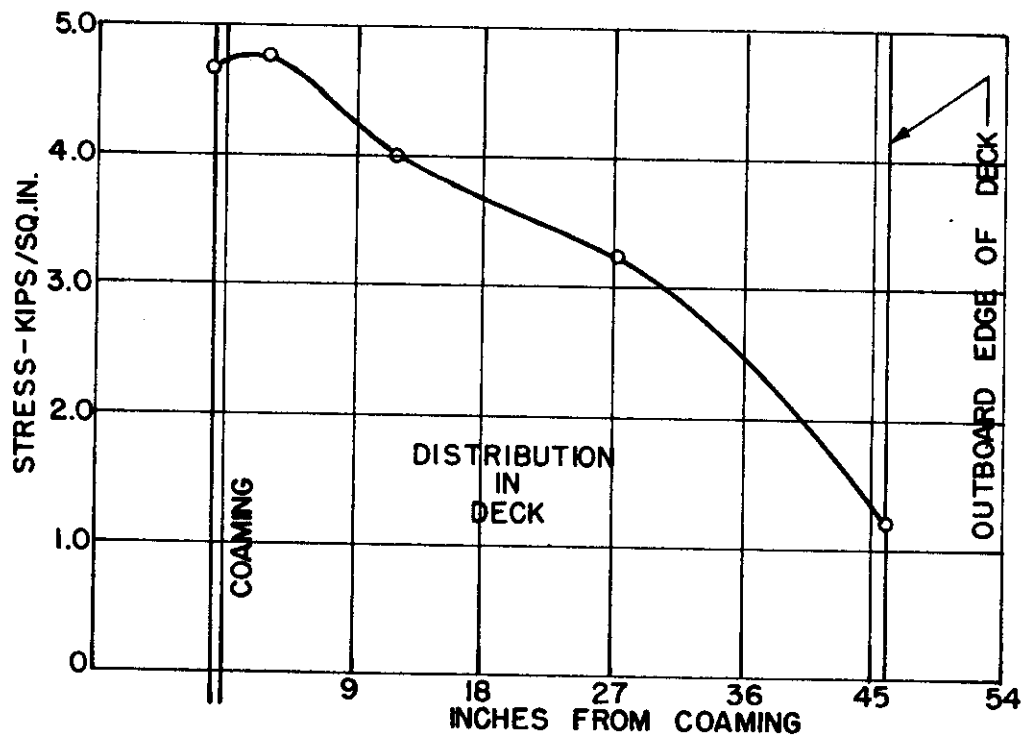
FIG. 75 LONGITUDINAL STRESS DISTRIBUTION IN DECK PLATE AND COAMING 36" AFT OF CORNER AT 200,000^{lb} LOAD, SPEC.34

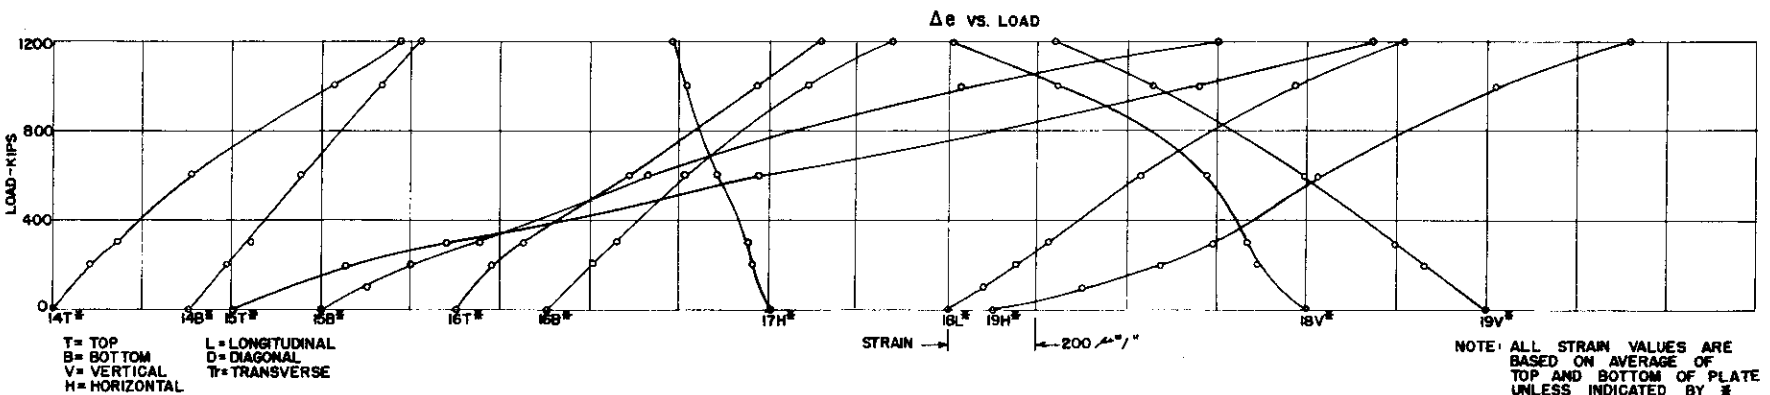
FIG. 78 LOAD-STRAIN CURVES FOR INDIVIDUAL GAGES, SPECIMEN 33

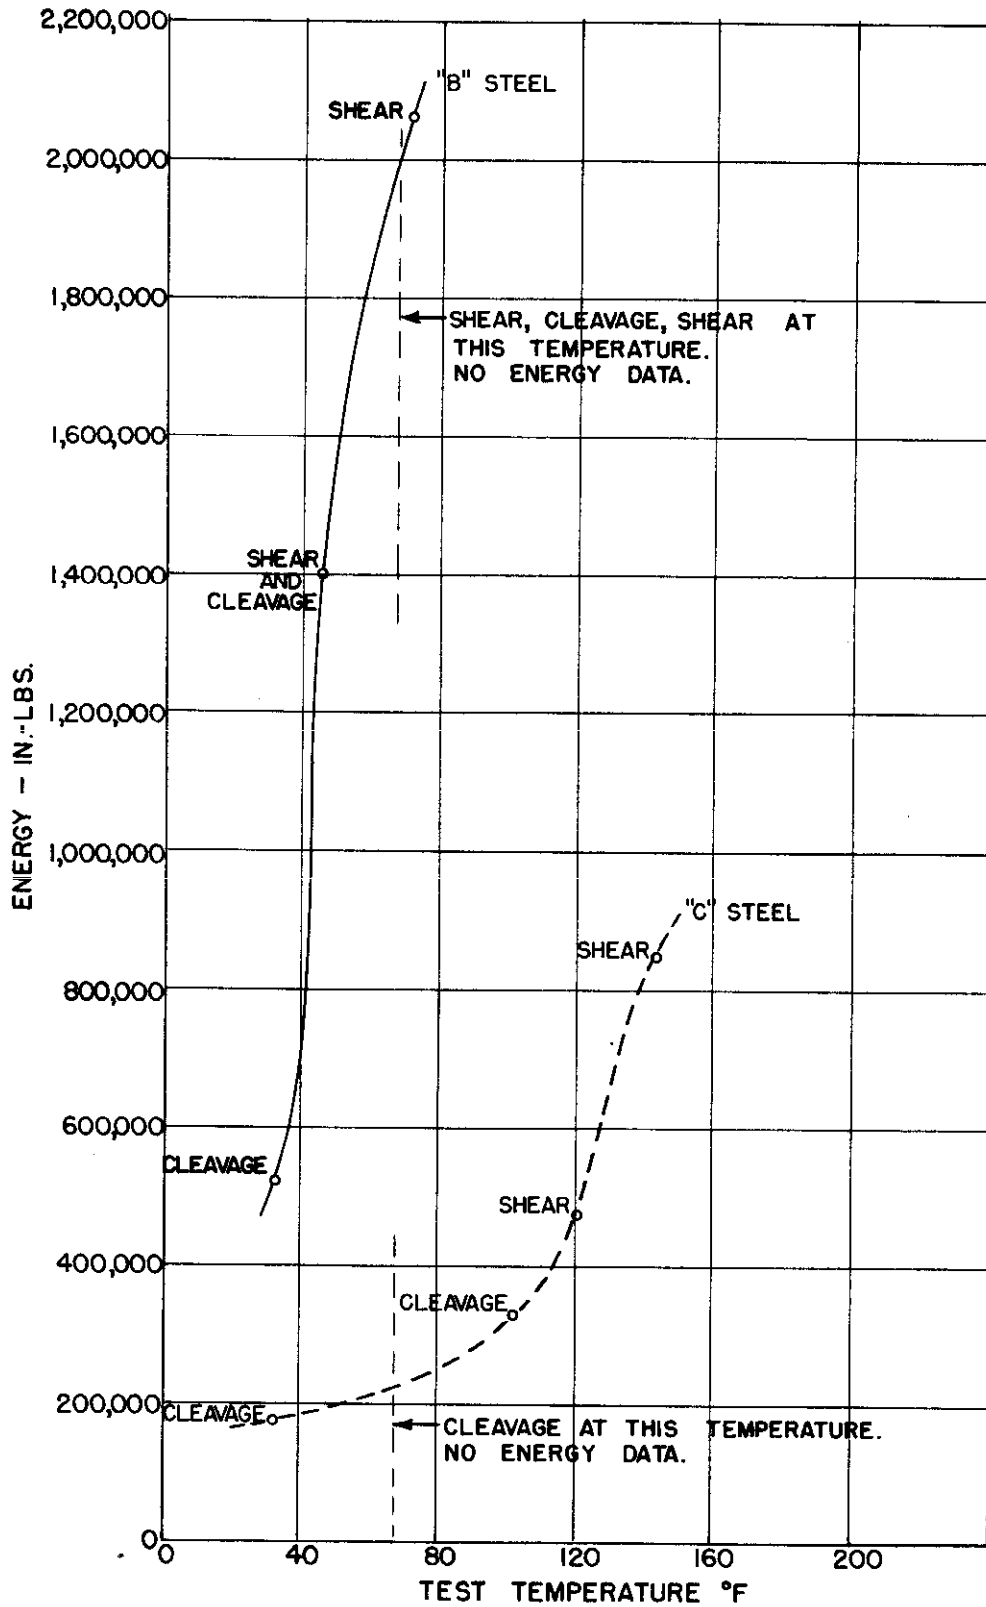
FIG. 81

TEMPERATURE TRANSITION CURVES
FOR HATCH CORNER SPECIMENS,
"B" AND "C" STEELS
