**CORRELATION OF LABORATORY TESTS WITH
FULL SCALE SHIP PLATE FRACTURE TESTS:
A STUDY OF STRAIN GRADIENTS**

**E. P. KLIER, F. C. WAGNER, J. L. FISHER
and M. GENSAMER**

**Pennsylvania State College
Under Bureau of Ships Contract NObs-31217**

SERIAL NO. SSC-17

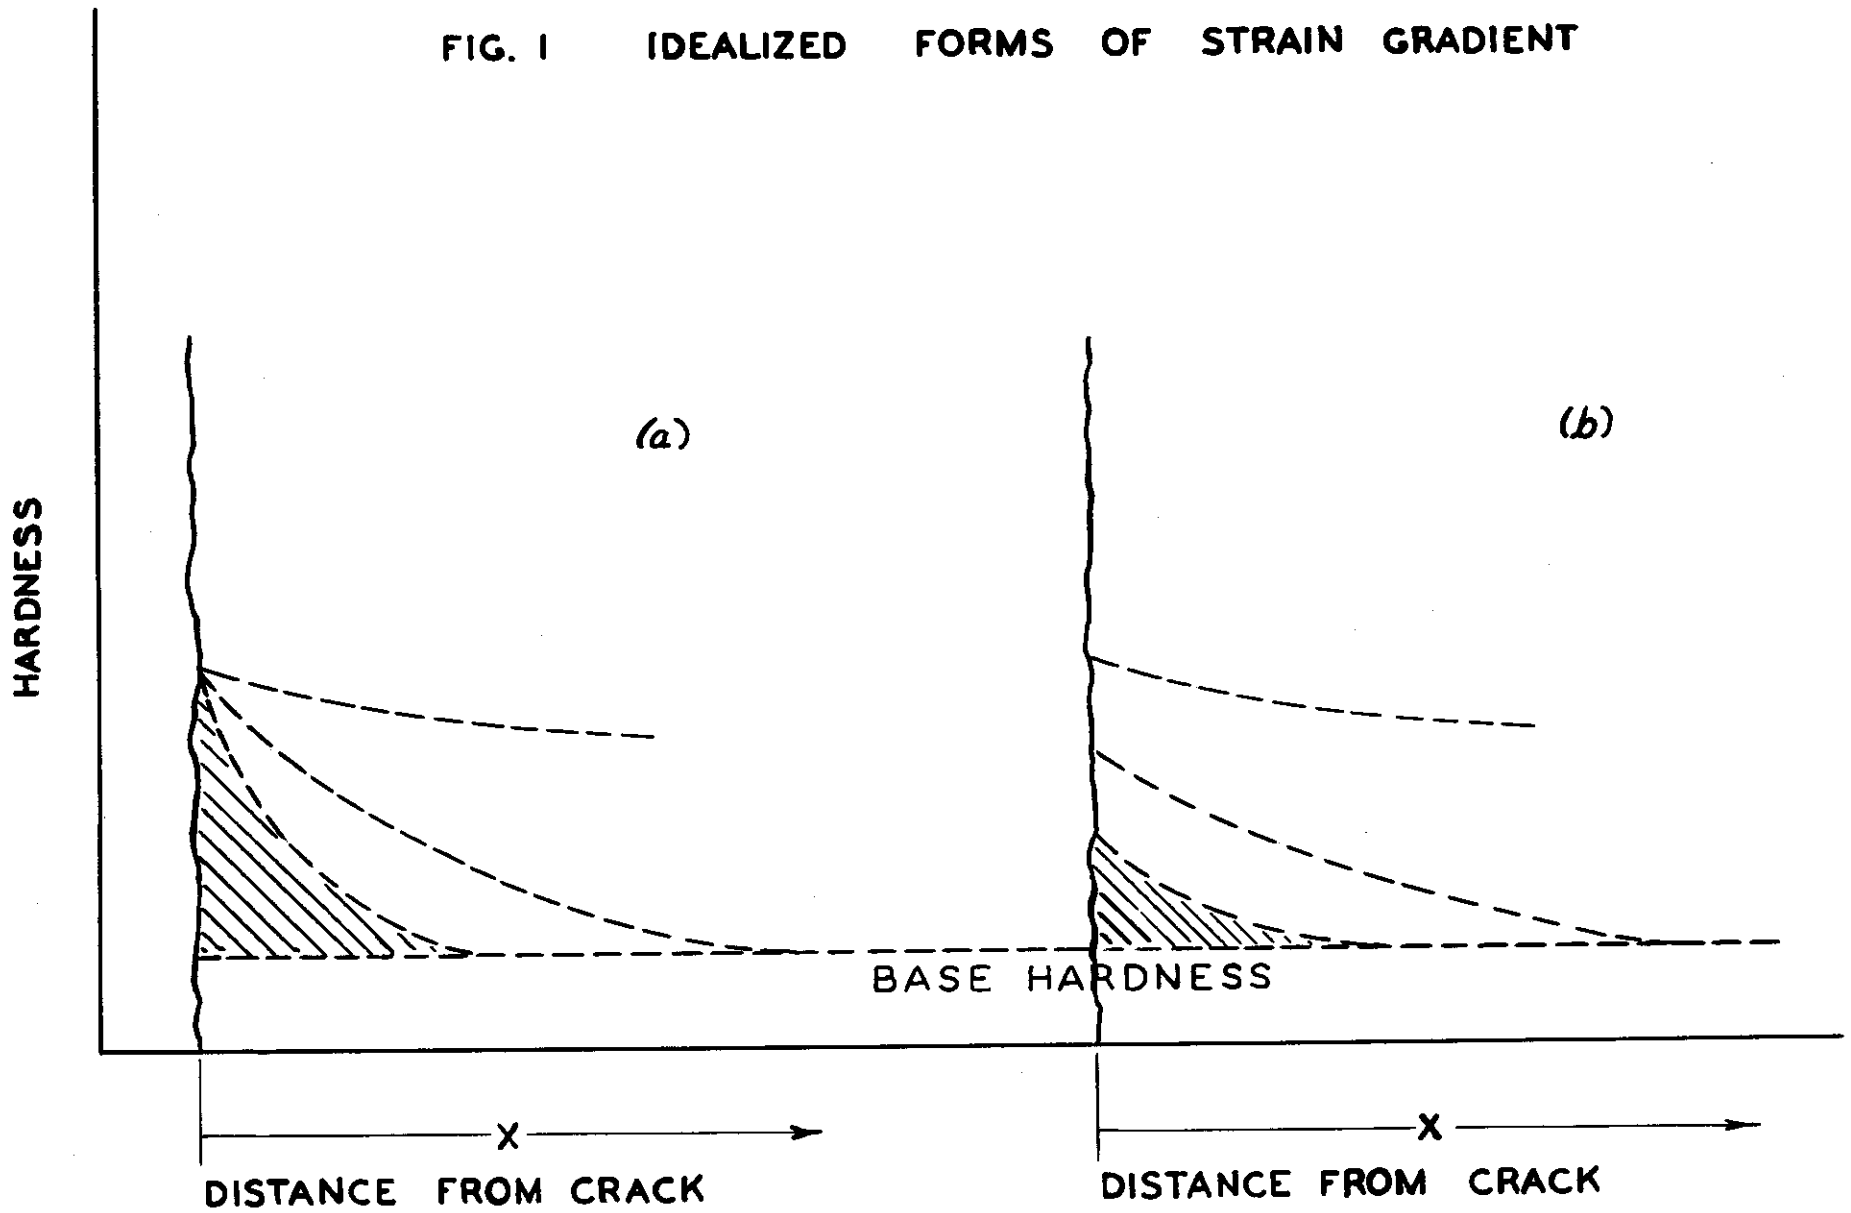
FIG. 1 IDEALIZED FORMS OF STRAIN GRADIENT

follows that brittle behavior, as contrasted with ductile behavior, must be associated with either (1) a smaller volume of strained metal or (2) lower strain intensity. Figure 1 schematically illustrates these two possible differences between ductile and brittle fractures.

In Figure 1(a), the strain intensity at the fracture surface is represented as being constant for all fractures, brittle and ductile. But the ductile fracture is represented by the gradual strain gradient, and will, therefore, be associated with a large volume of strained metal and consequently a large energy absorption; the brittle fracture is represented by the steep strain gradient and will, therefore, be associated with a small volume of strained metal and consequently a small energy absorption. Thus Figure 1(a) illustrates alternative (1) above. Alternative (2) is illustrated by Figure 1(b). Here, the strain intensity at the fracture surface is represented as being high for ductile fractures and low for brittle fractures. Since energy absorption increases with intensity of plastic strain, it follows that the fracture associated with high strain intensity will absorb a large amount of energy and will be ductile, while the fracture associated with the low strain intensity will not absorb much energy, and will be brittle.

fracture surface, the doublet is resolved as in pattern (a). This means that the strain, if it exists for the brittle fracture, was insufficient to be picked up by this X-ray diffraction technique. Since it is estimated that the X-ray procedure used will reveal a strain gradient of .0001 inch thickness, it is indicated that a strain gradient, if it exists adjacent to the brittle fracture surface, must be no thicker than 0.0001 inch. A gradient of this extent could, under no circumstances, lead to high energy absorption in its development. From this it follows that for practical purposes, the strain gradient construction presented in Figure 1b conforms with the experimental results.

The X-ray and metallographic data which have been presented argue against acceptance of the strain gradient type presented in Figure 1a. By elimination the strain gradient type presented in Figure 1b appears to describe the conditions at the fracture surface.

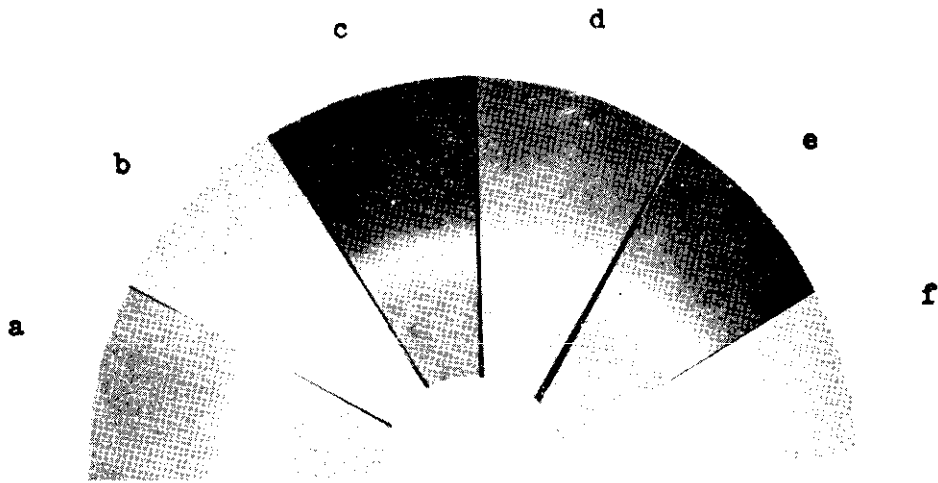
Fig. 2 - X-ray Patterns Steel A

The X-ray data are presented in Figure 2. Pattern (a) is for the virgin metal. The point of interest is the resolved doublet leading to two lines on the pattern (α_1 and α_2). These lines are typical and are used as reference lines. Patterns (b), (c), (d), and (e) were taken on ductile fracture surfaces. From the lack of resolution of the doublet it may be stated that extensive strain exists at the fracture surface. Finally in pattern (f), taken on a brittle

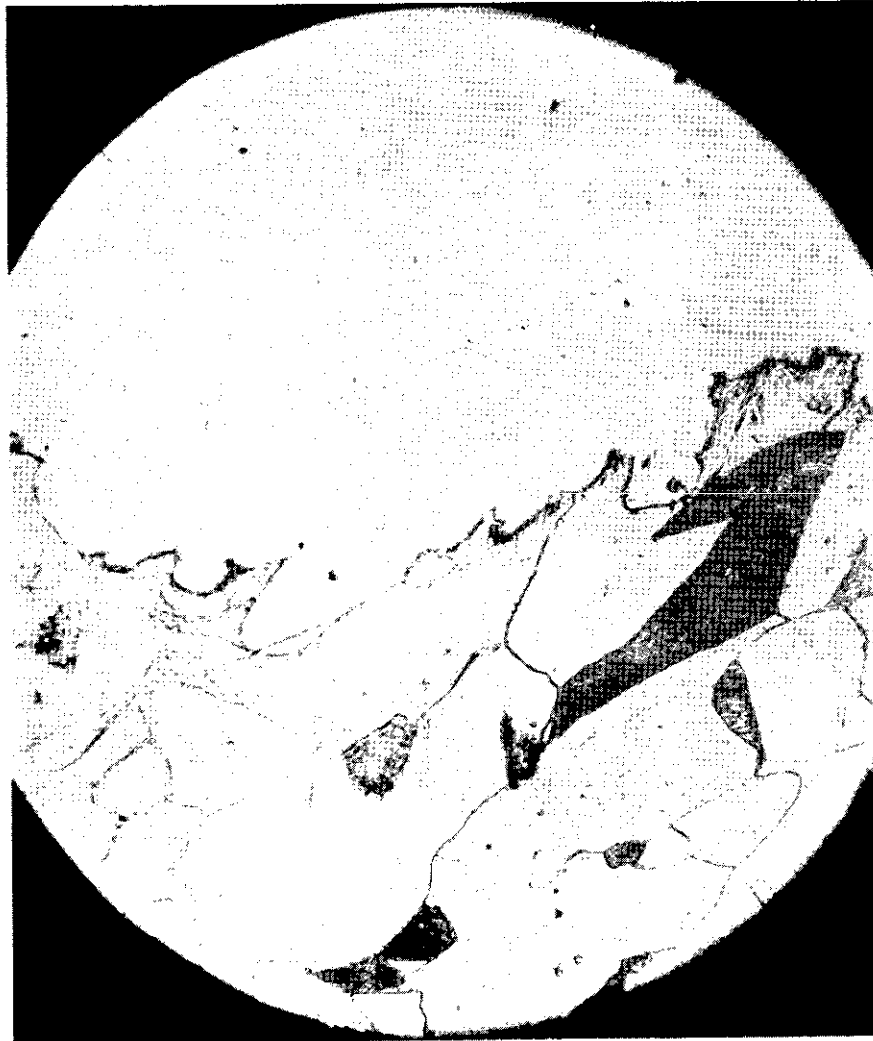
Fig. 3 - The Fracture Midway Through the Specimen Steel Dr.
This is a fully ductile specimen. (Cf. Fig. 26 & 27)
Nital Etch x 600.

Additional information in terms of metallographic data pertain to this point. Thus, in Figure 3, the fracture surface is typical of a ductile failure. The metallographic structure shows a highly torn and deformed zone at the fracture edge. This zone appears to be of the order of .01 inch thick. This region rapidly passes into a zone of much lower plastic strain, a zone, however, in which plastic strain is still appreciable, as indicated by the distorted grains. In Figure 4 the fracture presented is a brittle fracture. There is no evidence of plastic strain accompanying this fracture. The metallographic data, therefore, are in full agreement with the X-ray data for the consideration of the "ideal" brittle and ductile types of failure. Additional data concerning the metallography of what might be considered intermediate types of failure are presented in subsequent sections.

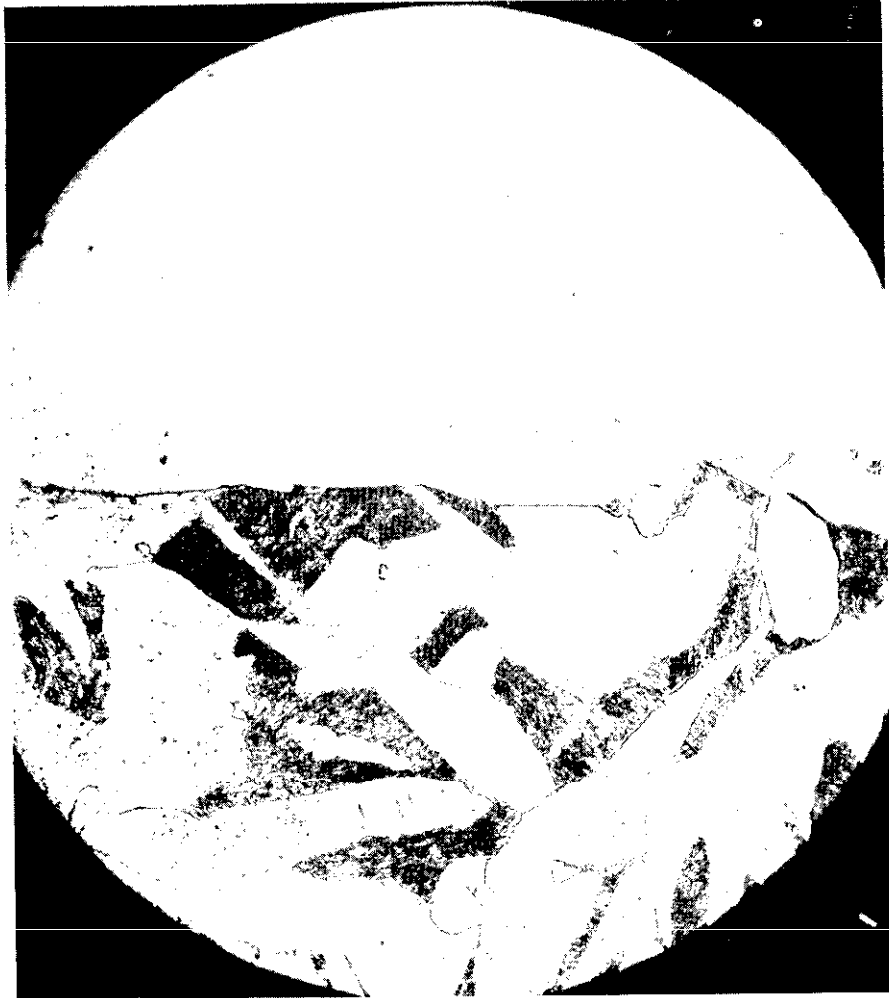
Fig. 4 - The Fracture Midway Through the Specimen Steel C.
This is a fully brittle specimen. (Cf. Fig. 5 & 6)
Nital Etch x 600.

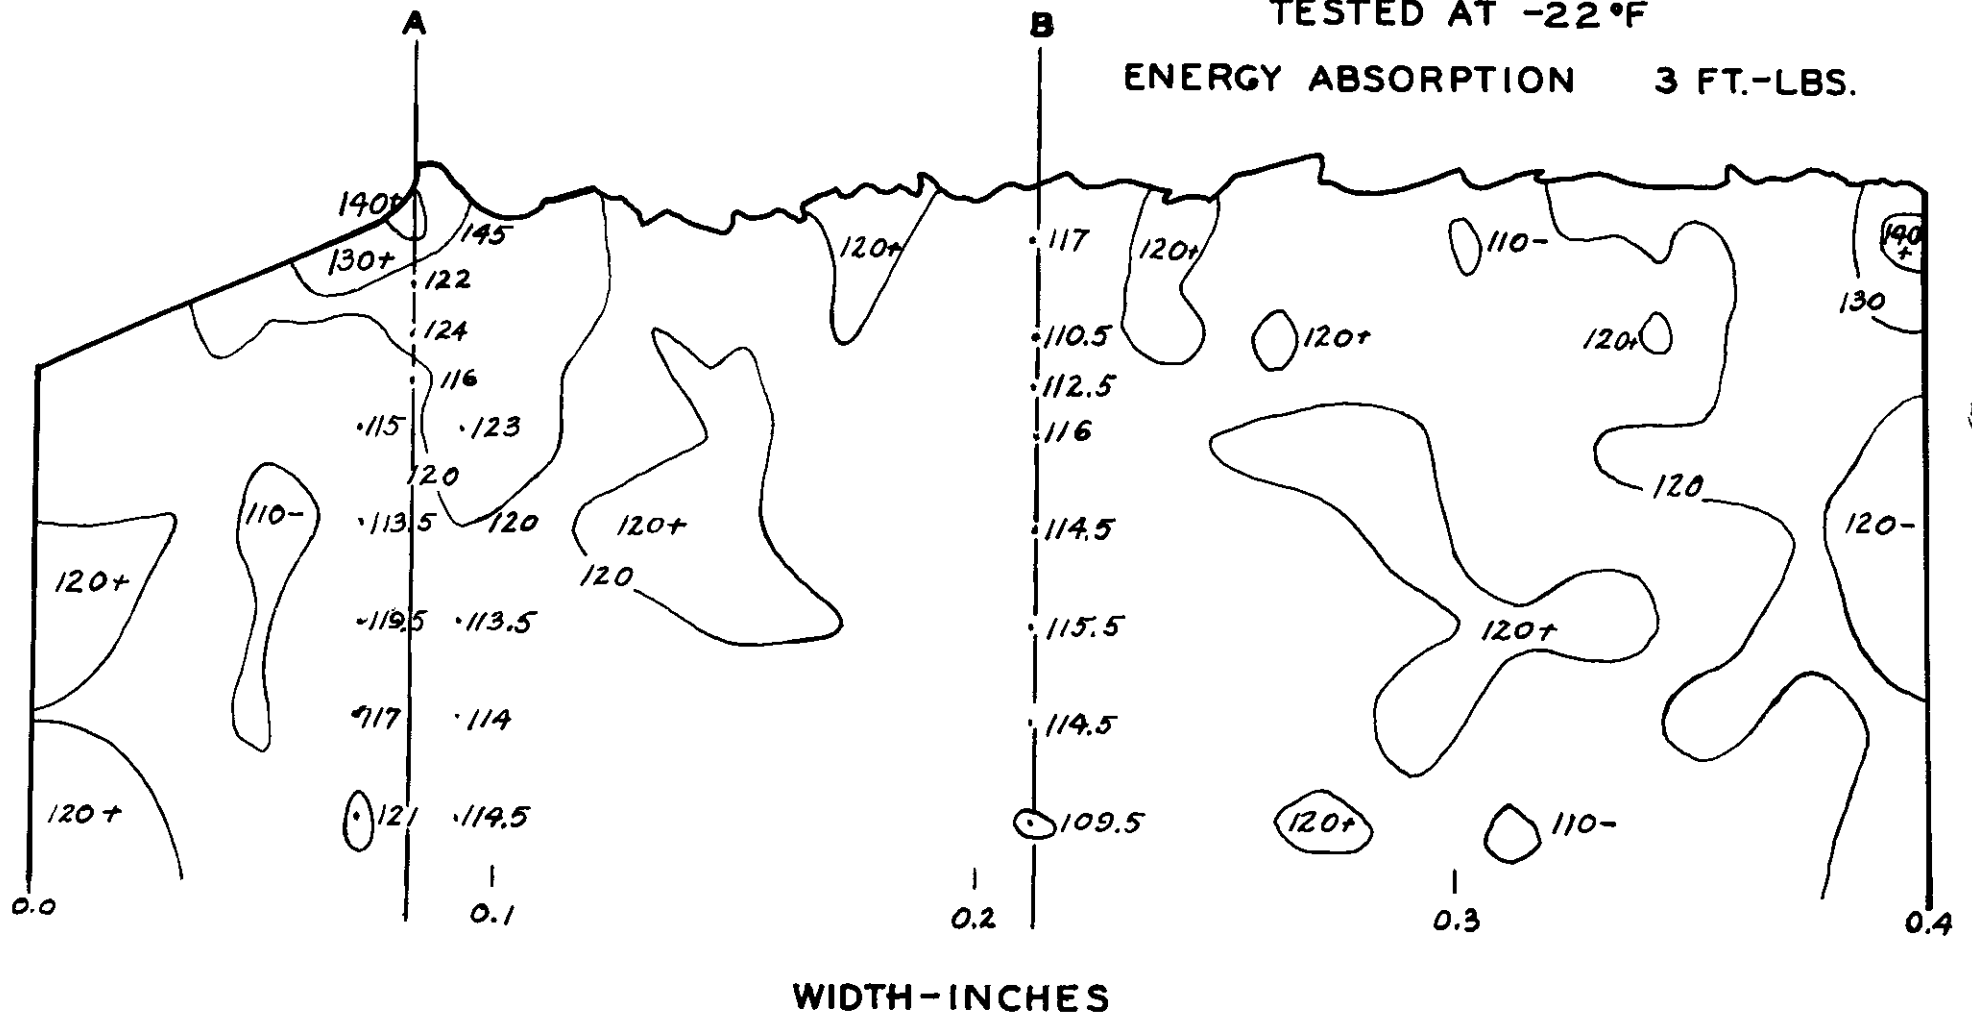
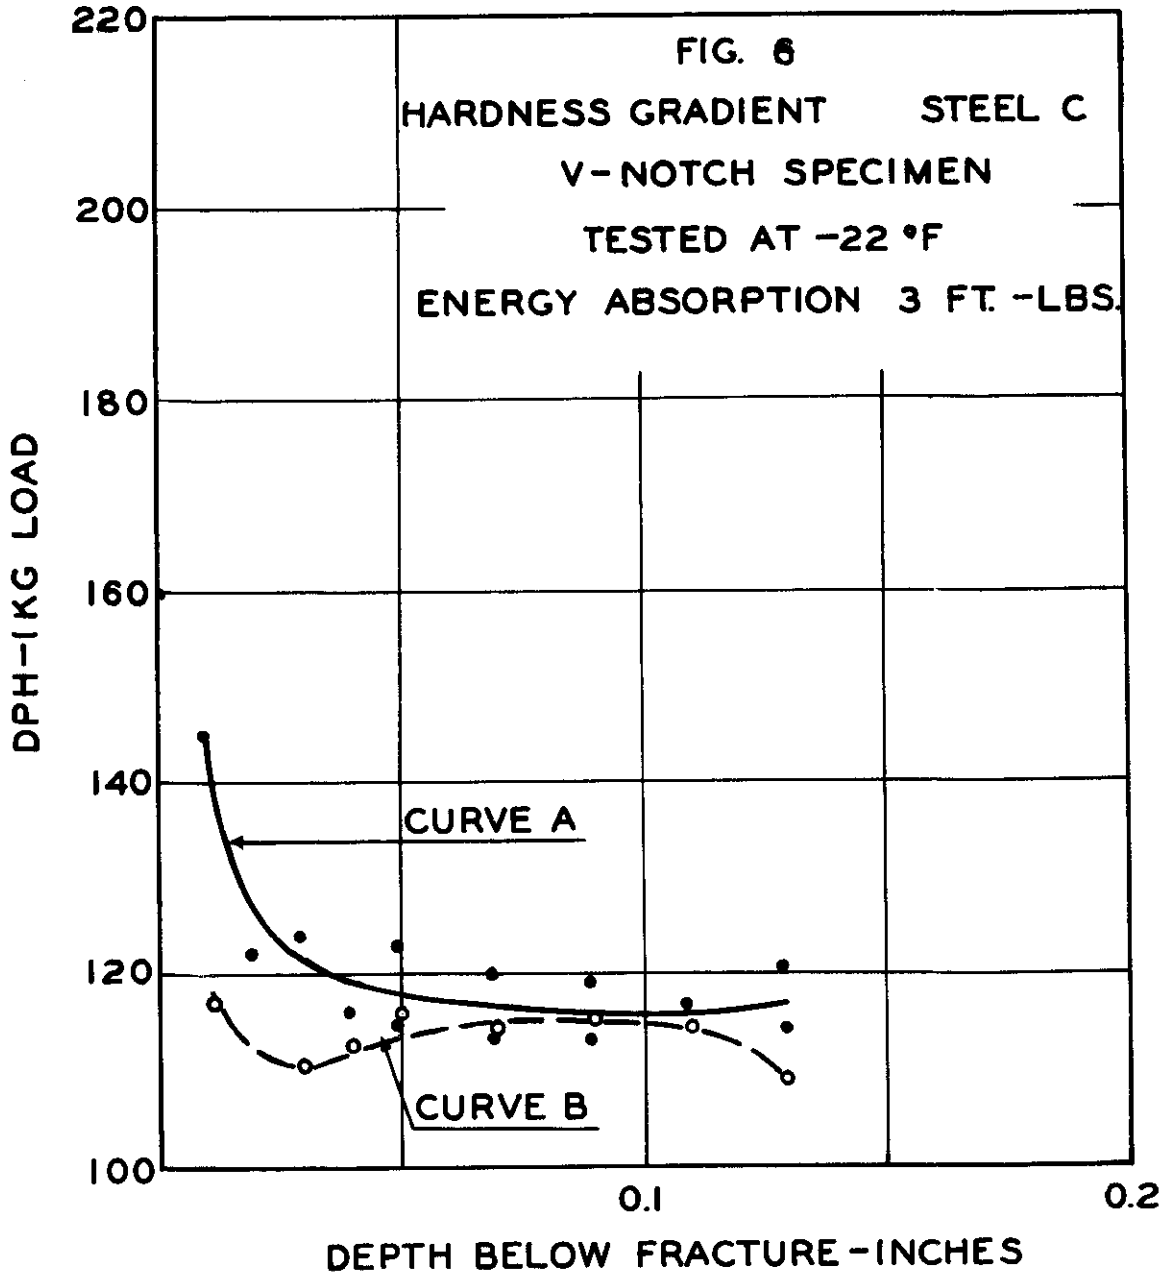
FIG. 5
 DPH CONTOURS STEEL C
 V-NOTCH SPECIMEN
 TESTED AT -22°F
 ENERGY ABSORPTION 3 FT.-LBS.

Group 1 - Low Energy Absorption, (<7 ft. lbs.) Figures 5,6,7, and 8. The specimen of steel C (Figures 5 and 6) with an energy absorption of 3 ft. lbs. would be considered "100% granular" by conventional usage. The hardness contour indicates very slight strains at the notch and under the tup, but the crack itself was not accompanied by strain which was discernible by the hardness measuring technique used. These same remarks apply to the specimen of steel E (Figures 7 and 8), with the exceptions that this fracture showed slightly more shear under the tup and greater strain at this location. Photomicrographs of this specimen (Figures 9, 10, and 11) are in agreement with the hardness data. It is evident that the crack in this specimen was completed before the major part of the straining occurred. This follows from the fact that it would not be possible to strain an uncracked specimen at the tup without causing a corresponding strain at the notch. Hence, most of the strain at the tup must have resulted from bending of the specimen after completion of the brittle portion of the crack.

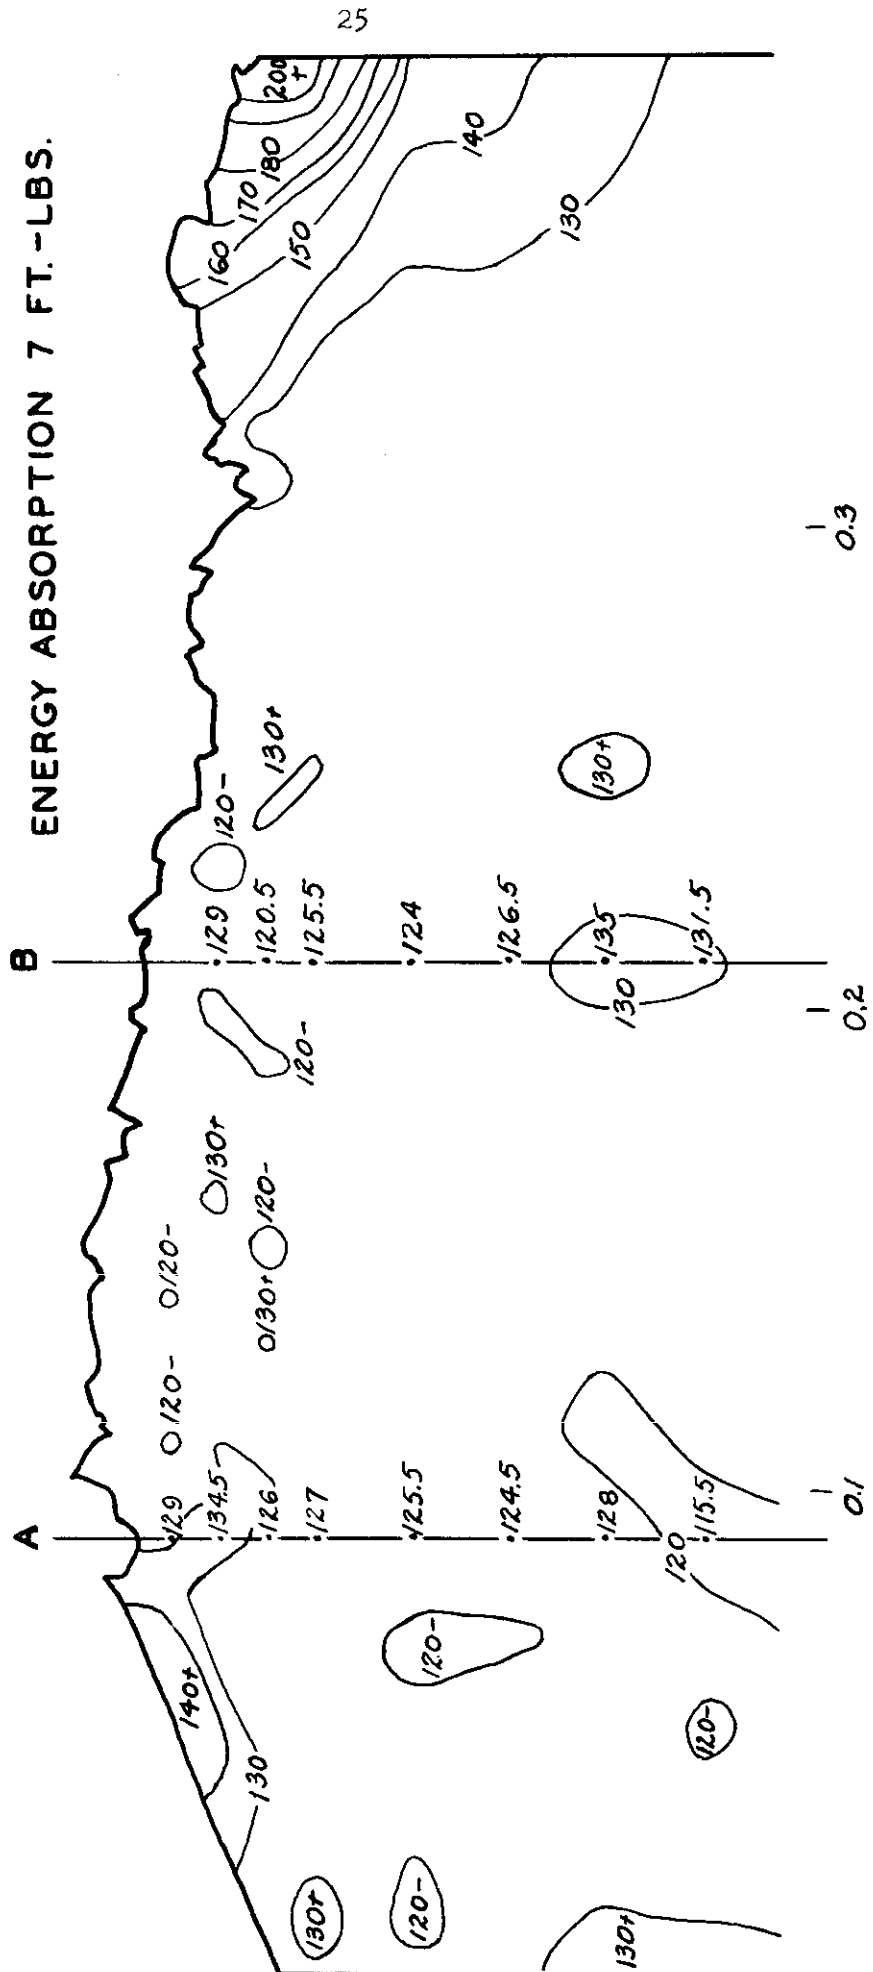
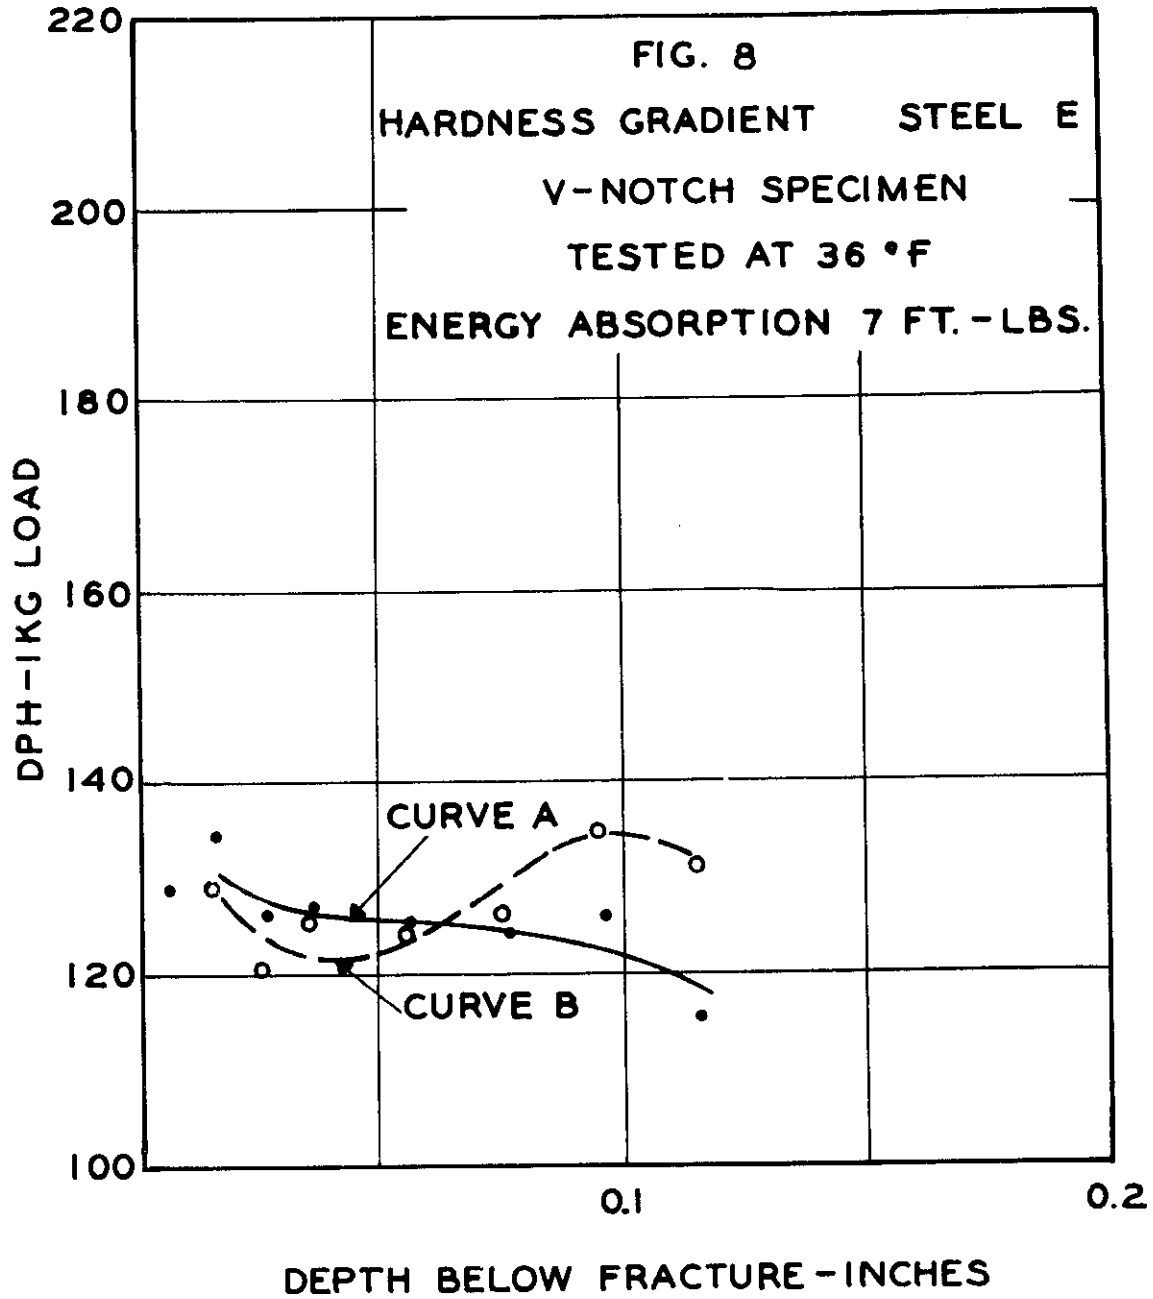
FIG. 7

DPH CONTOURS STEEL E

TESTED AT 36 °F

ENERGY ABSORPTION 7 FT.-LBS.

bar and at the back of the bar, of a "brittle" specimen (steel E, 36⁰E). The strain gradients of this specimen are represented by Figures 7 and 8. It can be seen that the hardness data and microstructures are in agreement, with the exception that microstructure (Figure 9) shows evidence of considerable plastic strain in a very restricted zone at the base of the notch, which strain is not evident in the hardness contour (Figure 7). This "disagreement" unquestionably reflects the greater sensitivity of metallographic examination, as compared with the hardness tests, and strongly suggests that the strain gradients at ductile fractures are actually much steeper and reach much higher strain values very near (< 0.01 ") to the crack surface than is indicated by the hardness contours. Figure 10 clearly demonstrates the total lack of any metallographic manifestations of strain at a clean cleavage separation.

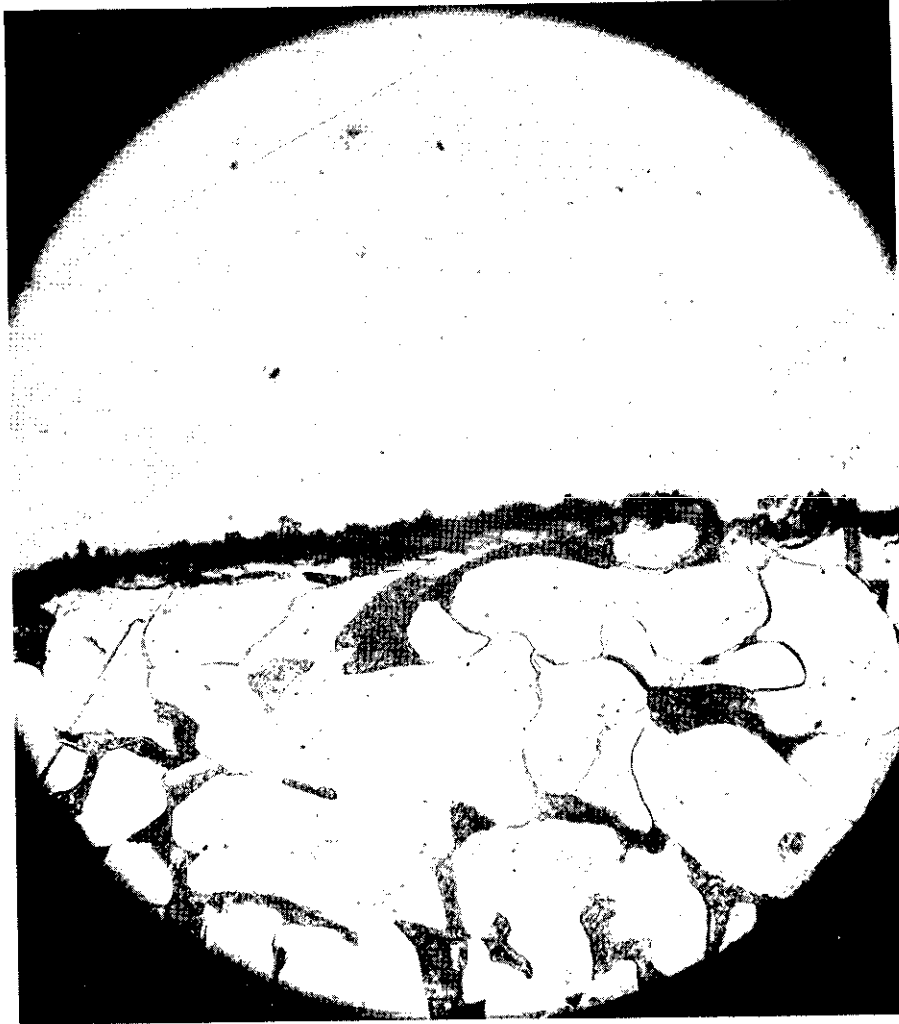
Fig. 9 - The Character of the Fracture at the Base of the Notch Steel E. (Cf. Fig. 7 & 8). Nital Etch x 600.

Figures 9, 10, and 11, respectively, illustrate the microstructures of sections which intersect the crack at the base of the notch, midway through the

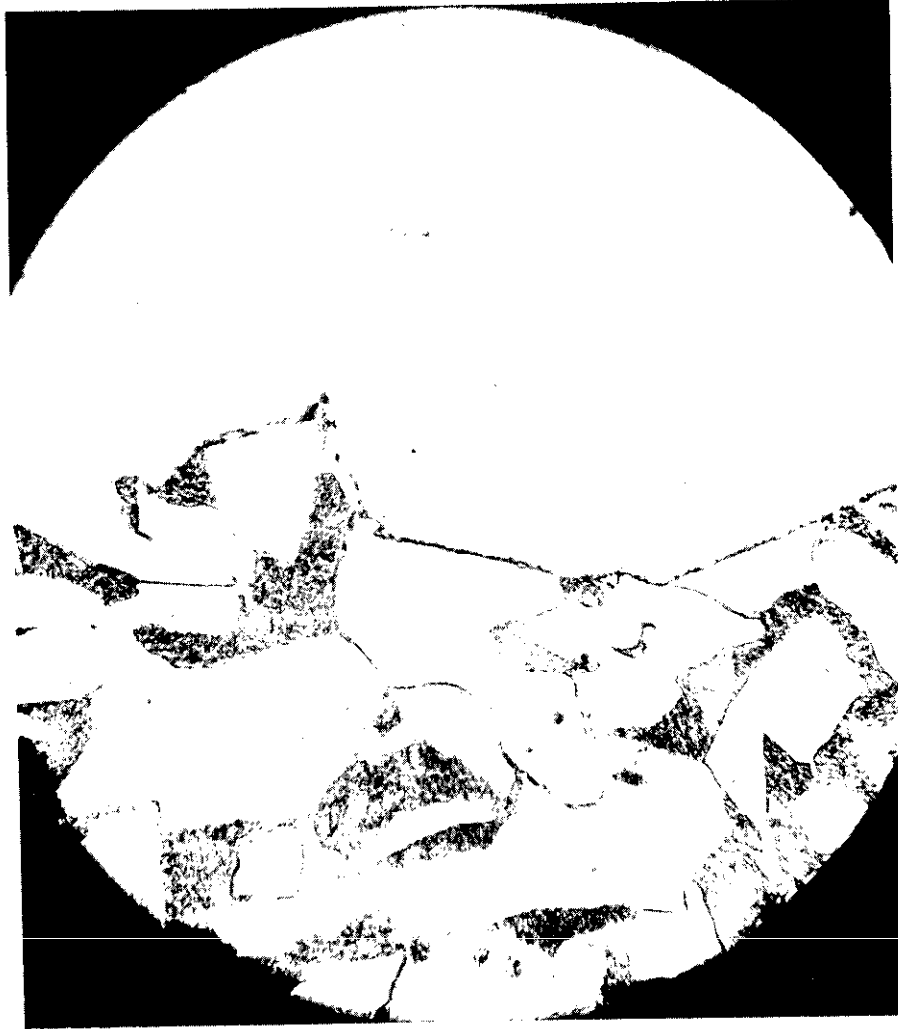
Fig, 10 - The Fracture Midway Through the Specimen Steel E.
(Cf. Fig. 7 & 8). Nital Etch x 600.

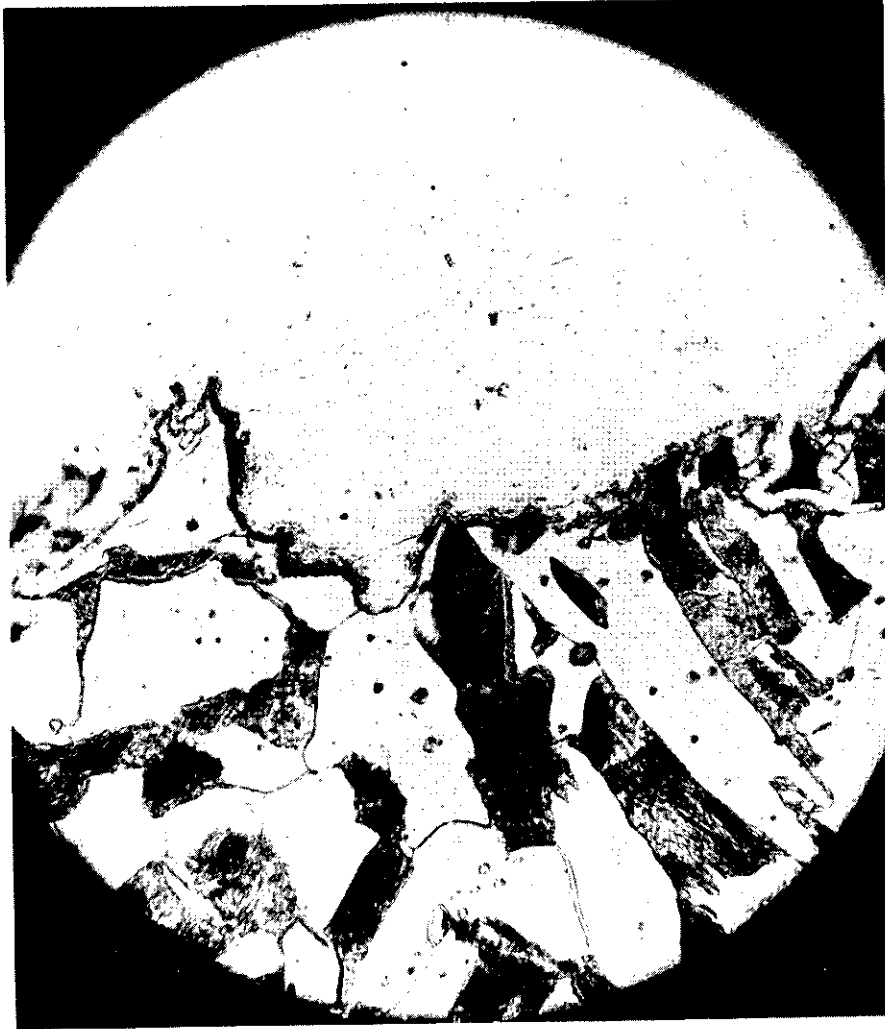
Fig. 11 - The Fracture at the back of the Specimen Steel E.
(Cf. Fig. 7 & 8). Nital Etch x 600.

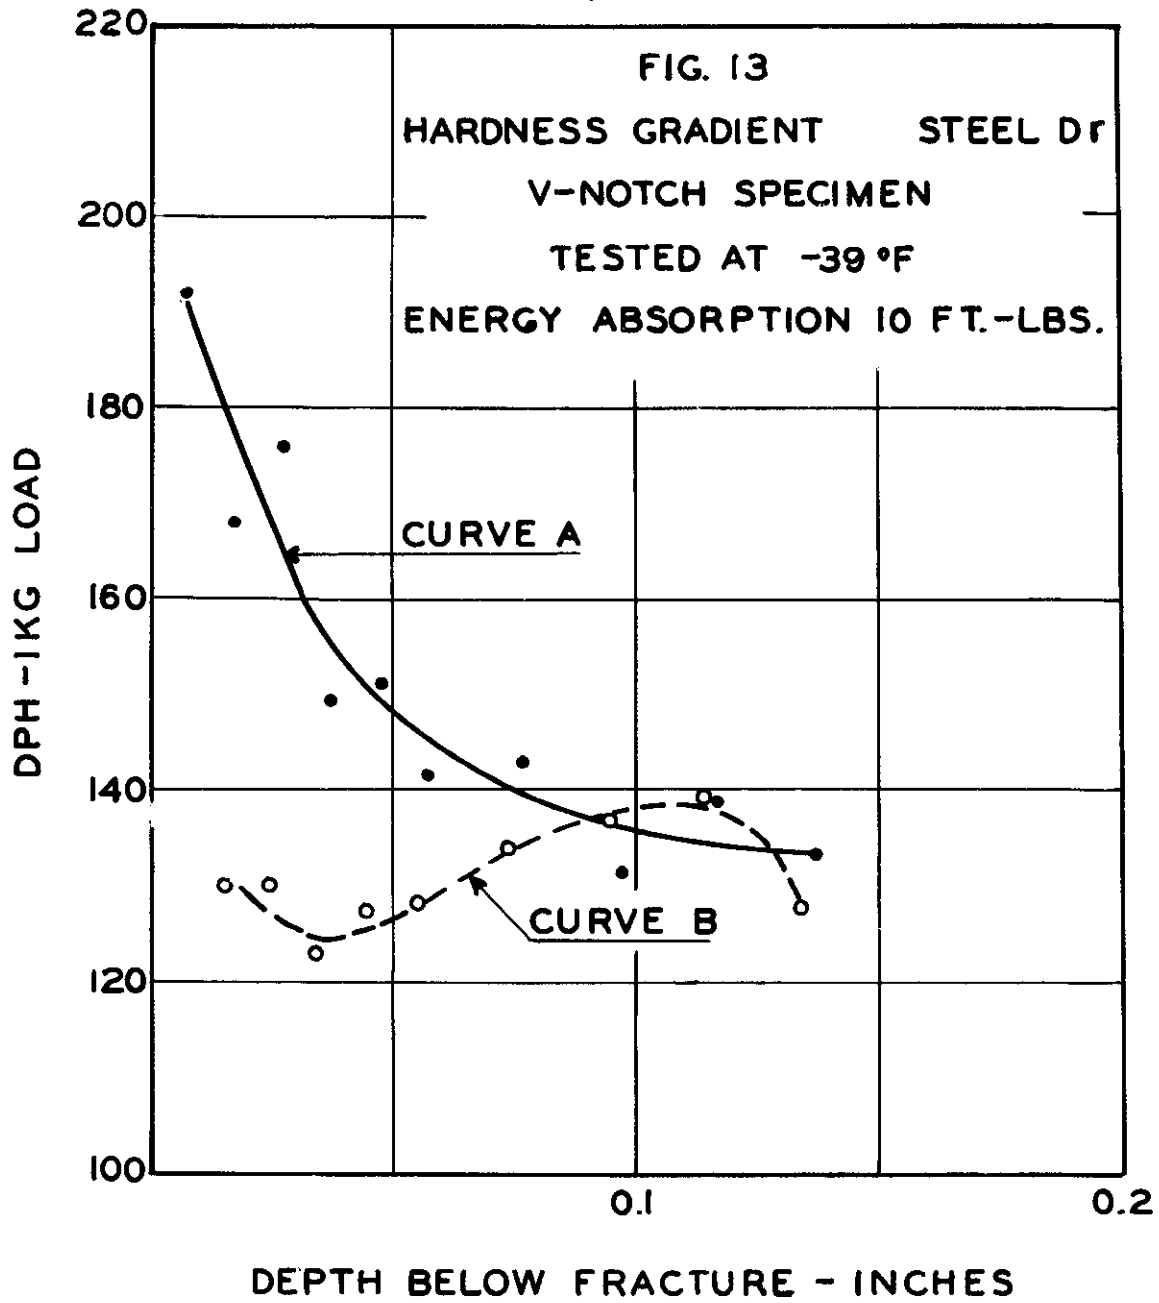
FIG. 12
 DPH CONTOURS STEEL Dr
 V-NOTCH SPECIMEN
 TESTED AT -39°F
 ENERGY ABSORPTION TO FT.-LBS.

Group 2 - Medium Low Energy Absorption (10-16 ft. lbs.) Figures 12-17. The hardness contours of this group are similar to those of group 1 with the exception the strain at the notch and the tup is greater, and consequently the length of the brittle crack through unstrained metal is shorter. The same analysis of straining prior to, and after, formation of the brittle crack applies. Notice that the brittle portion of the crack is still not accompanied by a macroscopic strain gradient.

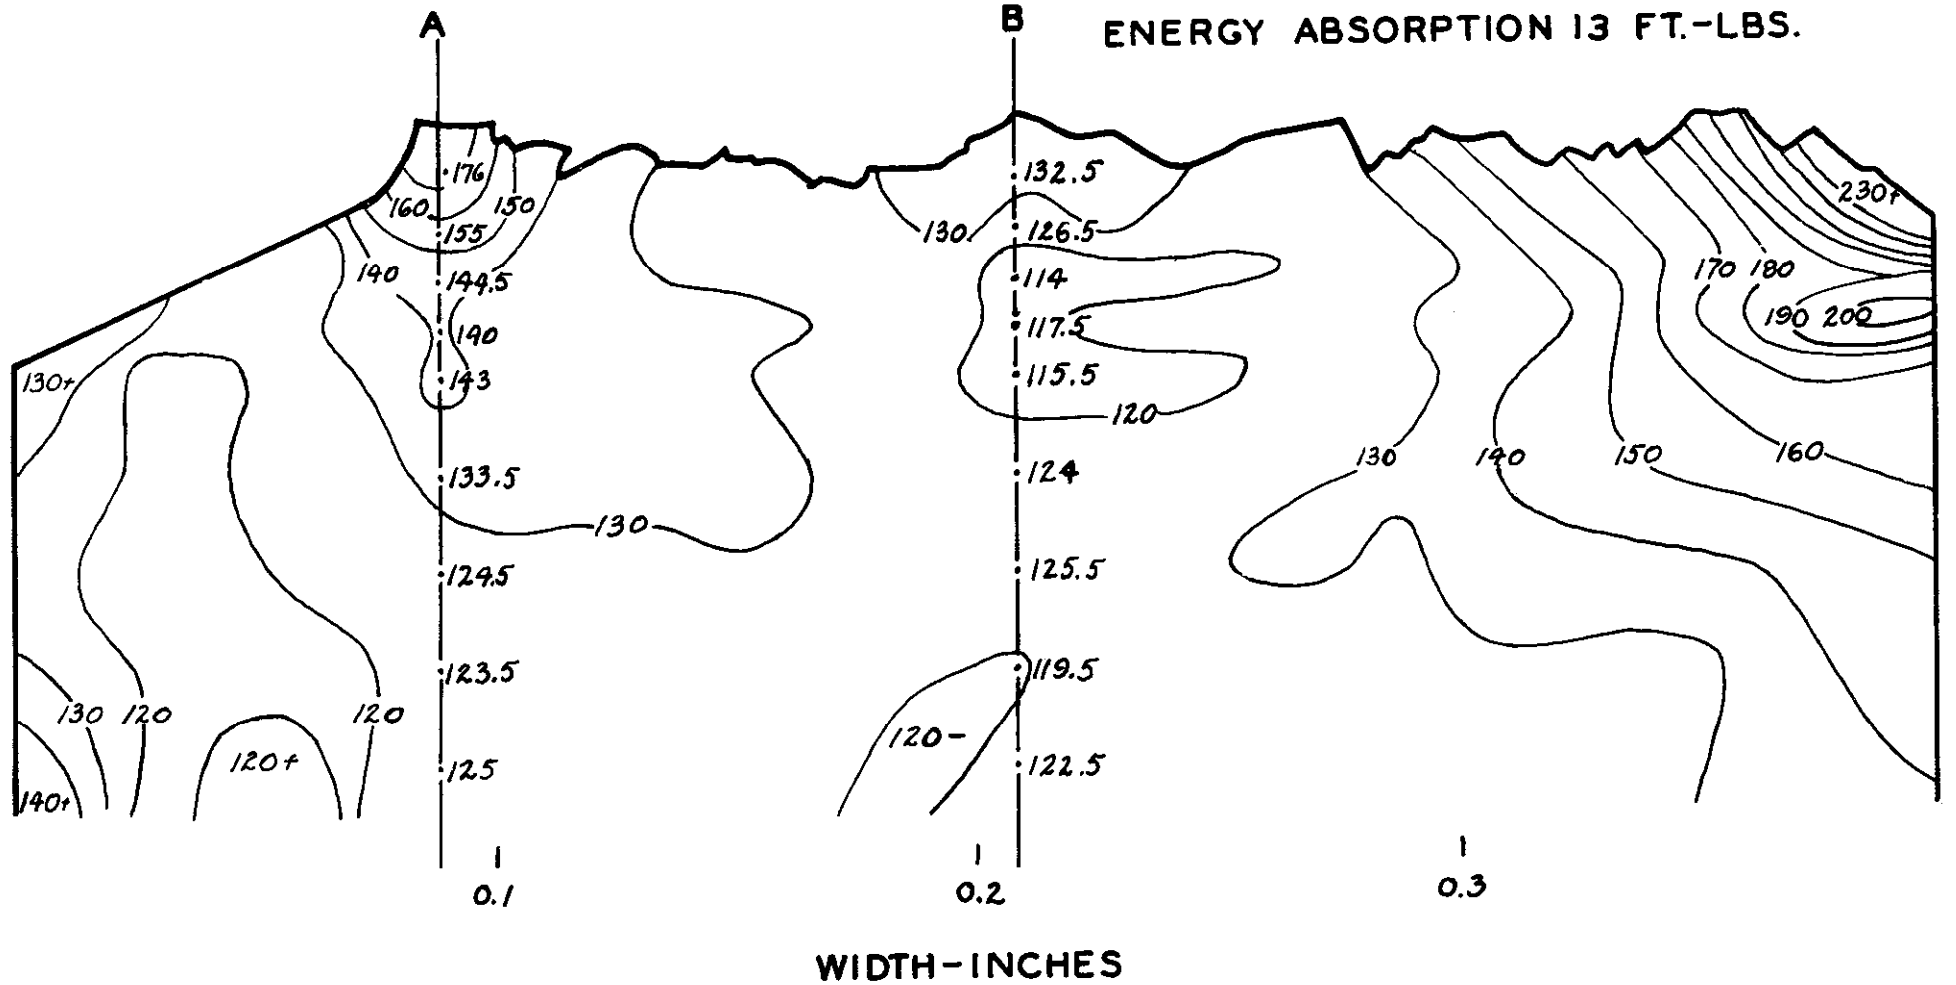
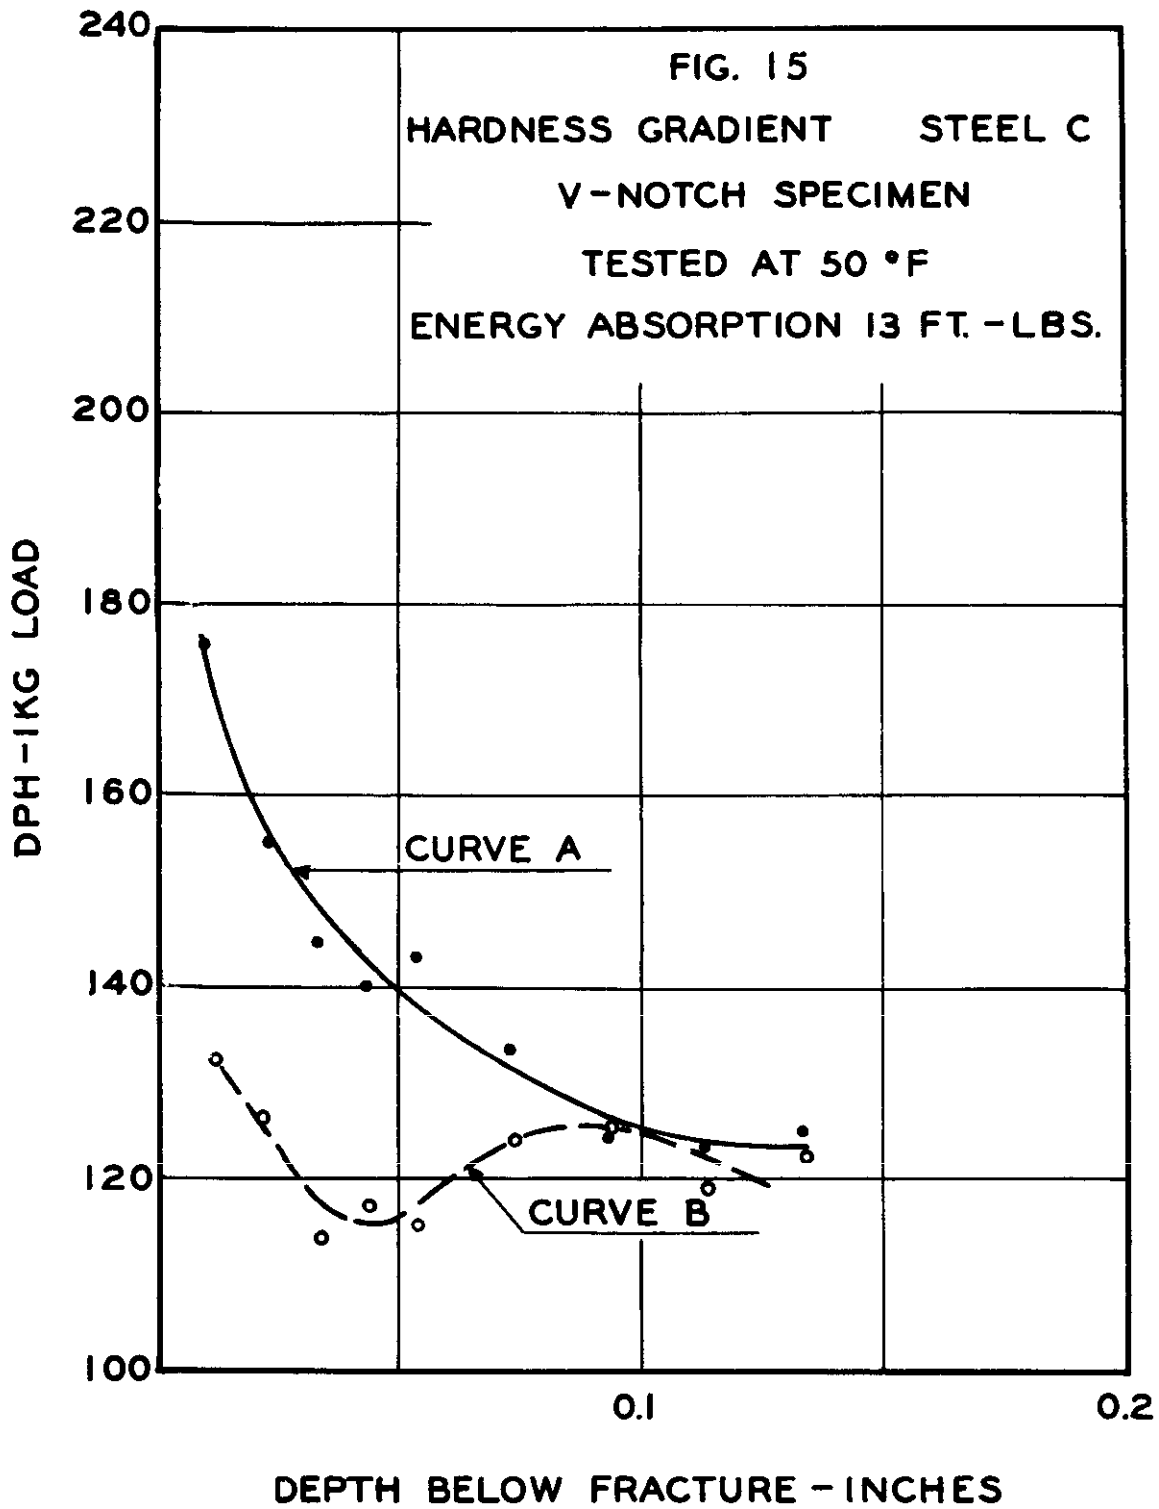
FIG. 14
 DPH CONTOURS STEEL C
 V-NOTCH SPECIMEN
 TESTED AT 50 °F
 ENERGY ABSORPTION 13 FT.-LBS.
