**CORRELATION OF LABORATORY TESTS WITH
FULL SCALE SHIP PLATE FRACTURE TESTS:
A STUDY OF STRAIN GRADIENTS**

**E. P. KLIER, F. C. WAGNER, J. L. FISHER
and M. GENSAMER**

**Pennsylvania State College
Under Bureau of Ships Contract NObs-31217**

SERIAL NO. SSC-17

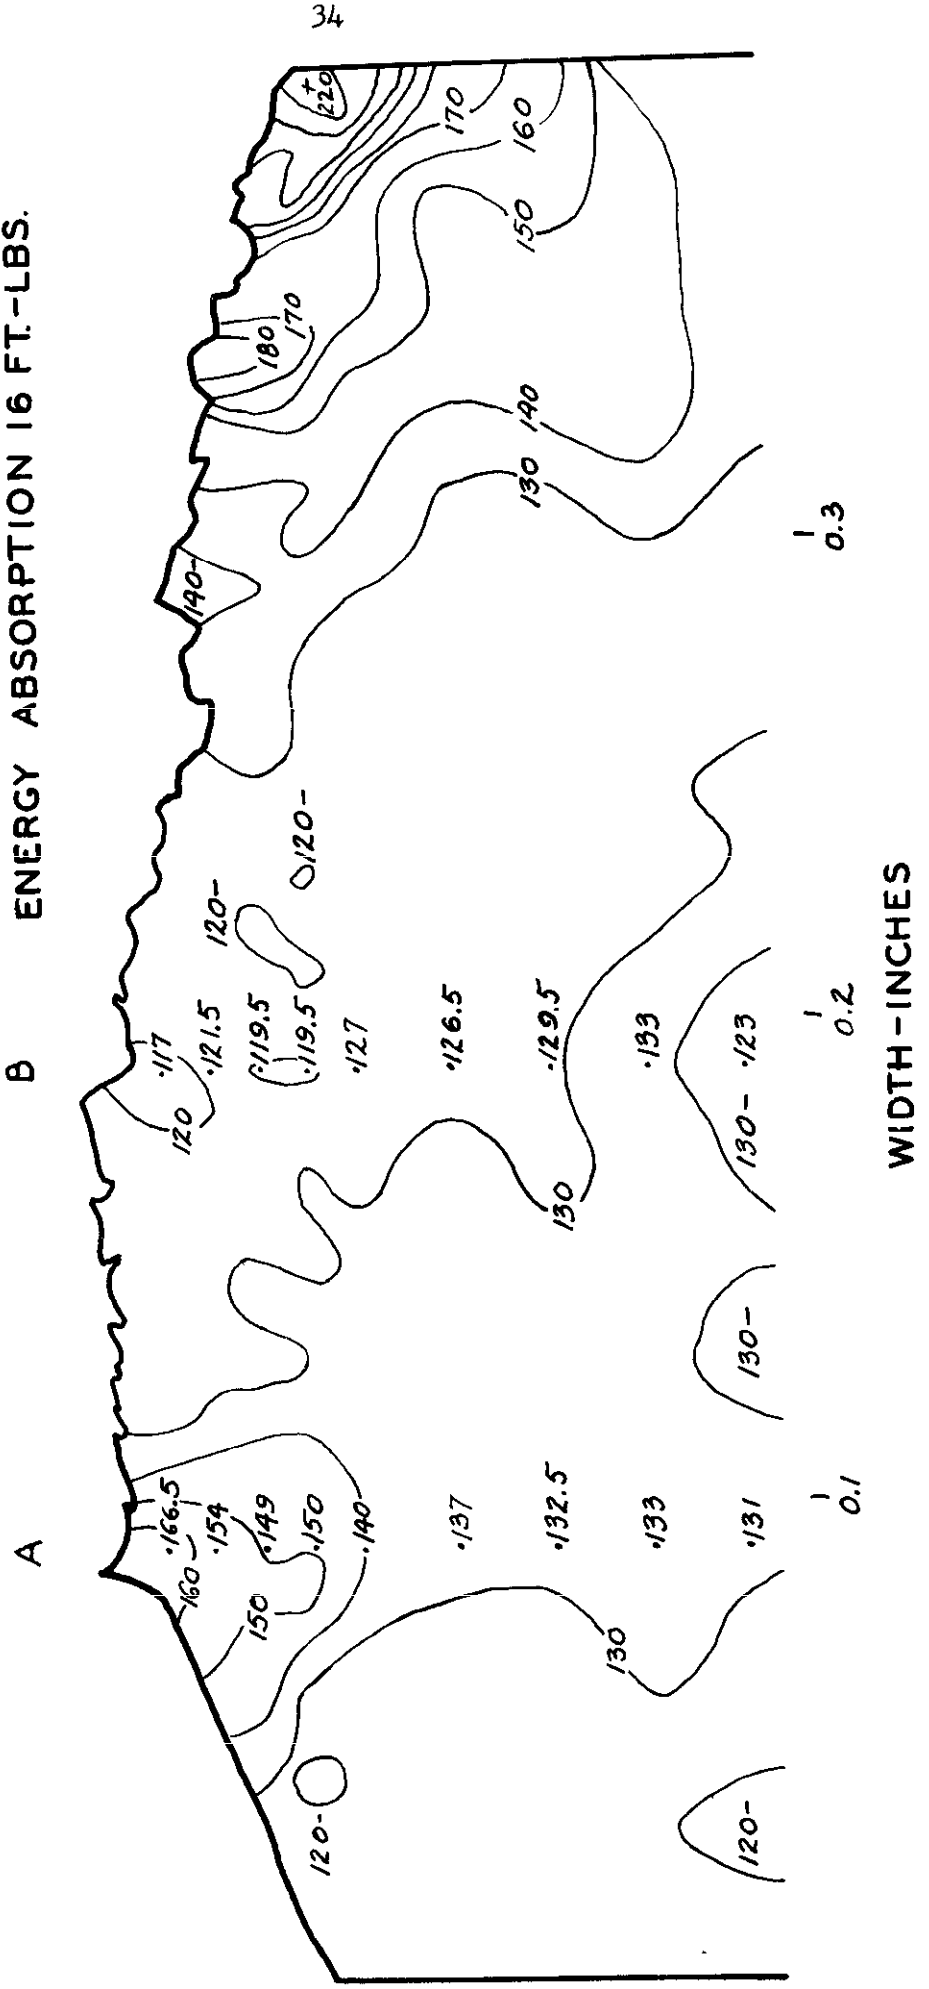
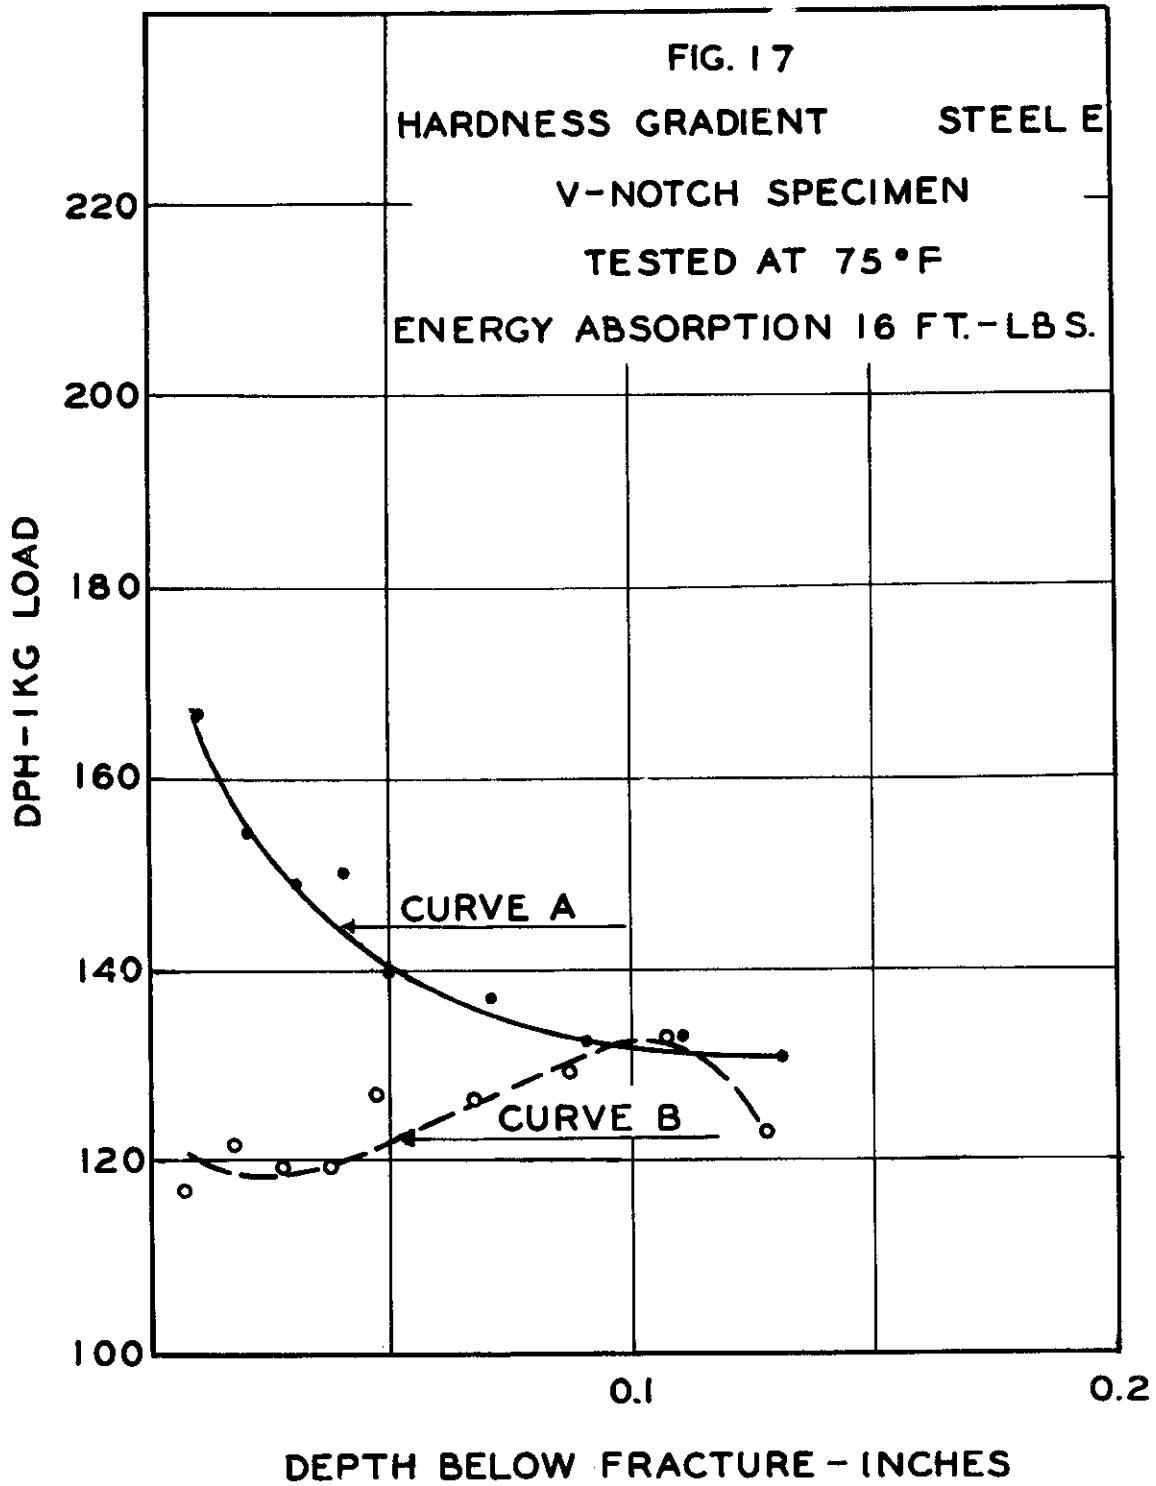
FIG. 16
 DPH CONTOURS STEEL E
 V-NOTCH SPECIMEN
 TESTED AT 75 °F
 ENERGY ABSORPTION 16 FT.-LBS.

Group 2 - Medium Low Energy Absorption (10-16 ft. lbs.) Figures 12-17. The hardness contours of this group are similar to those of group 1 with the exception the strain at the notch and the tup is greater, and consequently the length of the brittle crack through unstrained metal is shorter. The same analysis of straining prior to, and after, formation of the brittle crack applies. Notice that the brittle portion of the crack is still not accompanied by a macroscopic strain gradient.

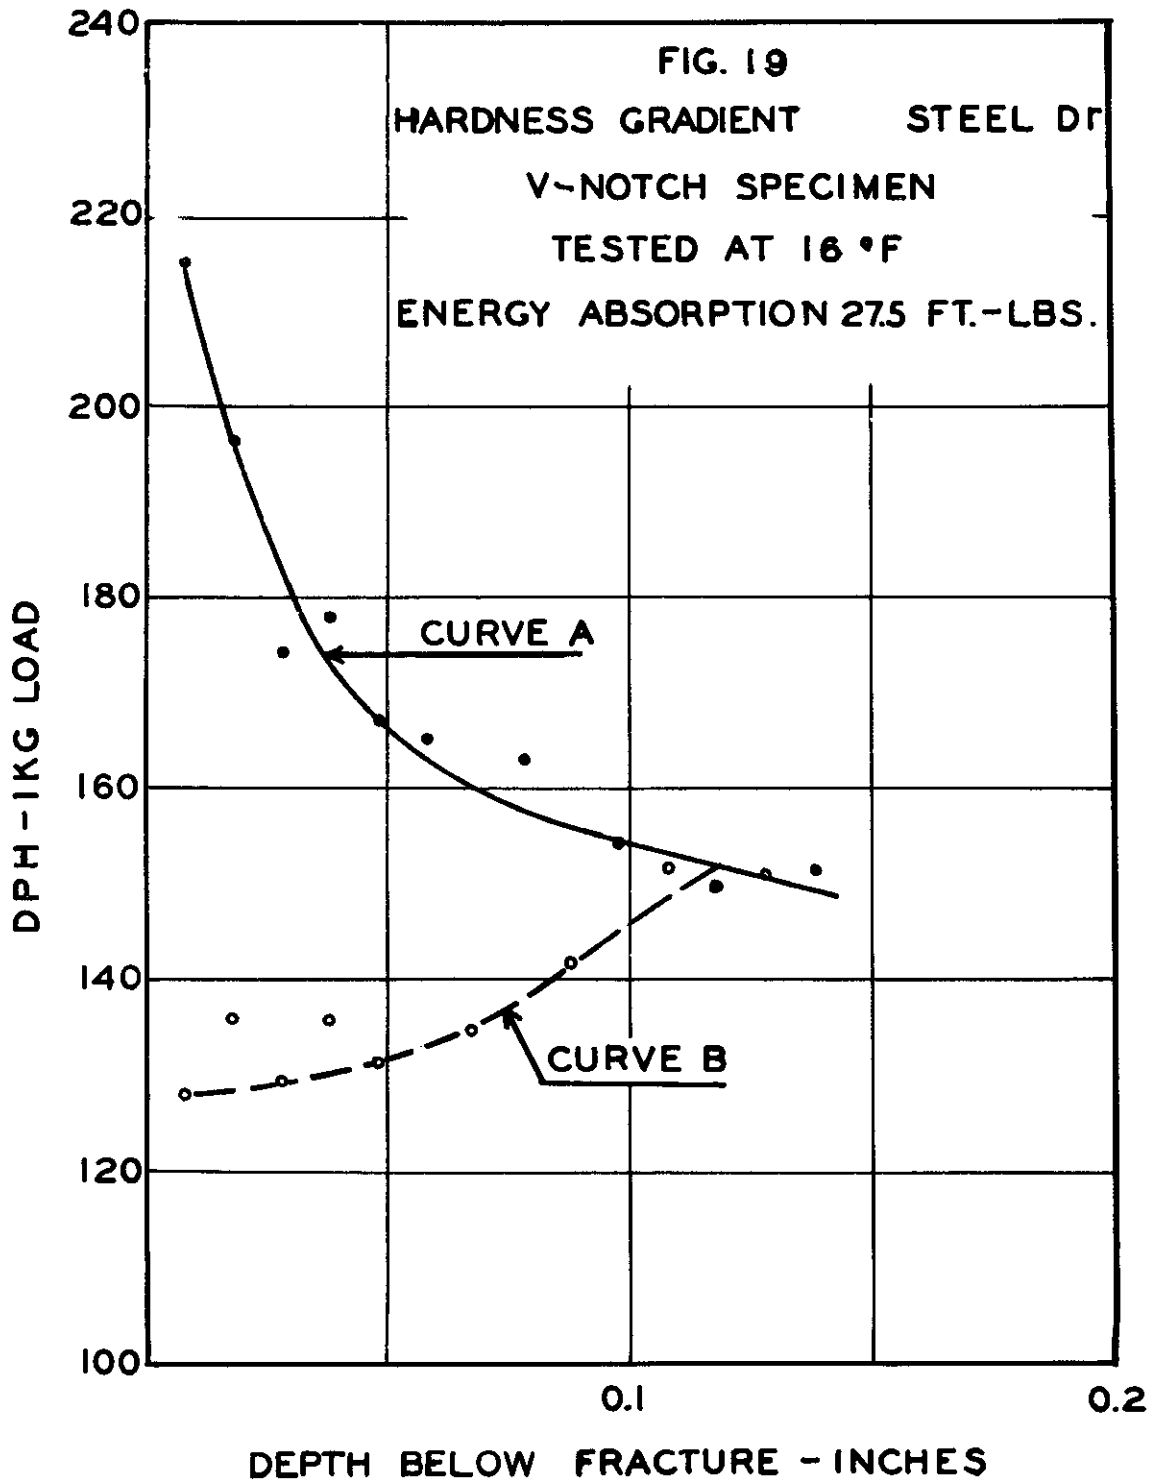
FIG. 18
 DPH CONTOURS STEEL DR
 V-NOTCH SPECIMEN
 TESTED AT 16 °F
 ENERGY ABSORPTION 27.5 FT.-LBS.

Group 3 - Medium High Energy Absorption (27.5 - 54.0 ft. lbs.) Figures 18-25. The hardness contours of this group are similar to those of groups 1 and 2 with the exceptions that the zones of strain at the notch and the tup are still greater and are extended sufficiently, at 45° to the specimen axis, to contact each other beneath the crack. (e.g. Figure 18). There still exist regions of brittle fracture, however, showing no macroscopic strain gradient, with the possible exceptions of curves B in Figures 16 and 23. These slight strain gradients likely result from the appreciable bending which occurred prior to the formation of the crack rather than from a mechanism accompanying the brittle crack. Note the marked rise of the B curves, which obviously reflects the extension of the strained zones at the notch and tup.

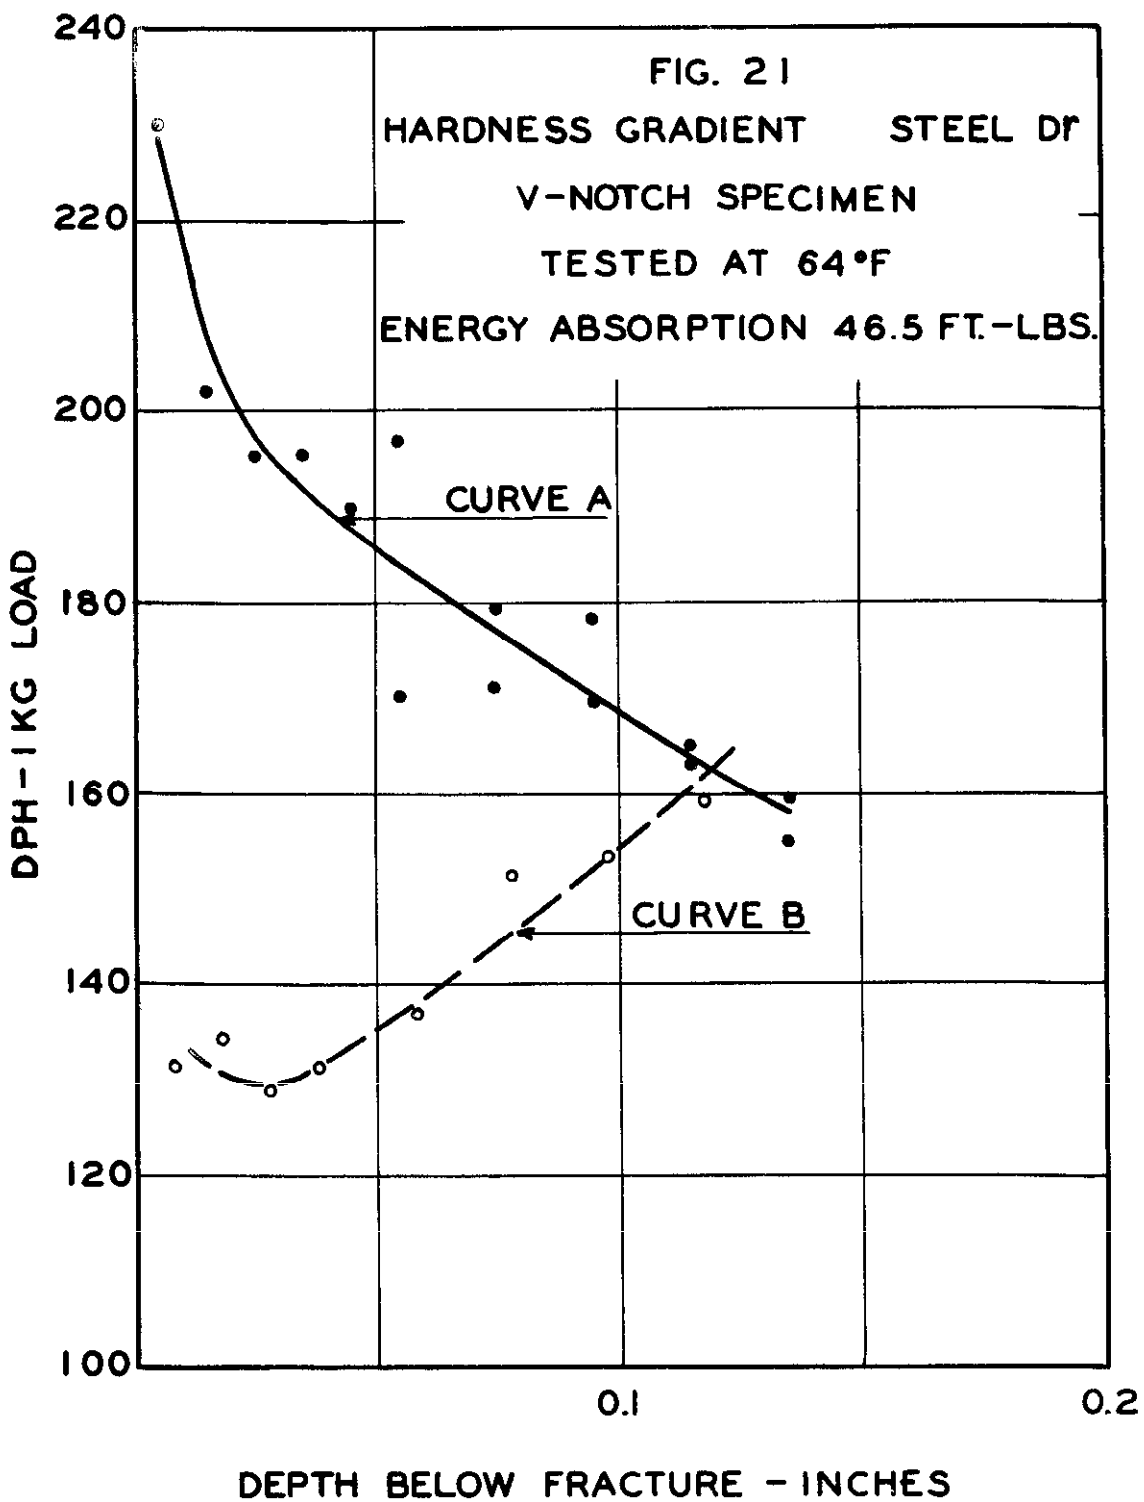
FIG. 20

DPH CONTOURS
STEEL DF
V-NOTCH SPECIMEN

TESTED AT 64°F
ENERGY ABSORPTION 46.5 FT.-LBS.

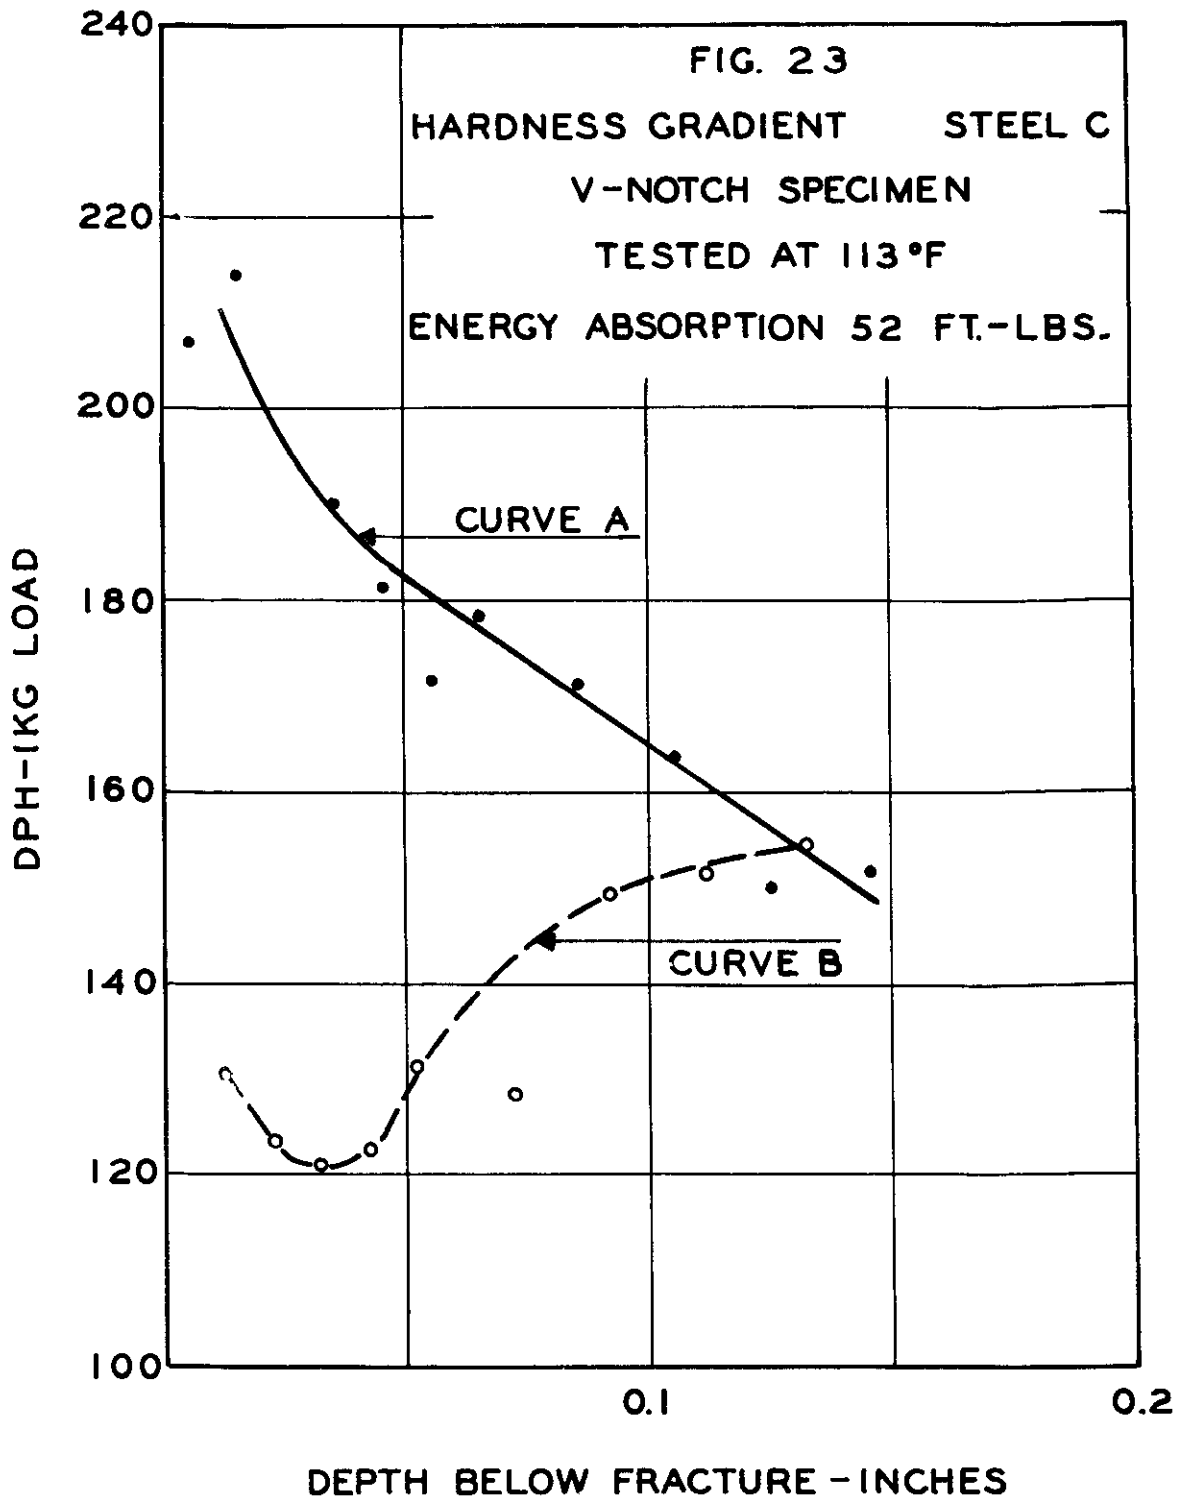
FIG. 22
 DPH CONTOURS STEEL C
 V-NOTCH SPECIMEN
 TESTED AT 113 °F
 ENERGY ABSORPTION 52 FT.-LBS.

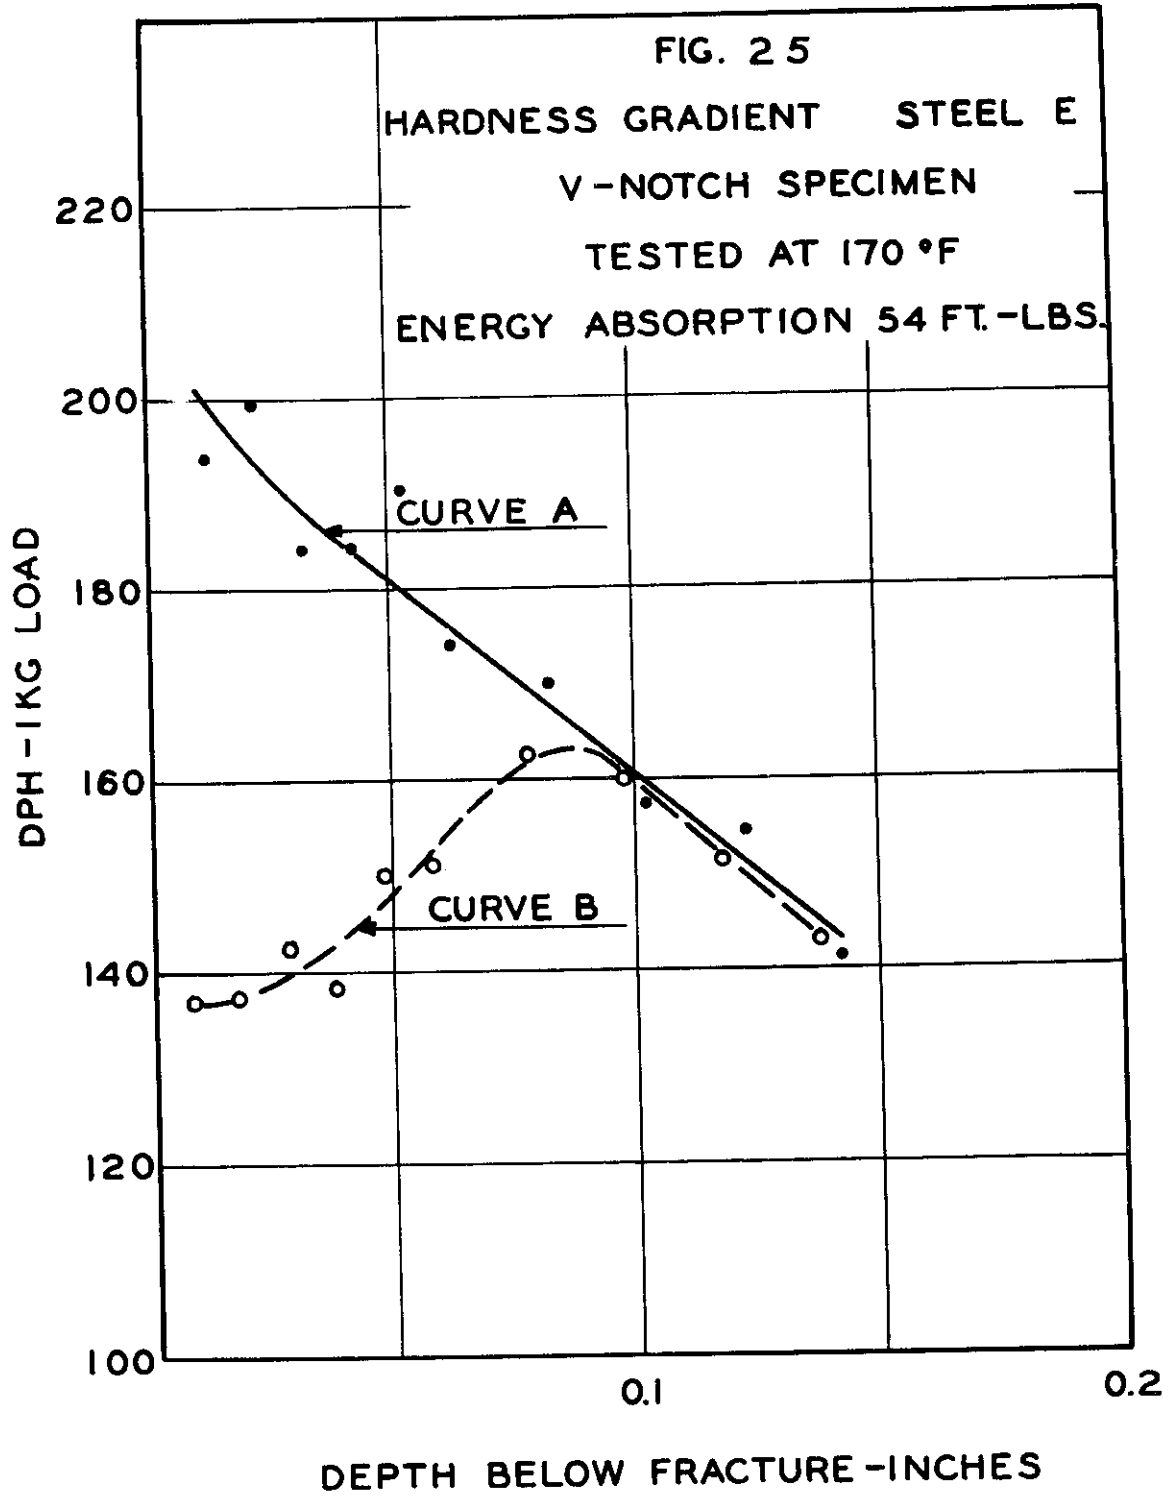
FIG. 24
 DPH CONTOURS STEEL E
 V-NOTCH SPECIMEN
 TESTED AT 170 °F
 ENERGY ABSORPTION 54 FT.-LBS.

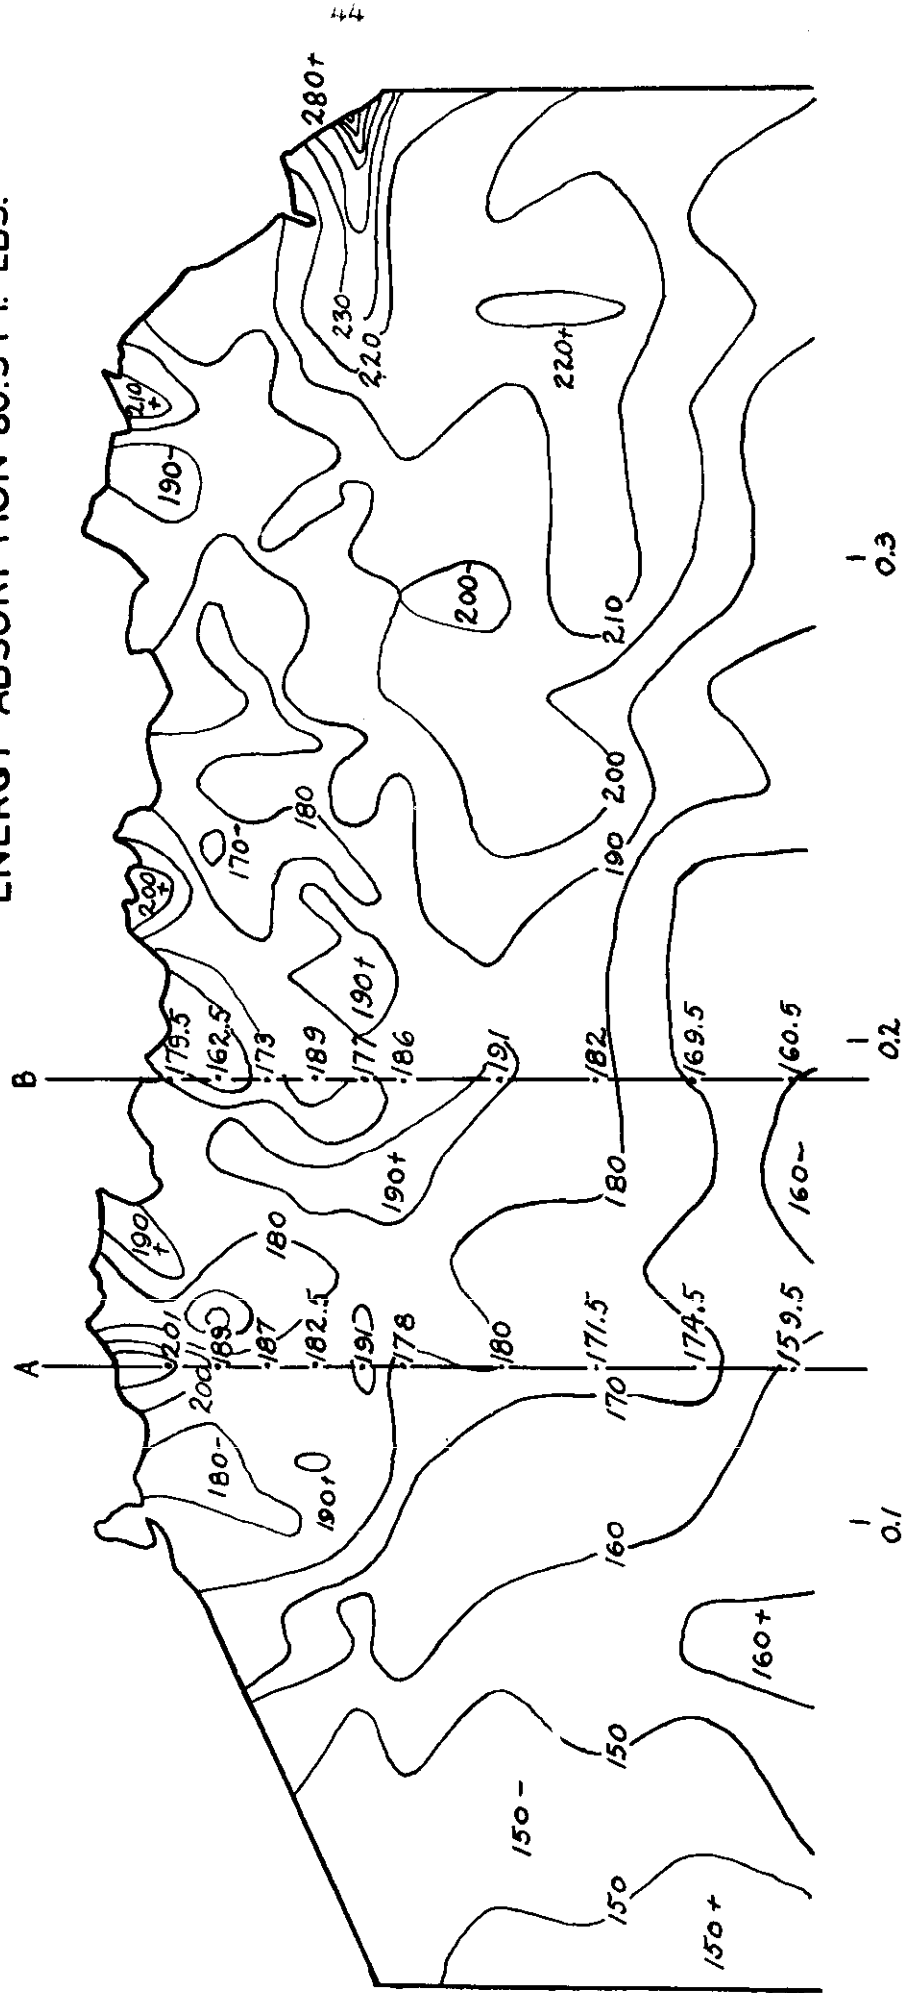
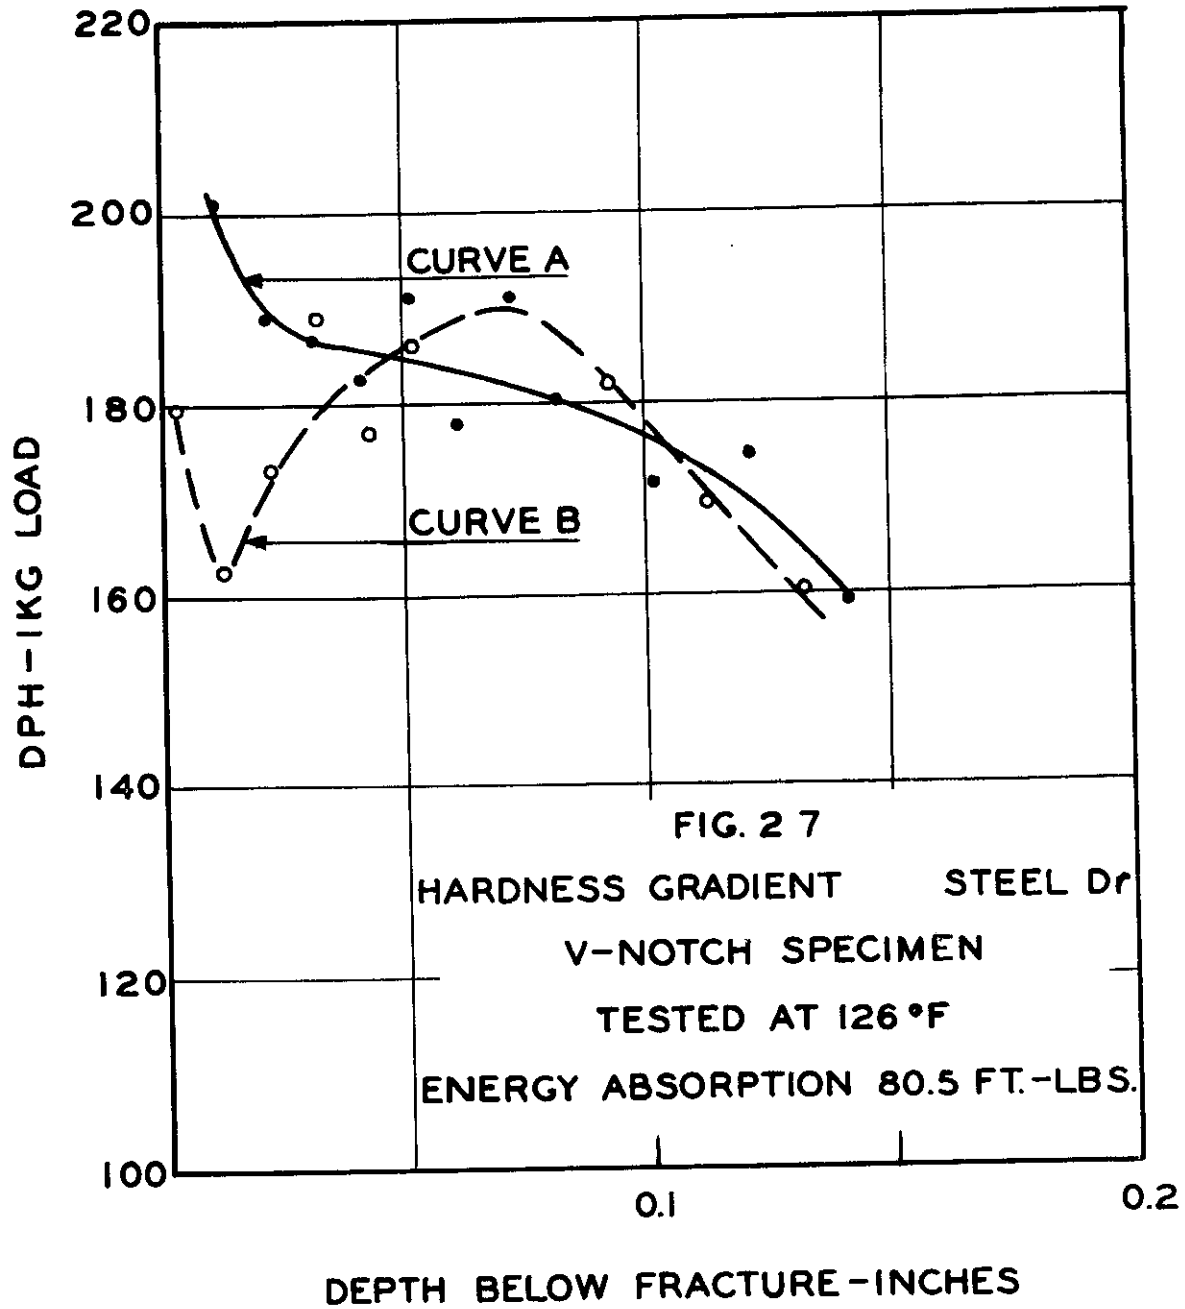
FIG. 2 6
 DPH CONTOURS STEEL DR
 V-NOTCH SPECIMEN
 TESTED AT 126 °F

ENERGY ABSORPTION 80.5 FT.-LBS.

Group 4 - High Energy Absorption (>70 ft. lbs.) Figures 26-31. These fractures were fully ductile ones. The hardness contours show that the region of no strain at the center of the bars has vanished. However, the intensity of the strain at the center of the bars is still much lower than it is near the notch and tup.

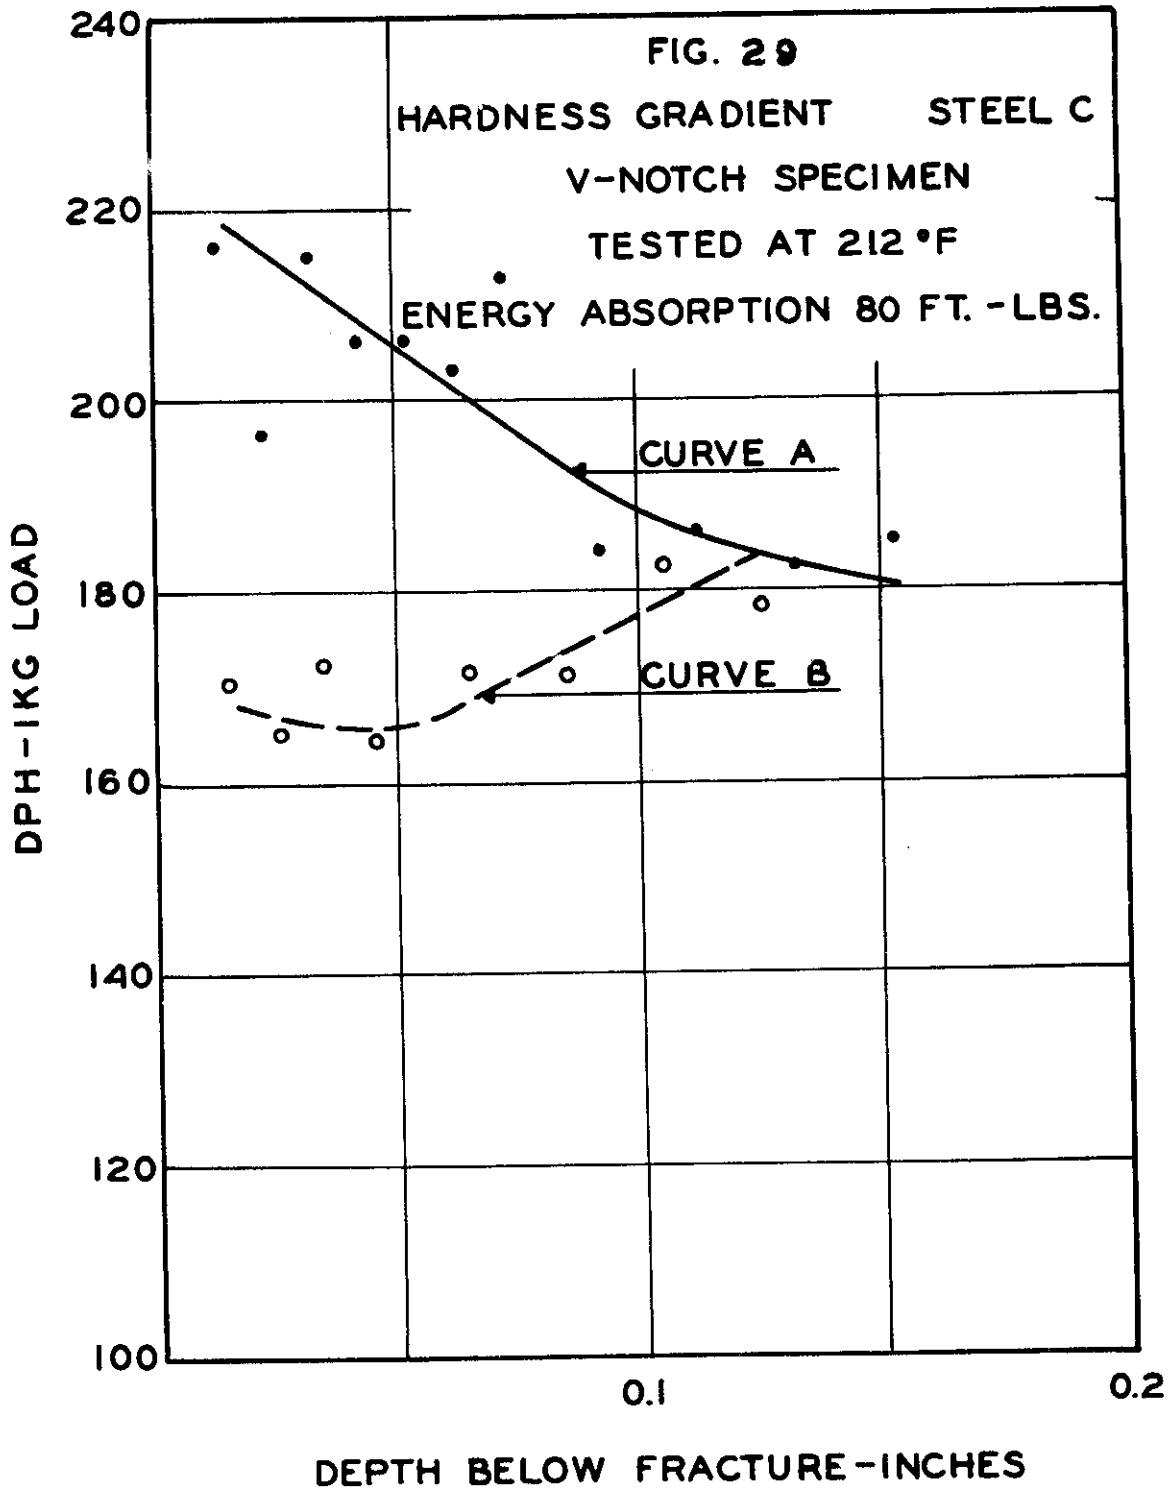
FIG. 28
DPH CONTOURS STEEL C
V-NOTCH SPECIMEN
TESTED AT 212 °F
ENERGY ABSORPTION 80 FT.-LBS.

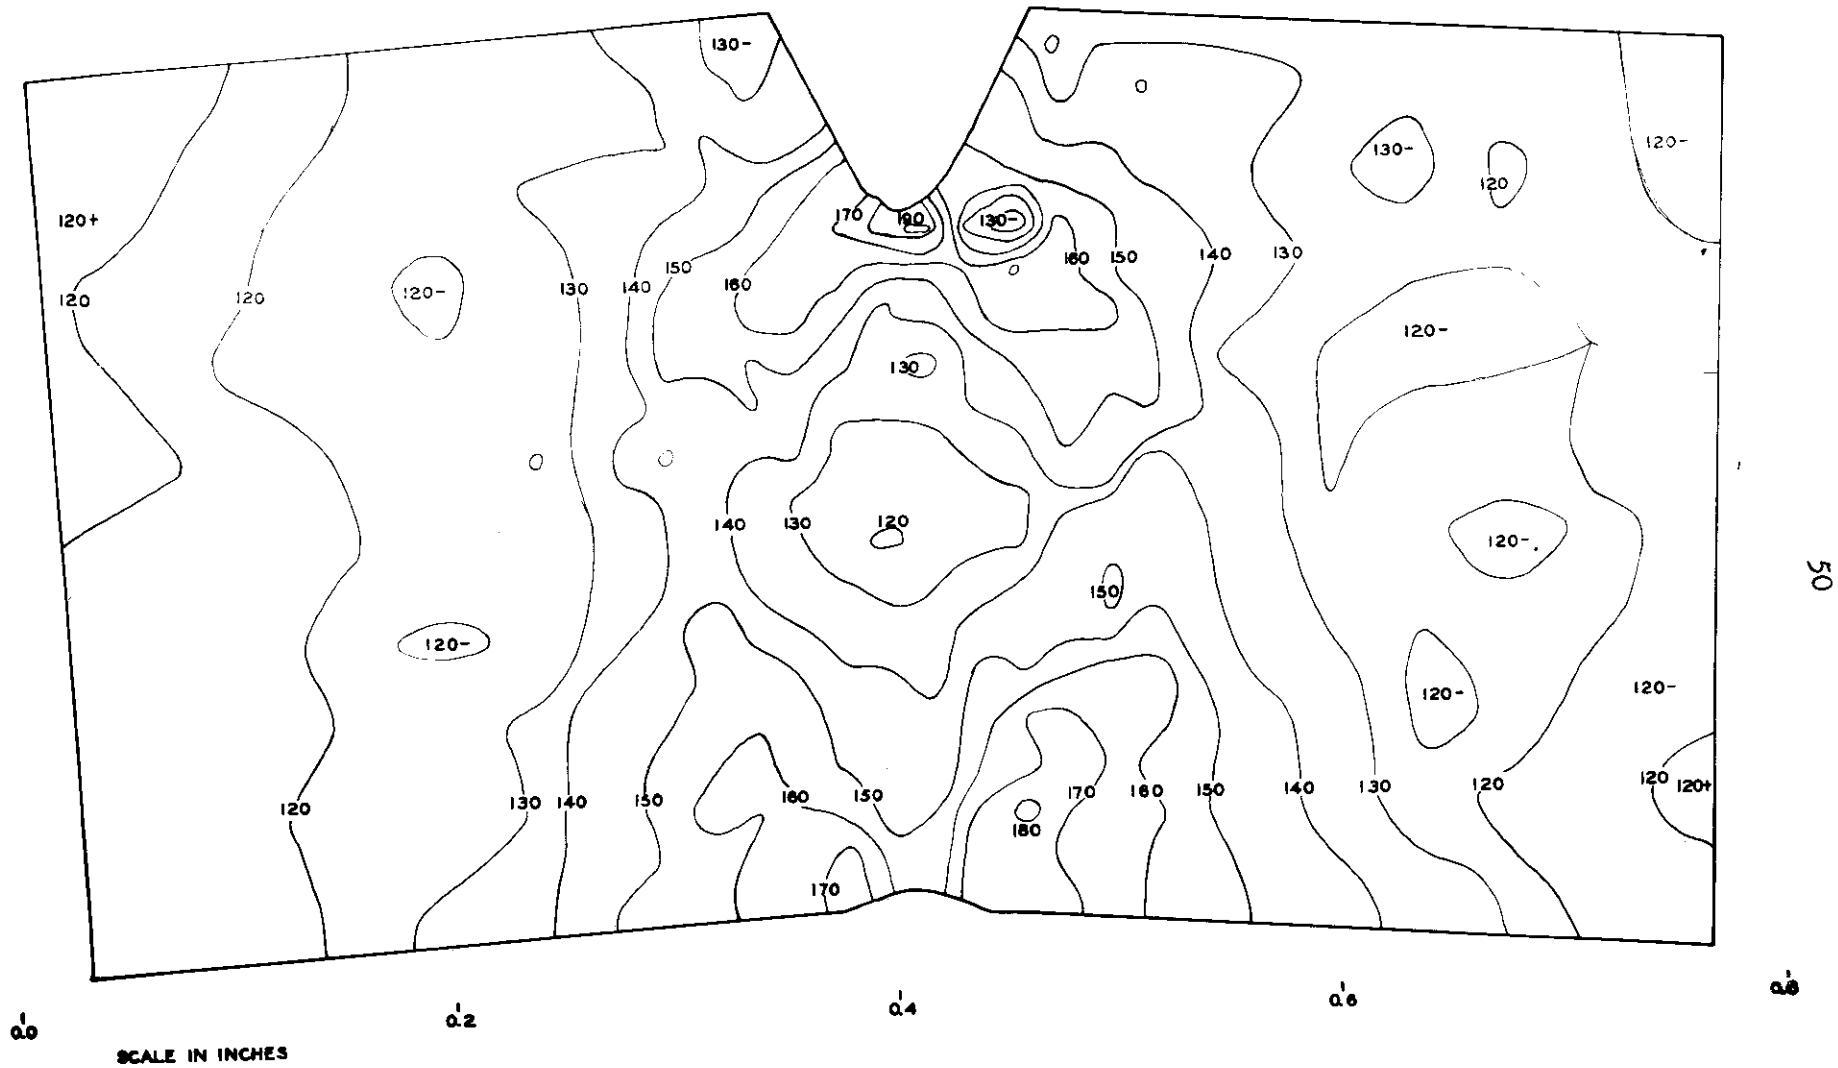
Fig. 32 - Hardness Contours - Steel C. Tested at 212°F; angle of bend = 9°, no crack formed. Kinetic Energy of Hammer = 13 ft. lbs.

The hardness contours of the three Charpy bars which were struck by a Charpy hammer possessing energy insufficient to cause complete fracture are shown in Figures 32, 33, and 34.

Figure 32 illustrates the distribution of the strain prior to crack formation for conditions of test under which ductile fracture would occur if energy sufficient to effect fracture were available. Notice the steep strain gradient under the notch and, to a lesser degree, at the top, and the strain free metal near to the neutral axis.

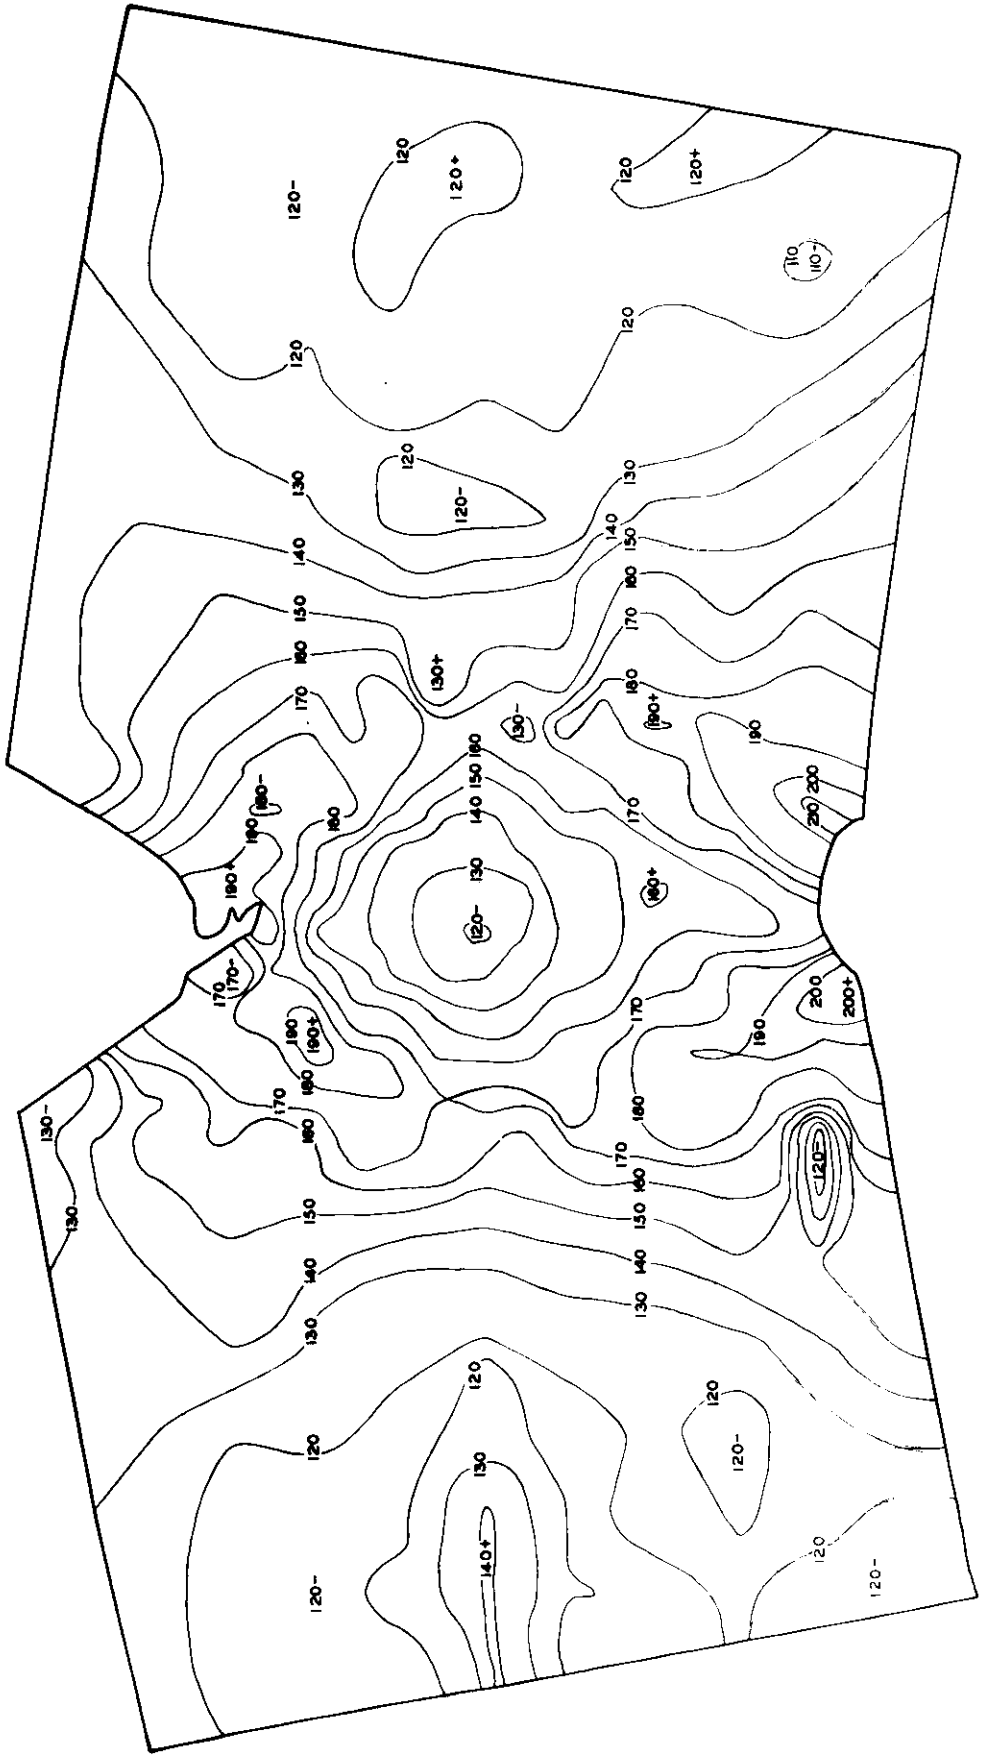
Fig. 33 - Hardness Contours - Steel C. Tested at 212°F, angle of bend = 22°, small crack formed. Kinetic Energy of Hammer = 34 ft. lbs.

Figure 33 differs from Figure 32 in degree only with the exception that a shallow ductile crack extends from the notch.

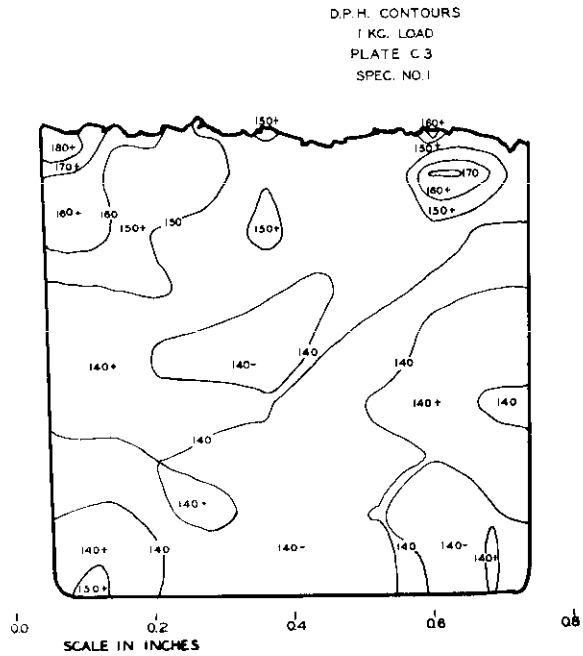
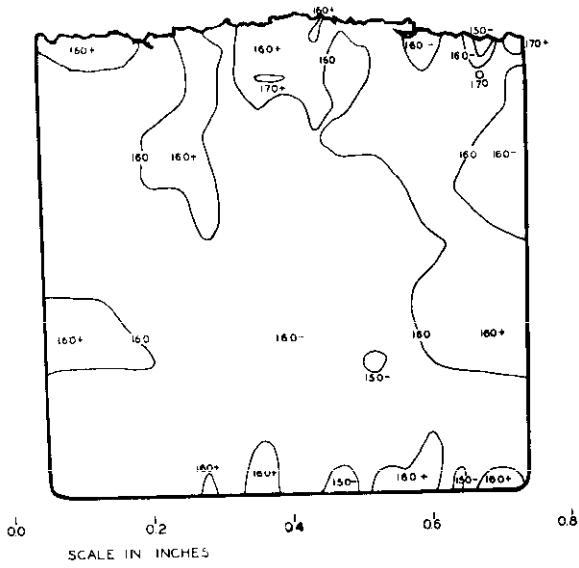
Fig. 37 - Hardness Contours - Specimen No. 1, Plate C-3.

Fig. 38 - Hardness Contours
 Specimen No. 2, Plate C-3

it is evident that this plate failed with a "brittle" crack terminating at the notch. Figure 36 indicates orientations and locations of the hardness survey specimens. Figures 37-40 show the hardness contours, from which two significant observations can be made:

(1) Some portions of this "brittle" crack are not accompanied by a discernible macroscopic strain gradient, i.e., the base hardness of the plate extends unchanged to the crack surface.

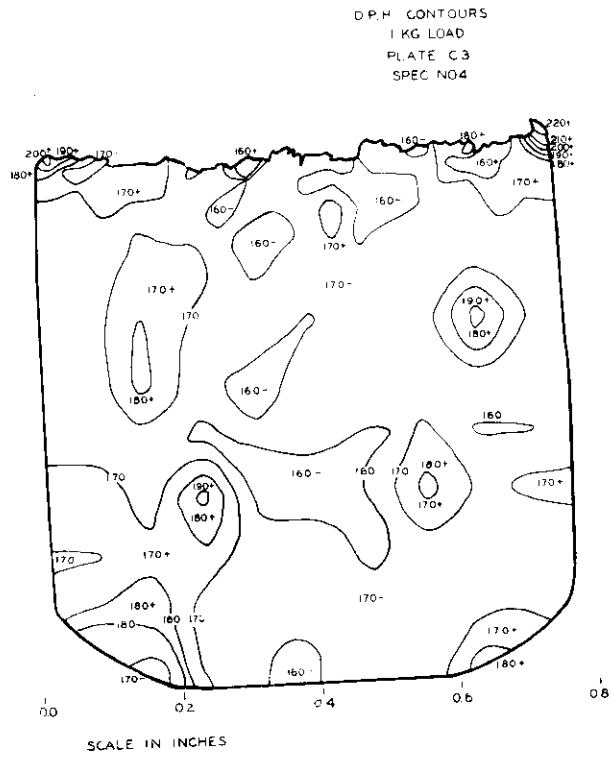
Fig. 40 - Hardness Contours
Specimen No. 4, Plate C-3

(2) Some portions of this "brittle" crack are accompanied by fairly steep and shallow strain gradients, which can occur in the center of the plate (e.g. Figure 39) but which are especially marked at the plate surface (e.g. Figure 40).
