**CORRELATION OF LABORATORY TESTS WITH
FULL SCALE SHIP PLATE FRACTURE TESTS:
A STUDY OF STRAIN GRADIENTS**

**E. P. KLIER, F. C. WAGNER, J. L. FISHER
and M. GENSAMER**

**Pennsylvania State College
Under Bureau of Ships Contract NObs-31217**

SERIAL NO. SSC-17

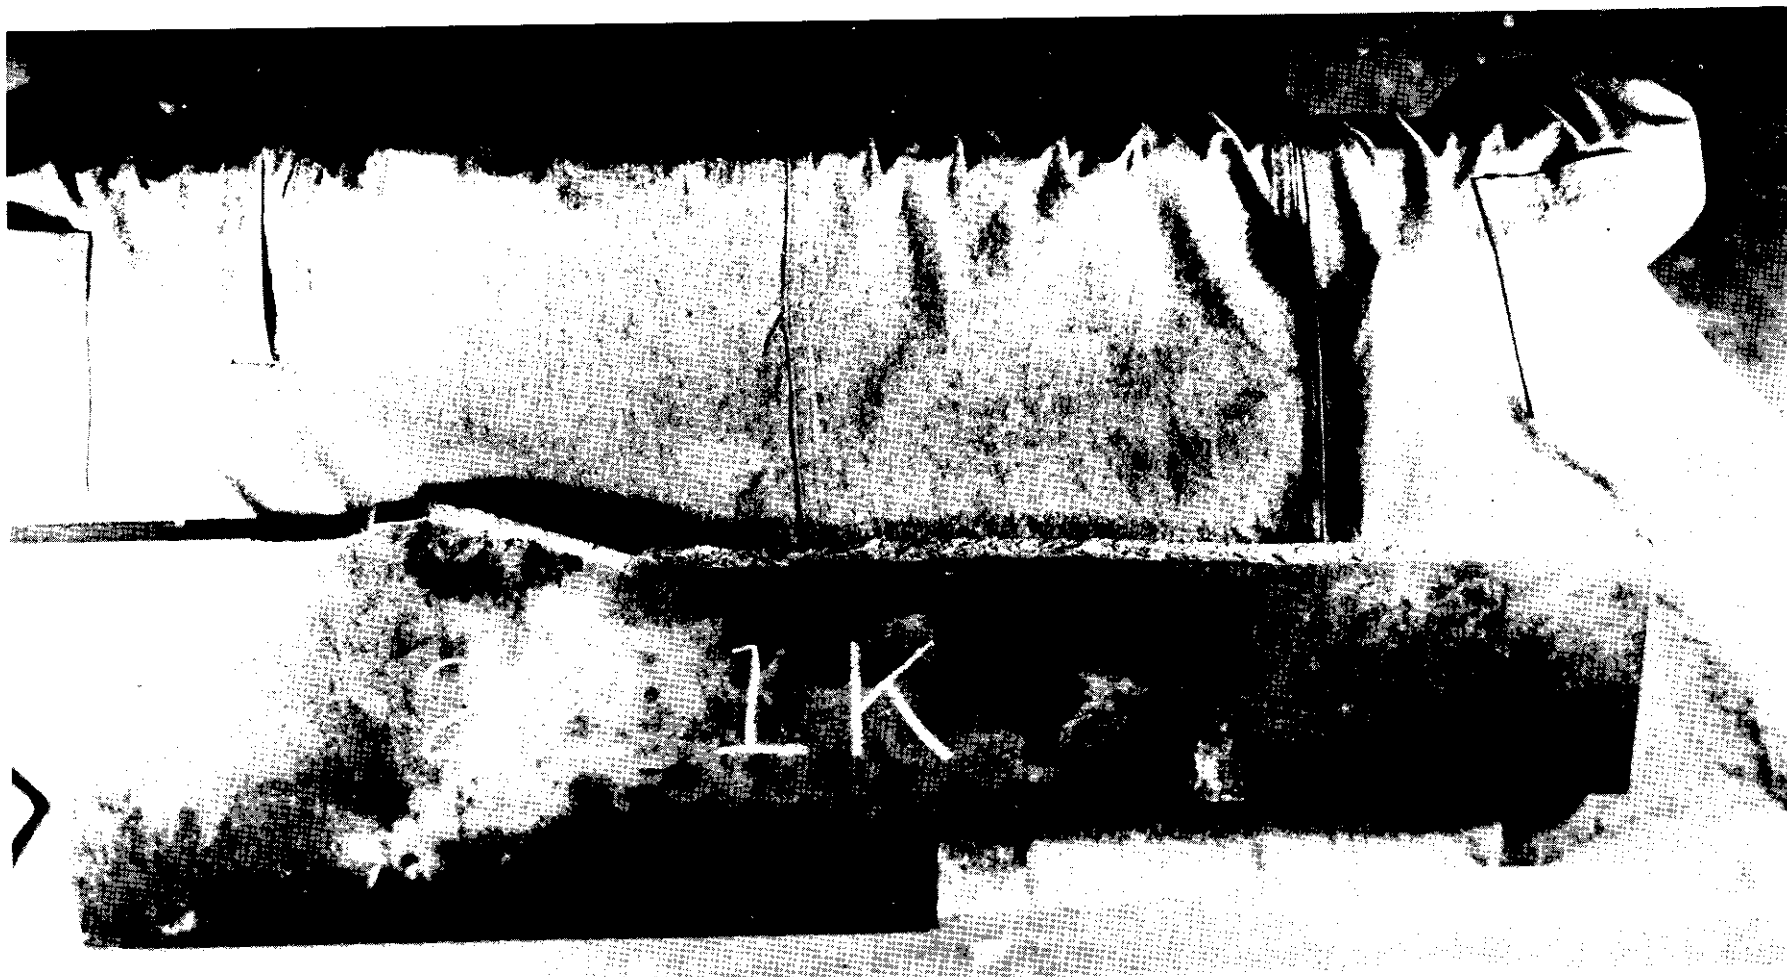
Fig. 41 - Photograph of Plate 22-1K.

Plate 22-1K is shown in line drawing by Figure 42. From its photograph, Figure 41, it is evident that the crack was "ductile" from the notch to the location of specimen No. 4, thence "brittle" to the plate edge. With the additional observation that the ductile portions of this crack show the expected strain gradient, (Figures 43-47) the remarks pertaining to plate previously discussed apply.

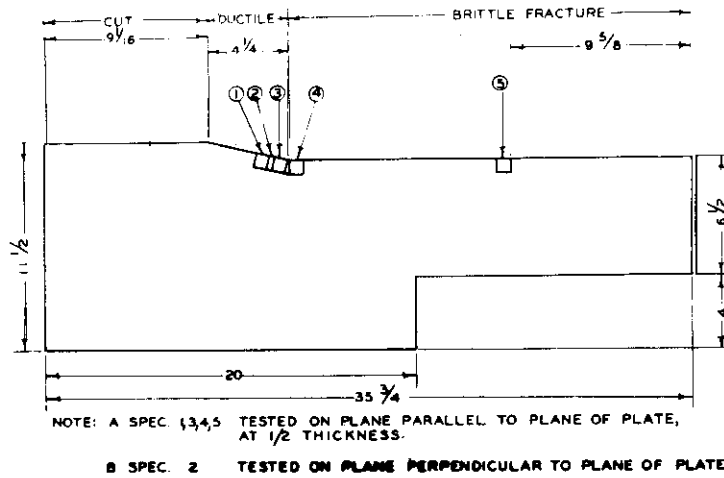
Fig. 42 - Line Drawing of Plate 22-1K.

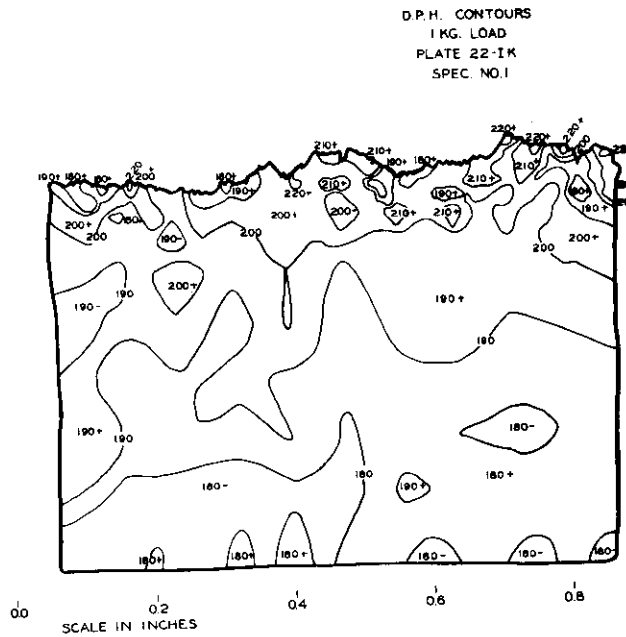
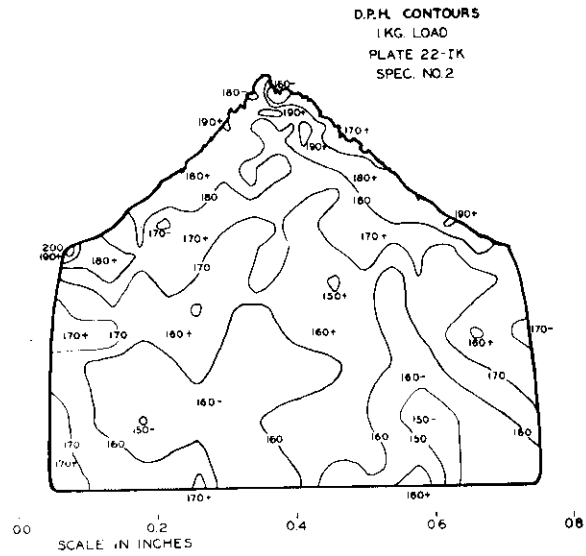
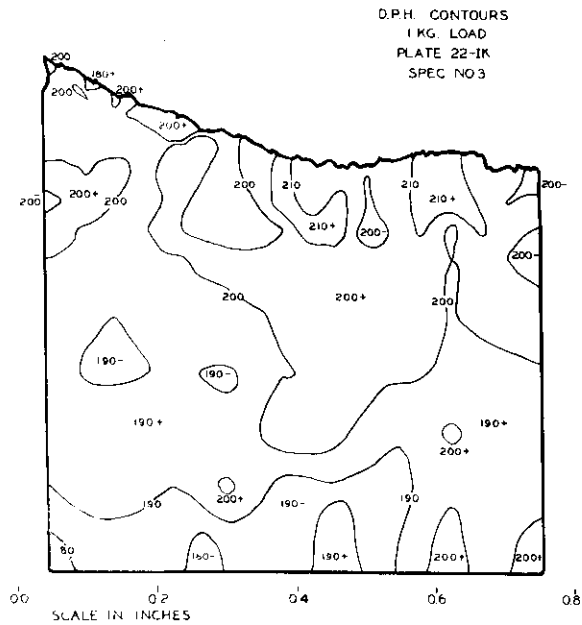
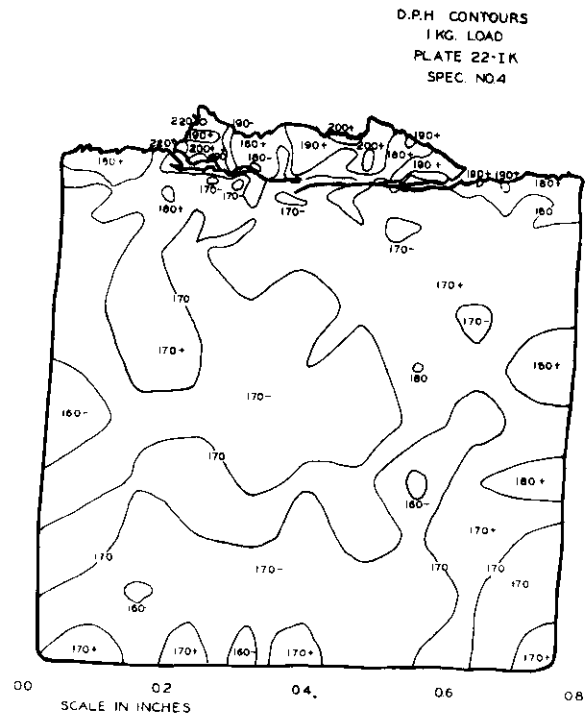
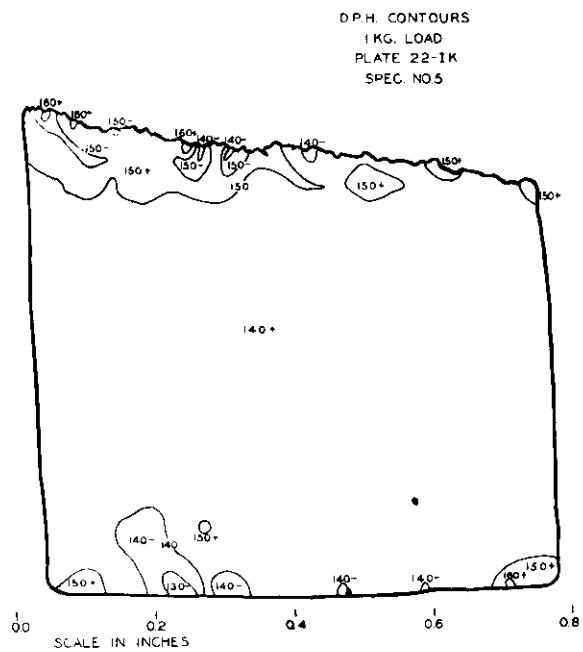
Fig. 43 - Hardness Contours
Specimen No. 1, Plate 22-1K.

**Fig. 44 - Hardness Contours
Specimen No. 2, Plate 22-1K.**

**Fig. 45 - Hardness Contours
Specimen No. 3, Plate 22-1K.**

Fig. 46 - Hardness Contours
Specimen No. 4, Plate 22-1K.

Fig. 47 - Hardness Contours
Specimen No. 5, Plate 22-1K.

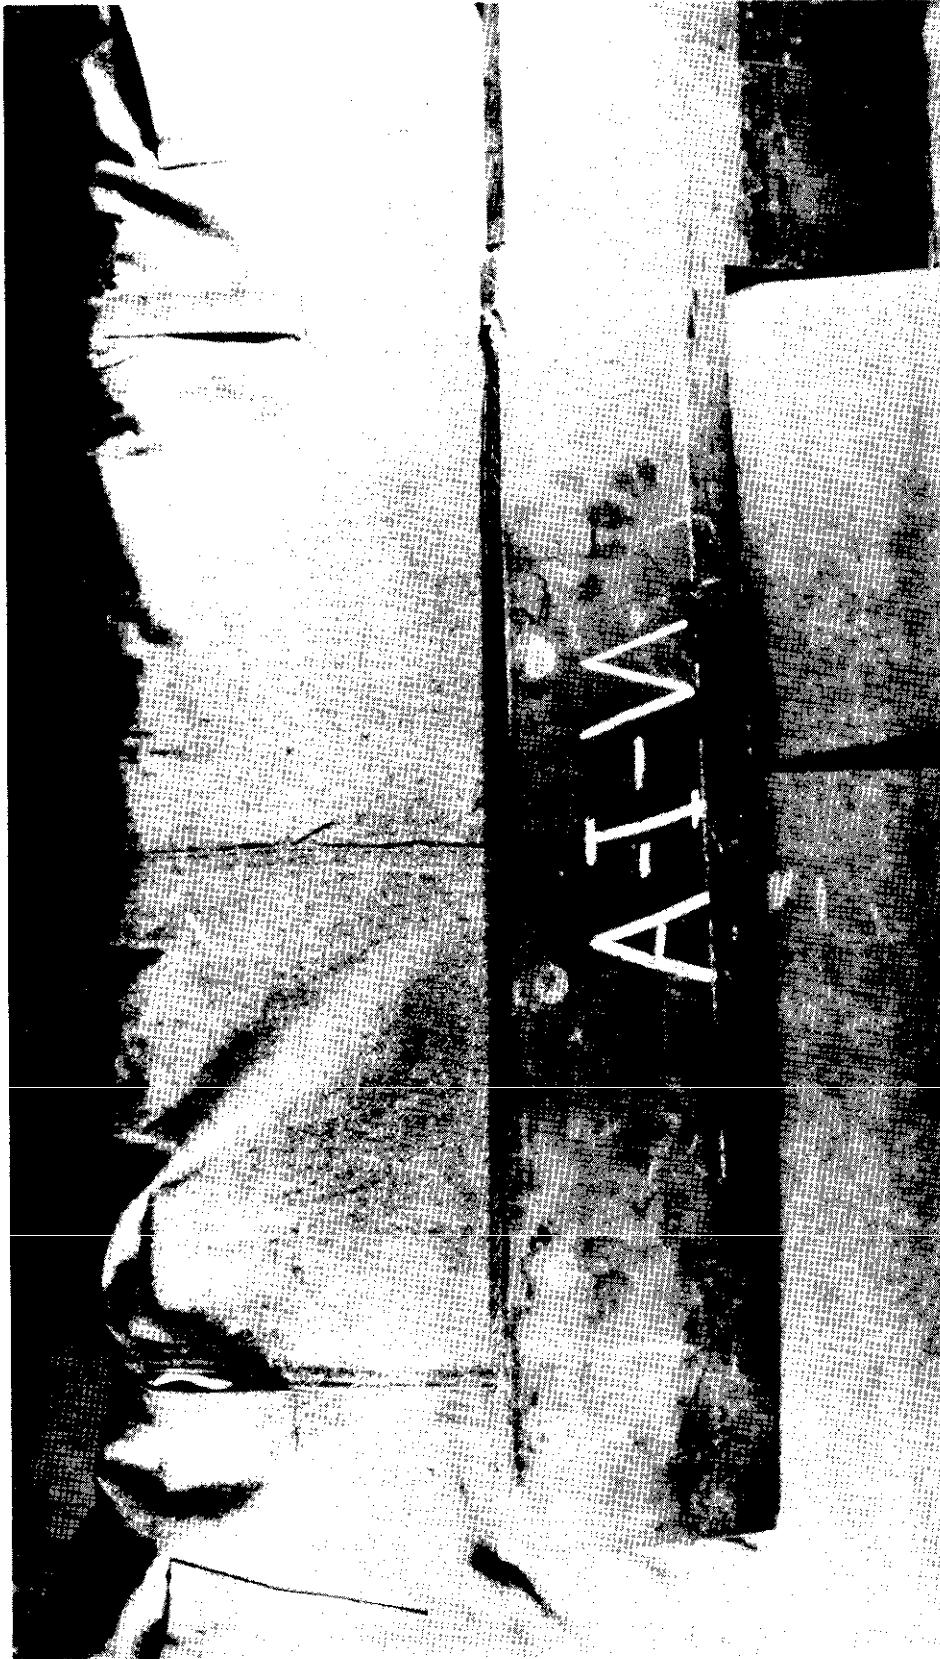
Fig. 48 - Photograph of Plate N-1-A.

Plate N-1-A is shown in line drawing by Figure 48. From its photograph, Figure 48, it is evident that the crack originated at the notch and extended in the "ductile" mode for approximately 1/2 inch before changing to the "brittle" mode. It should be noted⁹ that this plate was unusual in that it absorbed approximately 1/3 of the maximum energy observed for a totally "ductile" specimen of the same material. The strain gradients of those specimens near the notch, Figures 50, 51, and 52, closely resemble findings from the previous two plates. Figure 53, however, which represents "brittle" behavior, differs markedly from the other "brittle" contours in its demonstration of definite and uniformly developed macroscopic strain gradient. In this respect, Figure 53 is not unlike previously discussed contour maps which represent "ductile" behavior (cf. Figure 43), with the exception that the gradient slope does not sharply increase in steepness near to the fracture. It is suggested that the "brittle gradient" of Figure 53 might be related to the unusually high energy absorption, in that it could be reflecting general straining in a zone between the notch and the plate edge rather than a strain incidental to, or necessary for, propagation of the crack.

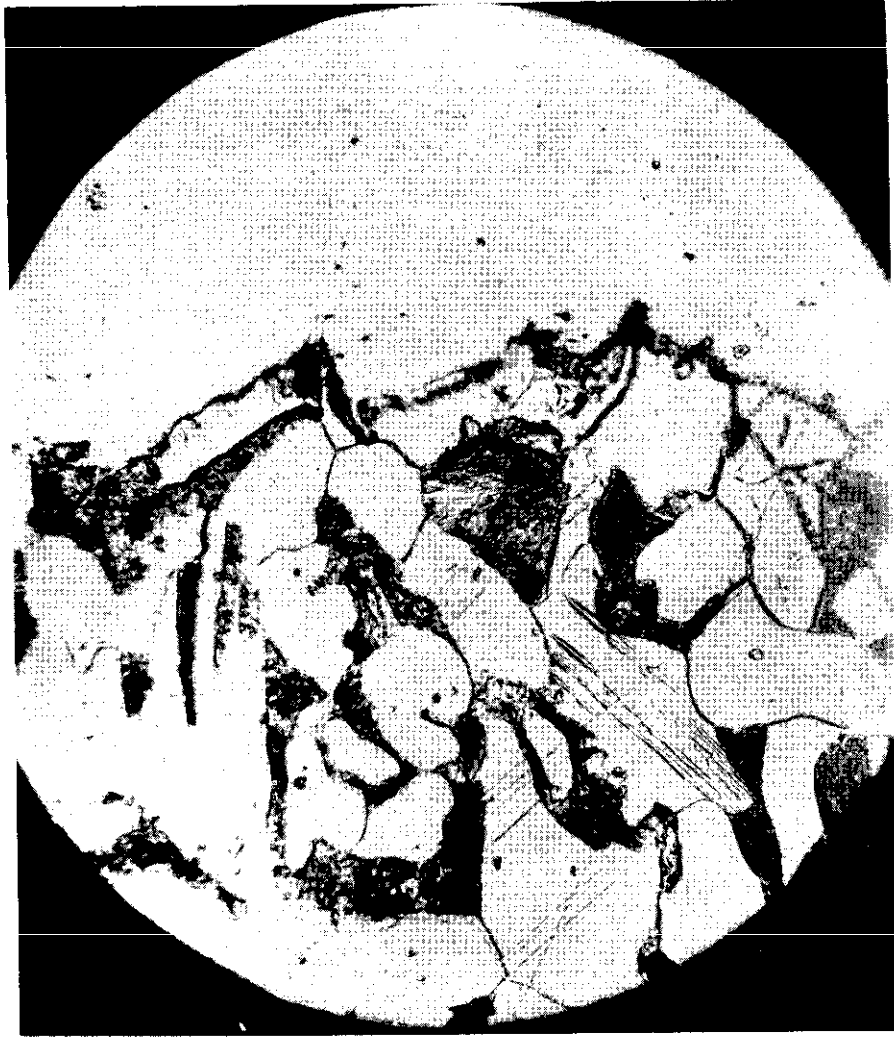
Fig. 54 - Deformation Twins in Steel C. Nital Etch x 600.

Figures 54 and 55, respectively illustrate deformation twins and strain lines, not necessarily typical, occurring in broken Charpy bars.

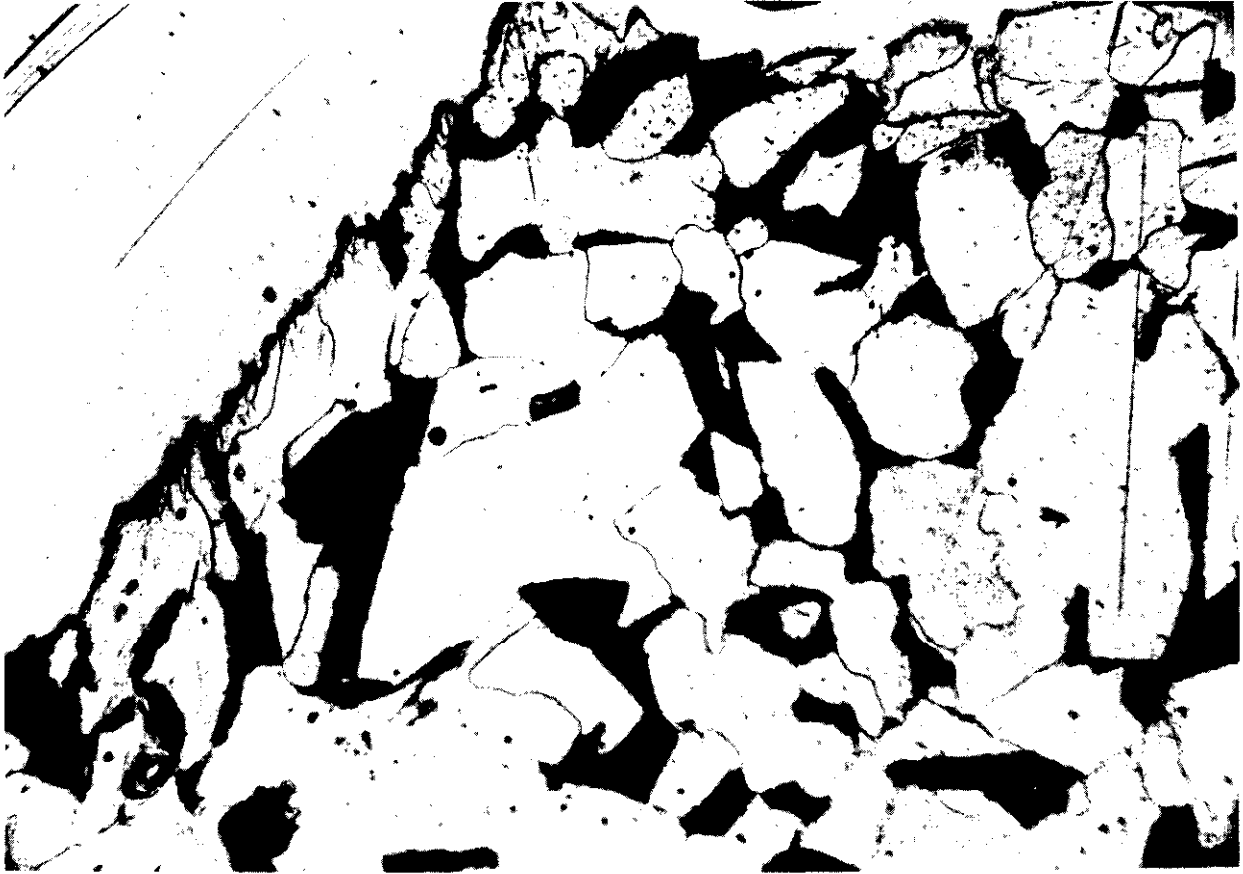
Fig. 56 - The Fracture for Specimen No. 4 Plate 22-1K showing Deformation Twins and Transition from Brittle to Ductile Failure. Nital Etch x 500

Figure 56 represents the location in plate 22-1-K at which the crack changed from the "ductile" to the "brittle" mode. Note the typical evidence of an appreciable strain gradient adjacent to the ductile part and the clean, strain-free cleavage adjacent to the brittle part of the crack.

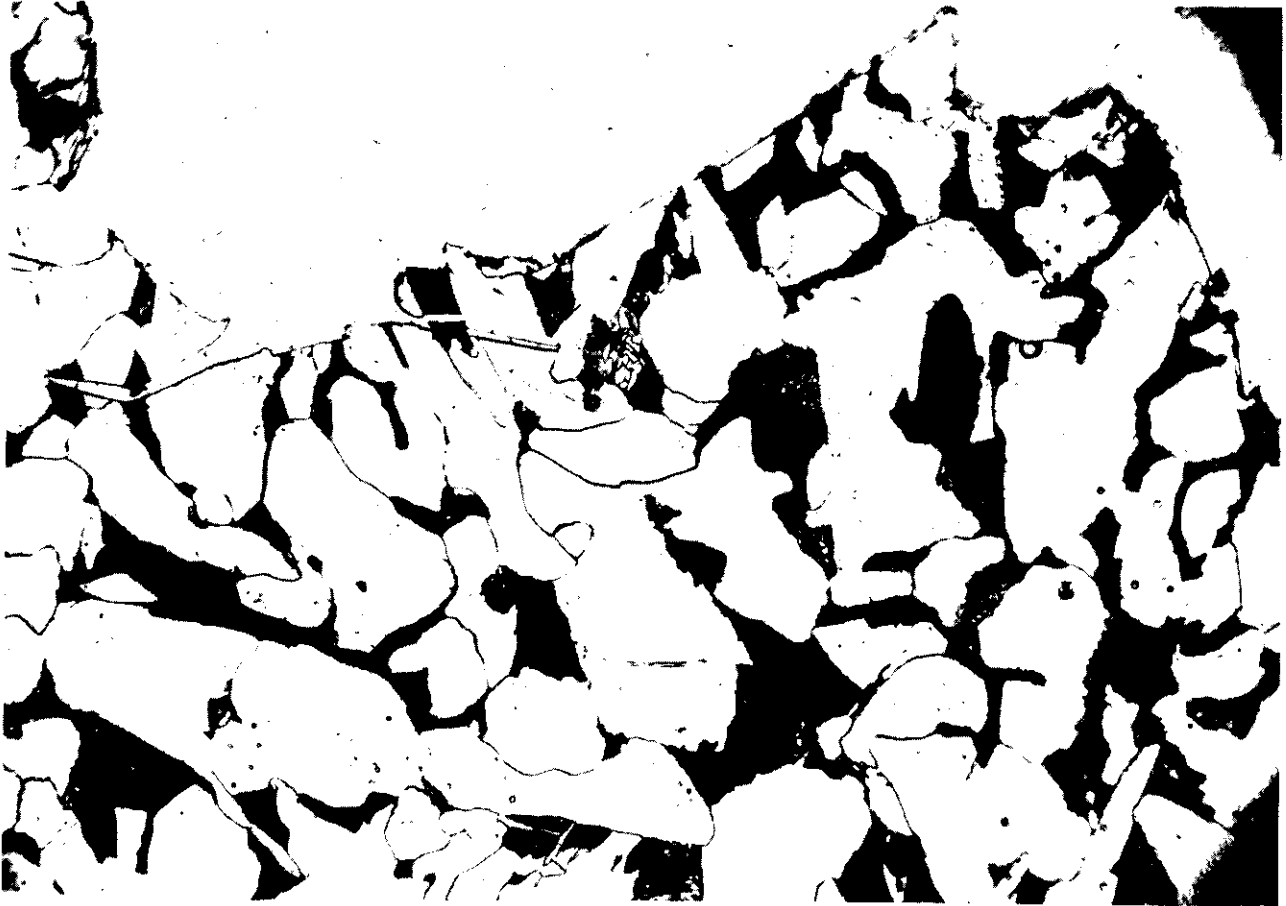
Fig. 57 - The Fracture for Specimen No. 5 Plate 22-1K showing Brittle Cracks of inter-and intra-granular types. Nital Etch x 500

Figure 57 represents a "brittle" location of the crack in plate 22-1-K. The previously mentioned characteristics of a cleavage fracture are illustrated. Note also the typical trans-crystalline path, which is interrupted by a very short inter-crystalline separation at the pearlite grain near crack midpoint.

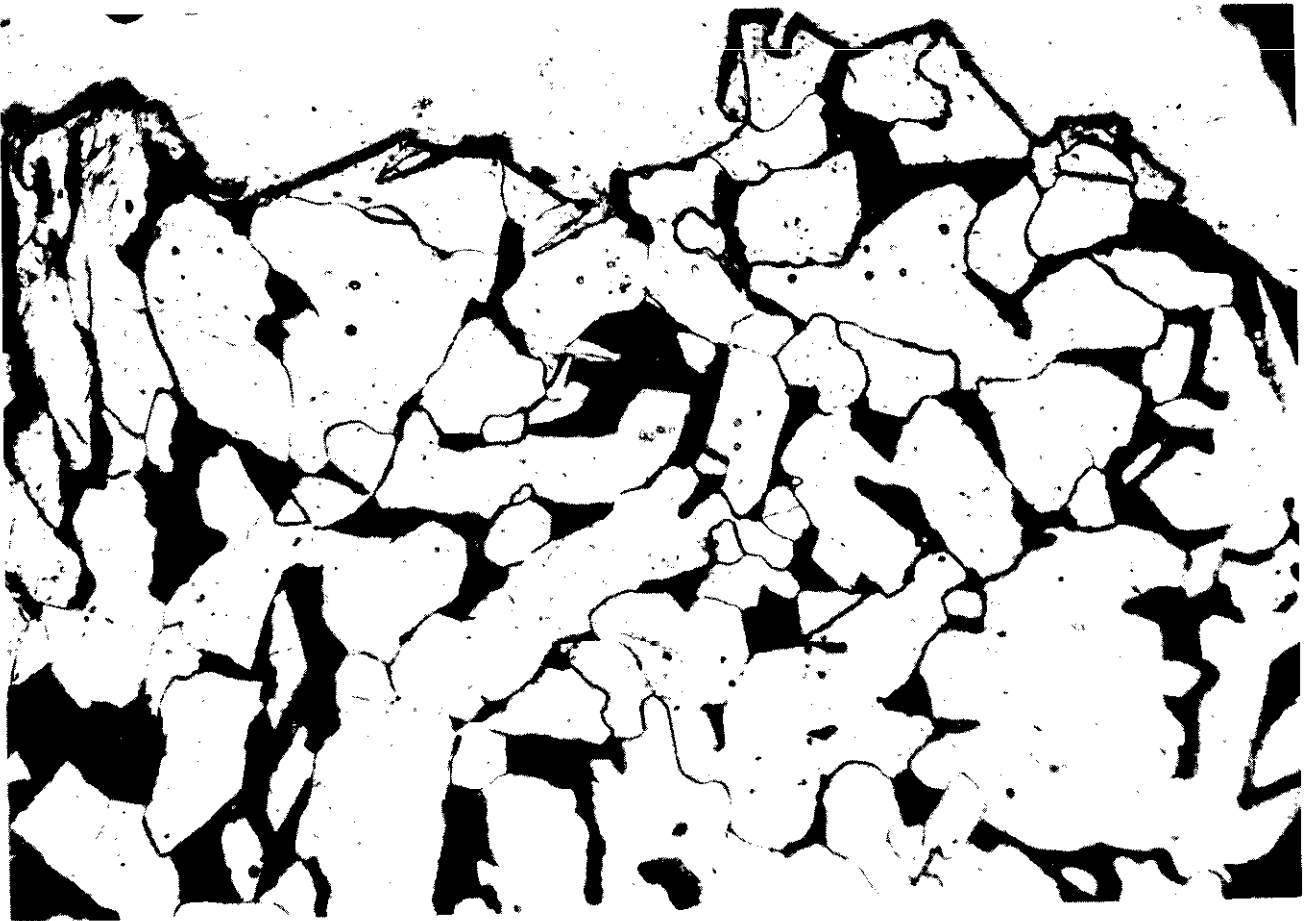
Fig. 58 - Another Region for Specimens No. 5 Plate 22-1K.
Nital Etch x 500

Figure 58 illustrates the above mentioned characteristics of a cleavage crack and in addition, reveals interesting behavior of the crack in the ferrite grain near its midpoint. Notice how the crack branch was arrested within the ferrite grain.
