SSC-204

SIMULATED PERFORMANCE TESTING FOR SHIP STRUCTURE COMPONENTS

Project SR-169, "Simulated Performance Testing"

Robert Sherman
Southwest Research Institute
San Antonio, Texas

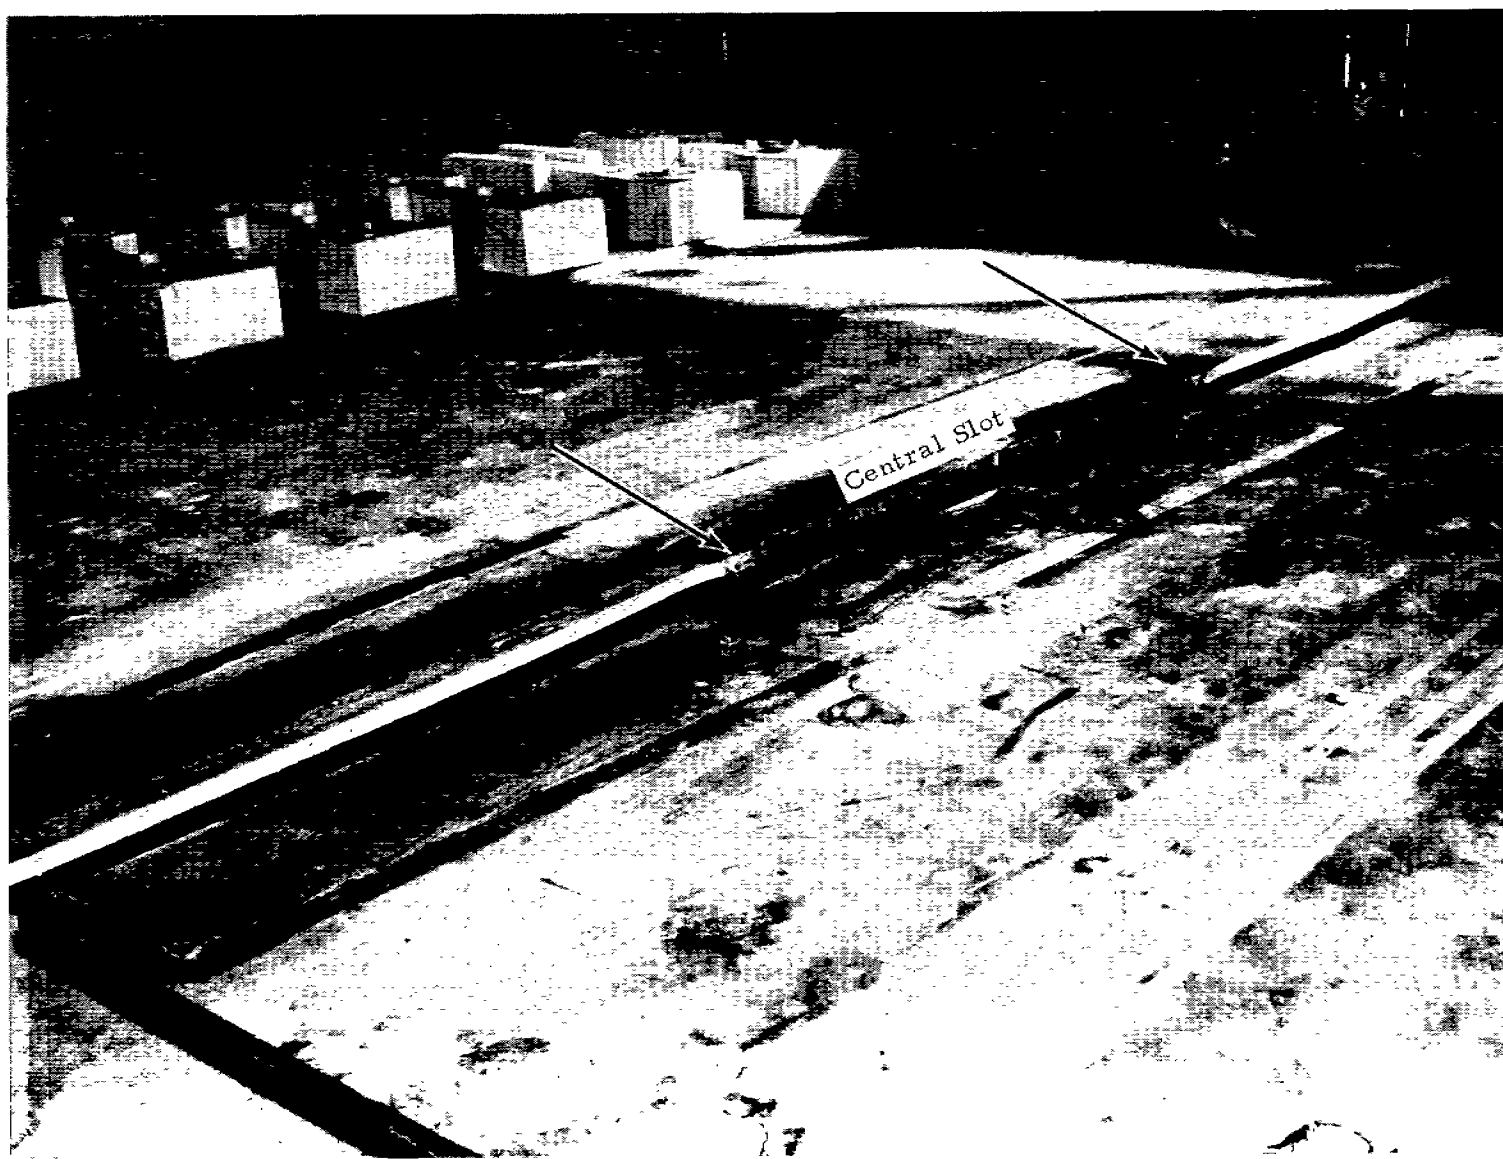
Fig. A-5. Overall View Of A Typical Fracture - Test A2; Configuration: Central Slot With Brittle Weld Bead, Each End; Test Temperature: -65°F ; Fracture Stress: 8,300 Psi On The Gross Section, 12,500 Psi Avg. On The Net.

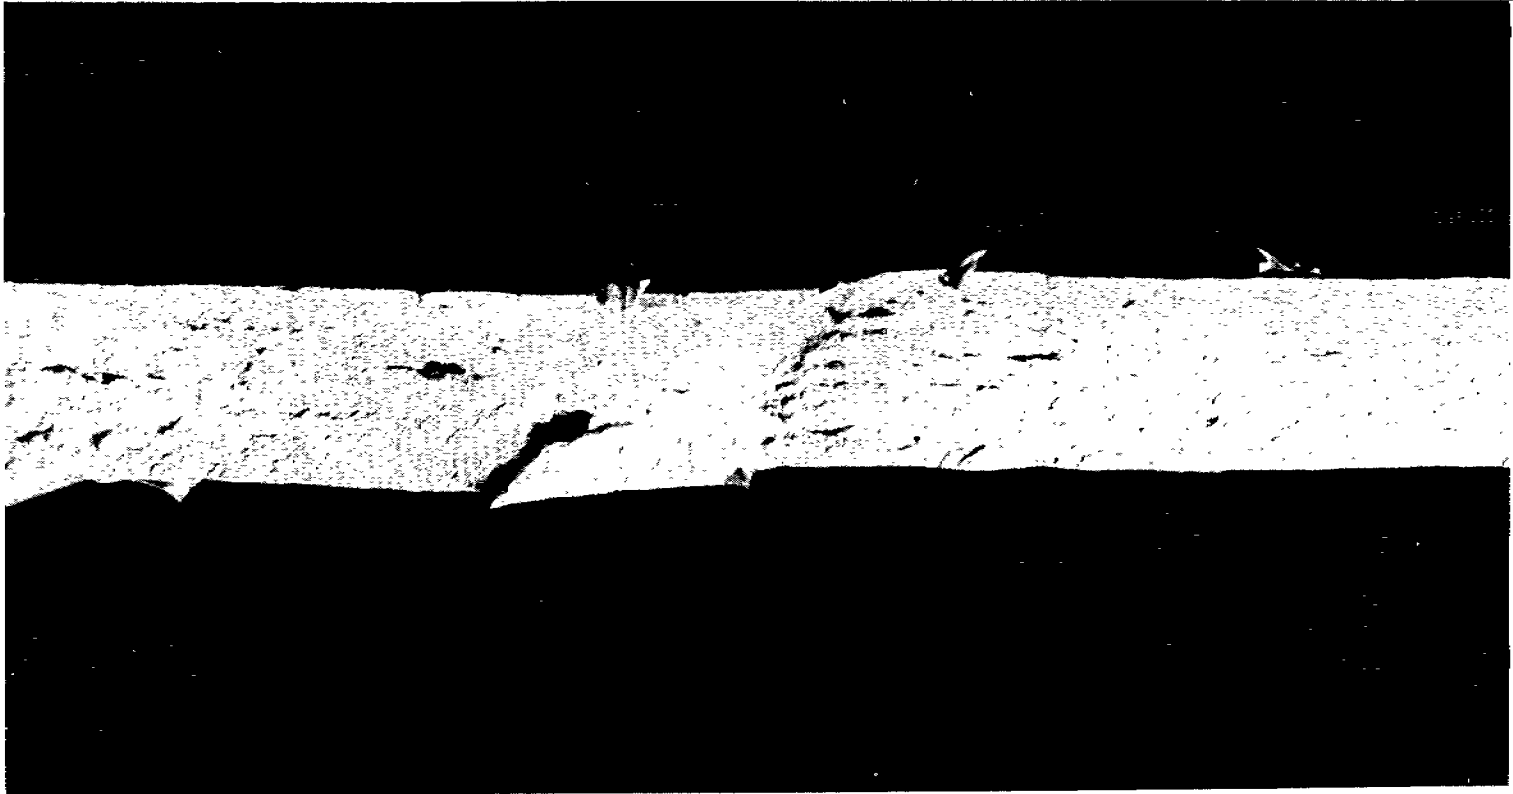
Fig. B-2. Appearance Of The Fracture Surface - Test B2; Specimen Configuration: Fatigue Crack Generated At The Tip Of A 6" Edge Slot; Test Temperature: +40°F; Fracture Stress: 32,000 Psi On The Gross Section; 33,700 Psi Avg. On The Net.
