**PROGRESS REPORT**  
**ON**  
**TWELVE INCH FLAT PLATE TESTS**

**Swarthmore College**  
**Under Bureau of Ships Contract NObs-45521**

**SERIAL NO. SSC-21**

**DATE: APRIL 15, 1949**

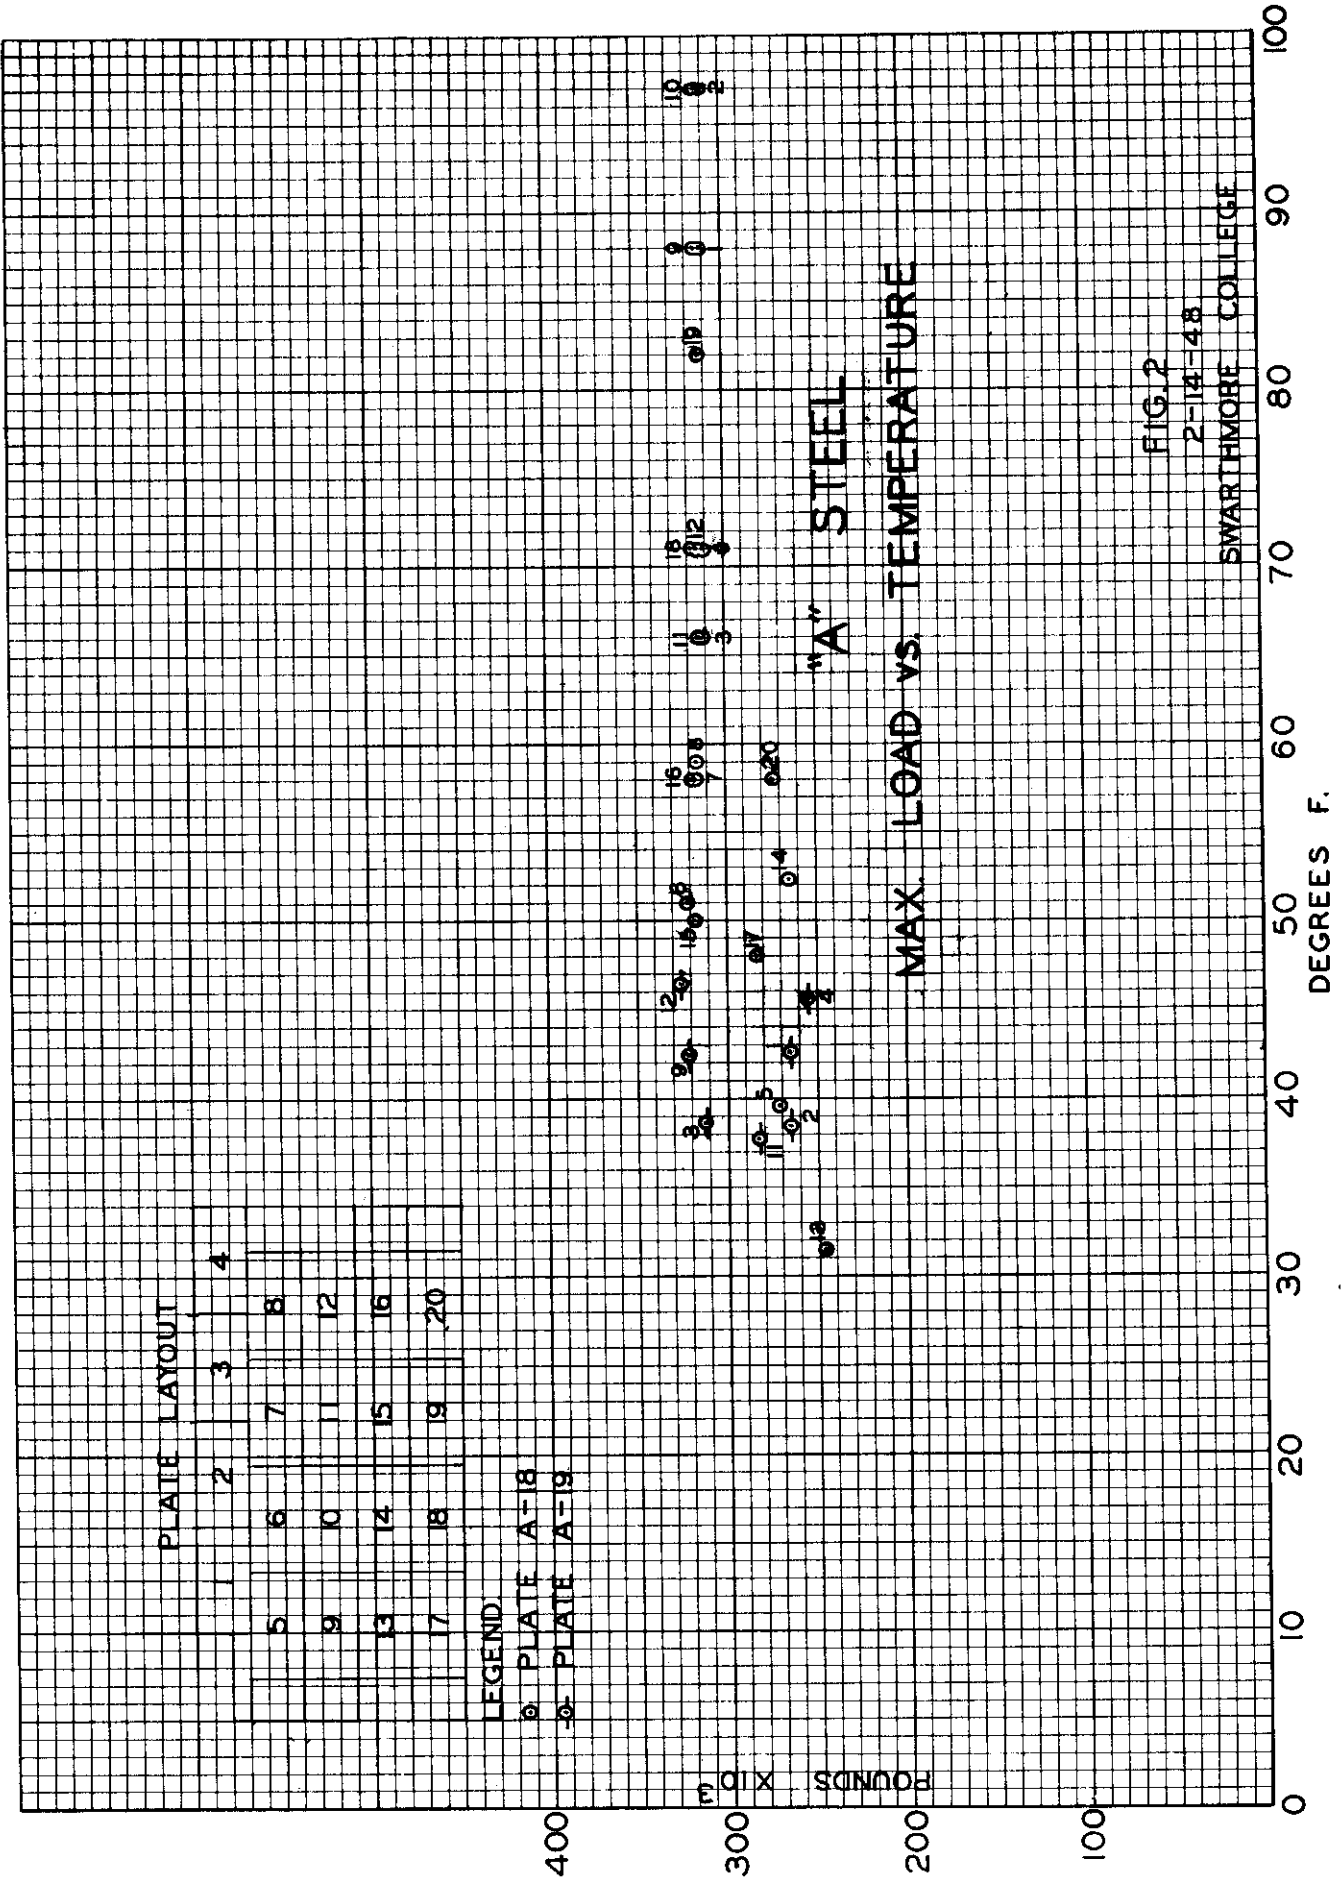
FIG. 2  
2-14-48  
SWARTHMORE COLLEGE

Figure 2 shows the maximum loads plotted as ordinates with temperatures as abscissas. In Figure 3, energies to maximum load are plotted as ordinates with temperatures as abscissas. The data obtained at the University of California<sup>1</sup> on plates 12" wide are superimposed on the Swarthmore data. Figure 4 is a plot of the percentage of shear failure in the various specimens of "A" steel.

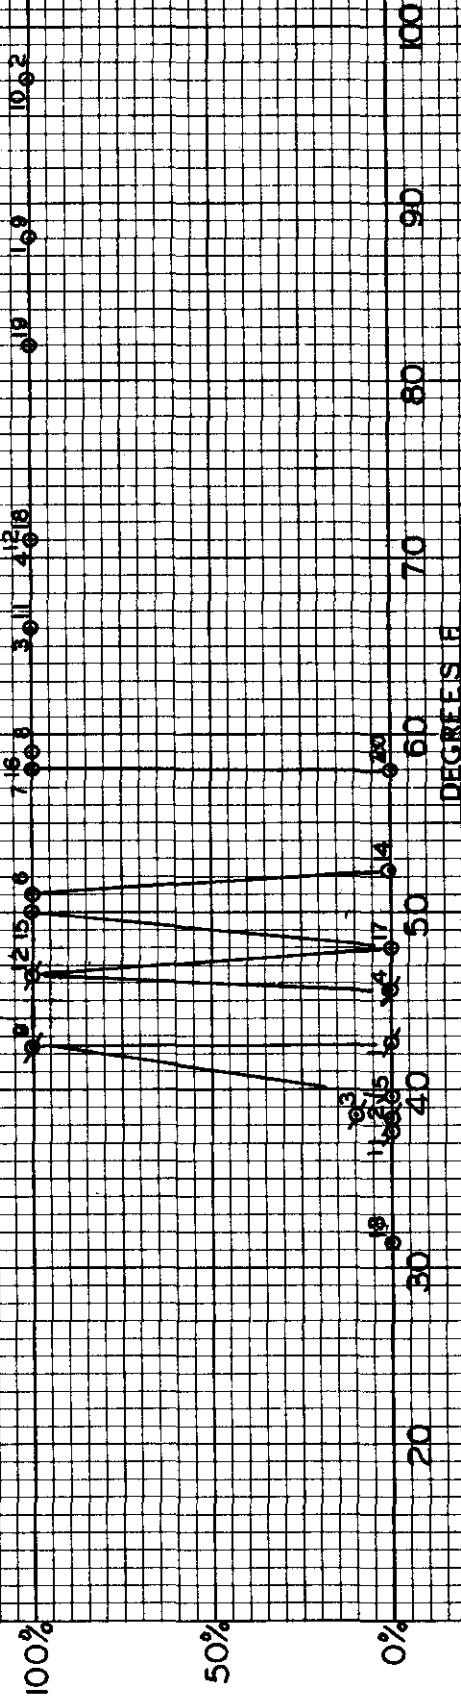
FIG. 4  
2-14-48  
SWARTHMORE COLLEGE

The transition temperature zone based on appearance of the fracture as evaluated in terms of the per cent of shear also lies between 42°F and 58°F. (See Figure 4).

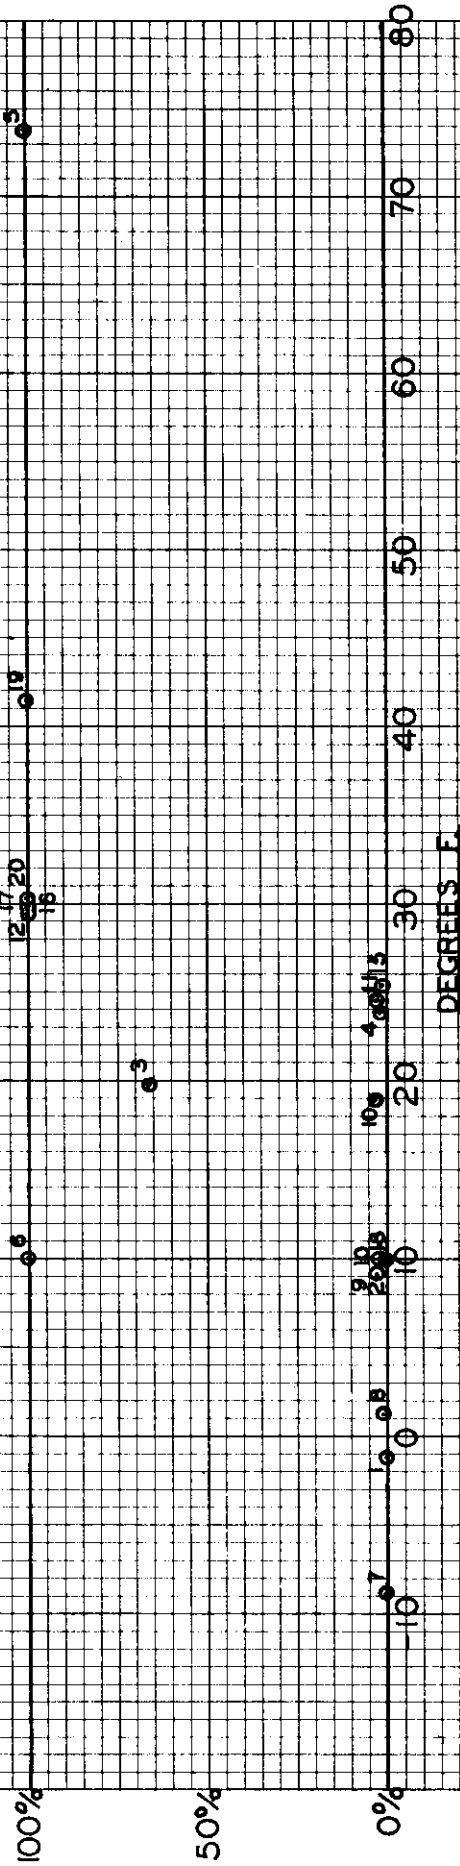
**FIG. 12**  
G-25-4B  
SWARTHMORE COLLEGE

The transition temperature zone based on appearance of the fracture as evaluated in terms of the per cent of shear also lies between 25° and 30°F. (See Figure 12).

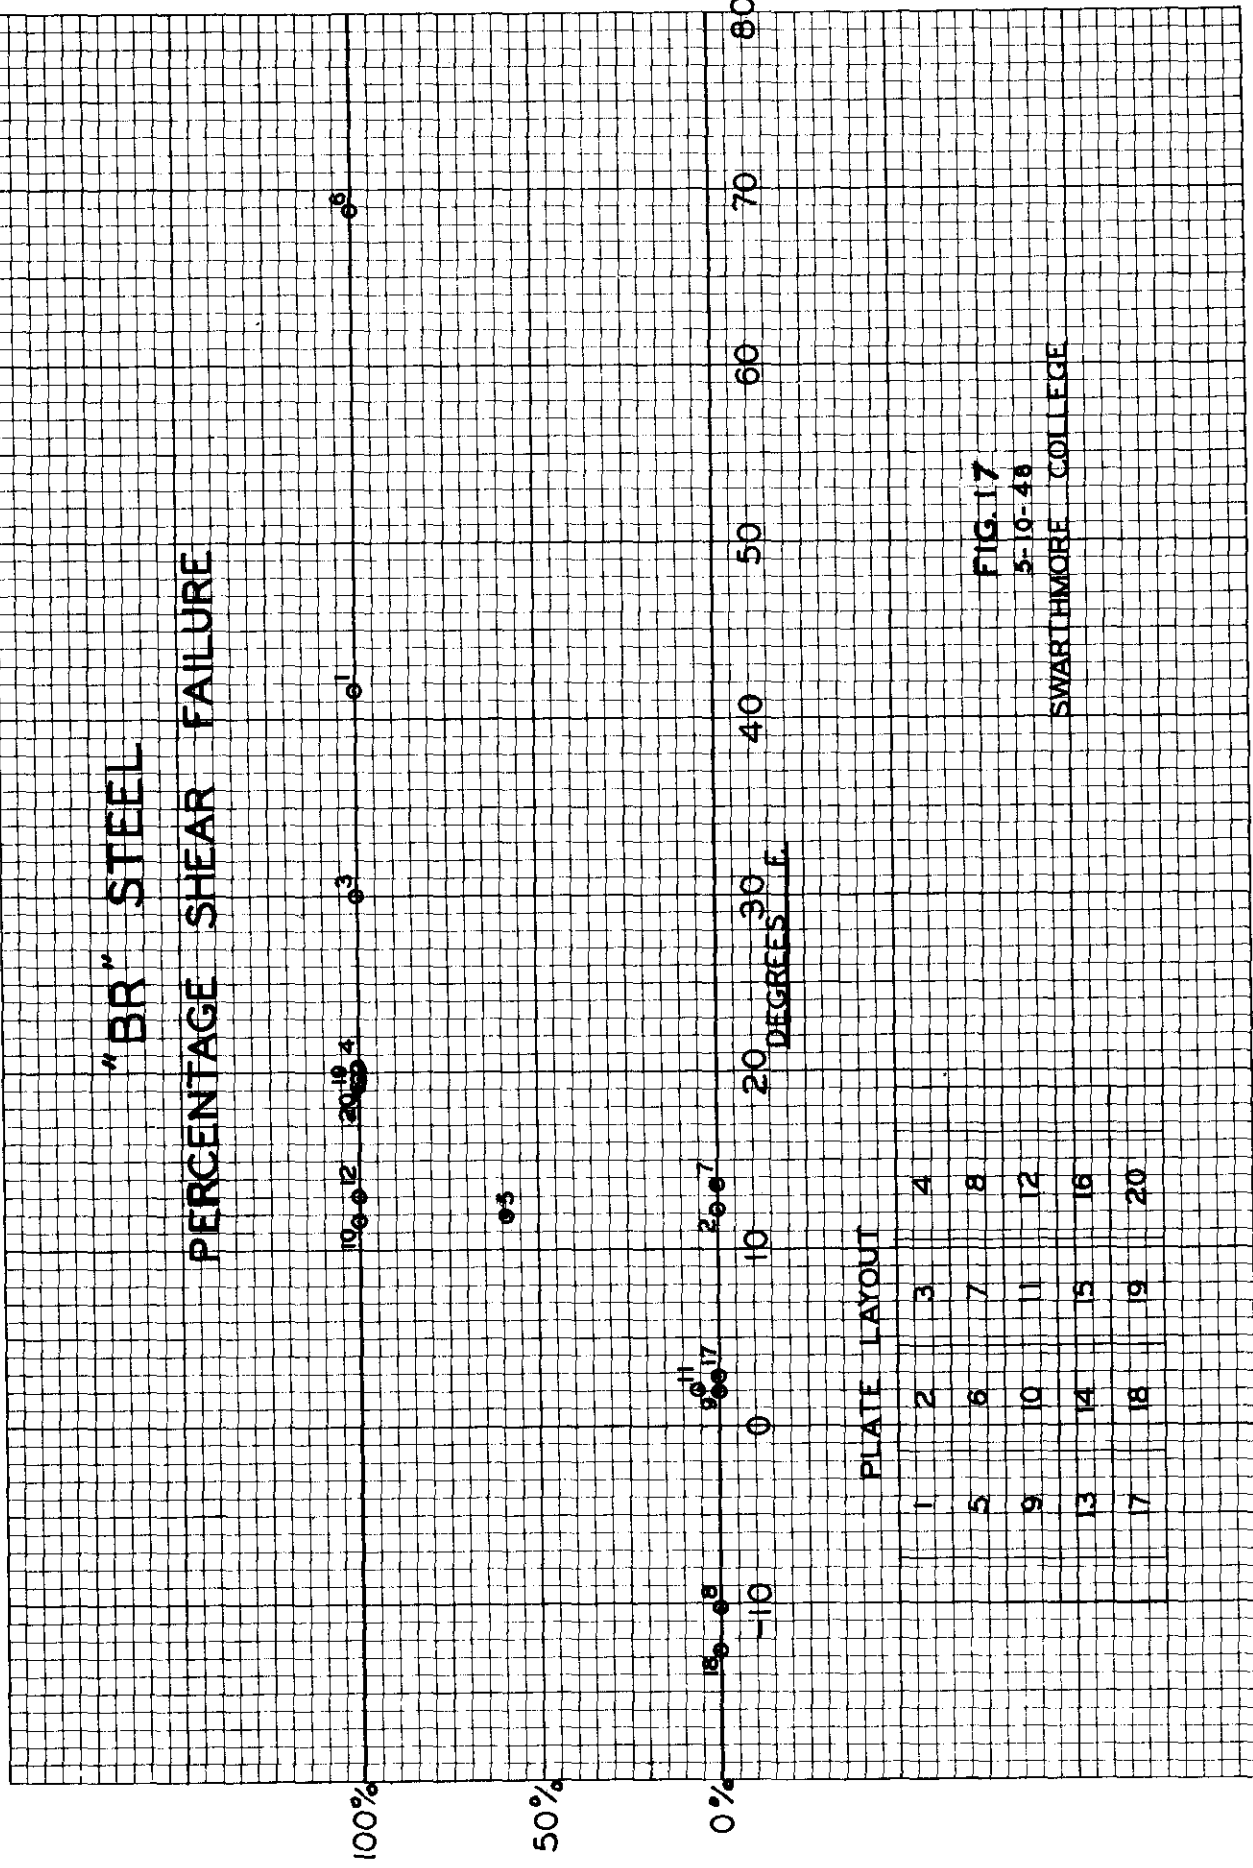
FIG. 17  
5-10-48  
SWARTHMORE COLLEGE

The transition temperature zone based on appearance of the fracture as evaluated in terms of the per cent of shear also lies between 10°F and 15°F. (See Figure 17).

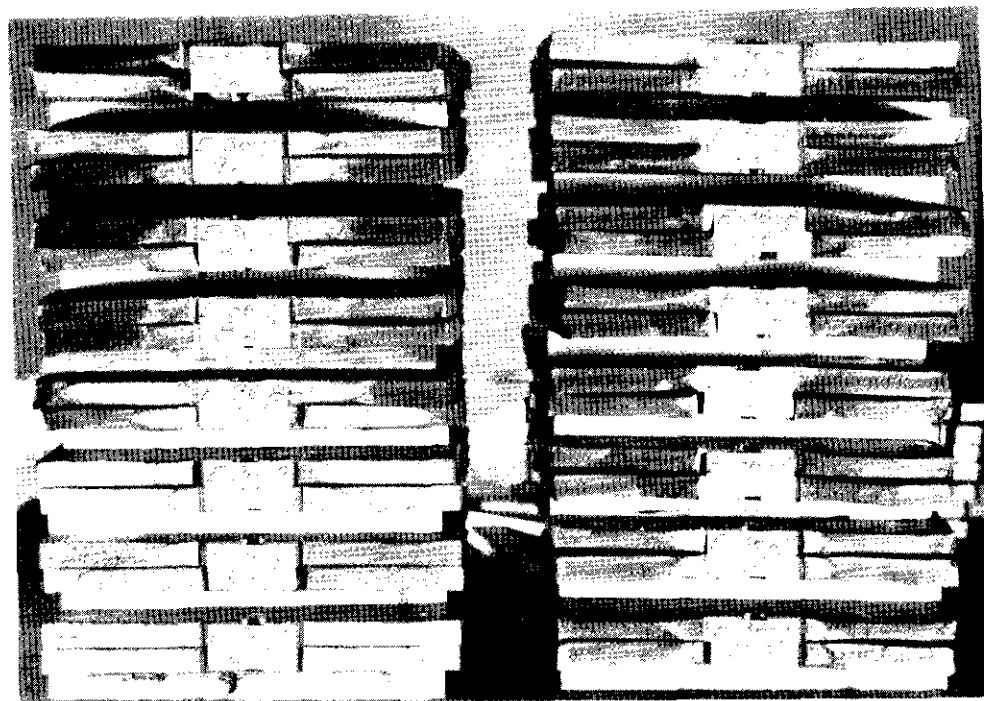
Fig. 22 "E" STEEL"

The behavior of the 16 specimens of "E" steel is quite erratic, although not to the degree found in "C" steel. It is interesting to note that only these two steels were characterized by "thumbnails" adjacent to the notch. These "thumbnails" are quite evident in Figure 22 which shows the fracture surfaces of "E" steel. The formation of the "thumbnails" was accompanied by a sharp snap clearly audible to the test crew, together with an abrupt drop in load of 20,000 to 50,000 lbs.

PHOTOGRAPH OF FRACTURE SURFACES

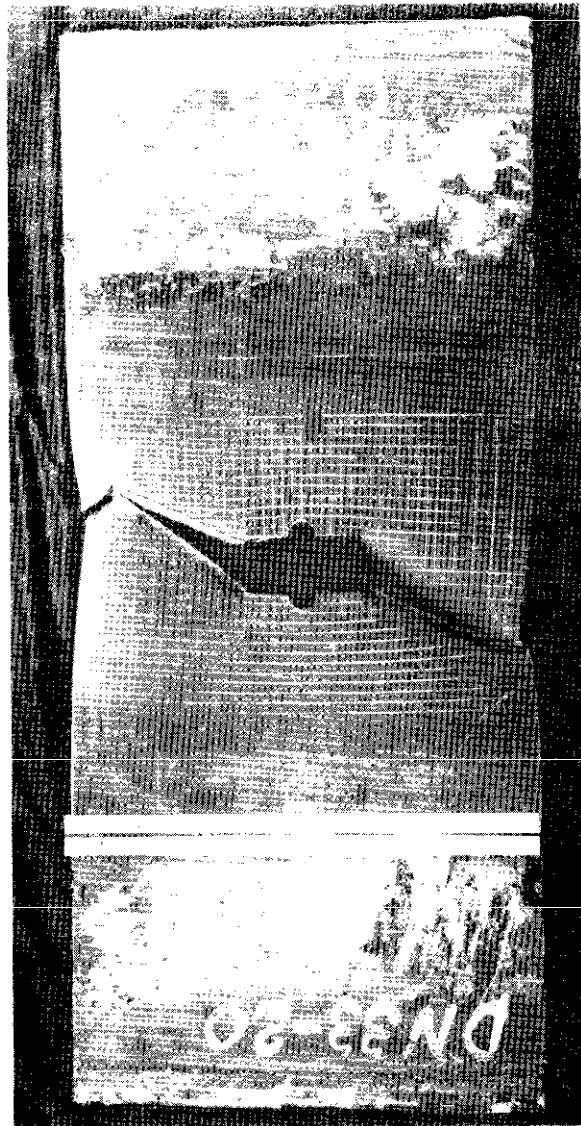
Fig. 28 - Specimen Dn-33-20

Photographs of the grids of the specimens having the lowest and highest energy absorption tested at Swarthmore are shown in Figures 27 and 28 respectively. Figure 29 depicts a cleavage - shear - cleavage fracture as exemplified by specimen C-24-8.

Highest Energy Absorption

The appearance of the fracture as based upon the per cent shear was estimated as follows: the sum of the lengths of shear tears on both sides of the notch was divided by the total length of fracture surface. It must be noted that the latter length is not always the 9" of net cross section since some ductile tears do not proceed straight across the specimen but make an angle to the transverse axis such as shown for specimen Dn-33-20 in Figure 28.

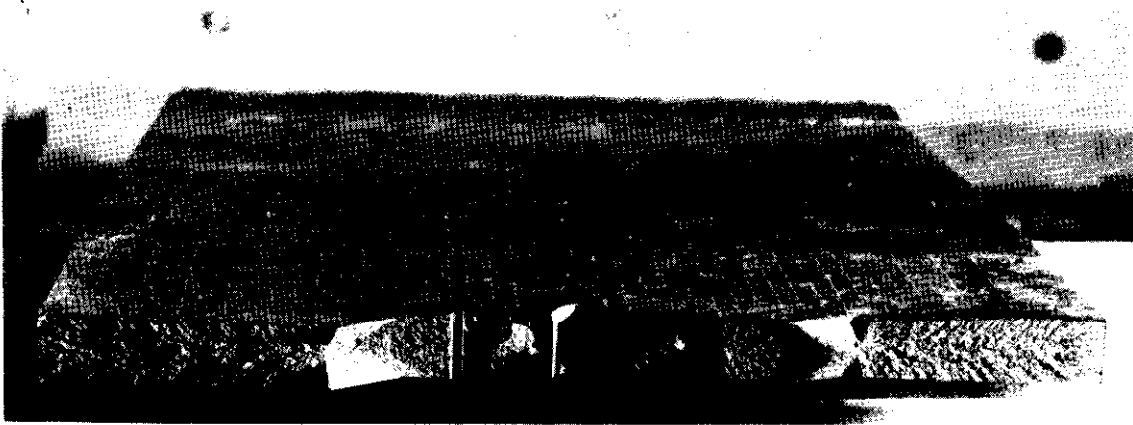
Fig. 29 - Specimen C-24-8

Example of Cleavage - Shear - Cleavage

Mode of Fracture

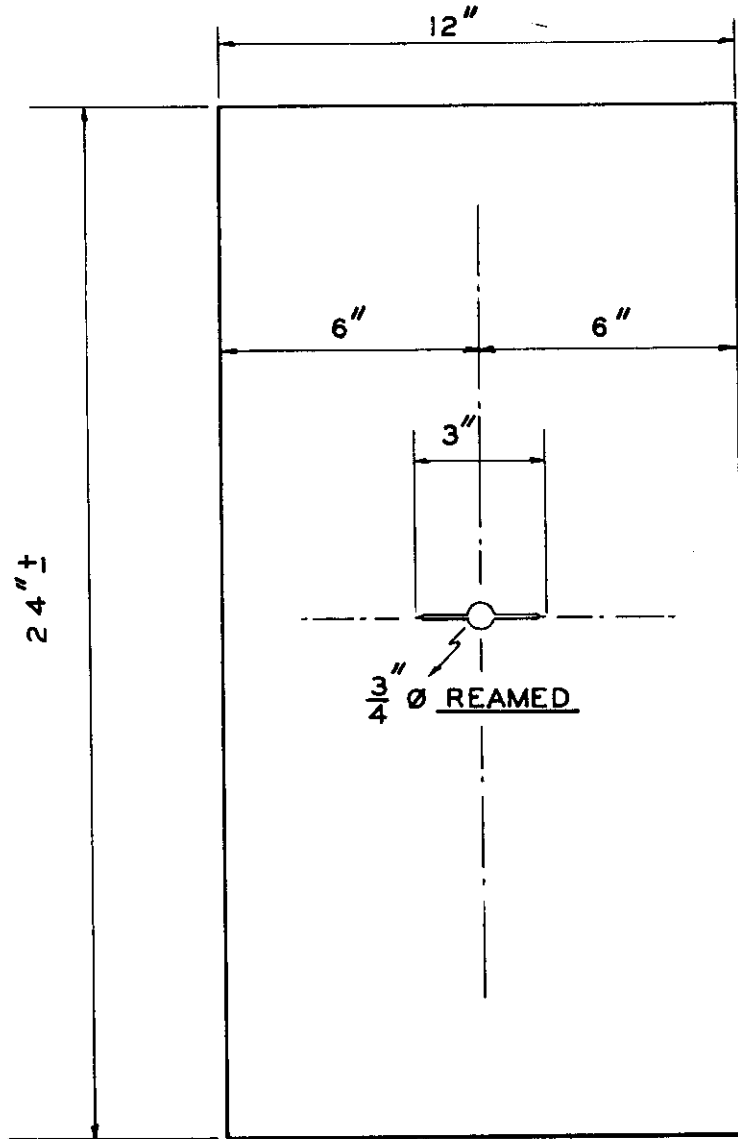
FIG. I-1

NOTCH LAYOUT

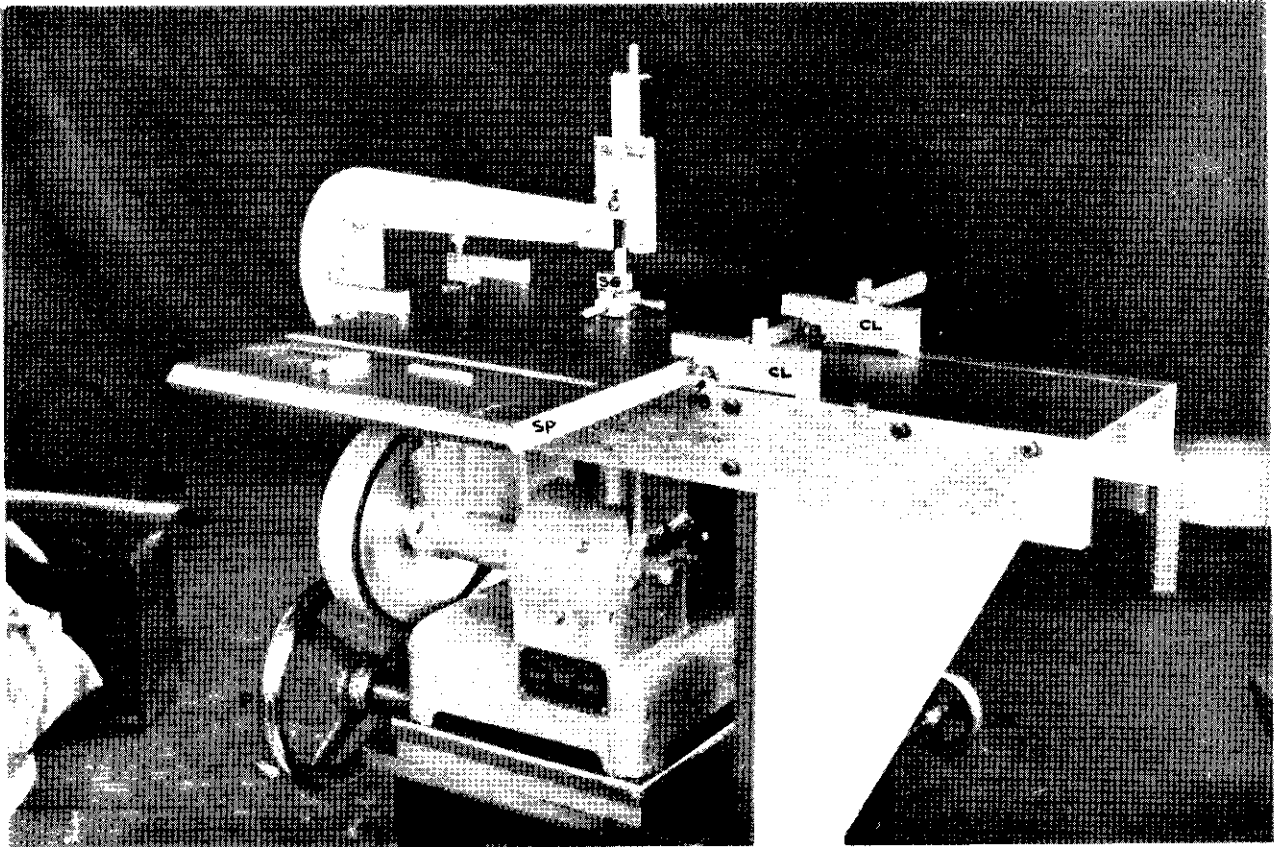
Fig. I-3 JIG SAW ASSEMBLY

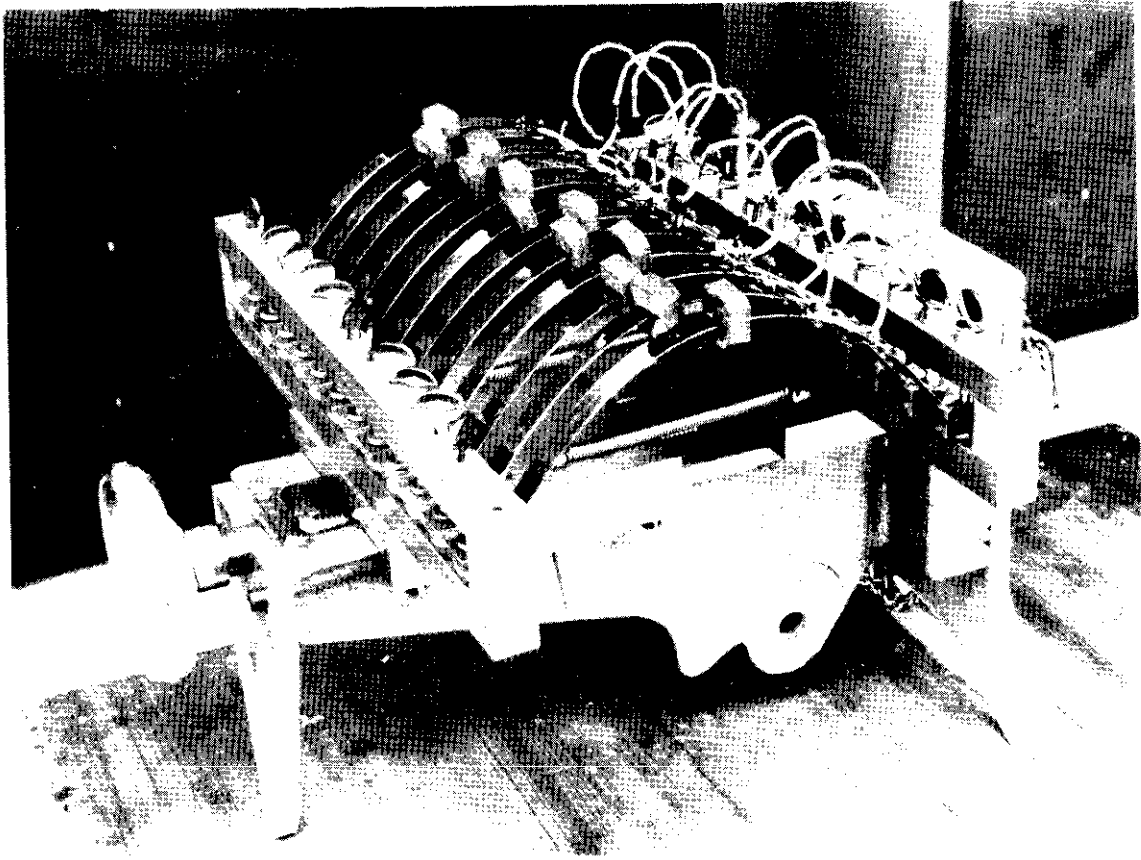
Fig. I-4 GAGES IN CALIBRATOR

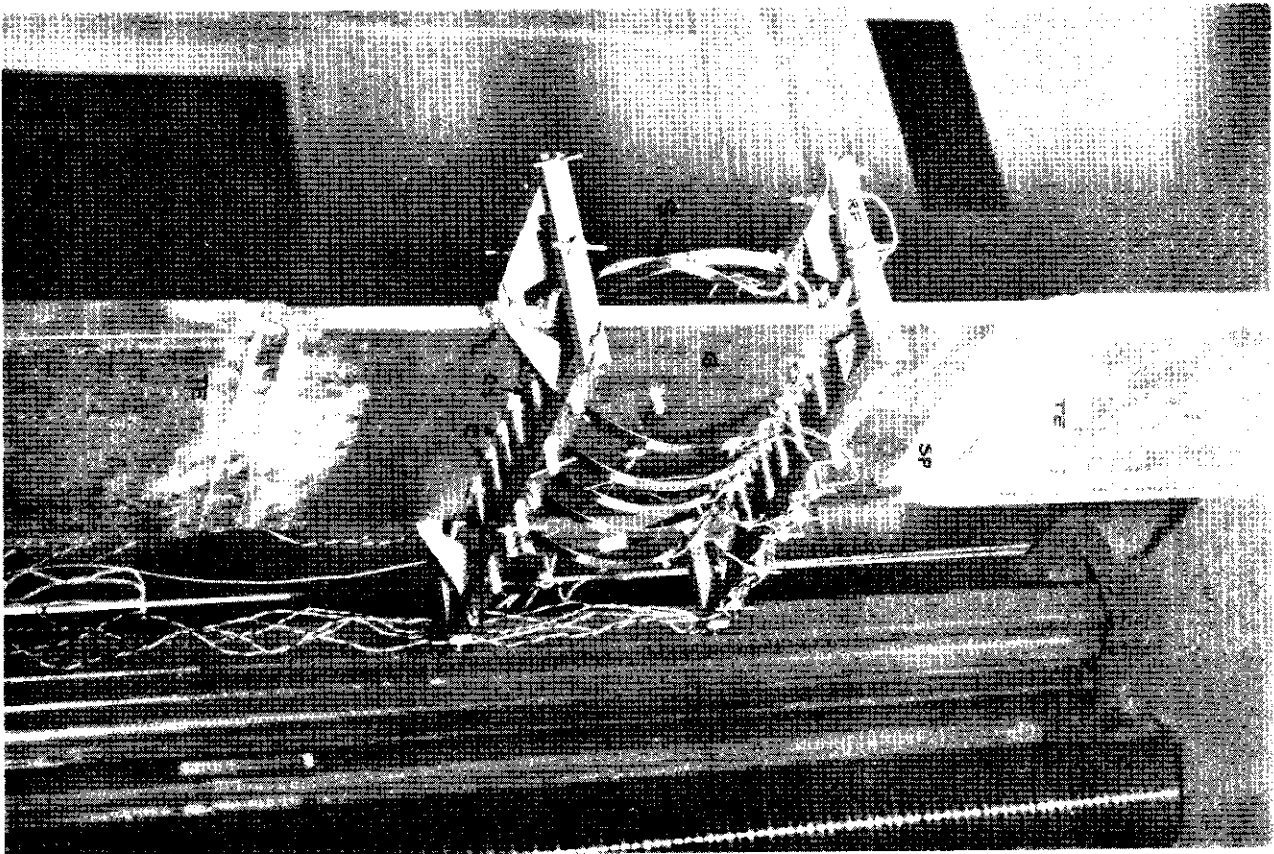
FIG. I-5 GAGE ASSEMBLY
