SERIAL NO. SSC-41

PROGRESS REPORT

**EVALUATION OF IMPROVED MATERIALS AND METHODS OF
FABRICATION FOR WELDED STEEL SHIPS**

**BATTELLE MEMORIAL INSTITUTE
Under Bureau of Ships Contract NObs-48015**

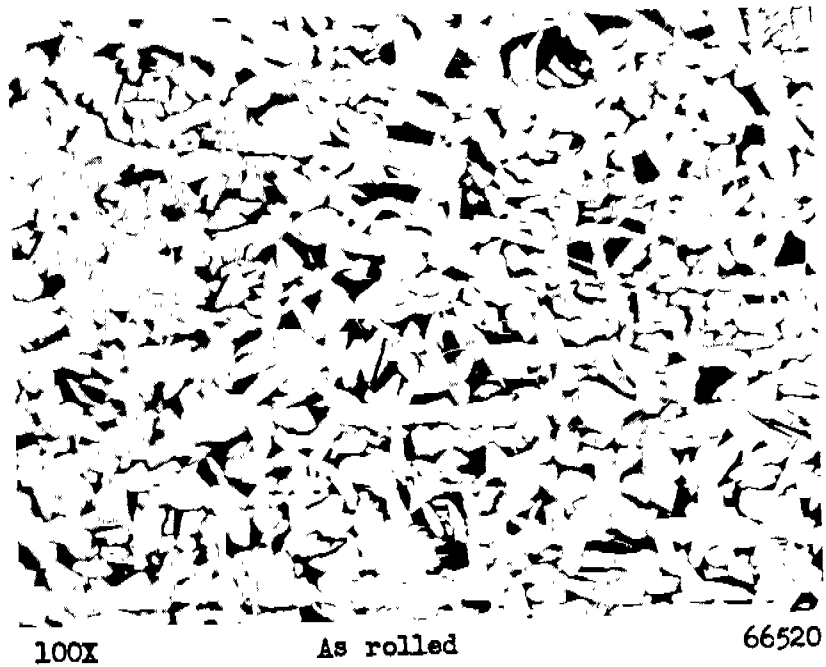
FIGURE 13. BANDING TENDENCIES OF COMPANY A
STEEL HEAT NUMBER 71P200-1 WHICH CRACKED
0 PER CENT IN STANDARD TESTS

The difference in the amount of pearlite in the bands of Steels 71P200-1 and 66P193-1 appeared greater than the difference in the carbon content of these two steels, as shown by the mill-check analyses. The mill-check analyses and Battelle analyses follow:
