FINAL REPORT

(Project SR-124)

**PART II: INVESTIGATION OF THE PERFORMANCE
OF WELDMENTS AND PRIME PLATE OF
ABS-B STEEL**

SHIP STRUCTURE COMMITTEE

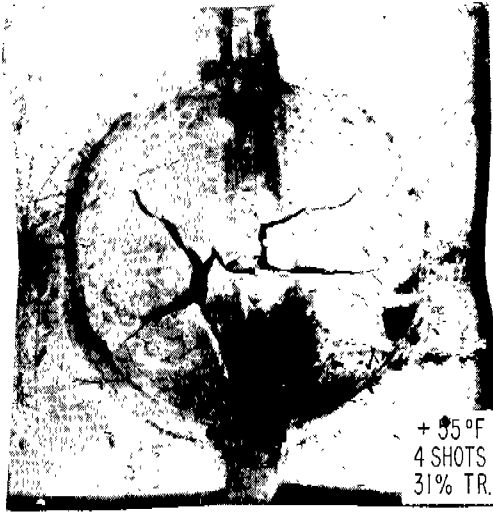
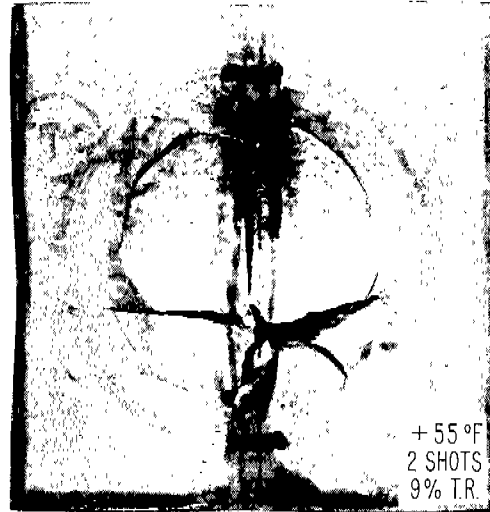
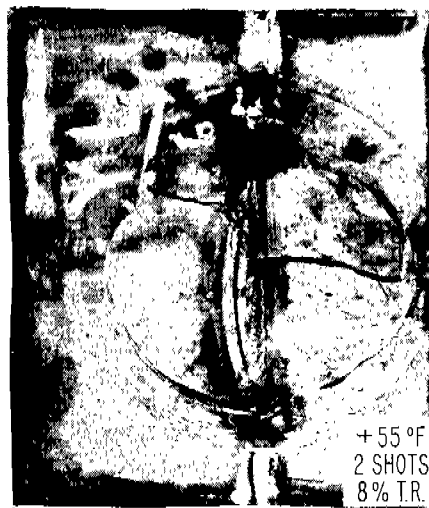
Fig. 7. Result of Tests Illustrating the Relative Severity of Arc Strikes and Partial Penetration Welds.

Figure 7 illustrates the results of the various tests which were conducted. Two partial penetration welds and two full penetration welds were bulge tested at 55°F. The partial penetration welds withstood 8--9% T.R. (thickness reduction of plate) prior to failure; one of the full penetration welds withstood 31% T.R. prior to failure; and the other withstood only 8% T.R. due to the presence of weld porosity. These results indicate a decrease in performance of approximately equal magnitude due to partial penetration and weld porosity. From a practical viewpoint of the performance of conventional

Following these tests, the effect of the presence of arc strikes was investigated. Material was removed from the sides of a bulge test sample (as denoted by the dotted area A and B shown in Figure 7), and arc strikes were applied using a carbon-arc technique. This method produces reproducible crack conditions adjacent to the arc strike crater. The use of conventional E6010 electrodes to produce arc strikes may also result in cracks but not reproducibly, i.e., the arc strikes which result may or may not be associated with sharp cracks. The next step was to determine the critical temperature below which deformation is not possible in the presence of the sharp cracks associated with arc strikes. This temperature may be determined from the Charpy V transition curve (below 10 ft-lb) or more expeditiously by means of the drop-weight technique. Based on the previously described drop-weight tests of ABS-B steel, it was suspected that the critical temperature was approximately 20°F; accordingly, sections A and B were drop-weight tested at 20°F. The resulting fractures indicated that this temperature was appropriate for the comparisons intended. Figure 8 (bottom) illustrates the type of cracks which are obtained with arc strikes and the fractured drop-weight specimens A and B (top).
