**EVALUATION OF WELD-JOINT FLAWS AS INITIATING  
POINTS OF BRITTLE FRACTURE**

D. C. Martin, R. S. Ryan, and P. J. Rieppel

Serial No. SSC-86

First Progress Report  
of  
Project SR-131

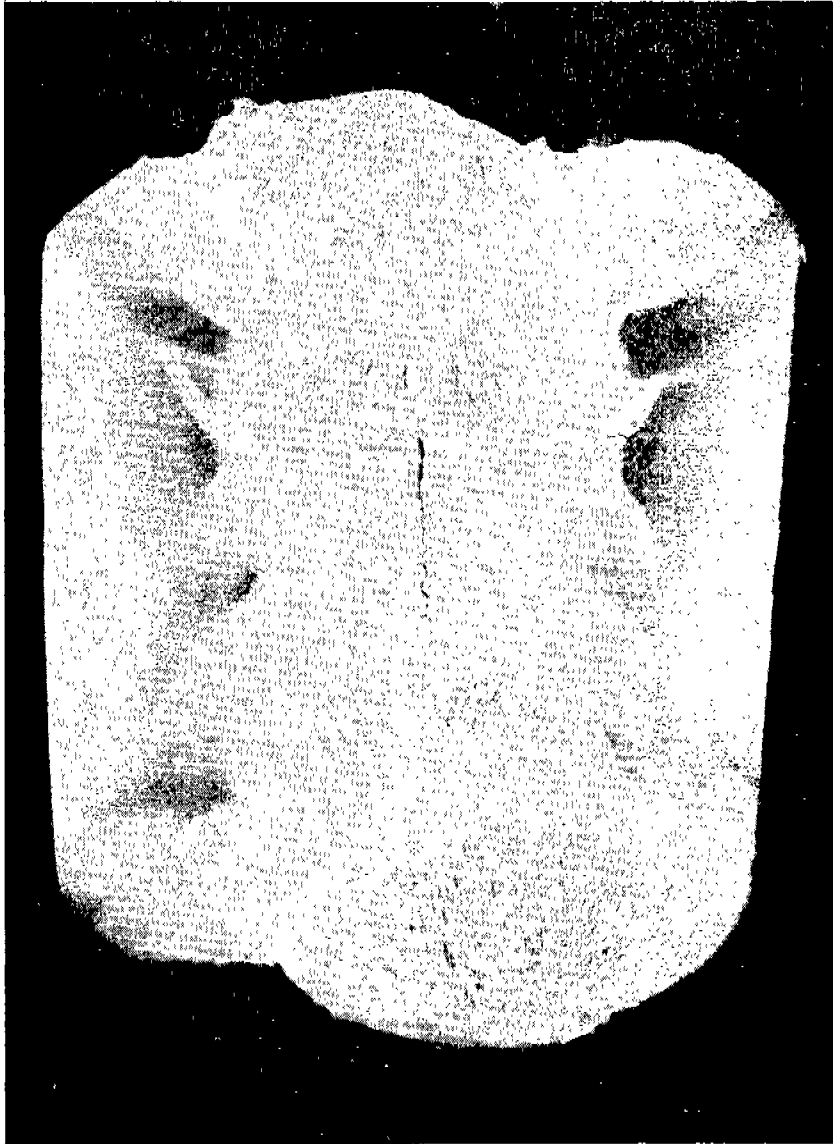
FIGURE 4. Crack in both root passes of a double-vee butt joint welded with E6020 Electrode. Subsequent passes welded with E6010 Electrode.

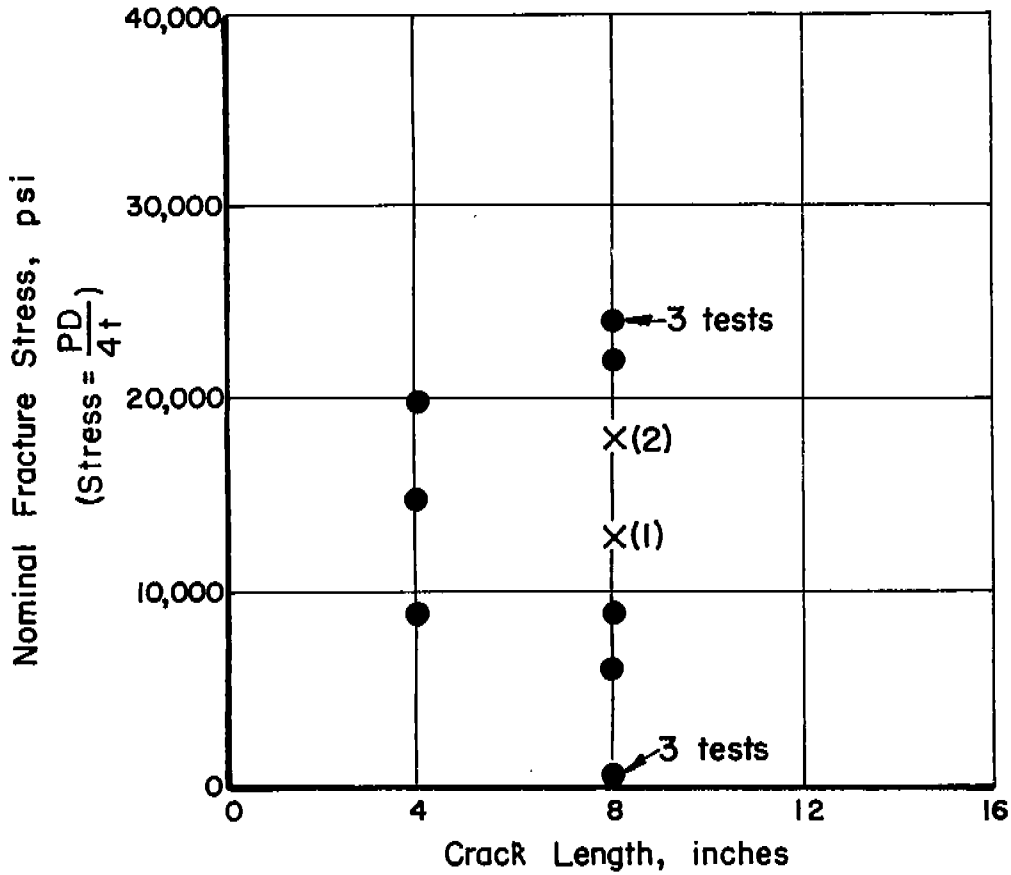
FIGURE II. COMPARISON OF RESULTS OF TESTS IN WHICH AN ATTEMPT WAS MADE TO INTRODUCE RESIDUAL STRESSES AT THE FLAW. NORMAL STRESSES REQUIRED TO INITIATE BRITTLE FRACTURE WITH 8-INCH CRACK WAS 24,000 PSI, WITH 4-INCH CRACK 30,000 PSI OR HIGHER

(1) Measured residual stress = 13,000 psi

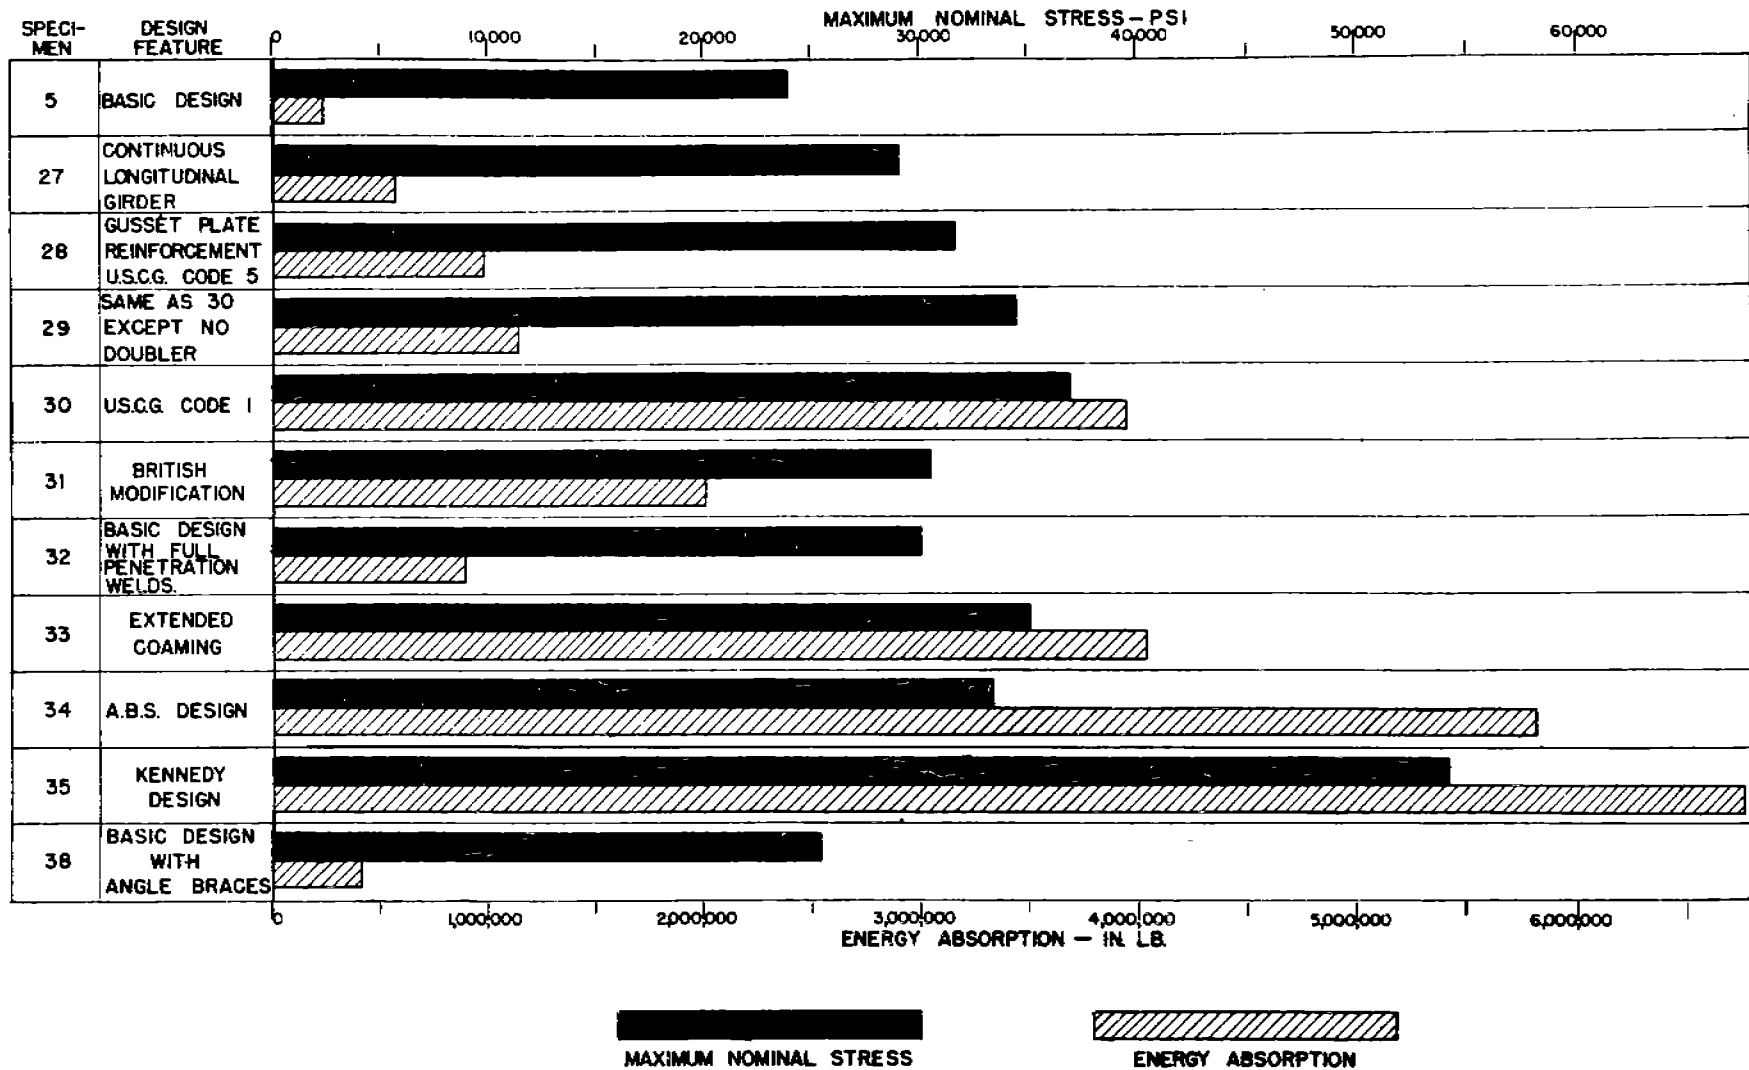
FIGURE A-2. COMPARISON OF VARIOUS DESIGNS OF HATCH CORNERS (14)

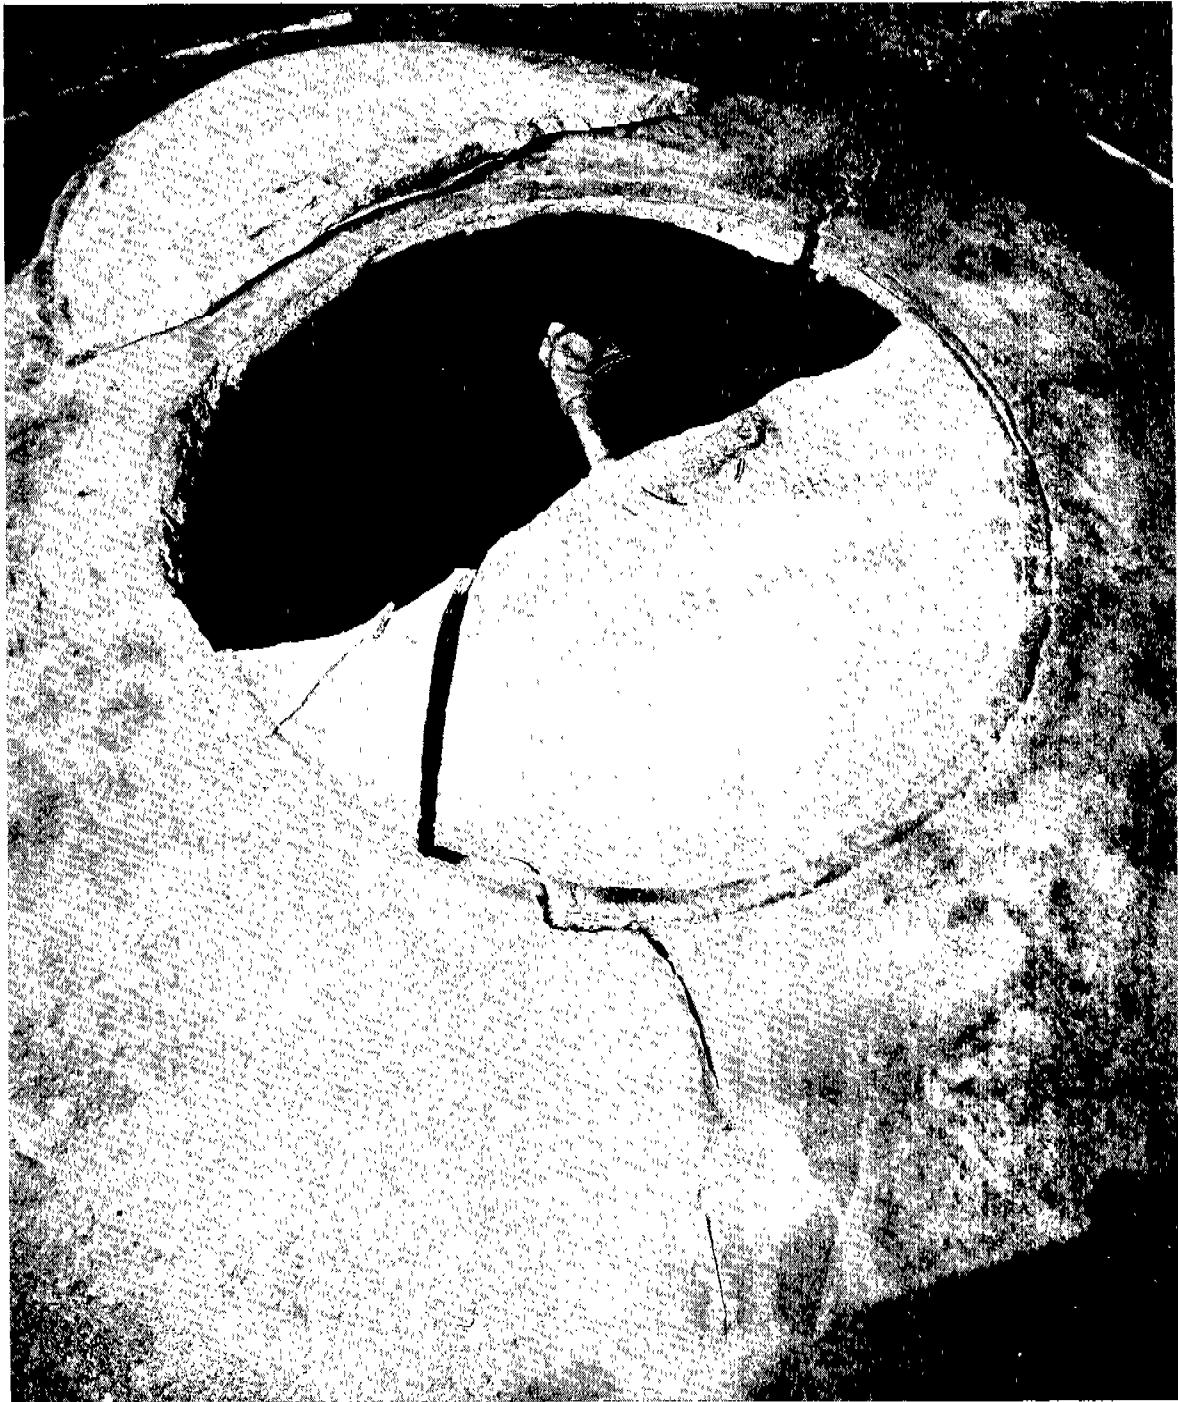
FIGURE D-4. Photograph showing fracture that turned at the E10016 joining weld and followed an old repair weld. It finally stopped in unrepaired T-1 after propagating 15-1/2 in. into the sphere on one side and 12 in. on the other.

The fracture of Test 66, as shown in Fig. D-4, propagated 15 1/2 in. into the sphere on one side of the disk and 12 in. on the other. The fracture turned at the E10016 joining weld to follow an old repair weld in the sphere part of the way down and then stopped after propagating about 5 in. in unrepaired T-1.
