## **High Solids Coatings Performance and Service History**

Mark Ingle, Naval Sea Systems Command  
Paul Slebodnick and James Martin, Naval Research Laboratory  
James Ellor and Patrick Cassidy, Elzly Technology Corporation

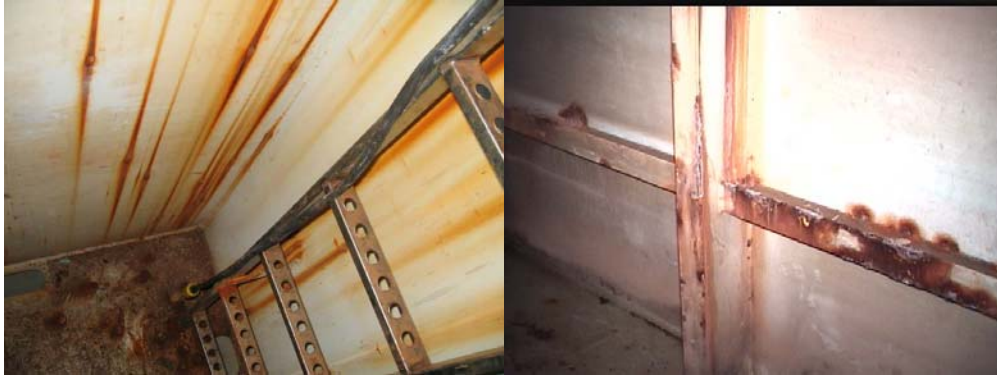
Figure 1 shows the typical appearance of a legacy coating system after about five years of service. From a performance standpoint, these coatings tend to suffer from pinhole rusting and poor protection of sharp edges, welds, and other complex “edges.”

**Figure 1 – Legacy Polyamide Epoxy Coatings Previously Favor for Navy Ship Tank Applications (approximately five years service)**

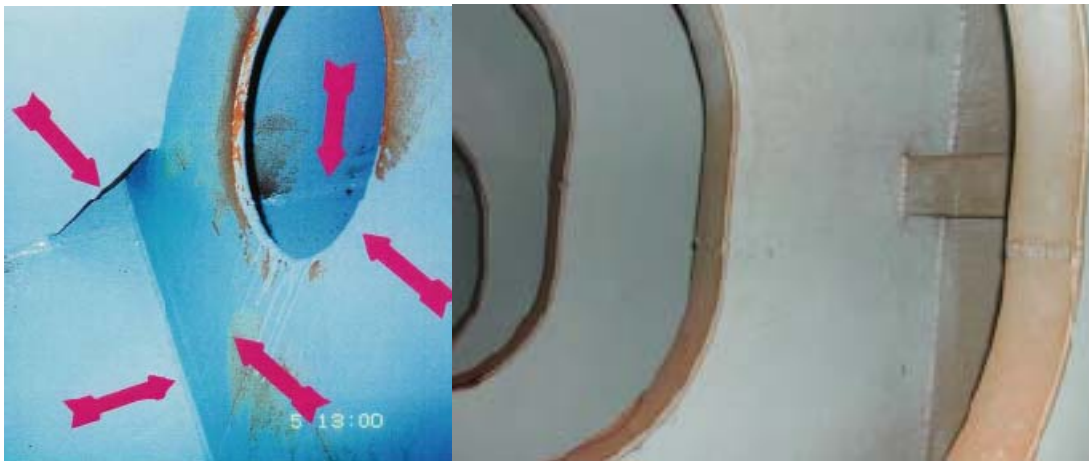
Figure 2 shows typical performance of some of the early installations of UHS coatings in seawater ballast tank service.

**Figure 2 – Ultra High Solids Coating Performance After Three Years (left) and Eleven Years (right). At Three Years, Discoloration is Staining. At Eleven Years there is less than 1% Coating Damage**

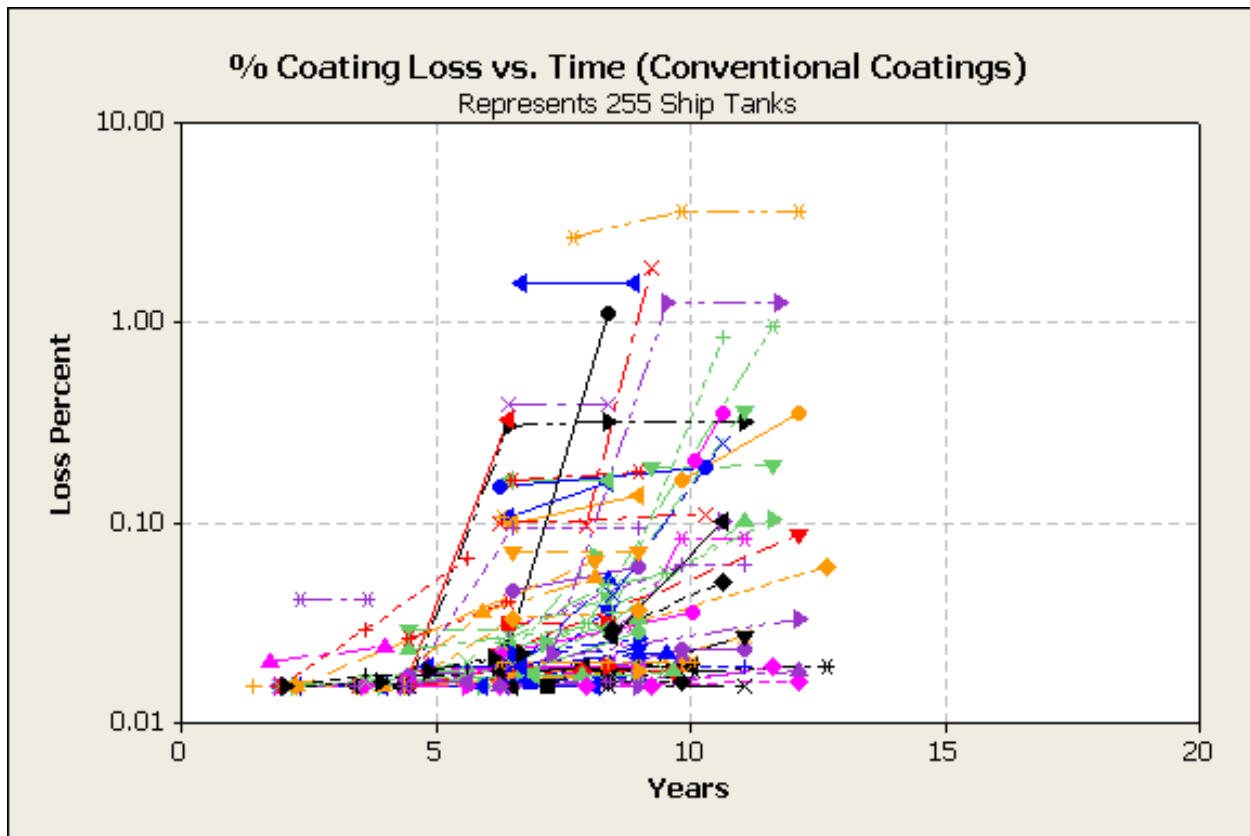
Figure 3 shows a graph of breakdown rate for legacy, solvent-based epoxy coatings including the Navy MIL-DTL-24441 coating system as well as commercial, solvent-based coatings qualified to MIL-PRF-23236.

**Figure 3 – Percent Coating Loss vs. Time for Conventional Coatings**

The first key observation in comparing Figures 3 and 4 is that the population of seawater ballast tanks with coating loss rates in excess of 0.10% is far higher for the legacy, solvent-based coating population than for the UHS coating population. In fact, careful examination of the Figure 4 data show only a single tank to have >0.10% coating loss. The Navy has no specific data on this tank, but as noted earlier, all tanks, regardless of tank service life are included in the UHS data pull while simply because of the history of UHS implementation, all tanks in the solvent-based population are inherently more than five years old. Again, understanding that the authors have no data on the one UHS tank with the >0.10% failure, one could easily postulate that this one tank had improper surface preparation, poor environmental controls during coating application, or any number of other “problems” that could lead to premature coating failure. Thus because all tanks are included in the Figure 4 data, including those that may be failing prematurely, while only tanks that have survived for five years or more (i.e., those tanks that had poorly applied coatings have failed already and been replaced) are included in Figure 3, the trend toward higher coating loss percentages in Figure 3 is clear.

One other key point in comparing the figures is that there are plenty of tanks in Figure 3 that have coating loss rates of <0.10%. Again understanding that coating application practices has a profound influence on coating service life, one could argue that solvent-based coatings, when

applied properly can provide a level of performance similar to UHS systems. However, the data show that most tanks with solvent-based coatings did start to experience coating breakdown after five years of service.

While the most obvious difference between the Figure 3 and Figure 4 data sets is the paint technology, it should be noted that the institutionalization of these new coatings was done in parallel with implementation of enhanced QA techniques and procedures. It is not entirely possible to separate the two effects. As discussed above the coating application workmanship is always important and can have a profound influence on overall coating system service life.
