SSC-320

A STUDY OF EXTREME WAVES AND THEIR EFFECTS ON SHIP STRUCTURE

SHIP STRUCTURE COMMITTEE

1983

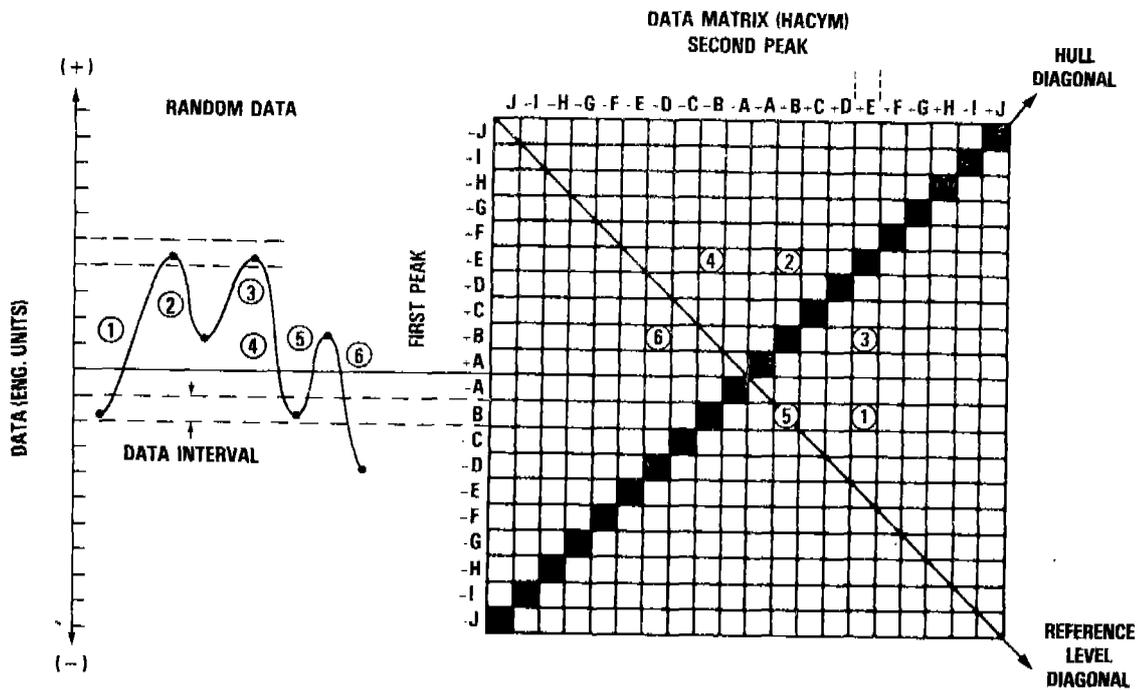
Figure 1 - Half-Cycle Counting of Random Time-Series Data

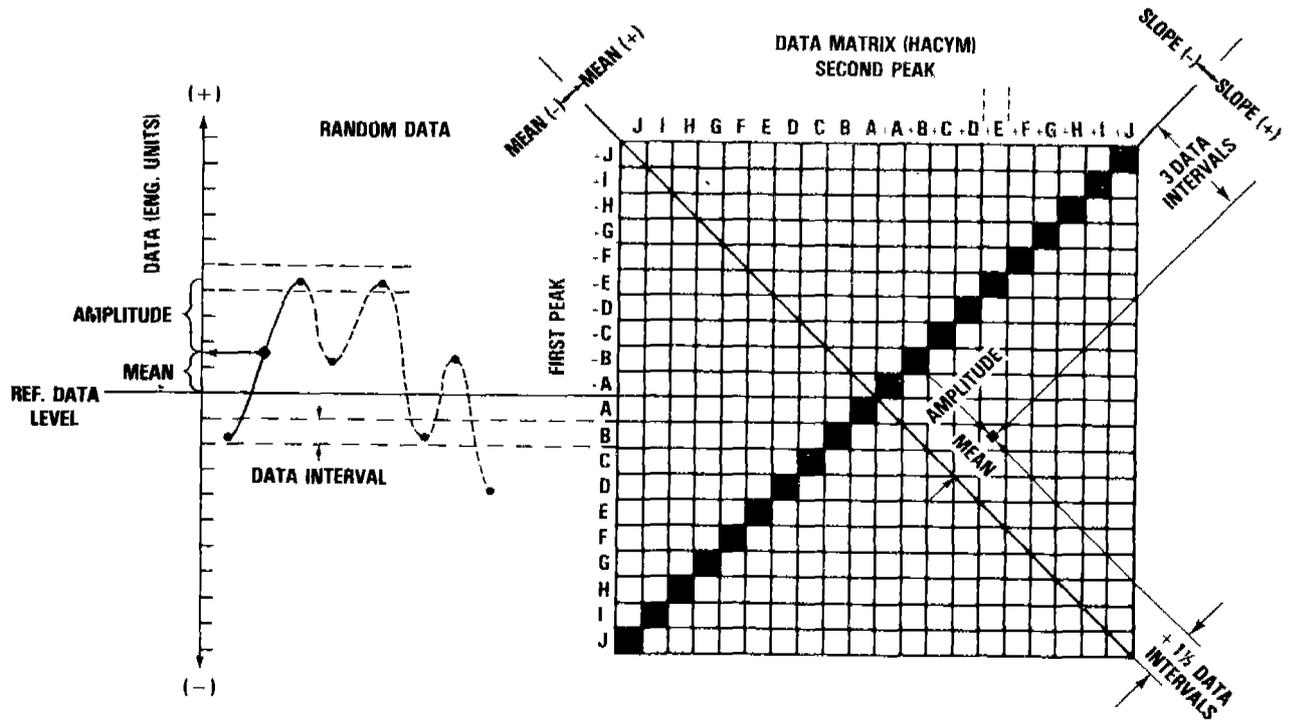
Figure 2 - Characterization of Half-Cycle Data Excursions Within the Half-Cycle Matrix

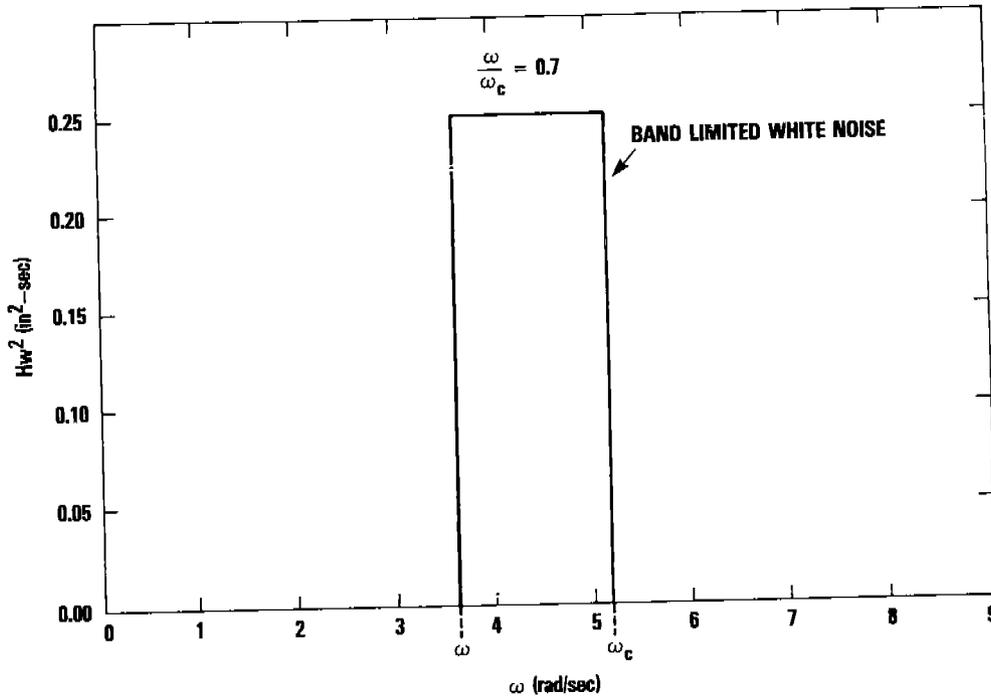
Figure 3 - Narrow-Band Variance Spectrum

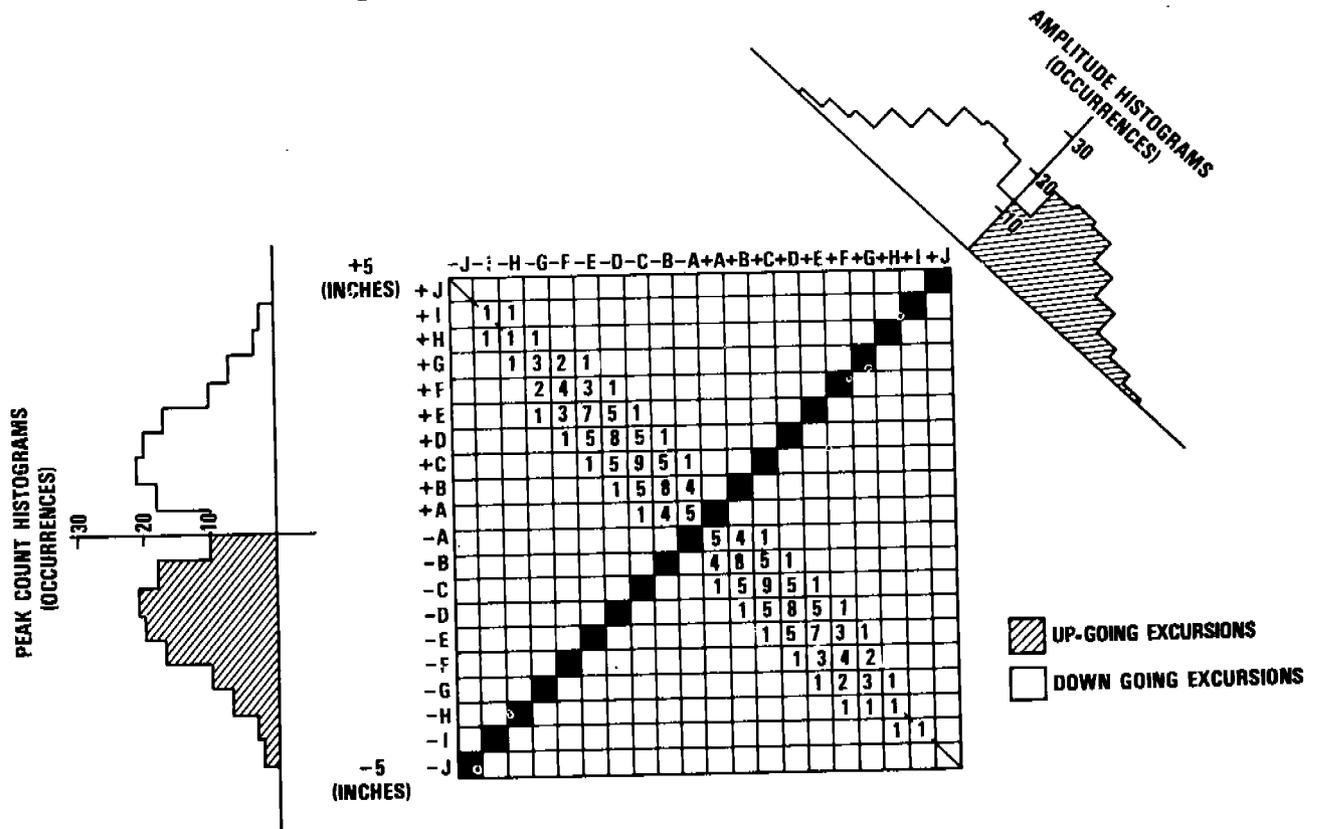
Figure 4 - HACYM Analysis of Narrow-Band Variance Spectrum ($\frac{\omega}{\omega_c} = 0.7$)

histograms of peak counts and amplitude occurrences.* The characteristic of symmetry derives from the Gaussian nature of the process since data events having the same absolute values of mean and amplitude can be expected to have an equal probability of occurrence. The Rayleigh distribution of peak counts follows from Yang's mathematical formulation of the problem and since it is a narrow-band process, the histograms of peak counts and amplitude occurrences both have a Rayleigh distribution. For a stochastic process which is not "narrow-band," the pattern of half-cycle counts will spread in the direction of the null diagonal and become more nearly circular. As found by Cartwright and Longuet-Higgins,⁵ the histograms of peak counts will approach a normal distribution as the width of the energy spectrum for a Gaussian process becomes increasingly large, i.e., as the process becomes more broadband. Thus, in general, one may expect that if wave height as a stochastic variable is Gaussian in nature the distribution of half-cycle counts in HACYM format will be symmetrical about the diagonals of the data matrix whether the process is substantially narrow-band or not. To the extent that the process is not narrow-band the HACYM dispersion pattern will necessarily increase in width.

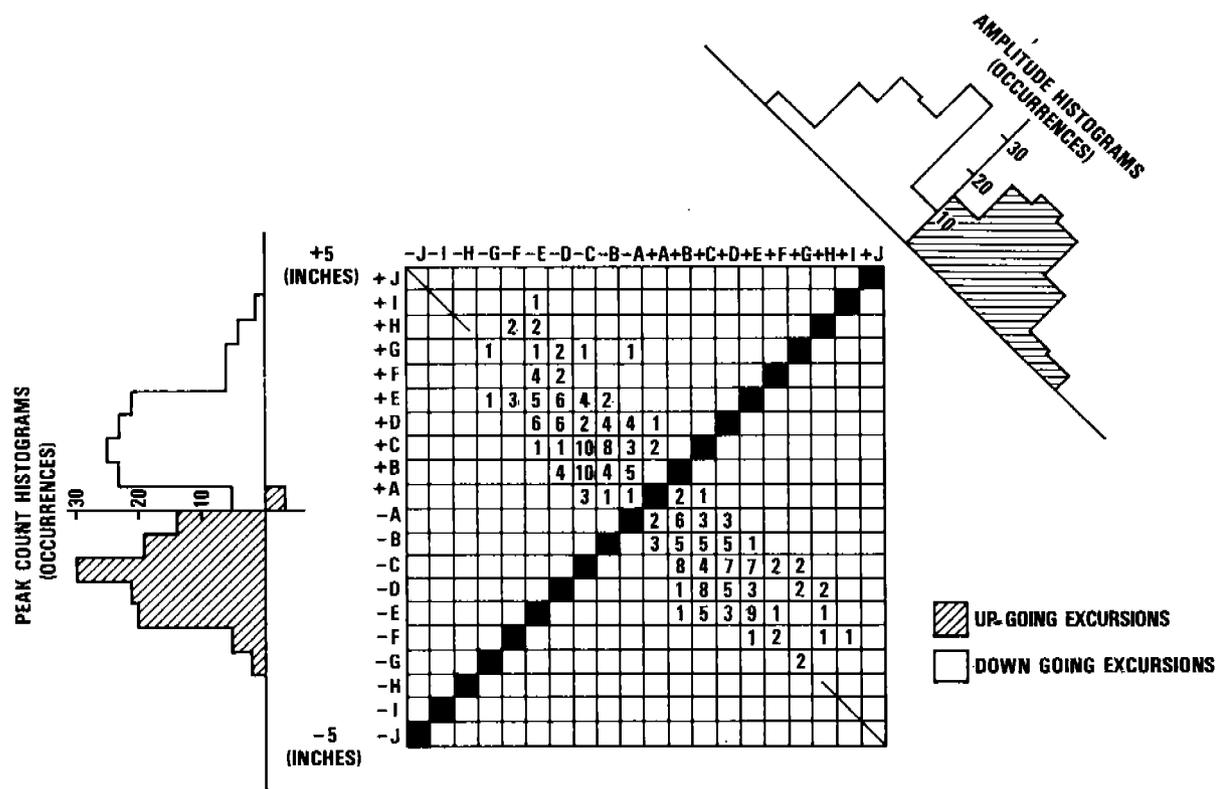
Figure 5 - HACYM Analysis of Test Tank Random Wave Data

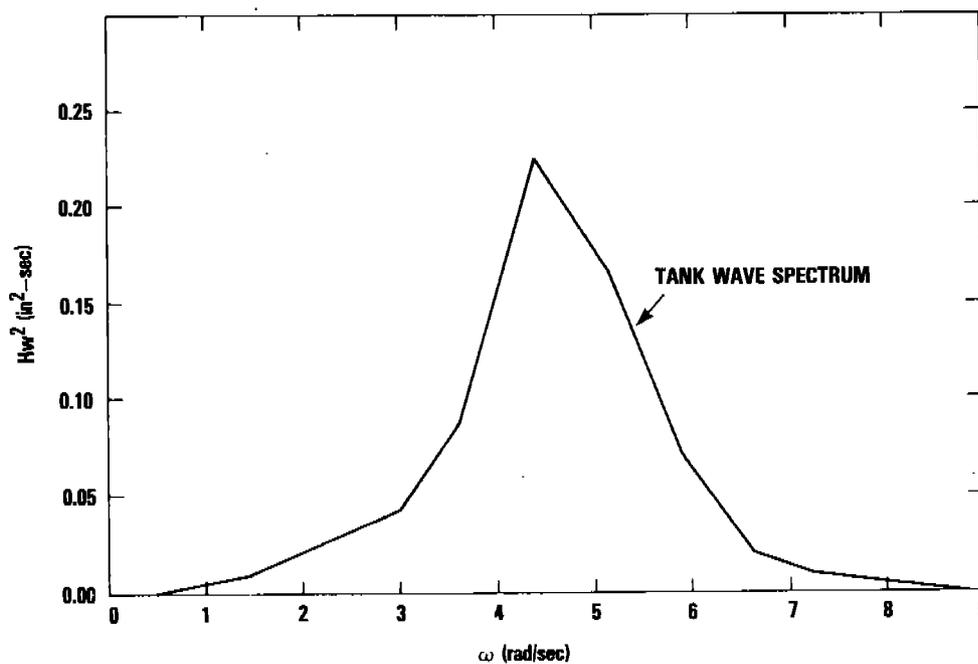
Figure 6 - Example Wave Height Variance Spectrum for Pneumatically Generated Tank Waves

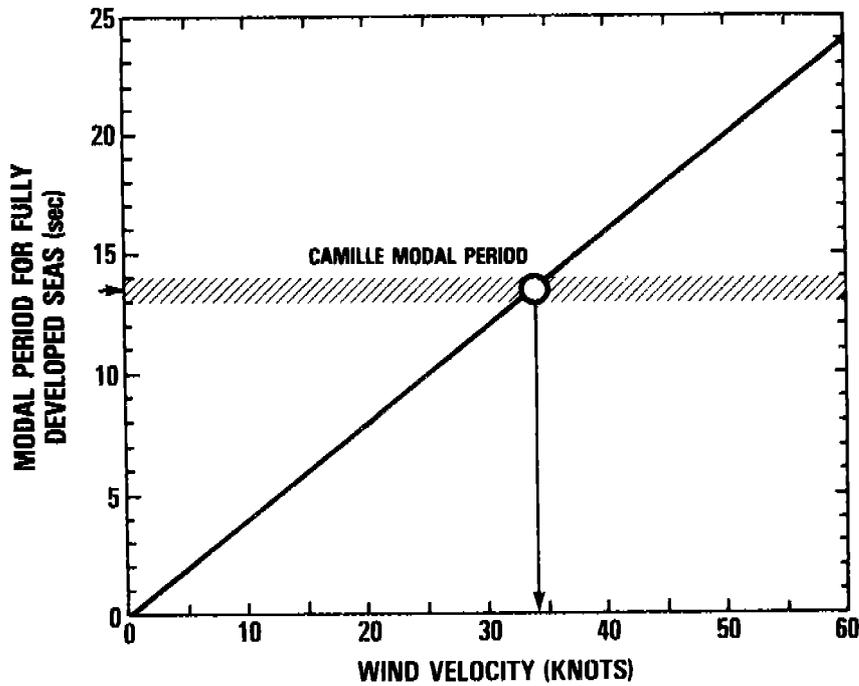
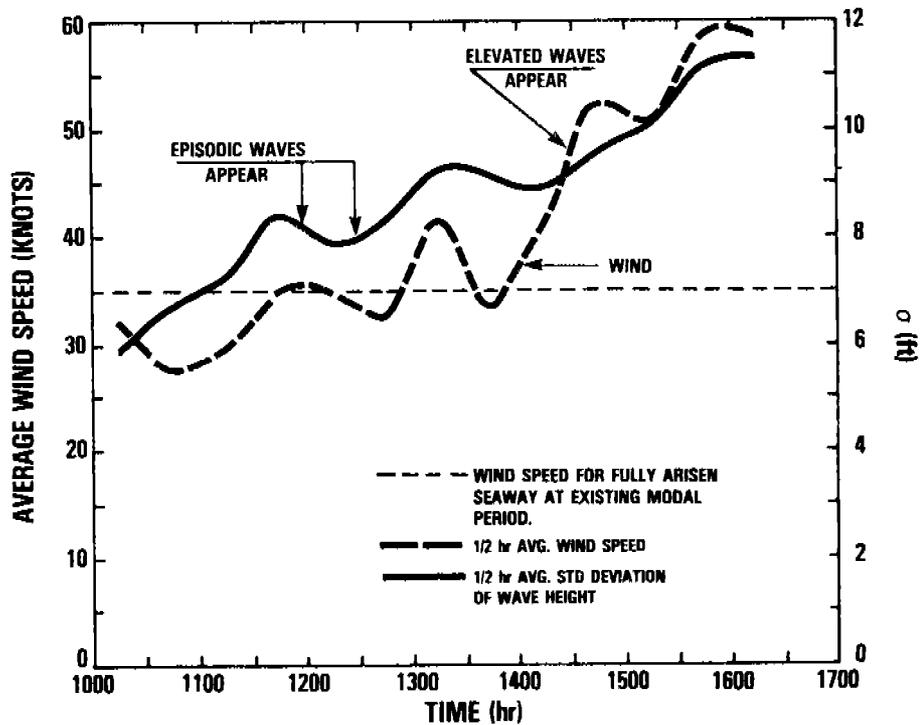
Figure 7 - Wind and Wave Correlations During Hurricane Camille

Figure 7a - Modal Period vs Average Wind Velocity for Fully Arisen Seas (from Table 2.1 of Reference 6)

Figure 7b - Comparison of Average Wind Speed and Standard Deviation of Wave Height During Hurricane Camille

****In Figure 7(b) no allowance has been made for possible misalignment of wind and waves, nor has a correction been made for relating the measured wind velocity to a standard height.

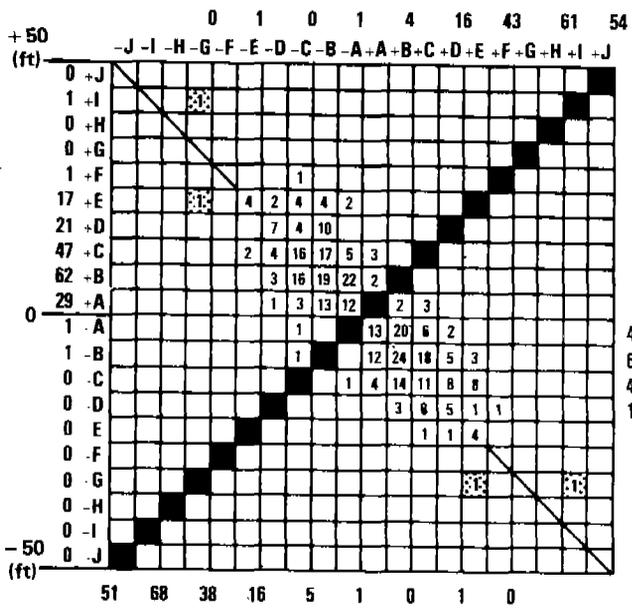
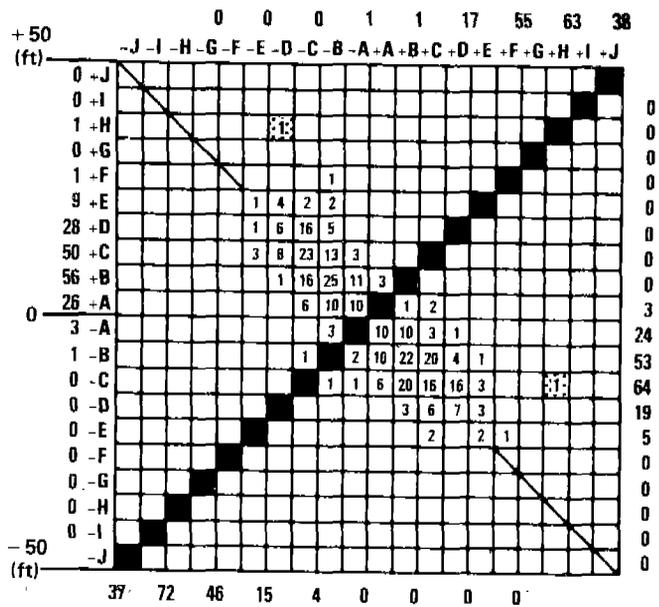
Figure 8 - Identification of Episodic Waves During Hurricane Camille

Whether or not the episodic waves of Figure 8 can be considered non-Gaussian cannot be easily determined. If the associated wave-height time-series were indeed Gaussian, particularly with respect to its extreme values, then the occurrence of an outlying wave event is possible although improbable. Regarding the improbability, Longuet-Higgins⁸ observed that "The general conclusion then appears that changes in the strength of the wind or other generating forces are more important in producing variability in the wave amplitude than is the statistical variation of the waves at any one time." From a sampling point of view, however, the episodic wave event remains a possible although improbable event. (From a wave research point of view, the study of episodic wave events logically requires a prior examination of the effects of energy dissipation due to wave breaking since this mechanism is likely to impose a natural limit on wave height under ordinary circumstances. With the results of such research in hand, the subject of episodic wave events could then be approached on a more meaningful basis.)

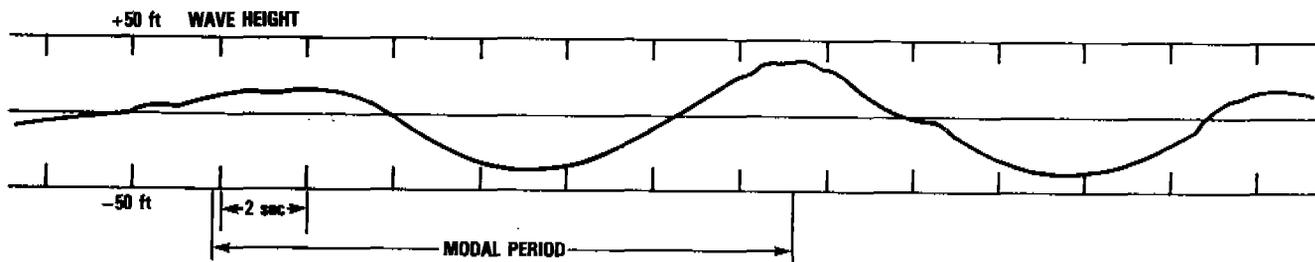
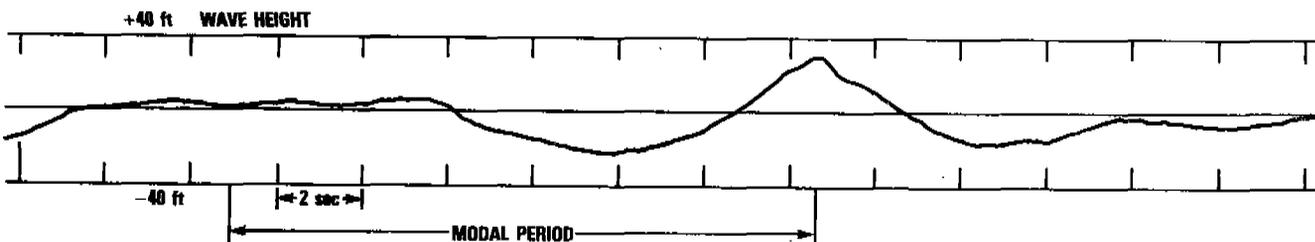
Figure 9 - Episodic Waves Recorded During Hurricane Camille

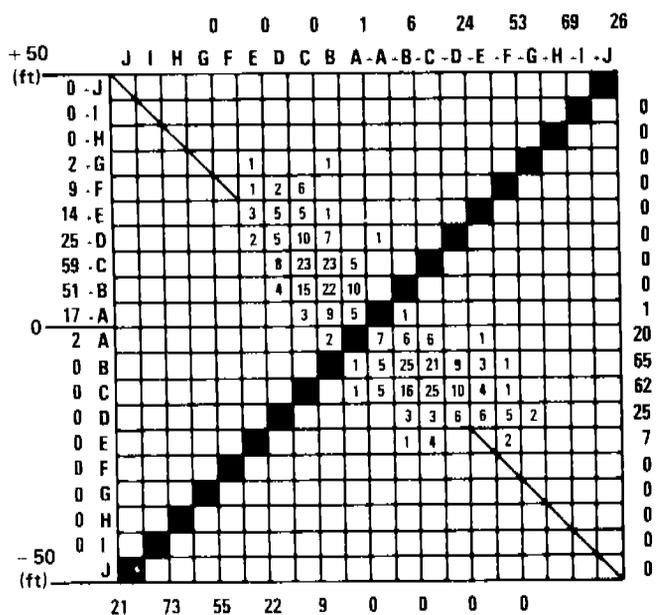
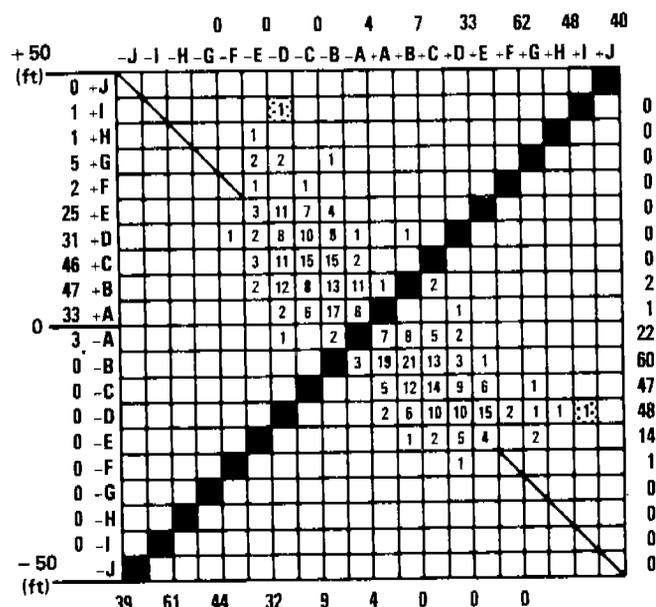
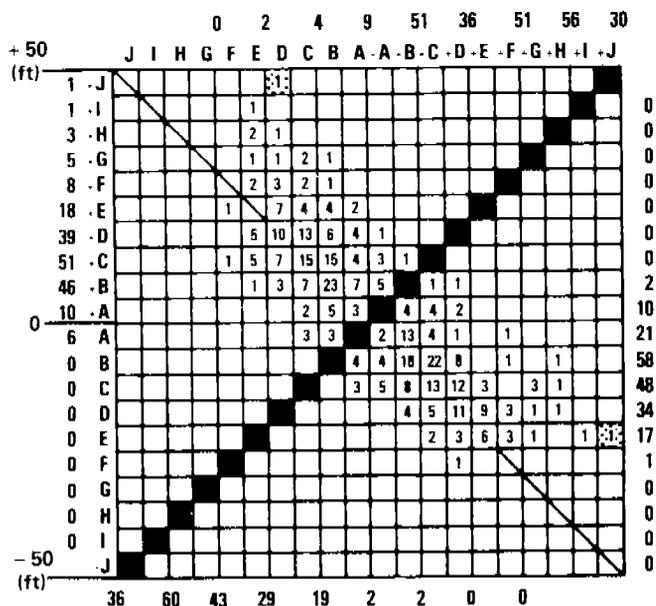
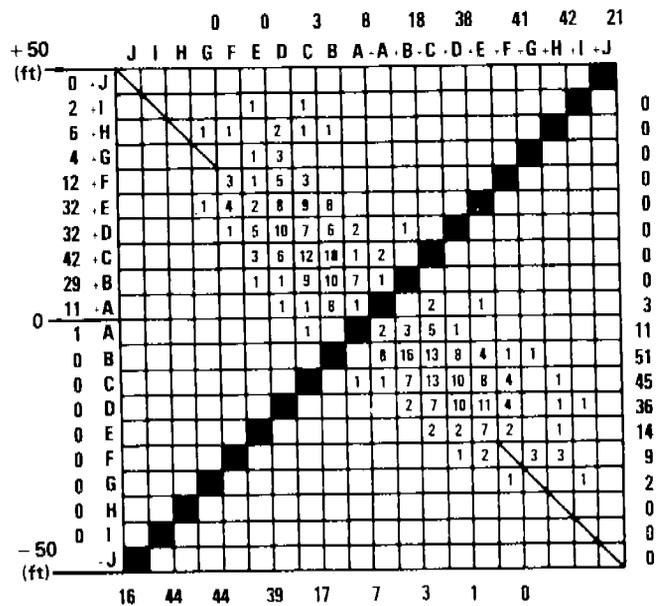
Figure 10 - Identification of Reoccurring Elevated Waves During Hurricane Camille

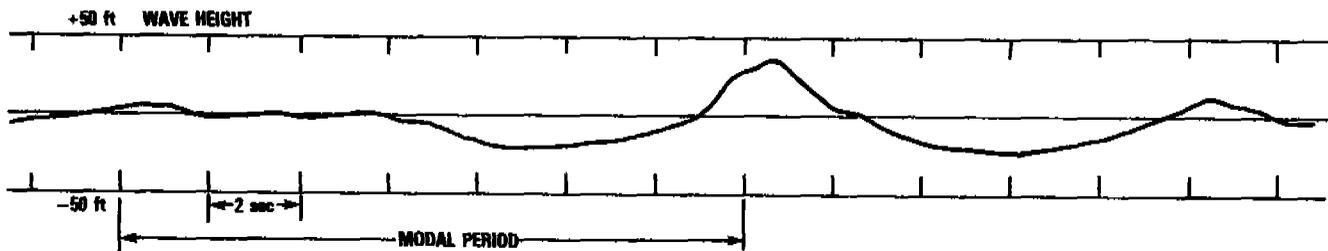
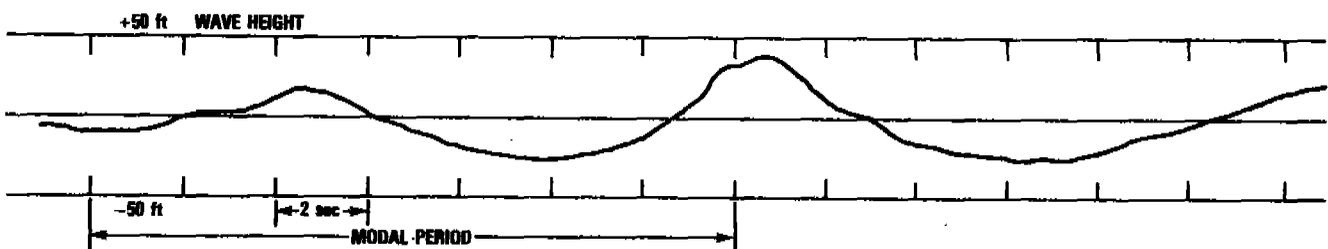
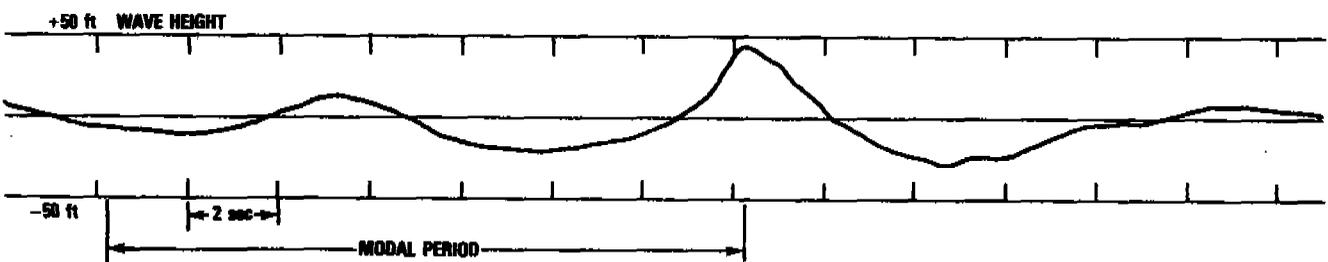
Figure 11 - Steep, Elevated Waves Recorded During Hurricane Camile

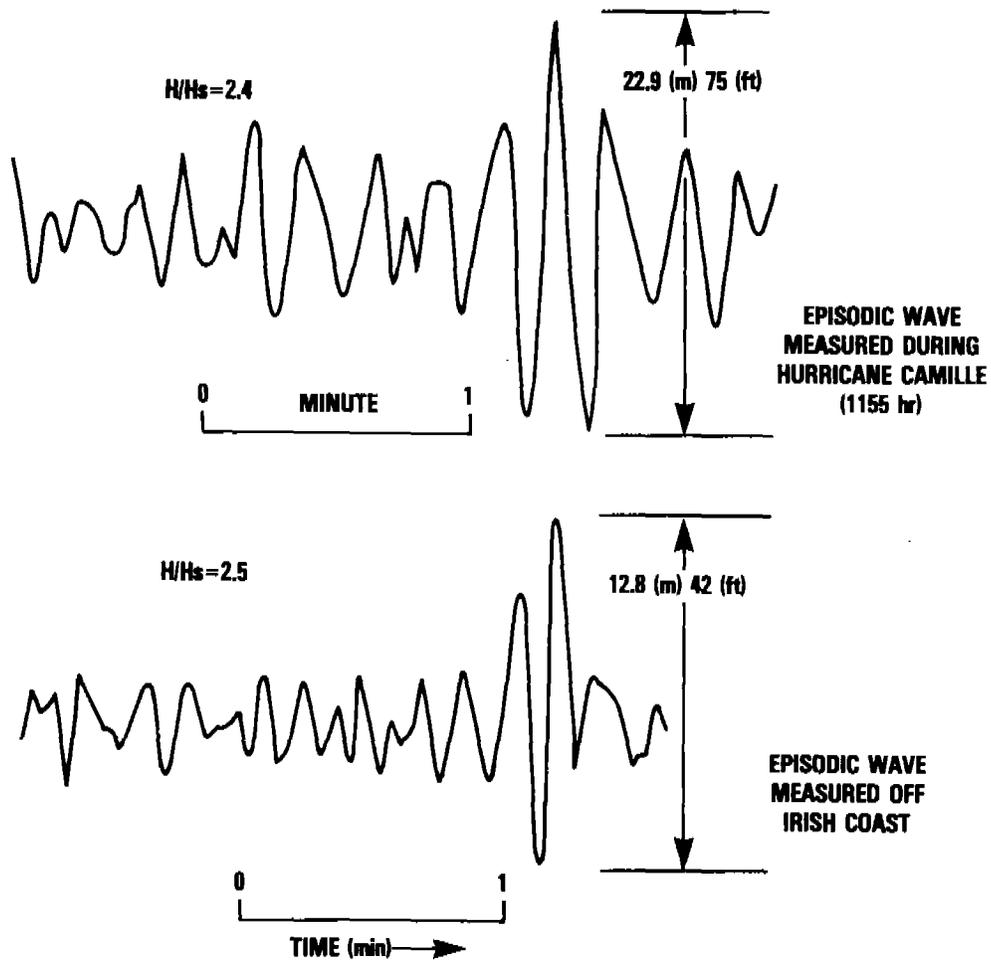
Figure 15 - Time-Domain Similarity of Episodic Waves from Different Storms

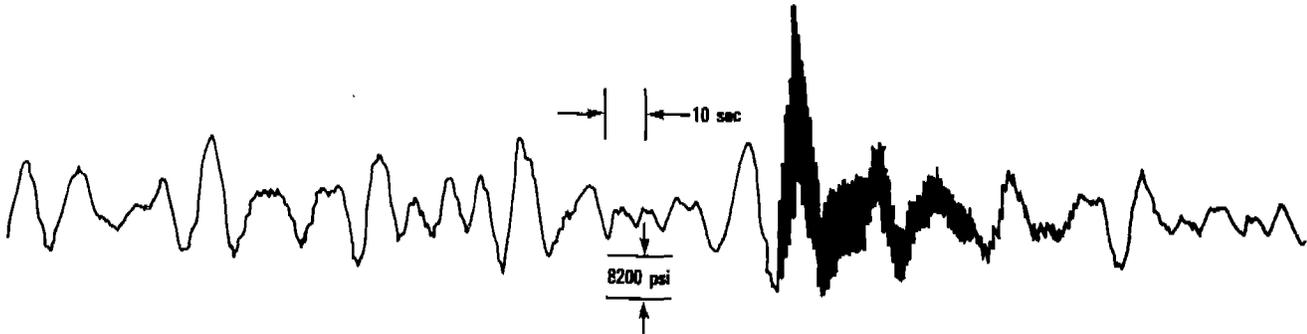
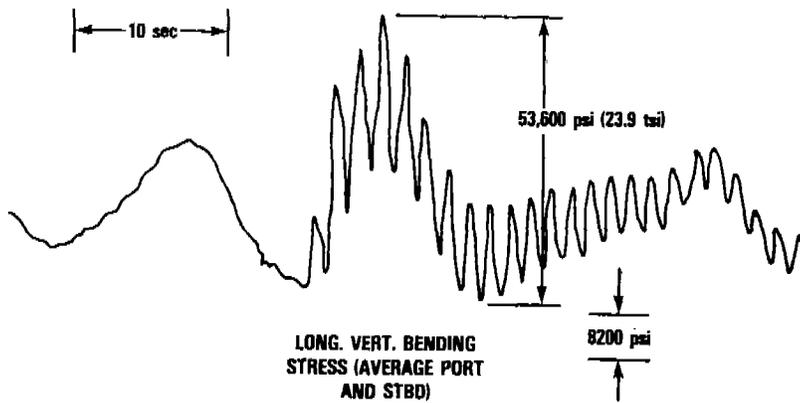
Figure 16a - Wave Induced Longitudinal Vertical Midship Bending Stress (Average of Port and Starboard)

Figure 16b - Expanded Time Scale Showing Combined Wave and Slam Induced Stresses

Figure 16 - Extreme Hull Girder Bending Stress Measured on S.S. SEA-LAND McLEAN During Winter Storm

The midship bending stress trace corresponding to the extreme stress event is shown in Figure 16. While the wave-induced bending component shown in Figure 16(a) is larger than any other for the preceding 1 1/2 hours, it was by no means episodic. The extreme nature of the stress event is largely the result of the slam-induced stress combined with it as shown in Figure 16(b). In this case, the dynamic stress is much larger than any other during the two-hour data analysis interval. In general, the ship showed very little tendency toward slamming although lateral whipping was relatively frequent. During the stressing event in question, a large lateral slam stress was induced approximately 1.6 seconds after the apparent bottom slam. The vertical accelerometer at midships indicated that each loading was of an impulsive nature.

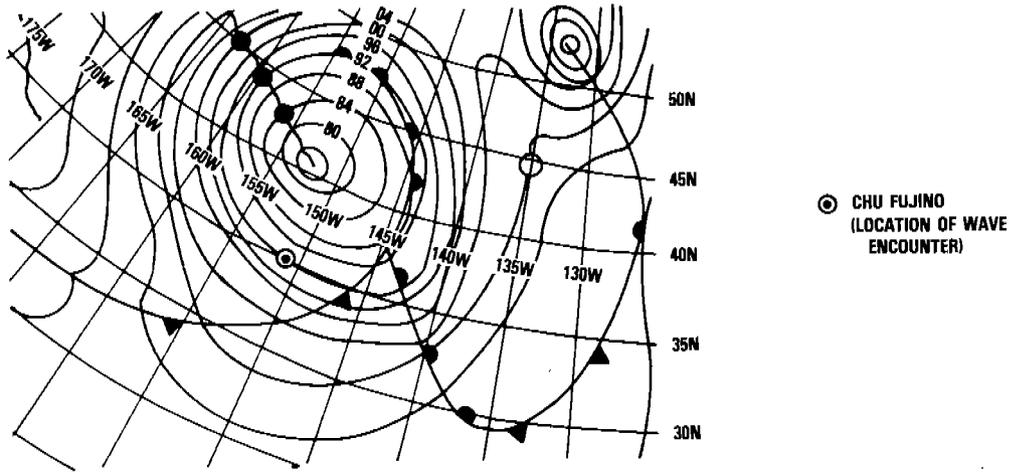
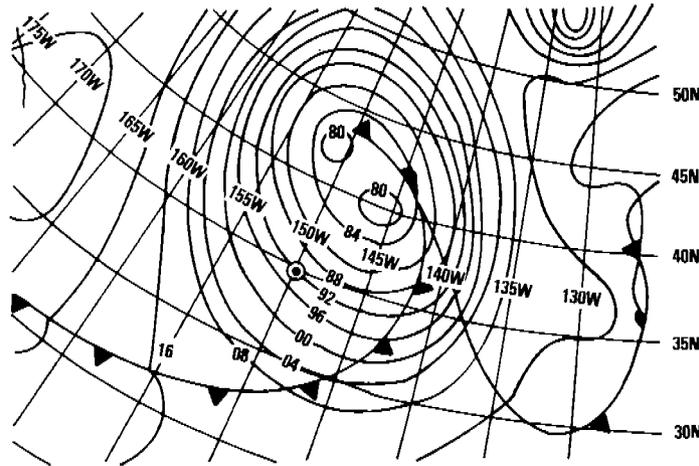
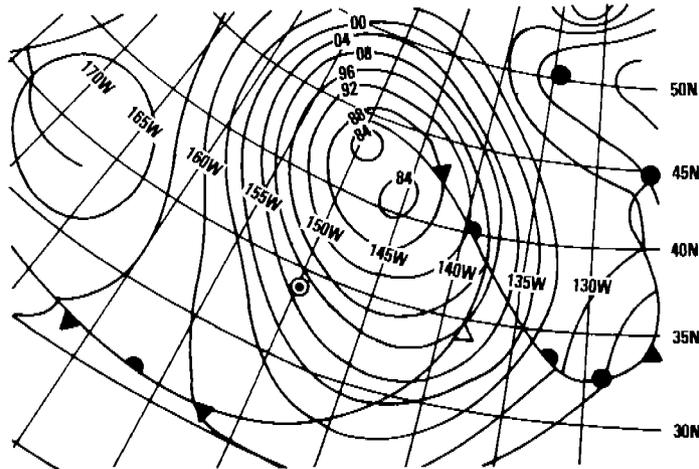
Figure 21 - Surface Weather Maps for Vicinity of CHU FUJINO Near Time of "Rogue" Wave Encounter at 0140 GMT on 29 December 1979

TTT The surface weather maps related to the MÜNCHEN casualty, Figure 19 and the corresponding maps for the episodic ("rogue") wave encounter by the CHU FUJINO, 0 of Figure 21 show considerable similarity. The comma-cloud pattern of Figure 22(a), however, was well developed some 24 hours before the damage incident in this case. Moreover, the surface analysis map of Figure 22(b) when compared to the cloud pattern shows that the TROF had already overtaken the occluded cold front at that time. The projection of the motion of the storm during the next 24 hours shown in Figure 22(a), suggests that the CHU FUJINO encountered a second and smaller TROF-like wind field originating at the head of the comma-shaped cloud by 0140 GMT when the episodic wave was encountered. The cloud pattern and surface weather map in this case are very similar to those found by Hamilton⁹ to be associated with the capsizing of NOAA Data Buoy EB-21 on 2 January 1977 at 46 N, 136 W. In general he finds four capsizings to be associated with the passage of a TROF located near the center of the
