**SSC – 479**

**LOCALIZED WELD REPAIR OF ALUMINUM STRUCTURES  
BY LOW-HEAT INPUT PROCESSES**

2025

**SSC – 479  
SR – 1484**

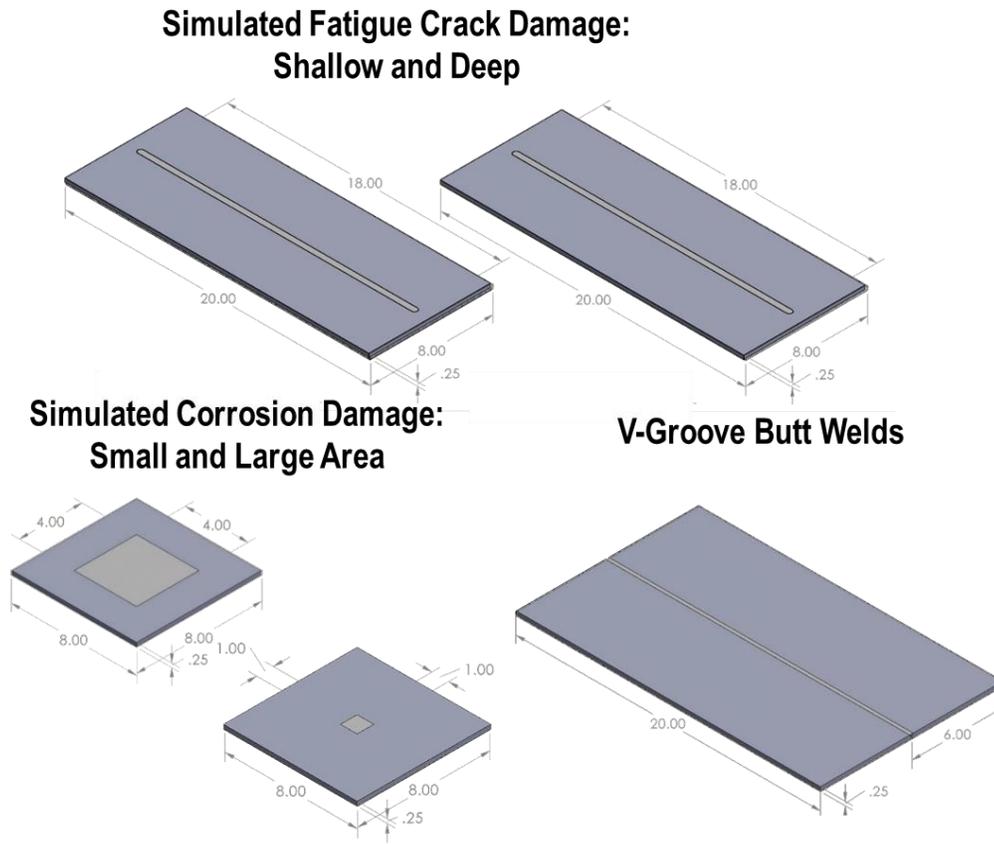
**Figure 1.** Geometries of the test articles used in this study.

Grade 5456-H116 plate in accordance with ASTM B928 [20] was procured in 0.250" thicknesses. These plates were procured from Pierce Aluminum, dual-certified to ASTM B928 grade 5456-H116 and grade 5456-H321 specifications. These plates arrived at NSWCCD in 8'x4' plates and were subsequently mechanically sheared to provide smaller test plates. Five types of test plates were created for this test program, including deep-V and shallow-V simulated fatigue crack repair areas, large and small corrosion repair areas, as well as a large number of V-groove butt joint weldments for mechanical test specimens.

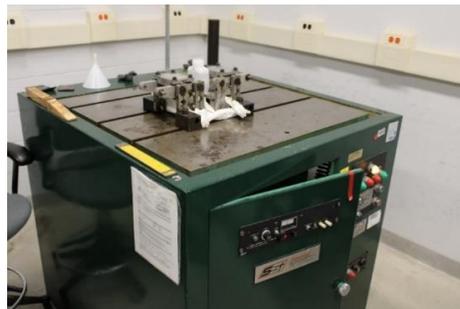
**Figure 2.** Sonntag SF-1U unit with seawater specimen loaded into machine.

Four point bend fatigue tests were performed with the following procedure. Specimens were cut via water-jet from a lab-sensitized V-groove butt welded plate. The edges were broken with a file and finished with a fine grit paper to ensure that surface cracks did not form from machining. Specimens were measured, and if required, prepped for seawater. Seawater cells were cut from 250mL plastic bottles and sealed with Momentive RTV 108. Seawater used met ASTM D1141 [23] standard. Specimens were loaded into the fatigue test machine. A Sonntag SF-1U unit was used for testing as seen in **Figure 2**. This machine uses a pendulum weight and LVDT on an isolated platform to test samples in fully-reversed four-point bend fatigue at approximately 30 hertz. Data was recorded to the nearest 1,000 cycle upon specimen failure, or runout was denoted past ten million ( $10^7$ ) cycles.

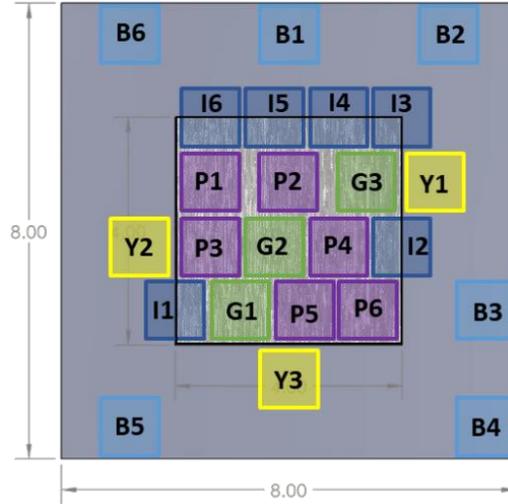
**Figure 3.** A schematic of samples sectioned from an AA5456 corrosion repair simulant plate with a cold-metal transfer welded region in the center. Samples labeled as bulk (BX) heat-affected (YX), weld (PX or GX), and weld/heat-affected zone interface (IX).

For electrochemical testing to assess possible changes in the corrosion performance of AA5456 subjected to cold-metal transfer (CMT) welding, 21 1" x 1" samples were cut from an 8" x 8" plate of lab-sensitized AA5456 welded with the CMT technique in a 4" x 4" area in the center to simulate corrosion repair. Samples were cut from four areas corresponding to different locations that may have been affected by the welding process: (1) six samples from the bulk alloy closer to the edges of the plate, (2) three samples surrounding the weld that will be referred to as the heat-affected zone (HAZ), (3) six samples across the interface of the weld and HAZ, and (4) nine samples from within the weld. **Figure 3** depicts the various sections provided as samples for this testing. Of the samples provided, three samples from each area were used for the electrochemical tests.

Open-circuit potential monitoring followed by anodic polarization measurements were conducted on nine of the samples corresponding to the bulk metal (area 1), HAZ (area 3), and the weld (area 4). These tests assess whether the fundamental corrosion properties, such as the open-circuit potential (OCP or  $E_{corr}$ ), stabilization of the surface, steady state corrosion current ( $i_{corr}$ ), anodic reaction kinetics, and pitting potential ( $E_{pit}$ ), vary due to microstructural changes that could be caused by the CMT process. Three replicates were used from each area to account for some of this statistical variance. AA5XXX alloys have expected OCPs between -0.75 to -0.85 V vs a saturated calomel electrode (SCE) reference when immersed in seawater solutions, but this shows substantial stochastic variation and can even span a range of -0.65 to -0.9 V vs SCE [25] [26].

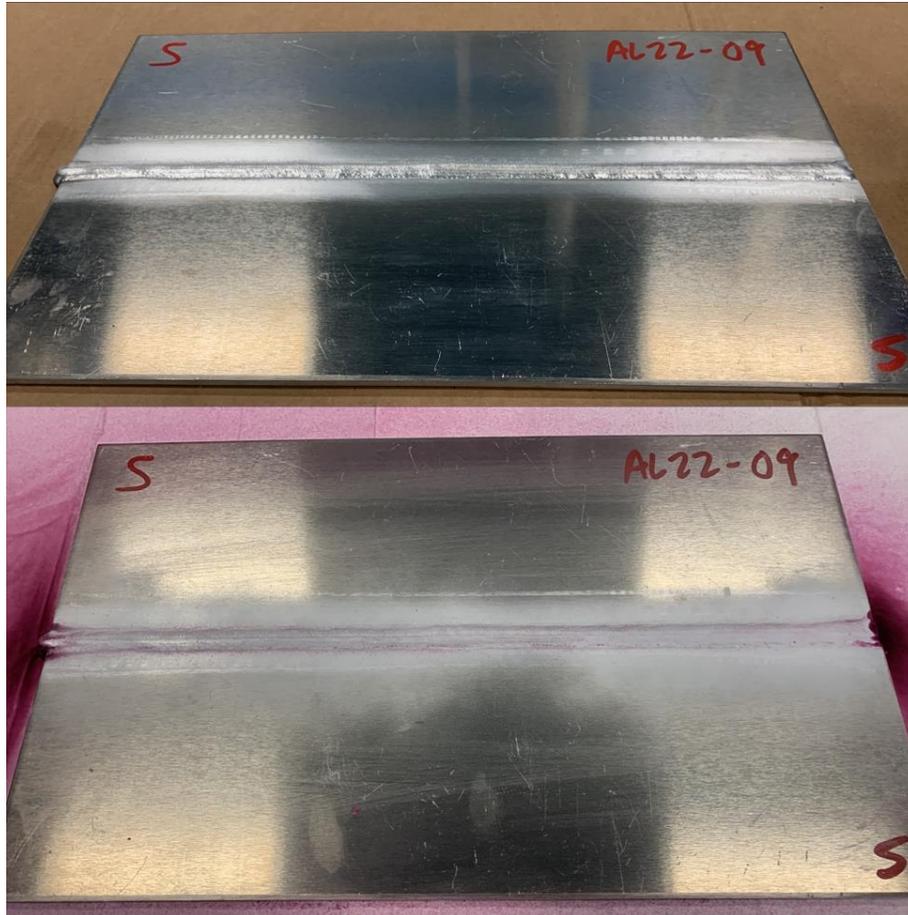
**Figure 4.** Test weldment used for PQR testing before and after visual and dye penetrant testing.

Visual (VT) and liquid penetrant (PT) inspection were carried out at NSWCCD on each of the V-Groove butt welds. It should be noted that this inspection was not performed by a Level II qualified inspector, though the procedures used were in compliance with NAVSEA TechPub T9074-AS-GIB-010/271 Rev 1 [29]. One of the test plates inspected in this way is shown in **Figure 4**. A close up image of the weld prior to coating with PT compounds is shown in **Figure 5**. Phased array ultrasonic inspection was performed on weldments prior to PQR testing. Neither visual and liquid penetrant testing nor phased array UT were able to identify any defects that caused concern in the PQR test weldment.

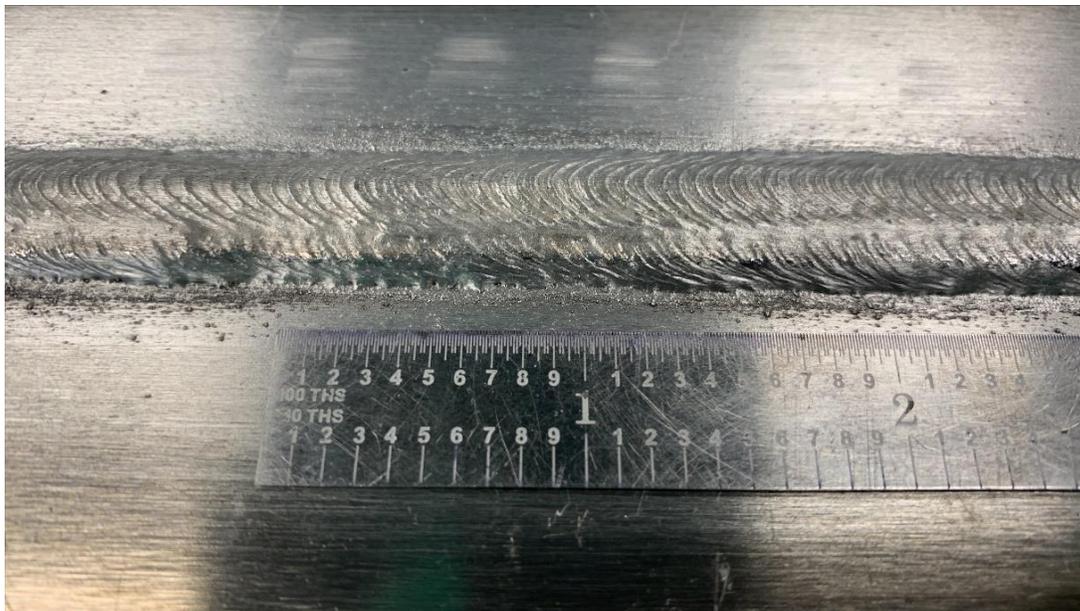
**Figure 5.** Close up photograph of one of the test weldments used for visual inspection.

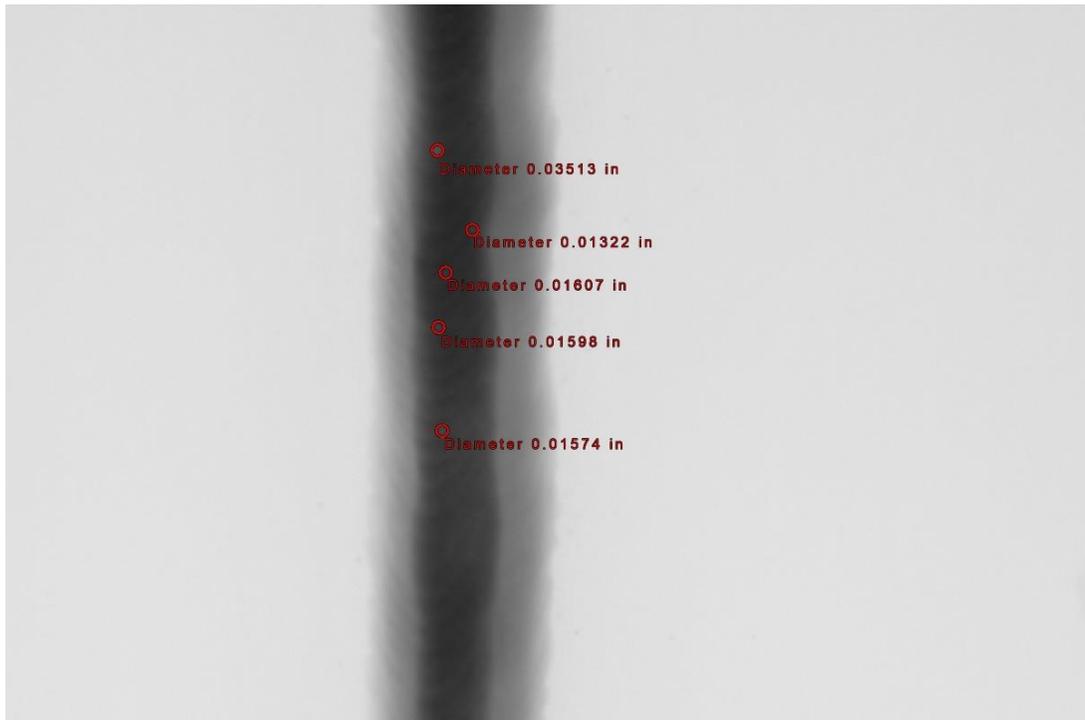
**Figure 6.** Digital radiography image showing indications in a lab sensitized grade 5456 aluminum weldment used for procedure qualification record (PQR) testing.

Digital radiography was performed at Naval Air Station Patuxent River. An XRayWorx X-ray source was used with an operating voltage of 90 kV at 300  $\mu$ A current. The tube to detector distance (FDD) was 1100 mm and the tube to object distance (FOD) was 728.9 mm. A number of porosity indications were observed with diameters between 0.01 and 0.03 inches, an example of which is shown in Error! Reference source not found..

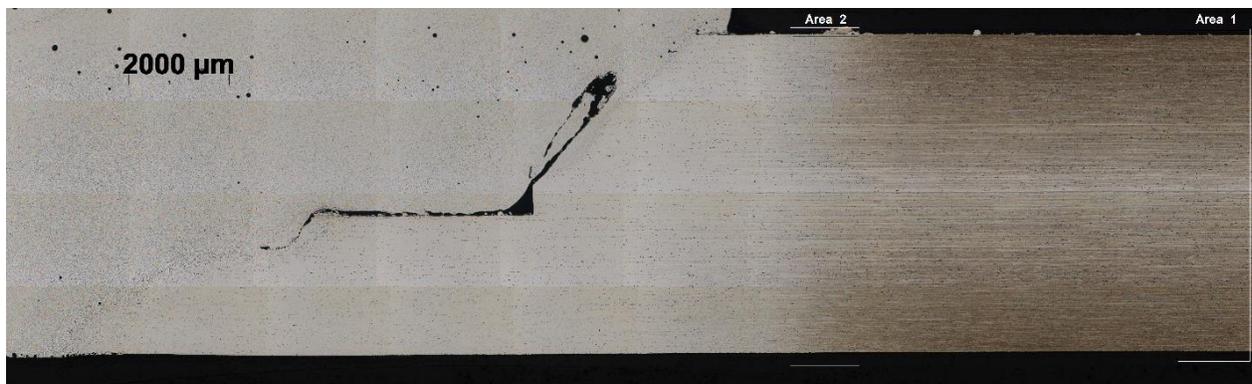
**Figure 7.** Cross section of corrosion repair plate showing a large lack of fusion defect.

Weldments were sectioned to inspect the quality of the welds and any internal defects. Specimens were etched with phosphoric acid to reveal the precipitate phase that was developed during the sensitization treatment and subsequent welding. **Figure 7** is a composite image taken from a cross-sectional specimen from one of the large corrosion area repair specimens. This image was selected to note the subsurface lack of fusion. This defect occurred despite care taken during welding and in spite of the optimized welding parameters developed to support procedure qualification testing. Defects like this suggest that the low heat input of the CMT process can still result in lack of fusion. These defects are especially problematic in areas where inspection techniques such as visual, magnifier-assisted visual, and liquid penetrant inspection cannot detect discontinuities. Defects of this type that do not intersect the surface are not apparent in VT or PT inspection. The large void depicted in **Figure 8** shows another example of a pore on the order of indications detected in the digital radiography inspection described previously.

Apparent in both **Figure 7** and **Figure 8** is the degree of sensitization of the baseplates as revealed by the phosphoric acid etch. This etch attacks the Mg-rich beta precipitates along grain boundaries, producing a dark response which is apparent across all specimens. The abundance and continuity of the beta precipitate phase supports the findings of the NAML T findings of sensitization in the base plates. **Figure 9** depicts the roots of a representative weldment (Fig. 9a) at progressively higher magnification. Porosity is apparent in both left and right weld roots and within the fusion zone (Fig. 9b and 9c), as well as a heightened precipitate etch response compared to the base metal. Closer examination of the right weld root (Fig. 9d) shows porosity at the interface as well as contiguous precipitation indicating apparent sensitization of the root.

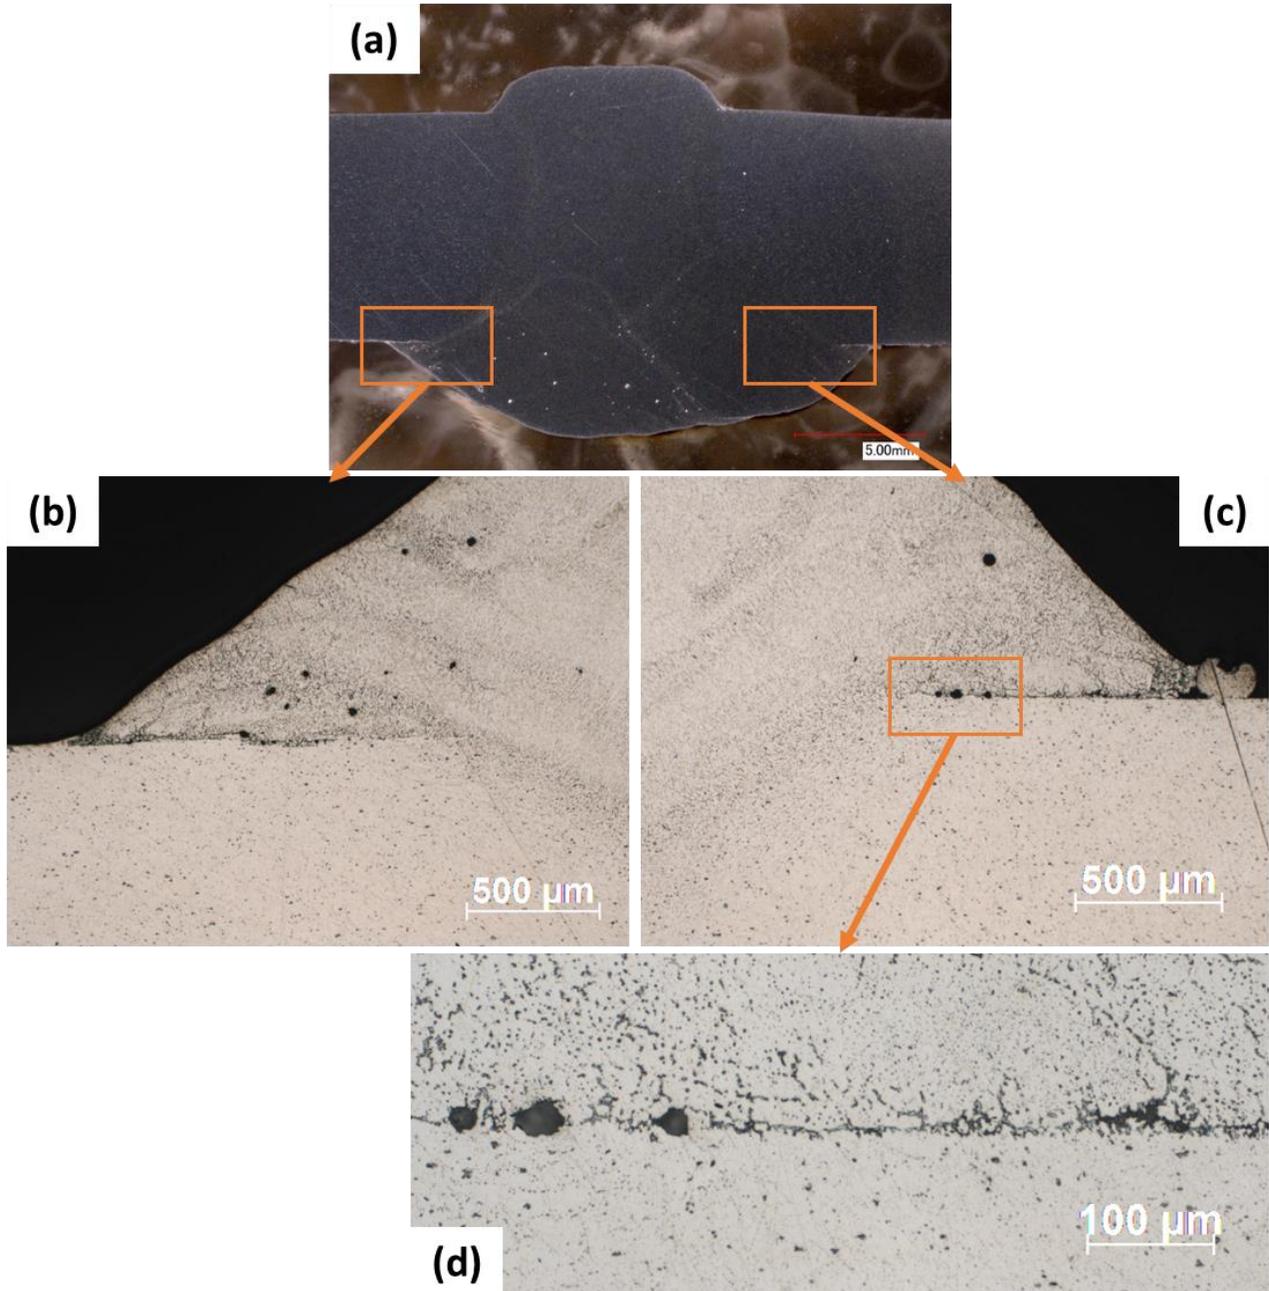
**Figure 9.** Metallography of the weld roots of one sensitized weldment (a) etched with phosphoric acid to reveal sensitization. Subfigures (b) and (c) show the left and right weld roots as indicated. Subfigure (d) shows a further magnified image of the fusion line of the right root.

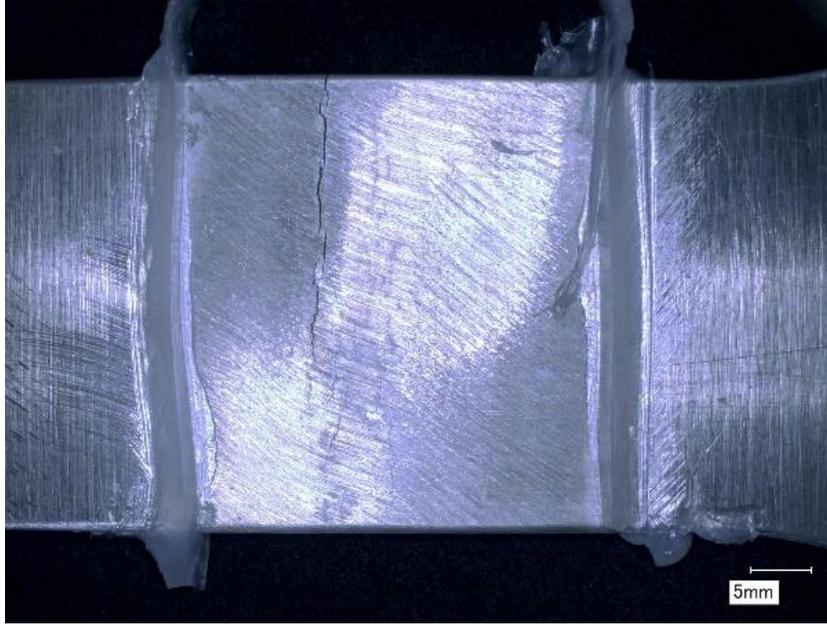
**Figure 10.** Fatigue failure for a specimen exposed to seawater.

Fatigue testing produced results expected of sensitized 5xxx series aluminum with a knock-down at all stress levels when testing in seawater. There was an approximately 3 times knock down in cycles to failure at 15 ksi. **Figure 11** shows the comparative fatigue performance in specimens exposed to seawater and air. Many specimens reached the runout condition and did not fail at 5 and 10 ksi load. For 10 ksi, it is impossible to know the true knockdown as most of the specimens in air were runouts and therefore did not fail. There would likely be a larger disparity in the curves had fatigue testing been conducted to a longer runout. Due to the limited failures and restricted stress ranges ASTM E739 cannot be accurately used to analyze these data trends. As a result, these results remain qualitative, however there was a definite reduction in fatigue performance in these specimens in seawater.

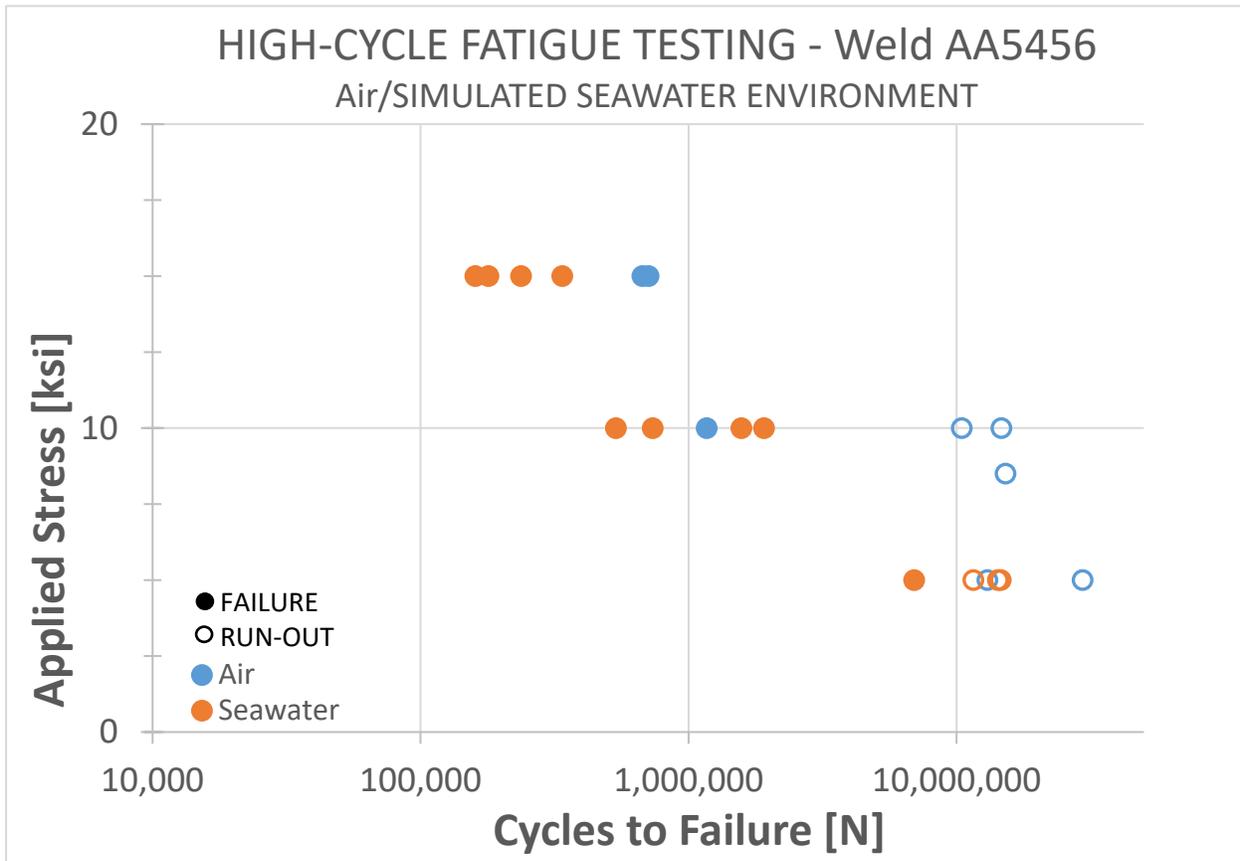
**Figure 11.** S-N curve for Welded 5456 aluminum in seawater and air.

The as-welded fatigue performance is consistent with previous studies using GMAW technology. Fatigue properties of the CMT-welded material are consistent with existing test data for welding of grade 5456-H116 aluminum shown in **Figure 12** [30]. This literature data demonstrates that even unsensitized 5456 Al plate is subject to a reduction in fatigue life in sea water. Welding with the conventional GMAW process results in a further loss relative to the plate form factor which is further exacerbated in sea water. These results demonstrate a similar sea water knockdown effect with the CMT process. However, further testing would be required in order to establish a quantitative and statistical comparison between the fatigue life of weldments produced between the two methods. Note that **Figure 12** below discusses grade 5456-H117 aluminum; upon consultation with the Aluminum Association, it was noted that the -H116 and -H117 tempers are equivalent, as they were manufacturer-proprietary tempers that were later consolidated into a single temper designated -H116.

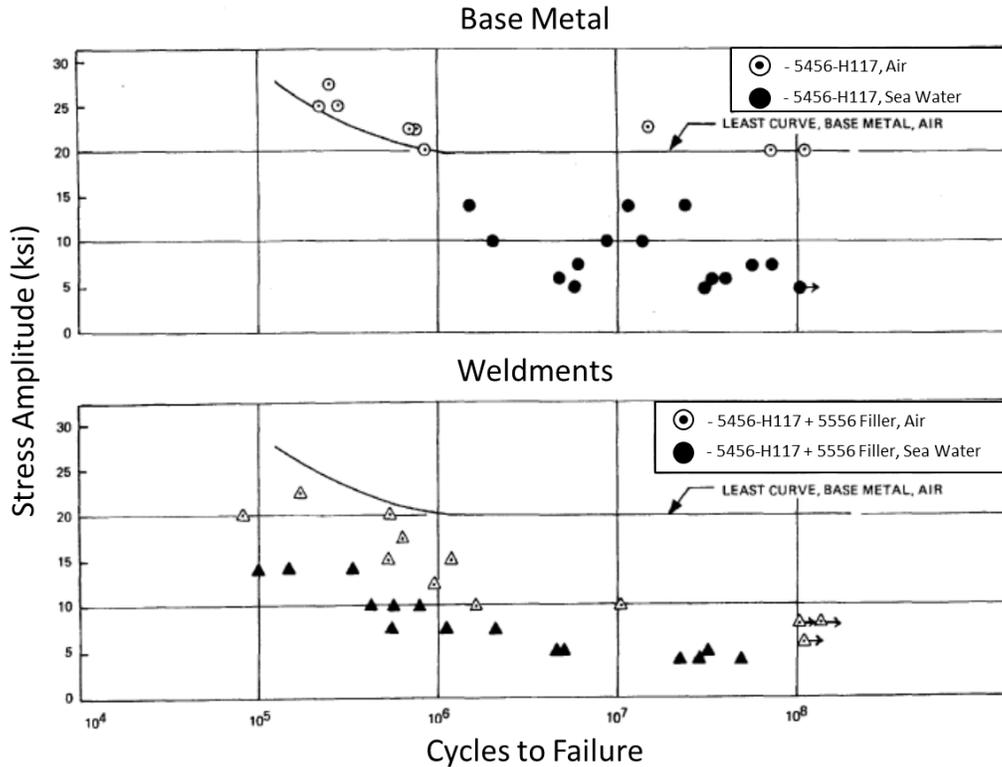
**Figure 12.** Fatigue curves for unsensitized 5456 aluminum base plate (top) and welds (bottom) in air and sea water. Adapted from [30].

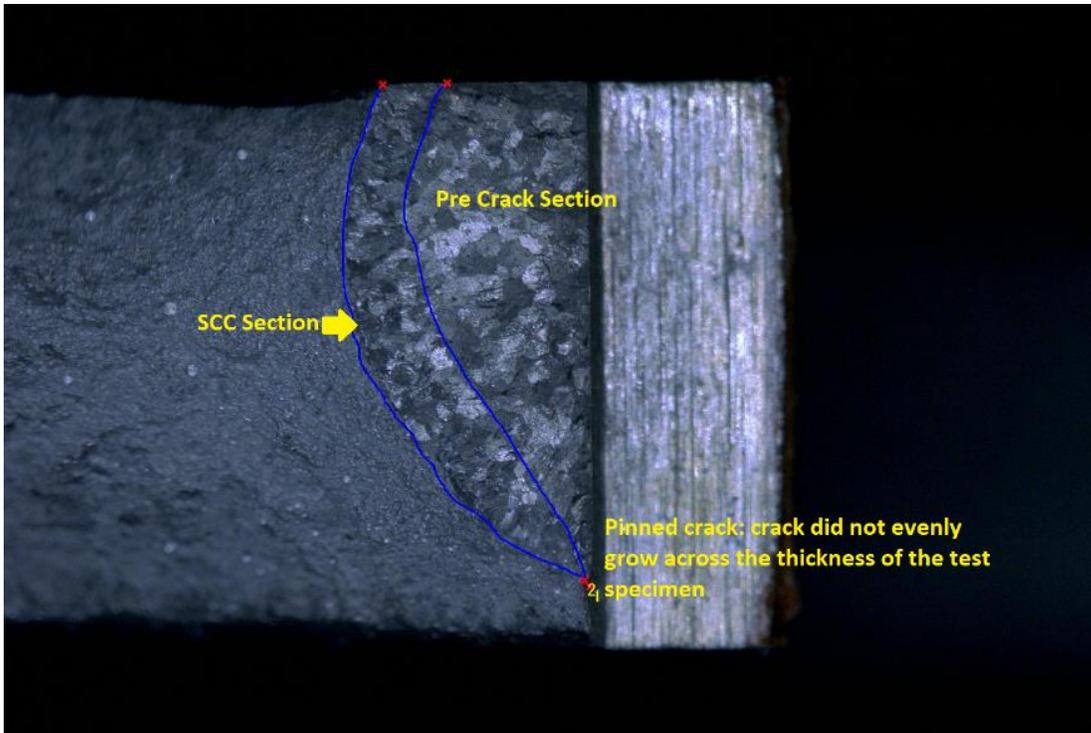
**Figure 13.** Pinned crack from a Welded SEN(T) specimen.

Stress corrosion testing did not yield any conclusive results. Due to residual stress profile across the weld, face to root, a straight pre-crack could not be obtained with standard operating procedures. An example of a specimen with a pinned crack that resulted in poor data is shown in **Figure 13**. Further work would be required to develop a procedure to produce a suitable crack. However, given previous testing it is possible to say that stress corrosion cracking in the present orientation, normal to the transverse plate axis (T-L), is negligible [31]. Aluminum alloy 5456 is commonly cold rolled to increase strength which creates an anisotropic microstructure. Because of this anisotropy, the orientation of loading greatly increases (or decreases) the susceptibility of these metals to crack when exposed to seawater. See **Figure 14** for crack growth rate trends based on crack orientation.

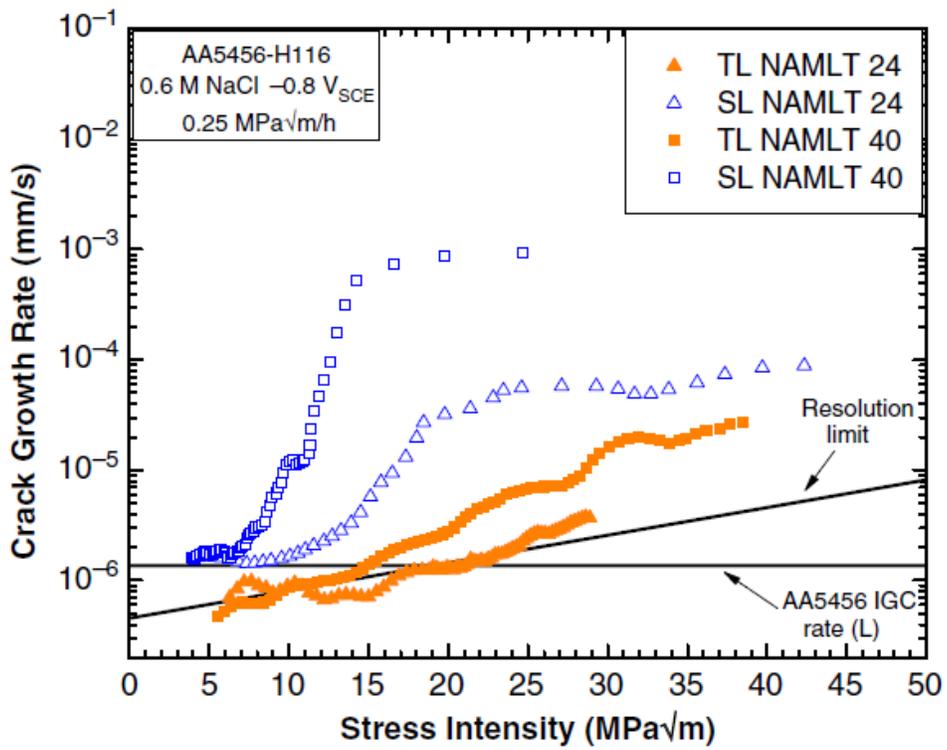
**Figure 14.** The effect of crack growth rate based on orientation in sensitized AA5456 [31].

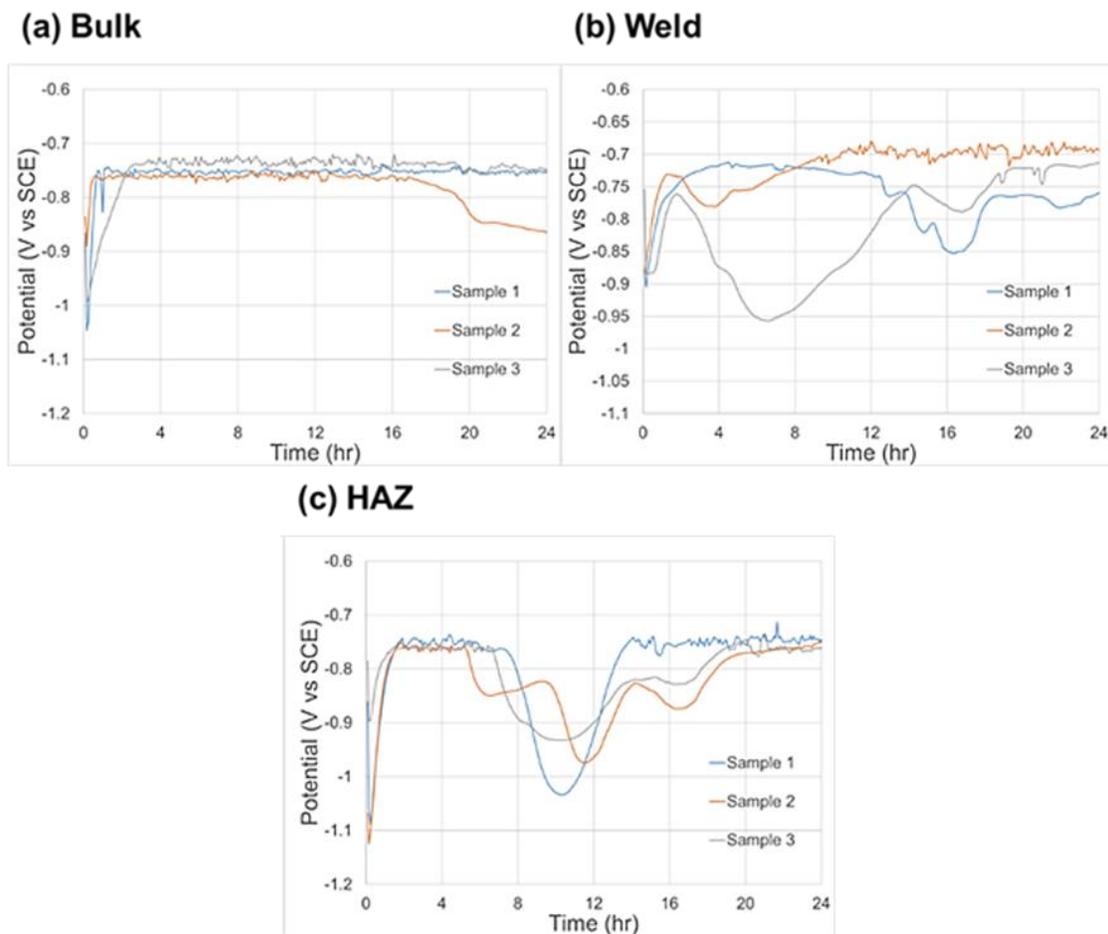
**Figure 15.** Open-circuit potential monitoring measurements taken for nine samples across three different areas of the welded plate: (a) bulk metal, (b) weld metal, and (c) the heat-affected zone (HAZ).

The measurements of open-circuit potential over a 24 hr immersion time are presented in **Figure 15**, with three plots broken out according by area of the plate samples were taken from: bulk metal (area 1, Fig. 15a), weld metal (area 4, Fig. 15b), and the HAZ (area 3, Fig.15c). For the bulk metal, it appears the surface stabilizes within the first 4 hrs of immersion, but the second sample shows some activity after 20 hrs of immersion causing the potential to start decreasing. The weld area samples show a more unstable OCP over the duration, with the second sample stabilizing close to 12 hrs of immersion, and the other two potentially stabilizing after 20 hrs. The HAZ samples show a mix between the results of the bulk and welded area, with initial

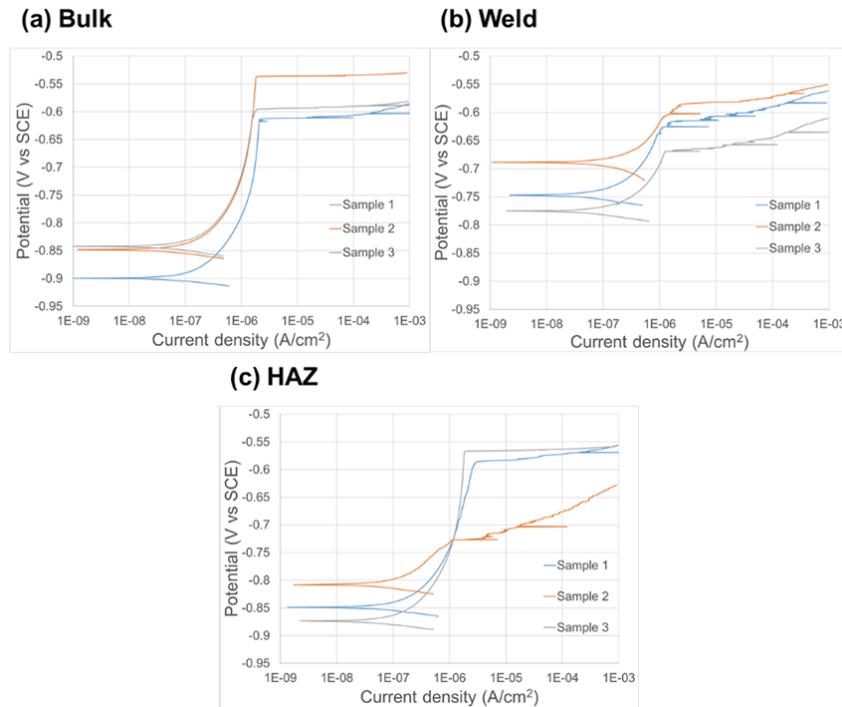
**Figure 16.** Anodic polarization curves taken for nine samples across three different areas of the welded plate: (a) bulk metal, (b) weld metal, and (c) the heat-affected zone (HAZ).

Anodic polarization curves for samples from the same areas as the OCP monitoring measurements are shown in **Figure 16** with Fig. 16a-c showing results for the bulk metal, weld metal, and HAZ areas, respectively. From these curves, parameters for  $E_{corr}$ ,  $i_{corr}$ ,  $E_{pit}$ , and  $\Delta E_{bd}$  were extracted and are summarized in **Table 5**. The term  $\Delta E_{bd}$  is determined by  $E_{pit} - E_{corr}$ , and it signifies the magnitude of the thermodynamic driving force for the stabilized

surface to experience breakdown and subsequently stable pitting. The curves visually demonstrate that both the bulk metal and HAZ areas had lower OCP values overall compared to the welded area, with average OCPs of -866, -843, and -742 mV vs SCE, respectively. Equilibrium corrosion current ( $i_{corr}$ ) values were comparable between the three areas, showing a range of 22-81 nA/cm<sup>2</sup>, with averages for the three areas coming out to 52, 45, and 63 nA/cm<sup>2</sup> between the bulk, welded, and HAZ areas, respectively. Pitting potentials ( $E_{pit}$ ) were comparable across each area, with the welded and HAZ areas showing averages of -626 and -627 mV vs SCE compared to the average of -583 mV vs SCE for the bulk region.

However, the differences in  $\Delta E_{bd}$  between regions, which provide the driving force for pitting, show the bulk areas with the largest difference of 283 mV compared to 217 mV for the HAZ and 117 mV for the welded area. This indicates the bulk metal has the least probable tendency to form stable pits, and this tendency increases moving towards the HAZ and then the welded area. Visually, the curves demonstrate metastable pitting events across some of the samples, judged by sudden horizontal spikes in current before the curve reaches  $E_{pit}$ . One such event can be seen on sample 1 of the bulk area. Several indications are seen on samples 1 and 2 of the welded area, and sample 2 of the HAZ shows some instability in metastable pitting right before  $E_{pit}$  on that curve.

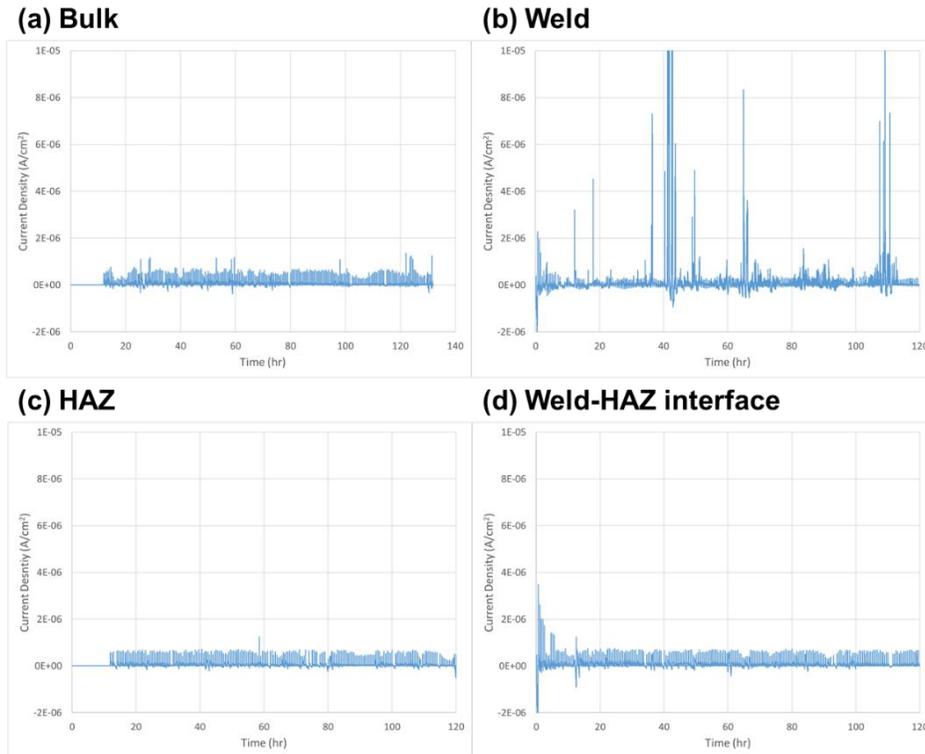
**Figure 17.** Example results of metastable pitting measurements for 4 samples from different areas of the welded plate: (a) bulk metal, (b) weld metal, (c) the heat-affected zone (HAZ), and (d) the weld/HAZ interface.

Examples of 4 potentiostatic pitting measurements are shown for the 4 different areas in **Figure 17**. A python script was developed to count instances of metastable pits for all 12 measurements, and these results are summarized in **Table 6**. As seen in the table, 10 out of the 12 samples did not show any evidence of metastable pit events, and the only 2 that did exhibit metastable pitting came from the welded area of the plate. As such, the examples shown in Fig. 17a, 17c, and 17d demonstrate what the majority of the data for the potentiostatic pitting measurements looked like.

The plot for Fig. 17b comes from the measurement for Sample 1 of the welded area, which exhibited a metastable pit count of 35, and possible stable pitting after 36.2 hrs of the measurement (total of 60.2 hrs of immersion). This instance of possible stable pitting is shown in **Figure 18**. In this instance, the higher current was maintained for only 6 min before readjusting to baseline following the next readjustment of the OCP, so it is believed that the measurement technique influenced the pitting behavior and affected the results to some extent. This may indicate that for welded materials the OCP measurement, potentiostatic hold cycle times may need to be decreased.

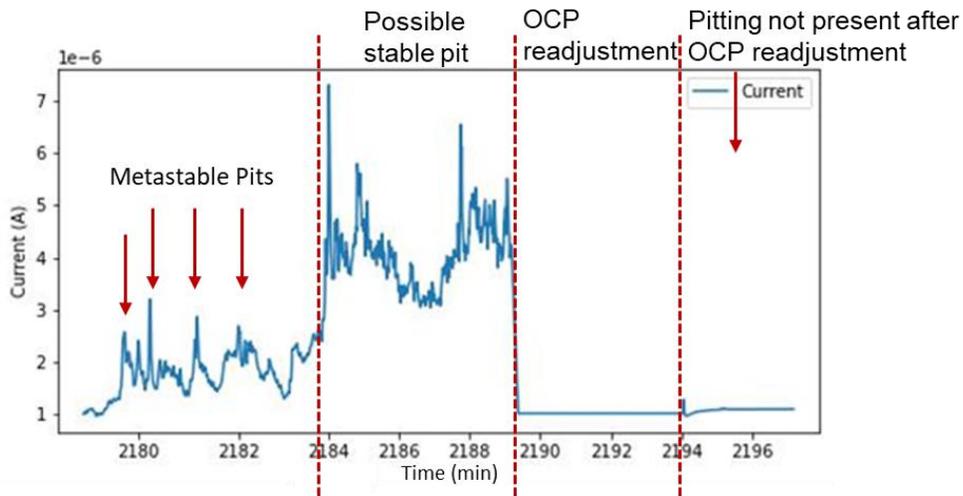
**Figure 18.** A subset of data from the potentiostatic pitting measurement of Sample 1 from the welded area of the plate. This subset shows a time period of metastable pitting involving into a more stable pitting current for a duration of 6 min. The OCP readjustment that occurs for 5 min every 25 min as part of this measurement shows afterward that this stable pitting event seems to have stopped.
