SSC-294

**FURTHER SURVEY
OF IN-SERVICE PERFORMANCE
OF STRUCTURAL DETAILS**

SHIP STRUCTURE COMMITTEE

1980

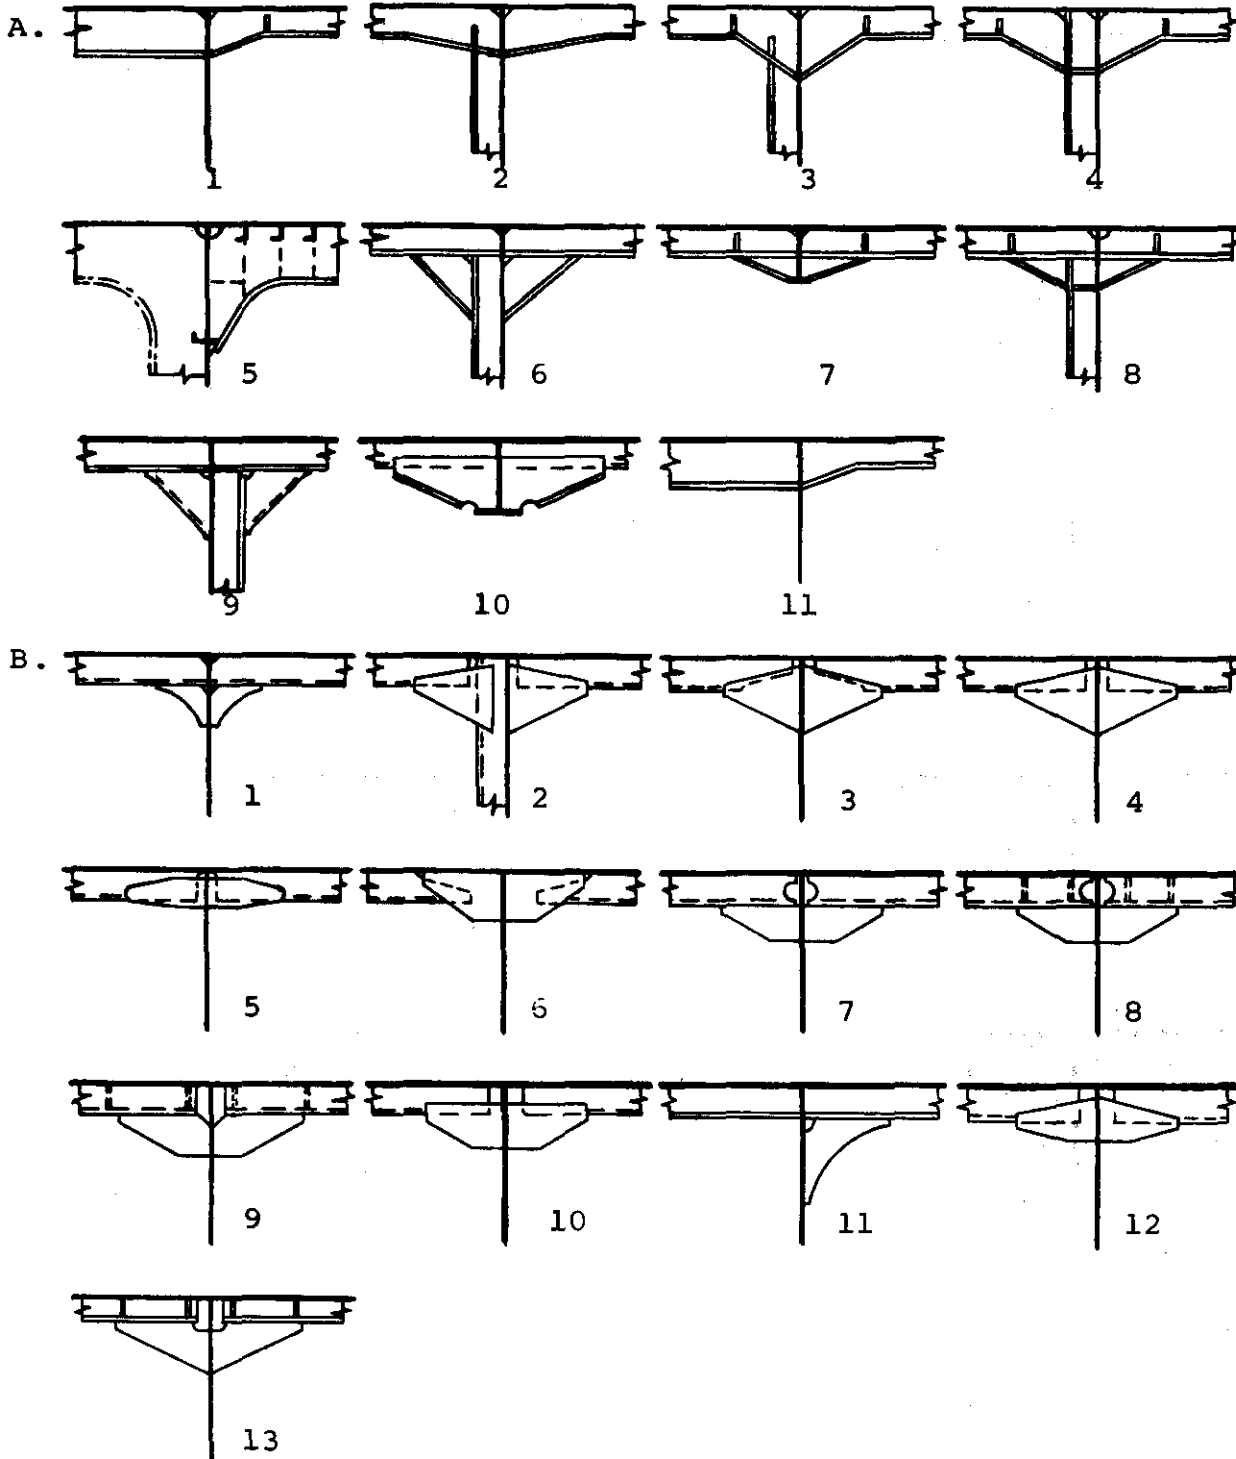
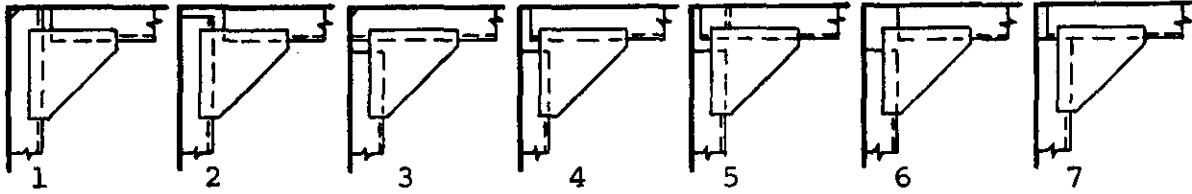
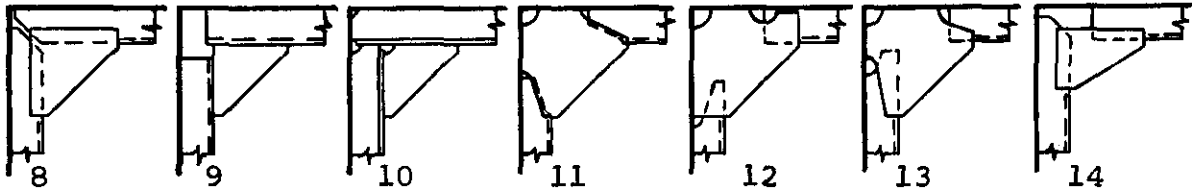
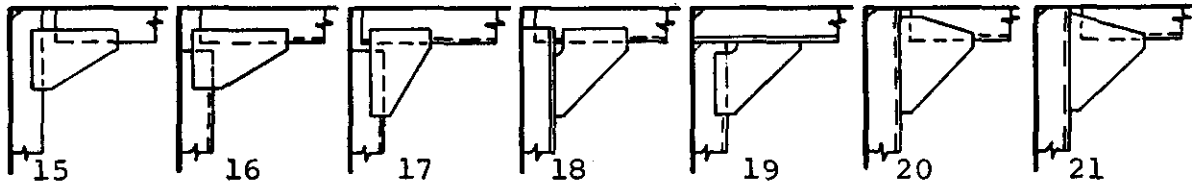
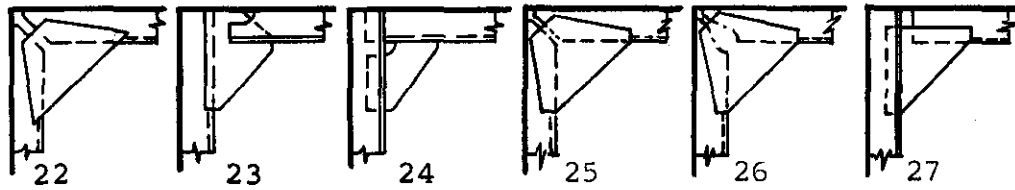
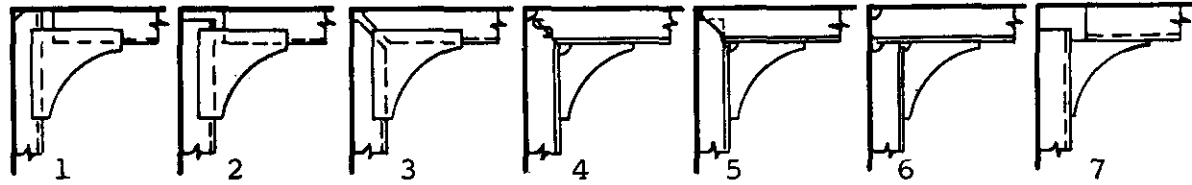
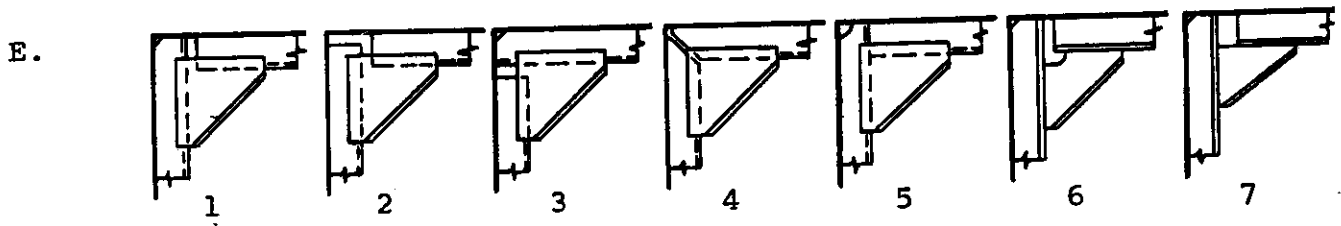
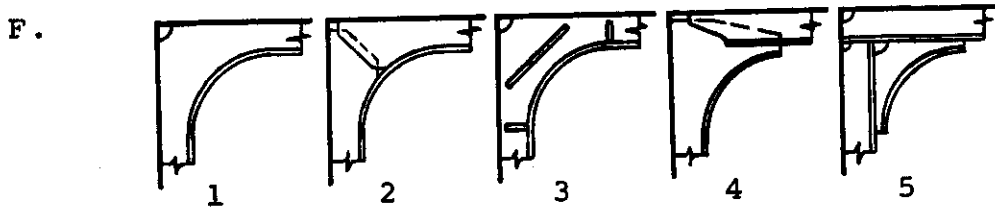
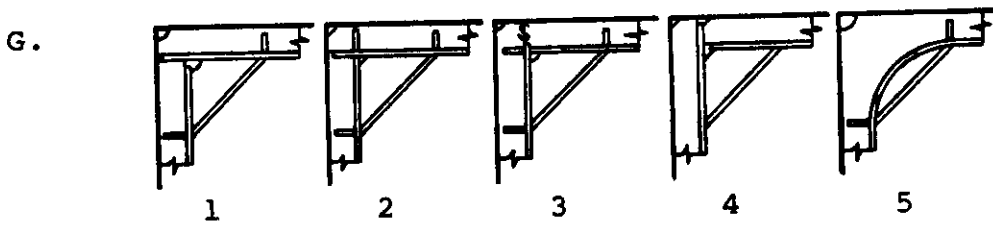
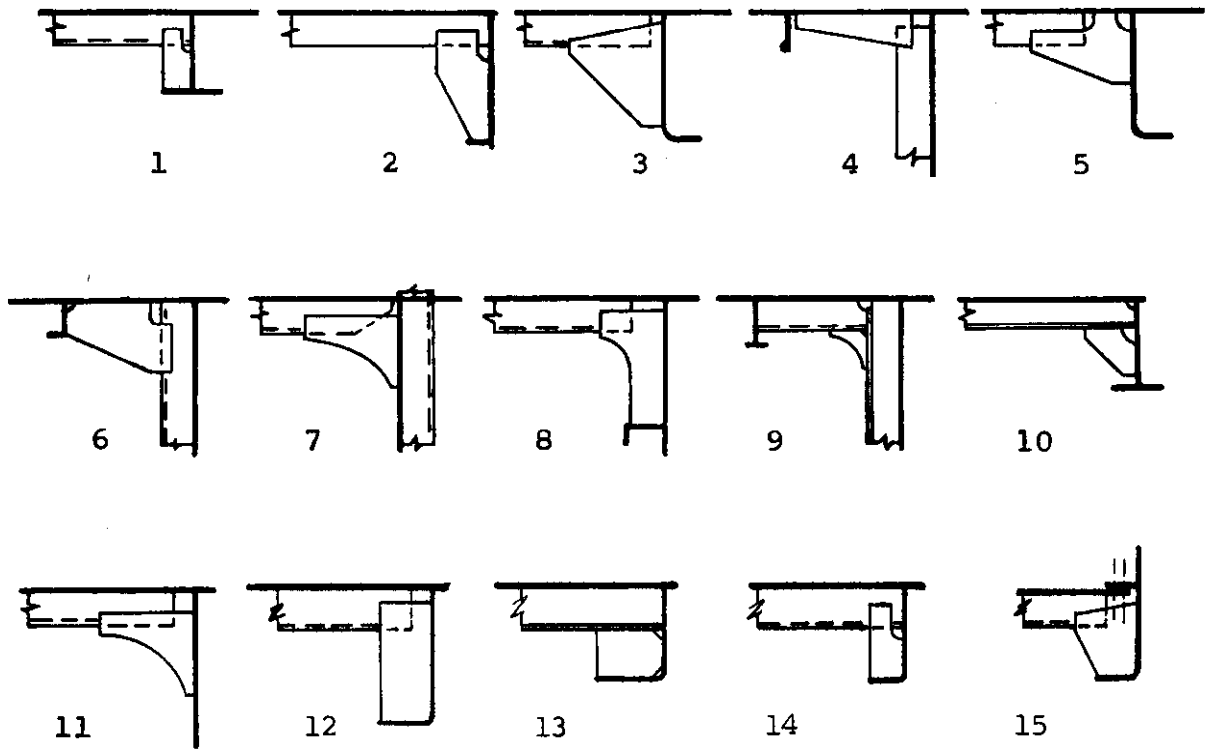
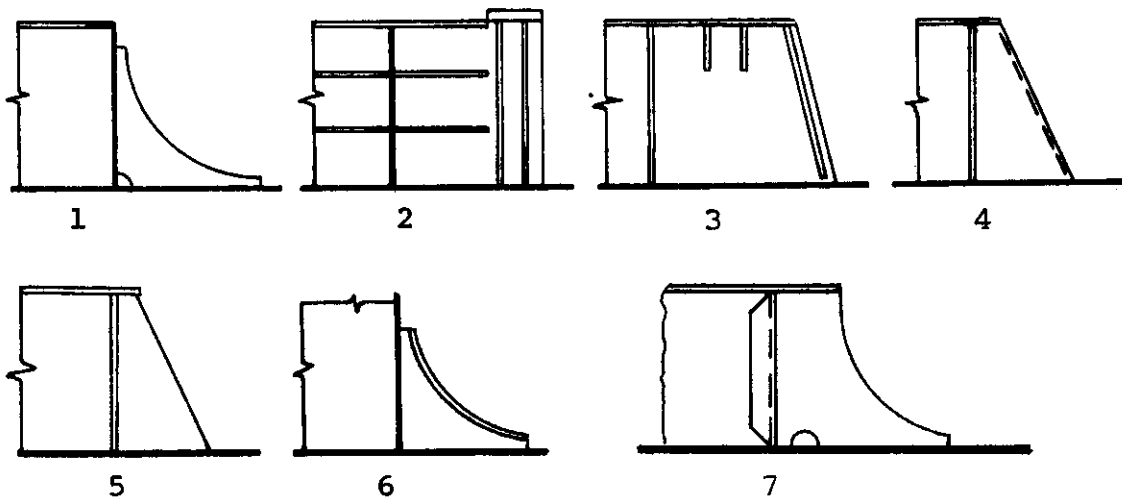
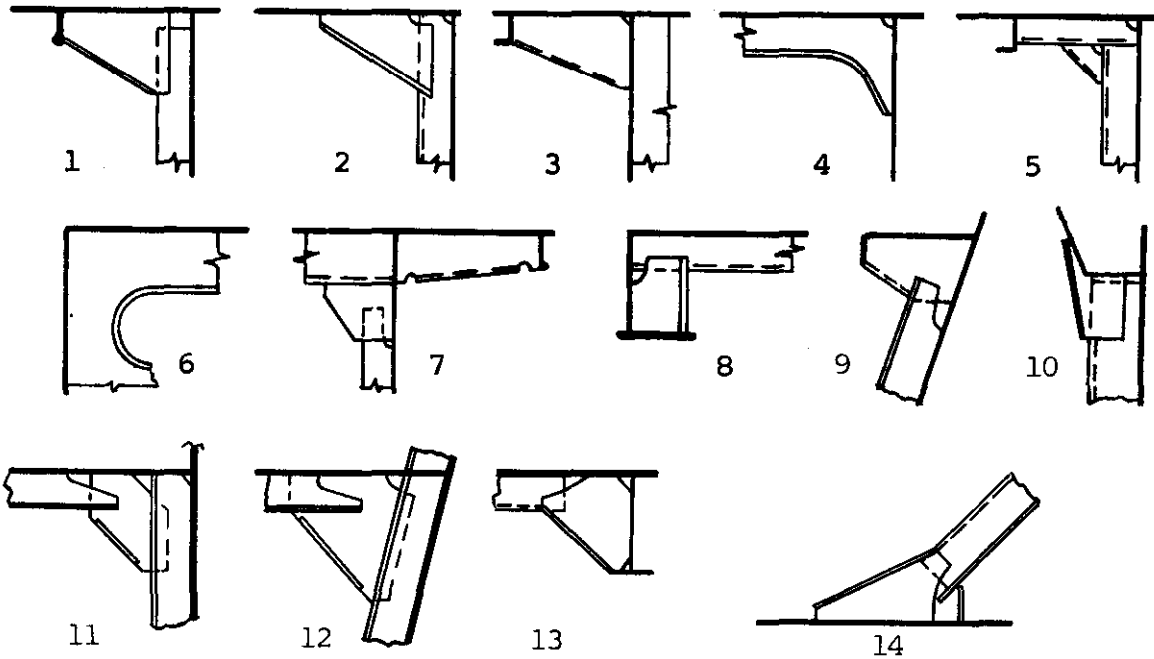
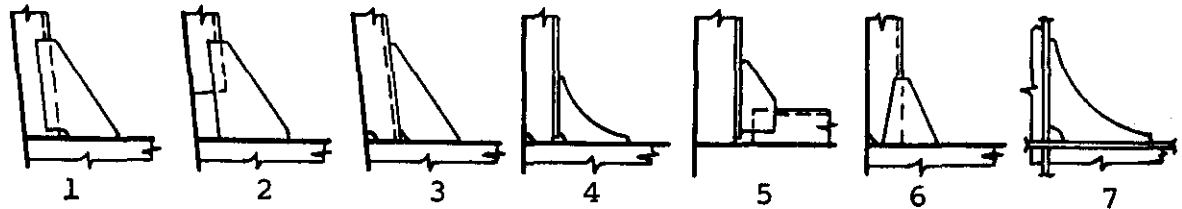
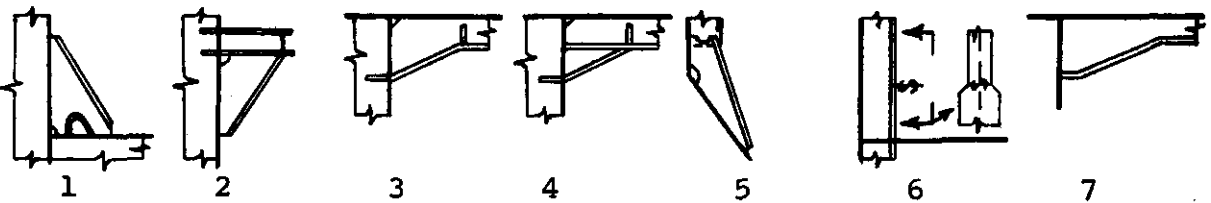
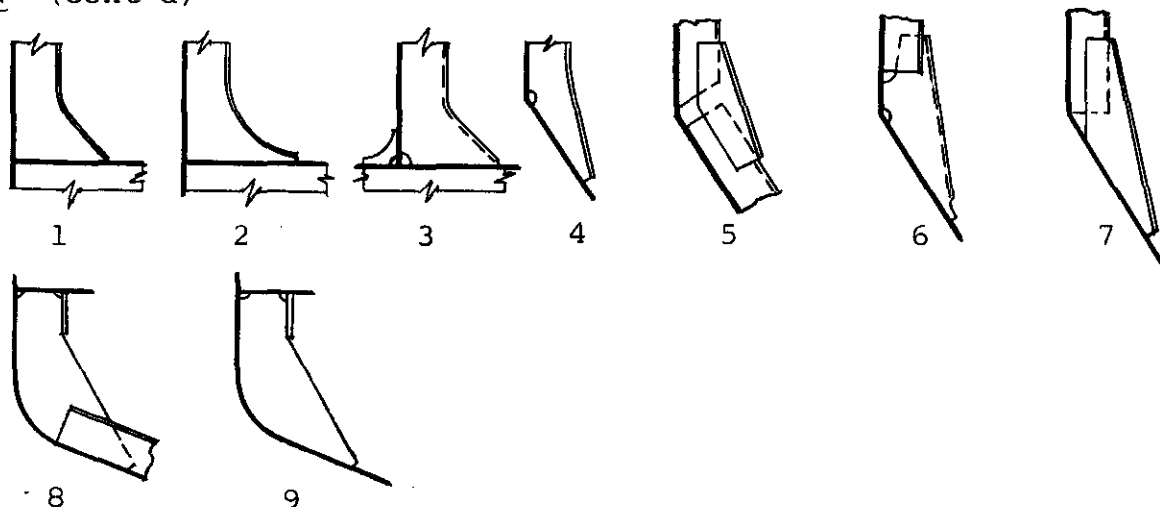
FIGURE 2

Figure 2 shows the 145 variations in configurations included in the 68,586 beam brackets observed in both surveys. The configurations that occur most often in the midship/cargo section of containerhips and general cargo ships are the corner bracket configurations 1-C-1, 1-C-25, 1-C-2, and 1-E-1. They also have a high failure rate, ranking number one, two, four and eight, respectively, in the top ten most prevalent failure details. In the first survey, detail 1-C-1 ranked third and detail 1-C-2 ranked eighth in the same category. Many of the group "C" corner bracket failures could be attributed to instability of the bracket plate panel. This was especially true on containerhips where long spans of shell framing were supported at the ends with unflanged triangular plate with very high breadth/thickness ratios. It was interesting to note that on general cargo ships where wood framing was attached to the shell framing flanges to protect the cargo there were less failures among the group "C" brackets. This was because the tightly wedged wood framing served as intermediate lateral supports for the shell framing and prevented the flanges from tripping under minor local collisions. The wood framing also assisted by forming a grid on the shell framing. Stability was not the problem with the group "E" flanged-plate brackets, because the shell framing or deck framing member usually cracked or buckled near the bracket connection first. Again, the major cause of these severe loads is collisions. It is realized that accidents do happen, but a lot of preventative measures, such as reinforced areas in the ship's hull designated as tug stations, and the use of heavy duty rubber fenders at piers and loading docks, could be applied.

Table 4 is a summary table of beam brackets observed in the second survey, plus the total observed for both surveys. Although the number of observed details increased by only 35%, the number of failures increased 154%. This was expected since the first survey had shown that the majority of the failures were located in the midship portion of the ship, predominately in structure adjacent to the side shell, and this is where the majority of the beam brackets are located for containerships, general cargo ships and bulk carriers. For instance, the corner brackets of group "C" increased in failures from 2% to 18.3%. The 7.65% failure rate for the midship/cargo section survey of Part II brought the average failure rate up from 1.75% for 50 ships to 3.28% for all 86 ships making beam brackets second to tripping brackets for the highest failure rate.

The transition brackets of family group "M" were quite common near the turn of the bilge and, thus, were quite susceptible to corrosion. Proper design, such as drain holes to prevent standing water and elimination of inaccessible areas, coupled with a regularly enforced maintenance program, would have prevented failures in this area.

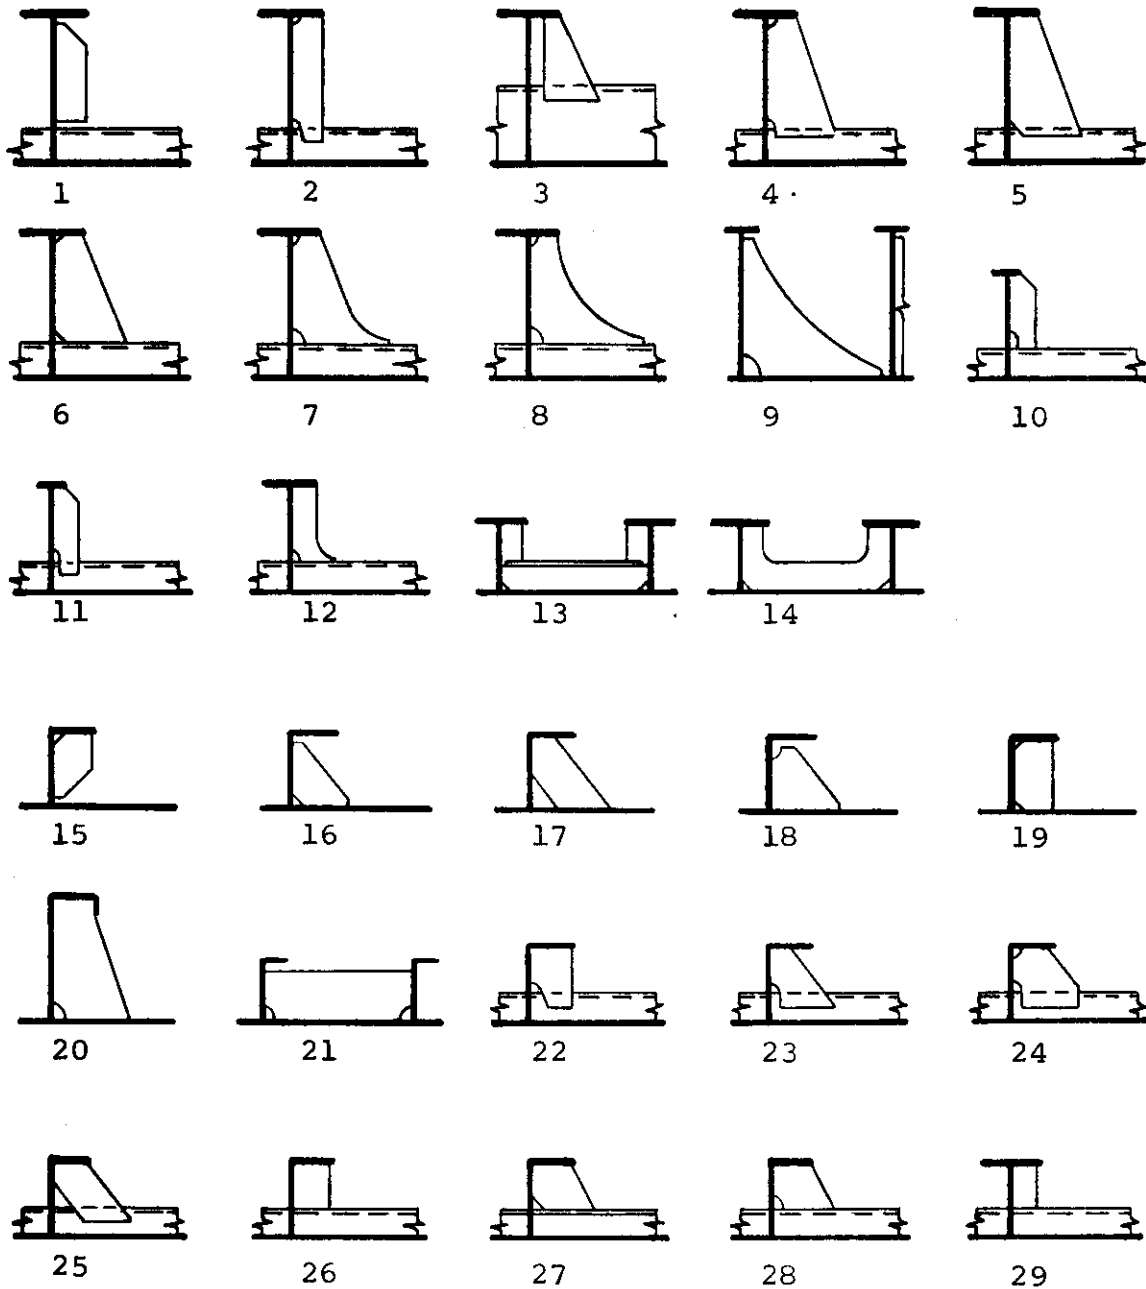
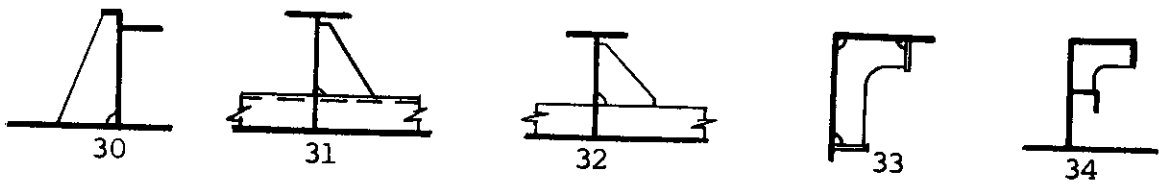
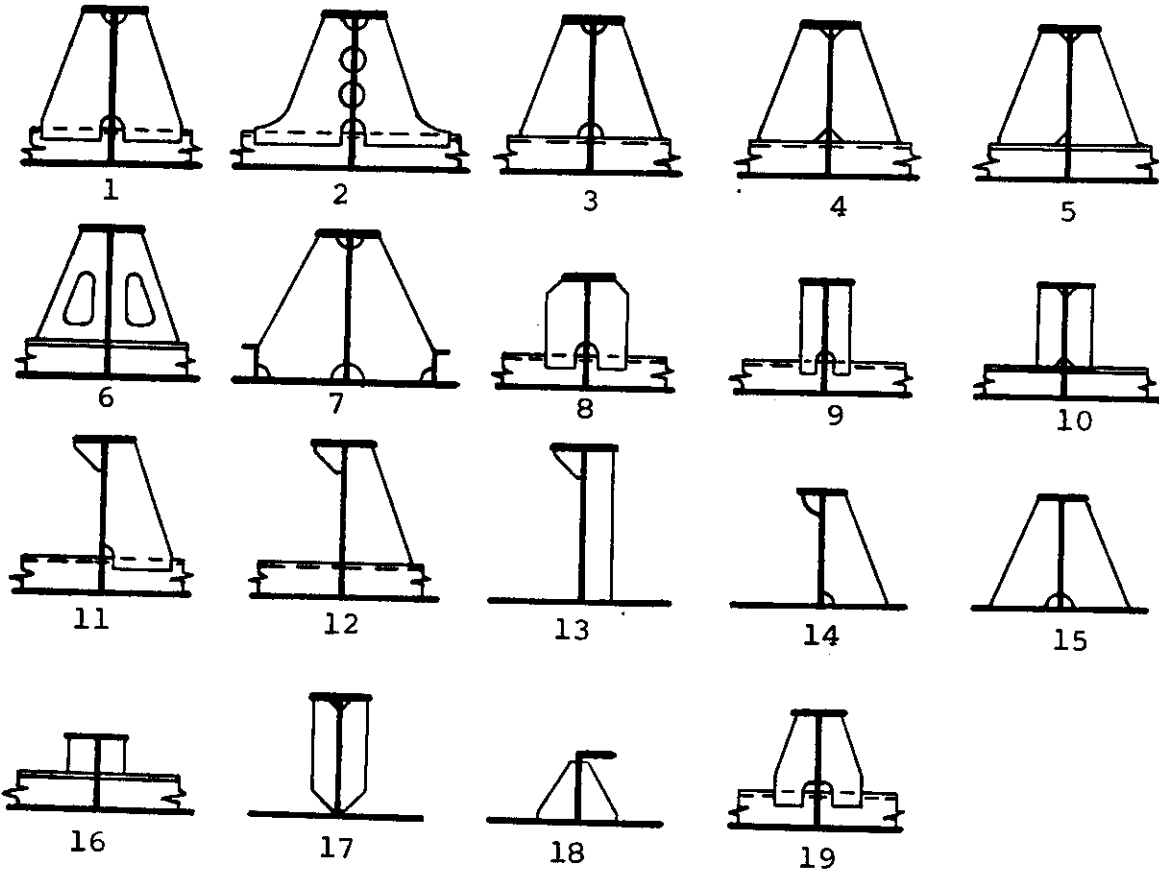
FIGURE 5

The three groups of tripping brackets, containing 82 different configurations, are shown in Figure 5. Sixteen new variations were found in the second survey with eleven belonging to group "C". Group "C" also continued to have the highest failure percentage rate of the three groups, thus, placing four details on the top ten most prevalent failure list and one detail on the top ten highest percentage failure list. Details 2-C-19, 2-C-11, 2-C-7, and 2-C-20 ranked third, fifth, sixth and tenth, respectively, under most prevalent failures. Details 2-A-20 and 2-C-27 were seventh and tenth under highest percentage failures.

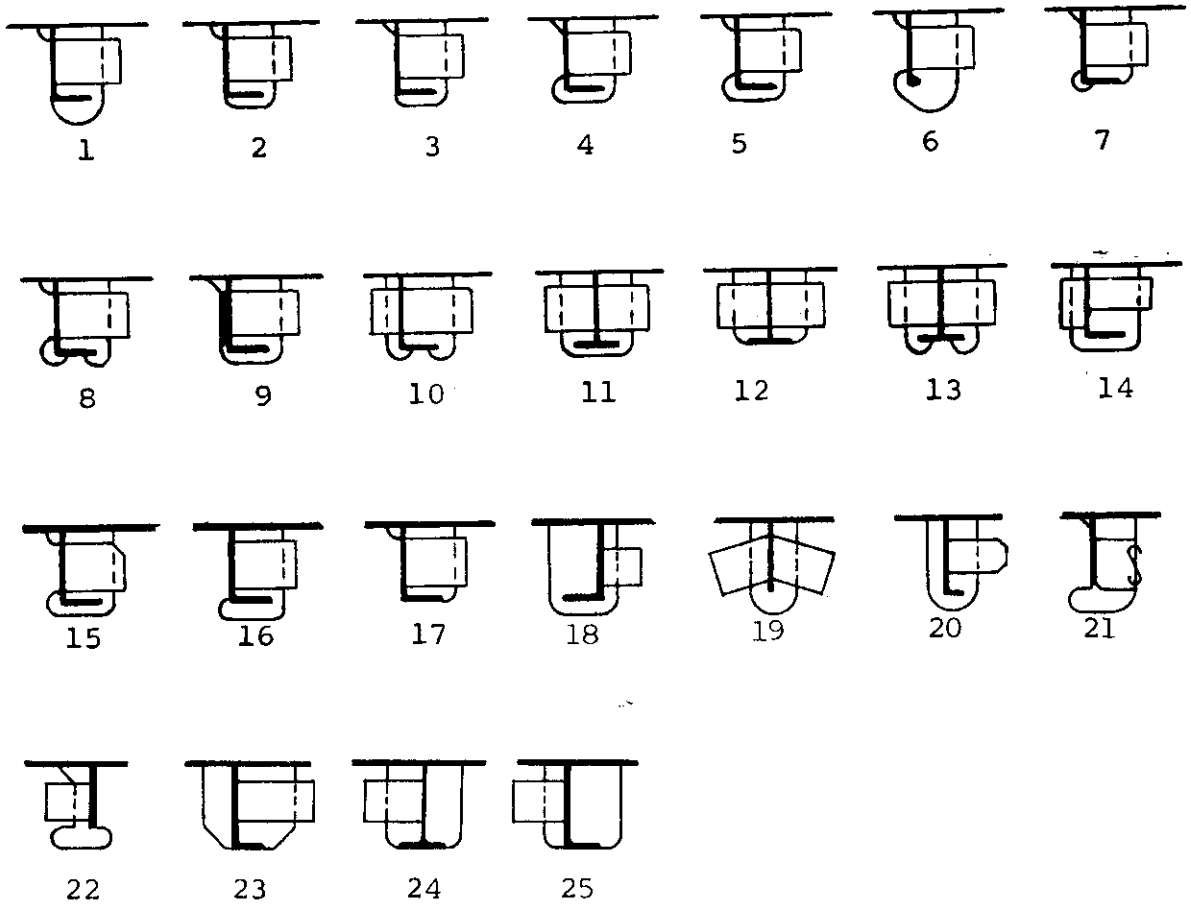
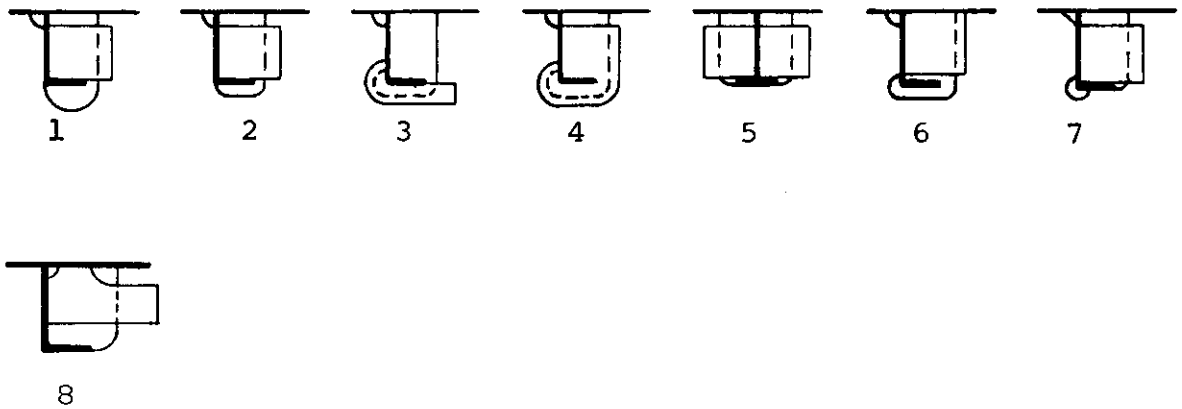
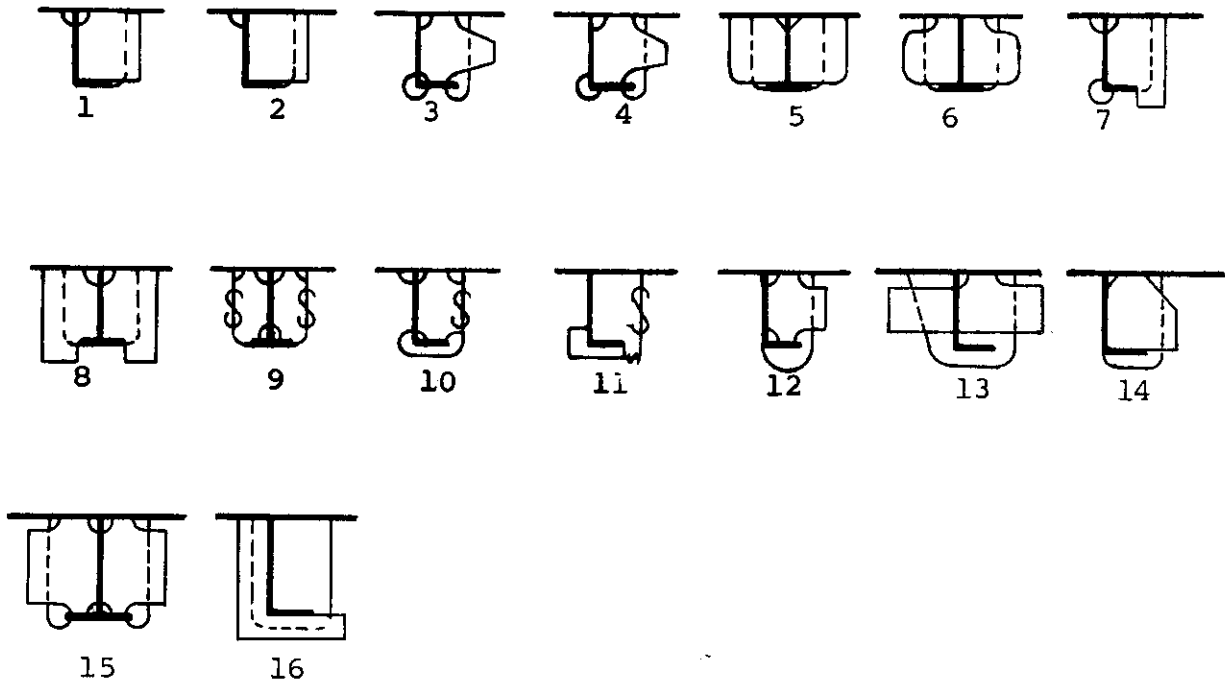
FIGURE 9

Of the 4,724 non-tight collar details observed in this thirty-six ship survey there were only five failures. Incomplete welding on detail 3-A-16 resulted in two detail failures on a bulk carrier while poor workmanship and bad welding accounted for three failures of detail 3-A-25 on a containership. Thirteen new variations in configurations were observed in this survey, thus resulting in an overall total of forty-nine configurations for the three group family. Figure 9 shows the forty-nine configurations, and Table 6 summarizes the results.

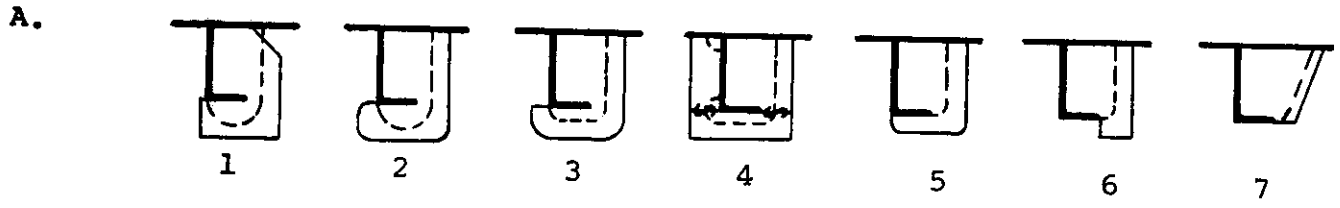
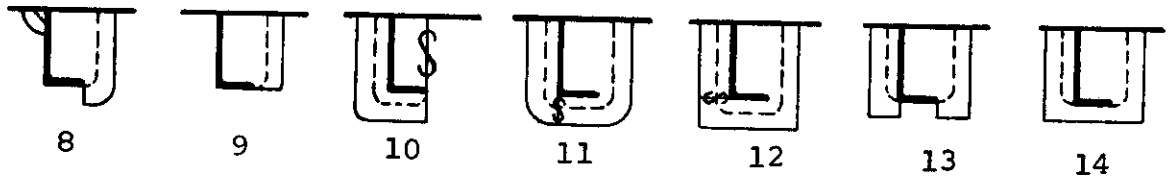
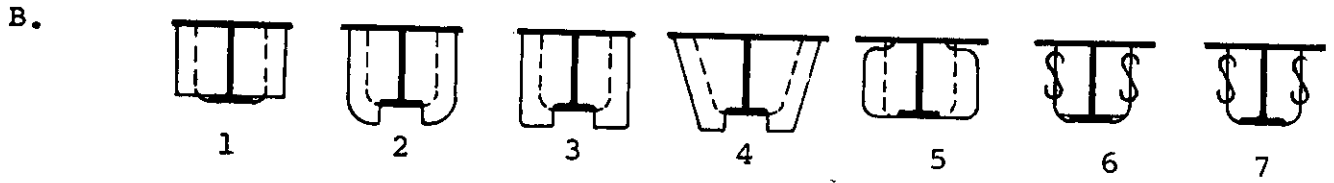
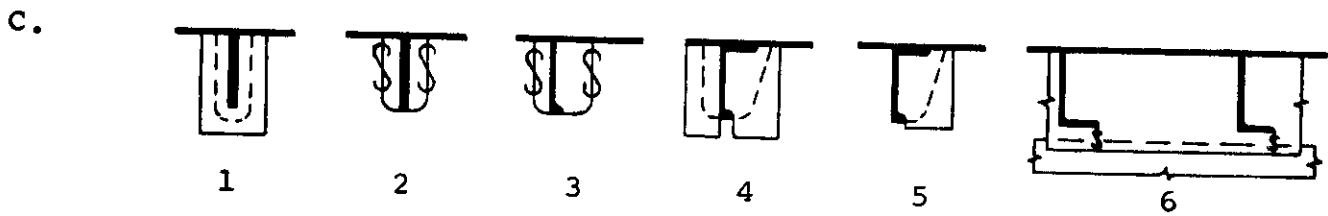
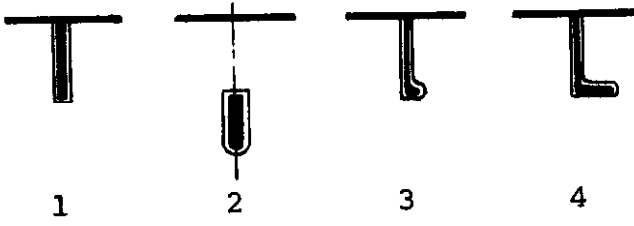
FIGURE 10

Figure 10 contains the thirty-three variations in configurations observed for the family of tight collars. Detail 4-C-7 is the only new configuration identified in this survey. Table 7 is a summary of the number of sound details observed as well as the total observed for both surveys.

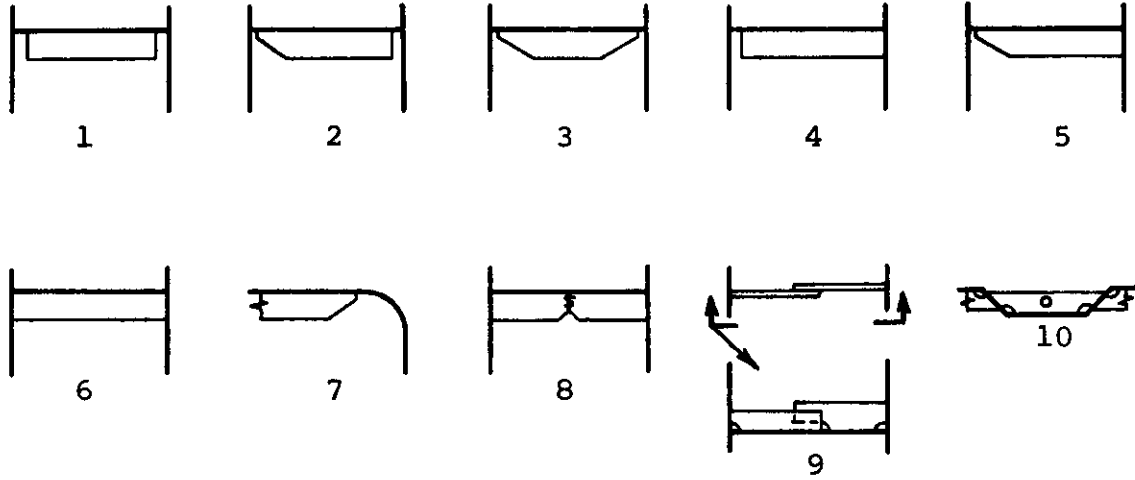
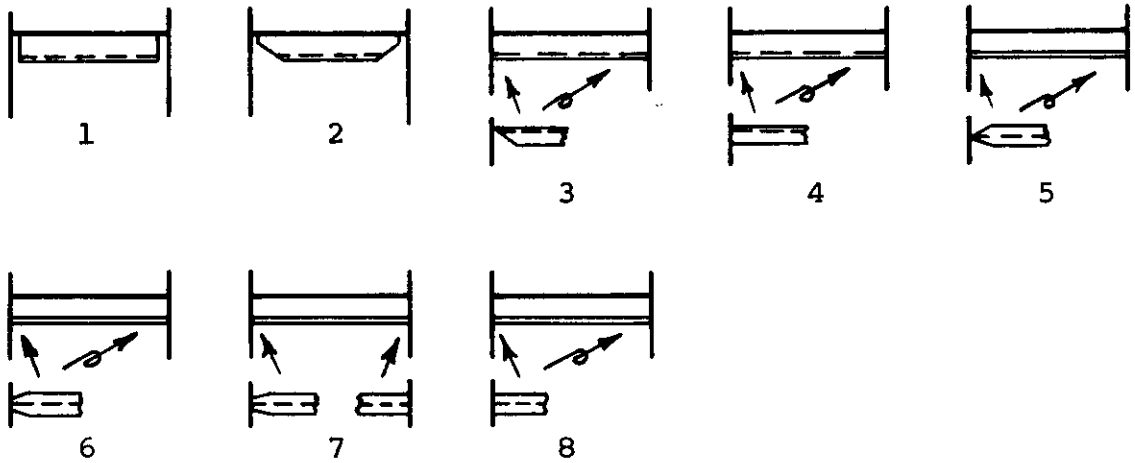
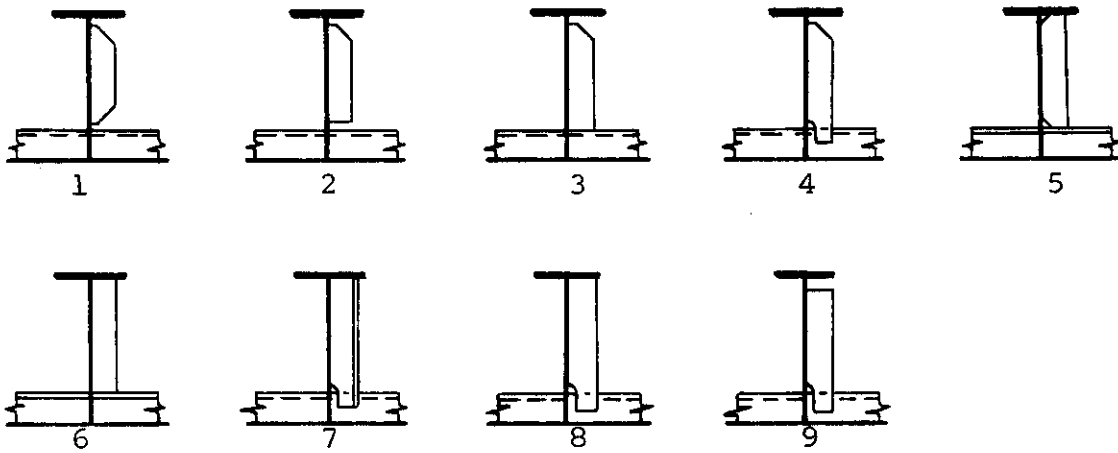
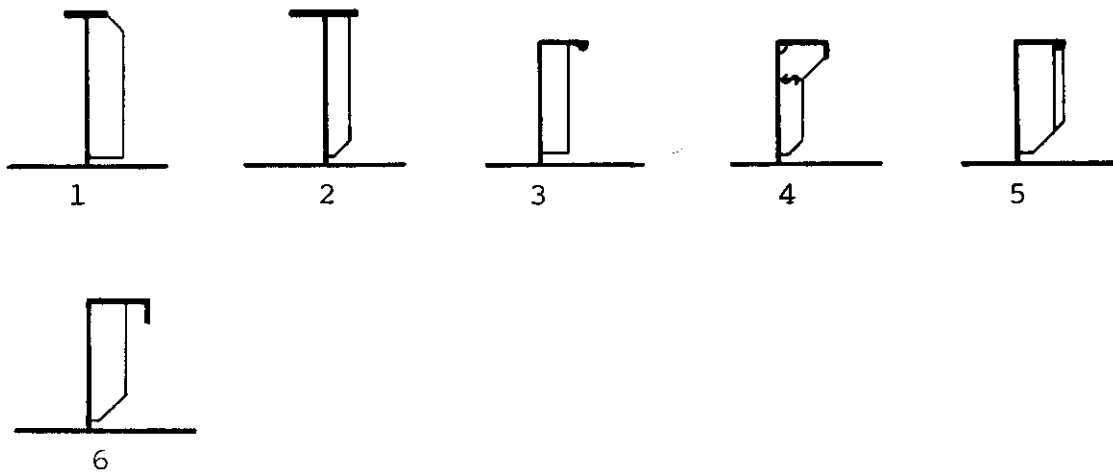
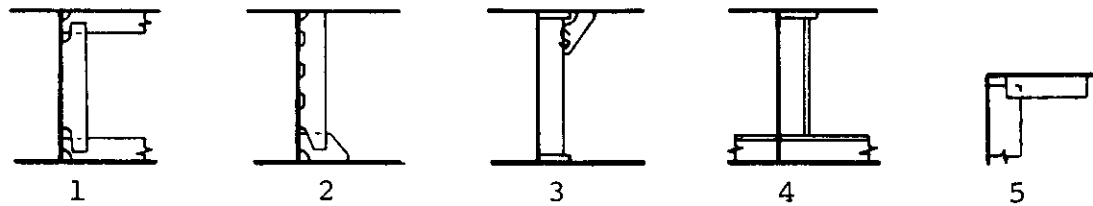
PANEL STIFFENER DETAILS
FAMILY NO. 12

Eighty-one percent of the failures recorded in the second survey were on general cargo ships. Groups "A" and "B" led the failure list with 200 and 270 failures, respectively. Group "C" had three failures, while group "D" had fifty-four failures that were found mainly on the main deck hatch coamings. Groups "E" and "F" were failure free.

Many of the failures in this family were caused by corrosion, impact from large objects, and misuse/abuse. On the general cargo ship mentioned above, corrosion was the prevalent cause of so many failures on details 12-A-3 and 12-B-2. Fifty-six percent of the panel stiffener configurations that had failures in the second survey had at least one failure due to impact loading, presumably by cargo. Stiffeners with sniped ends with no restraints to help keep the flange from tripping were especially vulnerable. Details 12-A-6 and 12-A-10 had many failures due to misuse/abuse. These panel stiffeners often had holes drilled in them to attach cables for holding down cargo. One such stiffener is shown in the photograph in Figure 29.

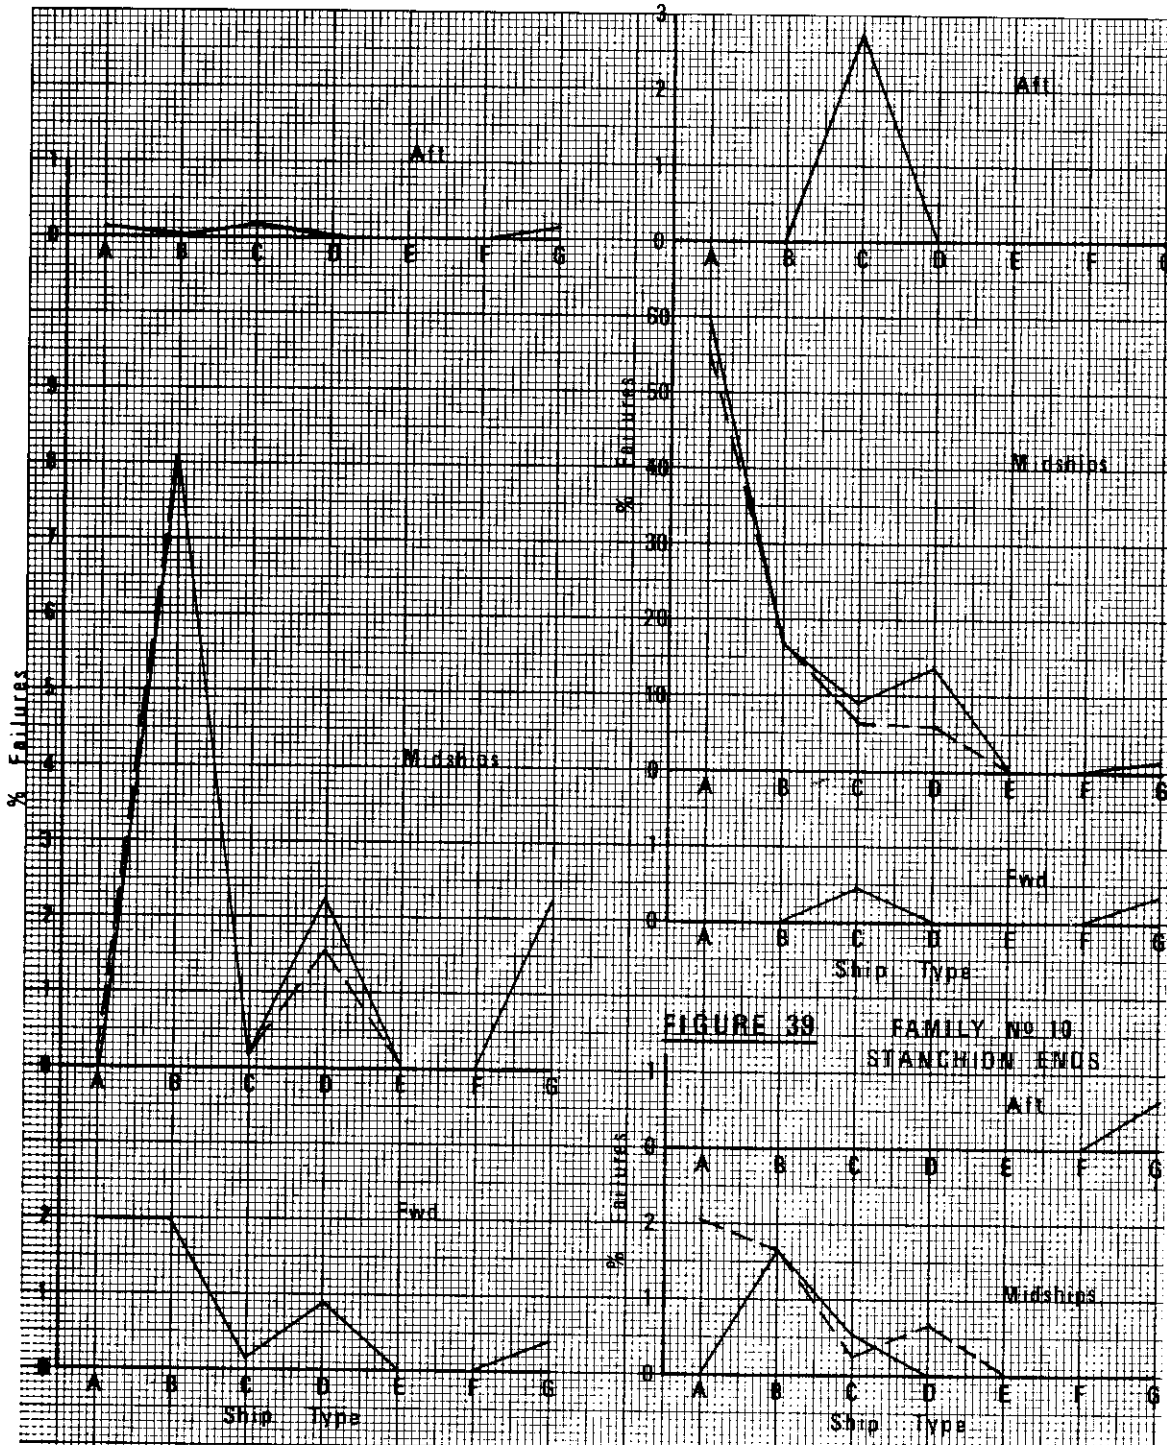
FIGURE 37 FAMILY NO 8
CLEARANCE CUTOUTS

The largest number of clearance cutouts were used in tankers, miscellaneous ships and combination carriers. Naval ships had the least and they were found in the aft section only. As shown in Figure 37, bulk and combination carriers had the highest failure percentage in the forward section of the ship. Detail 8-E-2 accounted for all of the bulk carrier failures and detail 8-E-7 for the combination carrier failures. In the midship section, detail 8-D-6 was responsible for the 8.1% failure rate on the combination carriers. The failure rate for bulk carriers, containerships, and general cargo ships, changed very little from the first survey, as shown in the midship plot of Figure 37. Very few clearance cutout failures were observed in the aft section of any of the ship types.

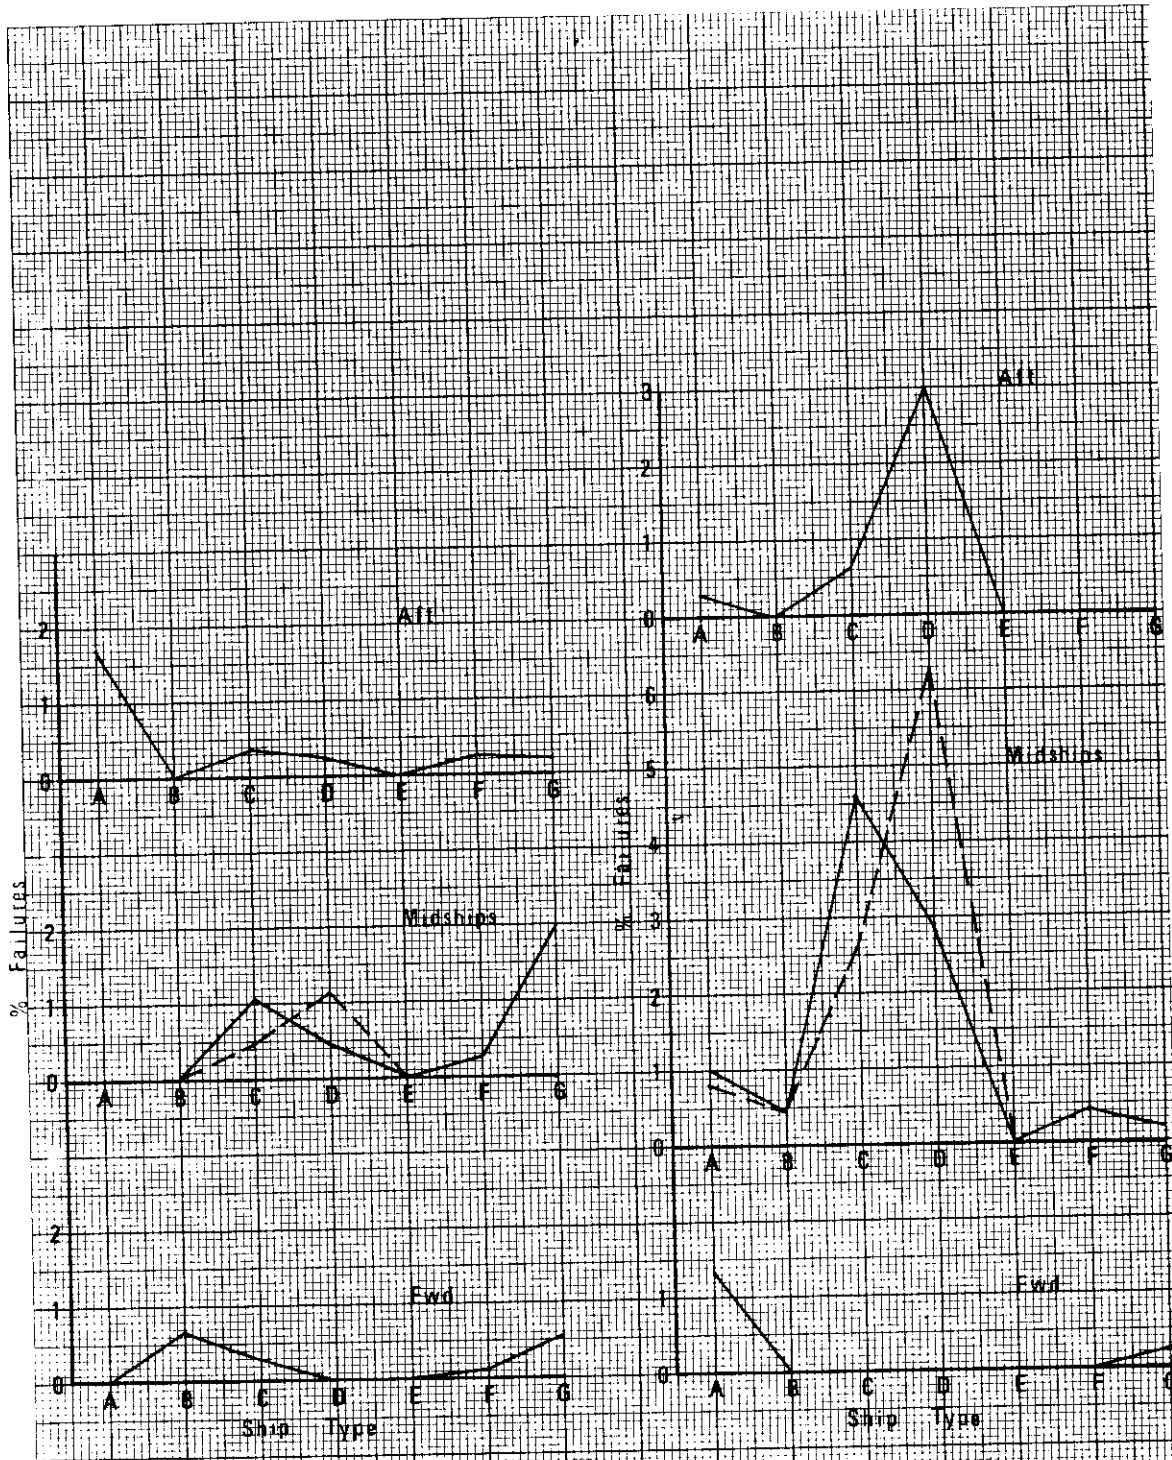
FIGURE 40

FAMILY NO. 11
STIFFENER ENDS
