SSC-337

**SHIP FRACTURE MECHANISMS
INVESTIGATION**

SHIP STRUCTURE COMMITTEE

1990

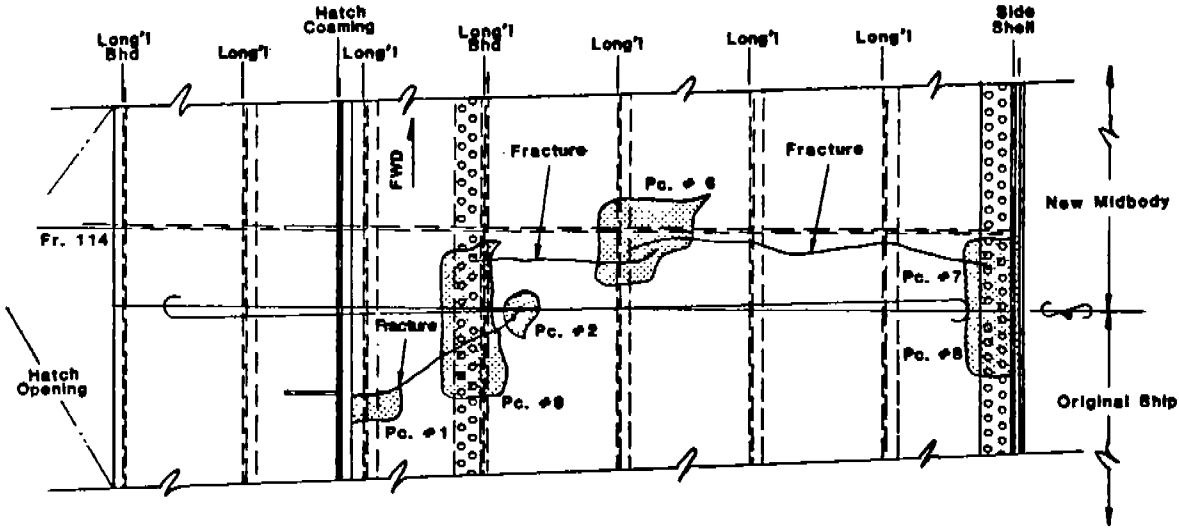
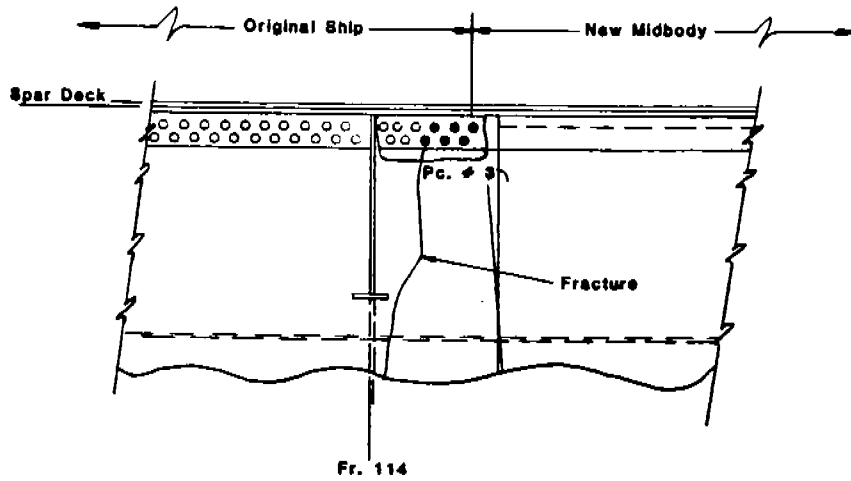
Figure 3-6 Location of Plating Samples from the Great Lakes Bulk Carrier

Nine samples were taken from the fractured plating and were shipped to Lehigh University for further examination of the fracture path, initiation sites, and arrest sites. The locations of these pieces in the spar deck are shown in Figure 3-6. A detailed description of the fracture samples is presented in [3-1]* and is summarized below.

Sample No. 6 contains two separate fractures, both of which appeared to either terminate or initiate in the sample. Cutting the sample to reveal the fracture surfaces showed that the crack extending toward the longitudinal bulkhead at the toe of a weld at the cutout in the longitudinal channel initiated in sample No. 6; see Figure 3-9. From this point the fracture ran both inboard and outboard. One end terminated in the plate a short distance outboard of the channel while the other end terminated at a rivet hole in sample No. 9. The growth directions of both of the fractures and the presence of the initiation was clear in the sample from the chevron markers.

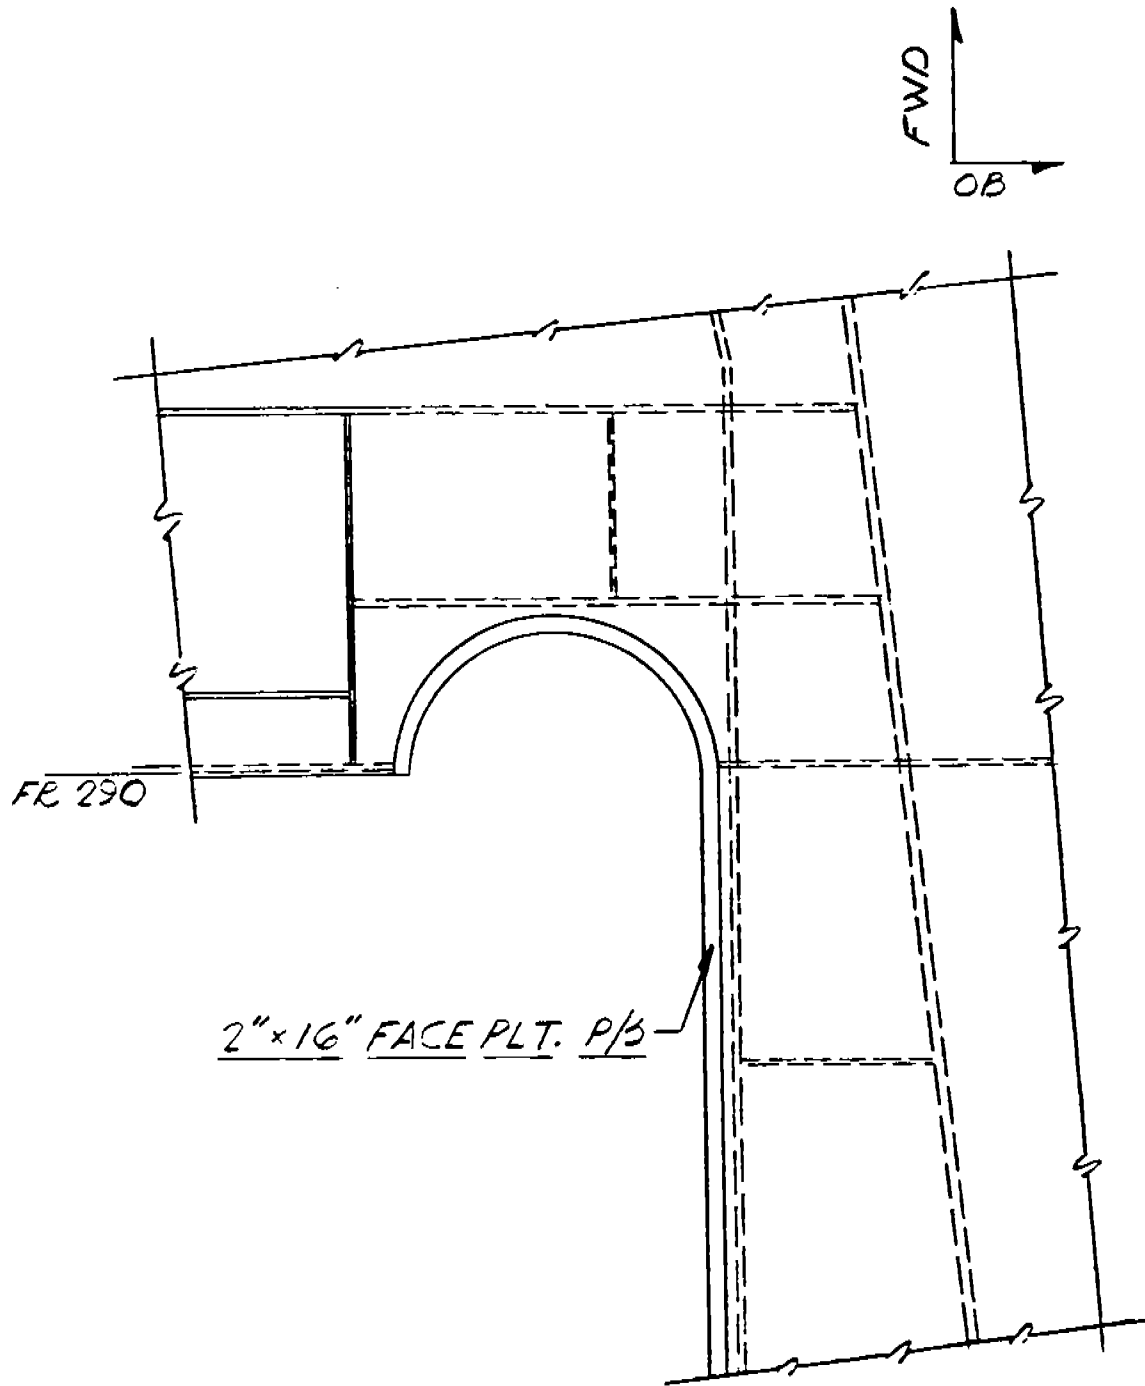
Figure 3-18 Face plate design for the forward hatch corner of the high speed containership

- Maximum stress at hull girder frequency (whipping) of 5,943 psi
- Mean stress (primarily from cargo and ballast distribution)* of 7,936 psi. hogging.

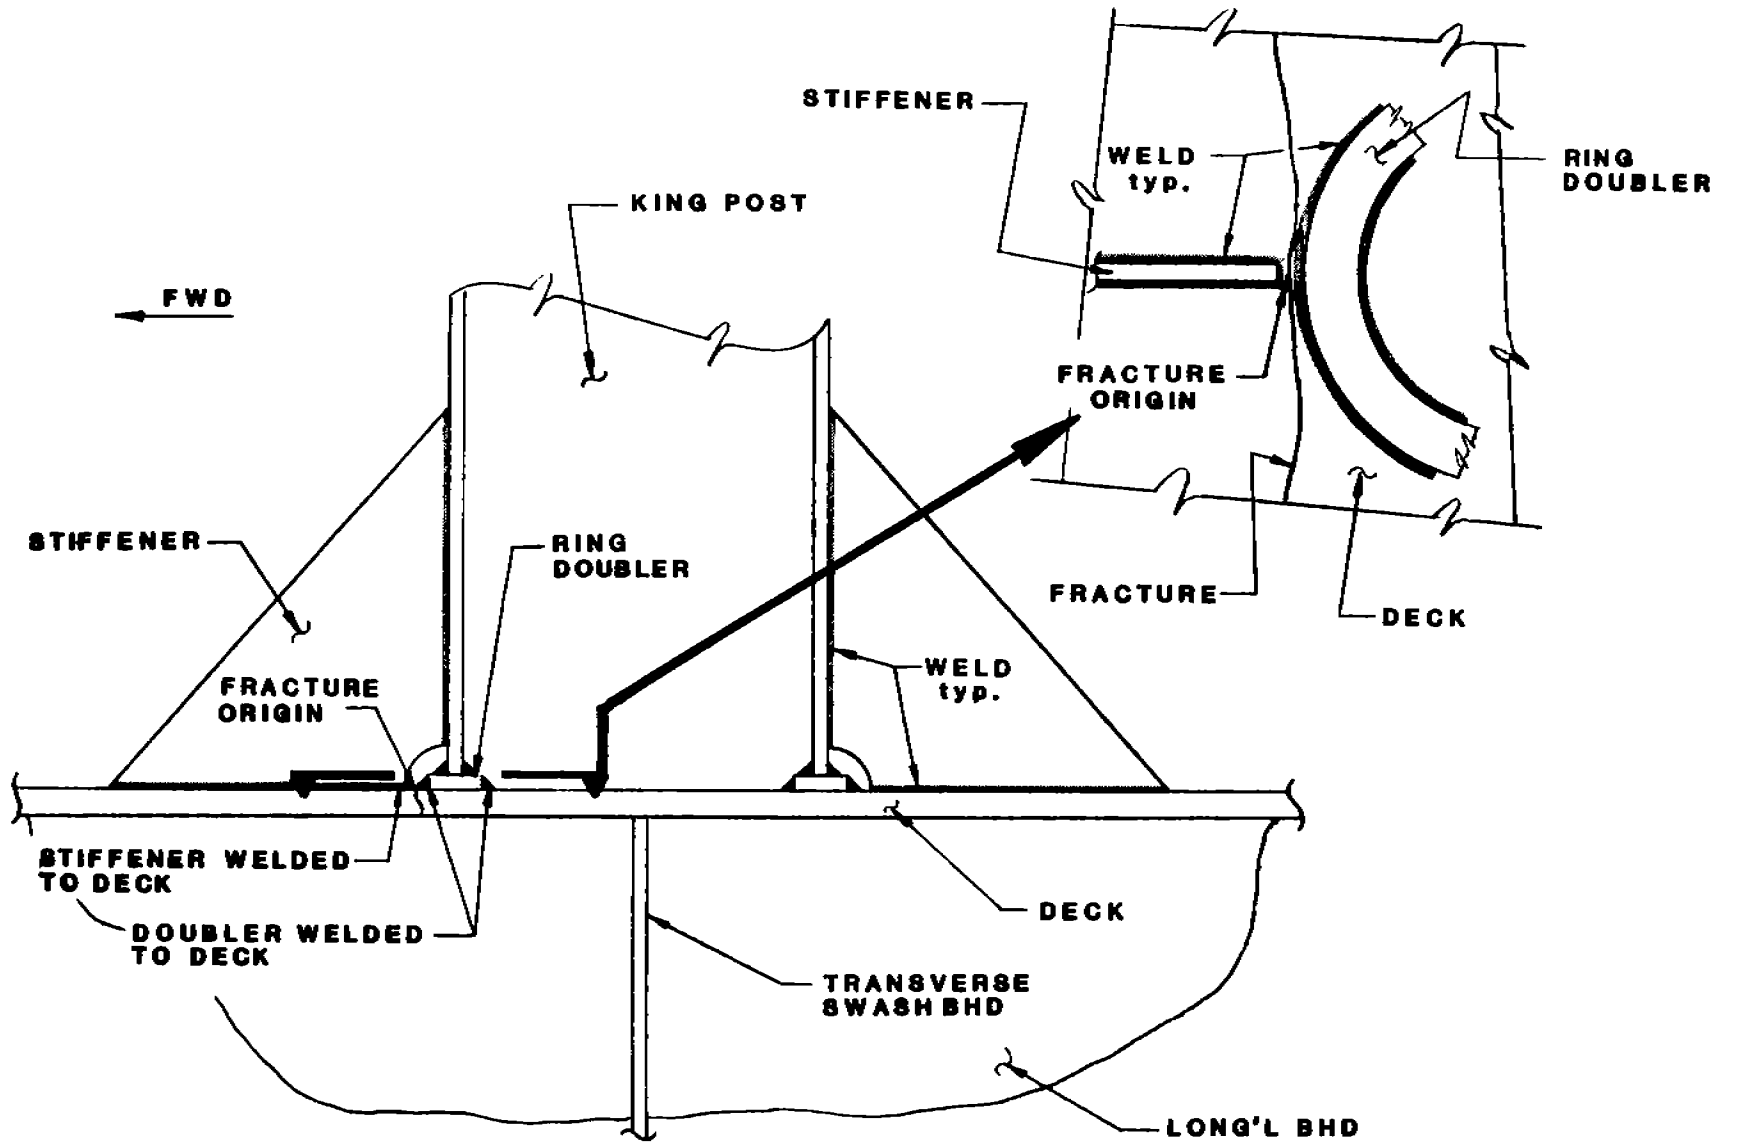
Figure 3-22 Structural Detail at the Fracture Origin on the Tank Barge

An unusual ballasting condition created a large stillwater bending moment with a resulting nominal stress of 23,515 psi in the deck, [3-4]. The combined effects of physical constraint, residual welding-induced stress and the nominal stress in the deck resulted in local stress sufficiently high to initiate a brittle fracture at the notch in the base of the king post.

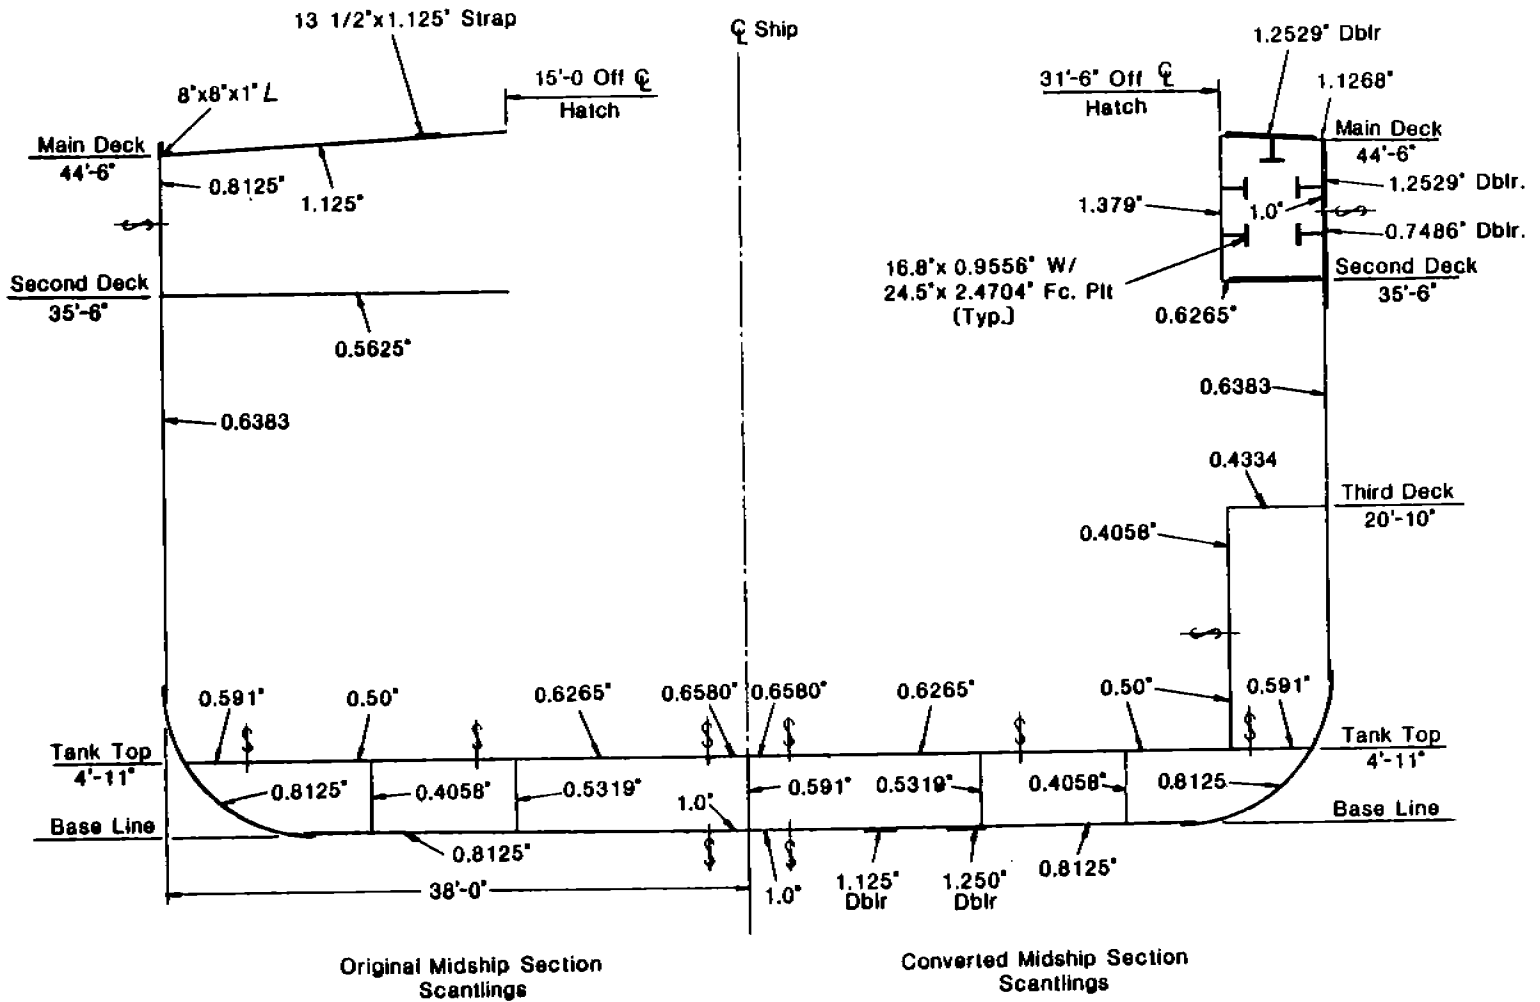
Figure 3-25 Midship Section of the Original Mariner Class and the Containership Conversion

Just before actual conversion work began it was agreed by the owners and classification society that the bottom plating of the new midbody would be Grade A plate, .8125 inch thick, the same thickness as the bottom plating of the original ship. The increase in section modulus required by the lengthening was achieved by the addition of doubler straps welded to the bottom, main deck and shear strake throughout the .4 length of the hull girder.

As part of the conversion, a significant amount of permanent ballast was added for stability considerations. Most of this ballast was placed in the ends of the vessel, which resulted in a large lightship still water hogging moment. At the time of the conversion there were no requirements for loading manuals on container ships to provide a means for determining bending moments.

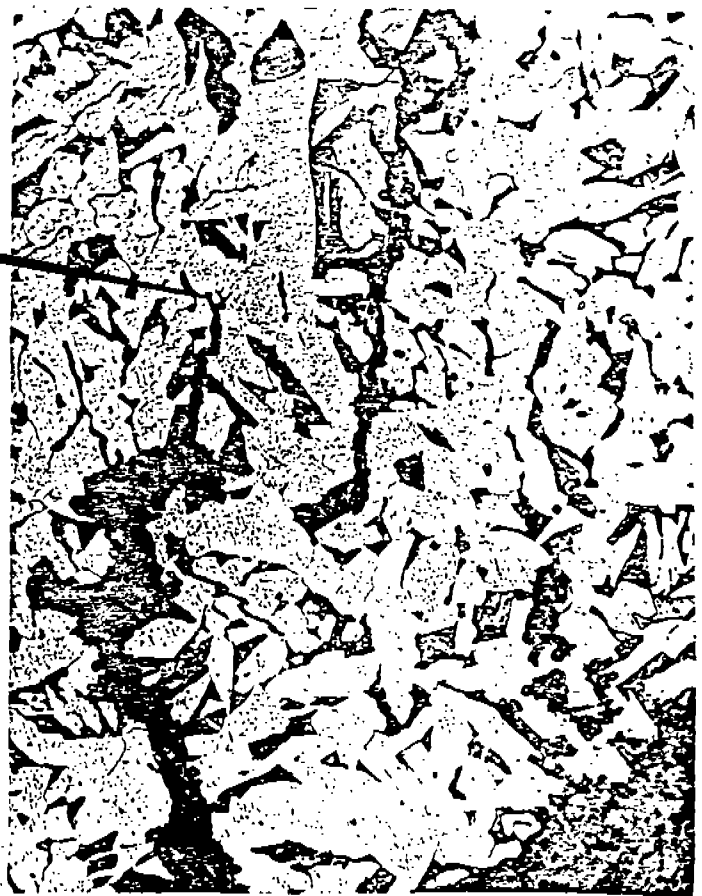
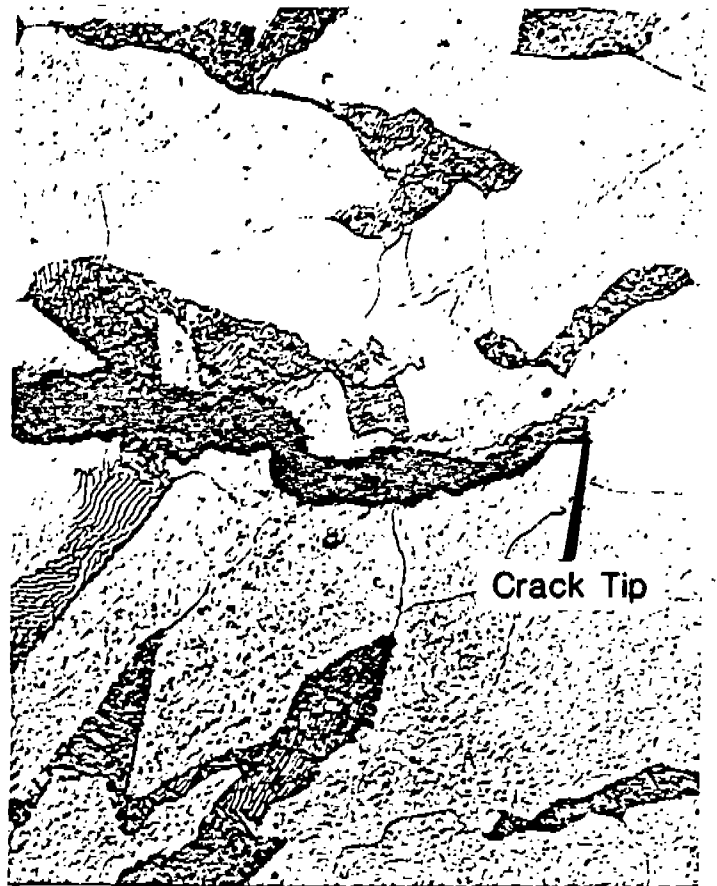
Figure 3-27 Microstructure in the vicinity of blunt crack tips of Figure 3-26

Visual inspection by ship owners' representatives showed that both surfaces were extensively corroded, with the exterior surface being the most severely effected. Examination of metallurgical specimens revealed the cracks in the plate and welds to be transgranular, to contain corrosion product, and to be characteristic of progressive fatigue cracking under the influence of corrosion. Several small cracks were examined by fractographic analysis as shown in Figure 3-27 where crack tip blunting can be observed. These cracks did propagate via corrosion fatigue and in more than one instance grew to a size where brittle fracture occurred and chevron patterns were observed.

The investigators of this project believe that the primary cause of the cracking problems on these vessels can be related to the original design and conversion. The high still water hogging moments cause the bottom plating to be loaded in compression. This combined with the water pressure eventually led to upward deflection of the bottom plating between transverse floors, as shown in Figure 3-28. As the ship worked in a seaway, these buckles formed hinge points at the frames and over the years fatigue damage accumulated at the hinge points and other stress concentrations such as butt welds. The ship lengthening, placement of ballast in the ends, reduced scantlings allowed by the use of ineffective strapping, unrestricted loading, poor welds and corrosion all contributed to the problem. Fatigue cracks first appeared at the weakest points, e.g., poor quality welds, notches and defects, and then spread to base plating.

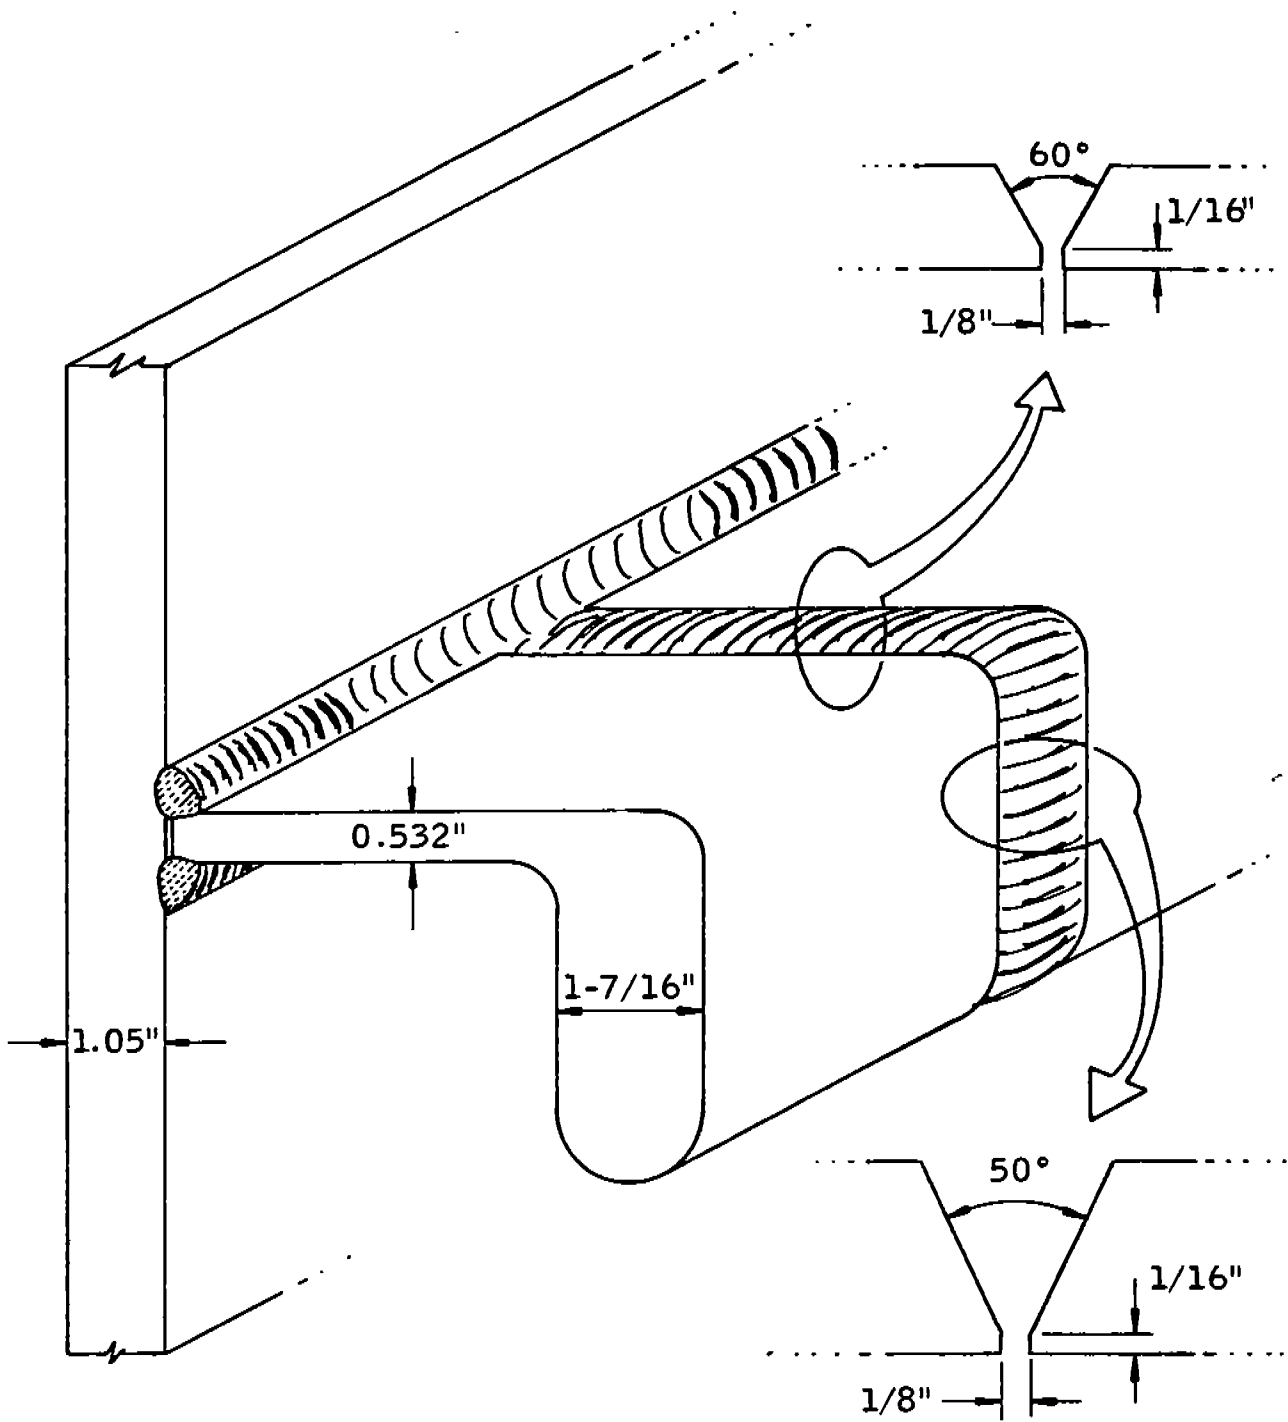
A detailed examination of the butt weld in No. 5 longitudinal showed that the weld was poorly made. Figure 3-40 is a sketch of how the weld attaching the longitudinals to the shell plate at the butt weld was supposed to be made. The butt welds in the web and face flange of longitudinal No. 5 are shown in Figure 3-41. The soundness of the web weld is good but it is obvious that the root was not back-chipped before back welding. The weld in the flange is extremely poor with effective fusion for less than half the depth. The lines "A", "B" and "C" indicate the angle of joint preparation. These welds obviously were not of the quality desired nor did they conform to the design joint of Figure 3-40.

Figure 3-40 Weld details as reported by the builder for butt and fillet welds on the longitudinals. Fillet weld is stopped short of butt. V'd side is welded complete, starting at shell plate and welding around to toe of flange. Opposite side is back-chipped and welded. Fillet weld to the shell is then completed.

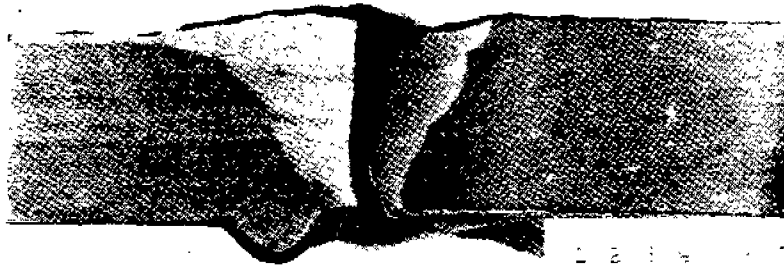
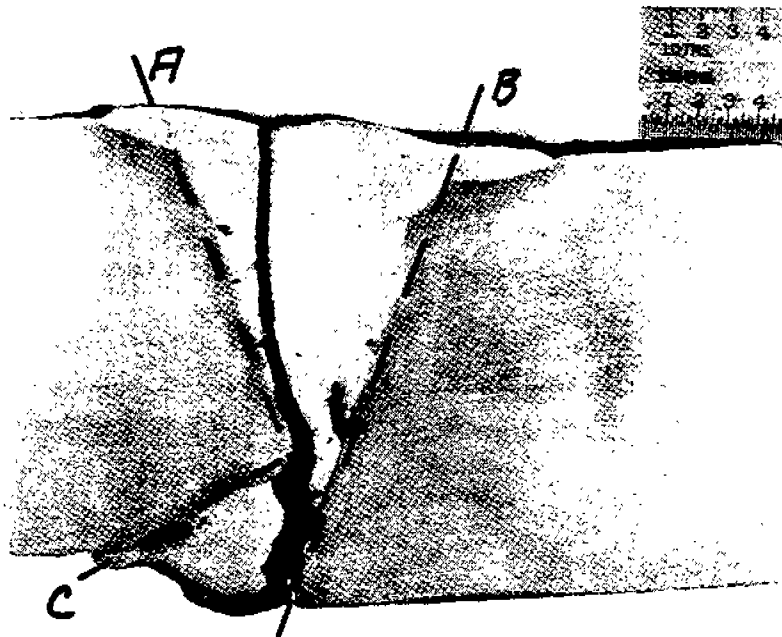
Figure 3-41 Cross sections through the butt welds in No. 5 longitudinal. Lines A, B and C indicate edge preparation prior to welding. The small beads were made from the underside or backside. Note wide cover pass. Specimen No. 3908; Etch, 4% Nital; Magn. 1.5x.

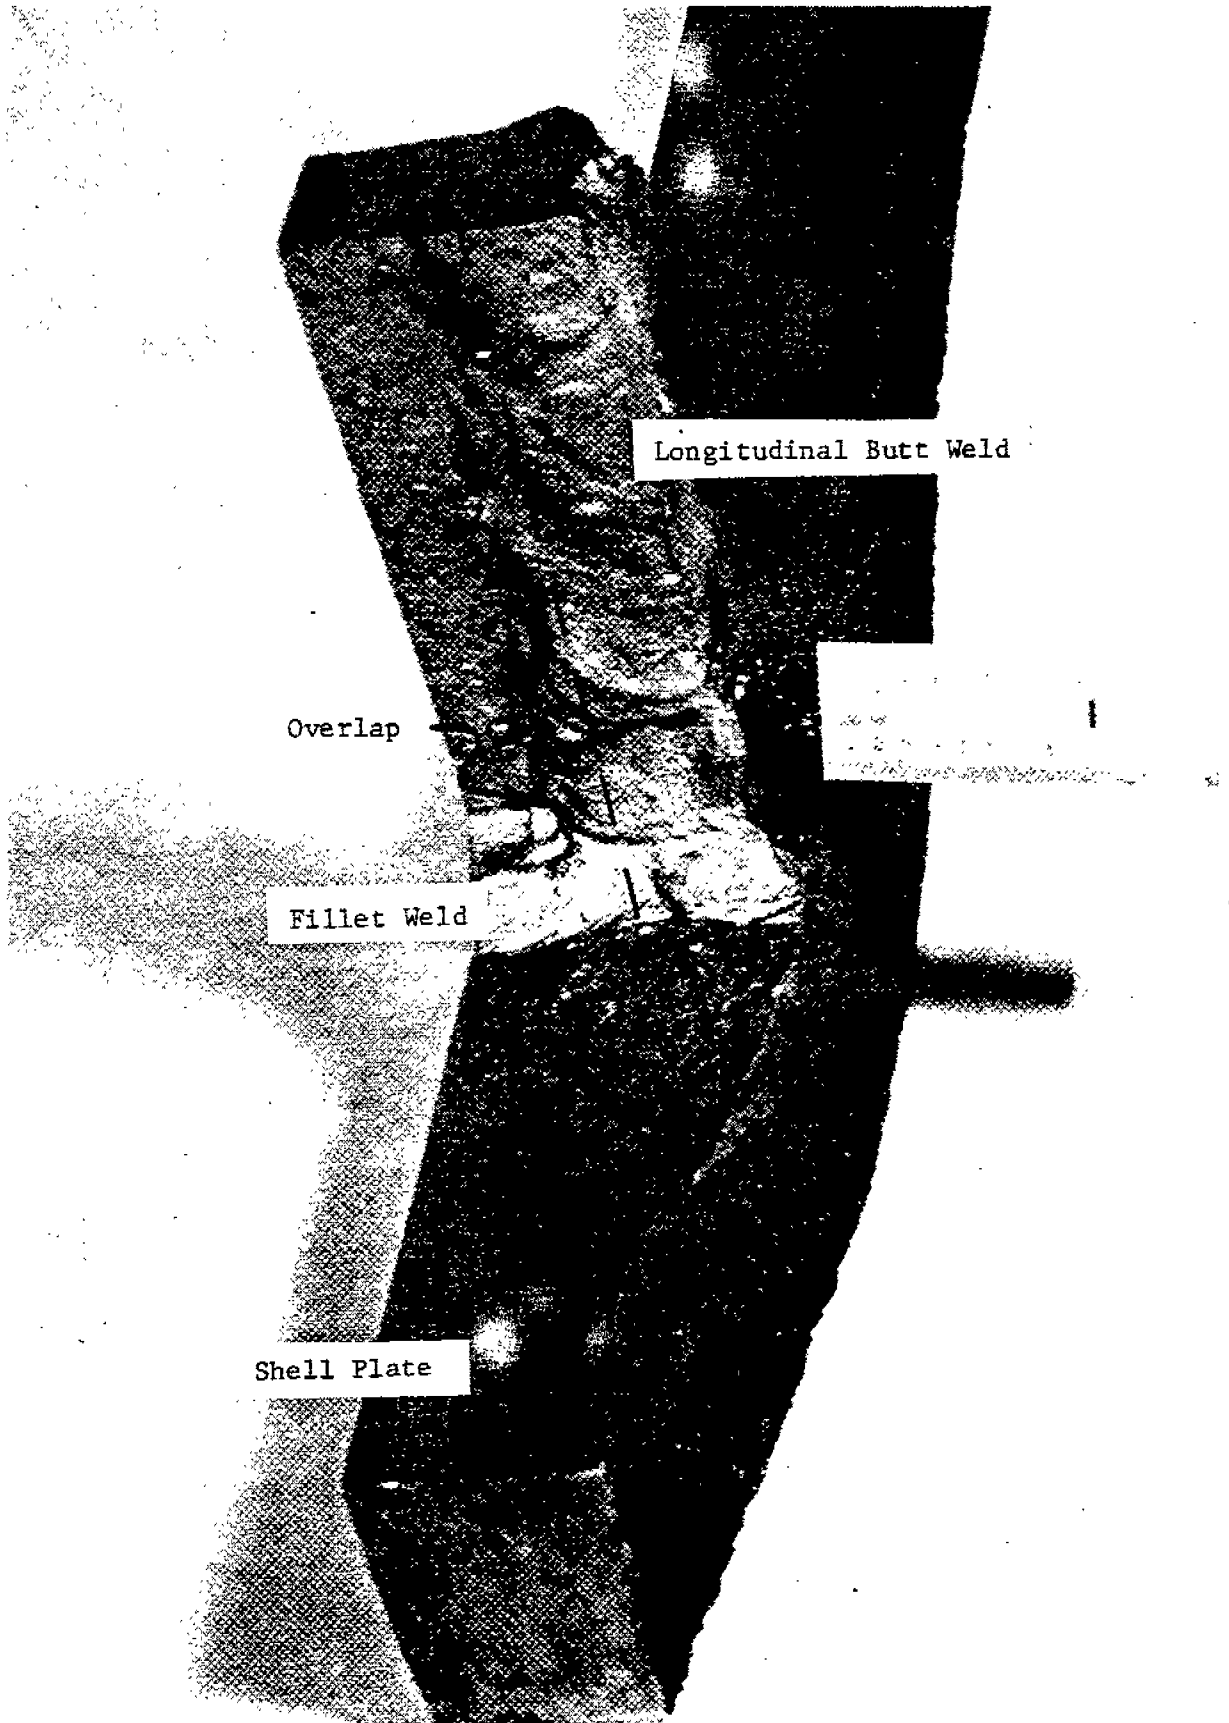
The fillet weld joining the longitudinals to the shell plate was not made in the correct sequence in addition to being of poor quality. The actual weld detail is shown in Figures 3-32, 3-42, and 3-43. In Figures 3-37 and 3-42 it is obvious that the back welding of the butt weld has been laid on top of the fillet weld. On Figure 3-42 the same can be seen for the V'd side of the butt weld. To illustrate this more clearly a section was taken through line A-B in Figure 3-43. This is shown on Figure 3-44. The grain structure clearly illustrates that the butt weld was made over, and hence after, the fillet weld. Also note the almost total lack of fusion of the fillet welds. The effect of this welding sequence is to promote cracking of the butt weld. By

Figure 3-43 Weld Joint of Longitudinal to Shell Plate Looking at Upper Surface of the Longitudinal Butt Weld. Section through line A-B shown in Figure 3-44. Specimen No. 3908; Magn: 1.9X.

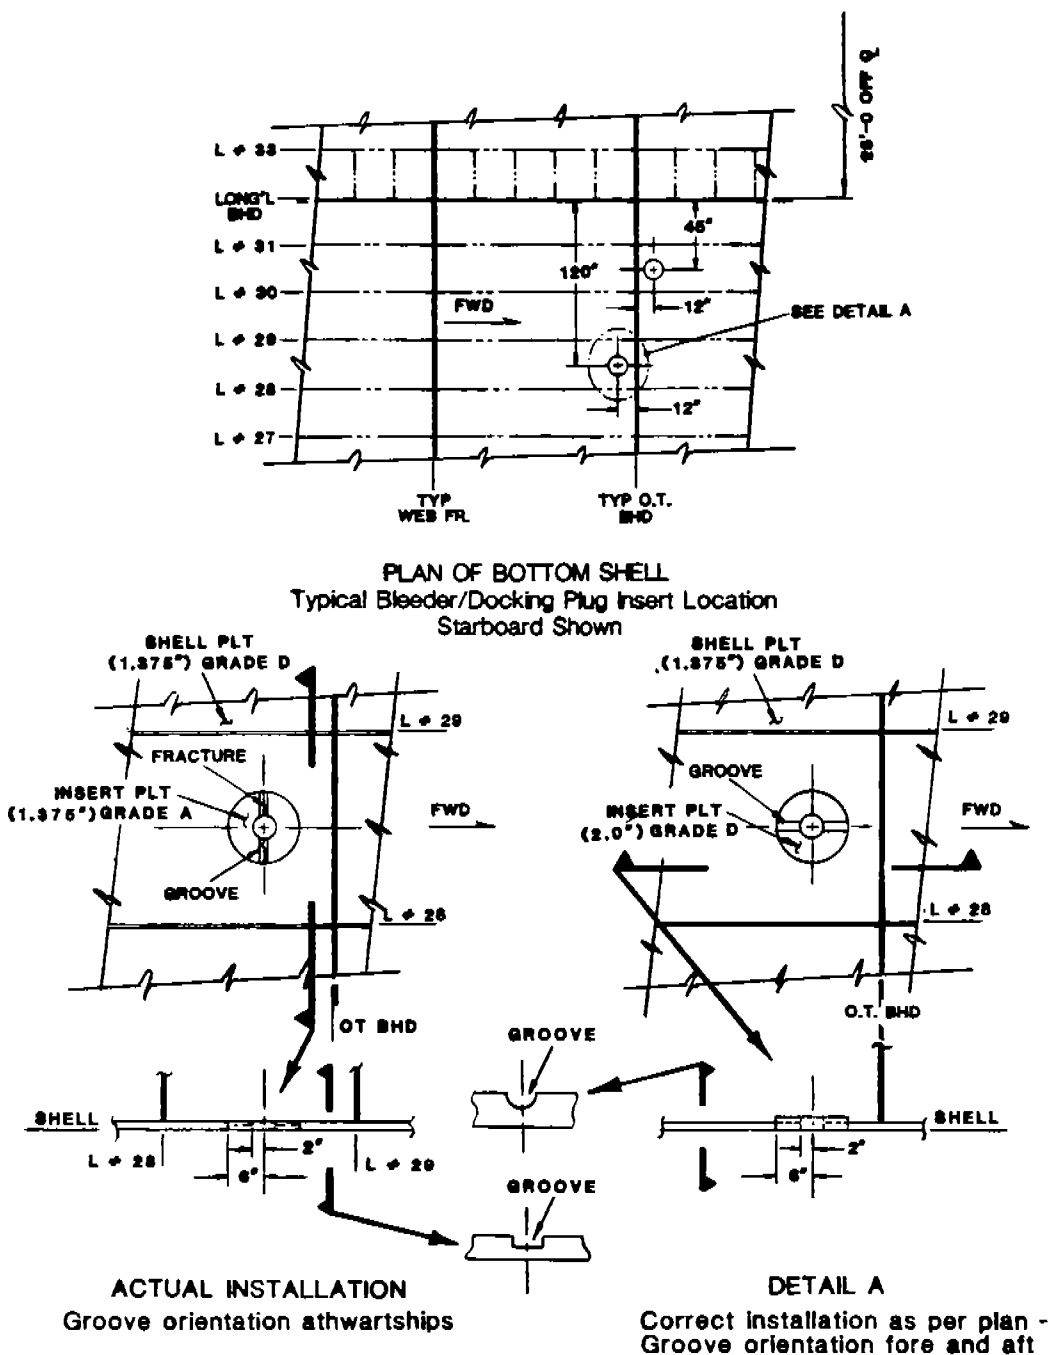
Figure 3-45 Structural Detail of the Docking Plug on the 70,000 DWT Tanker

The fracture was examined by the project investigators. The bleeder/docking plug is used for draining tank liquids in dry dock. There are usually one or two plugs per tank. These plugs are often located in insert plates as shown in Figure 3-45. These insert plates are thicker than the base shell plate to receive a threaded plug, and are often grooved to facilitate drainage. The

plans for the new forebody note that the groove should run fore and aft. The grooves in the insert plates examined on the ship were installed athwartship as shown in Figure 3-45. This tanker had two plugs per tank, all of which had grooves running athwartship. In all, four insert plates were fractured at these grooves.

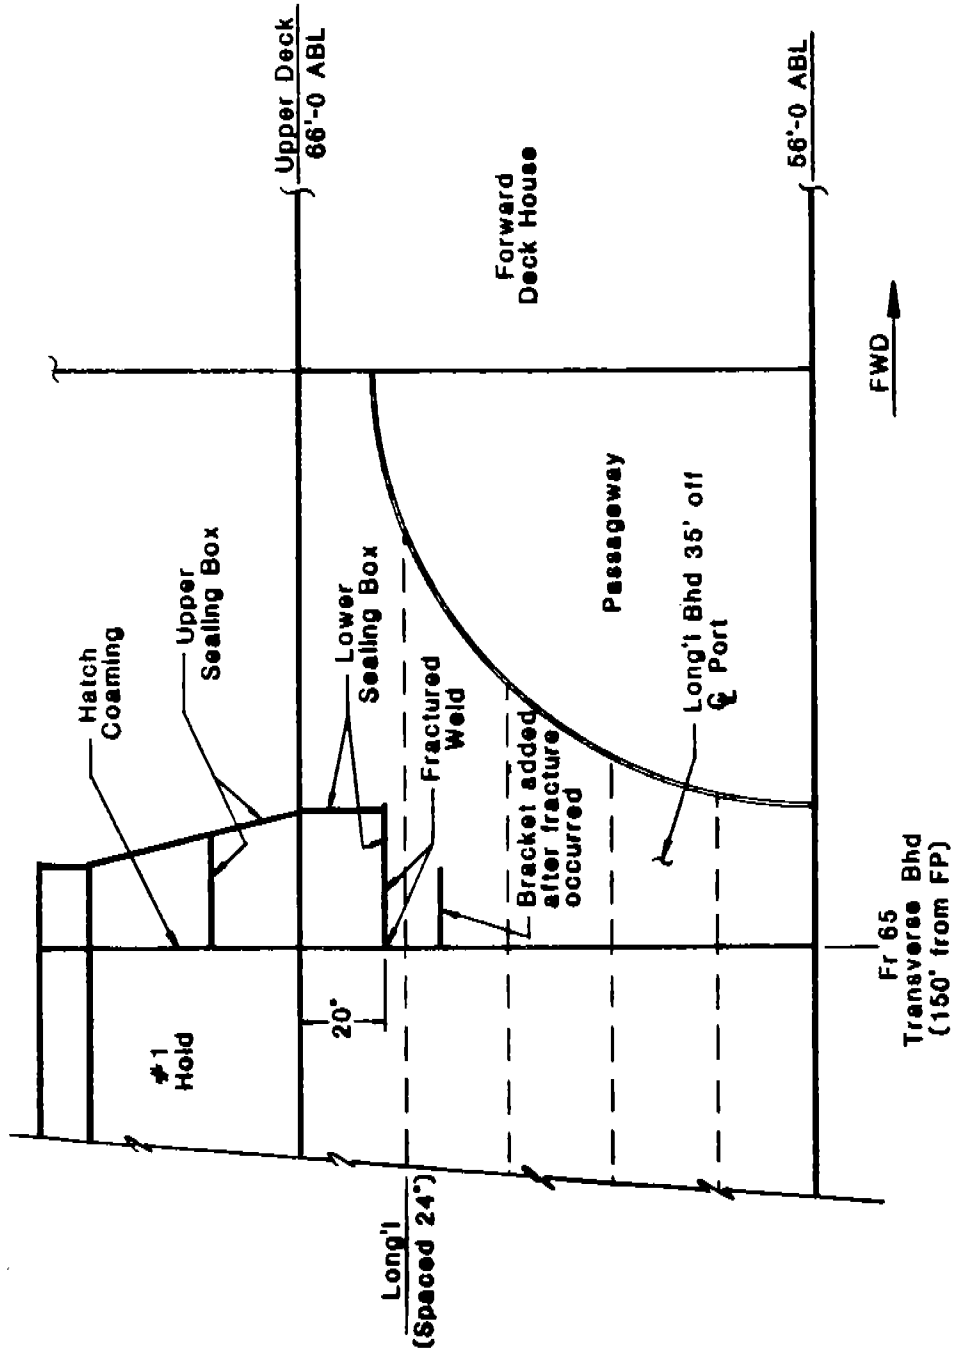
Figure 3-49 Longitudinal Bulkhead of the Containership With a Fractured Transverse Bulkhead

The crack is located in a transverse bulkhead where the longitudinal box girder intersects a transverse bulkhead. The transverse bulkhead is located at frame 65, 150 feet aft of the forward perpendicular. The crack is located on the port side of the ship in close proximity to the hatch corner cutout. The crack and local ship structure are shown in Figures 3-48, 3-49 and 3-50. The crack originated from a weld at the intersection of a lower sealing box, a transverse bulkhead and a longitudinal bulkhead of the box girder. The bulkhead is five-sixteenth of an inch thick and is attached to a longitudinal bulkhead that is one-half of an inch thick and heavily reinforced by longitudinals and deck structure.

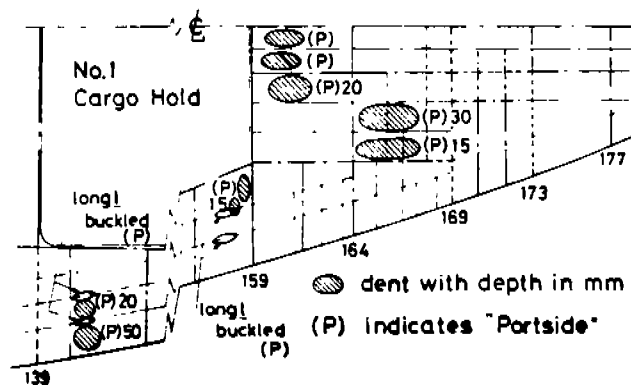
reported in excess of 9 m. As the storm front passed, the winds shifted from SW to NW and waves were encountered from the SW and NW, which resulted in confused seas. Waves were reported in excess of 20m. The crew reduced the ship speed to 7 knots and later increased the speed to 9 knots because the rudder steering gear malfunctioned. The ship experienced violent rolling and pitching motions in the confused seas. The fracture occurred when the ship encountered large waves, approximately three hours after the storm passed and the atmospheric pressure in the location of the ship had begun to rise. Following the storm, it was discovered that cargo-hold Number 1 and the forepeak tank contained sea water and the crew observed a fracture in the starboard side shell at the bow. Severe buckling of the deck and port side shell was also observed.

Figure 3-54 Deck Buckling in the Deck of the Containership Bow

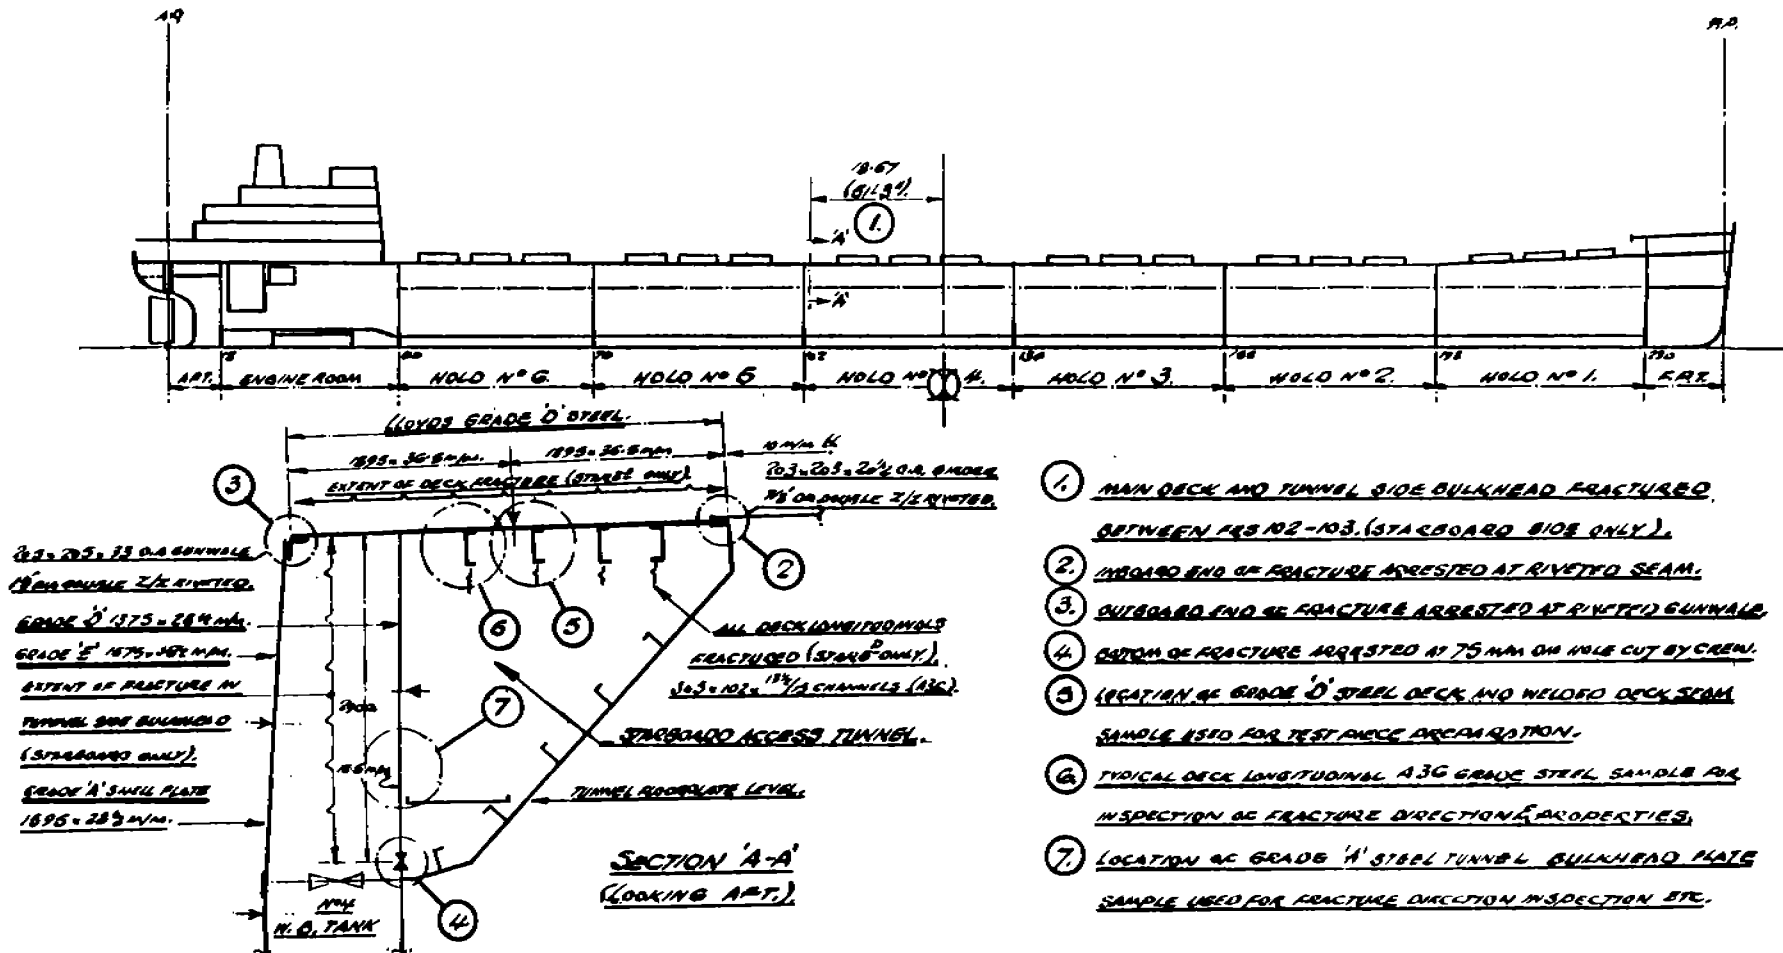
Figure 3-62 Profile and Structural Section of the Great Lakes Bulk Carrier Maindeck Fracture

way. The main deck fracture was 12'-5" long and was located approximately 61'-0" aft of amidships. The main deck was .89" thick. A fracture was also discovered in the adjacent longitudinal bulkhead. Figure 3-62 shows the location of the fracture in a profile drawing and the transverse section of the structure in a detail drawing. An inspection of the main deck and longitudinal bulkhead fracture while afloat prior to drydocking revealed the following:

The sample pieces were examined by those investigating the fracture. Summarized results of the tensile and impact testing, and spectrochemical analysis are given in Tables 3-3, 3-4 and 3-5 respectively. No records were available indicating the grade of steel used in the structure; however, spectrochemical analysis indicates that the main deck plating and longitudinals conform with Lloyds Grade D and ASTM A36 Grade steel. Laboratory testing of the samples from the main deck plating, welded seam material, and deck longitudinals show that the main deck steel plate exceeds Lloyds notch toughness requirements. The main deck longitudinals meet the specifications of ASTM A36 Grade steel, the notch toughness of which is lower than the deck plate to which it is attached, but similar to that of Lloyds Grade A. The deposited weld metal impact tests indicated that the deck butt weld seam was marginally below the specified minimum.

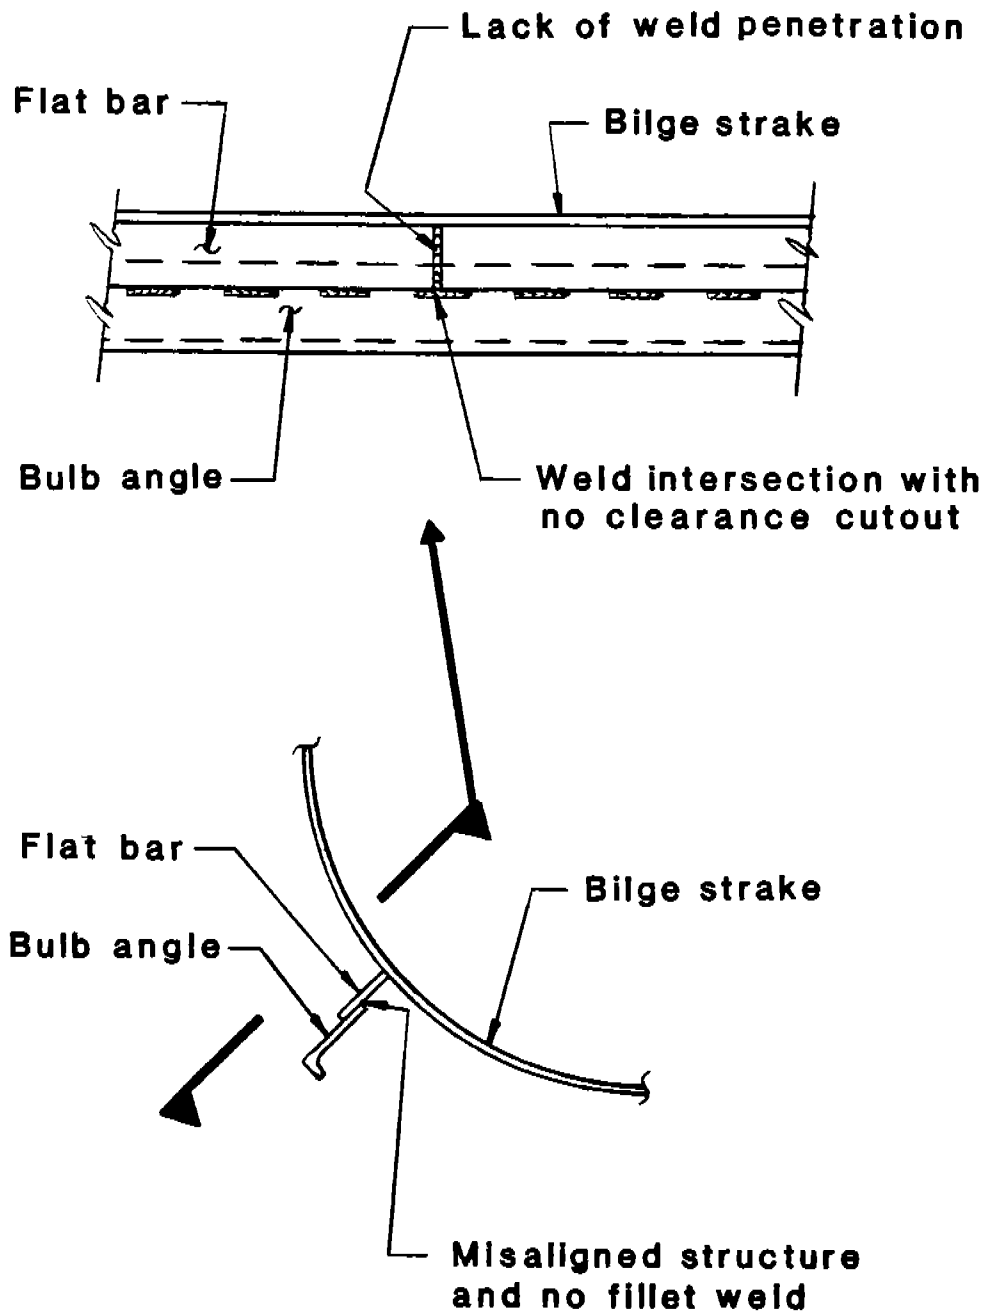
Figure 3-64 Bilge Strake Detail of the Tanker Hull Failure

Examination of the fracture surface on the salvaged stern section revealed that although there were initiation sites on both the port and starboard sheer strakes. The most important fracture had initiated in the port bilge keel flat bar butt weld at Frame 171. The weld showed a lack of penetration and no sign of a weld cutout at the side shell. The bilge keel detail is illustrated in Figure 3-64. After inspection of the fracture origin, it was learned that the bilge keel was damaged forward of Frame 171 from grounding and repaired at a drydocking prior to the fracture occurrence. It was apparent from the presence of the characteristic chevron markings that the fracture had occurred in a brittle manner and propagated from the butt weld across the bottom of the ship to the starboard bilge keel at Frame 174 and vertically up the port and starboard side. Many of the longitudinals had also failed in a brittle manner.

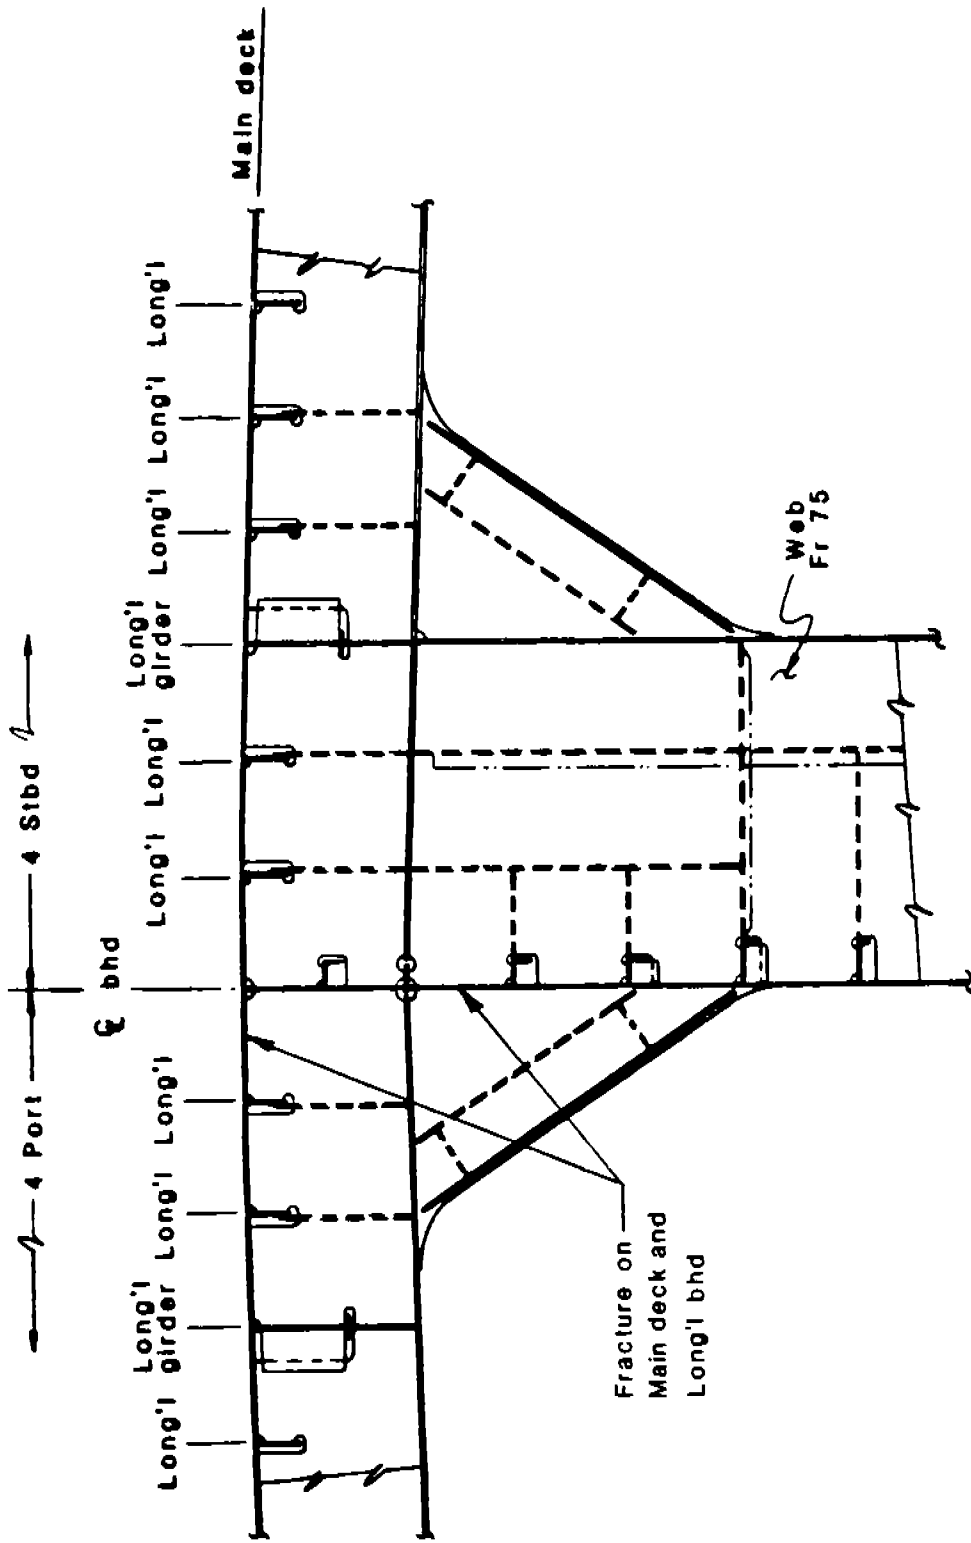
Figure 3-65 Structure of the Tanker With a Longitudinal Bulkhead Fracture

The fracture was located in a longitudinal bulkhead and main deck two feet aft of Frame 75. The location of the fracture and surrounding structures are illustrated in Figure 3-65. The steel in the vicinity of the fracture was ABS DH36 .75" thick.
