SSC-337

**SHIP FRACTURE MECHANISMS
INVESTIGATION**

SHIP STRUCTURE COMMITTEE

1990

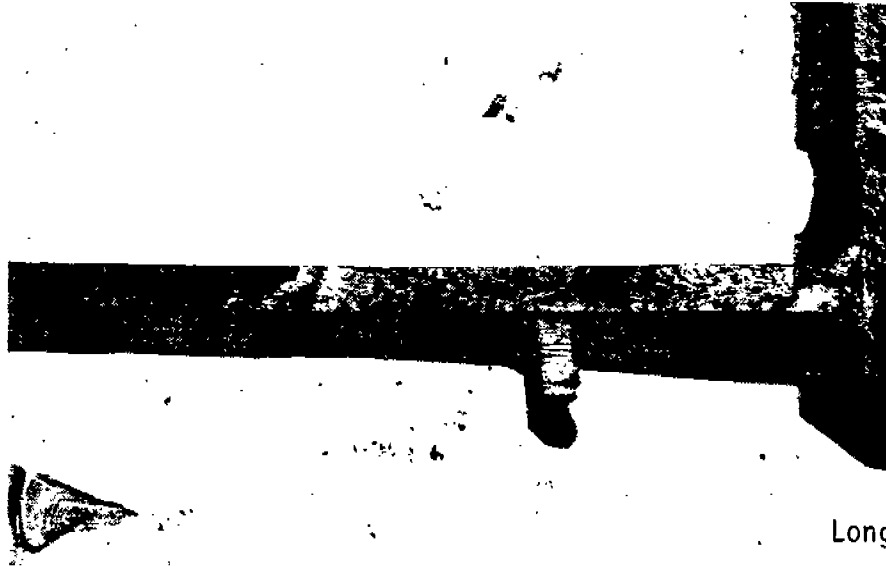
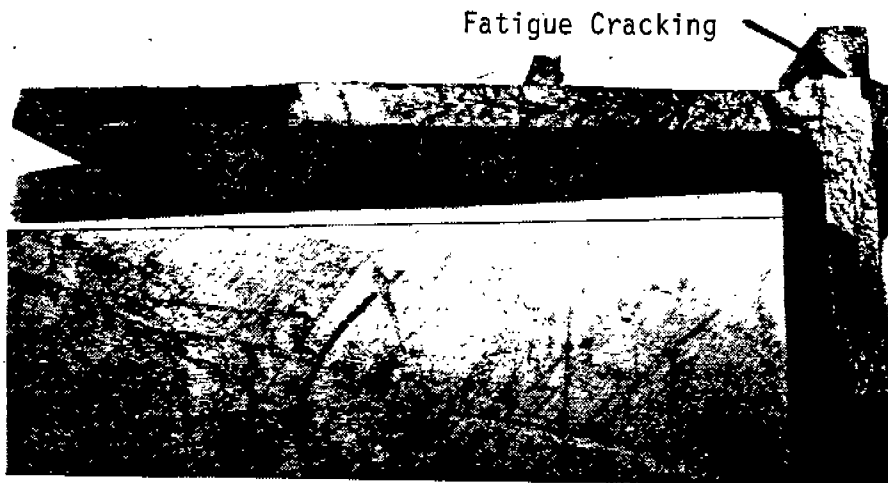
The project investigators believe that the fracture initiated by fatigue along the toe of a butt weld in the bulkhead, probably at several places, and progressed along the seam by both fatigue and brittle fracture. A clear brittle fracture region occurs in the bulkhead below the longitudinal shelf plate. The

Longitudinal
bulkhead

Longitudinal
Shelf

Fatigue Cracking

Figure 3-67 Details of the 123,000 DWT Tanker Fracture Surface

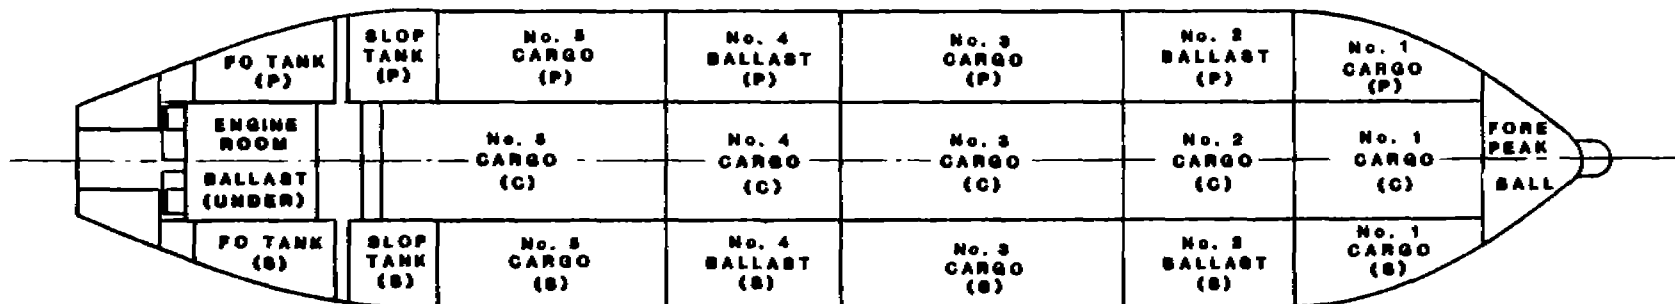
Figure 3-70 Cargo Hold Plan of the 173,000 DWT Tanker

A cargo tank arrangement drawing is shown in Figure 3-70. All main deck plate, with the exception of the outboard deck strakes port and starboard, is AH36. The outboard strakes on the main deck are DH36. The sheer strakes, bilge, and flat keel are DH36. All other structure is AH36.

The fractures were located approximately 50 ft forward of the deck house in way of No. 5 cargo tanks. The port side fractures occurred between Frames 63 and 64, in the main deck, 22 ft from the sheer strake and included:
