A CRITICAL SURVEY
of
**BRITTLE FAILURE IN CARBON PLATE STEEL STRUCTURES
OTHER THAN SHIPS**

by
M. E. SHANK
Massachusetts Institute of Technology

Prepared for
**NATIONAL RESEARCH COUNCIL'S
COMMITTEE ON SHIP STRUCTURAL DESIGN**
Advisory to
SHIP STRUCTURE COMMITTEE

December 1, 1953

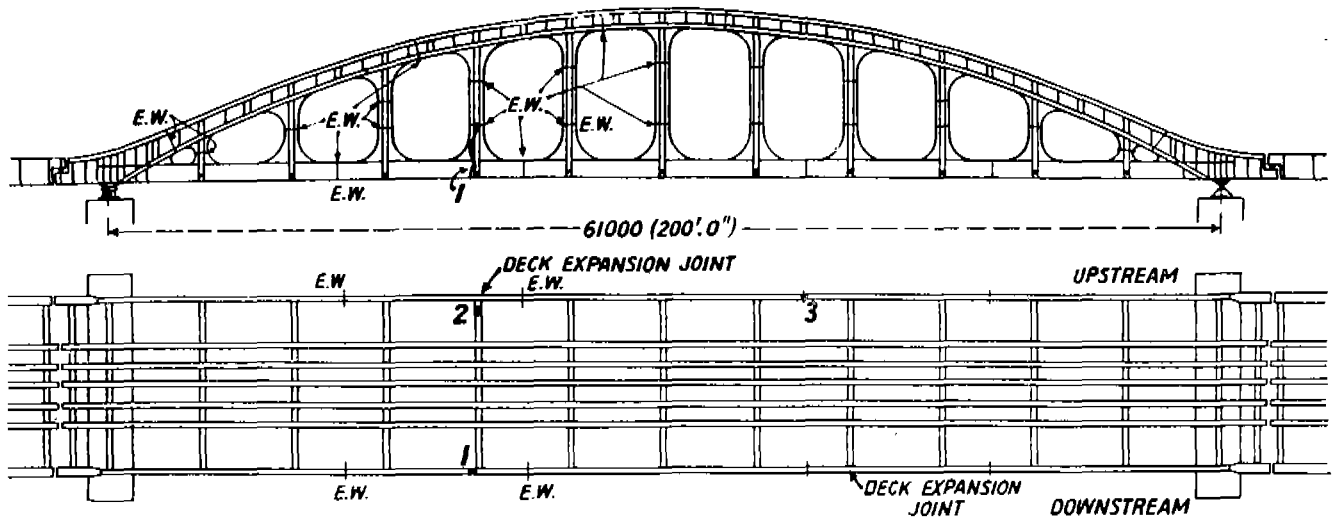
Fig. 9. Bottom chord fracture in Hasselt Bridge

Numerous investigators agree that the original fracture of the Hasselt Bridge started at a weld between a gusset and the lower chord.^{29, 31-33} *L'Ossature Metallique*²⁹ of February 1939 blamed the failure on residual stress. It stated: (1) That the welds were of good quality "but reveal certain imperfections." (2) The

Another investigator³⁹ gave detailed radiographic evidence showing the poor quality of the welds in the Hasselt Bridge. A residual stress of apparently 14000 psi was found in one welded joint. Another source⁴² quotes the residual stress as 6.35 to 12.6 tons per square inch (12,000–25,000 psi approximately).

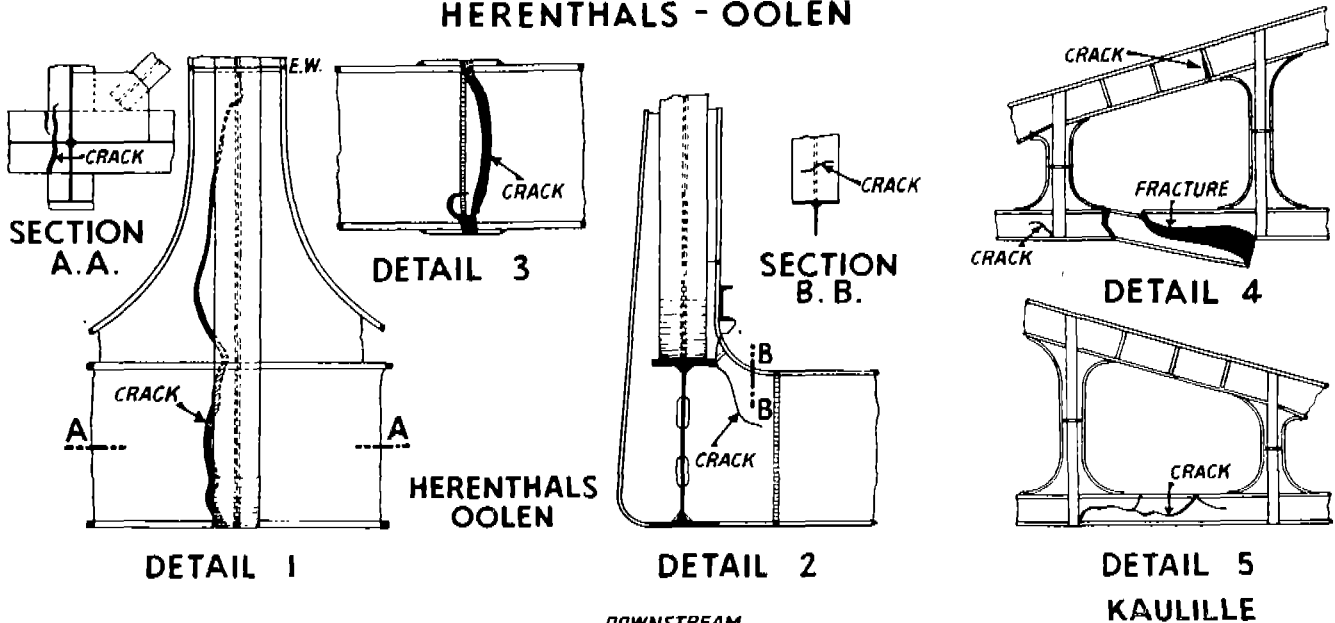
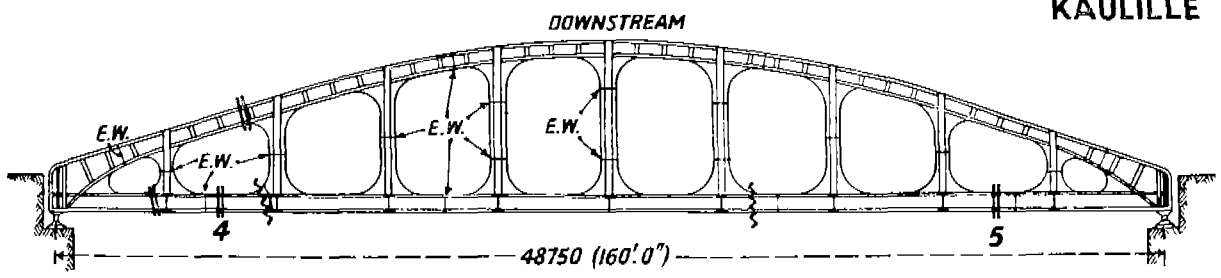
Fig. 10 Details of failures in two welded Vierendeel truss bridges

was 7° F. A total of six cracks were found in the lower chord. (See Fig. 10.) The bridge did not collapse.

Finally, Busch and Reuleke⁴³ report a comprehensive investigation undertaken in Germany of the failures of all three of the above-mentioned Vierendeel trusses. They found for the Hasselt Bridge that: (1) most failures occurred at junctions between verticals and the lower chord in butt welds connecting the flanges of both members; (2) on similar joints which were intact,

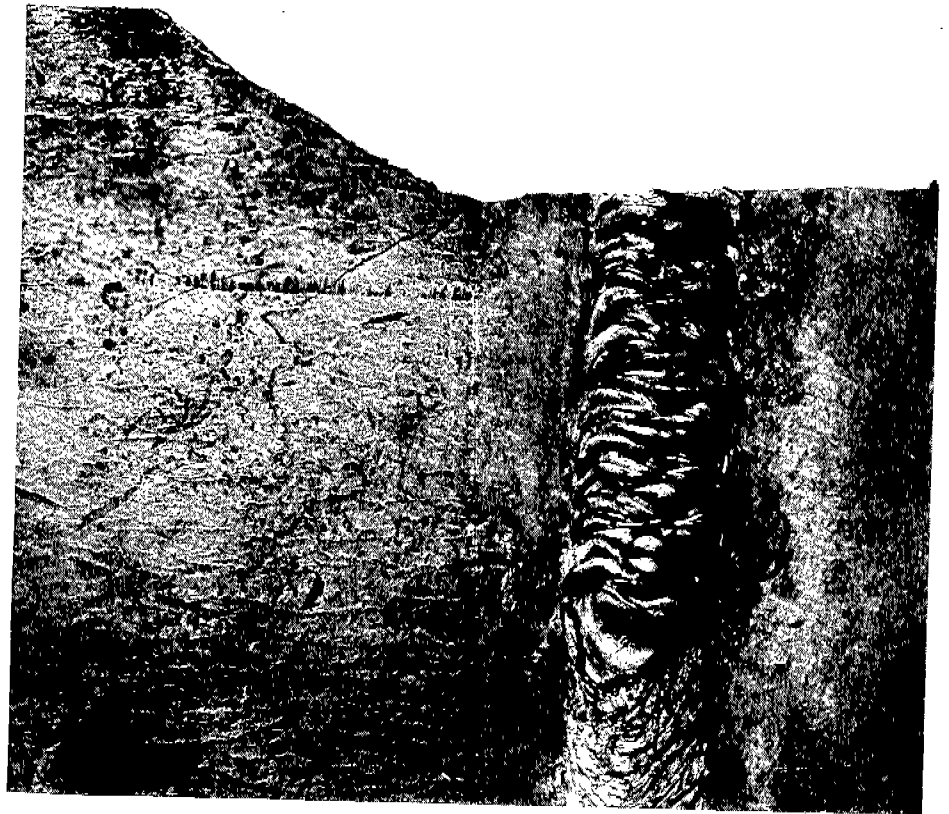
Fig. 32 Penstock failure

this location. Heavy, irregular beads, applied during repair, may have provided the notch effect. (See Fig. 32.)

Investigation showed that the fracture originated at this girth joint, which had been welded in place in the tunnel. A secondary crack, branching off the main fracture, indicates a point of stress concentration which may have been due to an undisclosed defect in the weld repair.

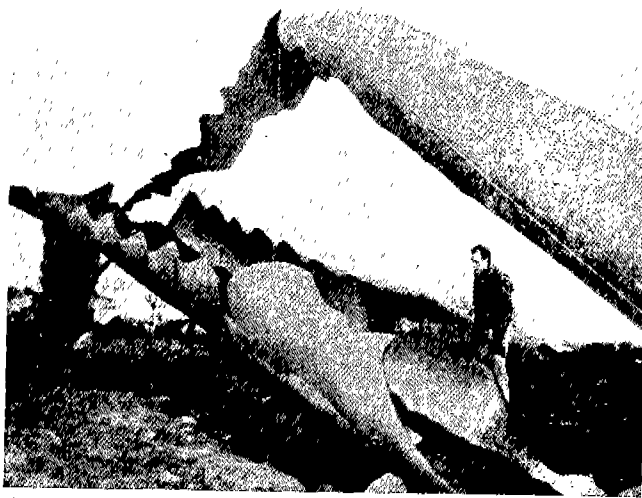
There is not very much published information concerning gas transmission line failures. One short article⁷³ describes failures as varying from 180 to 3200 ft in length. The failures here described occurred on test, after installation. The cause (presumably the initiating cause) is stated to be well known—namely gouging or scratching of the plate in transit or installation. The failures always follow a sine wave pattern, and look as though there had been an internal explosion.⁷³ (See Fig. 36.)

Fig. 36 Failure of a 30-in. gas transmission line, showing sinusoidal nature of the fracture. The longitudinal welded seam is seen to be intact. Presumably this failure occurred on test

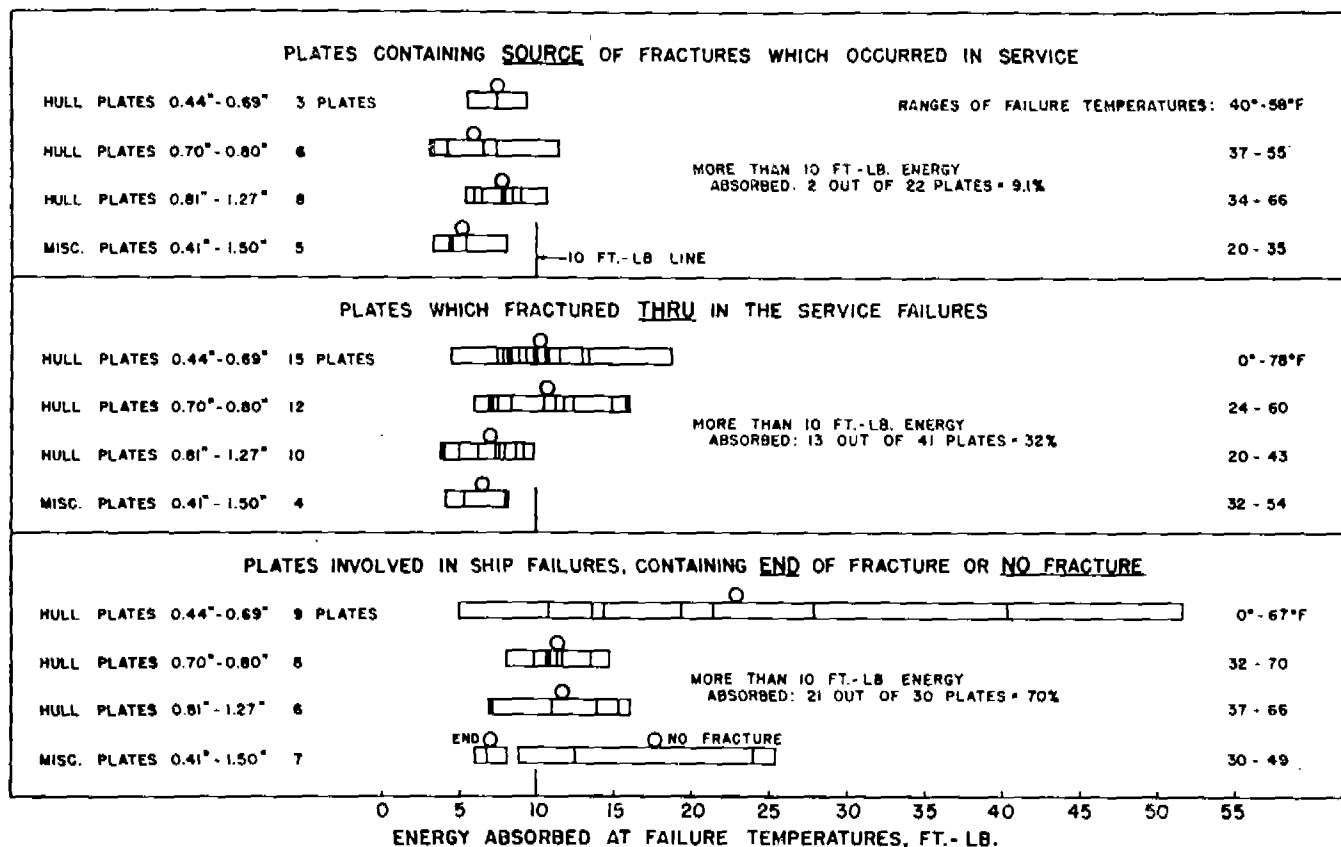
Fig. 45 Relation of energy absorbed by Charpy V-notch specimens at the temperatures of the ship failures to the nature of the fractures in ship plates. (From M. L. Williams, et al., Ship Structure Committee, NBS-3, "Investigation of Fractured Steel Plates Removed from Ships.")

plates from welded ships,¹¹² noted above. This ship plate investigation divided plates into three categories: (a) Source—a plate in which fracture originated, (b) through—a plate through which a fracture traveled, (c) end—a plate in which a fracture terminated. The highest value of impact energy for a ship source plate was 11.4 ft-lb at the temperature of failure. Of 22 source plates only 2, or 9.1%, had energies over 10 ft-lb. For end plates, or plates with no fracture, 21 out of 30 plates, or 70% had over 10 ft-lb. These data are shown in Fig. 45. Further, of 31 plates which were fracture sources only 10%, or 3 plates, had 15 ft-lb transition temperatures below 70° F. Of 82 plates which did not contain fracture sources, 67% had 15 ft-lb transition temperatures below 70° F. The report is a most valuable one. Its perusal is most highly recommended to those interested.
