Observation of Ship Damage over the Past Quarter Century

H. S. Townsend, Member, United States Salvage Association, Inc., New York, N.Y.

ABSTRACT

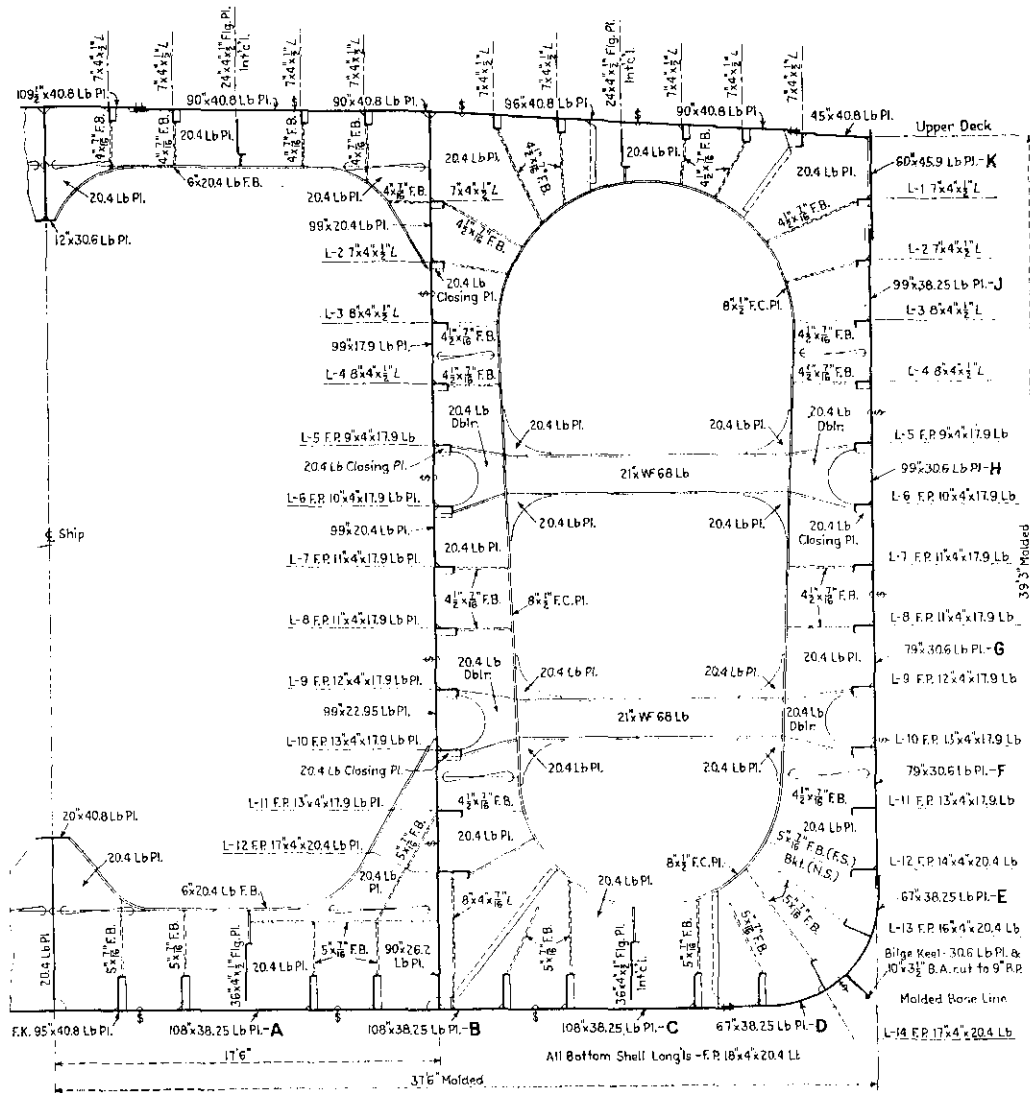
Fig. 8. Typical structure proposed for Jumbo "T2" (Ref. 16)

Figure 8 shows the marked change in structural arrangement for a "Jumbo" "T2" from original "T2" arrangement.
