PROGRESS REPORT

FATIGUE TESTS OF SHIP WELDS

S. C. HOLLISTER, J. GARCIA AND T. R. CUYKENDALL
CORNELL UNIVERSITY
Under Navy Contract NObs-31218

Serial No. SSC-7

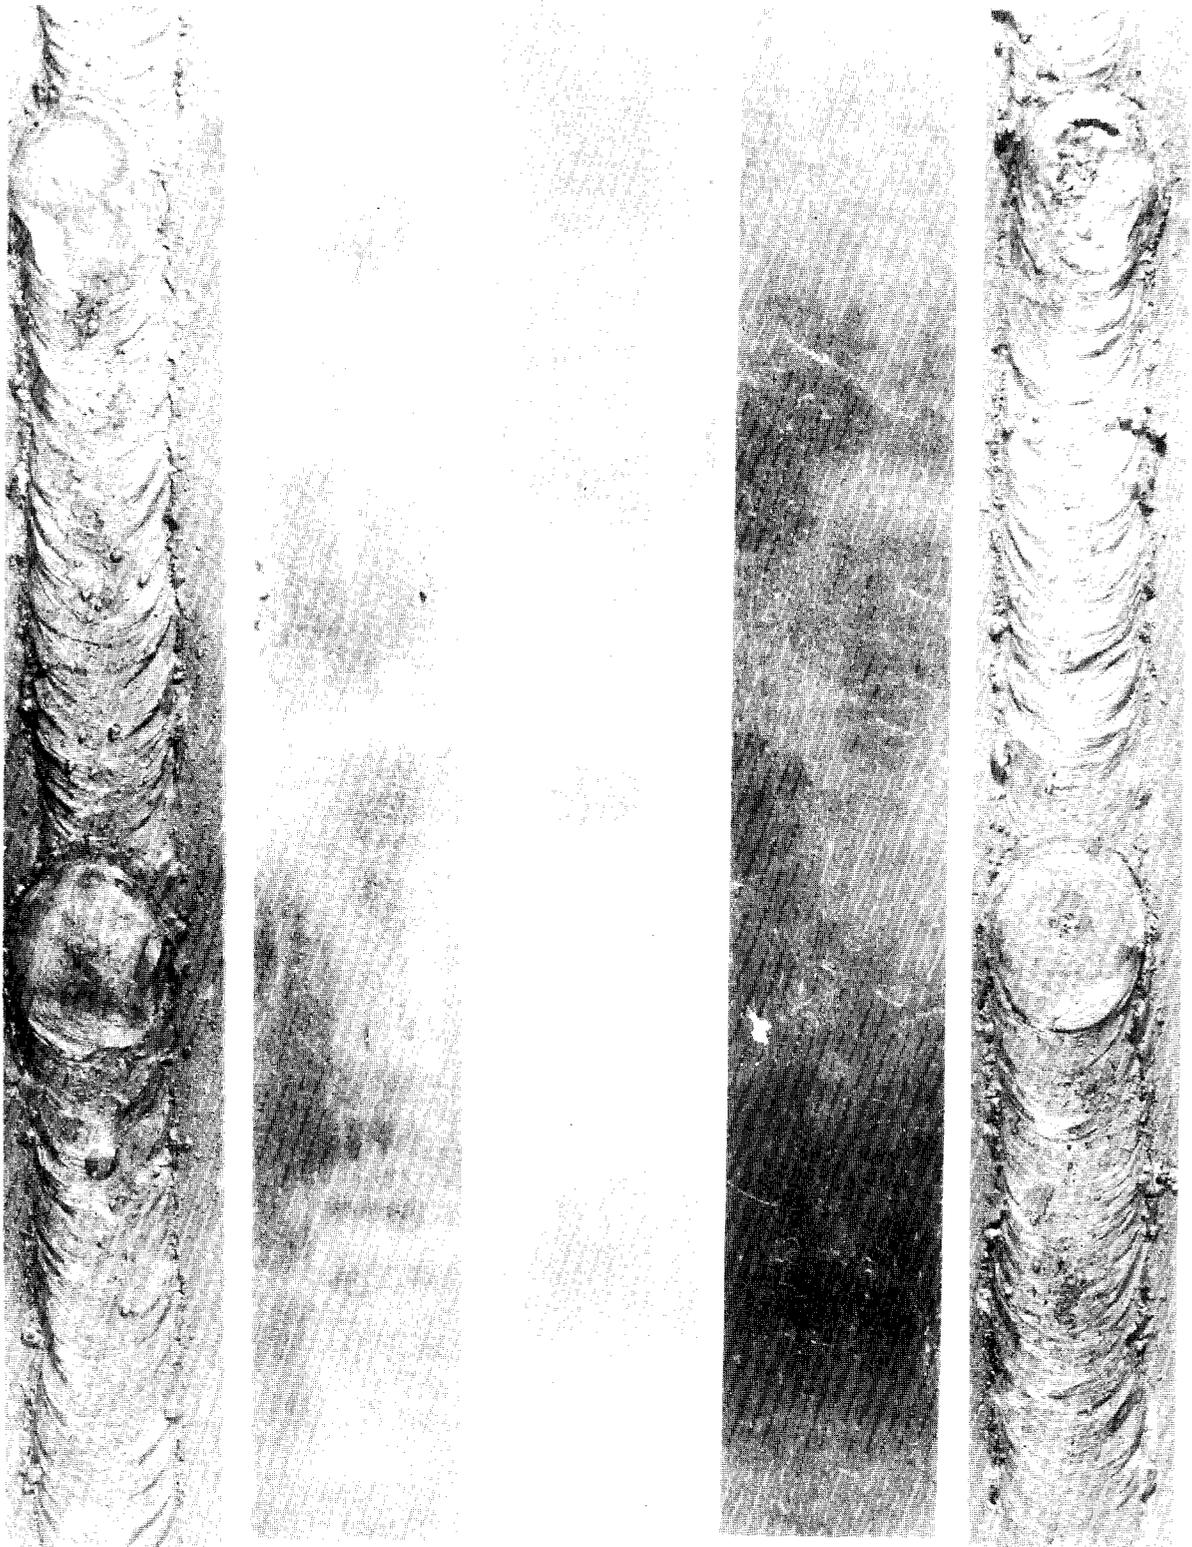
Figure 5 Specimen AB-3 32-40 in. From Top

The remaining scratches were very fine and in the direction of load application, and the surface finish, see Figs. 5 and 6, was such that a fatigue failure could easily be detected.

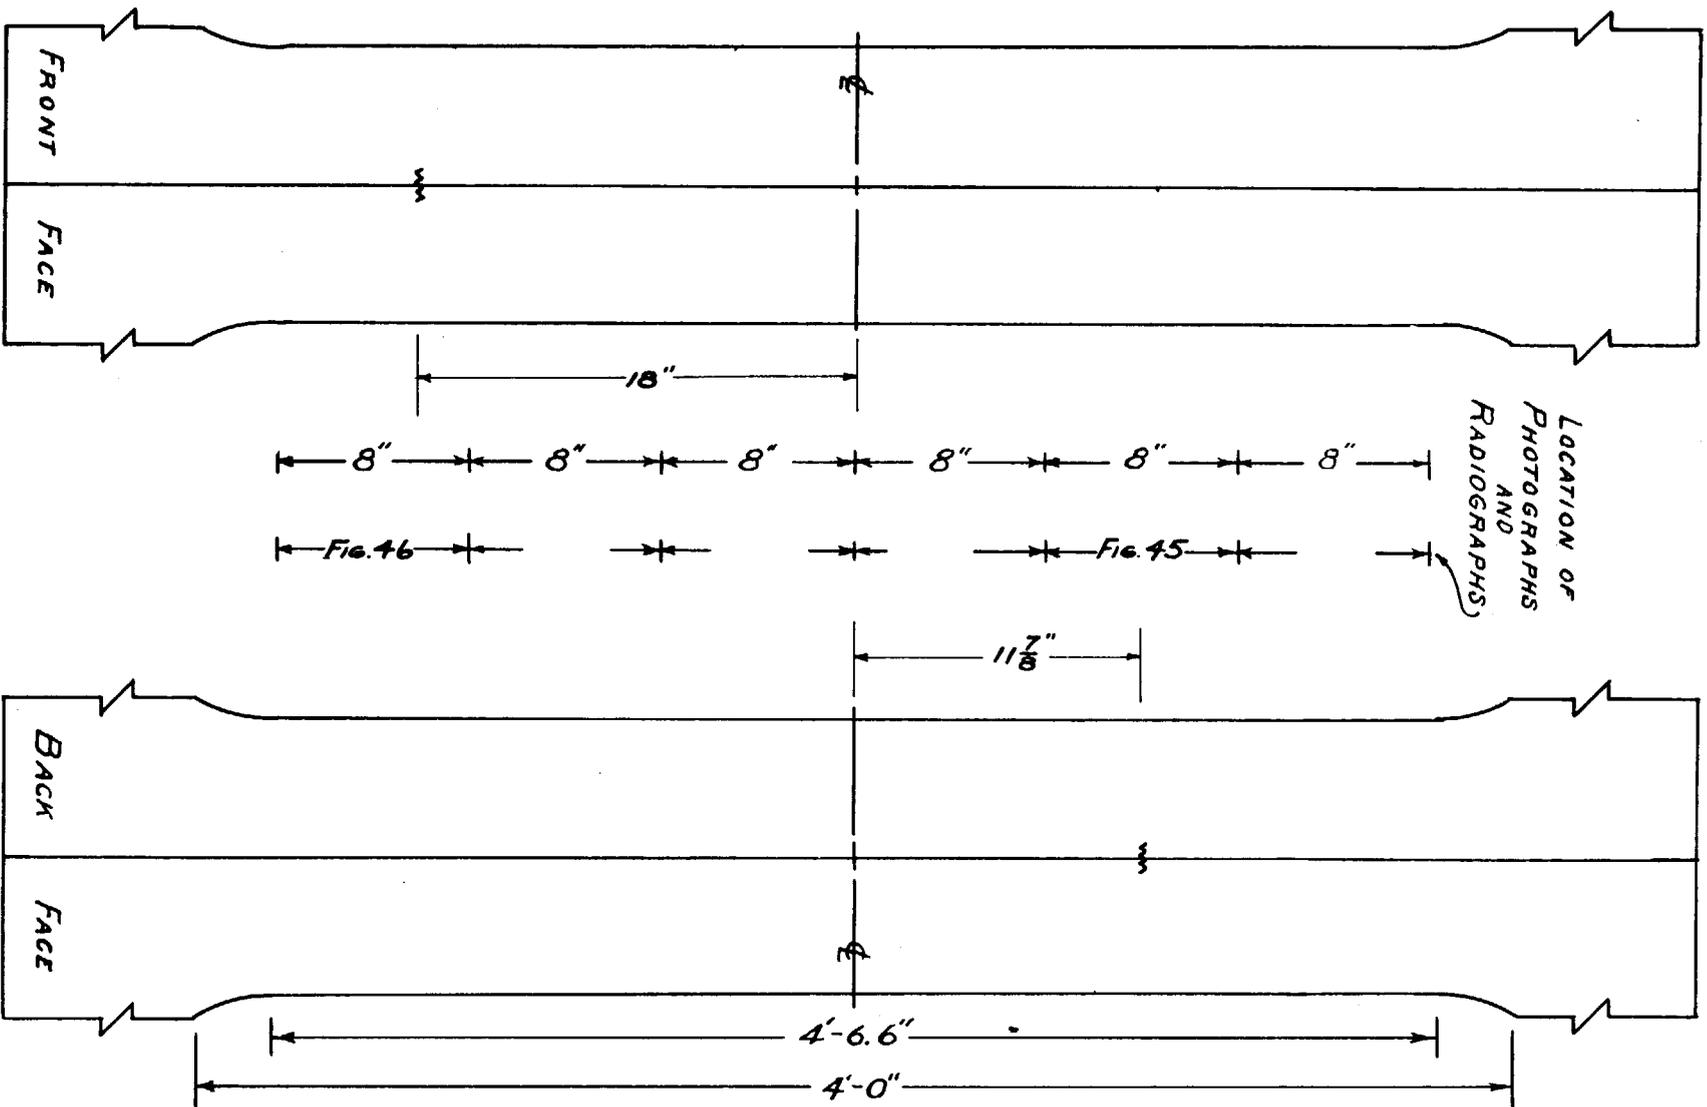
FIGURE 17

Location of Cracks, Fig. 17.

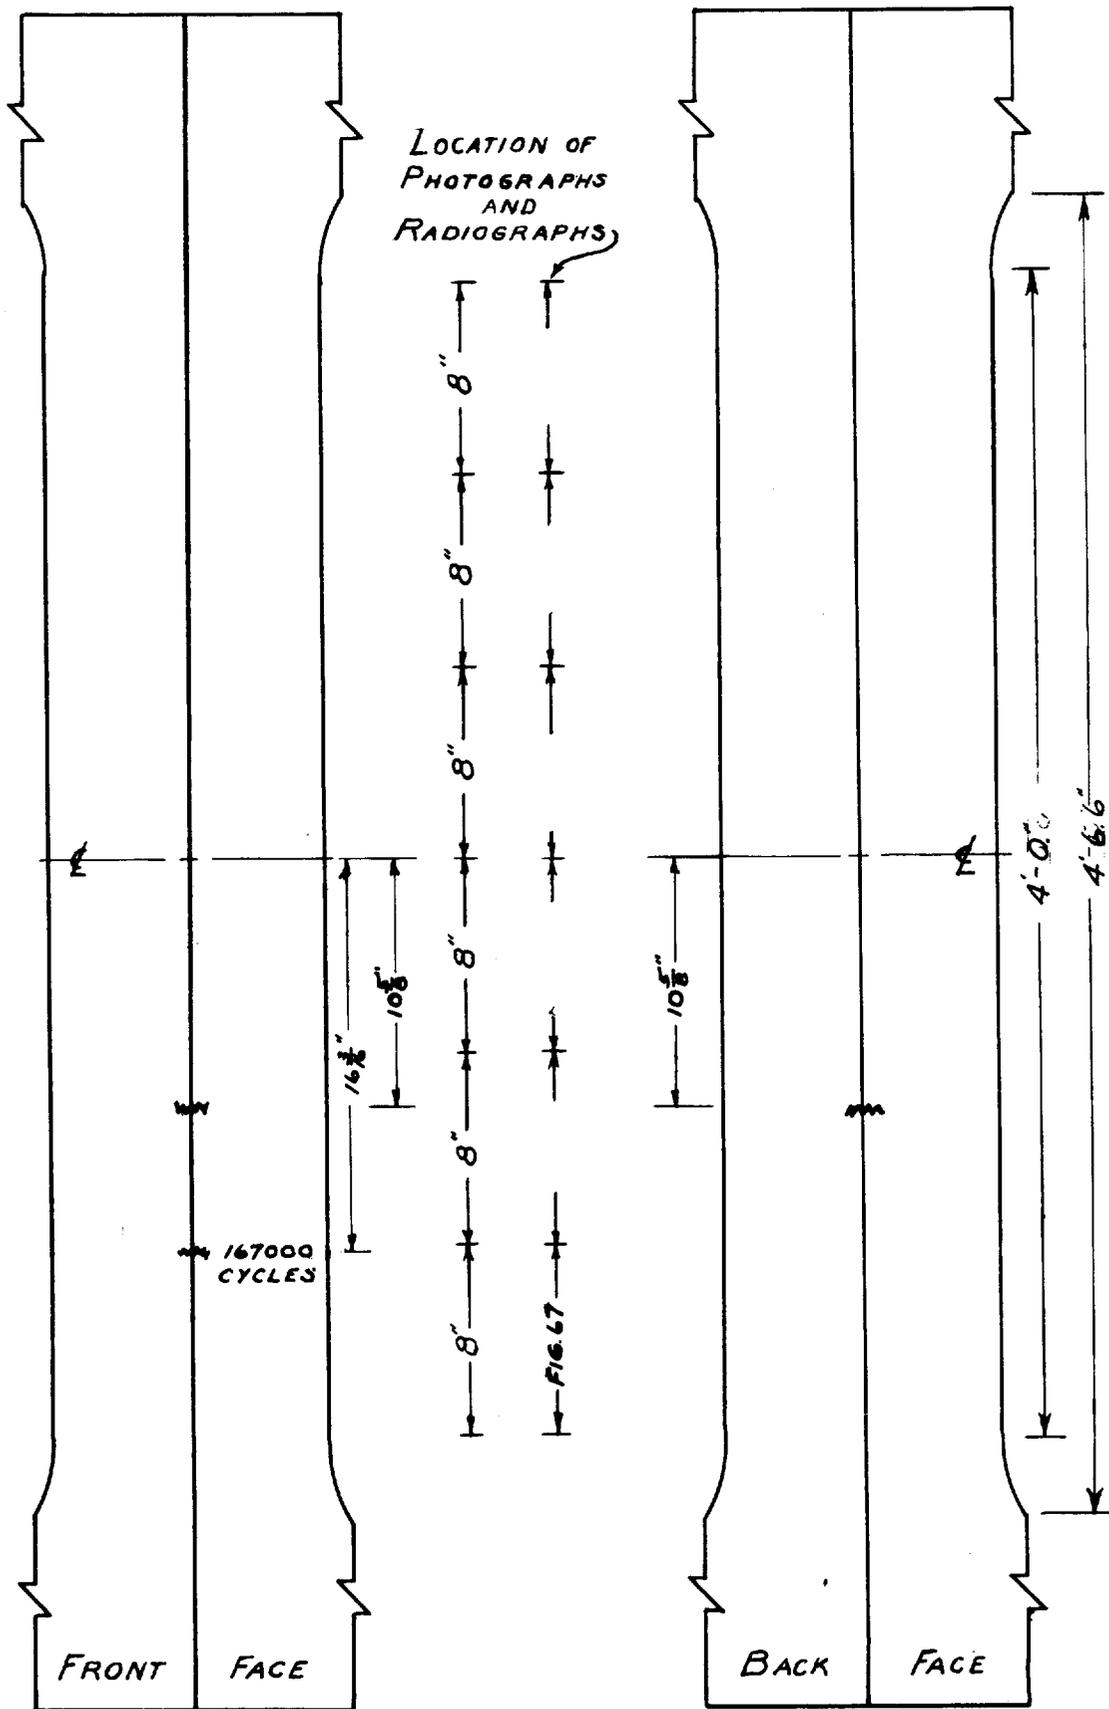
FIGURE 21

Location of Cracks, Fig. 21.

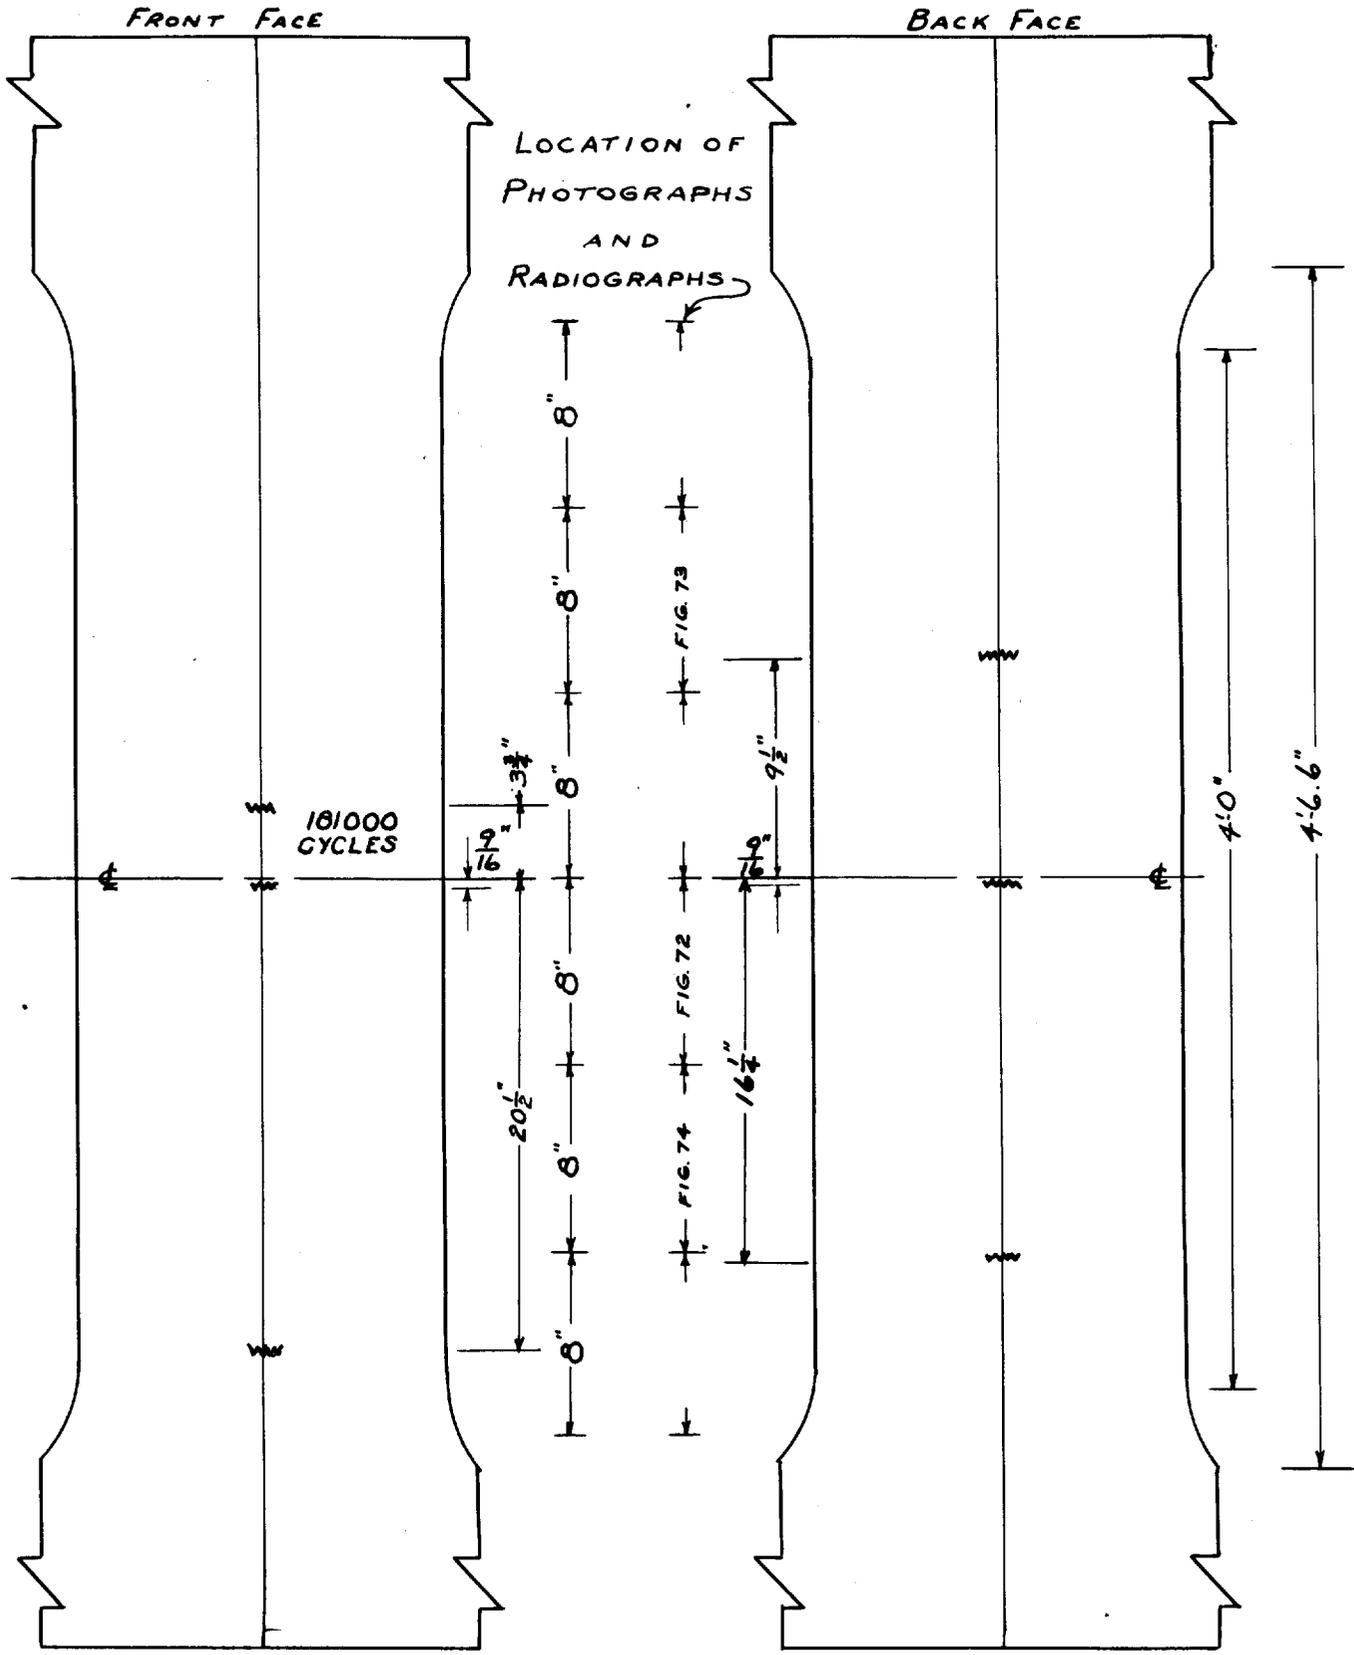
FIGURE 24

Location of Cracks, Fig. 24.

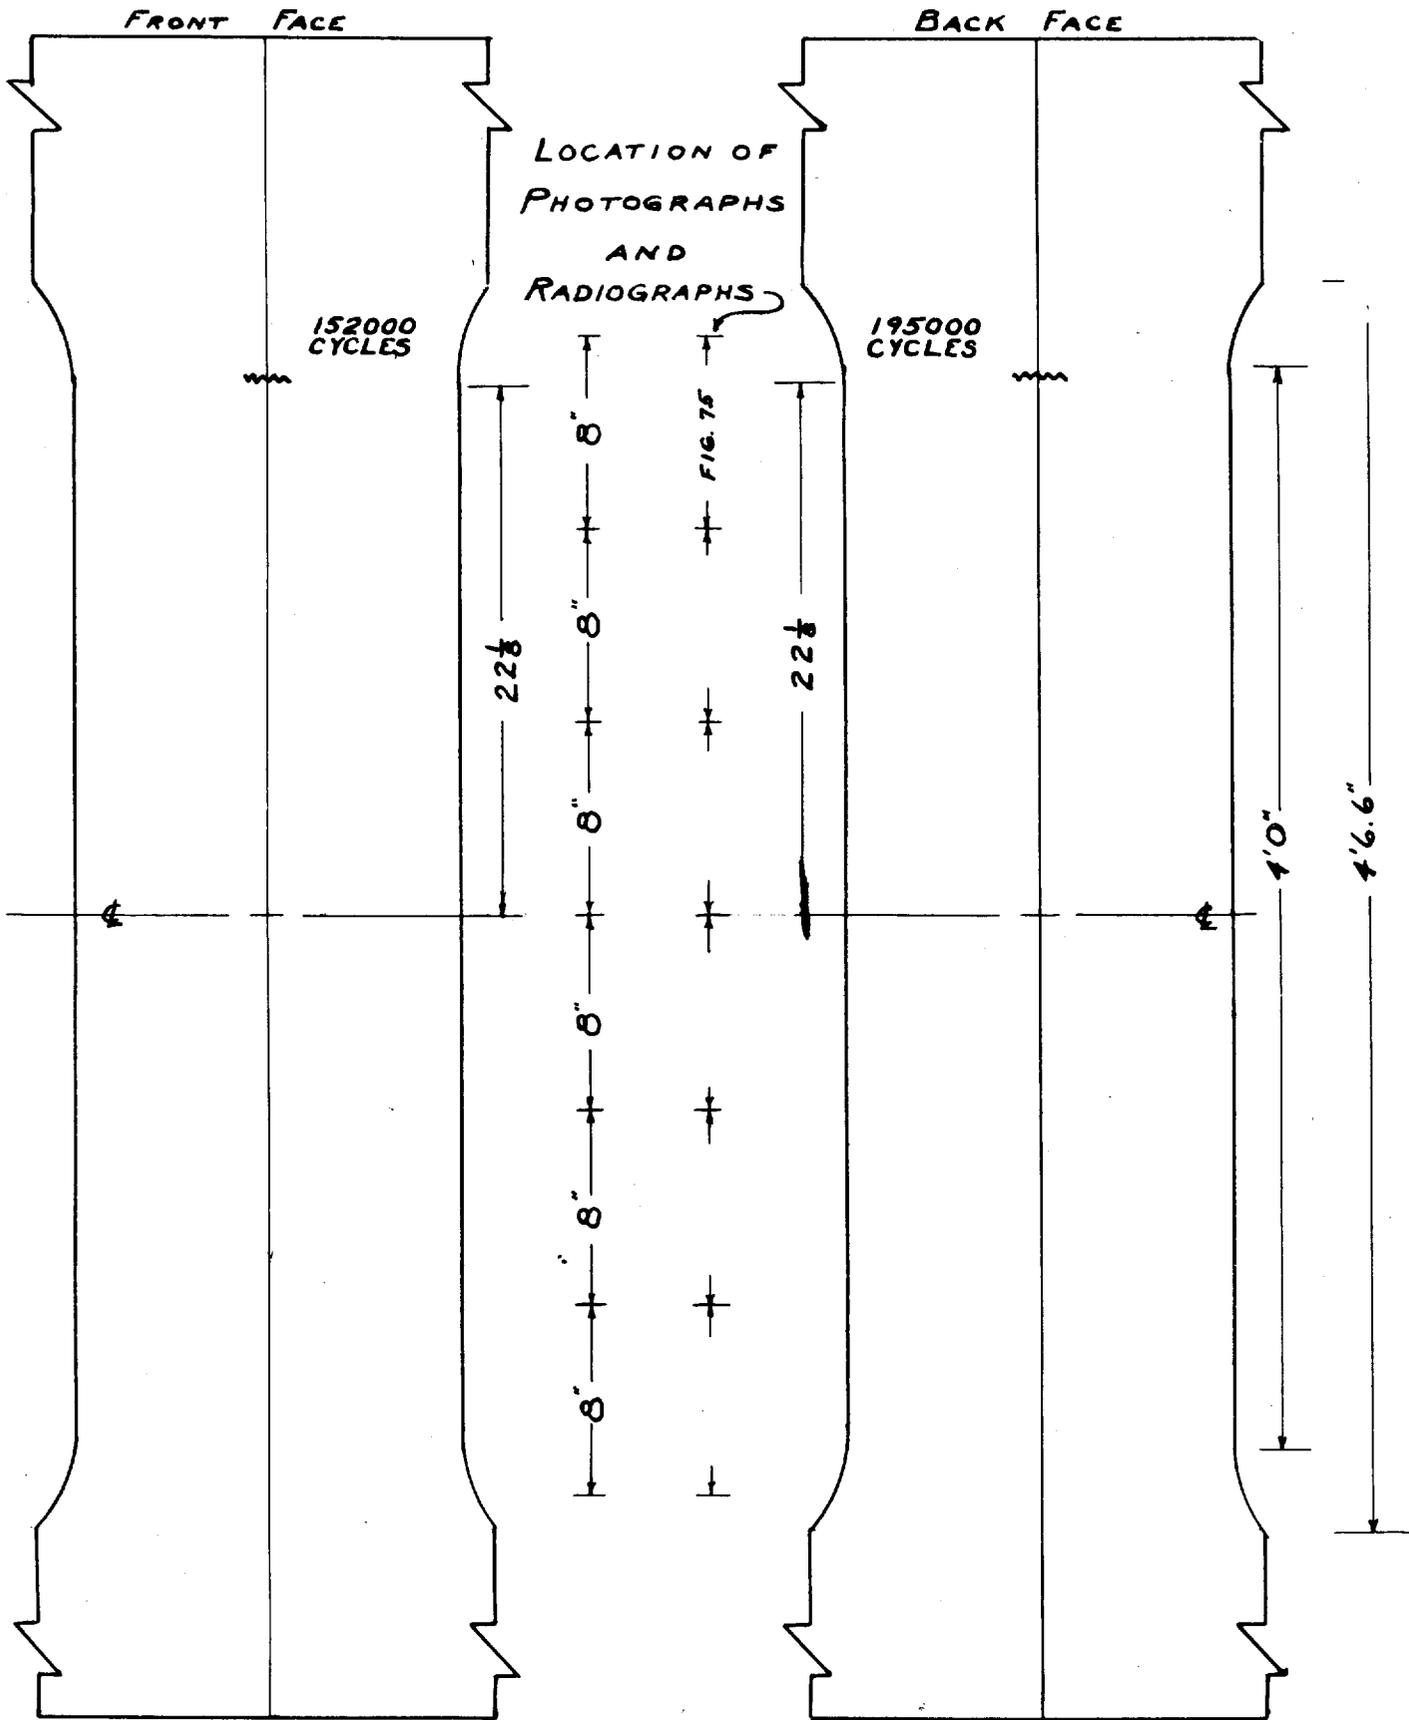
FIGURE 25

Location of Cracks, Fig. 25.

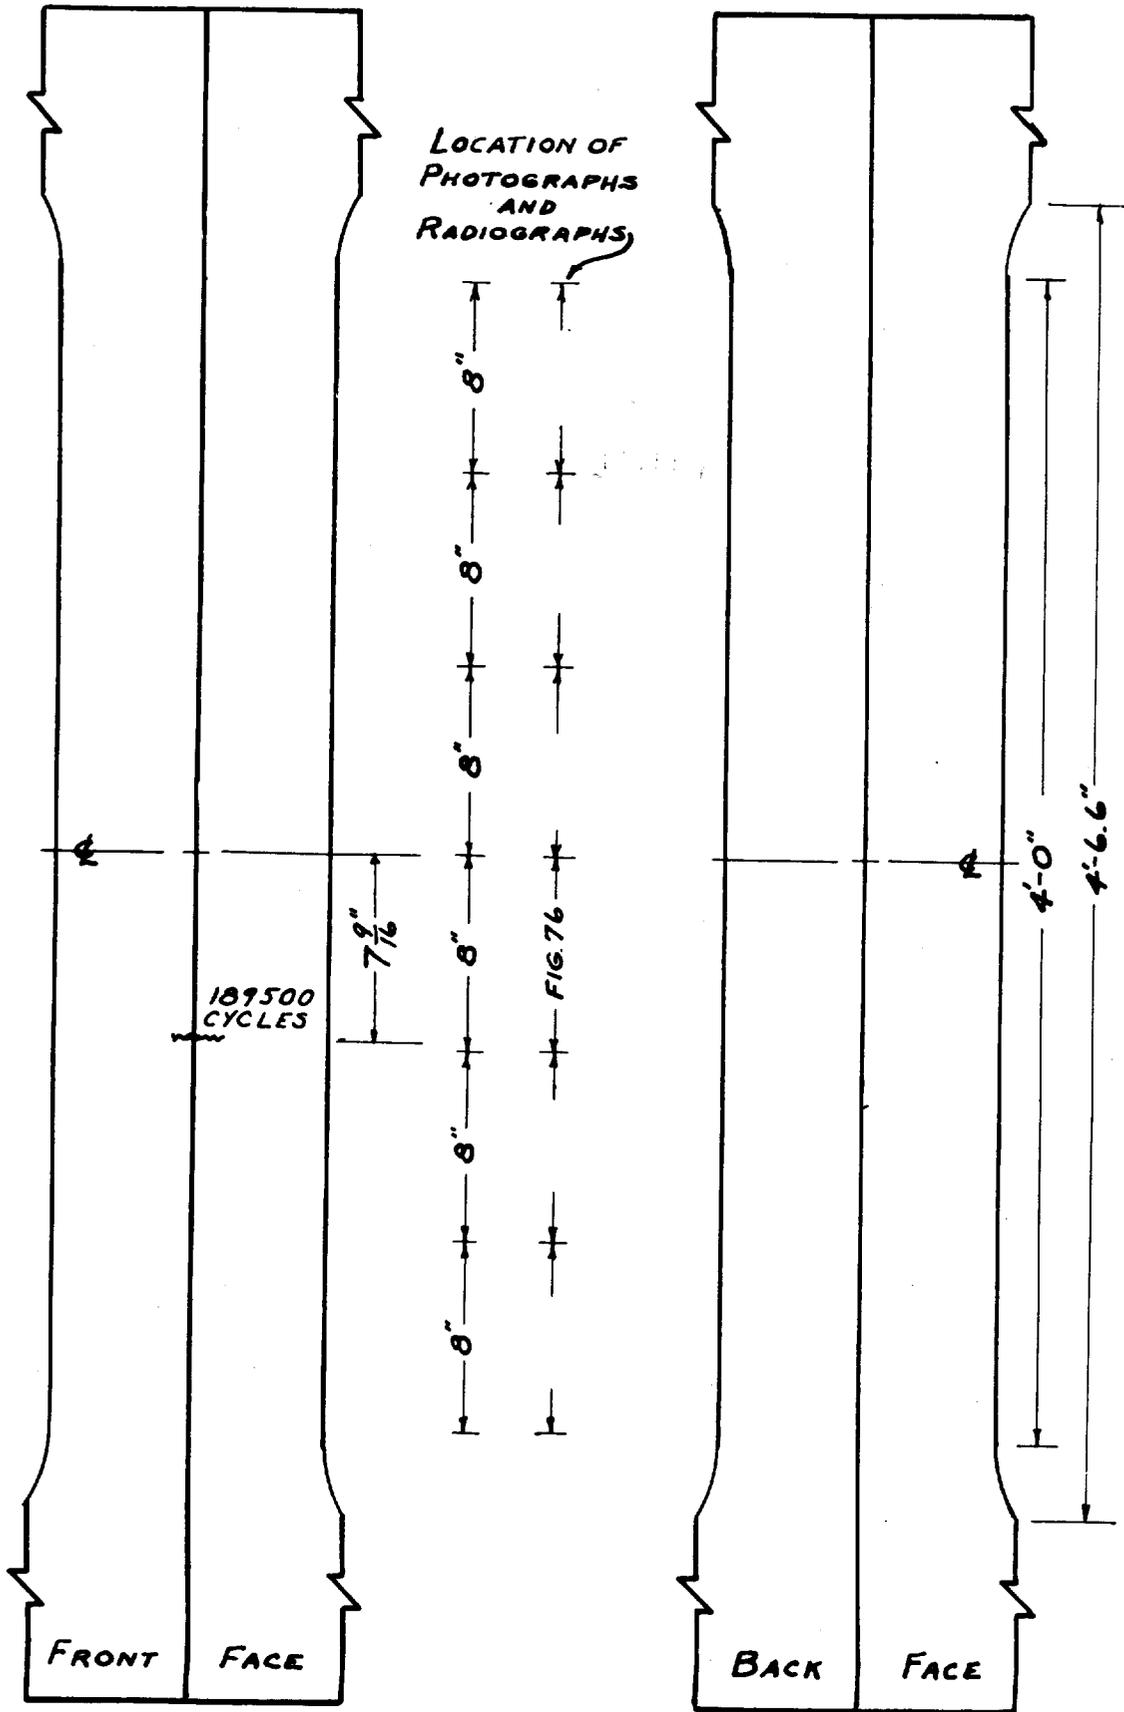
FIGURE 26

Location of Cracks, Fig. 26.

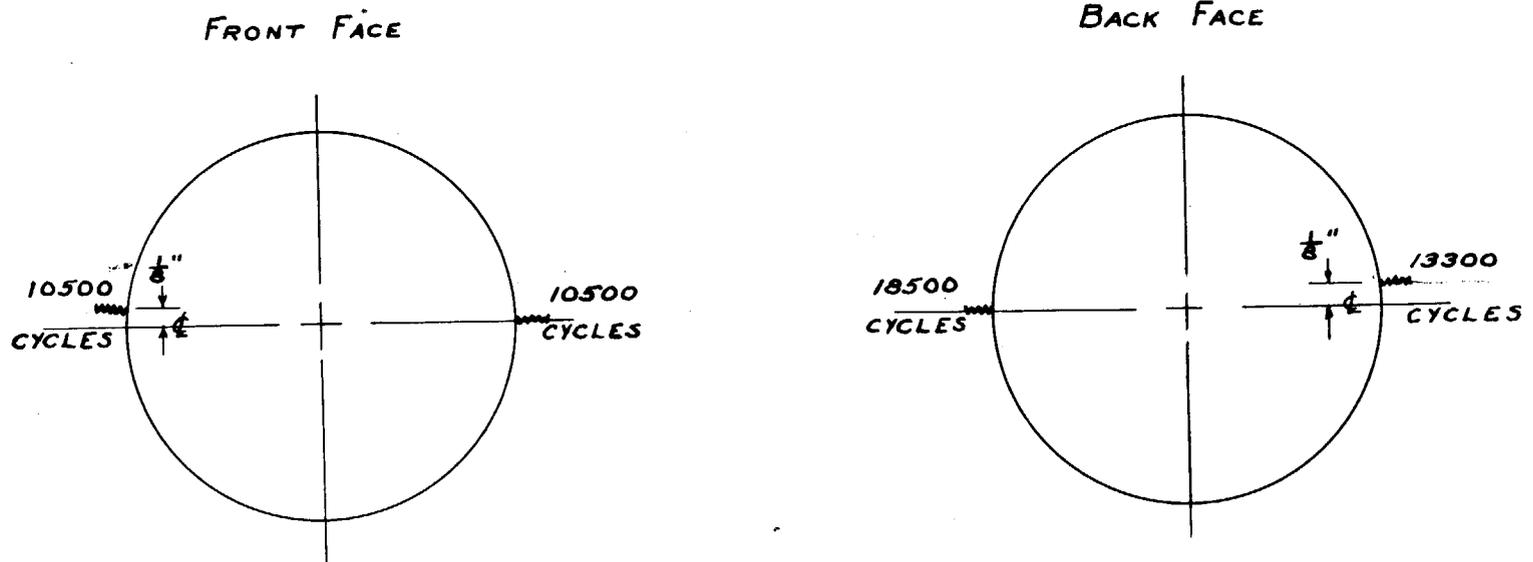
FIGURE 29

of the hole resulting from the flame cutting process. The crack traveled along a ripple in the flame cut surface and was visible on the back face of the specimen at 13,300 cycles. At nearly the same number of cycles a second crack appeared on the front right edge of the front face exactly on the transverse center line. This crack also traveled along a flame ripple (Fig. 80) to the back face of the specimen. The test had to be discontinued at 23,900 cycles because the cracks had spread about 2-1/2" to either side of the hole. The reduction in the cross-section caused plastic flow at the ends of the crack (see Fig. 80 and Fig. 29).

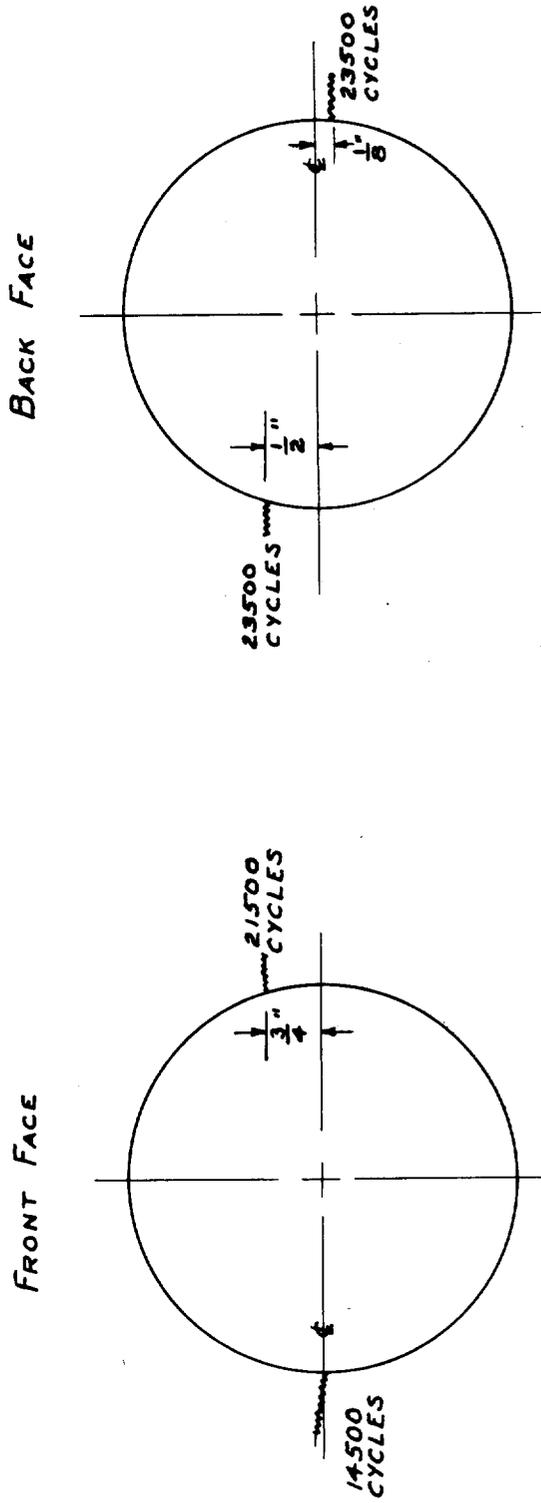
FIGURE 30

Fatigue Crack: 14,500 cycles, on the front left edge at the transverse center line of the hole. The crack followed a flame groove on the inside of the hole and appeared on the back face at 23,000 cycles. On the front right edge of the hole a crack developed 3/8" above the transverse center line at 21,500 cycles and at 23,500 cycles appeared on the back face. The test was stopped at 26,000 cycles because the cracks then extended approximately 5/8" into the metal at the sides of the hole (see Fig. 30).

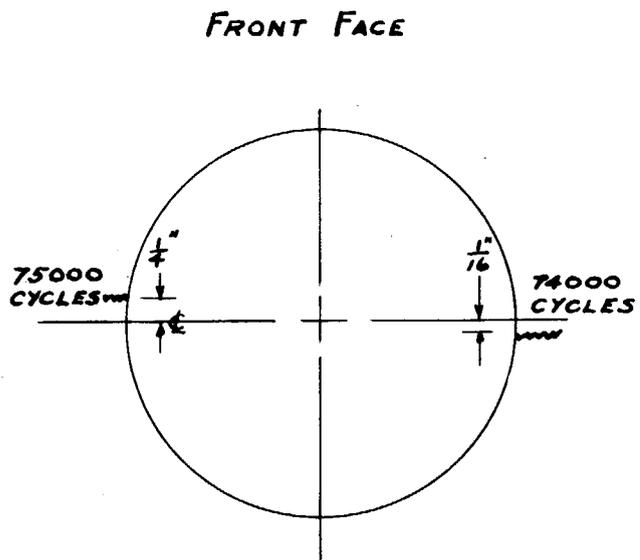
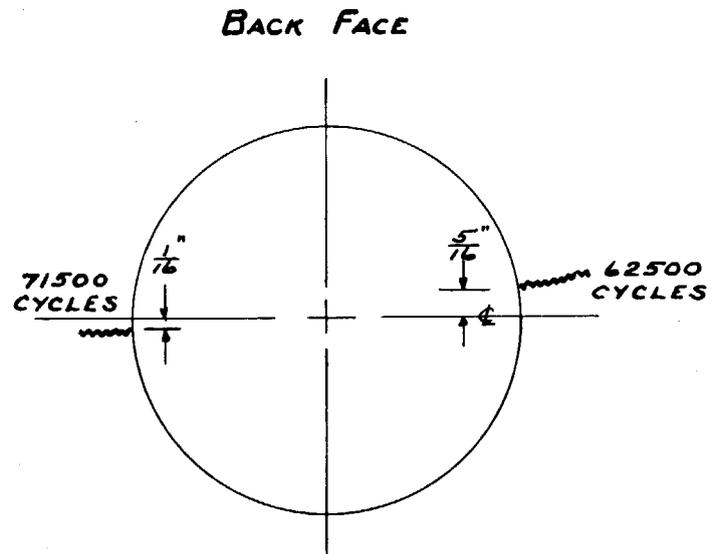
FIGURE 31

Note: Fig. 31 illustrates the quality of surface flame cut by hand for these two specimens.

62,500 cycles, on the back left edge of the hole (Fig. 82) about $5/16$ " above transverse center line. At 75,000 cycles, the fracture had traveled along the inside of the hole and became visible on the front face. At the end of the test (76,600 cycles) this crack was approximately $1-1/4$ " long on the back face and $1/4$ " long on the front face. The crack on the opposite side of the hole appeared at 71,500 cycles on the back right edge of the opening about $1/16$ " below the outer line. It traveled through to the front face, appeared there at 74,000 cycles. The test was stopped when Lueders' Lines formed on all faces of the specimen at the ends of the cracks. Location of Cracks, see Fig. 31.

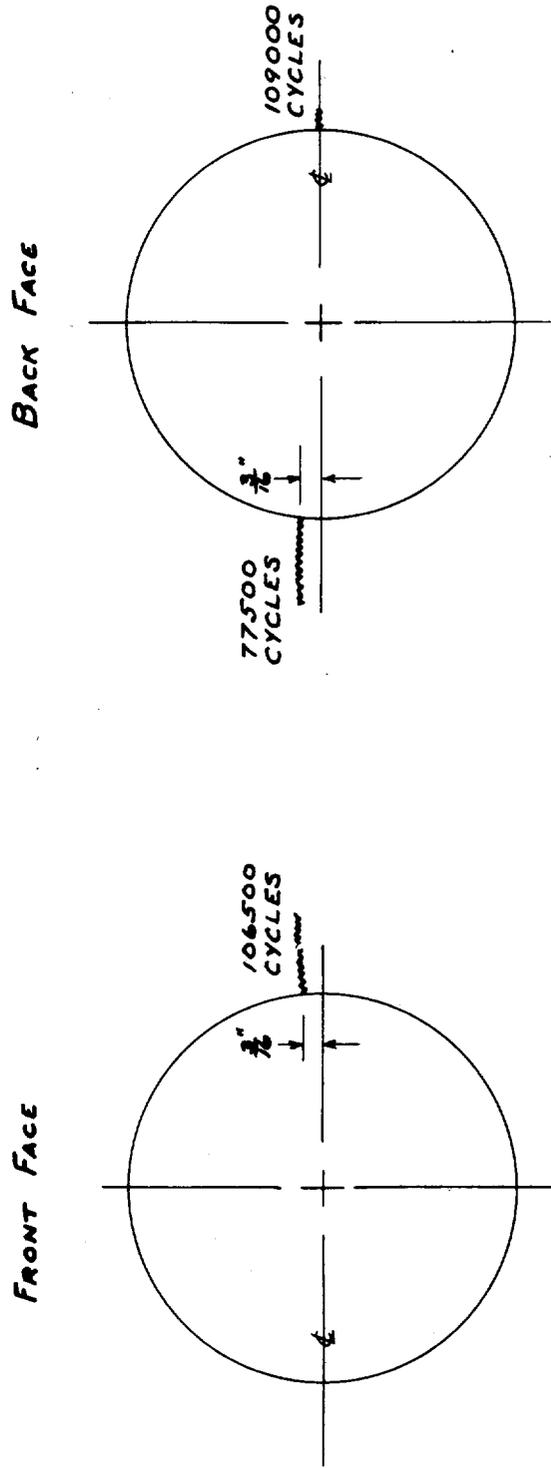
FIGURE 32

77,500 cycles on the back right edge of the hole about $3/16$ " above the transverse center line, this fracture appeared on the front face at 106,500 cycles (see Fig. 83). The crack continued to grow until at the end of the test (115,000 cycles) it was $1-1/2$ " long. On the opposite side of the hole, a very small crack appeared on the back edge at 109,000 cycles. In this specimen, more cycles of stress were required for the cracks to result in failure to carry load than seemed to be the case for specimens FA-1, 2 and FB-1. Location of Cracks, see Fig. 32.

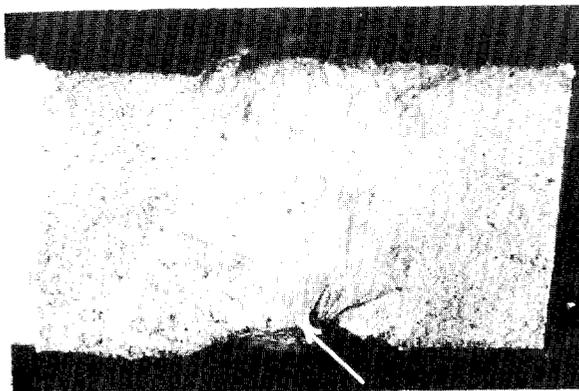
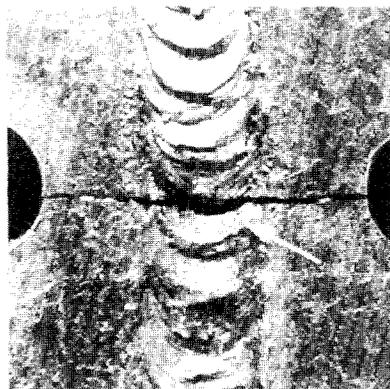
Figure 38

The crack appeared at a deep ripple in the weld. The fracture of the weld (Fig. 38) does not indicate clearly the origin of the fatigue crack. A comparison of the crystalline appearance of the metal near the weld surface with that of the metal near the root, leads one to assume that the crack started at a point of poor root fusion.

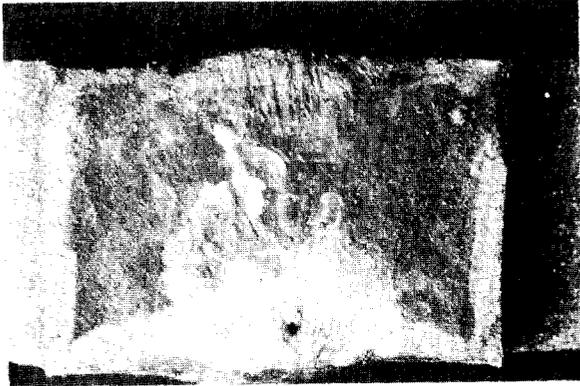
Figure 39

crack appeared in a deep ripple of the weld surface. The fracture (Fig. 39) shows that the fatigue crack propagated inward from its origin at the surface of the weld. In careful examination of the fracture, a small smooth surface could be discerned close to the front face, (arrow). The weld metal on the opposite side of the fracture had a rough appearance which would indicate a shear failure. In this case good fusion existed at the root of the weld.

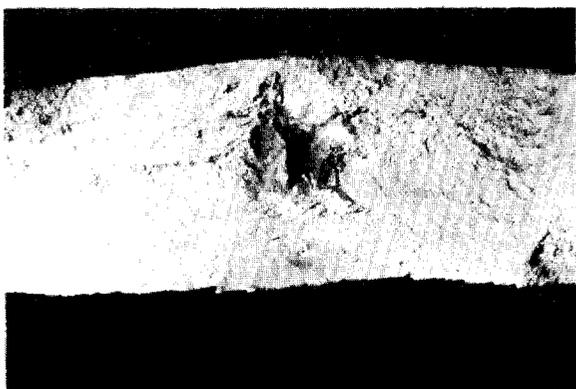
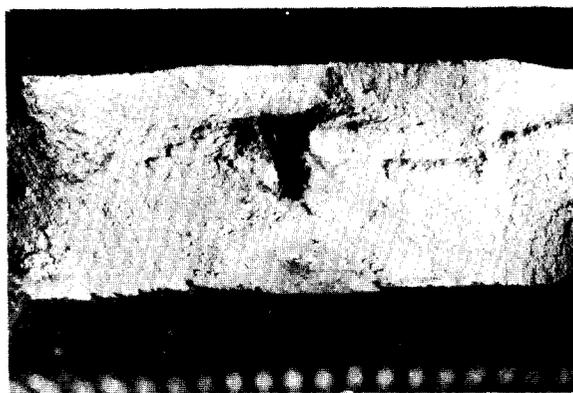
Crack 2-X, The lower third of test length. Figure 46 shows the same general characteristics as obtained for Crack No. 1-X above.

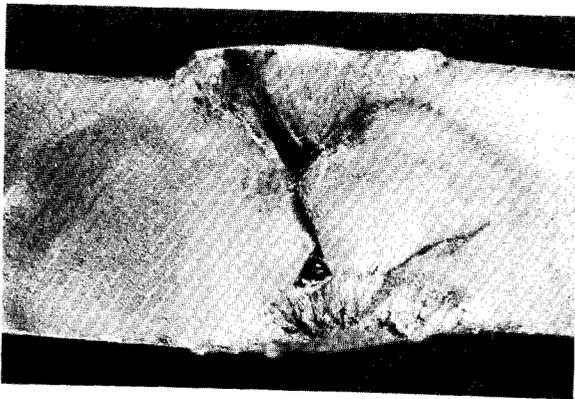
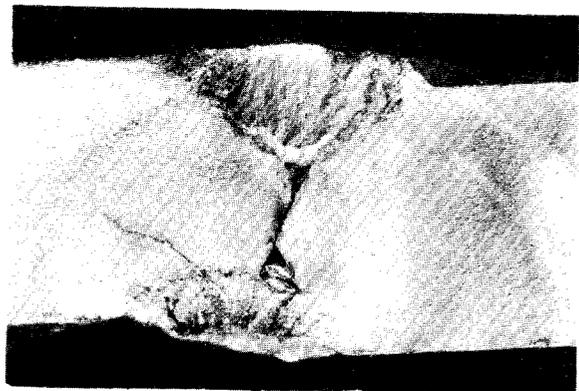
Figure 48

Crack No. 2-V, 193,000 cycles, front face, upper third of test length. The crack appeared at a pin-hole in one of the weld craters. The fracture (Fig. 48) indicated very poor fusion and distortion of the plates at the root. During the laying of the longitudinal weld beads, distortion of the plates occurred so that one bevel edge climbed over the other edge. From a study of the fracture it was concluded that the crack

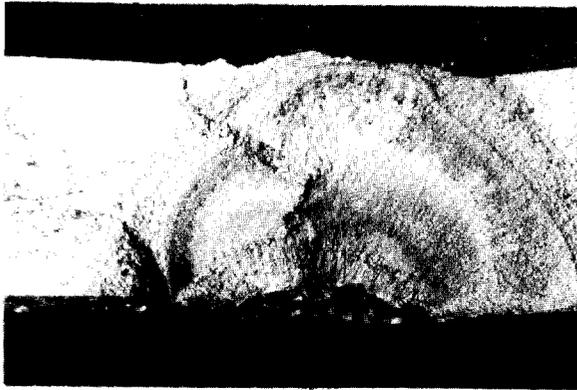
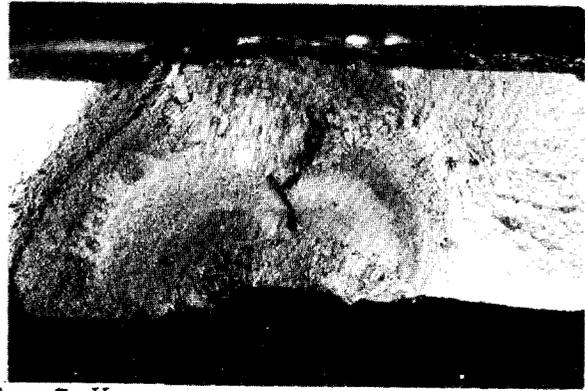
Specimen AC-1 Figure 49

Crack No. 3-V, 193,000 cycles, front face, beyond the test length. The crack appeared in a small pin-hole at a crater. At the end of the test, the crack was slightly wider than the weld. From the fracture (Fig. 49) it was difficult to determine at which point the crack started and in which direction it traveled. It is thought the crack started at the root.

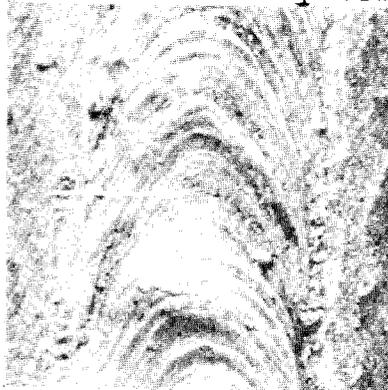
Specimen AC-1 Figure 50

Crack No. 4-V, 263,000 cycles, front face, lower third of test length. The crack formed at a ripple in the weld surface but did not grow as the test continued. After 300,000 cycles of stress it was not much larger in size than when first detected. This failure was so close to the 6-V crack that it could not be sectioned. However, when the weld length was pulled in the testing machine, the crack opened sufficiently (see Fig. 50) to reveal that it had originated at the surface of the weld.

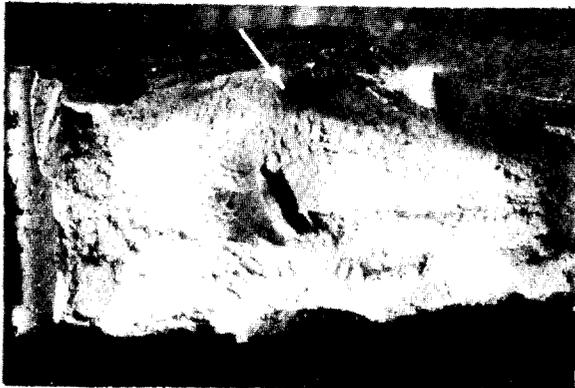
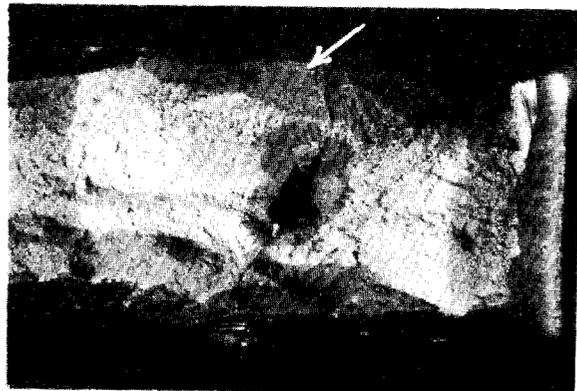
Specimen AC-1 Figure 51

Crack No. 5-V, 264,000 cycles, back face, upper third of the test length. The crack appeared in a ripple that was very close to a crater. Apparently the propagation of this crack was arrested, for when the test ended it was not much larger than when discovered. The fracture (Fig. 51) definitely showed that a small crack (arrows) started at the surface, although the root was not well fused.

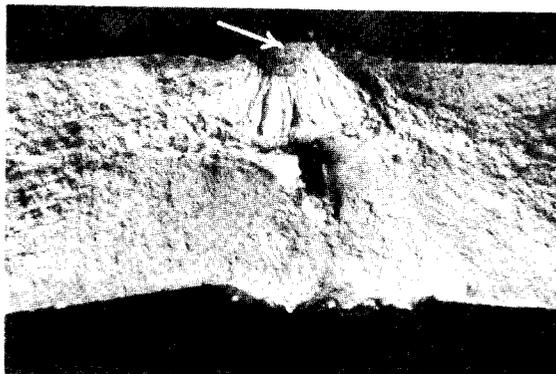
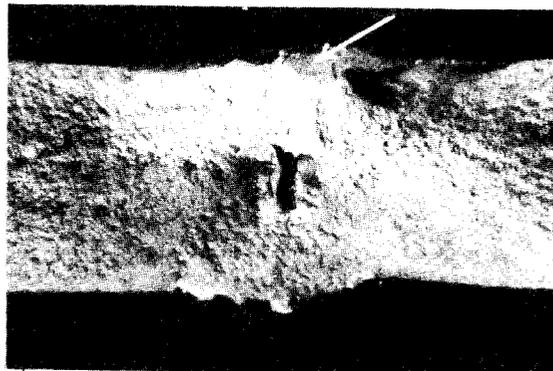
Specimen AC-1 Figure 52

Fig. 52) it is clear that the crack originated on the weld surface.

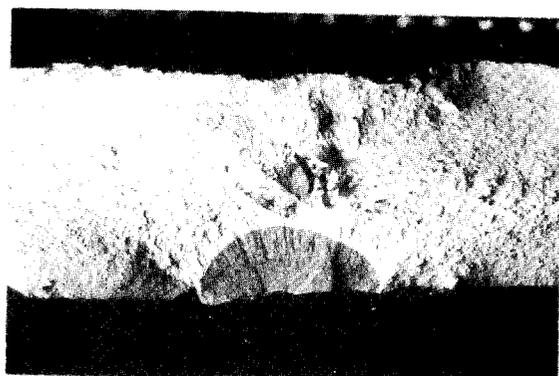
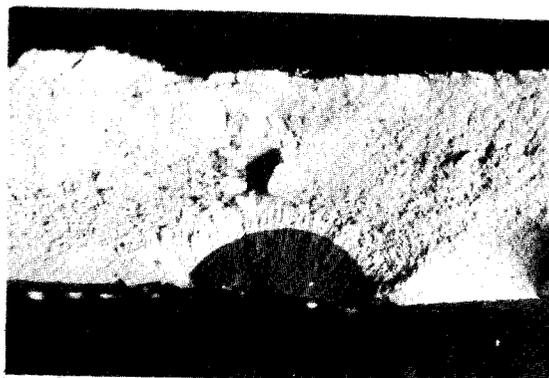
Figure 54

Crack No. 1-V, 199,000 cycles, top front face, beyond the test length. The crack appeared at the edge of a crater. At the end of the test (300,000 cycles) it was still small. The fracture (Fig. 54) showed that the crack definitely started at the surface, and was not caused by the poor fusion at the root of the weld. Also, the cross-section of the crater at this point does not show pit-holes or porosity.

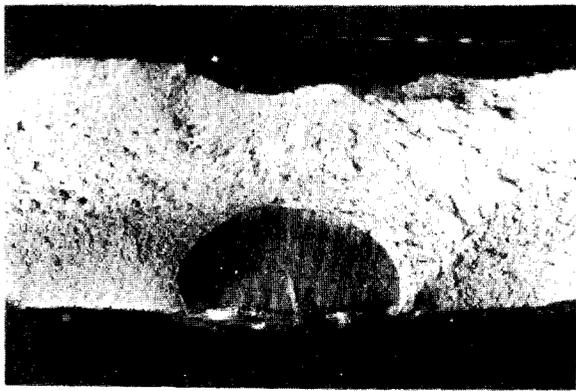
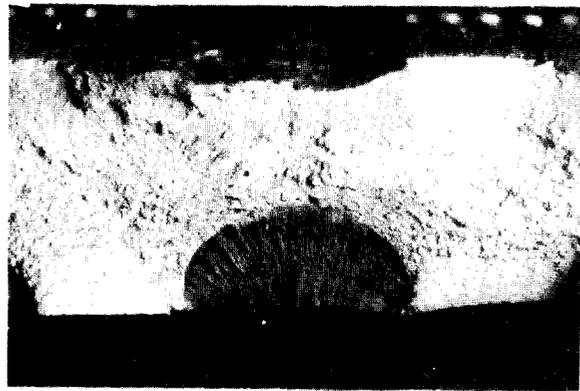
Specimen AC-2 Figure 55

that it did not involve the back-step sequence of welding but instead was of the continuous type. The fracture (Fig. 55) shows that good fusion was achieved at the root and that the fatigue crack commenced at the surface of the weld.

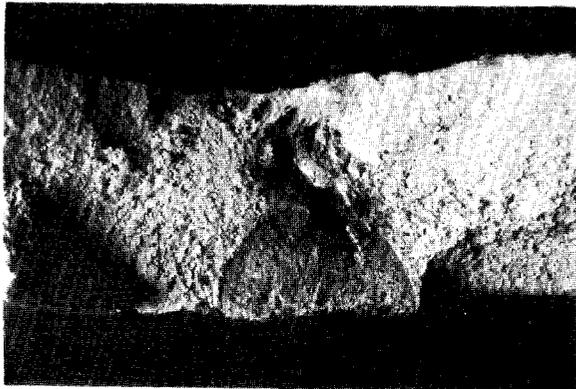
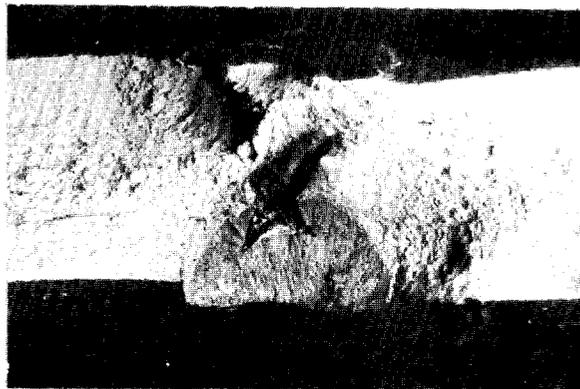
Specimen AC-2 Figure 56

Crack No. 3-V, 255,000 cycles, front face, lower third of the test length. The crack appeared on the surface of the weld at a pin-hole in a crater. At the end of the test (300,000 cycles) the crack remained small. The fracture (Fig. 56) indicates that the fatigue crack started at the root of the weld because of poor fusion there and that it traveled outward toward the front face of the specimen.

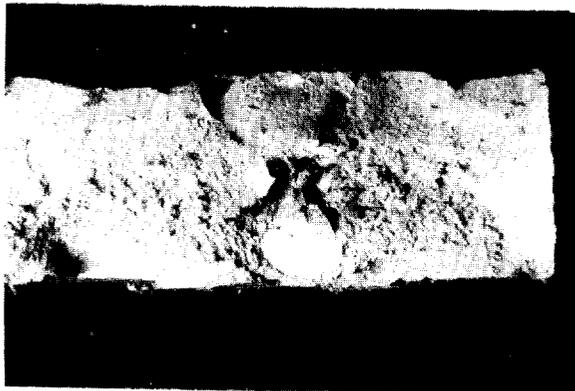
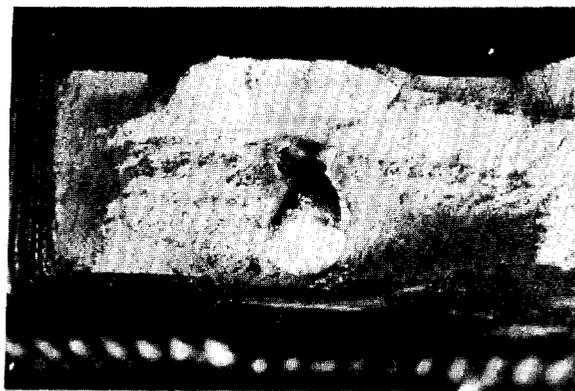
Specimen AC-2 Figure 57

Crack No. 4-II, The fracture (Fig. 57) indicated poor fusion at the root and also that a small fatigue crack started in the weld on the back face.

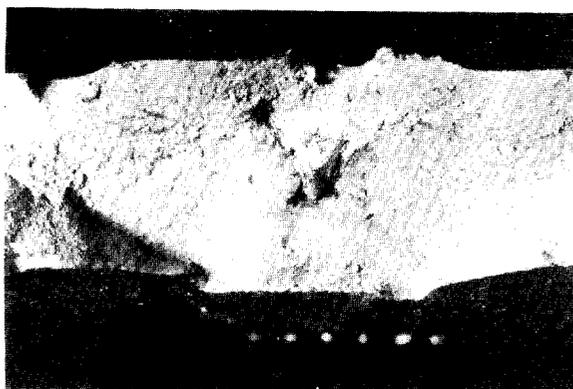
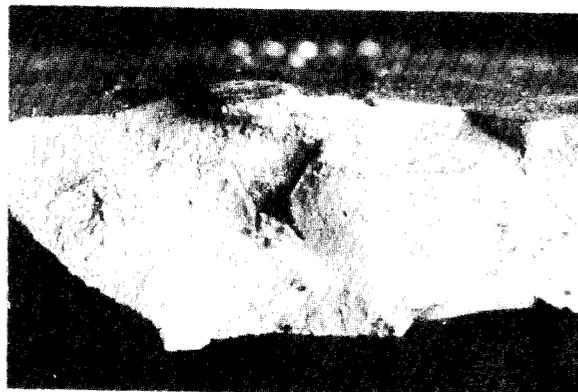
Figure 58

Crack No. 5-X, The fracture (Fig. 58) revealed the same characteristics as the failure described above.

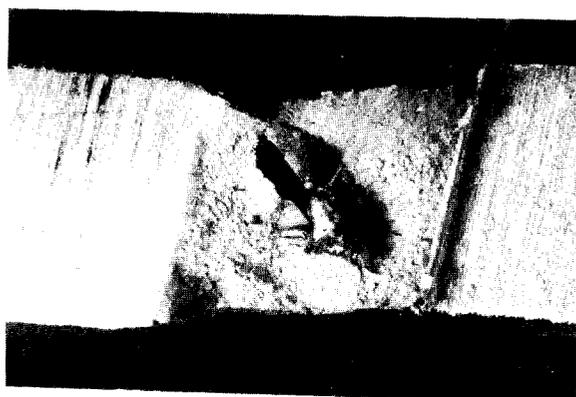
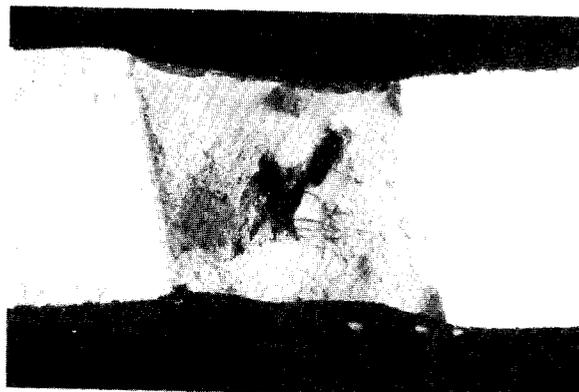
Figure 59

Crack No. 6-X, The fatigue crack (Fig. 59) evidently started because of a slag inclusion at the root. By the end of the test it had nearly reached the surface of the front weld.
