PROGRESS REPORT

FATIGUE TESTS OF SHIP WELDS

S. C. HOLLISTER, J. GARCIA AND T. R. CUYKENDALL
CORNELL UNIVERSITY
Under Navy Contract NObs-31218

Serial No. SSC-7

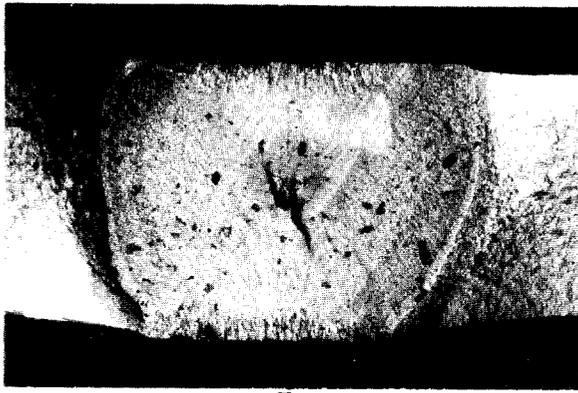
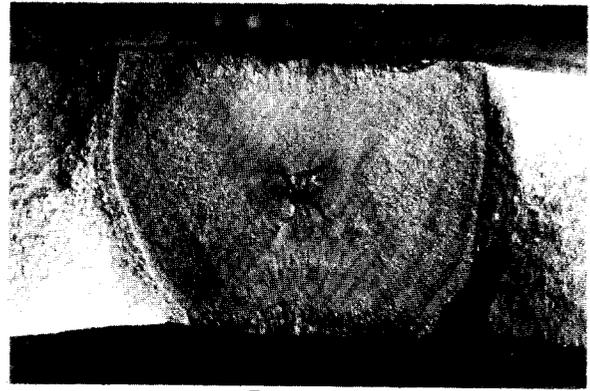
Figure 68

failure was across the weld, and at 159,000 cycles it broke through to the back face. At the end of the test (188,000 cycles) the fracture was 2" to either side of the center line of the weld. The fracture (see Fig. 68) showed poor fusion at the root of the weld. From the appearance of the section it is believed that the crack started at this point and traveled outward toward the faces of the weld.

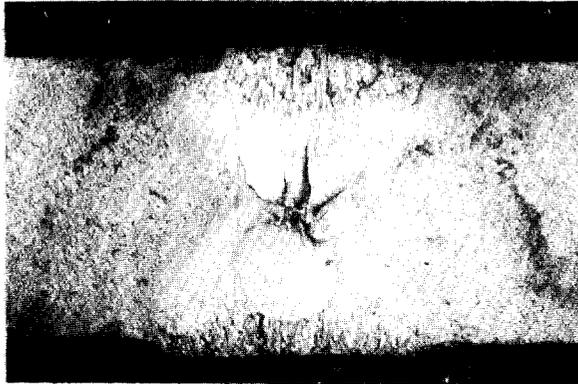
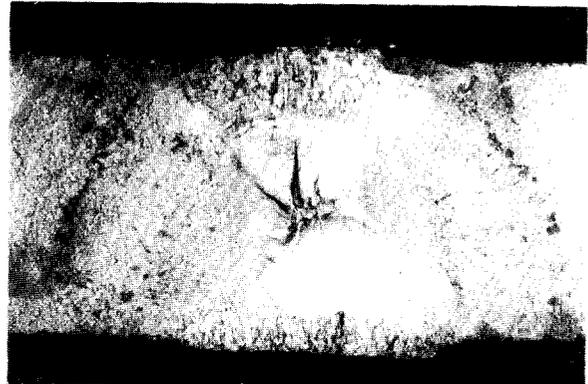
Figure 69

Crack No. 2-V, 168,000 cycles, top back face, beyond the test length, at a point where the weld had been ground flush. At 169,000 cycles the crack was almost the width of the weld, and at the termination of the test the crack had broken through to the front face. The fracture (Fig. 69) exposed, at the root of the weld, a slag inclusion which created this fatigue crack.

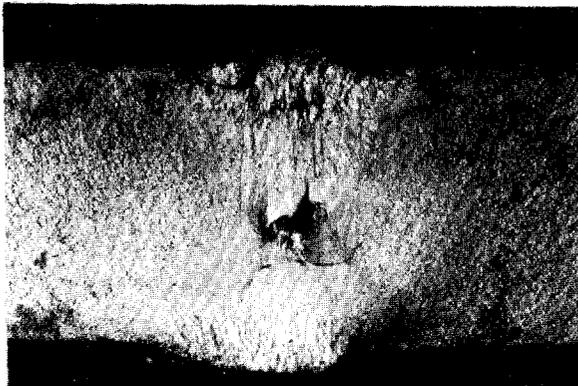
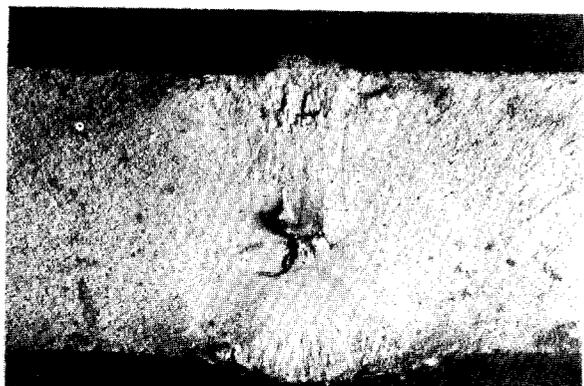
Figure 70

The fracture (Fig. 70) indicates that the crack started at the root of the weld where poor fusion existed.

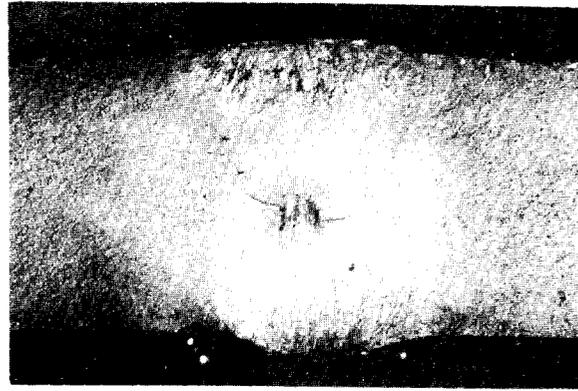
Figure 71

The crack became visible at the surface of the weld where there was a small pin-hole created by under-cutting, and traveled across the ripples of the weld and not along the ripple itself. It broke through to the back face at 218,000 cycles; at the completion of the test (234,000 cycles) the crack was 3" wide on the front face. The fracture (Fig. 71) shows that the fatigue crack started at the root.

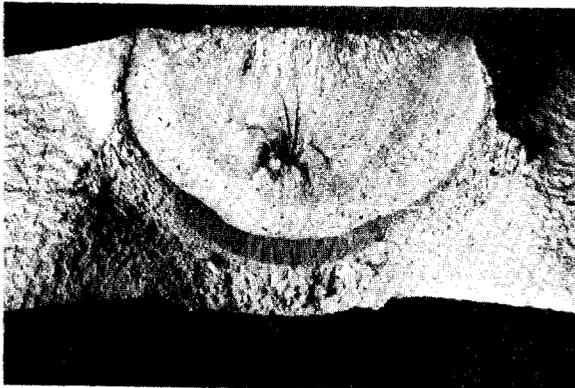
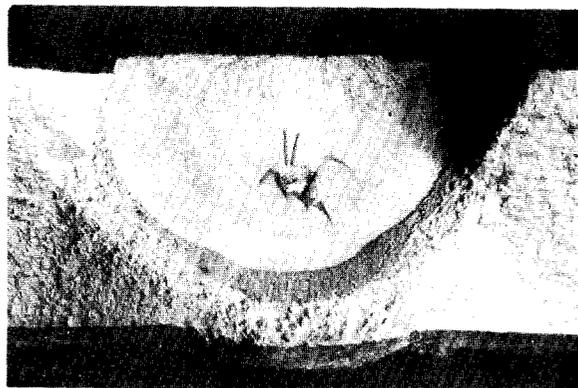
Specimen DE-1 Figure 73

The fracture (Fig. 73) indicated poor fusion at the root of the weld; it is believed that the fracture traveled from the root toward the back face of the specimen.

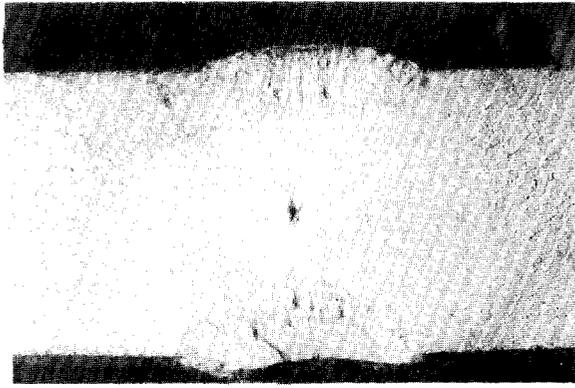
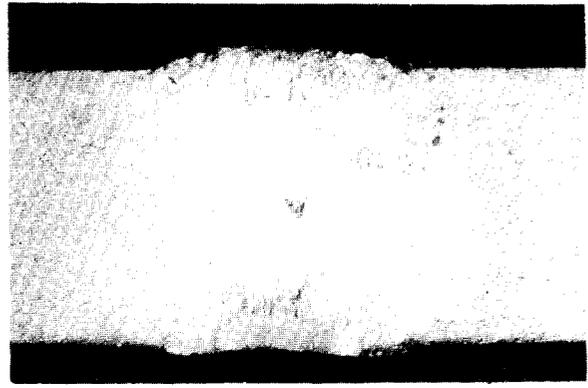
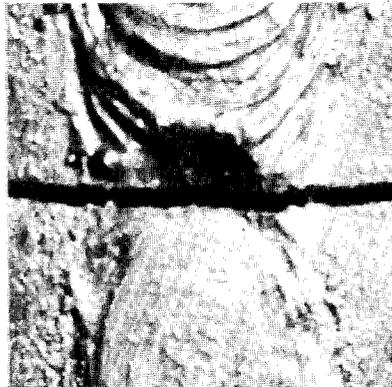
Specimen DE-1 Figure 74

Crack No. 3-X, Approximately 230,000 cycles; back face, lower third of the test length. This crack was detected in the same manner as the 2-X crack, and the cycles to failure was estimated from the data taken during the test. The fracture (Fig. 74) revealed poor fusion at the root where the fracture started.

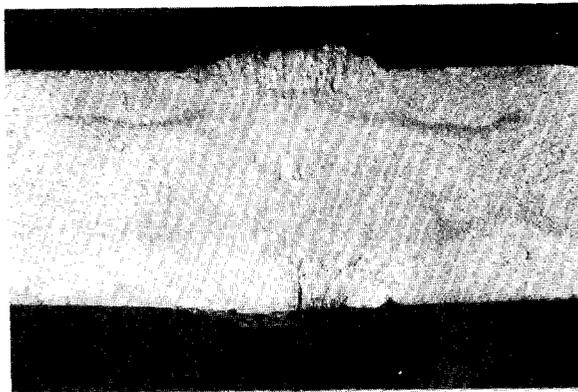
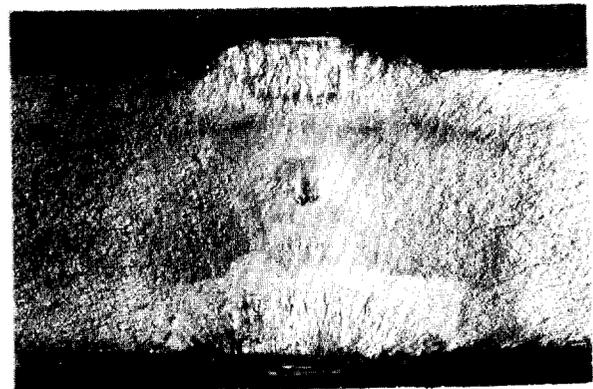
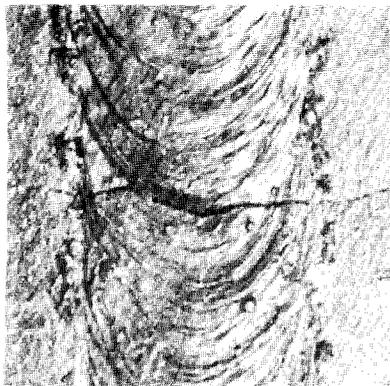
Specimen DE-2 Figure 75

Crack No. 1-V, 152,000 cycles, front face, upper third of the test length. When first seen the crack was in a deep ripple of the weld surface. At 167,000 cycles the crack was the full width of the weld; at 195,000 cycles the crack broke through to the back face; at 209,000 cycles the crack was approximately 3-1/2" wide, and at the end of the test (234,000 cycles) the crack had become 7" wide. The fracture (Fig. 75) showed that the crack had started on the front surface of the weld.

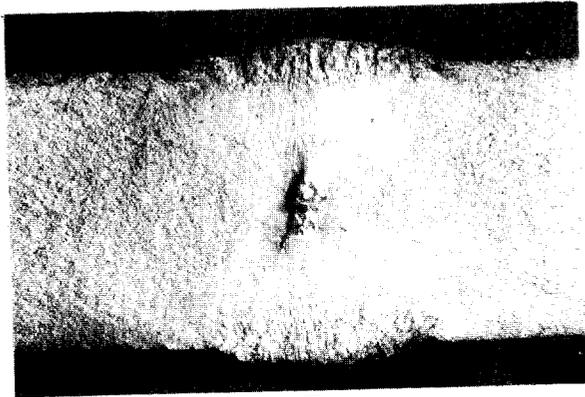
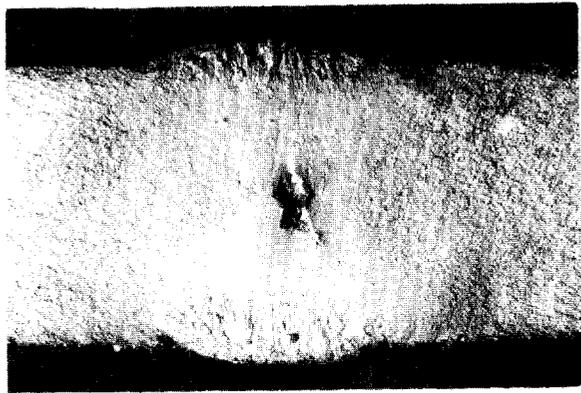
Specimen EE-1 Figure 76

The crack also was first seen in a deep ripple of the weld metal. The crack propagated rapidly; at 192,000 cycles it was the full width of the weld surface; at 208,000 cycles it was seen on the back face, and at the end of the test (219,000 cycles) the crack was 2" wide on the front and back faces. It was not possible to determine definitely from the fracture (Fig. 76) the point of the weld at which the crack originated.

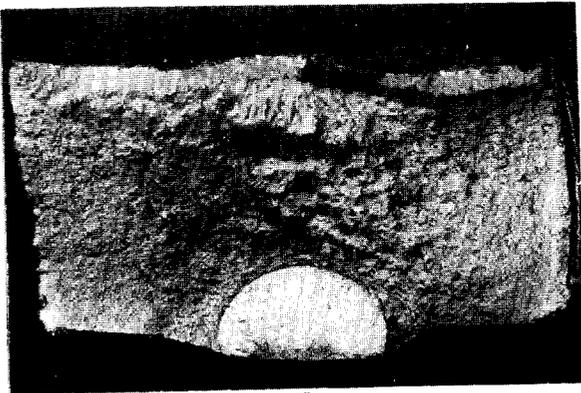
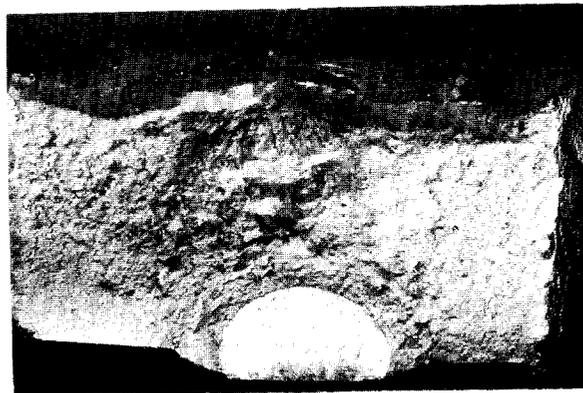
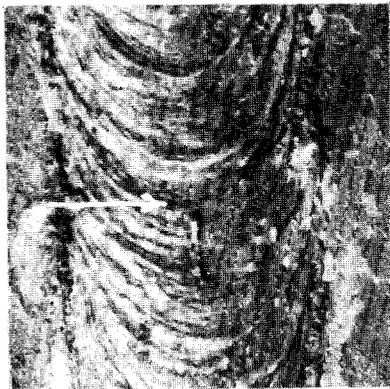
Figure 77

The crack appeared across the ripples of the weld surface. The crack was seen on the front face at 223,000 cycles and became 2-1/2" wide at the end of the test (246,300 cycles). The fracture (Fig. 77) shows a slag inclusion at the root of the weld where the fatigue crack originated.

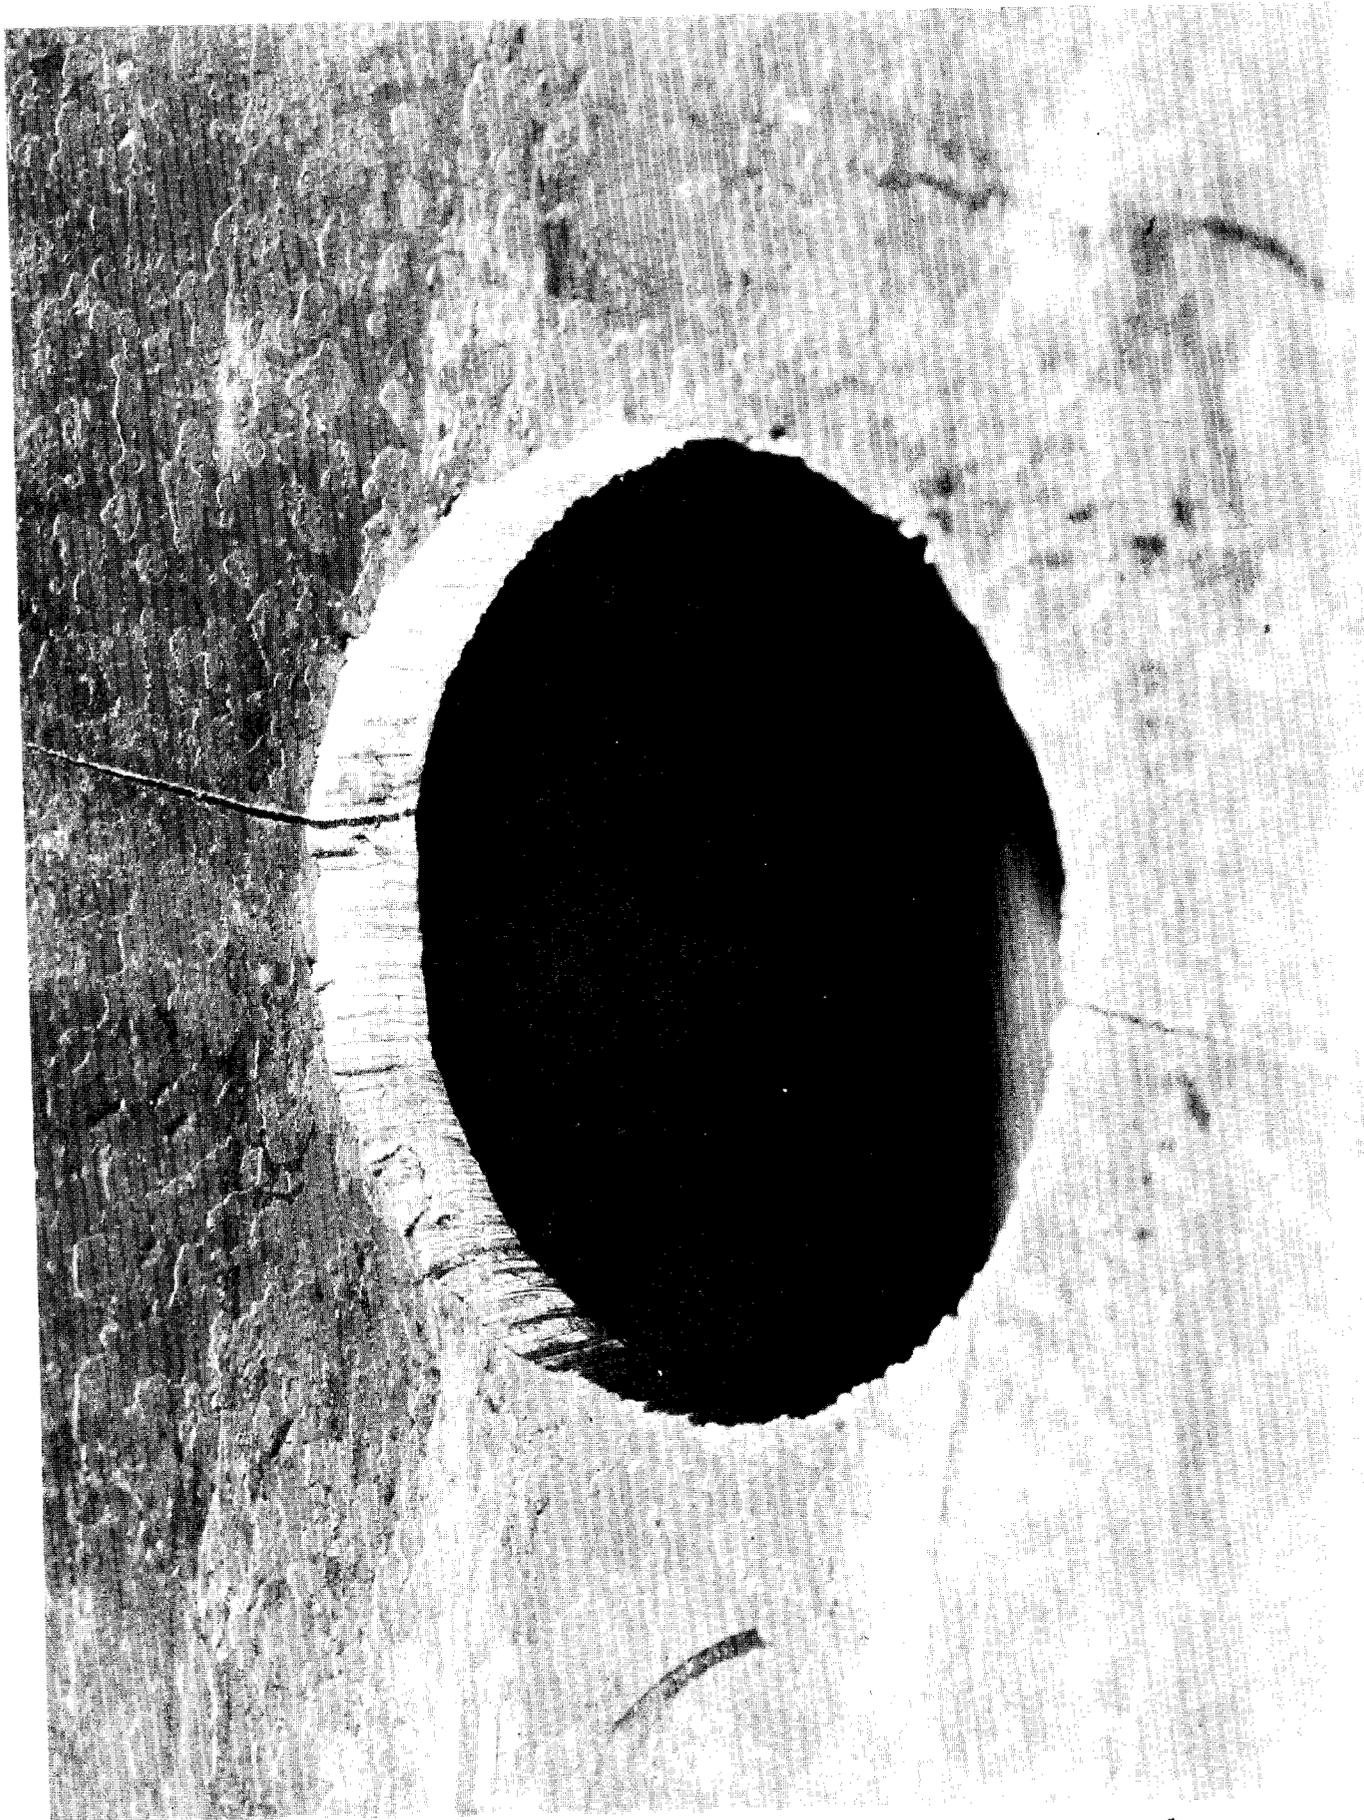
Figure 78

Crack No. 2-X, Radiographs of the weld indicated a fracture which was verified by a sectioning of the weld (Fig. 78). The crack definitely started at the front surface in a ripple of the weld and propagated inward.

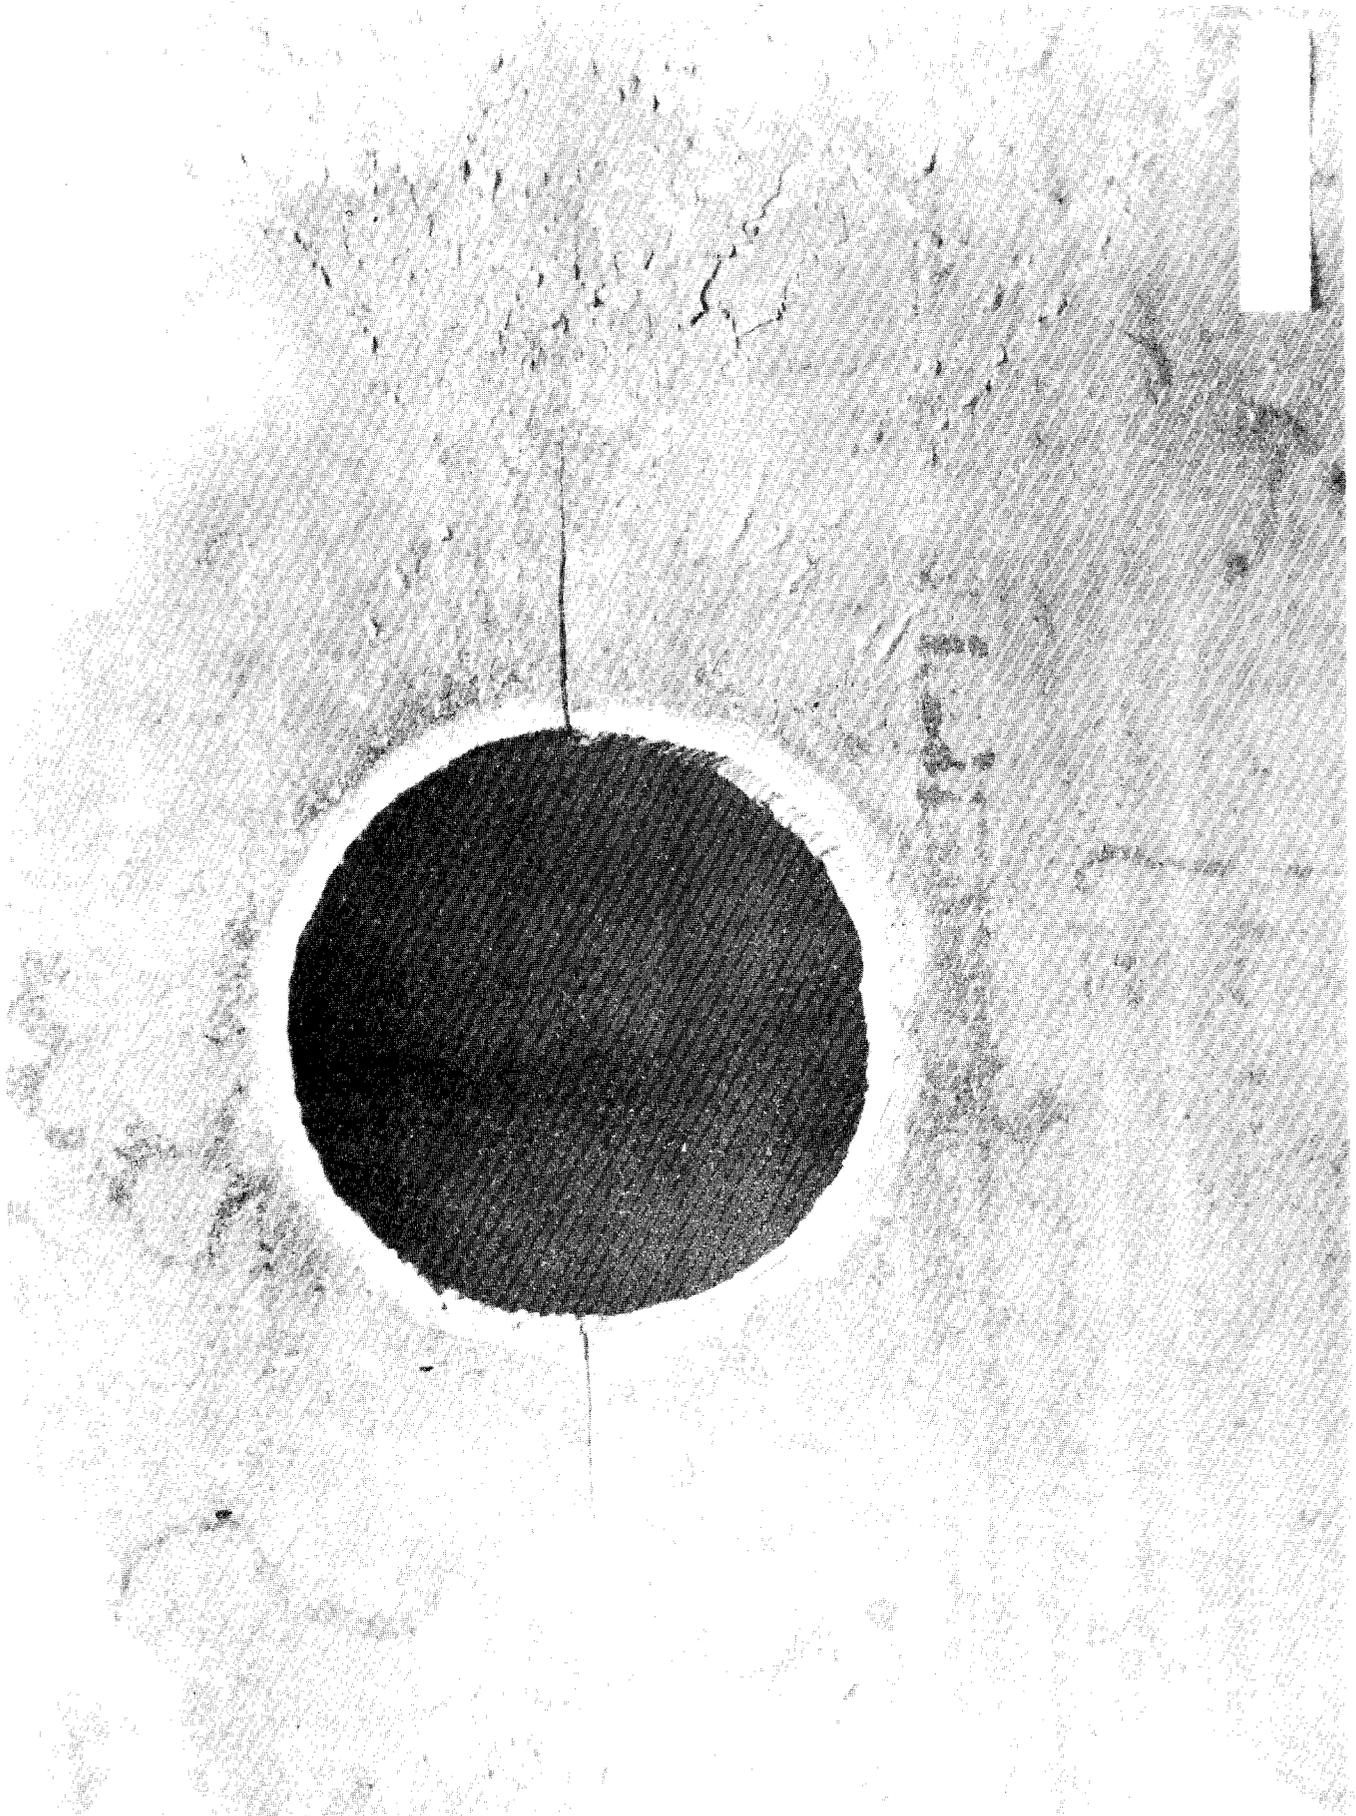
Figure 79 Specimen FA-1 Front Bottom

Fatigue Crack: 10,500 cycles, on the front left edge about 1/2" above the transverse center line of the hole, see Fig. 79. The crack did not start in a small notch on the inside surface

of the hole resulting from the flame cutting process. The crack traveled along a ripple in the flame cut surface and was visible on the back face of the specimen at 13,300 cycles. At nearly the same number of cycles a second crack appeared on the front right edge of the front face exactly on the transverse center line. This crack also traveled along a flame ripple (Fig. 80) to the back face of the specimen. The test had to be discontinued at 23,900 cycles because the cracks had spread about 2-1/2" to either side of the hole. The reduction in the cross-section caused plastic flow at the ends of the crack (see Fig. 80 and Fig. 29).

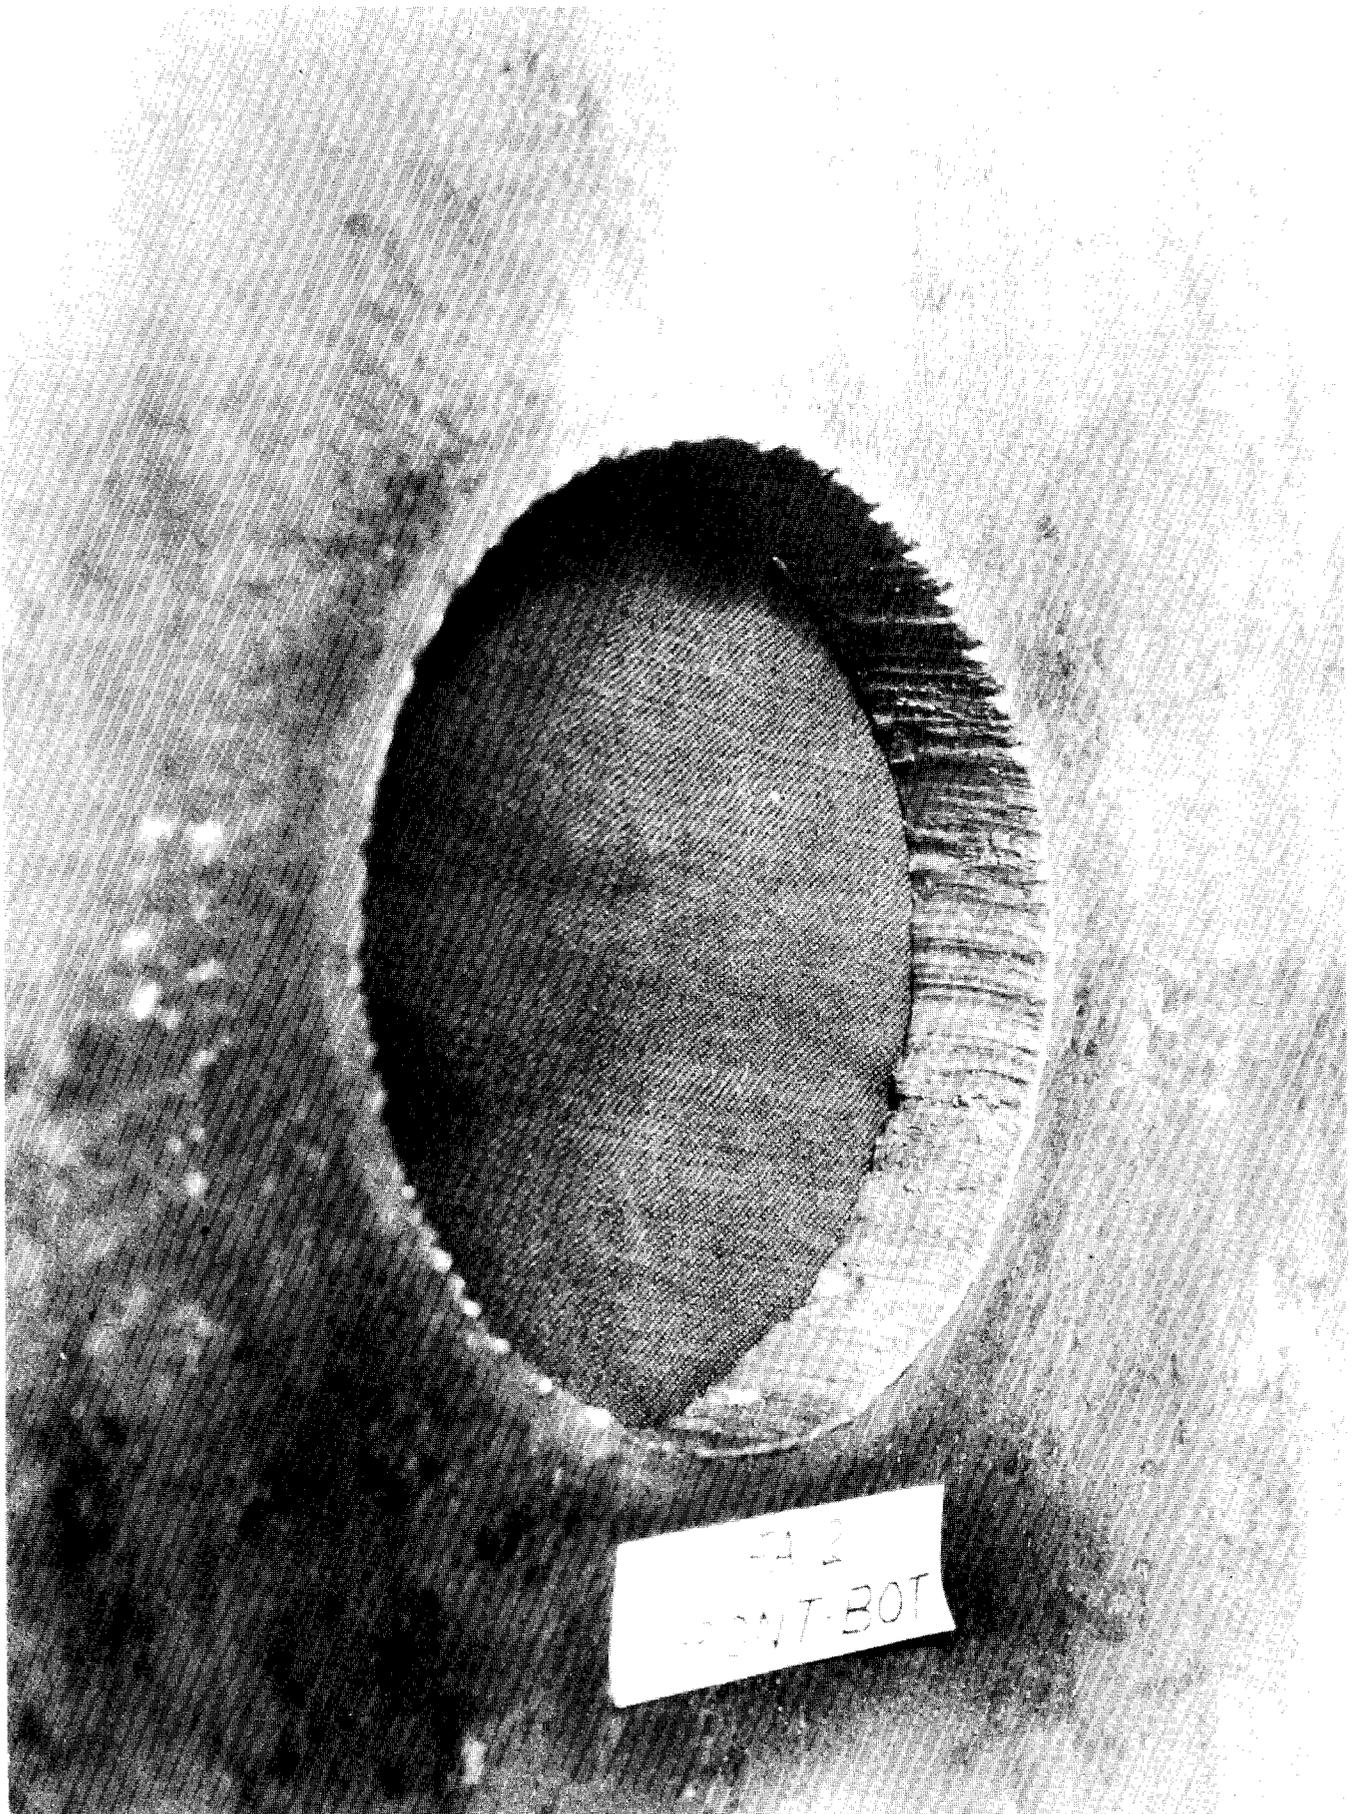
Figure 80 Specimen FA-1 Back Bottom

Flame Stress: In the photograph of the plate, Fig. 80, radial "lines" are seen where the scale has been chipped away; evidence that plastic flow of the metal has extended some three to four inches from the edge of the hole. These shear lines occurred during the flame cutting of the hole, and indicate that considerable residual stress may exist in the region adjacent to the surface of the hole. No annealing or other heat treatment was given the

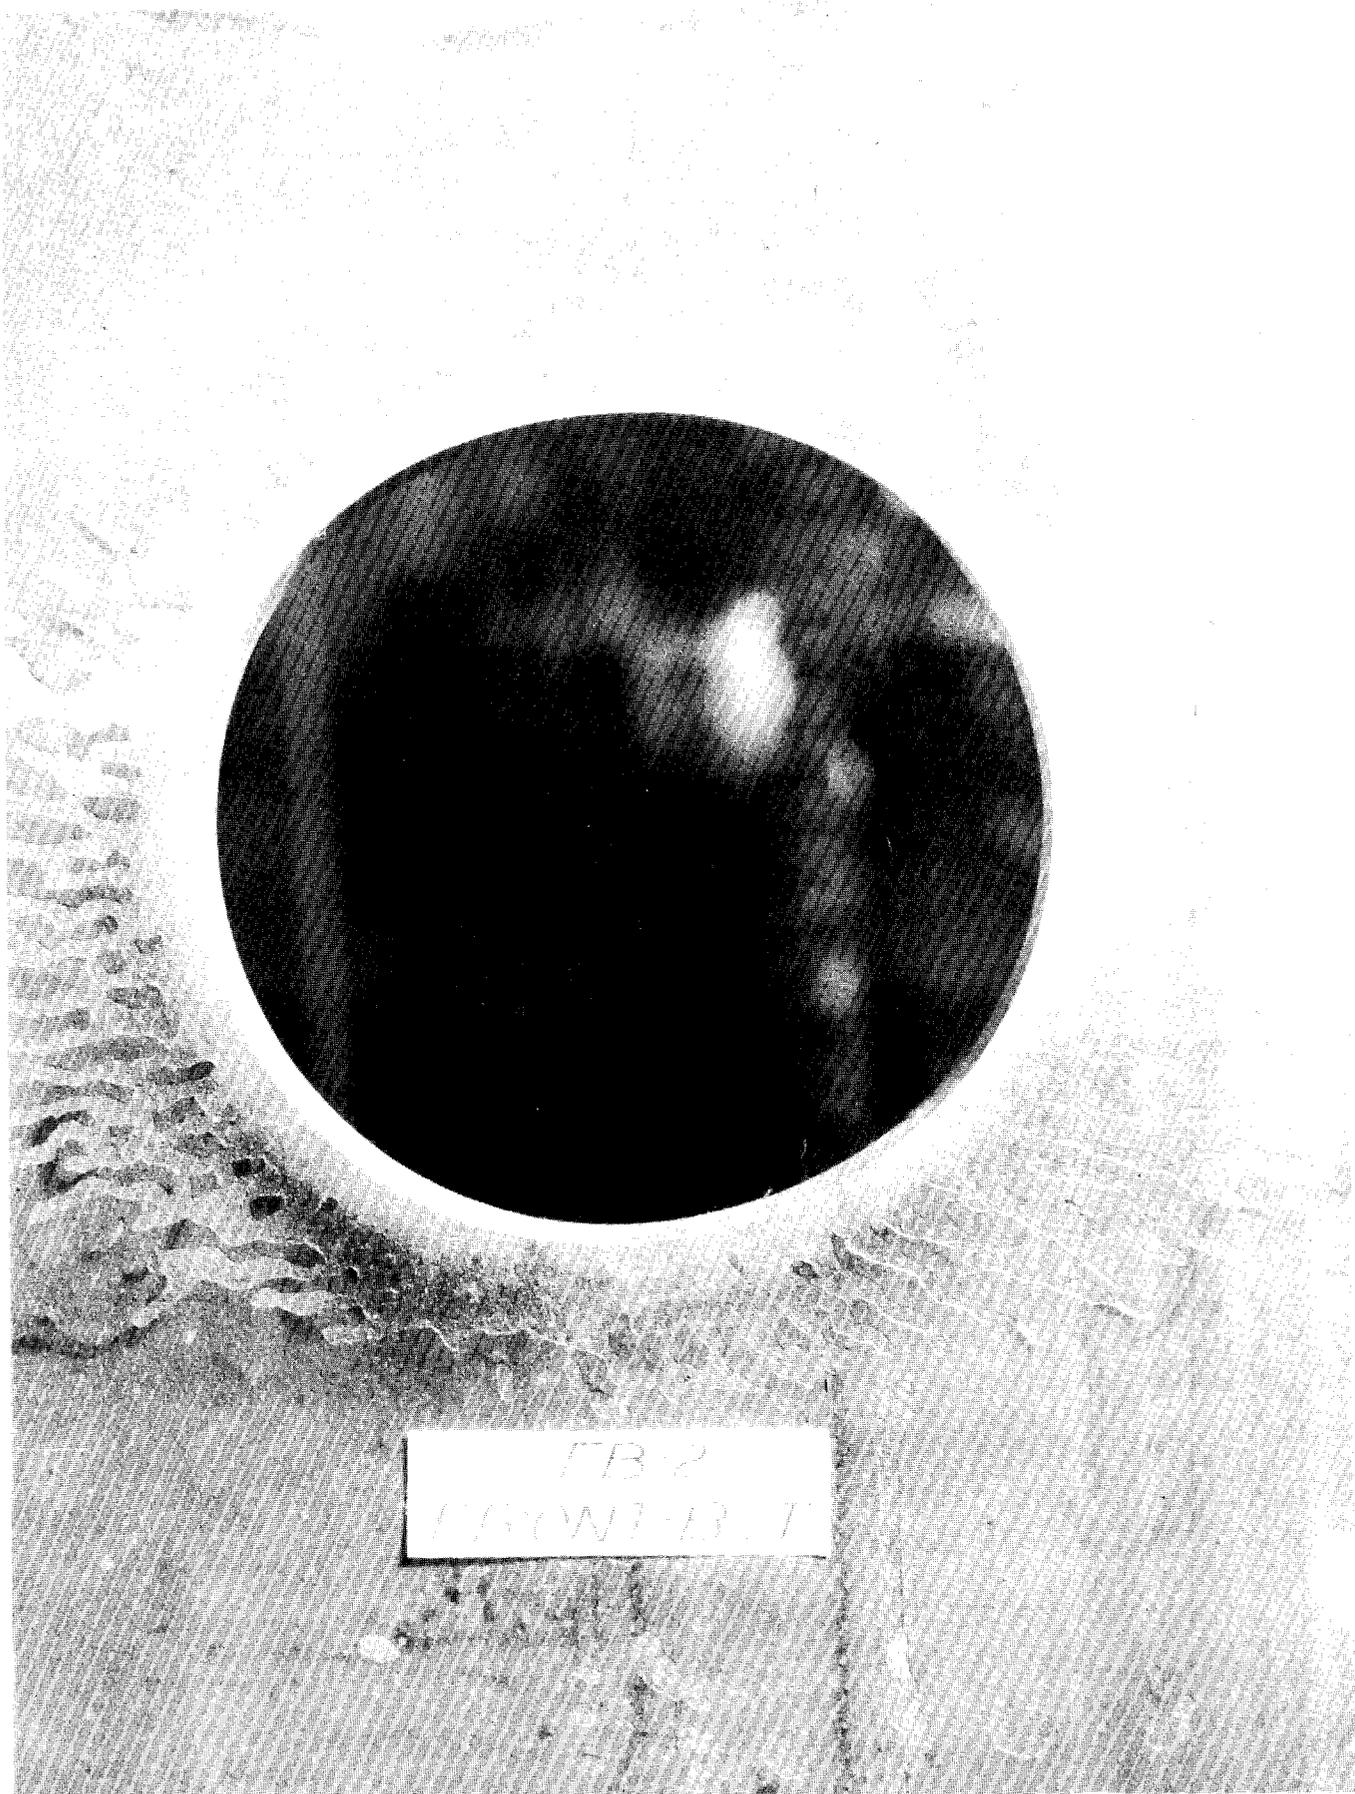
Figure 82 Specimen FB-1 Back Bottom

Coarse grinding of the inner surface of the hole on specimens FB-1 and 2 was done with a Norton A16 - P4B5 wheel driven by a Black and Decker, portable 5" grinder. Finish grinding was done with a Norton A36-QB wheel on an Aro-Grinder (air). The finished surface was quite smooth, see Figs. 82 and 83. In this process all the burned metal but not over 1/16" depth of metal was removed.

62,500 cycles, on the back left edge of the hole (Fig. 82) about $5/16$ " above transverse center line. At 75,000 cycles, the fracture had traveled along the inside of the hole and became visible on the front face. At the end of the test (76,600 cycles) this crack was approximately $1-1/4$ " long on the back face and $1/4$ " long on the front face. The crack on the opposite side of the hole appeared at 71,500 cycles on the back right edge of the opening about $1/16$ " below the outer line. It traveled through to the front face, appeared there at 74,000 cycles. The test was stopped when Lueders' Lines formed on all faces of the specimen at the ends of the cracks. Location of Cracks, see Fig. 31.
