SSC-425

**FATIGUE STRENGTH AND
ADEQUACY OF WELD REPAIRS**

SHIP STRUCTURE COMMITTEE
2003

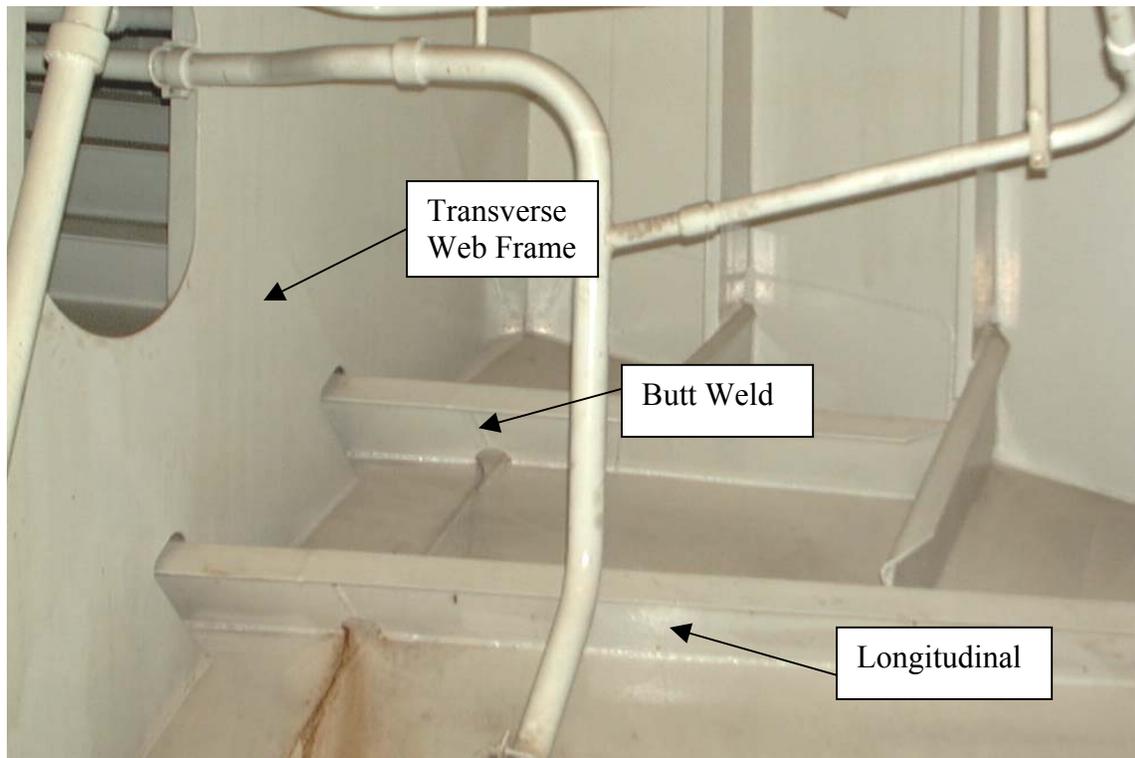
In project SR-1376, a literature search was conducted to determine the types of ship details which should be used for fatigue tests of weld repairs [37]. In addition, a survey was conducted of over 50 shipyards, ship owners, operators, regulators, surveyors, universities, consultants, and other agencies with an interest in ship repair in the U.S.A., Europe, and Asia. Previous Ship Structure Committee Reports were also reviewed and the results included in a project interim report [64]. Results indicated that the three details with highest priority for repair research were 1) brackets at the intersections of web frames and girders with bulkheads; 2) the intersection of longitudinal stiffeners with transverse web frames or bulkheads; and 3) butt welds in stiffeners and girders. An example of all three of these details can be seen in Figure 2.4, which is a photograph taken in the engine room of a containership.

Figure 2.4: Fatigue-sensitive details found in ship structures [65]

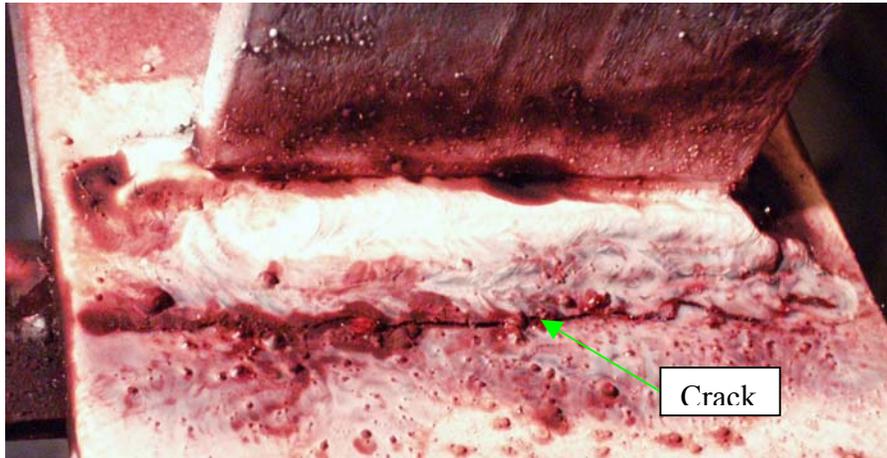
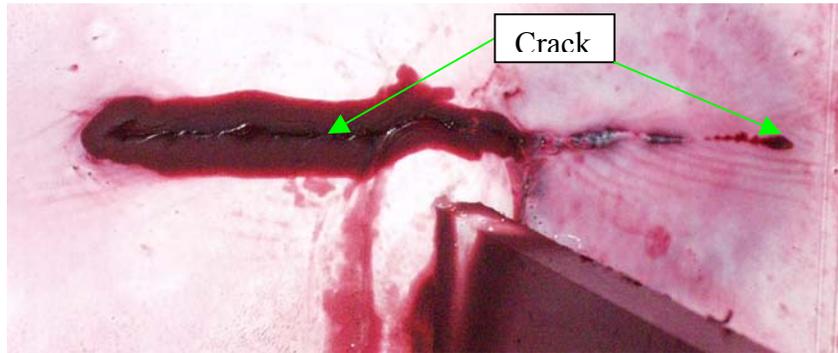
a) Typical crack at flange end of attachment.

b) Typical crack at web end of attachment.

Figure 3.8: Typical cracks in simple-attachment specimens (enhanced by dye penetrant) at the point defined as “failure”.

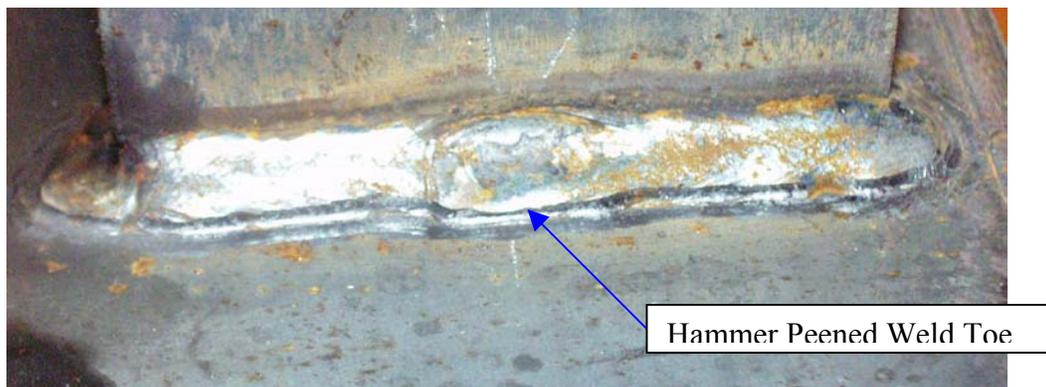
Figure 3.9: Preemptive hammer peening the weld toe.

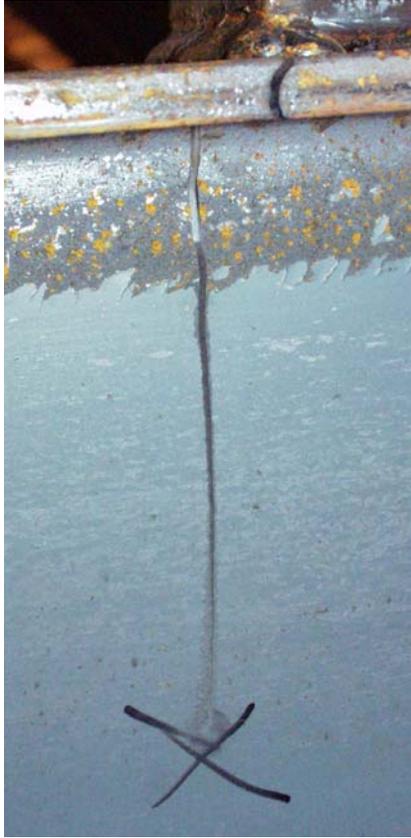
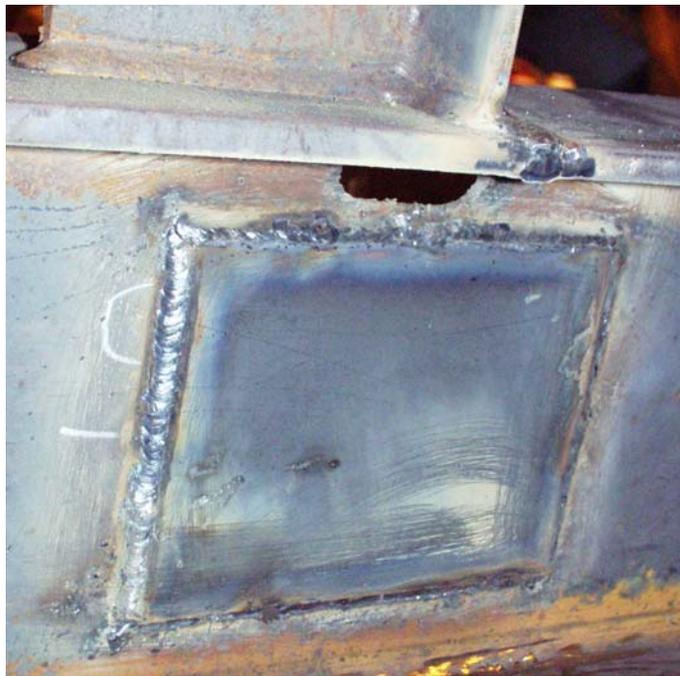
a) Large crack.

b) Repair of crack.

Figure 3.17: Simple attachment specimen doubler plate repair.

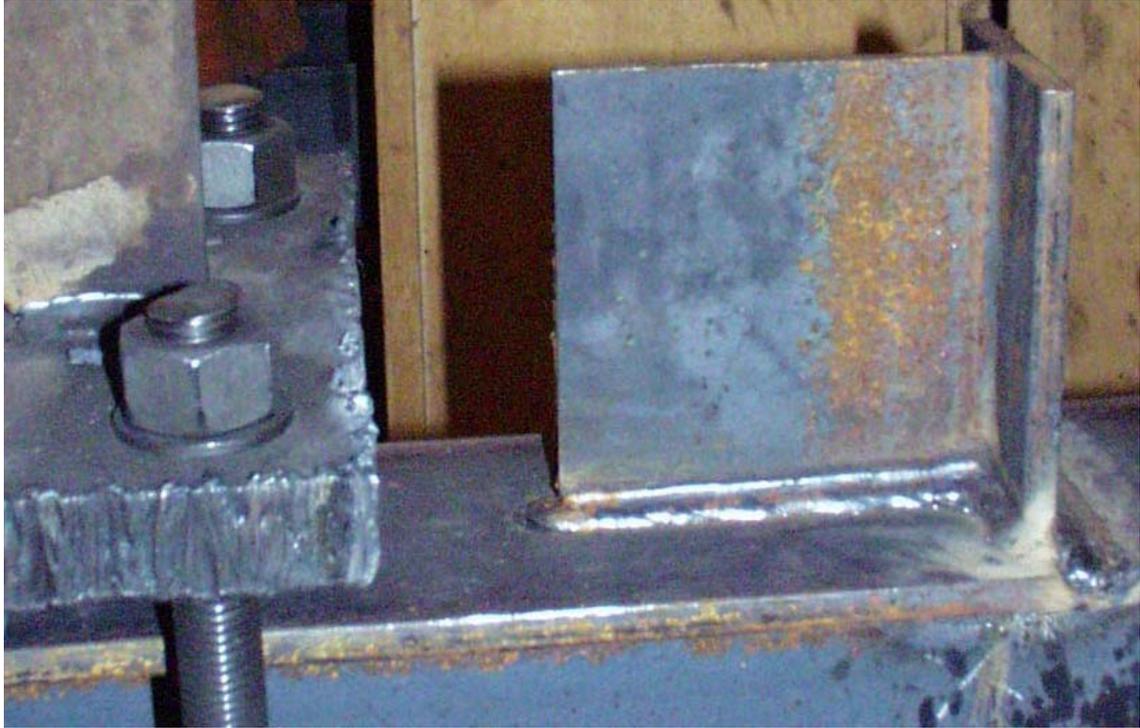
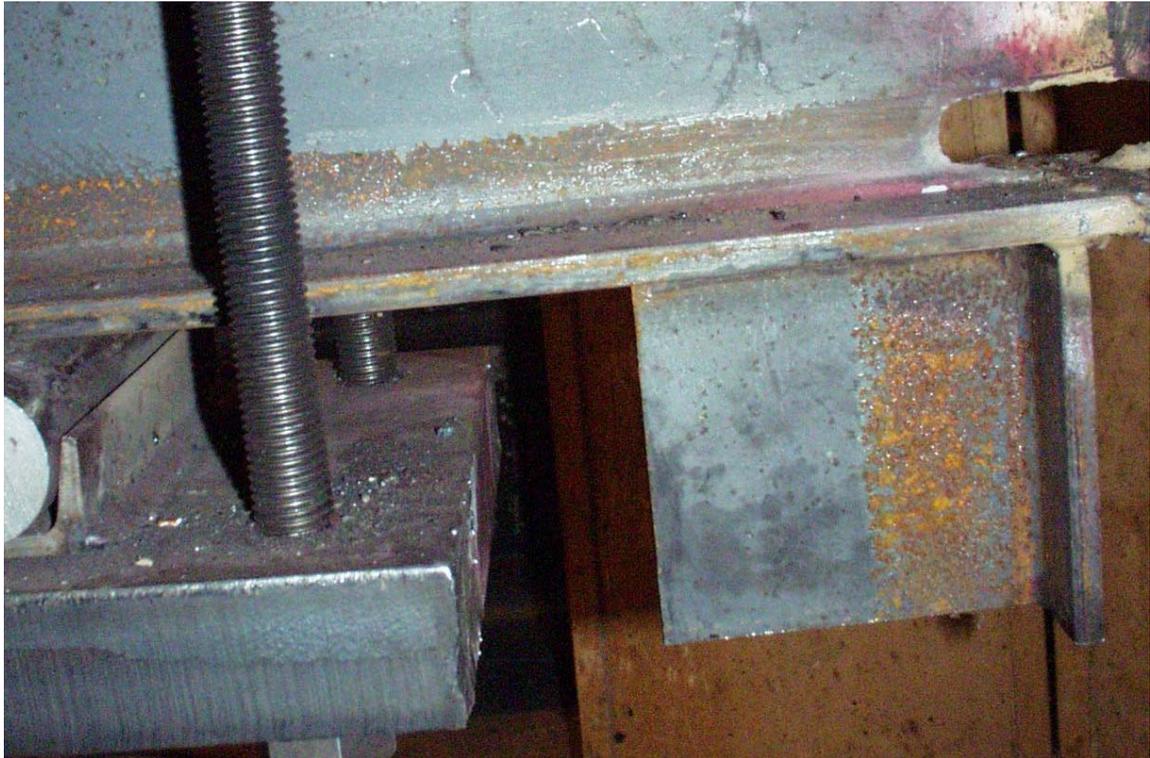
Figure 3.18: Area of specimen with inadequate access to attachment for weld repairs.

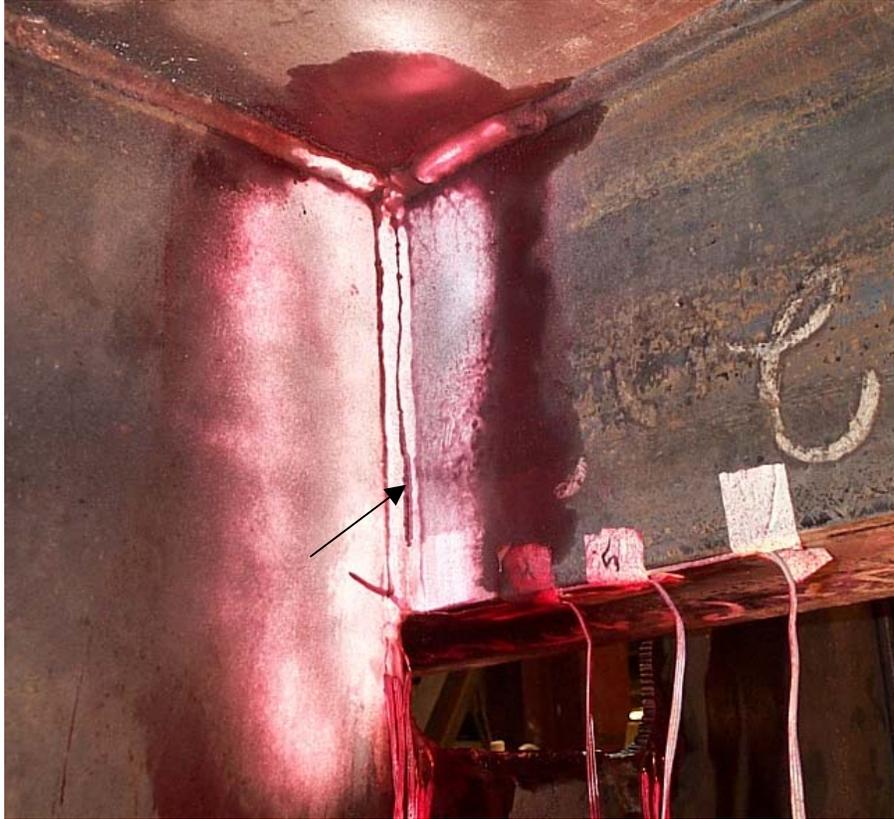
Figure 3.80: Crack along back of longitudinal at connection to web frame (specimen 1)

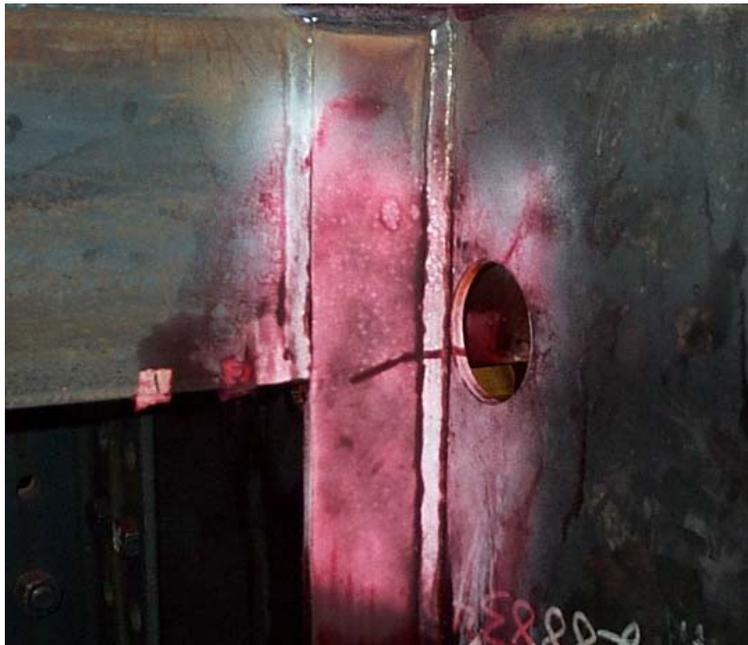
Figure 3.83: Crack propagating from stop hole into flat bar stiffener (specimen 1)

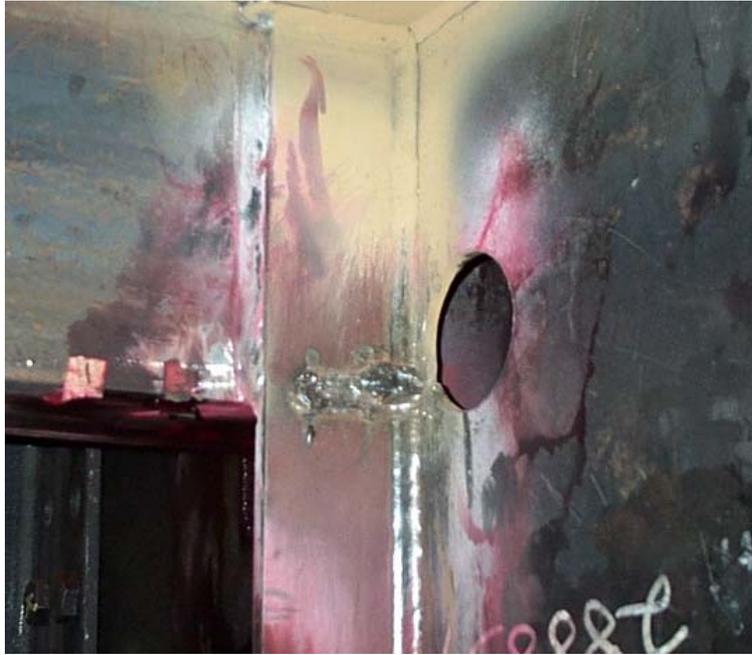
Figure 3.84: First weld repair of cracked flat bar stiffener (specimen 1)

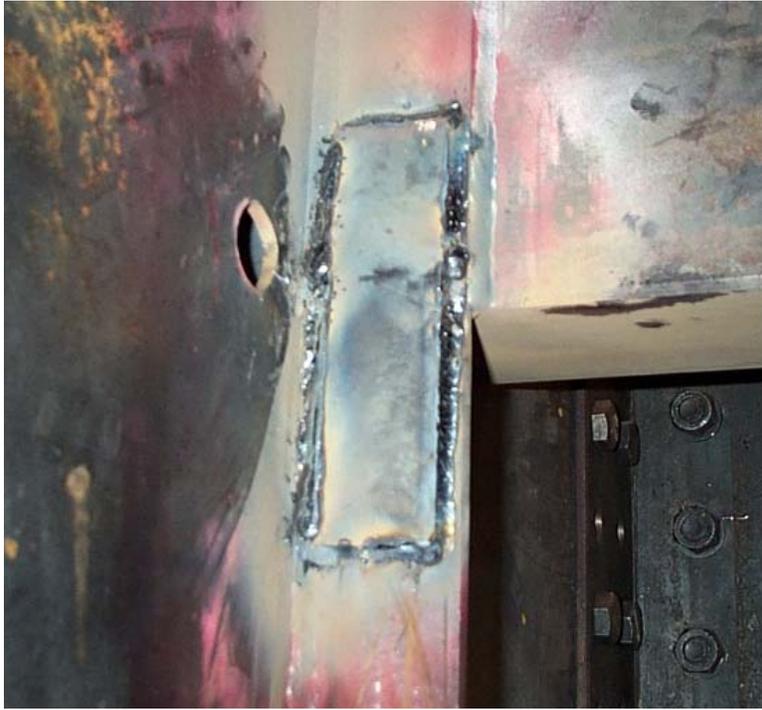
Figure 3.88: Doubler welded to flat bar stiffener (specimen 2)

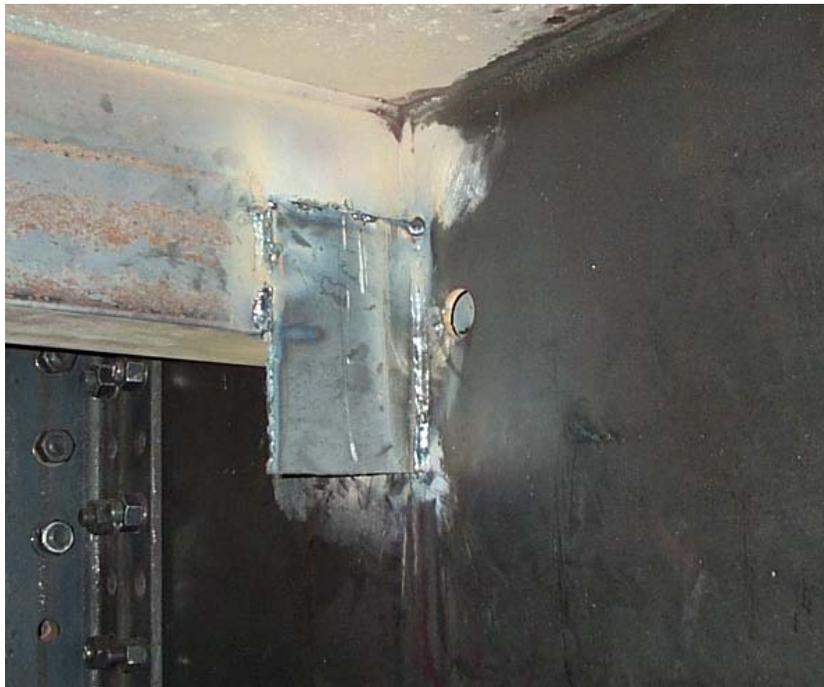
Figure 3.89: Additional bracket (specimen 2)

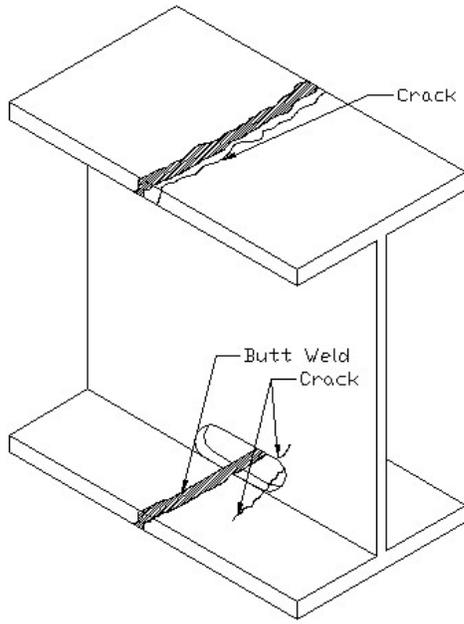
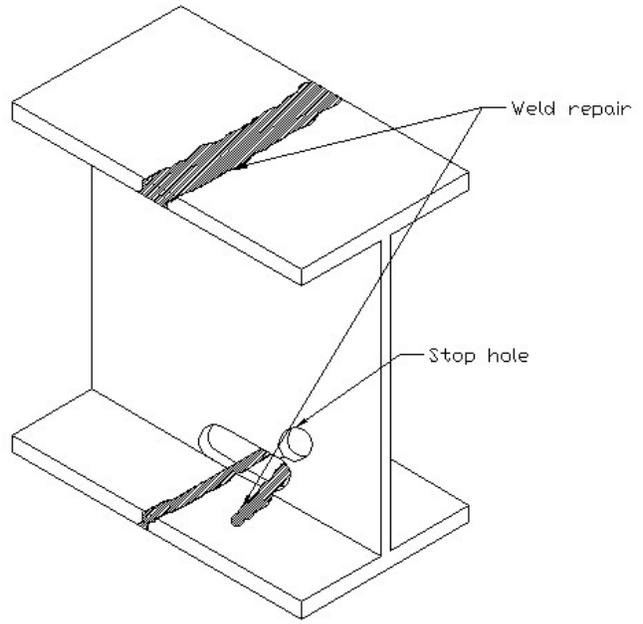
Figure 3: Cracks and repairs at butt welds and access holes.

Sketch of Damage

Cracks at access holes or drain holes that are too large to stop by drilling holes may be repaired as follows. A 25 mm hole is used to temporarily stop the crack. The crack is then arc-gouged between the weld-access hole and the stop-hole and welded (Figure 3). The best repair is a U-preparation with the weld made from one side and then backgouged and rewelded from the other side. After welding, the edge of the weld at the access hole should be ground flush and a slightly larger stop hole, 38 mm in diameter, should be drilled to remove the edge condition of the weld. This repair will restore the access hole to a Category D detail.

Sketch of Repair

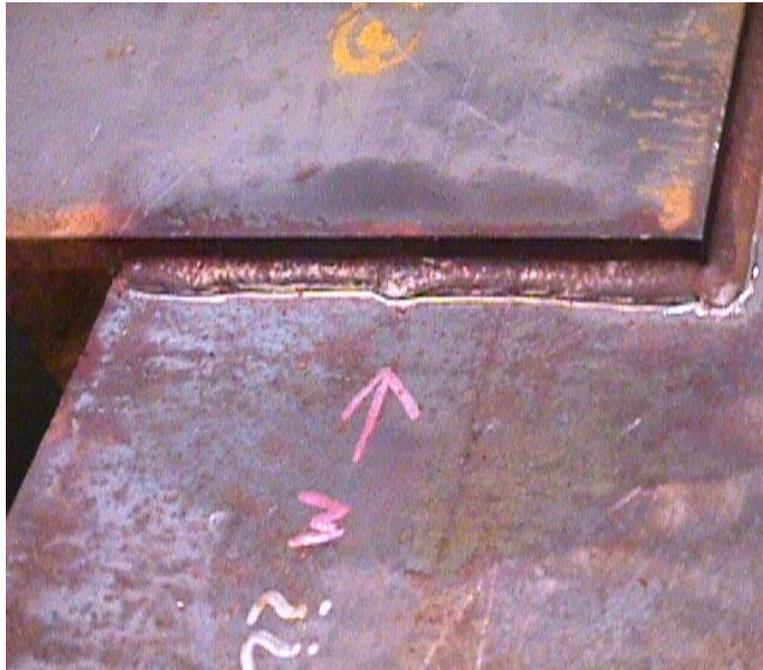
Figure 5: Peened weld that had a surface crack at fillet welded attachment

3.7 **Fillet welded attachments** – The original details are typically Category E when they are new. Shallow cracks, less than 3 mm deep, may be repaired by hammer peening (Figure 5). Surface cracks along weld toes with a total length less than 30 mm will typically be less than 3 mm deep, while surface cracks at wrap-around welds on the nose of stiffeners may exceed 3 mm in depth when they have a total length greater than 12 mm. Hammer peening should be applied to all weld toes where the weld axis is perpendicular to the principal stress range, usually the weld toes parallel to the crack that formed. The hammer peening will create a Category D detail. The life of the hammer peened welds will typically be at least twice the life of the original detail

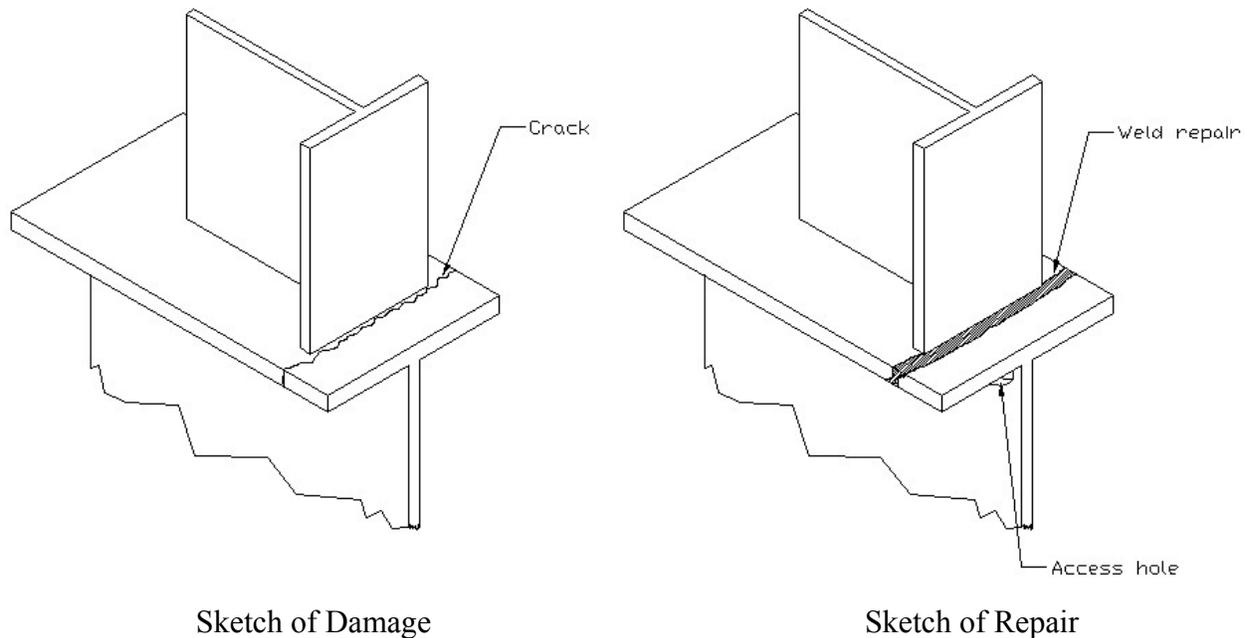
Figure 6: Crack and repair at attachment detail

Deeper cracks may be repaired effectively using air arc-gouging and welding (Figure 6). If a crack is nearly all the way across the flange of a stiffener or other element, it is preferred to gouge a groove across the whole element so the weld may be terminated at the edges by cascading the weld beads. If a weld is in a continuous plate or is much less than the width of the plate, it is preferred that the weld repairs be made between drilled holes at least 25 mm diameter at the crack tips, and that after welding the holes are enlarged to 38 mm to clean up the weld ends. It is recognized that this is not always possible, and the test data show it is acceptable to terminate the weld in a gradually tapered groove.

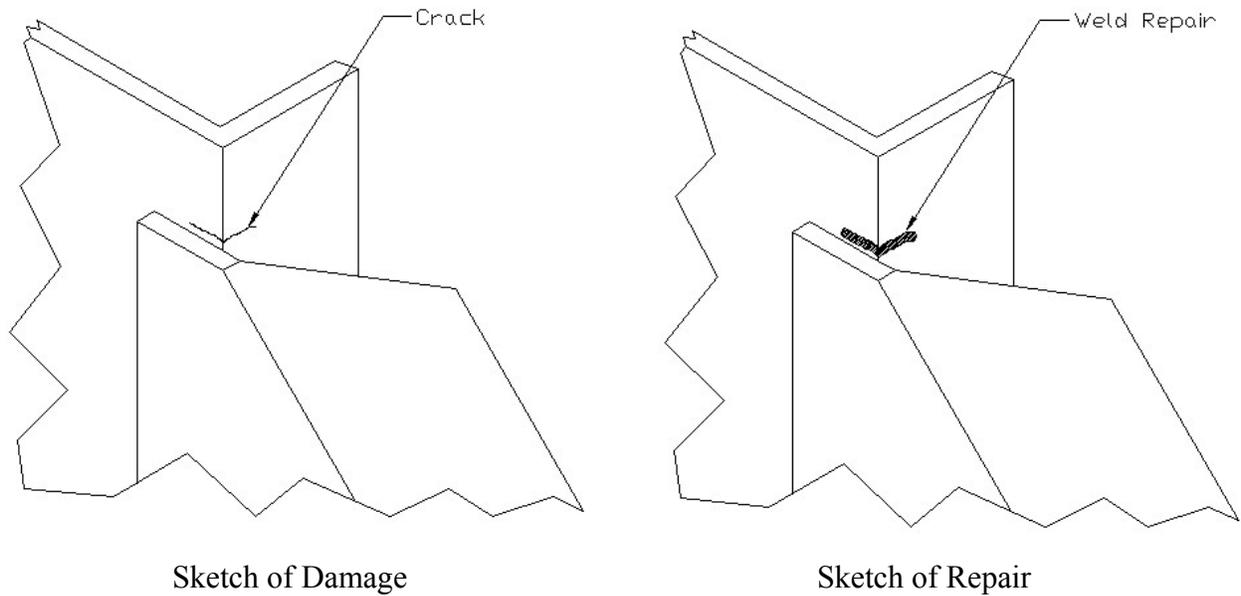
Figure 7: Crack and repair at bracket detail.

Deeper cracks may be repaired effectively using air arc-gouging and welding (Figure 7). The weld repair may be considered as a new Category E' detail, regardless of the weld type, i.e. either two-sided or one-sided complete joint penetration welds, with and without

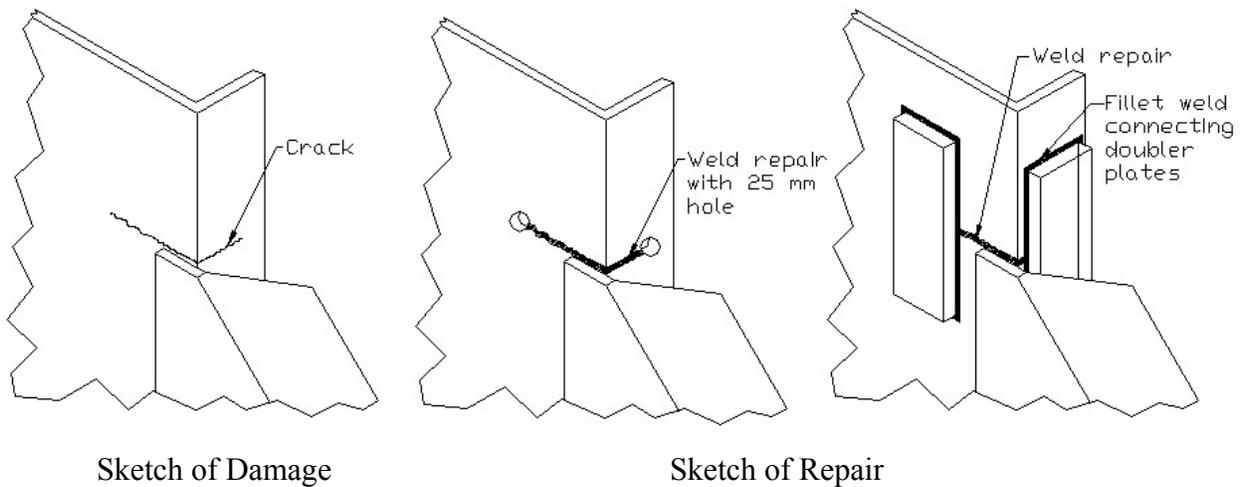
Figure 8: Crack and doubler plate repair at bracket detail

In addition to the weld repair, small doubler plates may be welded on to reinforce the structure and reduce the stress ranges locally (Figure 8). The terminations of these doublers will usually be a Category E detail, so this should give a residual life equal to the life of the original detail. This reinforcement may be useful when a detail has been repaired multiple times and the weld quality is very questionable. It will effectively move the critical location to a new location, the termination of the doubler, so future cracking will not take place at the old repair locations.

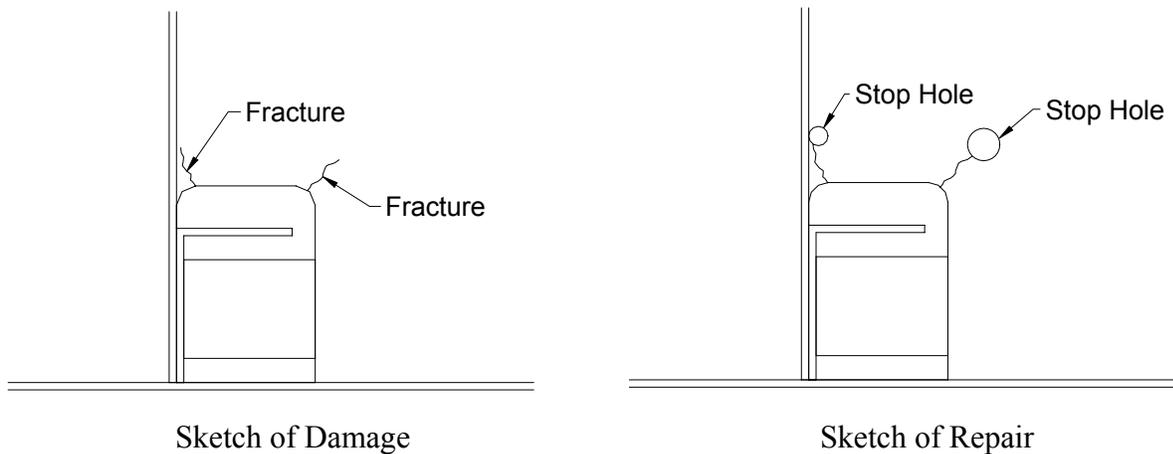
Most often, cracks occur in the web frame at the cutout where the longitudinal passes through (Figure 9). These cracks commonly initiate at the curved radii of the

Figure 9: Cracks and repairs in the web frame occurring at the cutout

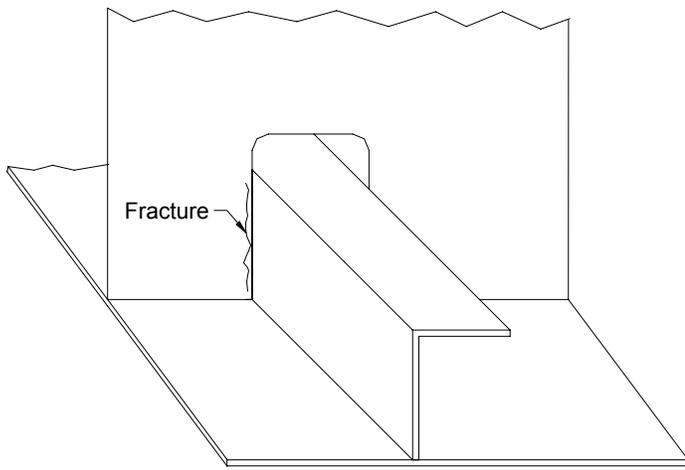
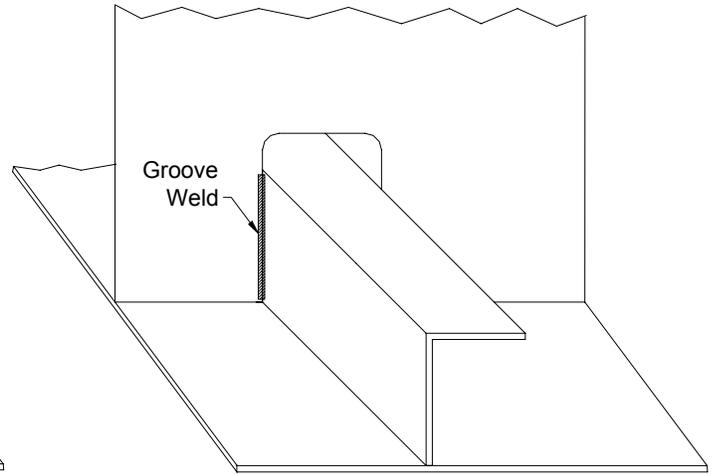
Figure 10: Crack and repair for failed weld connecting longitudinal to web frame

Cracks may also occur at the root of the weld connecting the long leg of the longitudinal stiffener to the webframe (Figure 10). These cracks are best repaired by arc-gouging and replacing the fillet weld with a groove weld. An additional fillet weld should be added on top of the groove weld for reinforcement. Once this is complete, the toes of the repair weld should be hammer peened. This repair will increase the fatigue strength to Category C, approximately four times the original life of the detail.

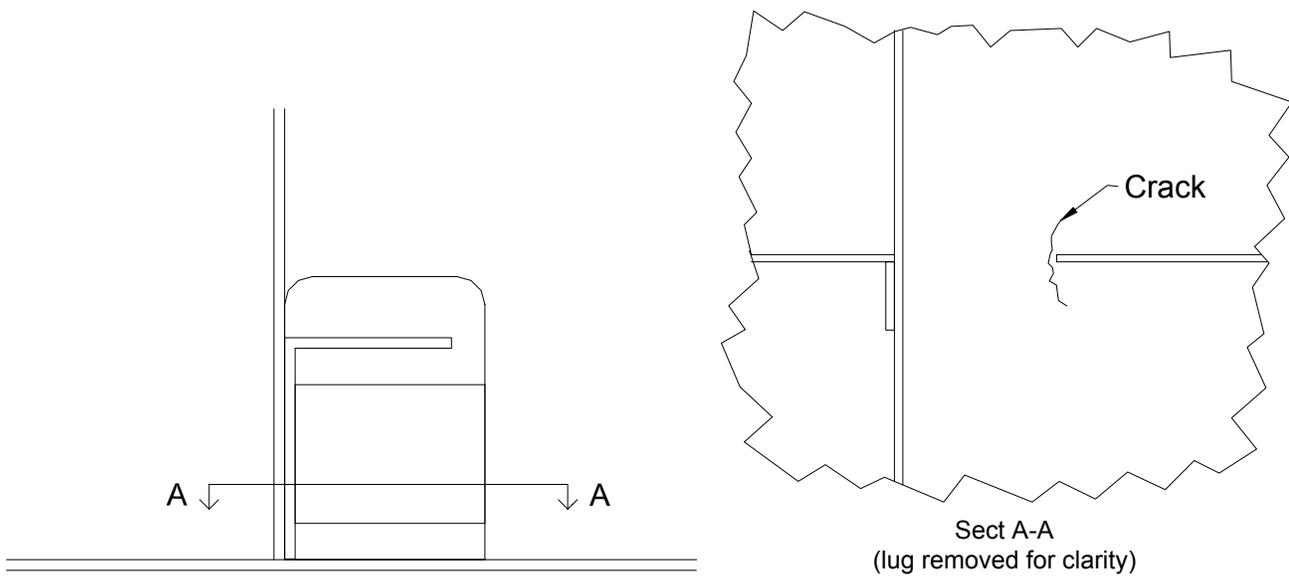
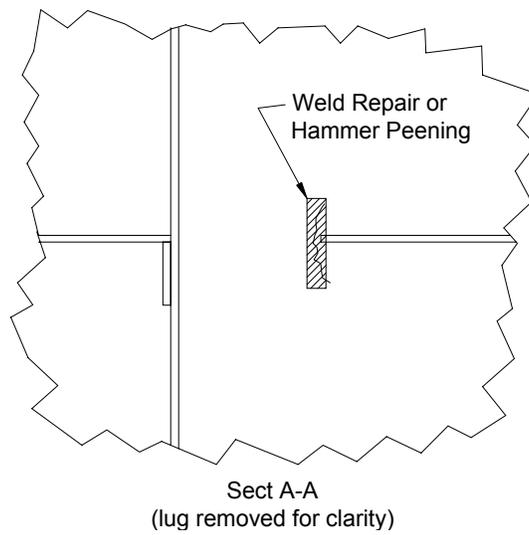
Figure 11: Crack and repair in sideshell at wrap-around weld at web frame cutout

Cracks occurring at the toe of the wrap-around weld at the web frame cutout (Figure 11) may be repaired by hammer peening if their depth is 3 mm or less. Surface cracks at this location will typically be less than 3 mm deep if they have a total length less than 12 mm. The crack length should be verified using dye penetrant testing (PT) or magnetic particle testing (MT). If there is sufficient concern about the depth of the crack, the depth can often be determined using the shear-wave ultrasonic-testing (UT) technique. Hammer peening should be applied all the way around the toe of this wrap-around weld and will create a Category C detail, making the repair life four times the life of the original detail. This repair should be reinspected regularly, however, to make sure that the initial crack was removed by the peening operation.

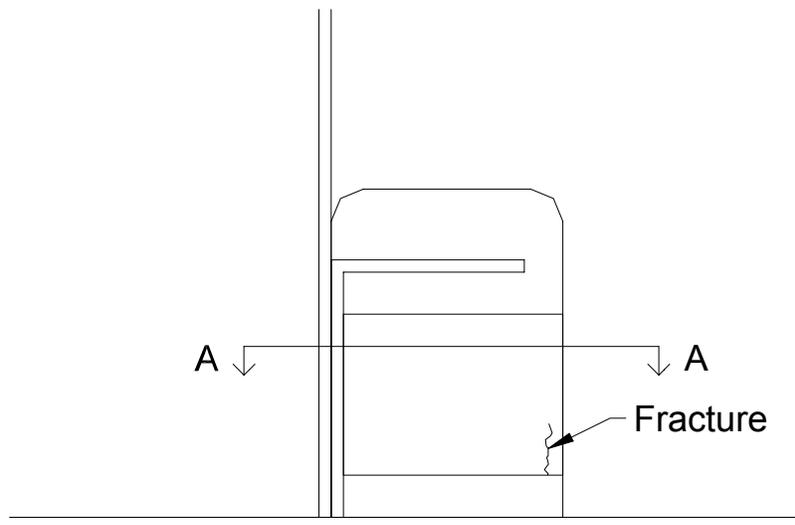
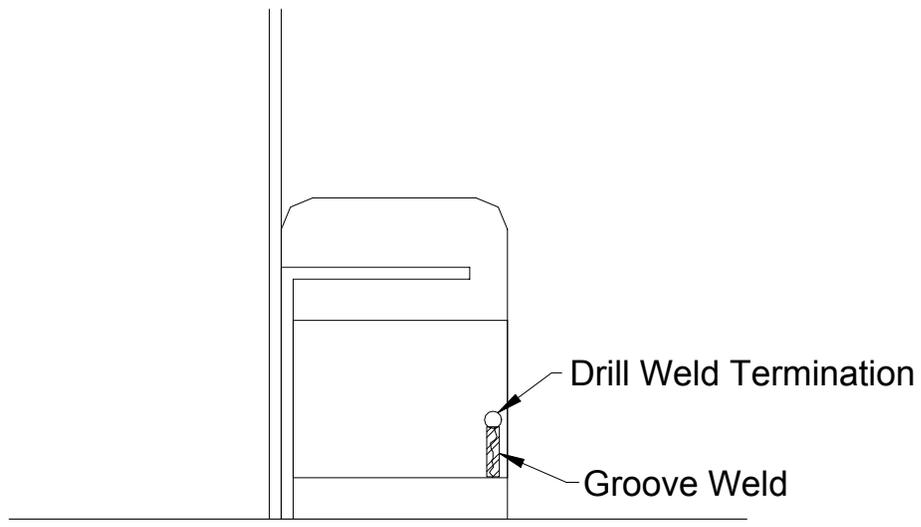
Figure 12: Crack and repair in lug plate

If this estimated residual life is not satisfactory, an additional lug plate of the same dimensions can be added to the opposite side of the web frame in addition to the weld repairs described above. This will improve the repair to Category E, the same as the original detail, but will cut the stress range in half, thus improving the life by a factor of eight.

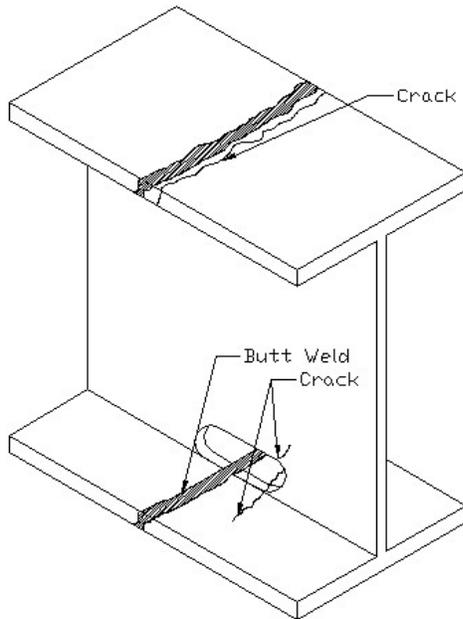
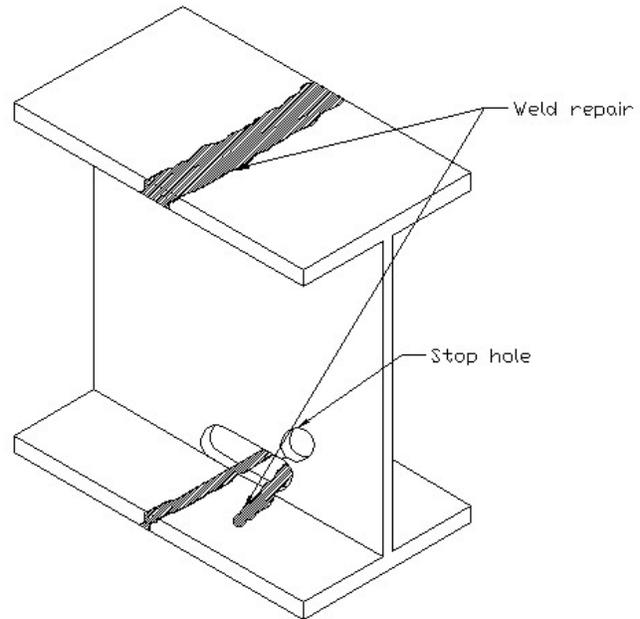
Repair Design Example #1

Cracks at butt welds and weld access holes in longitudinal stiffeners and girders.

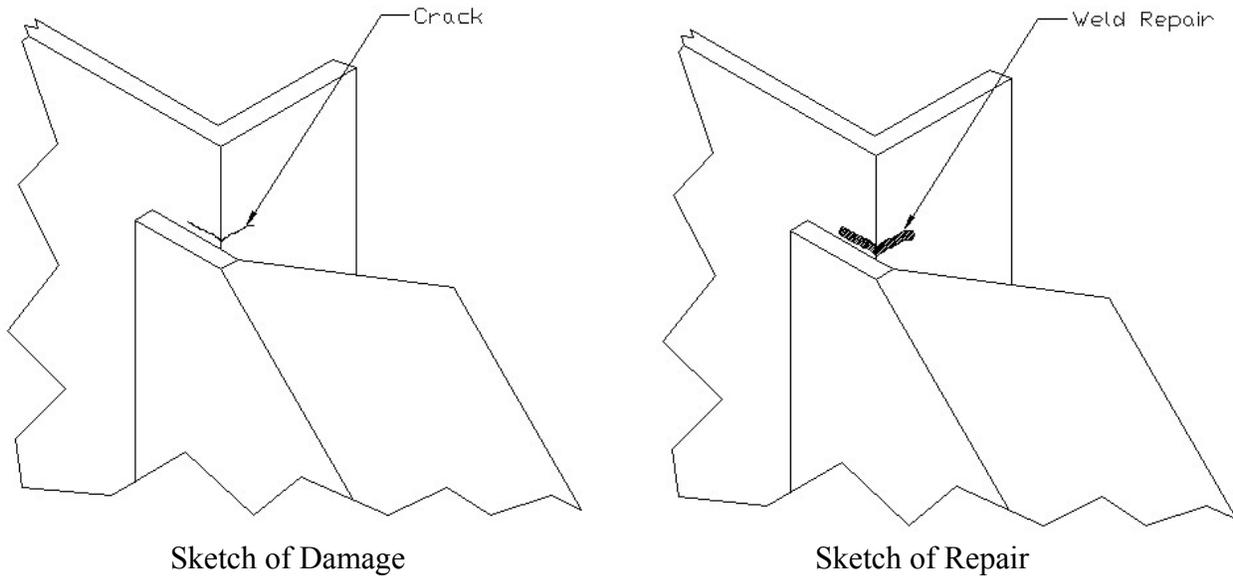
Repair Design Example #2

Cracks initiate from the weld toe at the end of a bracket and propagated into girders and web frames. They are repaired before they reach through thickness.

8. Locate crack tips using dye penetrant testing. Mark 6 mm past the crack tips using a permanent marker or paint stick.
9. Clean the area around the crack, especially at tips, removing as much corrosion product as possible.
10. Air-arc gouge out the entire crack using a 3 to 6 mm copper gouging rod and extending between the two marks from step 1.
11. Chip out slag and clean gouged area of debris.
12. Fill the vee-gouged area with stringer welds, using either the shielded metal arc welding (SMAW) or flux-core arc welding (FCAW) processes with a low hydrogen all position fill material.

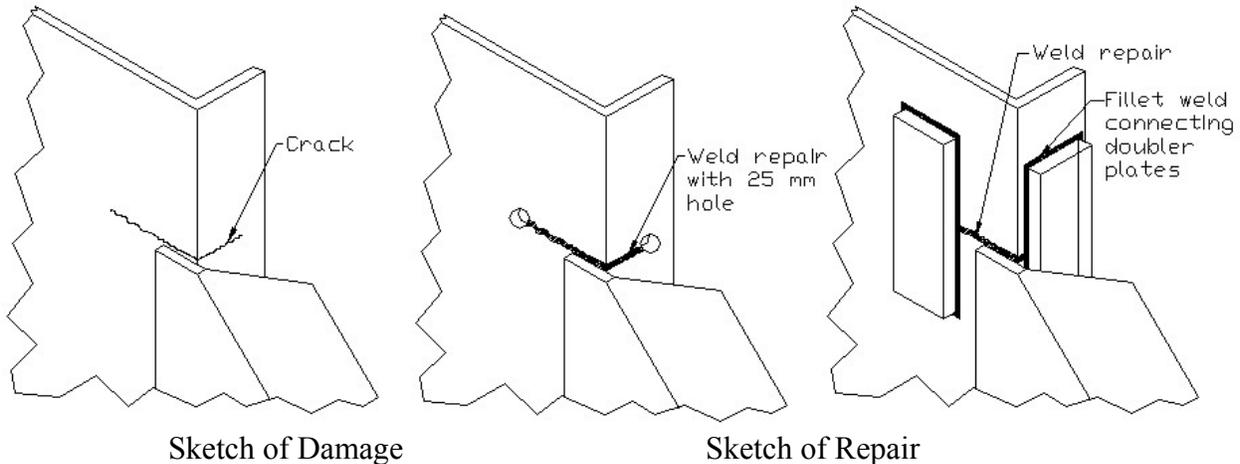
Repair Design Example #3

Cracks occur at the weld toe connecting a bracket to a girder or web frame. The crack has propagated to a through-thickness crack that extends away from the bracket into the girder or web frame.

1. Locate crack tips using dye penetrant testing. Mark about 6 mm past the crack tips using a steel punch.
2. Clean the area around the crack, especially at tips, removing as much corrosion product as possible.

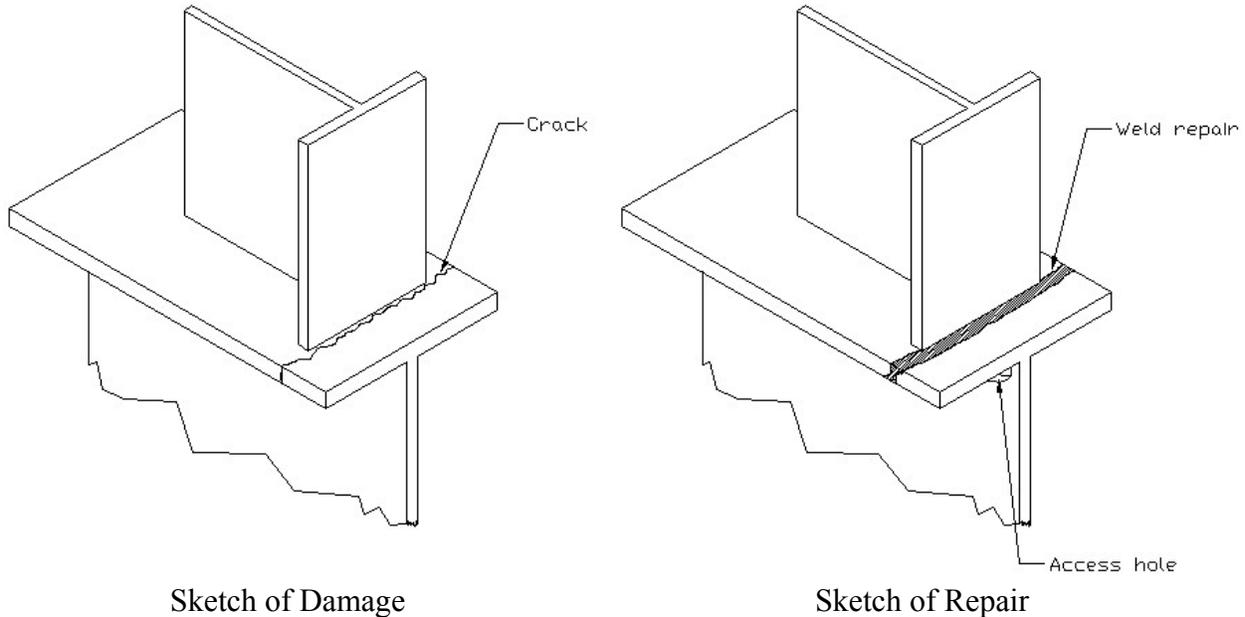
Repair Design Example #4

Cracks occur at the weld toe connecting an attachment to a girder or web frame. The crack has propagated to a through thickness crack that extends through the flange and into the web.

1. Locate crack tips using dye penetrant testing. Mark 6 mm past the crack tips using a permanent marker or paint stick.
2. Clean the area around the crack, especially at the tips, removing as much corrosion product as possible.

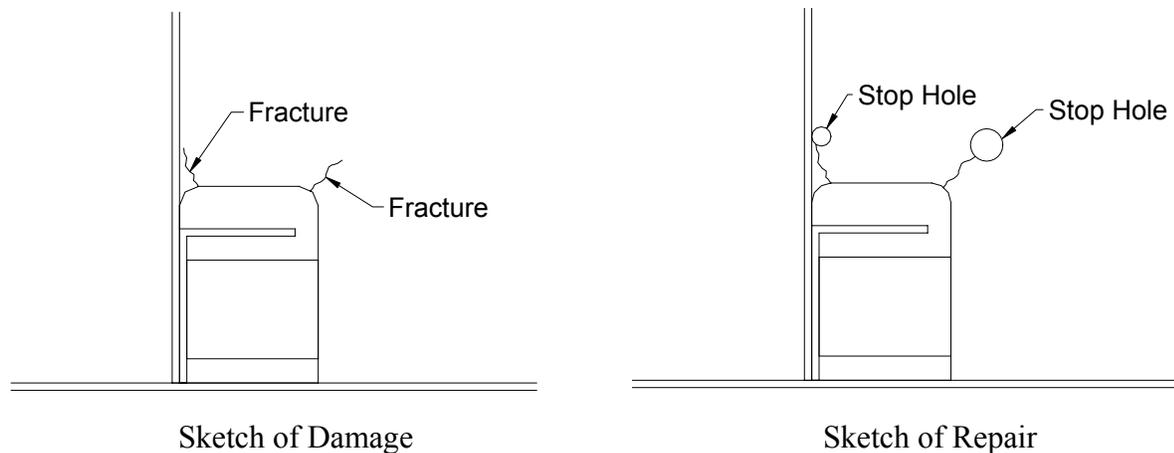
Repair Design Example #5

Fractures in way of a cutout for the passage of a longitudinal through a transverse primary member. These may occur at connections to the inner or outer bottom or side shells.

5. Locate crack tip using dye penetrant testing. Mark the crack tip using a steel punch.
6. Clean the area around the crack, especially at tip, removing as much corrosion product as possible.
7. Measure crack length and determine diameter of hole to drill using equation A-1.
8. Drill hole such that visible crack tip is located at the edge of the stop hole.

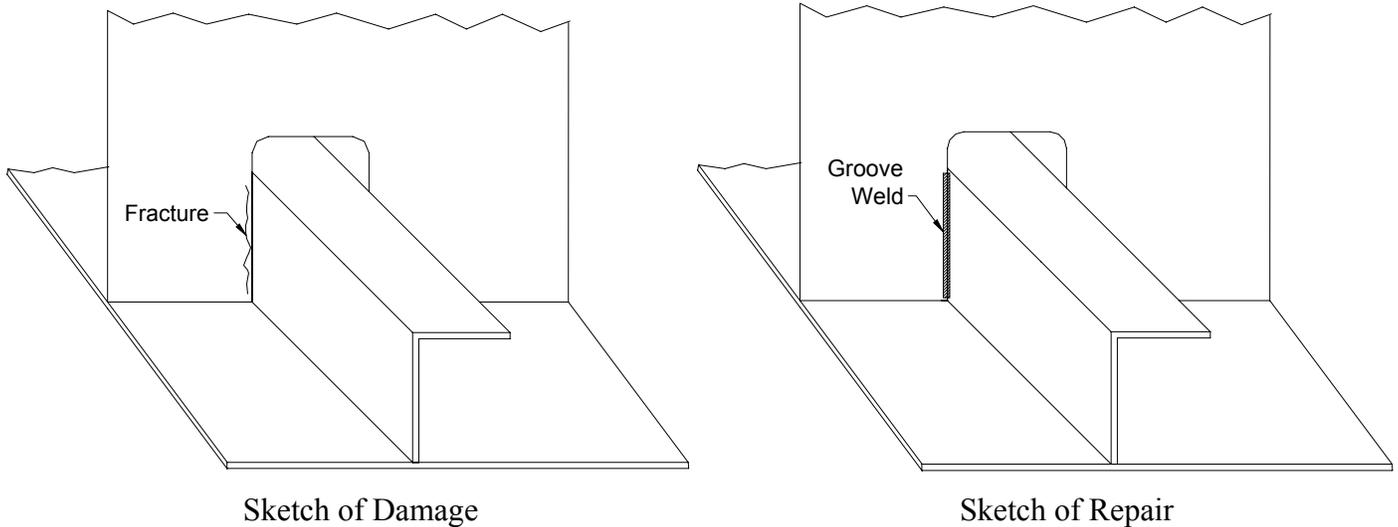
Repair Design Example #6

Fractures at the passage of a longitudinal through a transverse primary member. Fracture occurs at the root of the weld connecting the longitudinal to the transverse member. These may occur at connections to the inner or outer bottoms or side shells.

1. Locate entire length of crack using dye penetrant testing.
2. Clean the area around the crack removing as much corrosion product as possible.
3. Using an air arc-gouger, cut away the weld and base metal in the web frame along the entire length of the crack, and beyond each crack tip approximately 10 mm. Cut so that a vee-shaped edge preparation is achieved in the transverse member where it connects to the longitudinal. Clean out any slag with a chipping hammer.
4. Groove weld the transverse member to the longitudinal using SMAW or FCAW and low hydrogen, all-position fill material. Fill the edge preparation and add a few extra passes of fillet weld on top of the groove weld for reinforcement.
5. Hammer peen the toes of the repair weld in accordance with procedures given in 5.3.

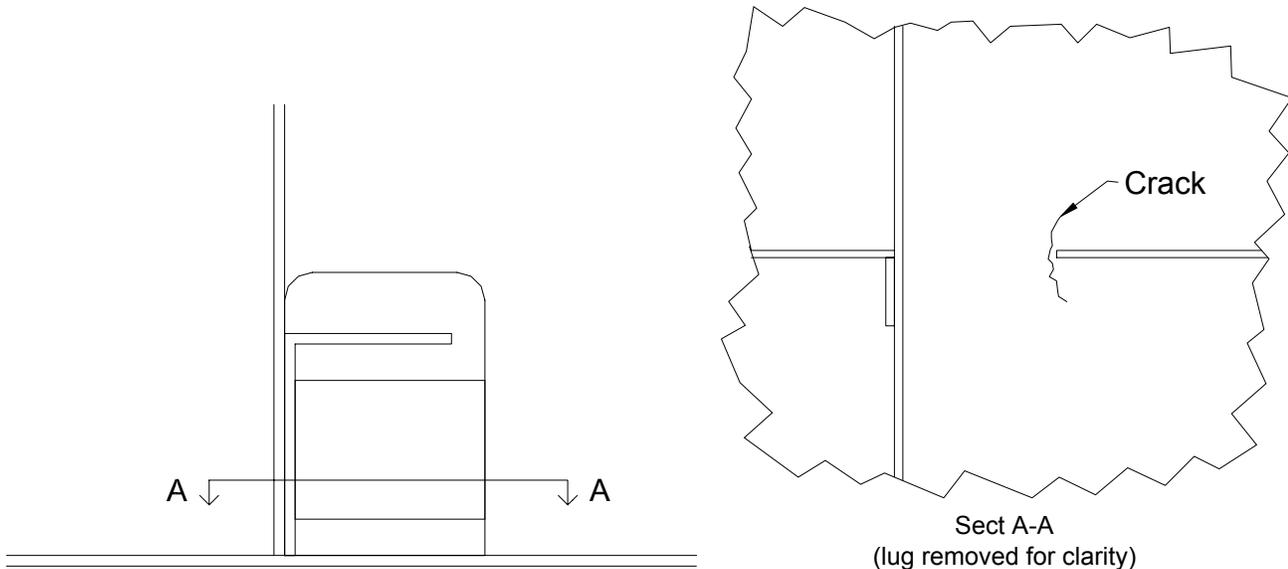
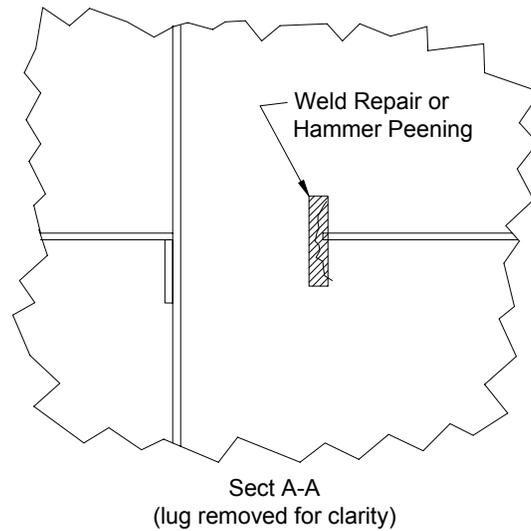
Repair Design Example #7

Fractures occurring in inner or outer bottom or sideshell at a cutout in a transverse web frame where a longitudinal passes through.

- b. Remove any slag with a chipping hammer.
 - c. Weld the gouged area using SMAW or FCAW with low hydrogen all position fill material. Use sufficient voltage to penetrate the last 10 percent of the plate thickness. Use enough passes to provide reinforcement above the plate surface.

- d. Hammer peen the toes of the repair weld using at least four passes.

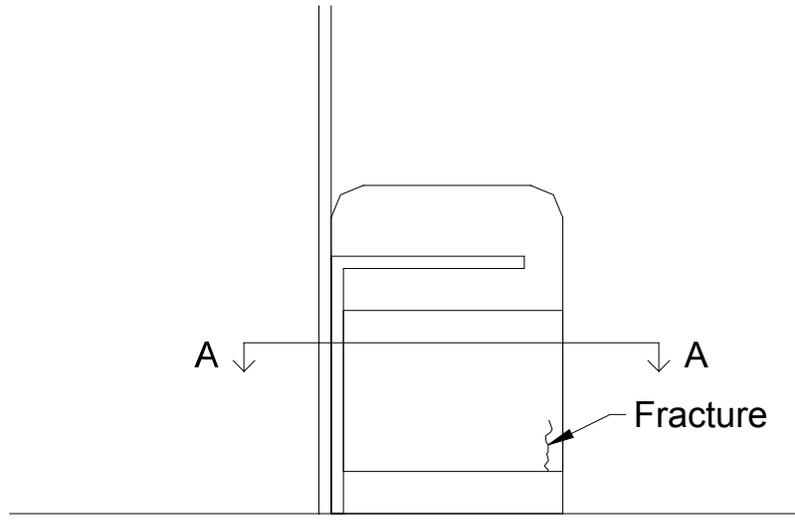
Repair Design Example #8

Fracture in a lug plate at the connection between transverse web frames and longitudinals.
