SSC-425

**FATIGUE STRENGTH AND
ADEQUACY OF WELD REPAIRS**

SHIP STRUCTURE COMMITTEE
2003

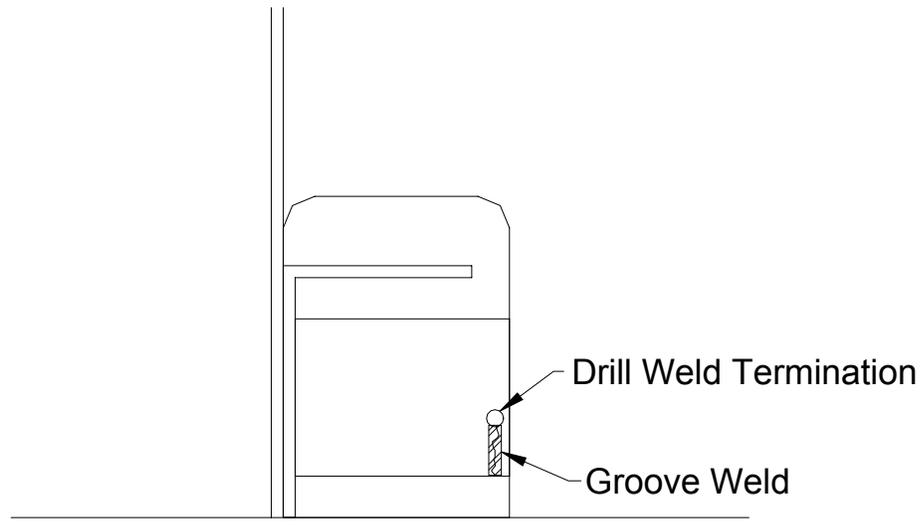
Sketch of Repair

Fracture in a lug plate at the connection between transverse web frames and longitudinals.

Repair 1:

1. Clean the area around the crack, removing as much corrosion product as possible.
2. Locate the entire crack length using dye penetrant testing.
3. Repair using a two-sided weld repair as follows:

- a. Air arc-gouge a vee-shaped groove along the length of the crack and approximately 10 mm beyond each crack tip. The depth of the vee-shaped groove should be approximately 75 percent of the plate thickness.

- d. Back-gouge a vee-shaped groove along the other side of the crack, penetrating deep enough to reach the first repair weld and completely remove the crack.

- e. Weld this second groove in the same manner.
 - f. Grind the weld termination area smooth and drill a 19 mm diameter hole to remove weld termination defects.

- g. Hammer peen the toes of the repair weld using at least four passes.
4. (Optional) The fatigue strength can be improved by modifying the detail and adding a second lug plate on the opposite side of the transverse web frame. This would cut the stress range at this location in half, thus giving an increase in life by a factor of eight compared to the original. The second lug should be fillet-welded to the web frame and groove welded to the longitudinal. (See below.)

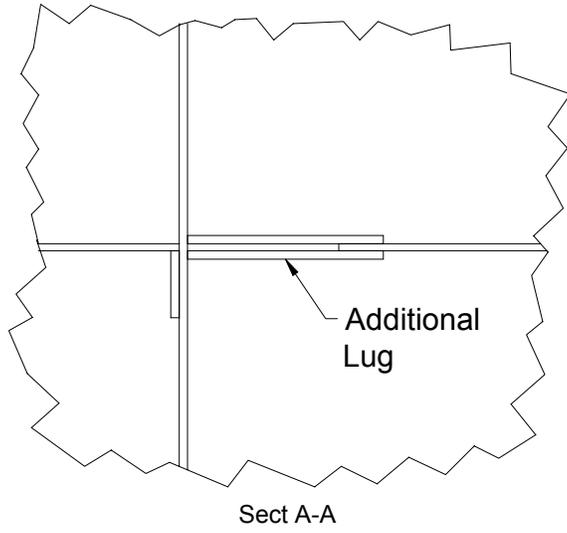
Sketch of Modified Detail

1. The original detail can be considered BS 7608 Category F2. The two-sided weld repair with hammer peening can be expected to be Category W. Adding a second lug restores the detail to Category F2, but cuts the stress range in half.
2. The ratio of the fatigue strength of the repaired to original detail is 0.57 for the weld repair alone. For the modified detail this ratio is 2.0.
3. The ratio of the remaining life of the repaired vs. original detail is $(0.57)^3 = 0.19$ for the weld repair plus hammer peening. This detail will likely need to be reinspected frequently if this repair strategy is used. If the detail is modified as described above, the ratio becomes $(2.0)^3 = 8.0$, and the repair can be considered permanent.
