## **Ship Structure Committee Case Study**

### **Double Hull Tank Barges: Two Fleets, Two Approaches to OPA90 Phase-Out**

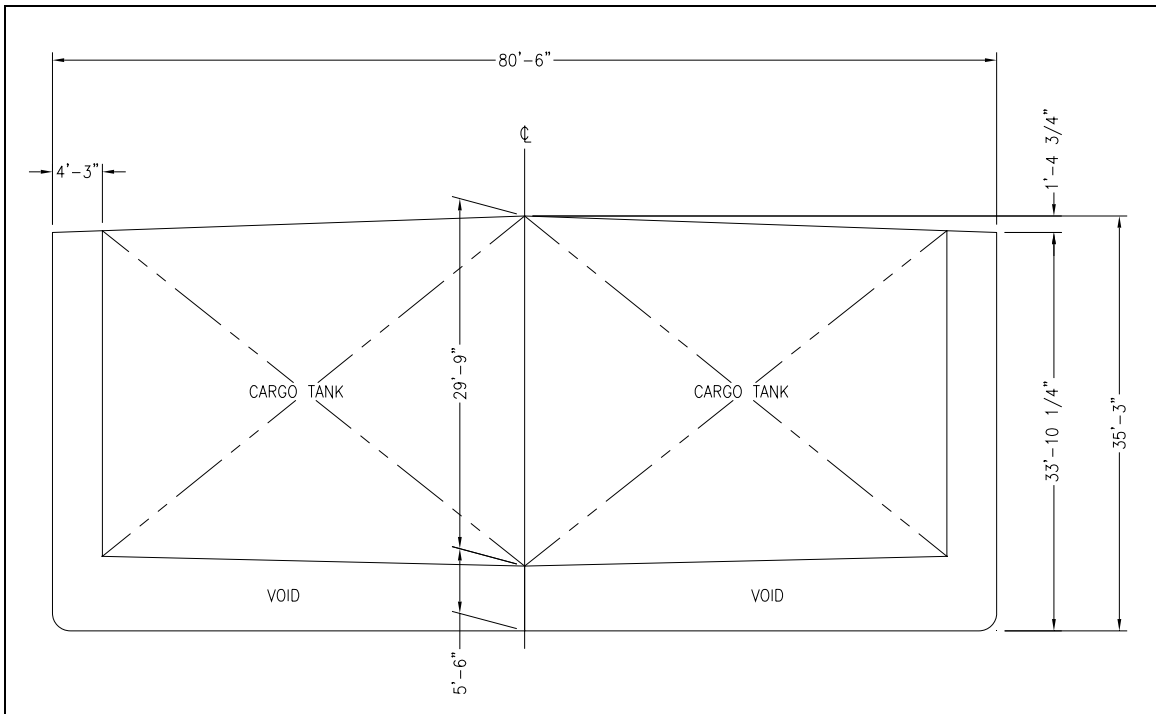
**Figure 1.** Midship Section – RTC-120 Double Hull

RTC’s double hull refit barges were engineered by Guarino and Cox and built at Bollinger Shipyards. The approach is simple – a double hull, in the form of ballast J-tanks, is fit around the existing vessel. The existing hull becomes the new inner bottom and wing bulkhead. This maintains the existing cargo capacity, arrangement, and piping. The beam and depth of the barge are increased accordingly. The vessel’s draft is less than the original because the additional steel weight is offset by the larger waterplane area.

The following table summarizes the modification to the RTC-120.

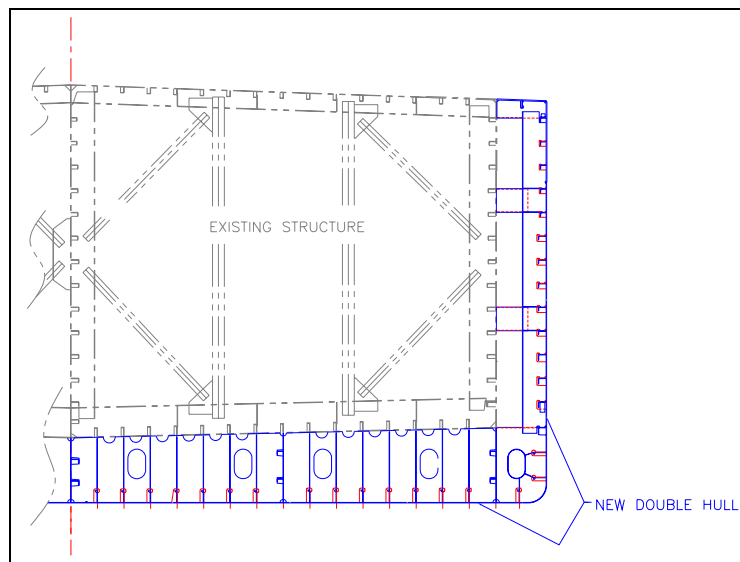
**Figure 2. Double Hull Structure – RTC-120**

Scantlings were designed based on ABS rule requirements for a new oil barge for ocean service as shown in Figure 2. Ultrasonic thickness testing was done on the existing vessel to ensure that the original steel was still sufficient.

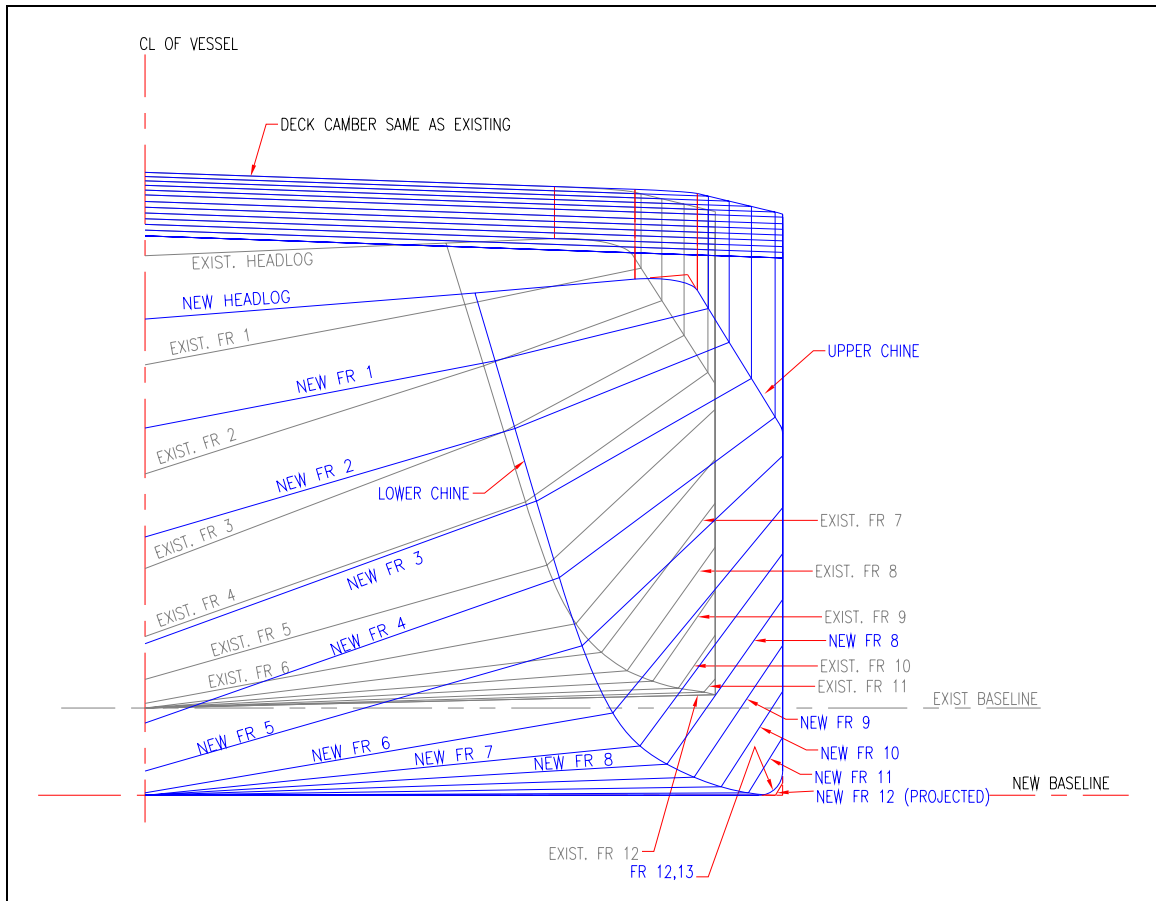
**Figure 3. Revised Bow Lines – RTC-120**

As shown in Figure 3, rather than attempting to fair in the new cargo block dimensions to the existing bow and stern, the new side and bottom were carried over the length of the barge. Although no special analysis was done to predict the impact of the modified lines on hull performance, RTC reports no adverse effects. The only modification necessary was an adjustment to the notch to account for the lower draft.

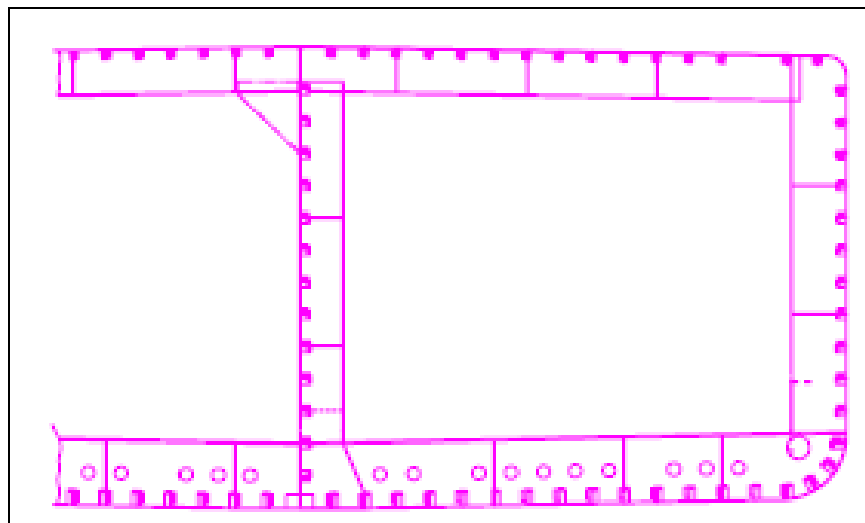
**Figure 4. Pre-Mod Midship Section – M-214**

Figure 4 shows a typical midship section for one of the two classes of Maritrans' single hull barges. These barges are built much like tankers with longitudinal stiffeners and heavy transverse frames. (Three of Maritrans' single hull barges were originally built similar to the smaller RTC barges with columns and diagonal beams providing some transverse stiffening. However, the rebuild process was similar for these barges.) Figure 5 shows the modified section. Existing structure is depicted in pink, while new structure is depicted in green.

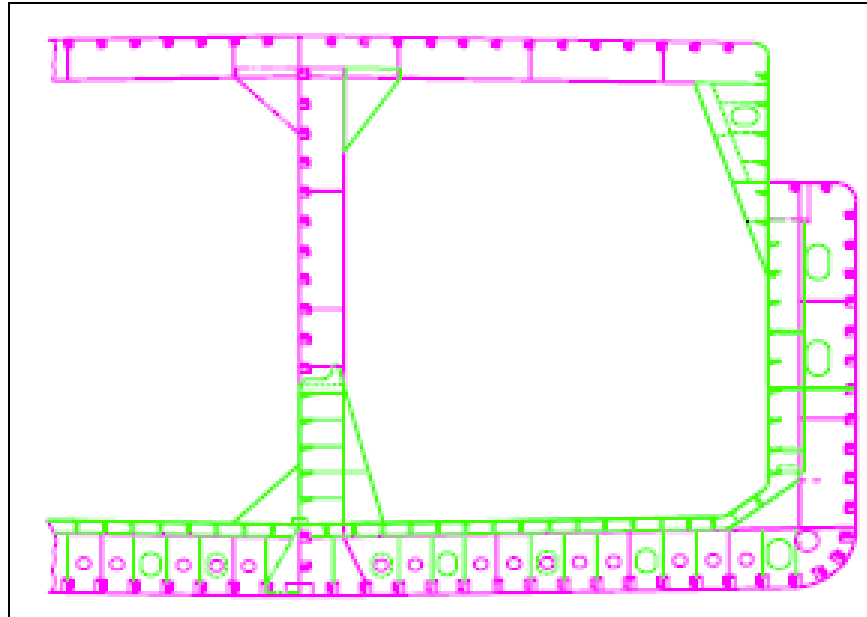
**Figure 5.** Post-Mod Midship Section – M-214

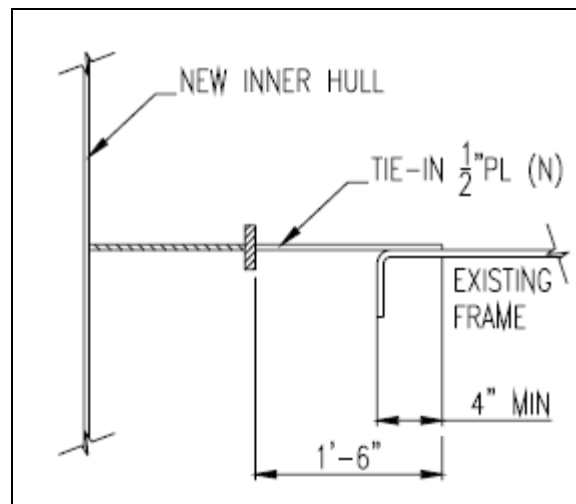
**Figure 6.** Inner Side Construction – M-214

The height of the existing transverse frame is not as high as required by OPA-90 for the double bottom of the barge (B/15), so filler plates are added to get the proper depth. The filler plates are fabricated to be two inches deeper than the new inner bottom longitudinal, creating a gap that leads to a simplified and innovative fit-up. In the ballast tank there is a similar filler plate structure, except that the existing frame is a flanged plate and the new structure laps on it. (See Figure 6.)

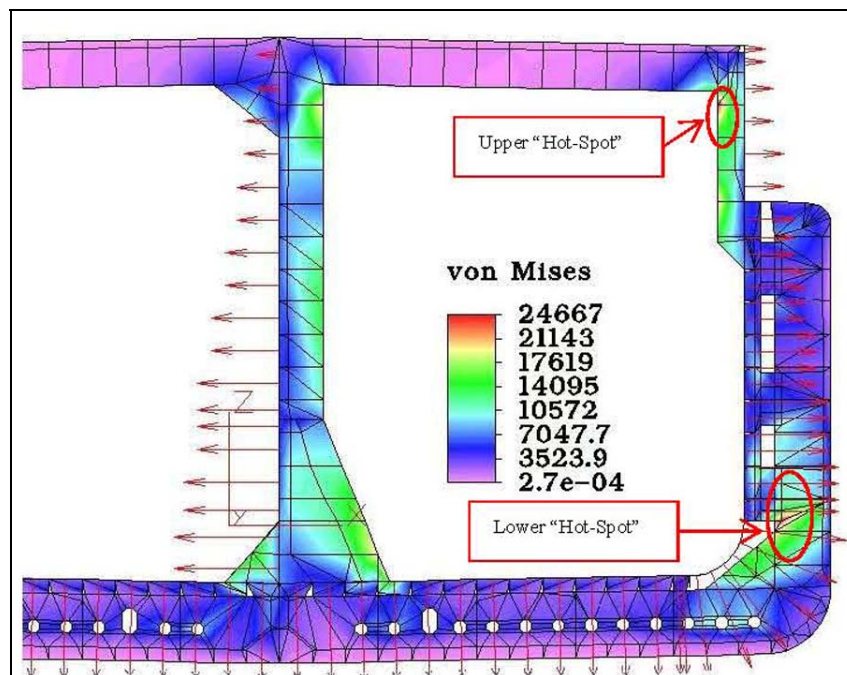
**Figure 7.** Areas for Elevated Stress

As displayed in Figure 7, the majority of the structure is below 20 ksi with only two "hotspots" above. The first "hot-spot" is located at the upper intersection of the bracket structure between the transverse bottom framing and the transverse side framing. The second "hot-spot" is located near the intersection of the upper trunk deck transverse framing and the vertical framing on the new longitudinal wing bulkhead. After further investigation and mesh refinement, it was decided that in the upper area, the levels of stress are reported inappropriately high due to model geometry.

The lower “hot-spot” occurs at a sharp corner and from what is known about the way the vessel deflects, this location is a prime area for high shear and bending moment-related stresses. In addition, the original design for this corner bracket was a bent flange toe-ing to one side. FEA showed that this asymmetrical section was causing out of plane bending. In order to mitigate this, flat bars pictured in Figure 8 have been added to balance the flanges and create a symmetrical section.

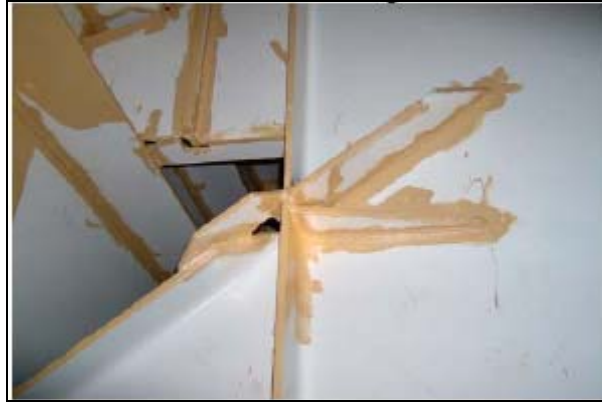
**Figure 8.** Structural Reinforcement – Bilge Bracket

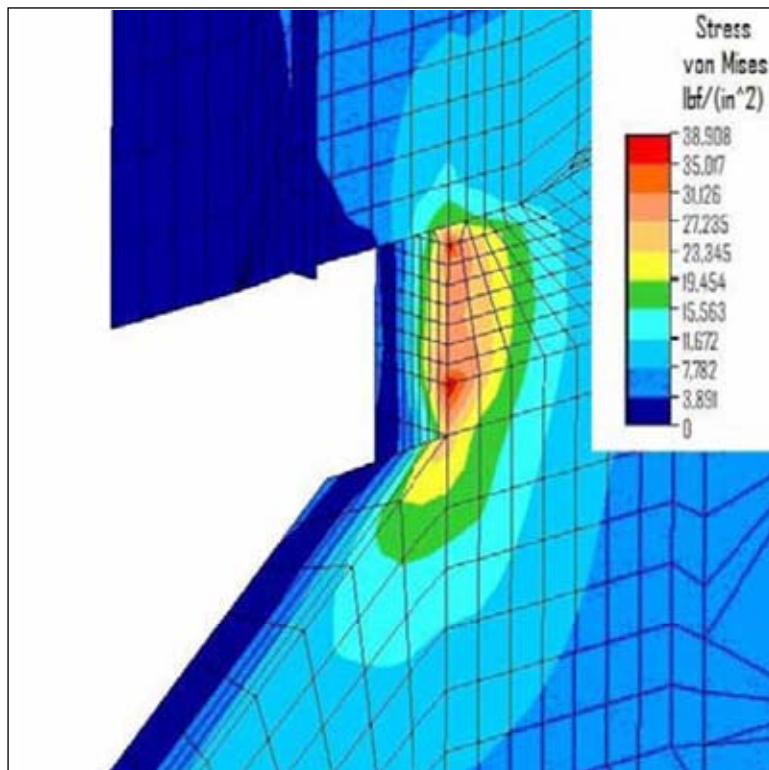
**Figure 9.** Detail of As-Designed Bracket

Figures 9 and 10 compare the FEA results of the as-designed bracket and the reinforced bracket.

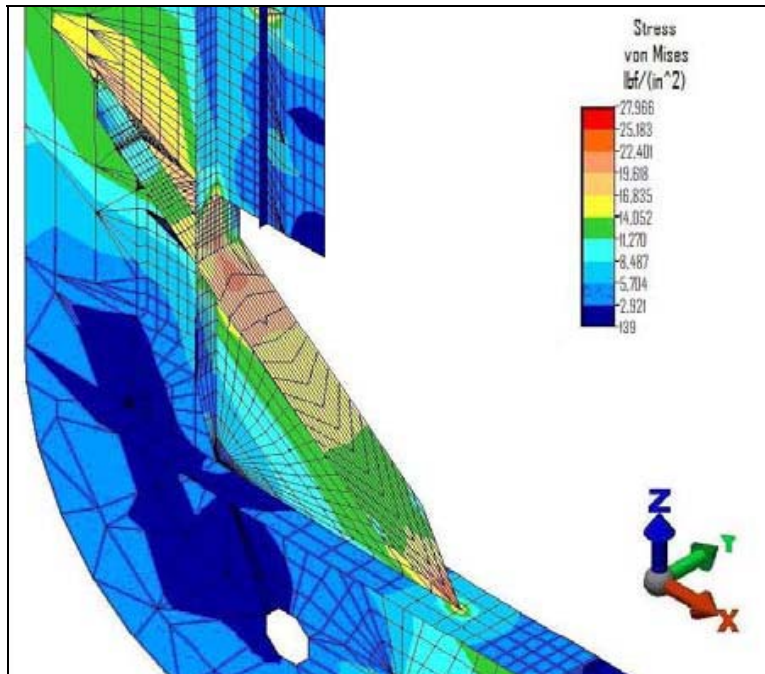
**Figure 10.** Stress Results of Reinforced Bracket
